# Arboricultural Impact Assessment Report

Kingscliff Mixed Use Development – 4-8 Bells Boulevard, Kingscliff

State Significant Development Application no. SSD-83069459

Date: 26 June 2026

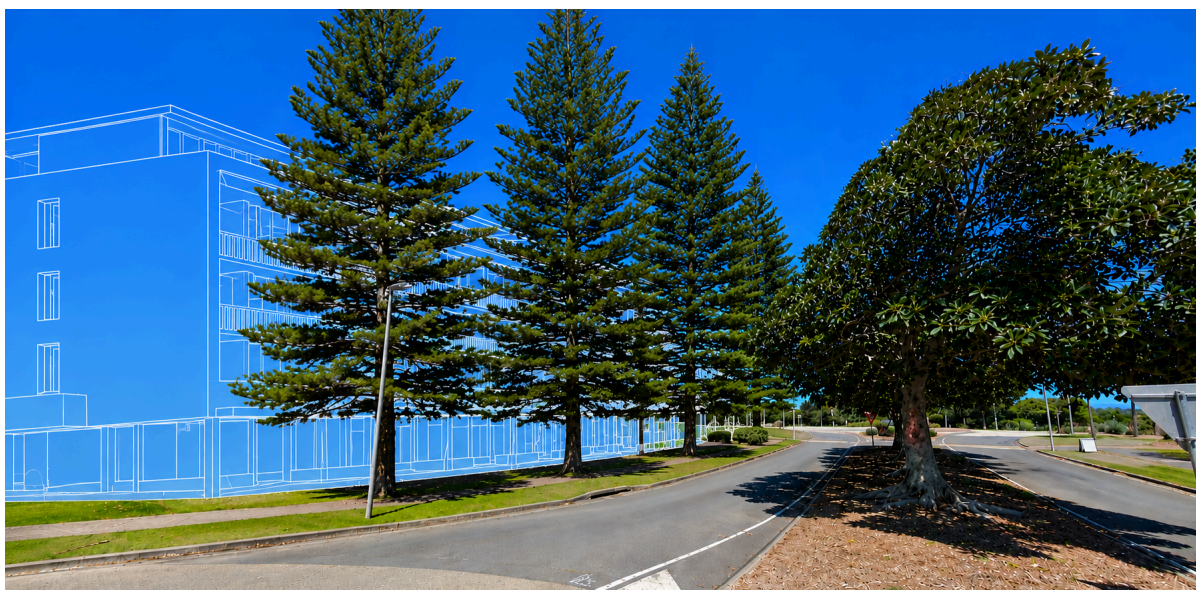
- Furthermore, the **mature size of Norfolk Island Pines**—which can easily exceed 30 meters in height—is fundamentally incompatible with the restricted space of this narrow street easement and the footprint of the new high-rise.

Plate 1: Projected size of mature Norfolk Island Pine Trees in relation to the proposed built form.

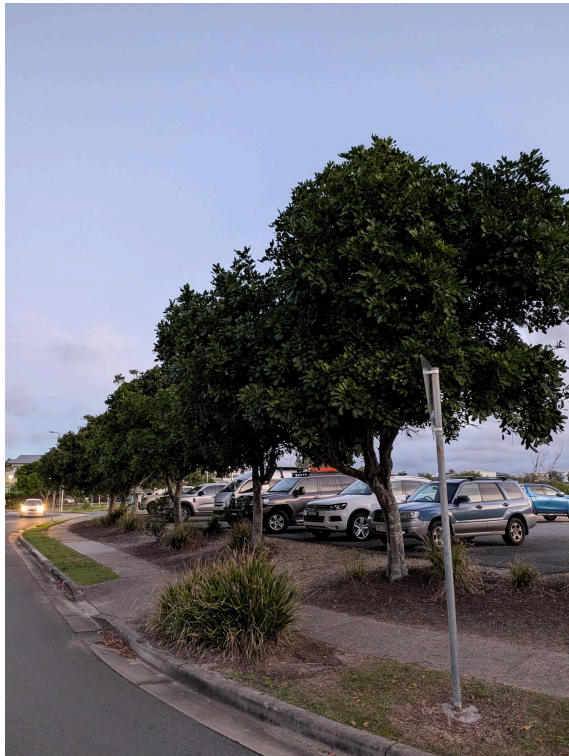
Plate 2: Linear planted Tuckeroo (*Cupaniopsis anacardioides*) T12-17

In all cases, the proposed impacts are deemed unmitigable to a level that would ensure safe, vigorous, and sustainable tree retention, necessitating removal to prevent the creation of compromised and high-risk long-term landscape assets.

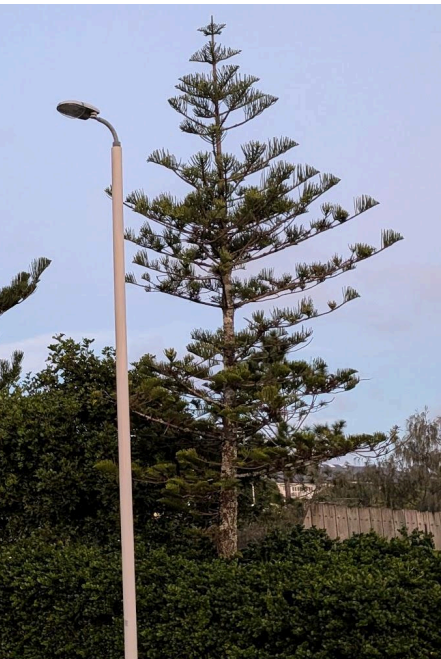
| Tree Number & Identification | DBH (cm)<br>DARB (cm) | Age Class | NRZ (m)<br>SRZ (m) | Recommendations <sup>20</sup><br>Nature of any AS4970 NRZ encroachment | Plates |
|---|---|---|---|---|---|
| T1<br>Norfolk island pine<br><i>Araucaria heterophylla</i><br>Native endemic forest species | 29<br>31<br>10<br>5 | Semi-mature<br>Fair<br>Good | 3.4<br>2<br>2 | REMOVE TREE<br><br>A total encroachment of 36% within the NRZ from 16% for the built basement floor area and 20% for the 1.5m disturbance buffer.<br><br>Balanced crown | |

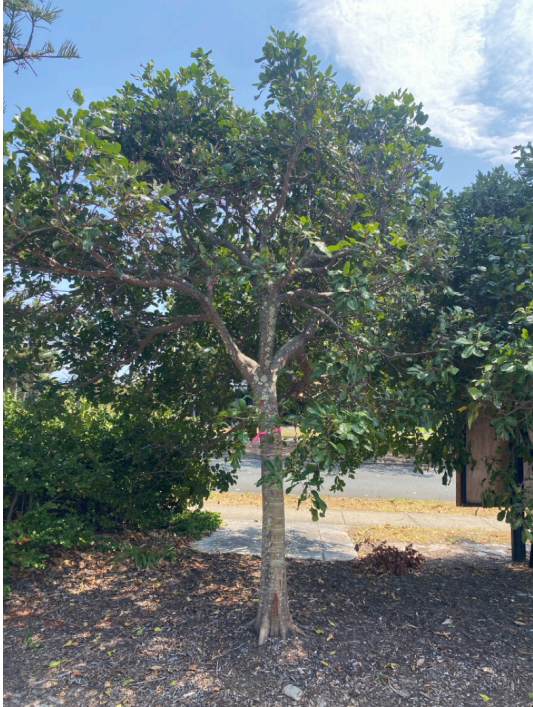
| Tree Number & Identification<br>Species<br>Characteristics | DBH (cm)<br>DARB (cm)<br>Height & Spread (m) | Age Class<br>Health<br>Condition | NRZ (m)<br>SRZ (m)<br>Encroachment to Tree <sup>19</sup> (m) | Recommendations <sup>20</sup><br>Nature of any AS4970 NRZ encroachment<br>Health & Condition Observations and Comments | Plates |
|---|---|---|---|---|---|
| T2<br>Tuckeroo<br><i>Cupaniopsis anacardioides</i><br>Native endemic forest species | 16<br>25<br>3<br>3 | Semi-mature<br>Good<br>Fair | 2<br>1.8<br>0 | REMOVE TREE<br><br>A total encroachment of 70% within the NRZ from basement levels, aboveground form and awning/construction 1.5m buffer off facade.<br><br>Balanced crown, minor surface wounds on lower trunk/buttreass roots. Multi-stemmed at 1.8m. | |

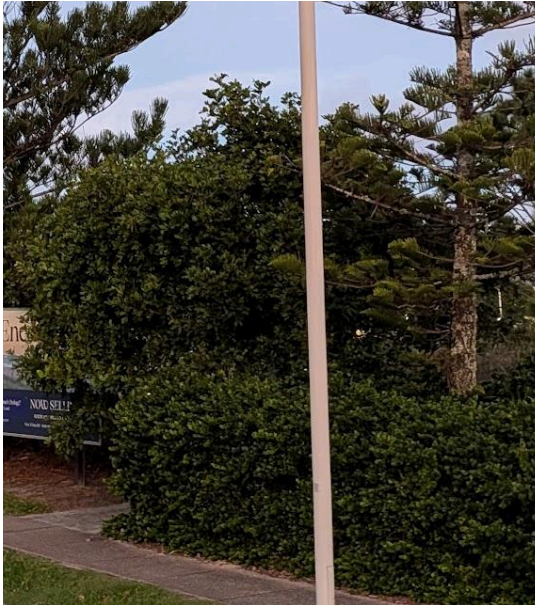
| Tree Number & Identification<br>Species<br>Characteristics | DBH (cm)<br>DARB (cm)<br>Height & Spread (m) | Age Class<br>Health<br>Condition | NRZ (m)<br>SRZ (m)<br>Encroachment to Tree <sup>19</sup> (m) | Recommendations <sup>20</sup><br>Nature of any AS4970 NRZ encroachment<br>Health & Condition Observations and Comments | Plates |
|---|---|---|---|---|---|
| T3<br>Tuckeroo<br><i>Cupaniopsis anacardioides</i><br>Native endemic forest species | 12<br>16<br>13<br>2.5 | Semi-mature<br>Fair<br>Good | 2<br>1.5<br>0 | REMOVE TREE<br><br>A total encroachment of 73.6% within the NRZ from basement levels, aboveground form and awning/construction 1.5m buffer off facade.<br><br>Balanced/symmetrical crown, Exposed surface structural roots in SRZ. | |

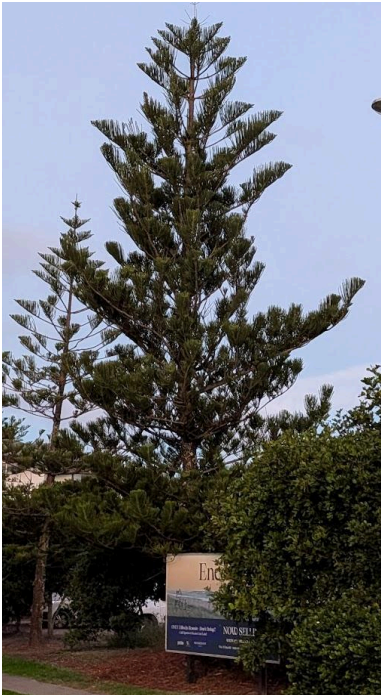
| Tree Number & Identification<br>Species<br>Characteristics | DBH (cm)<br>DARB (cm)<br>Height & Spread (m) | Age Class<br>Health<br>Condition | NRZ (m)<br>SRZ (m)<br>Encroachment to Tree <sup>19</sup> (m) | Recommendations <sup>20</sup><br>Nature of any AS4970 NRZ encroachment<br>Health & Condition Observations and Comments | Plates |
|---|---|---|---|---|---|
| T4<br>Norfolk island pine<br><i>Araucaria heterophylla</i><br>Native endemic forest species | 41<br>49<br>8<br>5 | Semi-mature<br>Good<br>Good | 4<br>2.4<br>0.8 | REMOVE TREE<br><br>A total encroachment of 37% within the NRZ from basement levels and significant canopy pruning requirements from aboveground form and awning/construction 1.5m buffer off facade.<br>Balanced symmetrical crown | |

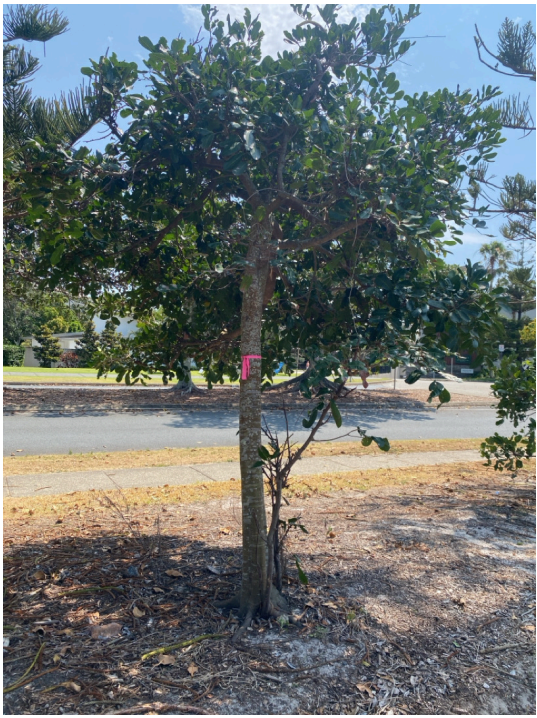
| Tree Number & Identification<br>Species<br>Characteristics | DBH (cm)<br>DARB (cm)<br>Height & Spread (m) | Age Class<br>Health<br>Condition | NRZ (m)<br>SRZ (m)<br>Encroachment to Tree <sup>19</sup> (m) | Recommendations <sup>20</sup><br>Nature of any AS4970 NRZ encroachment<br>Health & Condition Observations and Comments | Plates |
|---|---|---|---|---|---|
| T5<br>Tuckeroo<br><i>Cupaniopsis anacardioides</i><br>Native endemic forest species | 11<br>16<br>3<br>1.9 | Juvenile<br><br>Fair<br>Fair | 2<br><br>1.5<br>0 | REMOVE TREE<br><br>A total encroachment of 62.4% within the NRZ from basement levels, aboveground form and awning/construction 1.5m buffer off facade.<br><br>Balanced crown, minor surface wounds on lower trunk/buttress roots. | |

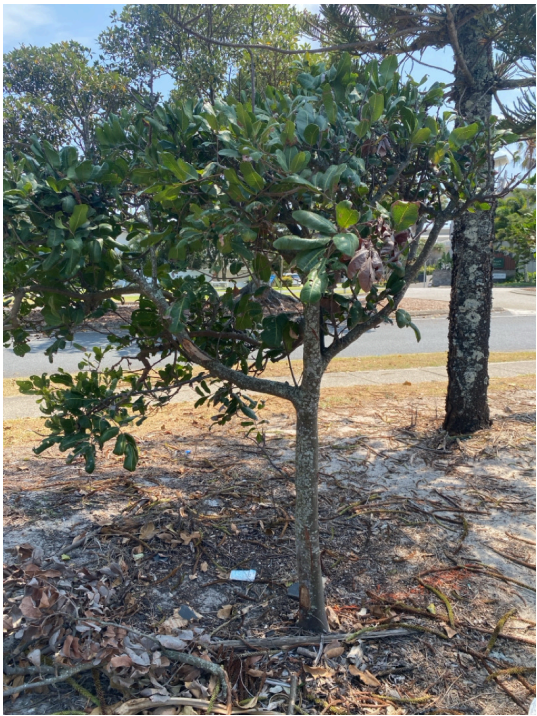
| Tree Number & Identification<br>Species<br>Characteristics | DBH (cm)<br>DARB (cm)<br>Height & Spread (m) | Age Class<br>Health<br>Condition | NRZ (m)<br>SRZ (m)<br>Encroachment to Tree <sup>19</sup> (m) | Recommendations <sup>20</sup><br>Nature of any AS4970 NRZ encroachment<br>Health & Condition Observations and Comments | Plates |
|---|---|---|---|---|---|
| T6<br>Tuckeroo<br><i>Cupaniopsis anacardioides</i><br>Native endemic forest species | 25<br>35<br>2<br>1.5 | Semi-mature<br>Fair<br>Fair | 2<br>1.5<br>0 | REMOVE TREE<br><br>A total encroachment of 68% within the NRZ from basement levels, aboveground form and awning/construction 1.5m buffer off facade.<br>North East; spreading; minor light reaching, minor surface wounds on lower trunk/buttreass roots.<br>Multi-stemmed at 1.8m. | |

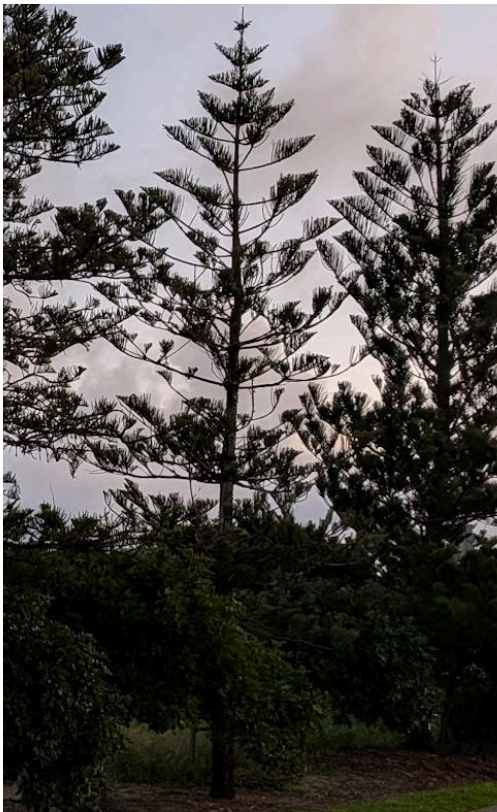
| Tree Number & Identification<br>Species<br>Characteristics | DBH (cm)<br>DARB (cm)<br>Height & Spread (m) | Age Class<br>Health<br>Condition | NRZ (m)<br>SRZ (m)<br>Encroachment to Tree <sup>19</sup> (m) | Recommendations <sup>20</sup><br>Nature of any AS4970 NRZ encroachment<br>Health & Condition Observations and Comments | Plates |
|---|---|---|---|---|---|
| T7<br>Norfolk island pine<br><i>Araucaria heterophylla</i><br>Native endemic forest species | 29<br>35<br>7<br>5 | Semi-mature<br>Fair<br>Fair | 3.4<br>2.1<br>1 | <p>REMOVE TREE</p> <p>A total encroachment of 29.7% within the NRZ from basement levels and significant canopy pruning requirements from aboveground form and awning/construction 1.5m buffer off facade.</p> <p>Balanced crown, Moderate crown foliage density, Moderately low Live Crown Ratio (LCR).</p> | |

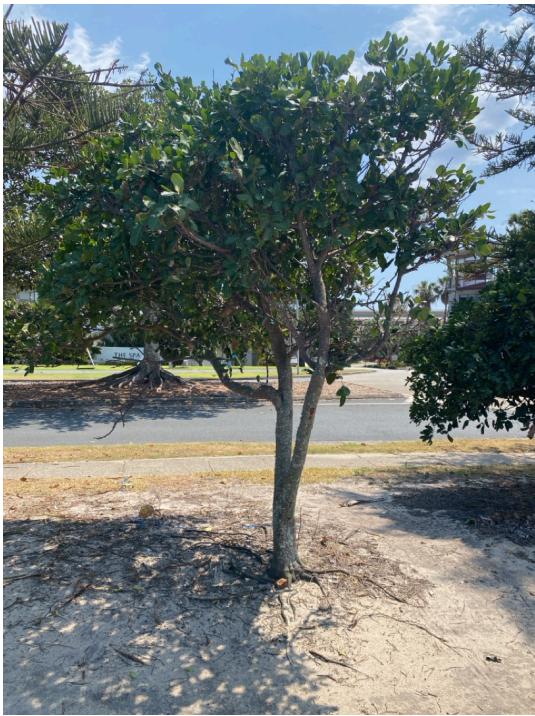
| Tree Number & Identification<br>Species<br>Characteristics | DBH (cm)<br>DARB (cm)<br>Height & Spread (m) | Age Class<br>Health<br>Condition | NRZ (m)<br>SRZ (m)<br>Encroachment to Tree <sup>19</sup> (m) | Recommendations <sup>20</sup><br>Nature of any AS4970 NRZ encroachment<br>Health & Condition Observations and Comments | Plates |
|---|---|---|---|---|---|
| T8<br>Tuckeroo<br><i>Cupaniopsis anacardioides</i><br>Native endemic forest species | 13<br>17<br>3<br>3 | Semi-mature<br>Good<br>Fair | 2<br>1.6<br>0 | REMOVE TREE<br><br>A total encroachment of 62.4% within the NRZ from basement levels, aboveground form and awning/construction 1.5m buffer off facade.<br>Balanced crown, minor surface wounds on lower trunk/buttreass roots. Co-dominant stem at 0.4m.<br>Exposed surface structural roots in SRZ | |

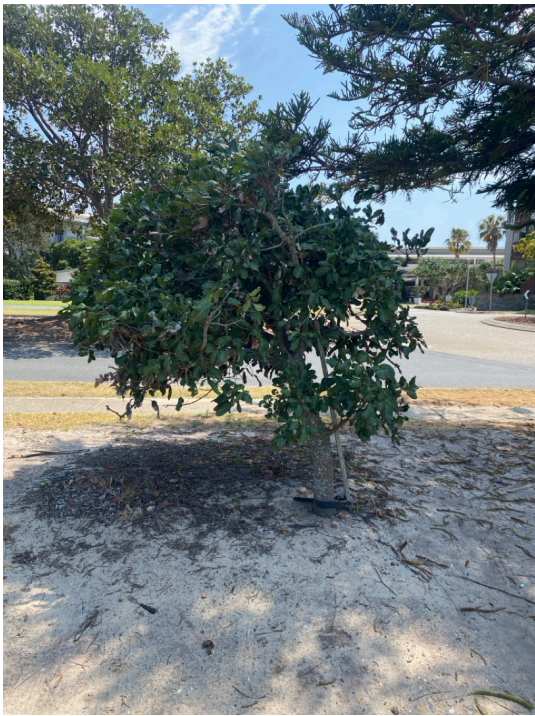
| Tree Number & Identification<br>Species<br>Characteristics | DBH (cm)<br>DARB (cm)<br>Height & Spread (m) | Age Class<br>Health<br>Condition | NRZ (m)<br>SRZ (m)<br>Encroachment to Tree <sup>19</sup> (m) | Recommendations <sup>20</sup><br>Nature of any AS4970 NRZ encroachment<br>Health & Condition Observations and Comments | Plates |
|---|---|---|---|---|---|
| T9<br>Tuckeroo<br><i>Cupaniopsis anacardioides</i><br>Native endemic forest species | 17<br>14<br>2.5<br>2.5 | Semi-mature<br><br>Fair<br>Fair | 2.1<br>1.5<br>0 | REMOVE TREE<br><br>A total encroachment of 67.9% within the NRZ from basement levels, aboveground form and awning/construction 1.5m buffer off facade.<br><br>Balanced crown, minor surface wounds on lower trunk/buttress roots. Multi-stemmed at 1.8m. | |

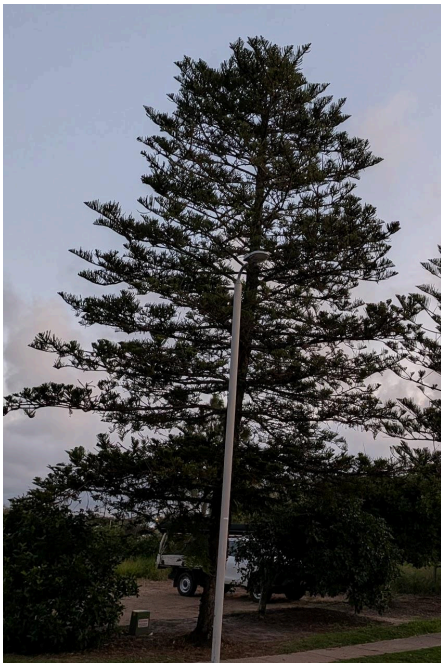
| Tree Number & Identification<br>Species<br>Characteristics | DBH (cm)<br>DARB (cm)<br>Height & Spread (m) | Age Class<br>Health<br>Condition | NRZ (m)<br>SRZ (m)<br>Encroachment to Tree <sup>19</sup> (m) | Recommendations <sup>20</sup><br>Nature of any AS4970 NRZ encroachment<br>Health & Condition Observations and Comments | Plates |
|---|---|---|---|---|---|
| T10<br>Norfolk island pine<br><i>Araucaria heterophylla</i><br>Native endemic forest species | 39<br>45<br>9<br>7 | Semi-mature<br>Fair<br>Fair | 4.6<br>2.3<br>1.1 | REMOVE TREE<br><br>A total encroachment of 28.5% within the NRZ from basement levels and significant canopy pruning requirements from aboveground form and awning/construction 1.5m buffer off facade.<br><br>Balanced crown, Moderate crown foliage density, Moderately low Live Crown Ratio (LCR). | |

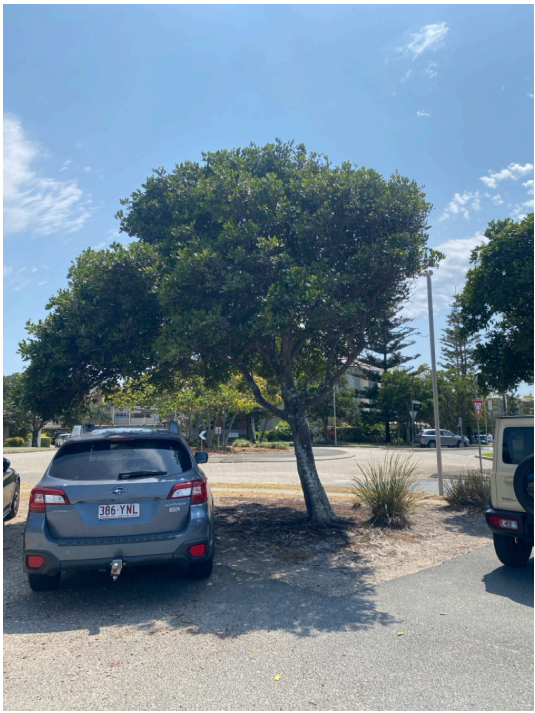
| Tree Number & Identification<br>Species<br>Characteristics | DBH (cm)<br>DARB (cm)<br>Height & Spread (m) | Age Class<br>Health<br>Condition | NRZ (m)<br>SRZ (m)<br>Encroachment to Tree <sup>19</sup> (m) | Recommendations <sup>20</sup><br>Nature of any AS4970 NRZ encroachment<br>Health & Condition Observations and Comments | Plates |
|---|---|---|---|---|---|
| T11<br>Tuckeroo<br><i>Cupaniopsis anacardioides</i><br>Native endemic forest species | 31<br>38<br>6<br>5 | Semi-mature<br>Good<br>Fair | 3.8<br>12.2<br>0 | REMOVE TREE<br><br>A total encroachment of 98.3% within the NRZ from basement levels, aboveground form and awning/construction 1.5m buffer off facade.<br><br>Unbalanced crown, minor trunk lean to the NW.<br><br>Multi-stemmed at 1.4m. | |

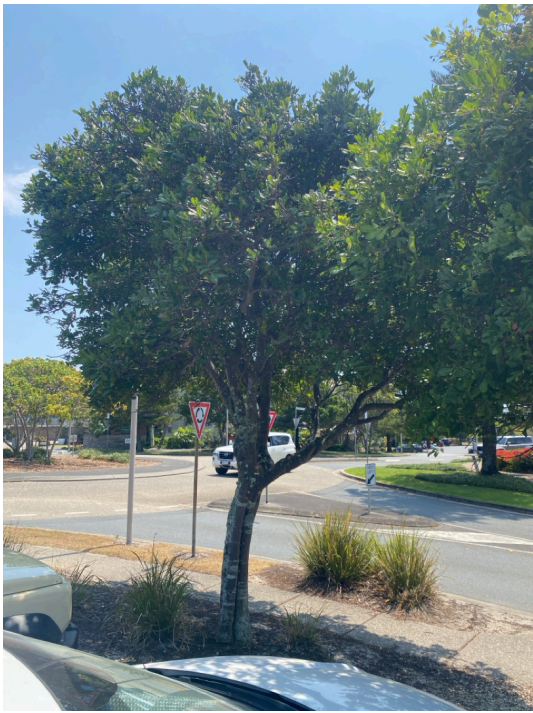
| Tree Number & Identification<br>Species<br>Characteristics | DBH (cm)<br>DARB (cm)<br>Height & Spread (m) | Age Class<br>Health<br>Condition | NRZ (m)<br>SRZ (m)<br>Encroachment to Tree <sup>19</sup> (m) | Recommendations <sup>20</sup><br>Nature of any AS4970 NRZ encroachment<br>Health & Condition Observations and Comments | Plates |
|---|---|---|---|---|---|
| T12<br>Tuckeroo<br><i>Cupaniopsis anacardioides</i><br>Native endemic forest species | 31<br>36<br>5<br>6 | Semi-mature<br>Good<br>Fair | 3.8<br>2.1<br>0 | REMOVE TREE<br><br>A total encroachment of 85.5% within the NRZ from basement levels, aboveground form and awning/construction 1.5m buffer off facade.<br><br>Balanced crown. Multi-stemmed at 1m. | |

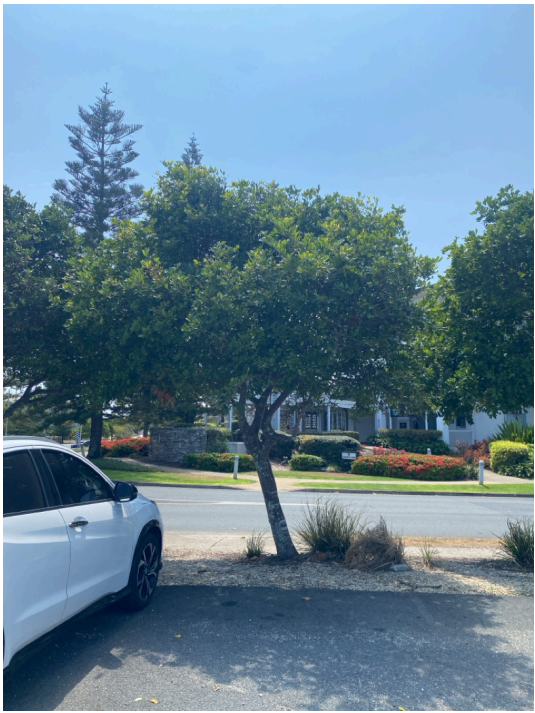
| Tree Number & Identification<br>Species<br>Characteristics | DBH (cm)<br>DARB (cm)<br>Height & Spread (m) | Age Class<br>Health<br>Condition | NRZ (m)<br>SRZ (m)<br>Encroachment to Tree <sup>19</sup> (m) | Recommendations <sup>20</sup><br>Nature of any AS4970 NRZ encroachment<br>Health & Condition Observations and Comments | Plates |
|---|---|---|---|---|---|
| T13<br>Tuckeroo<br><i>Cupaniopsis anacardioides</i><br>Native endemic forest species | 21<br>28<br>5<br>5 | Semi-mature<br>Good<br>Fair | 2.6<br>1.9<br>0 | REMOVE TREE<br><br>A total encroachment of 100% within the NRZ from basement levels, aboveground form and awning/construction 1.5m buffer off facade.<br><br>Balanced crown, minor trunk lean to the NW.<br>Multi-stemmed at 1.4m. | |

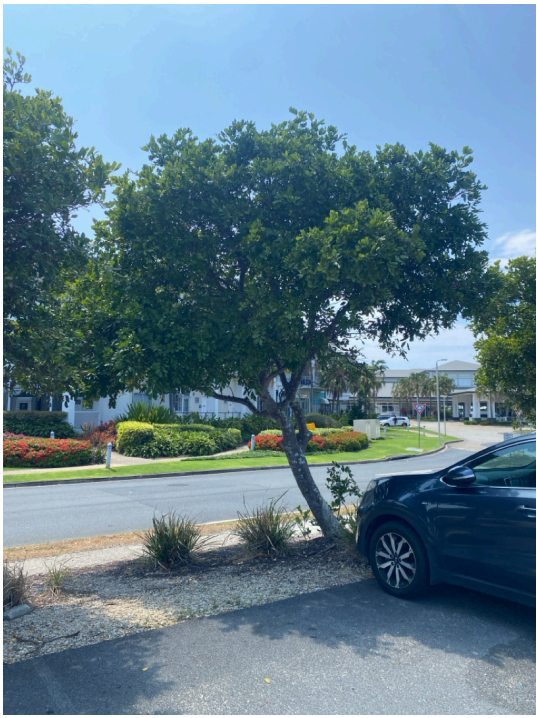
| Tree Number & Identification<br>Species<br>Characteristics | DBH (cm)<br>DARB (cm)<br>Height & Spread (m) | Age Class<br>Health<br>Condition | NRZ (m)<br>SRZ (m)<br>Encroachment to Tree <sup>19</sup> (m) | Recommendations <sup>20</sup><br>Nature of any AS4970 NRZ encroachment<br>Health & Condition Observations and Comments | Plates |
|---|---|---|---|---|---|
| T14<br>Tuckeroo<br><i>Cupaniopsis anacardioides</i><br>Native endemic forest species | 26<br>30<br>6<br>5 | Semi-mature<br>Good<br>Fair | 3.1<br>2<br>0 | REMOVE TREE<br><br>A total encroachment of 87% within the NRZ from basement levels, aboveground form and awning/construction 1.5m buffer off facade.<br>Balanced crown, moderate trunk lean to NW, corrected, minor surface wounds on lower trunk/buttress roots.<br>Multi-stemmed at 1.5m. | |

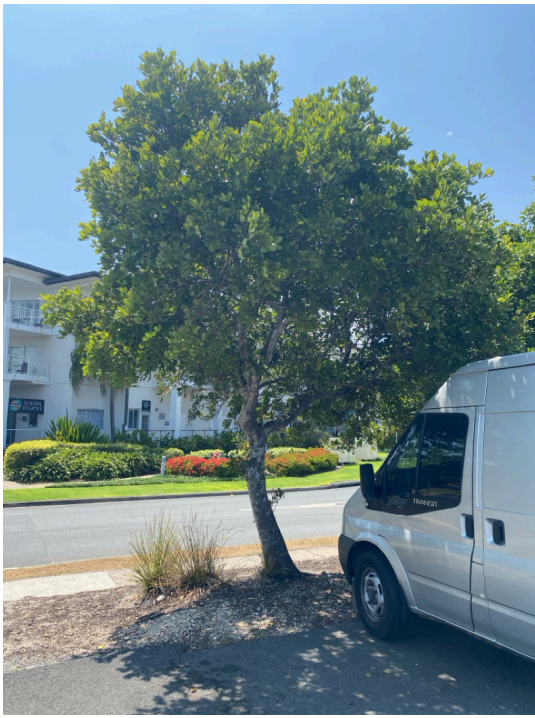
| Tree Number & Identification<br>Species<br>Characteristics | DBH (cm)<br>DARB (cm)<br>Height & Spread (m) | Age Class<br>Health<br>Condition | NRZ (m)<br>SRZ (m)<br>Encroachment to Tree <sup>19</sup> (m) | Recommendations <sup>20</sup><br>Nature of any AS4970 NRZ encroachment<br>Health & Condition Observations and Comments | Plates |
|---|---|---|---|---|---|
| T15<br>Tuckeroo<br><i>Cupaniopsis anacardioides</i><br>Native endemic forest species | 20<br>31<br>6<br>4.5 | Semi-mature<br>Good<br>Fair | 2.4<br>2<br>0 | REMOVE TREE<br><br>A total encroachment of 86% within the NRZ from basement levels, aboveground form and awning/construction 1.5m buffer off facade.<br><br>Balanced crown, minor stem lean corrected, surface wounds on lower trunk/buttreass roots. Multi-stemmed at 1.3m. | |

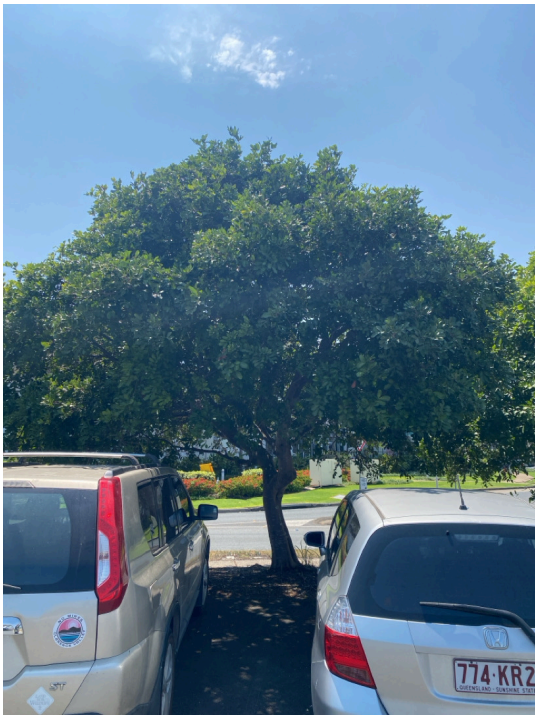
| Tree Number & Identification<br>Species<br>Characteristics | DBH (cm)<br>DARB (cm)<br>Height & Spread (m) | Age Class<br>Health<br>Condition | NRZ (m)<br>SRZ (m)<br>Encroachment to Tree <sup>19</sup> (m) | Recommendations <sup>20</sup><br>Nature of any AS4970 NRZ encroachment<br>Health & Condition Observations and Comments | Plates |
|---|---|---|---|---|---|
| T16<br>Tuckeroo<br><i>Cupaniopsis anacardioides</i><br>Native endemic forest species | 34<br>39<br>6<br>7 | Semi-mature<br>Good<br>Fair | 4.1<br>2.2<br>0 | REMOVE TREE<br><br>A total encroachment of 57.5% within the NRZ from basement levels, aboveground form and awning/construction 1.5m buffer off facade.<br><br>Balanced crown, Multi-stemmed at 1.4m. | |

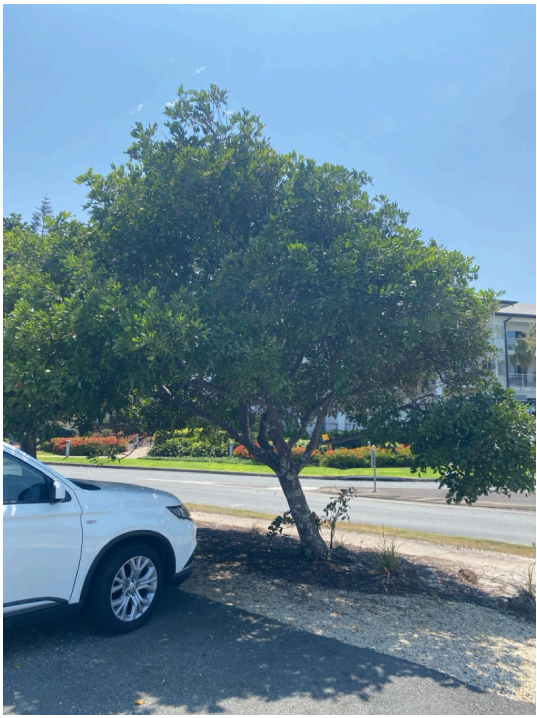
| Tree Number & Identification<br>Species<br>Characteristics | DBH (cm)<br>DARB (cm)<br>Height & Spread (m) | Age Class<br>Health<br>Condition | NRZ (m)<br>SRZ (m)<br>Encroachment to Tree <sup>19</sup> (m) | Recommendations <sup>20</sup><br>Nature of any AS4970 NRZ encroachment<br>Health & Condition Observations and Comments | Plates |
|---|---|---|---|---|---|
| T17<br>Tuckeroo<br><i>Cupaniopsis anacardioides</i><br>Native endemic forest species | 25<br>33<br>6<br>7 | Semi-mature<br>Good<br>Fair | 3<br>2<br>0 | REMOVE TREE<br><br>A total encroachment of 60% within the NRZ from basement levels<br><br>Balanced crown, moderate trunk lean to the NW, exposed surface roots and surface wounds on lower trunk/buttreass roots. Multi-stemmed at 1.2m. | |
