# **PAVEMENT ASSESSMENT REPORT**

## **COLLECTOR RD – BETWEEN FEDERAL HWY AND BARINA QUARRY**

### **COLLECTOR FOR COLLECTOR RESOURCES**

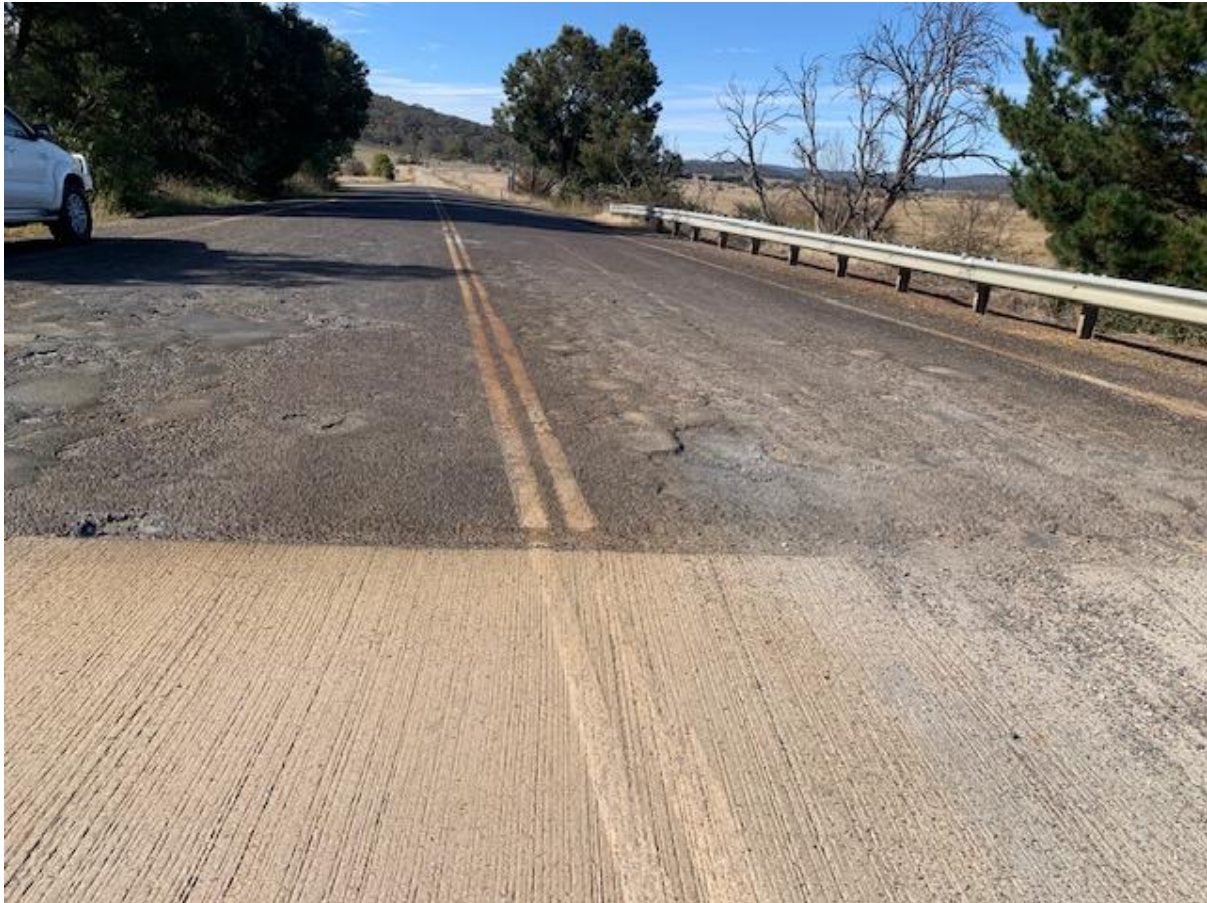
The first failed area is at chainage 0m, just off the Highway.

This failure is mainly due to shear forces, braking and turning from heavy vehicles. There is no deformation and the base seems to have been stabilised, as there was refusal during DCP testing. There is an existing 20mm seal.

For the first area, remove the existing seal and cold mix, assess the existing base to assess whether new material needs to be added after tyning, regrade and compact, then reseal. A high stress seal should be designed for this area.

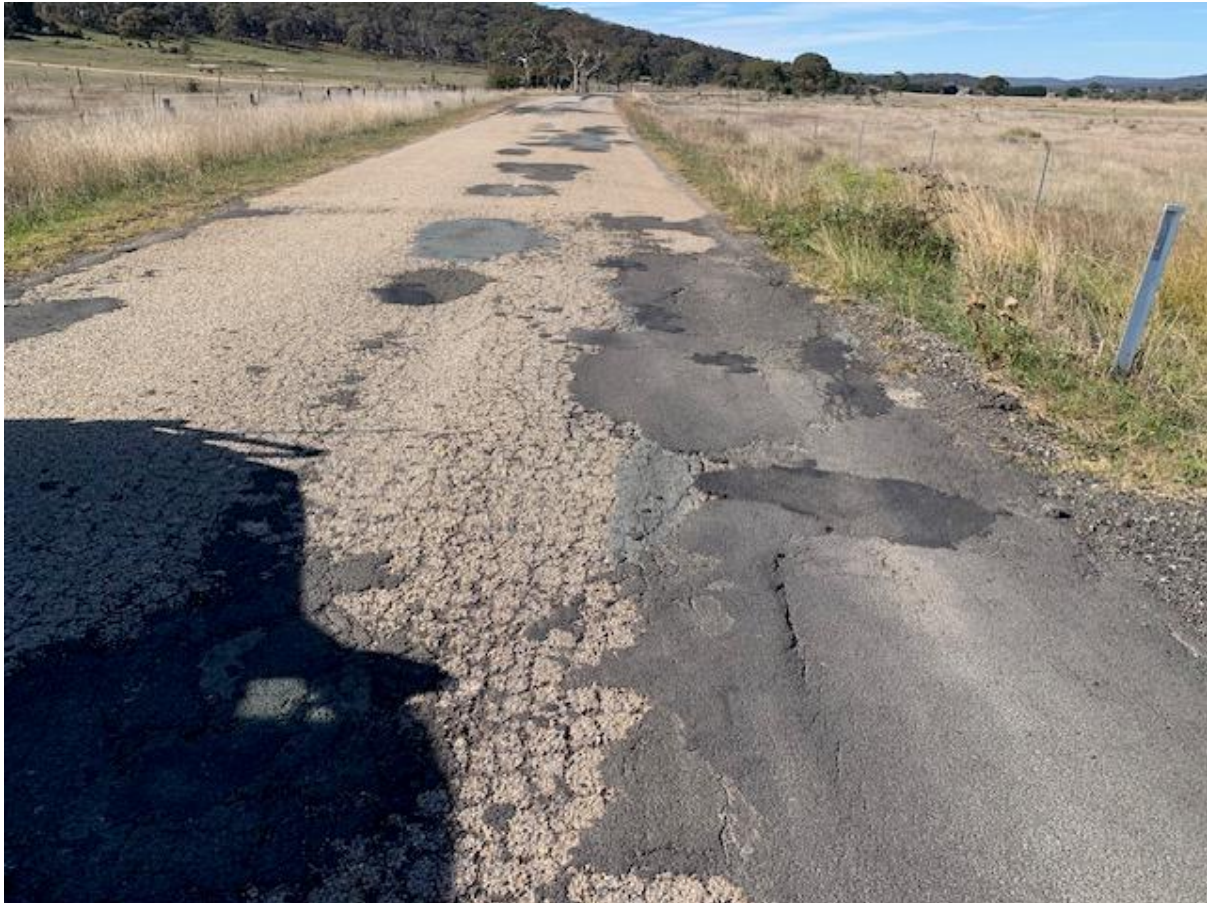
The second area is at chainage 300m.

This areas failure in mainly due to poor drainage. Over the years of traffic, silt has built up along the edge of the seal, making the shoulders higher than the pavement, causing water to remain on the pavement. The existing pavement is a 14mm seal which is badly cracked, pot holed with some deformation on the right hand edge, all caused by water.

For the second and third areas it is recommended that the following be carried out:

- Trim all areas from built up silt back to pavement level

- Remove the existing failed sealed areas and cold mixed pot holes
- Tyne the existing gravel base and add new DGB 20, regrade and compact
- Prime new gravel areas
- Seal the total area with a 14/10 seal.
- Regrade shoulders with a 3% cross fall away from the pavement towards the table drain and culverts
- Clear all table drains and culverts from overgrown grass and debris.

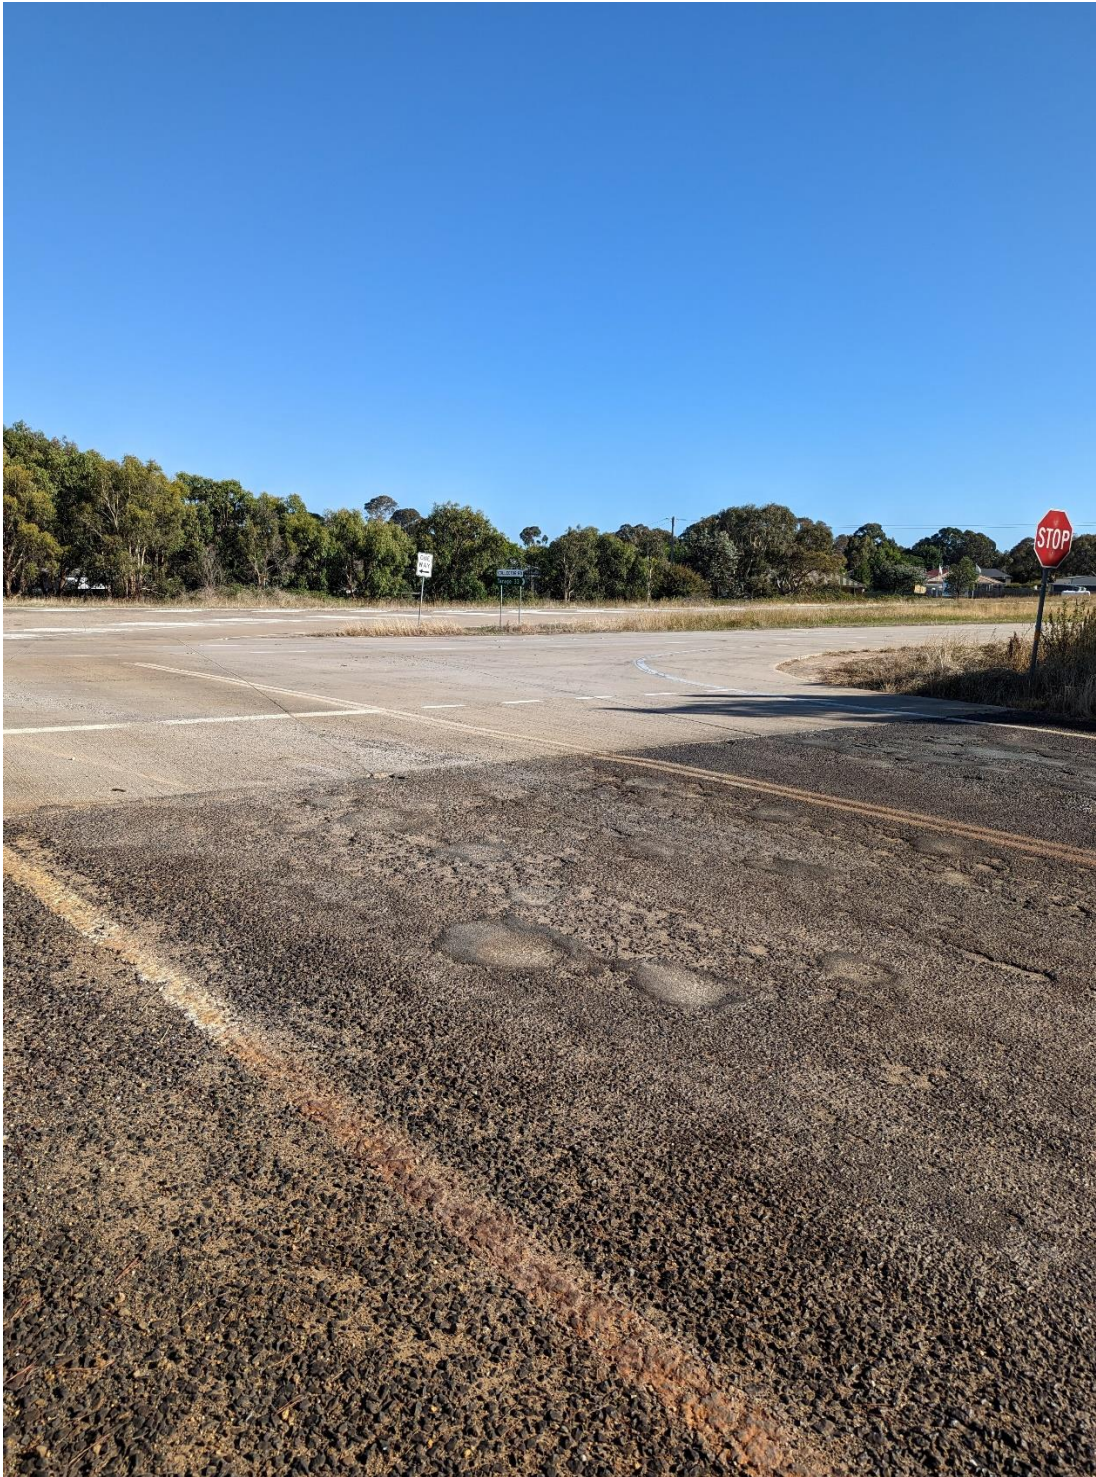
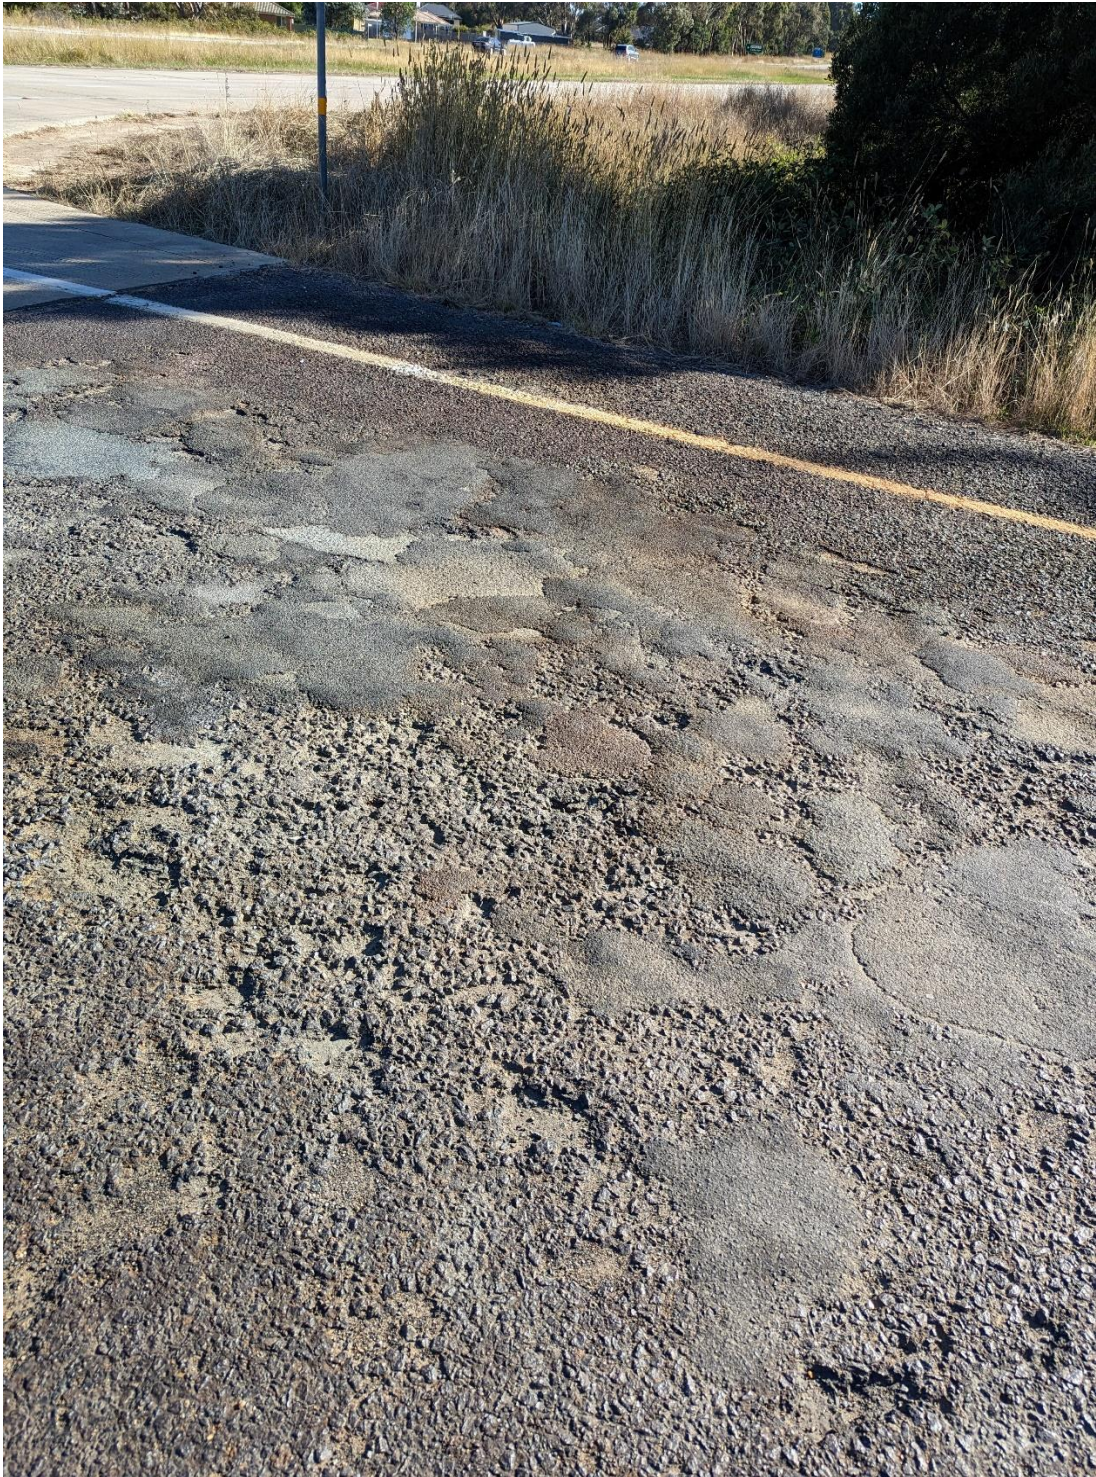
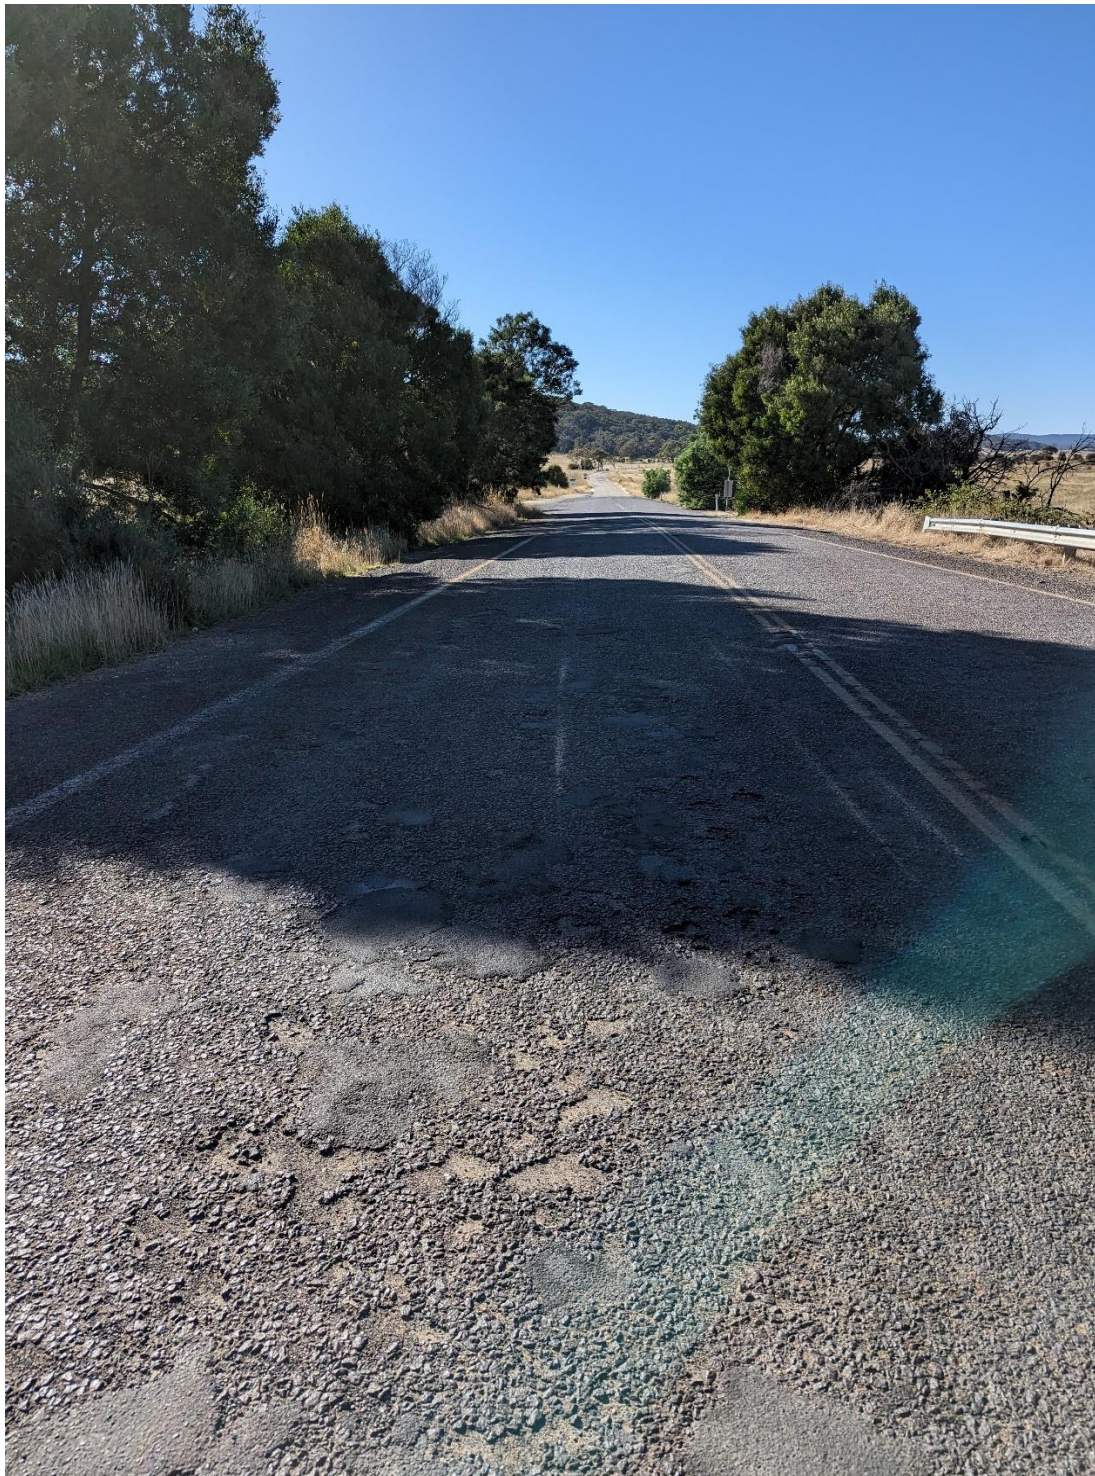
| Project: Collector Road | Location: Zone A |

| Pavement Zone Reference | Approximate Chainages (m) | Pavement Geometry and Immediate Surrounds | Pavement Surfacing and Defects | Possible Causes of Defects |
|---|---|---|---|---|
| A | 0 – 143 | <ul style="list-style-type: none"> <li>Two single lanes and layout area.</li> <li>Low embankment, possible culvert structure</li> <li>Eastbound sealed shoulder</li> <li>Limited westbound sealed shoulder</li> <li>Vegetated shoulders and mature trees</li> </ul> | <ul style="list-style-type: none"> <li>Significant defects</li> <li>Multiple Chip Seals</li> <li>Patching</li> <li>Possible delamination</li> <li>Loss of aggregate and binder</li> </ul> | <ul style="list-style-type: none"> <li>Load associated disintegration of the base.</li> <li>Poor quality base material</li> <li>Poor adhesion to underlying layers</li> <li>Dislodgment initiated by cracking</li> <li>Water seepage</li> </ul> |

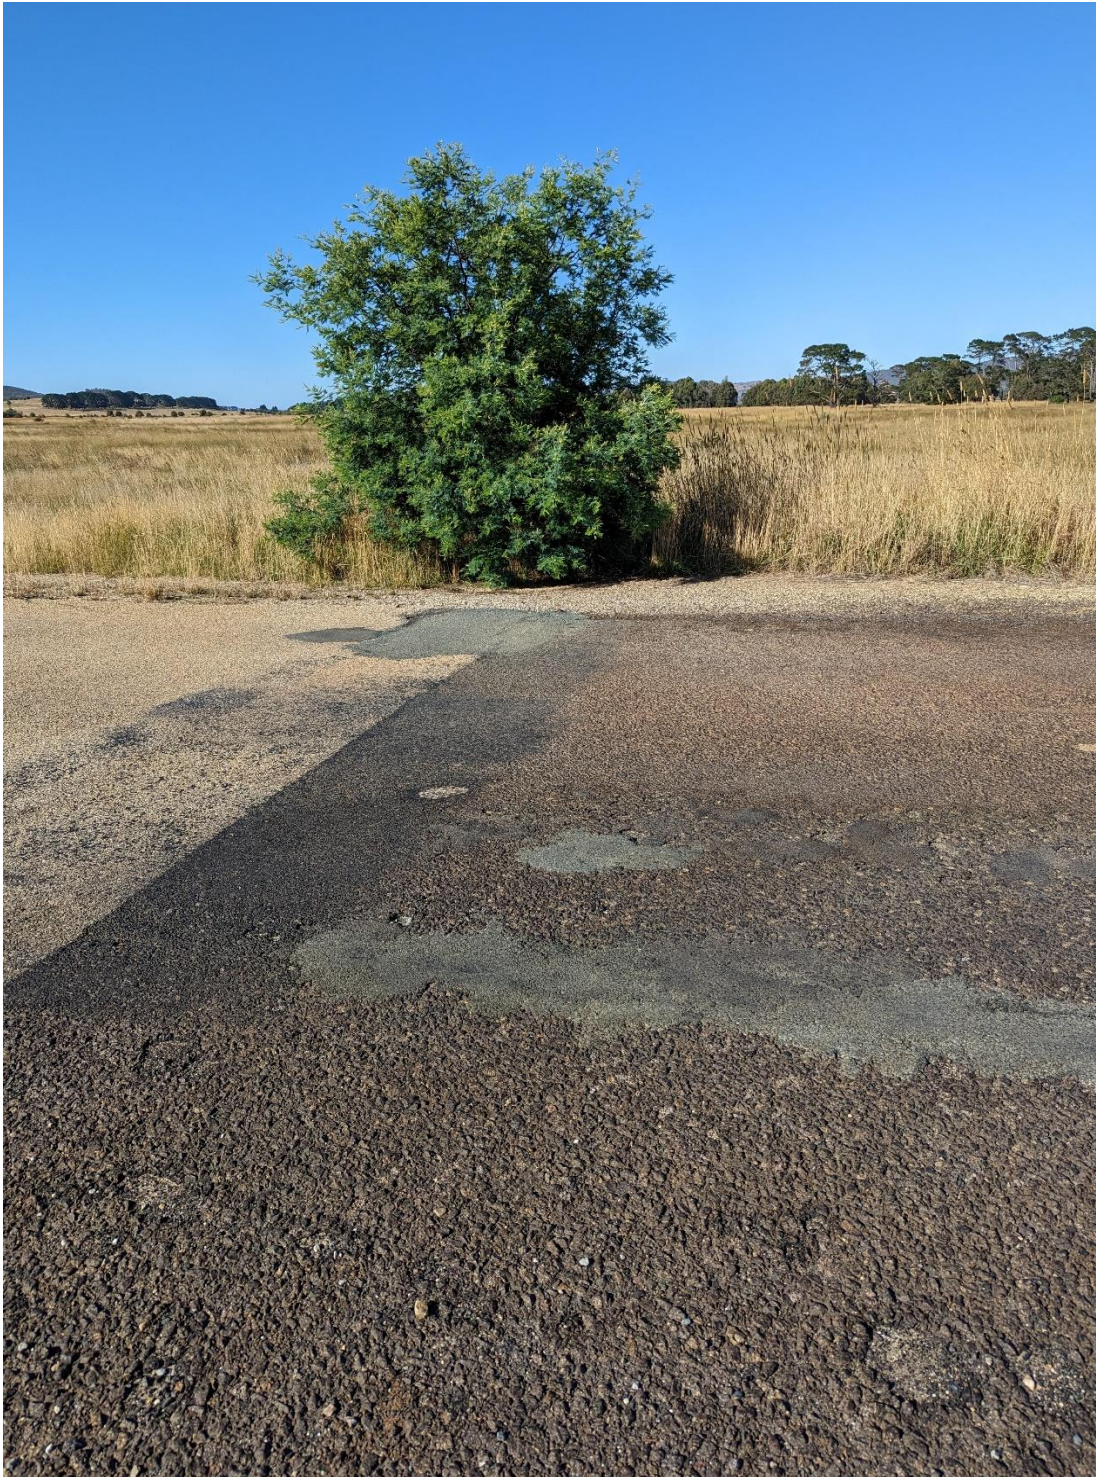
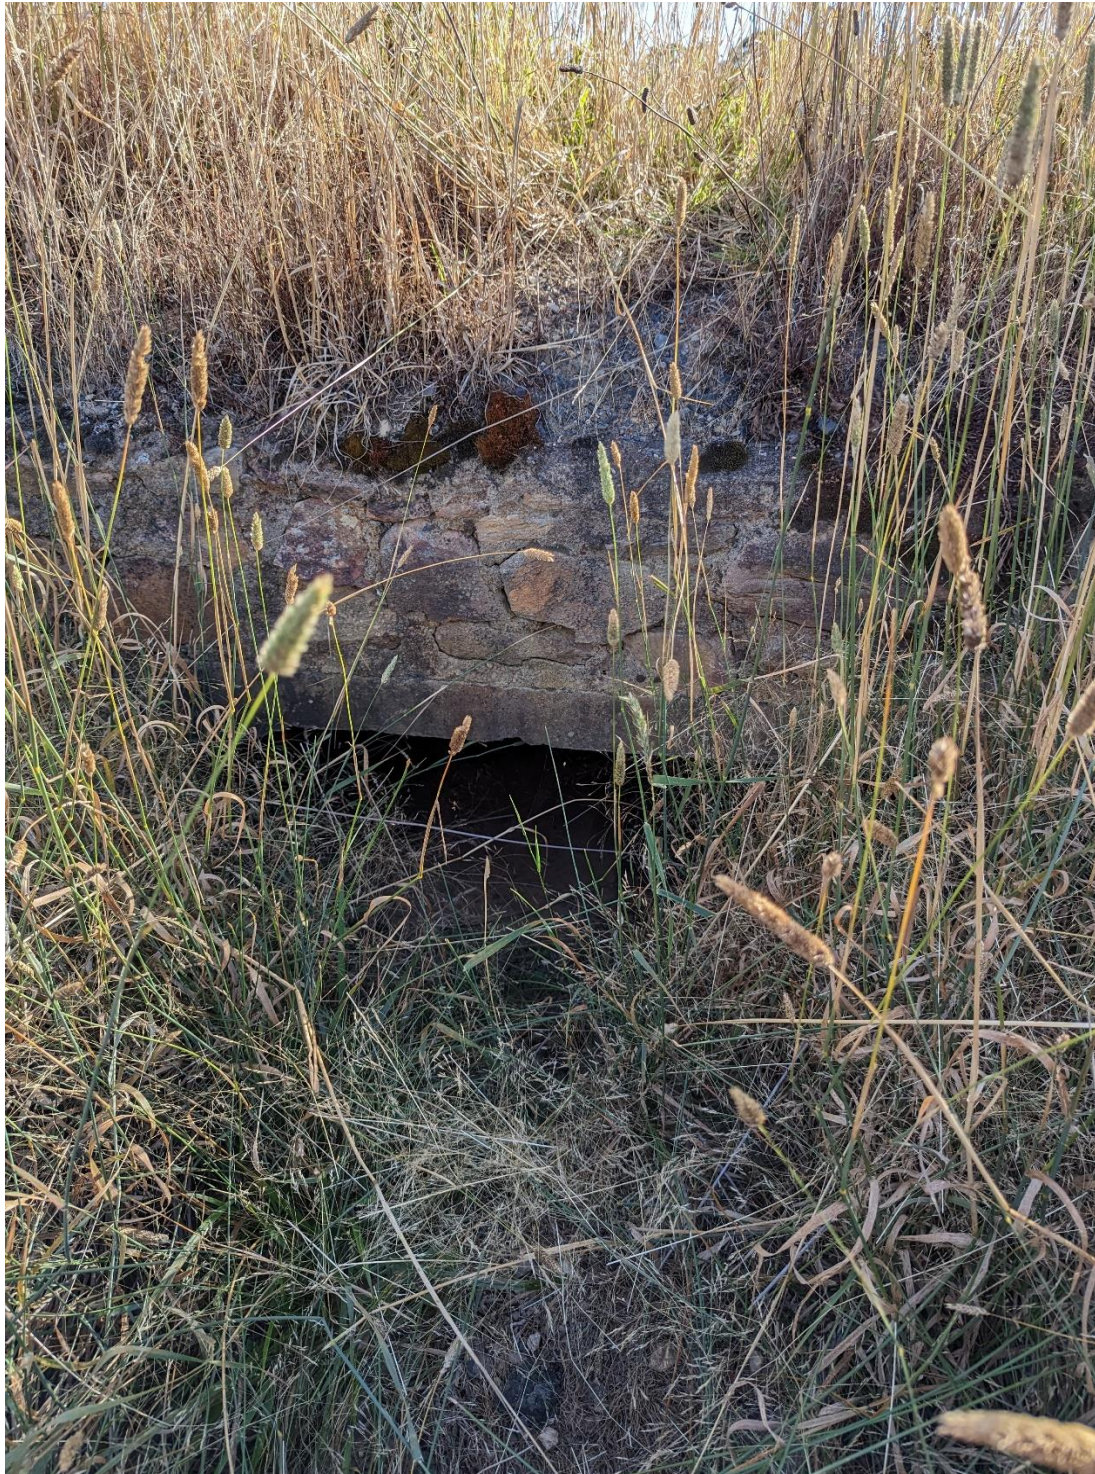
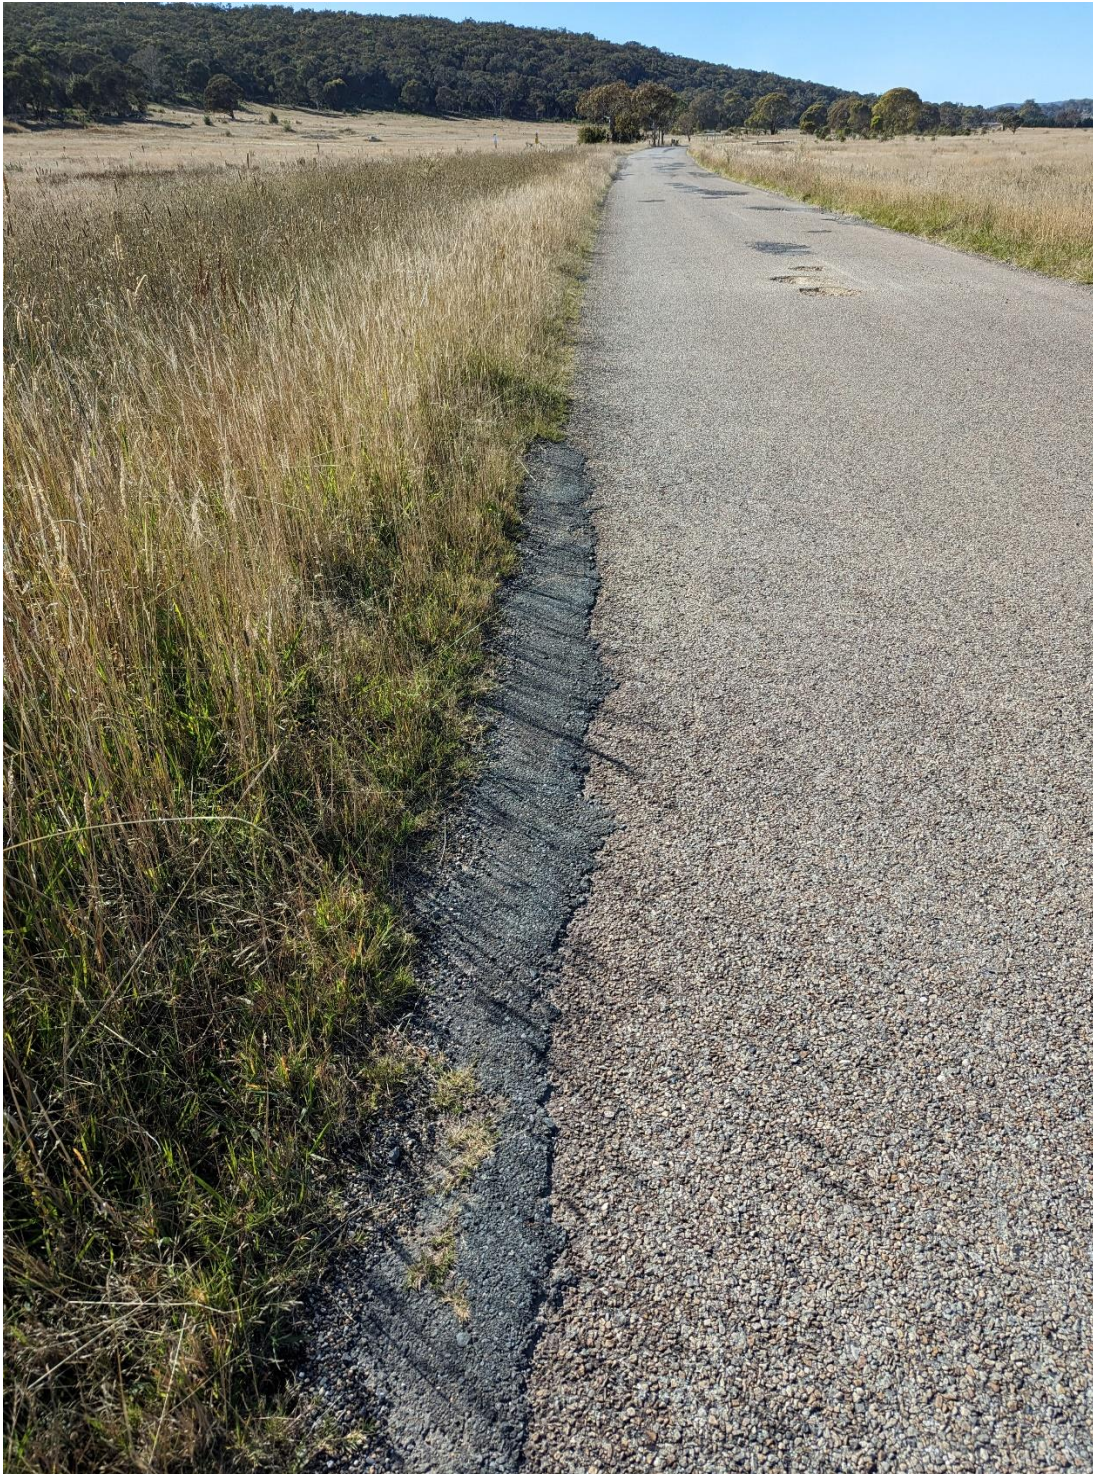
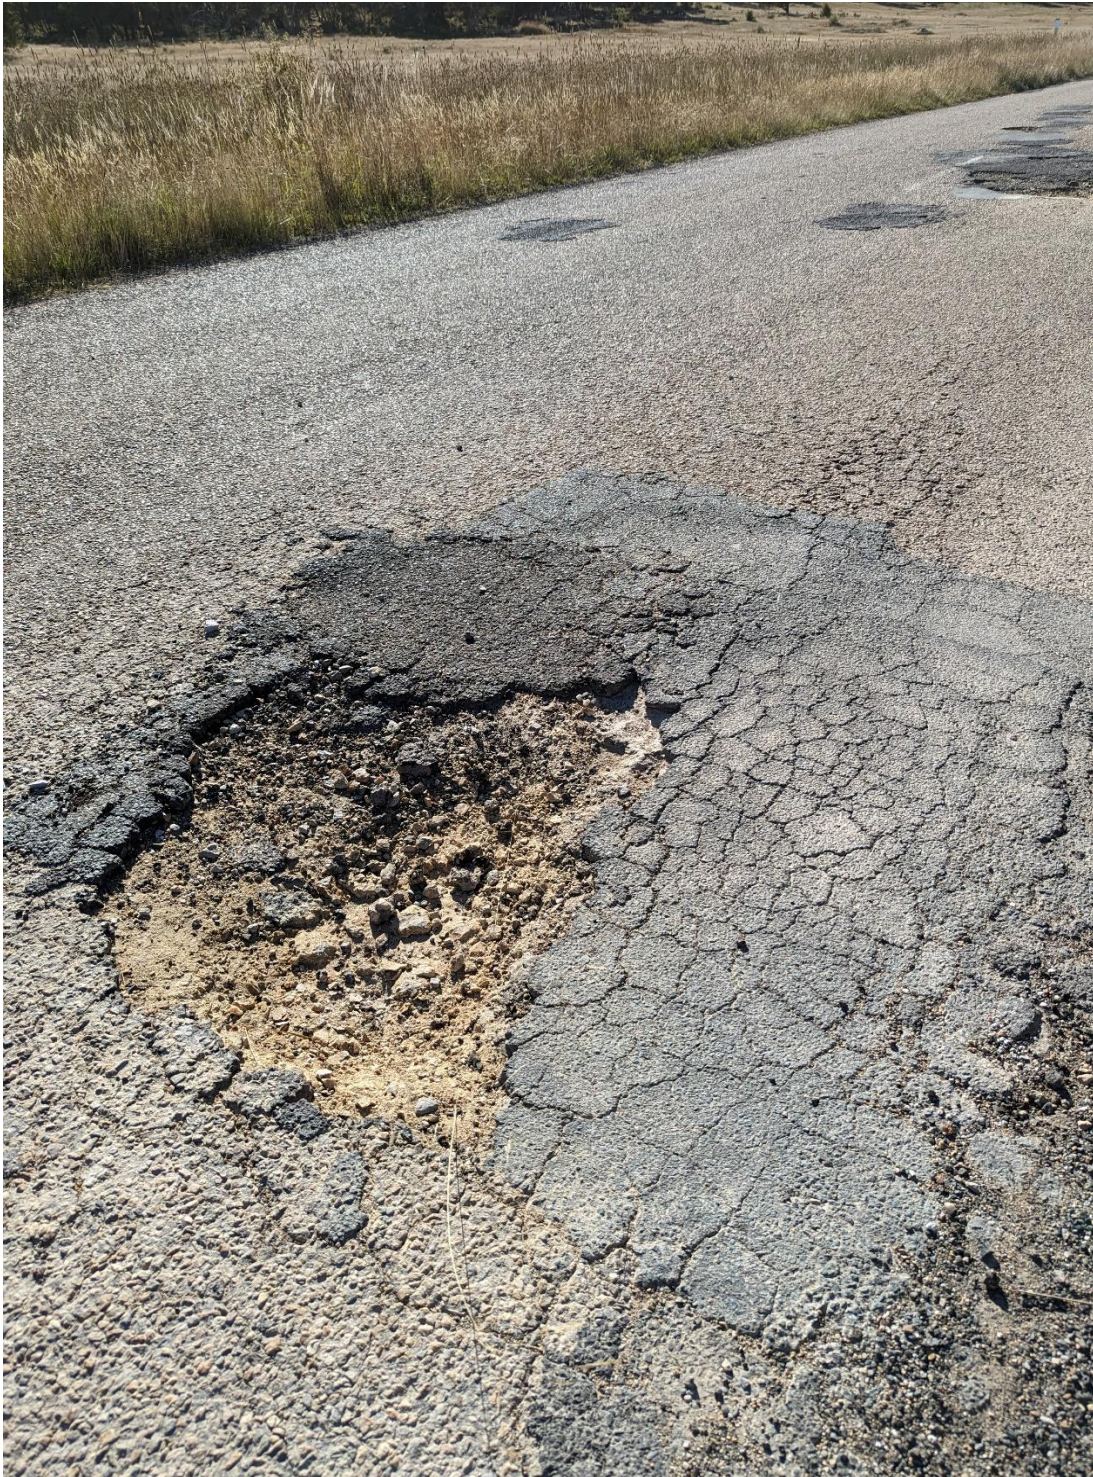
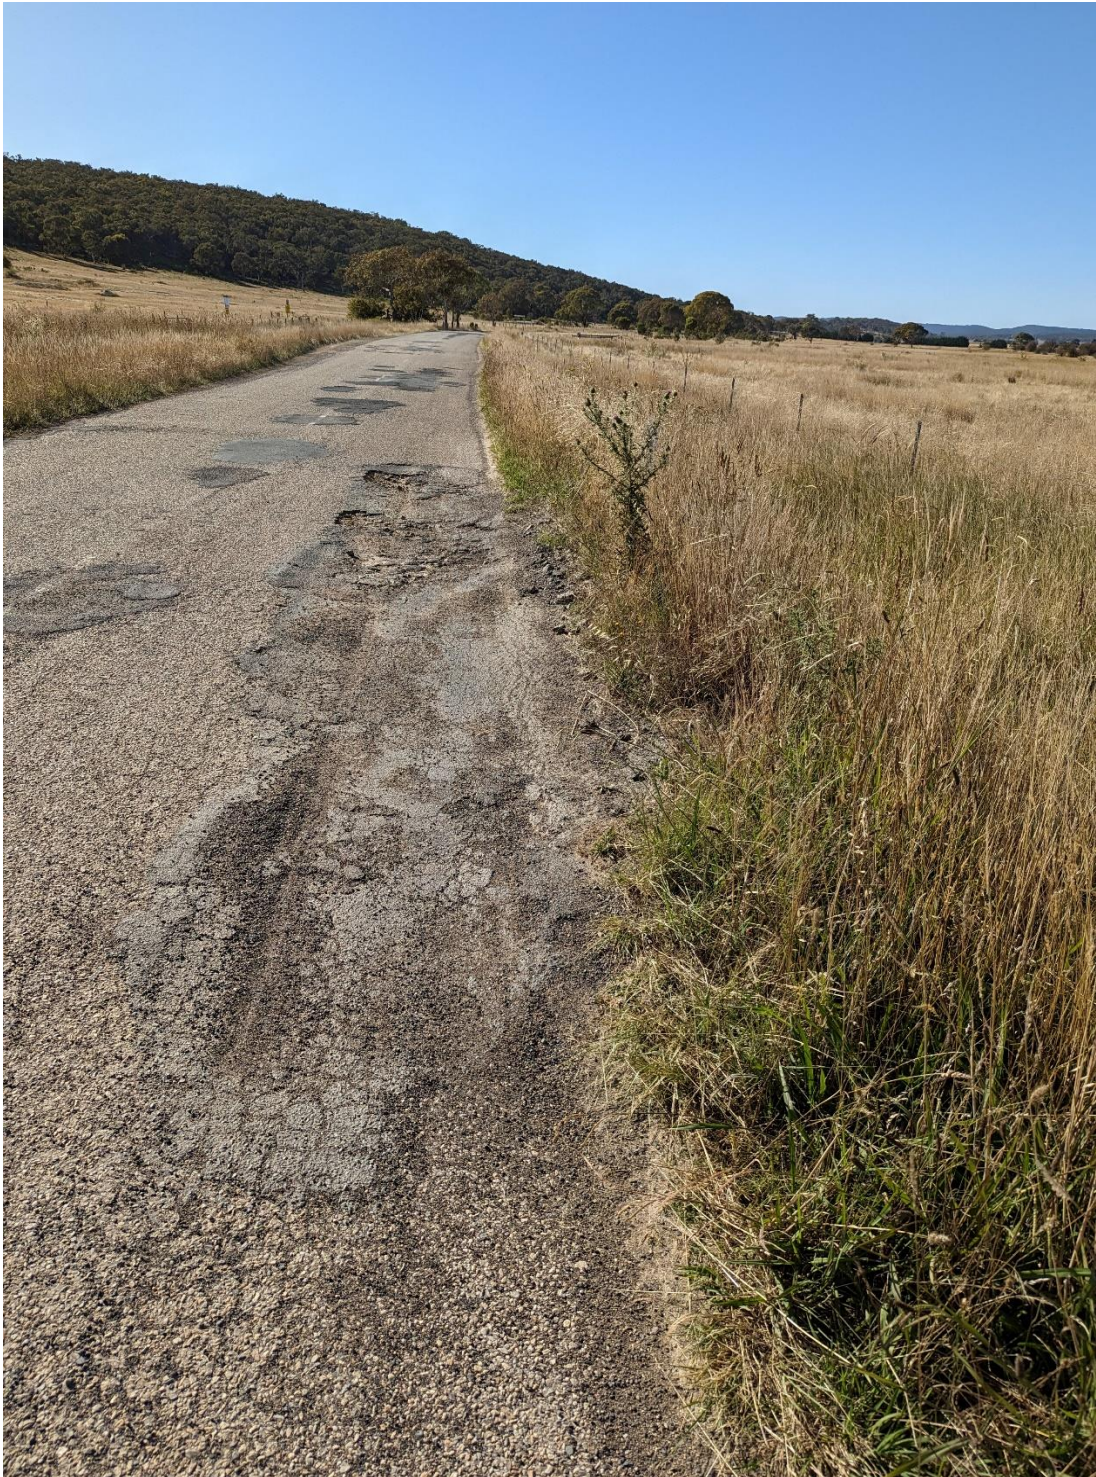
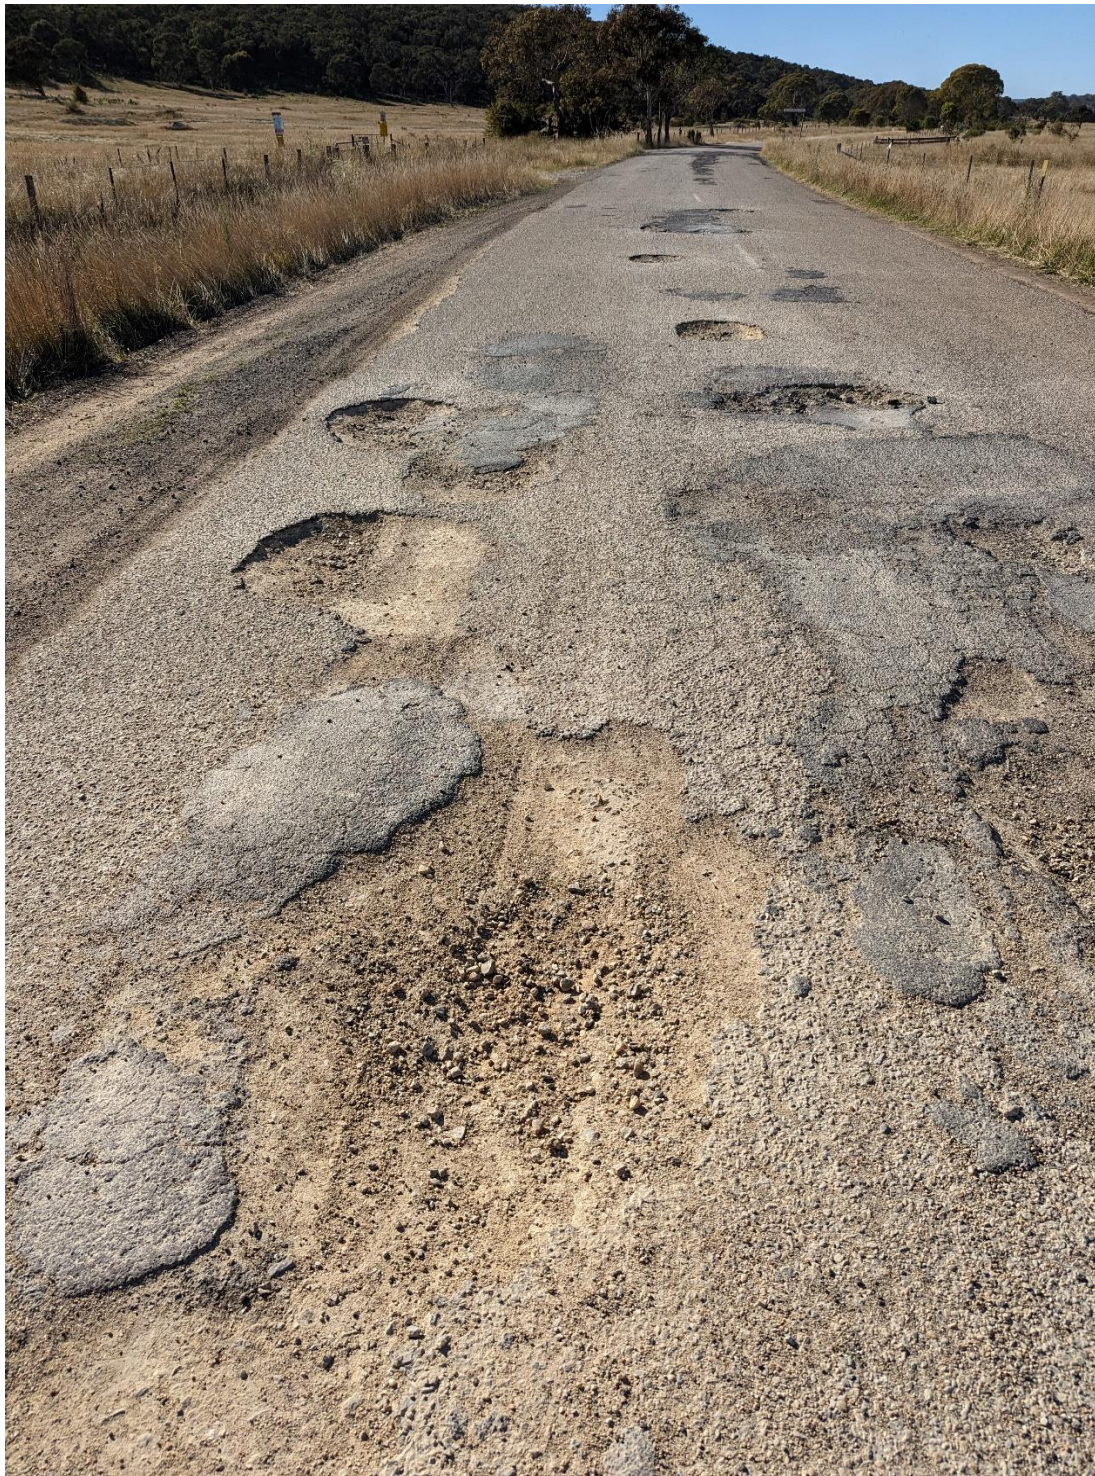
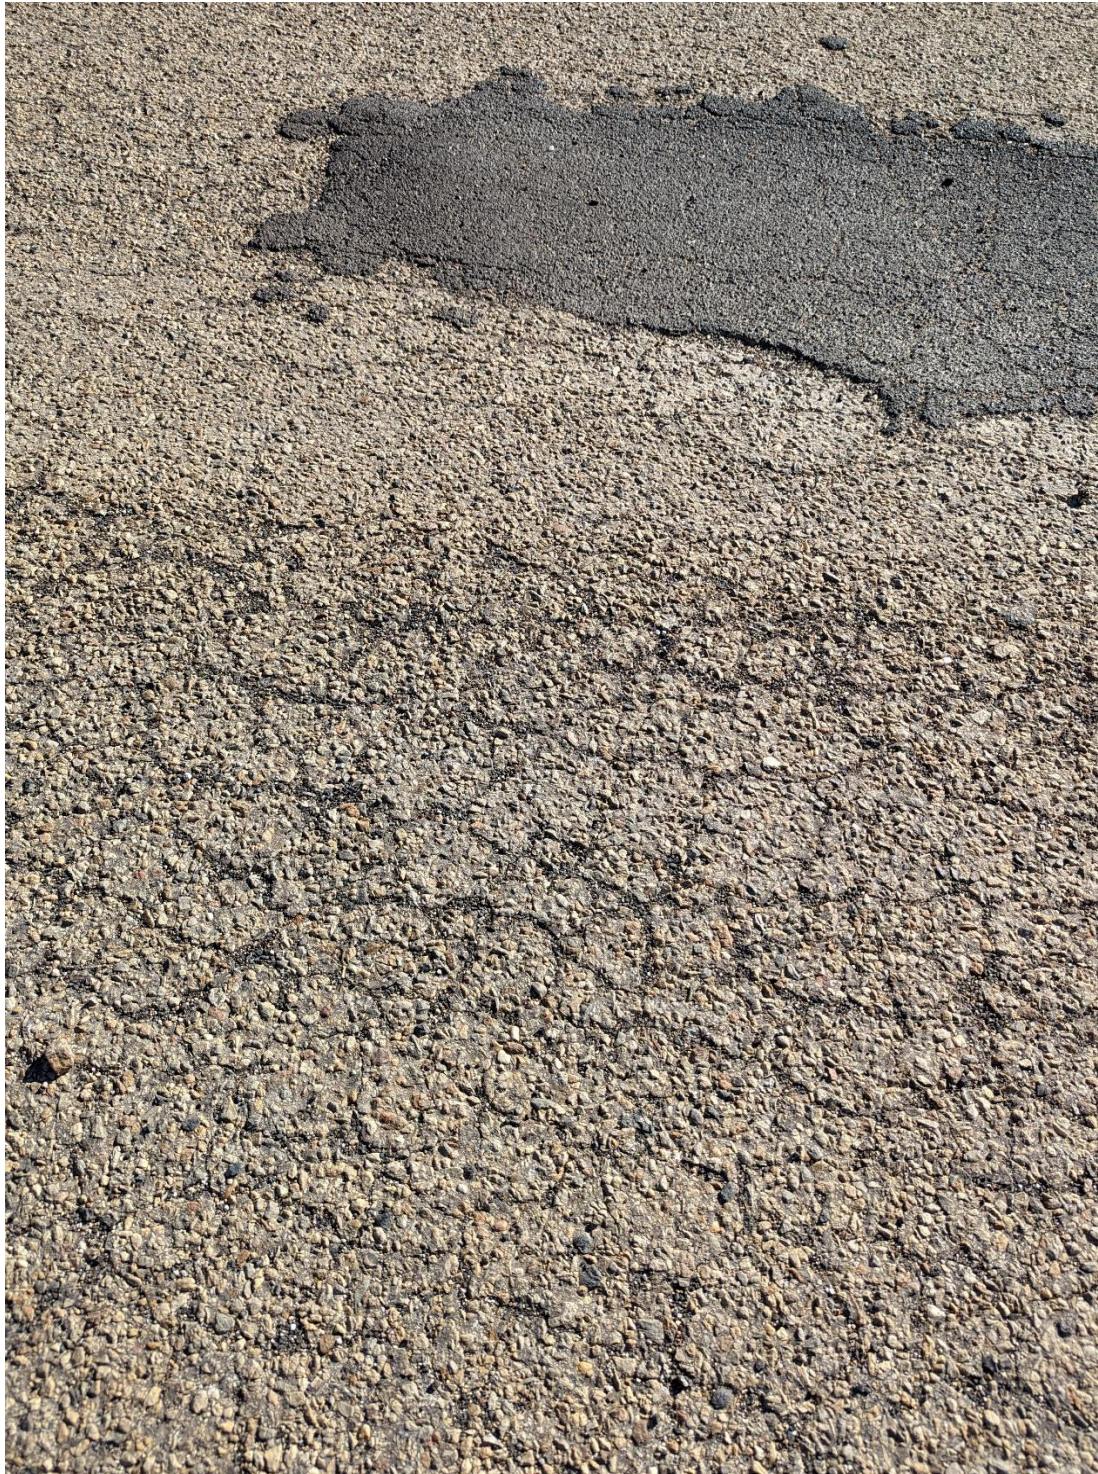
| Project: Collector Road | Location: Zone B |

| Pavement Zone Reference | Approximate Chainages (m) | Pavement Geometry and Immediate Surrounds | Pavement Surfacing and Defects | Possible Causes of Defects |
|---|---|---|---|---|
| B | 143 – 425 | <ul style="list-style-type: none"> <li>Low embankment, culvert structure</li> <li>Two single lanes</li> <li>No sealed shoulder</li> <li>Vegetated shoulder</li> <li>Culvert structure partially blocked.</li> </ul> | <ul style="list-style-type: none"> <li>Significant defects</li> <li>Spray seal</li> <li>Edge break</li> <li>Edge drop off</li> <li>Potholes</li> <li>Patching</li> <li>Crocodile cracking</li> <li>Rutting</li> <li>Longitudinal cracking</li> </ul> | <ul style="list-style-type: none"> <li>Water ingress</li> <li>Structural overloading of the pavement e.g. inadequate thickness or quality</li> <li>Poor construction control</li> <li>Poor drainage</li> <li>Pavement in terminal conditions</li> </ul> |

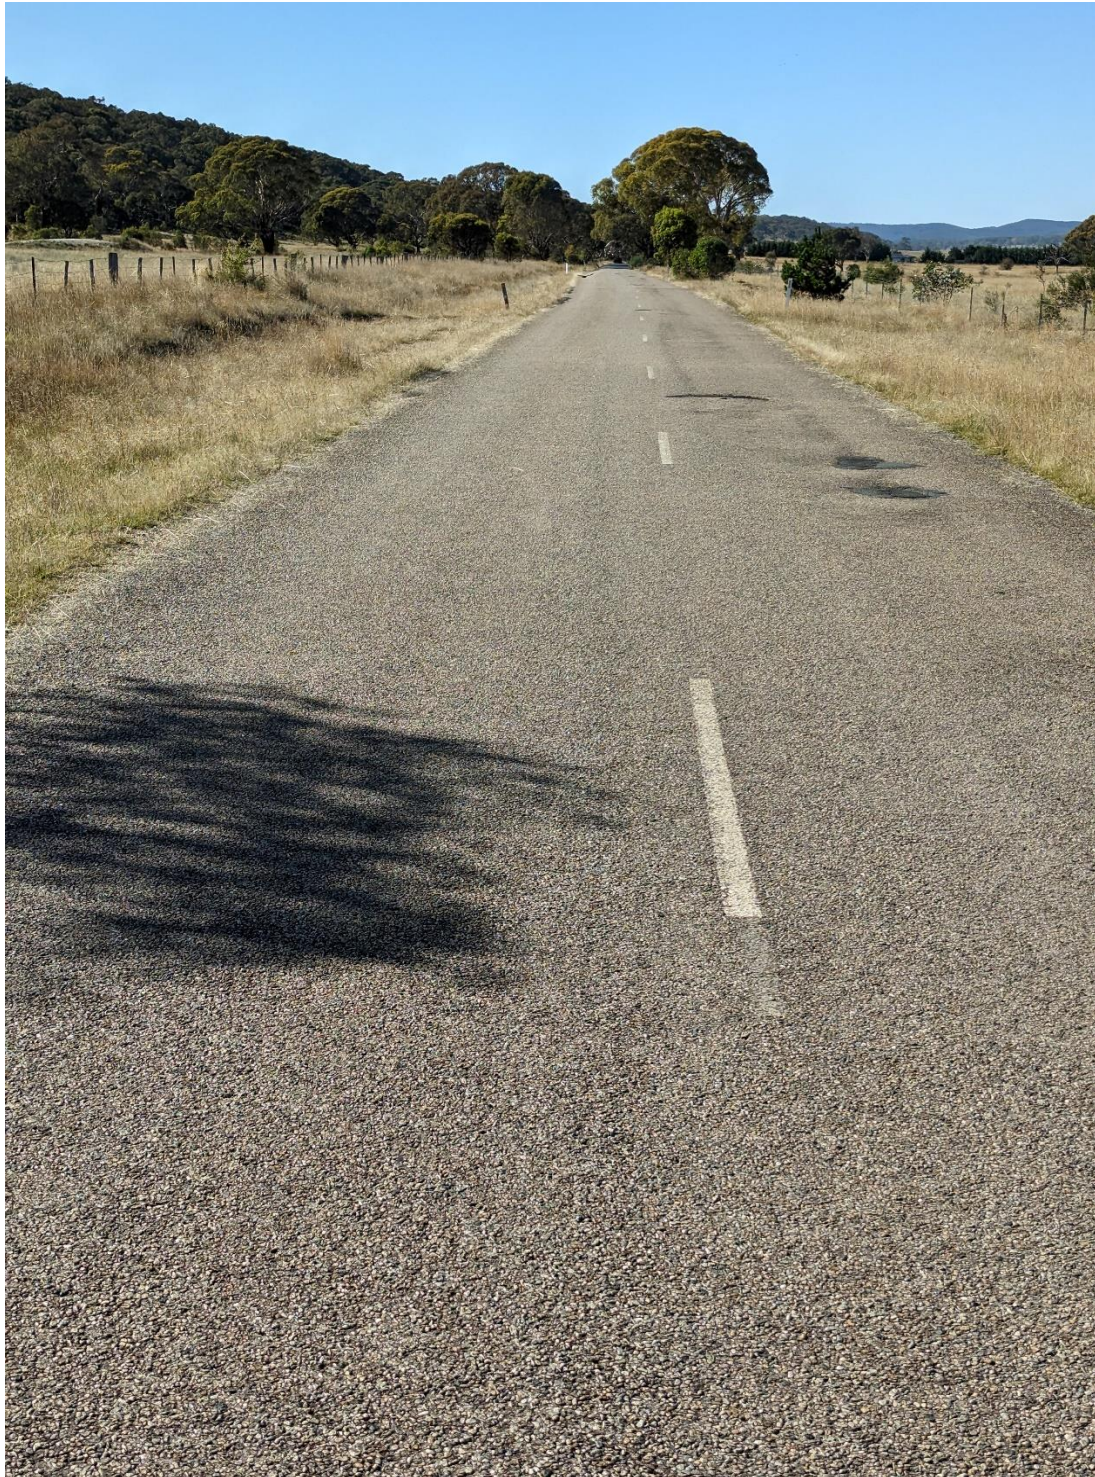
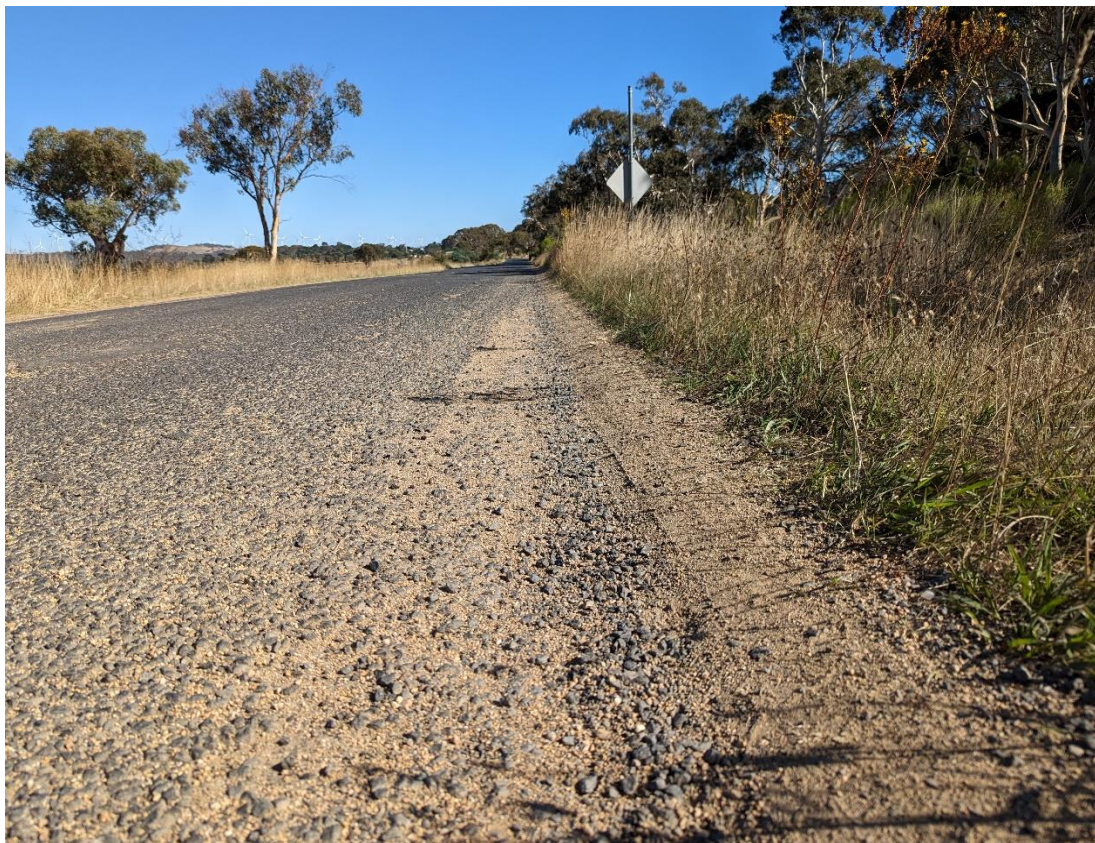
| Project: Collector Road | Location: Zone C |

| Pavement Zone Reference | Approximate Chainages (m) | Pavement Geometry and Immediate Surrounds | Pavement Surfacing and Defects | Possible Causes of Defects |
|---|---|---|---|---|
| C | 425 – 860 | <ul style="list-style-type: none"> <li>See Zone B</li> </ul> | <ul style="list-style-type: none"> <li>Some defects, see Zone B</li> </ul> | <ul style="list-style-type: none"> <li>See Zone B</li> </ul> |
