# **PAVEMENT ASSESSMENT REPORT**

## **COLLECTOR RD – BETWEEN FEDERAL HWY AND BARINA QUARRY**

### **COLLECTOR FOR COLLECTOR RESOURCES**

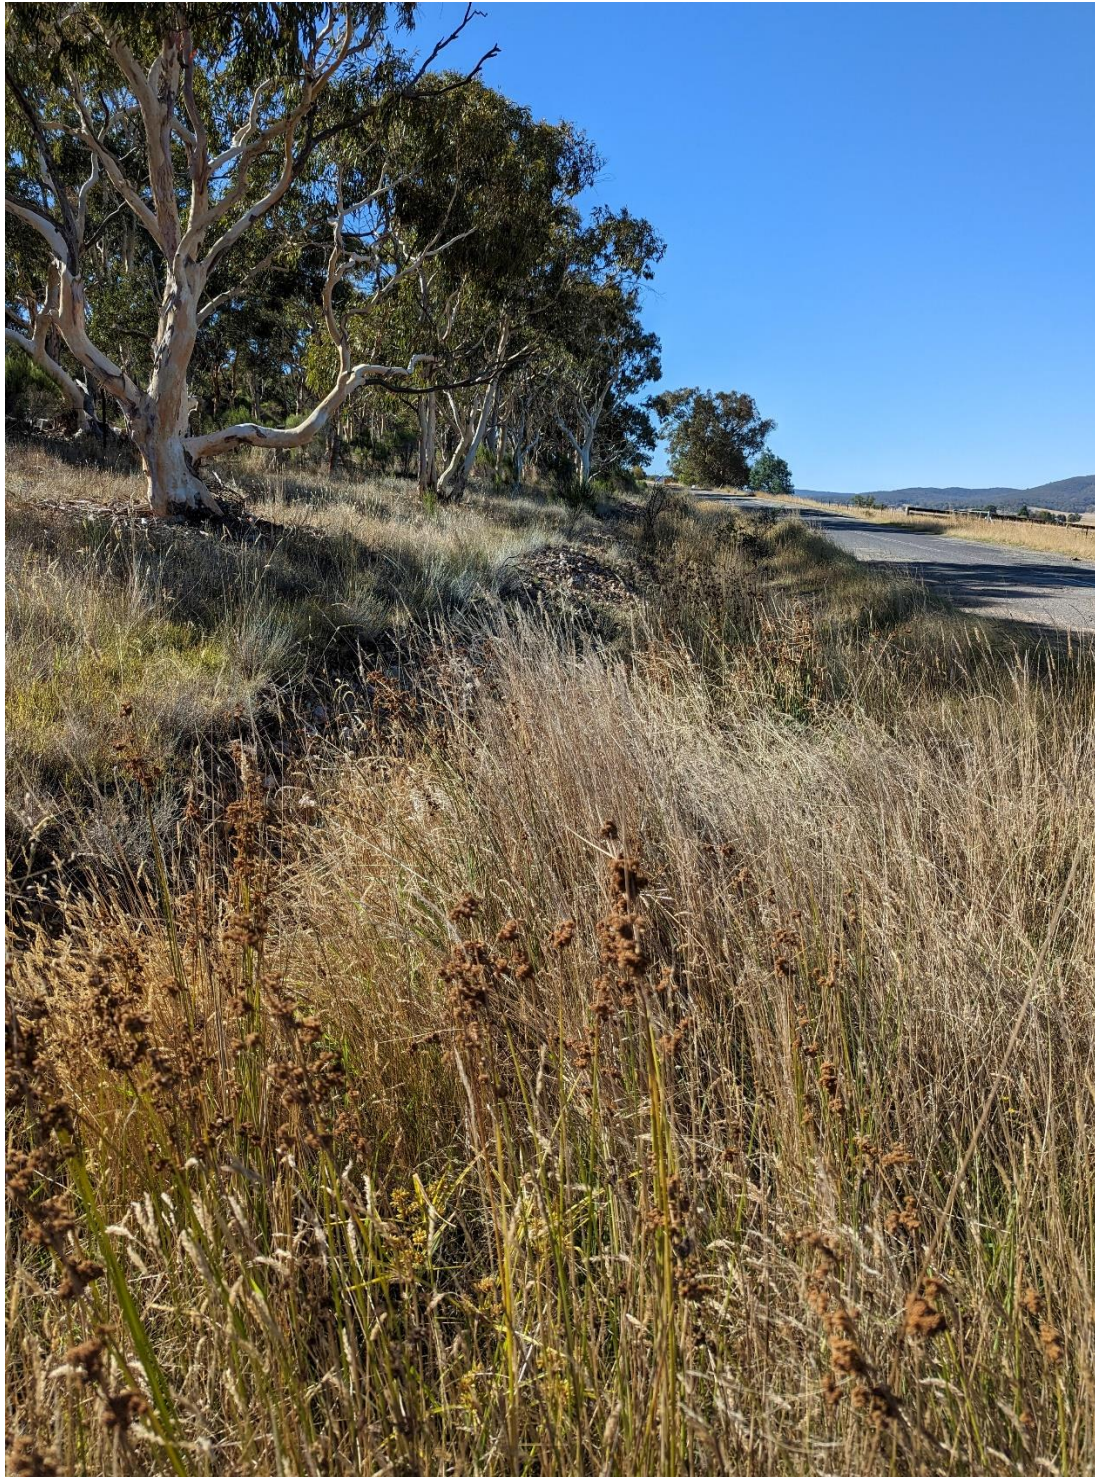
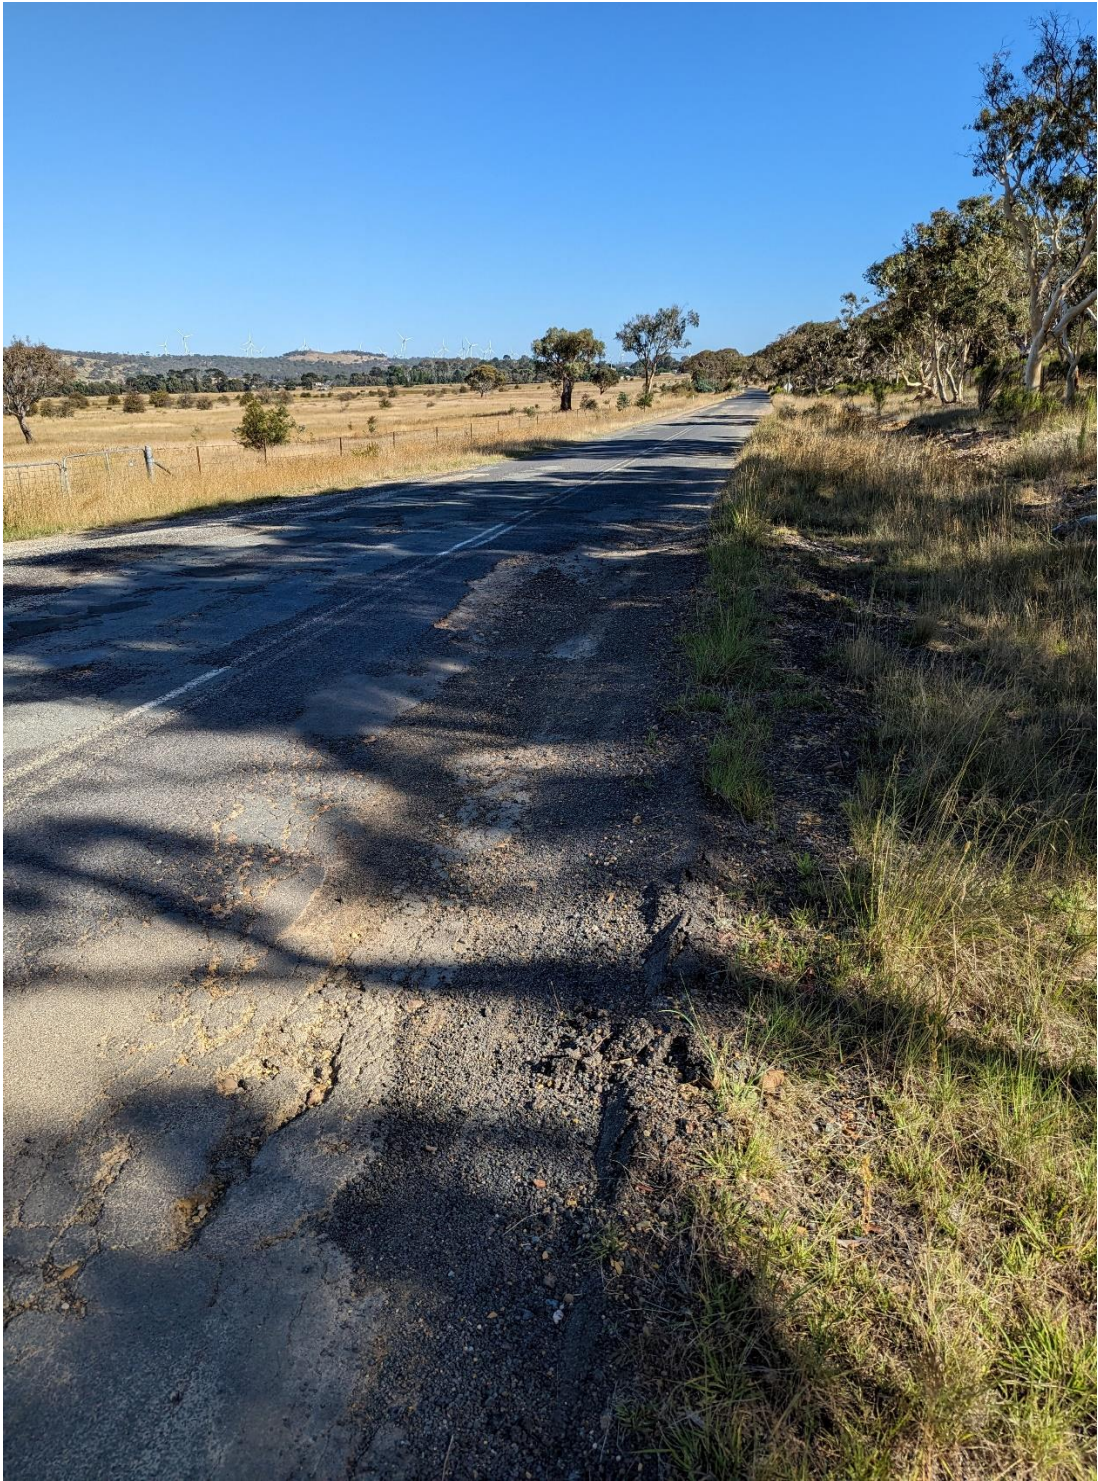
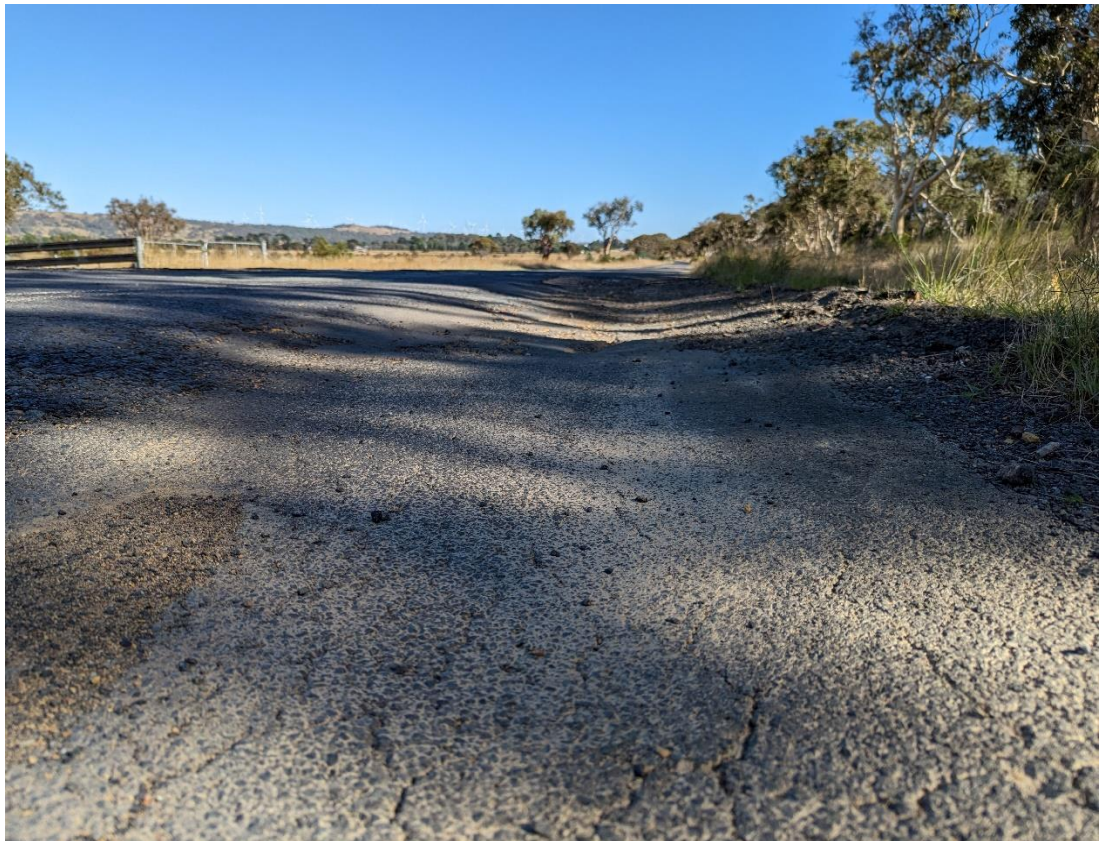
| Project: Collector Road | Location: Zone D |

| Pavement Zone Reference | Approximate Chainages (m) | Pavement Geometry and Immediate Surrounds | Pavement Surfacing and Defects | Possible Causes of Defects |
|---|---|---|---|---|
| D | 860 – 1,320 | <ul style="list-style-type: none"> <li>Within a low cut to the east.</li> <li>Low embankment to the west.</li> <li>Two single lanes.</li> <li>No sealed shoulder</li> <li>Vegetated shoulder</li> <li>Partially blocked culvert</li> </ul> | <ul style="list-style-type: none"> <li>Spray seal</li> <li>Significant defects</li> <li>Edge break</li> <li>Edge drop off</li> <li>Potholes</li> <li>Patching</li> <li>Crocodile cracking</li> <li>Rutting</li> <li>Longitudinal cracking</li> </ul> | <ul style="list-style-type: none"> <li>Water ingress</li> <li>Structural overloading of the pavement e.g. inadequate thickness or quality</li> <li>Poor construction control</li> <li>Poor drainage</li> <li>Pavement in terminal condition</li> </ul> |

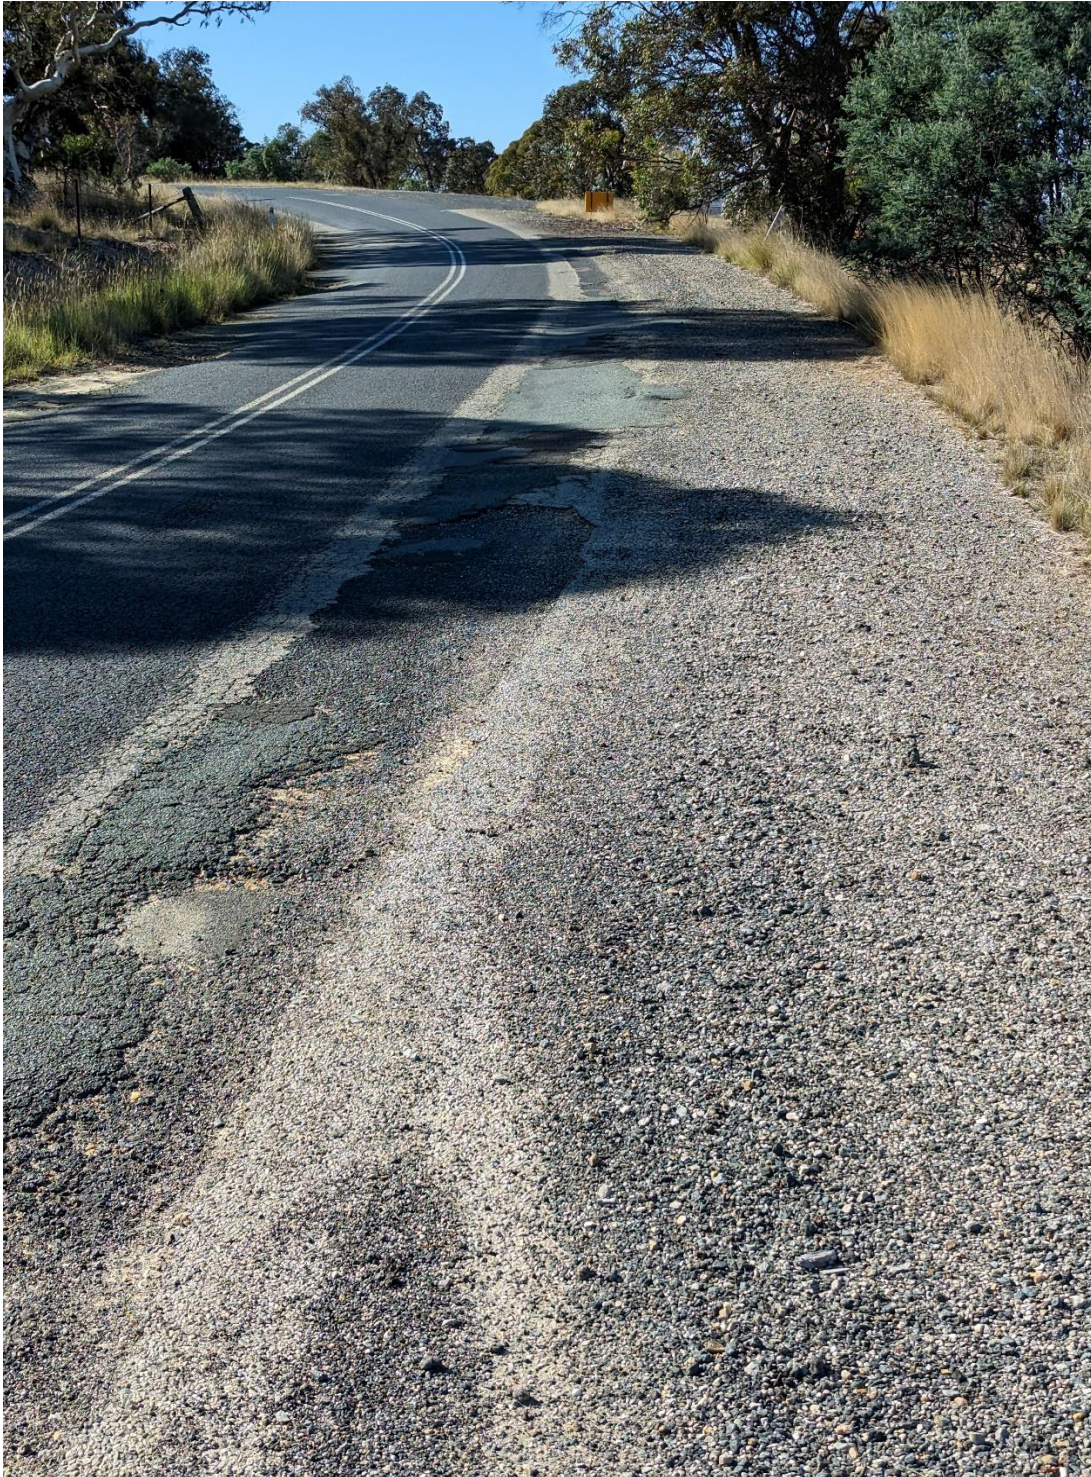
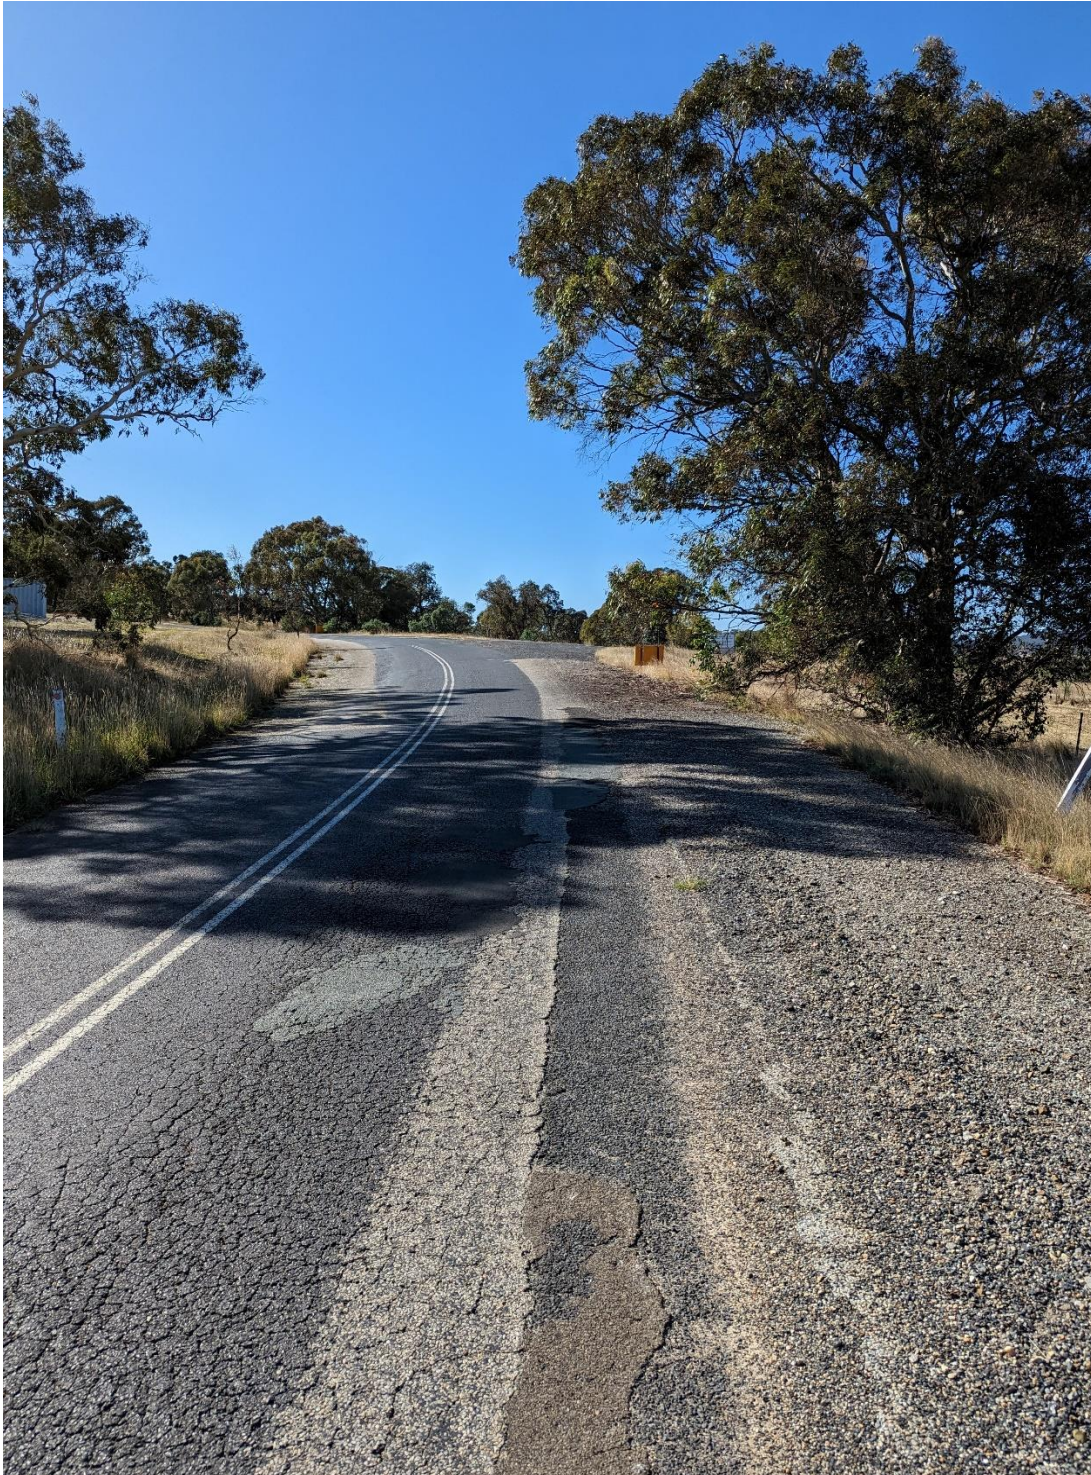
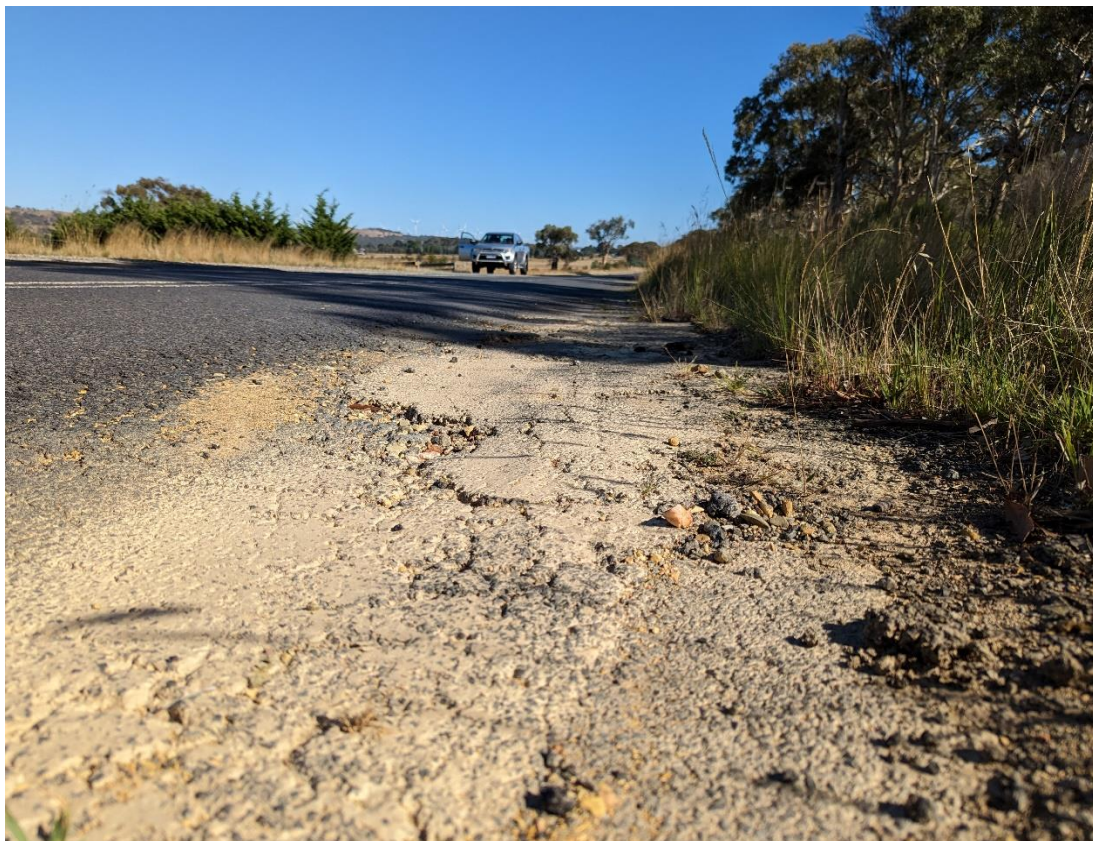
| Project: Collector Road | Location: Zone E |

| Pavement Zone Reference | Approximate Chainages (m) | Pavement Geometry and Immediate Surrounds | Pavement Surfacing and Defects | Possible Causes of Defects |
|---|---|---|---|---|
| E | 1,320 – 1,540 | <ul style="list-style-type: none"> <li>Within a low cut to the east.</li> <li>Low embankment to the west.</li> <li>Possible culvert structure.</li> </ul> | <ul style="list-style-type: none"> <li>Spray seal(s)</li> <li>Significant defects</li> <li>Edge break</li> </ul> | <ul style="list-style-type: none"> <li>Water ingress</li> <li>Structural overloading of the pavement e.g. inadequate</li> </ul> |

| Pavement Zone Reference | Approximate Chainages (m) | Pavement Geometry and Immediate Surrounds | Pavement Surfacing and Defects | Possible Causes of Defects |
|---|---|---|---|---|
| | | <ul style="list-style-type: none"> <li>Two single lanes.</li> <li>No sealed shoulder</li> <li>Vegetated shoulder with mature trees.</li> <li>Pavement likely widened</li> </ul> | <ul style="list-style-type: none"> <li>Edge drop off</li> <li>Potholes</li> <li>Patching</li> <li>Crocodile cracking</li> <li>Rutting</li> <li>Crescent shaped cracking in shoulder widening</li> <li>Worst defects outbound from the quarry, westbound</li> </ul> | <ul style="list-style-type: none"> <li>thickness or quality</li> <li>Poor construction control</li> <li>Poor drainage</li> <li>High horizontal shear forces associated with turning and accelerating</li> </ul> |

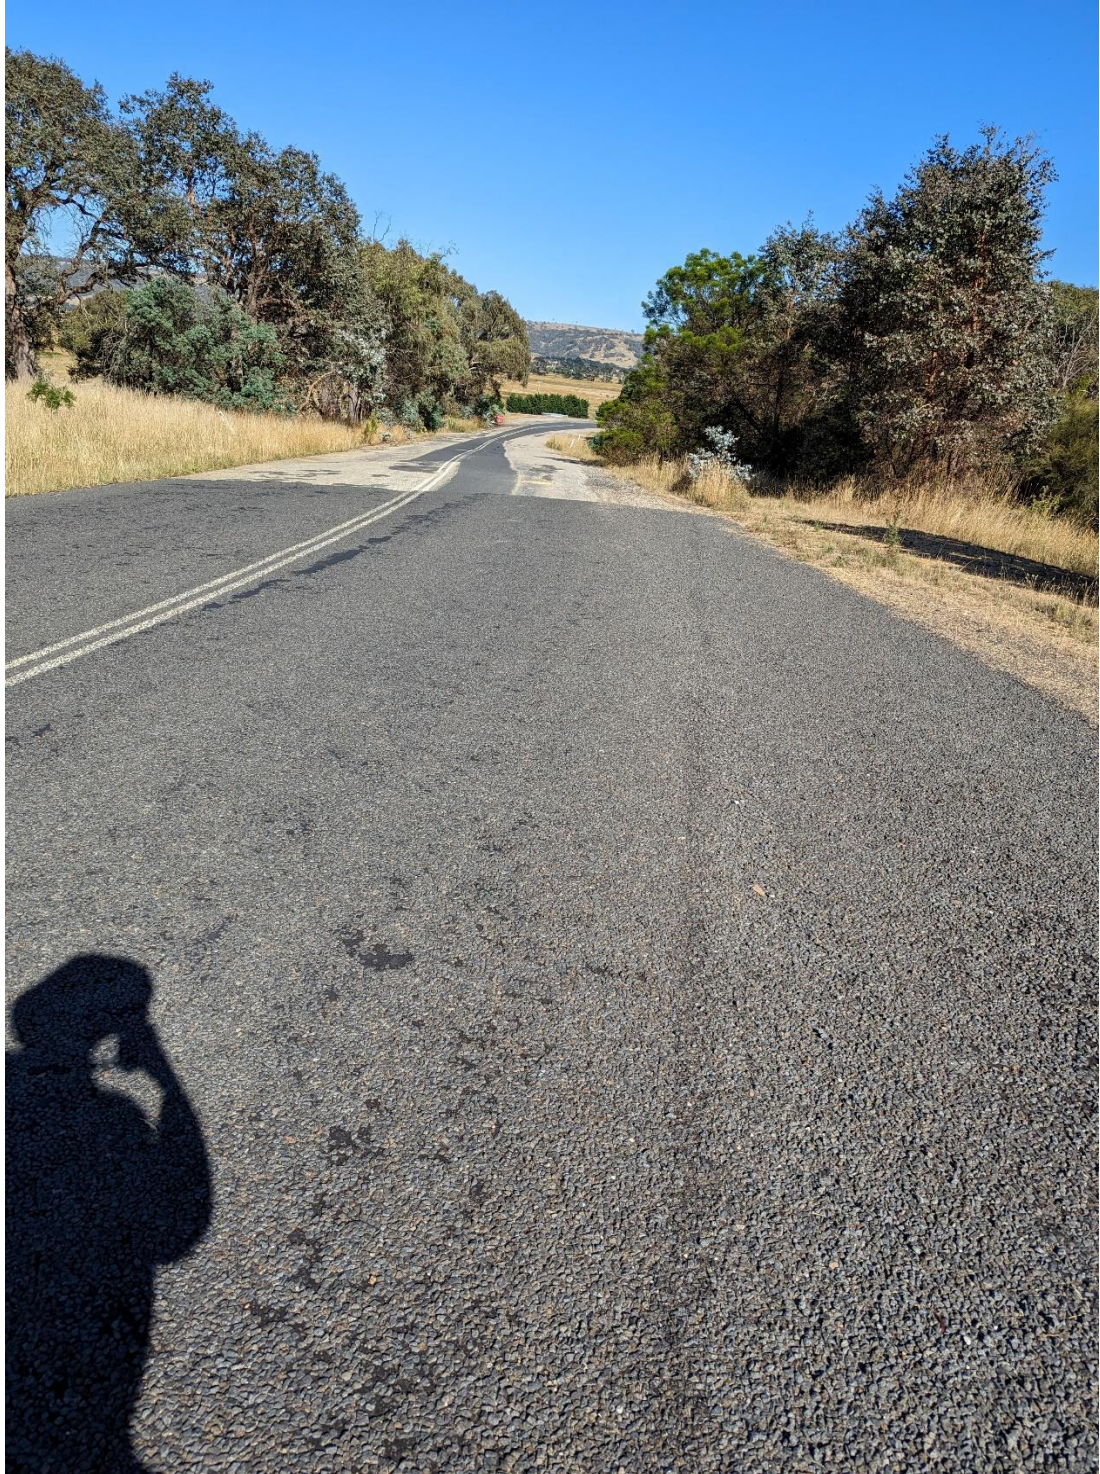
| Project: Collector Road | Location: Zone F |

| Pavement Zone Reference | Approximate Chainages (m) | Pavement Geometry and Immediate Surrounds | Pavement Surfacing and Defects | Possible Causes of Defects |
|---|---|---|---|---|
| F | 1,540 – 1,600 | <ul style="list-style-type: none"> <li>Broadly at existing grade</li> </ul> | <ul style="list-style-type: none"> <li>Spray seal</li> <li>Pavement in good condition</li> </ul> | - |
