### **ARBORIST INSPECTION AND TREE REMOVAL AT PICTON HIGH SCHOOL.**

Horticultural Management Services was engaged to conduct an Arboriculture Assessment of One-(1) River Red Gum (*Eucalyptus camaldulensis*) that is located near the old Building B site.

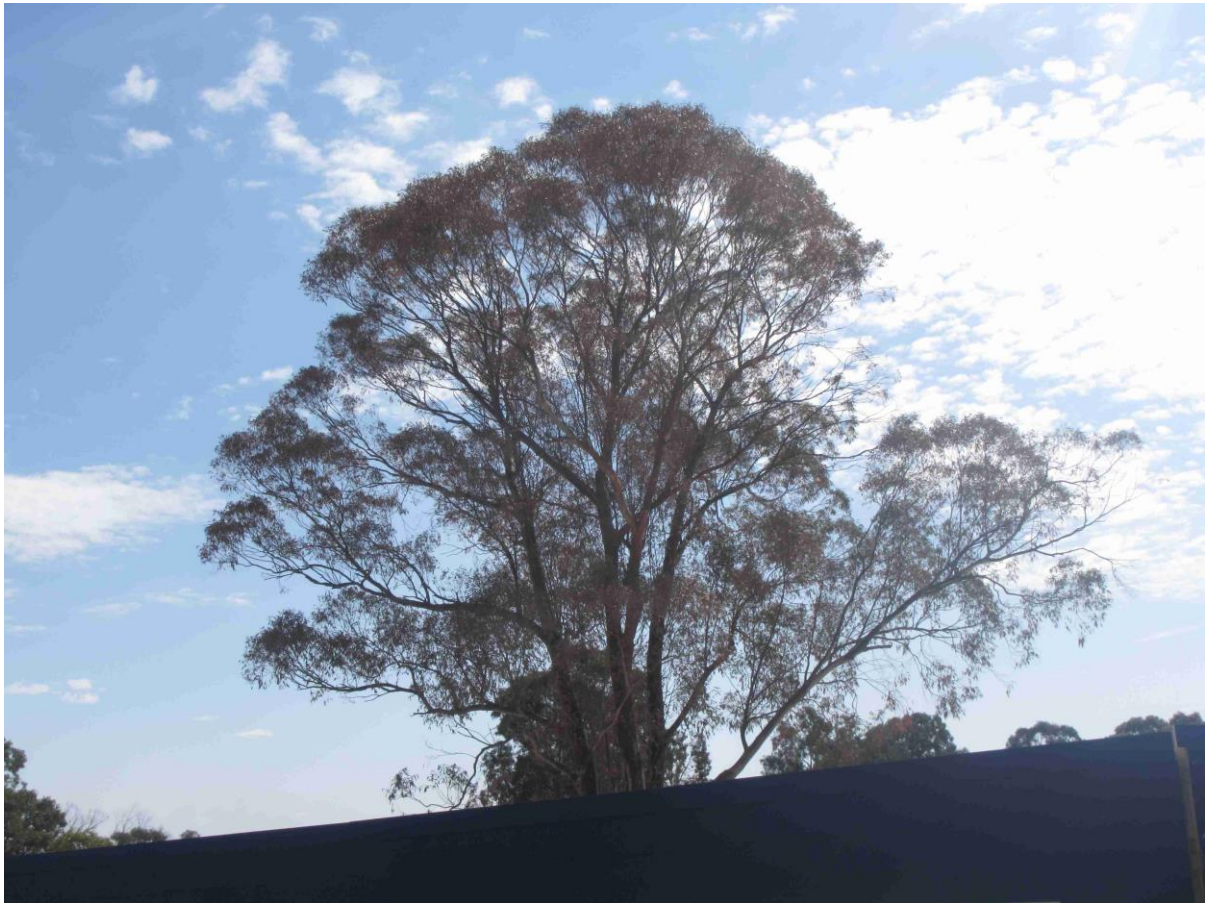
**Figure 1 Shows looking at the trees canopy from a distance.**

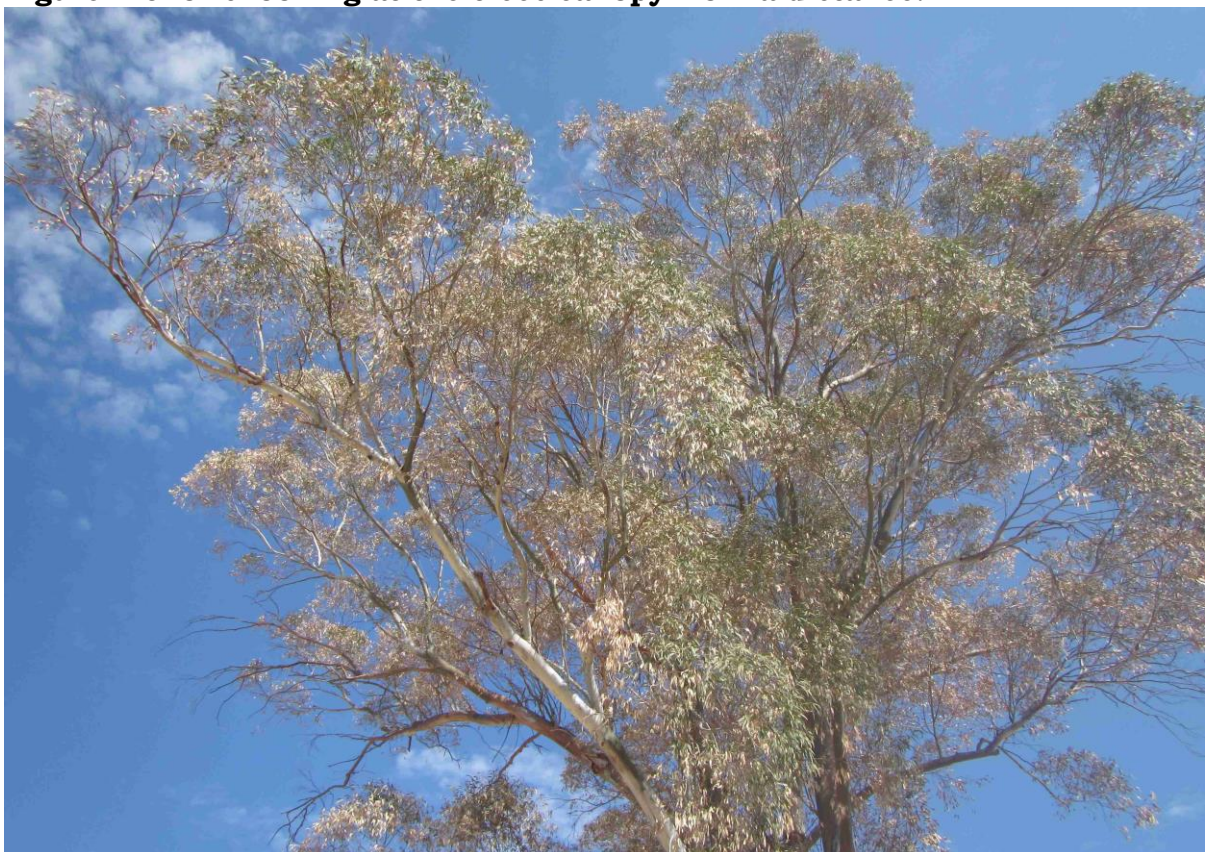
**Figure 2 Shows minor sections of live canopy.**

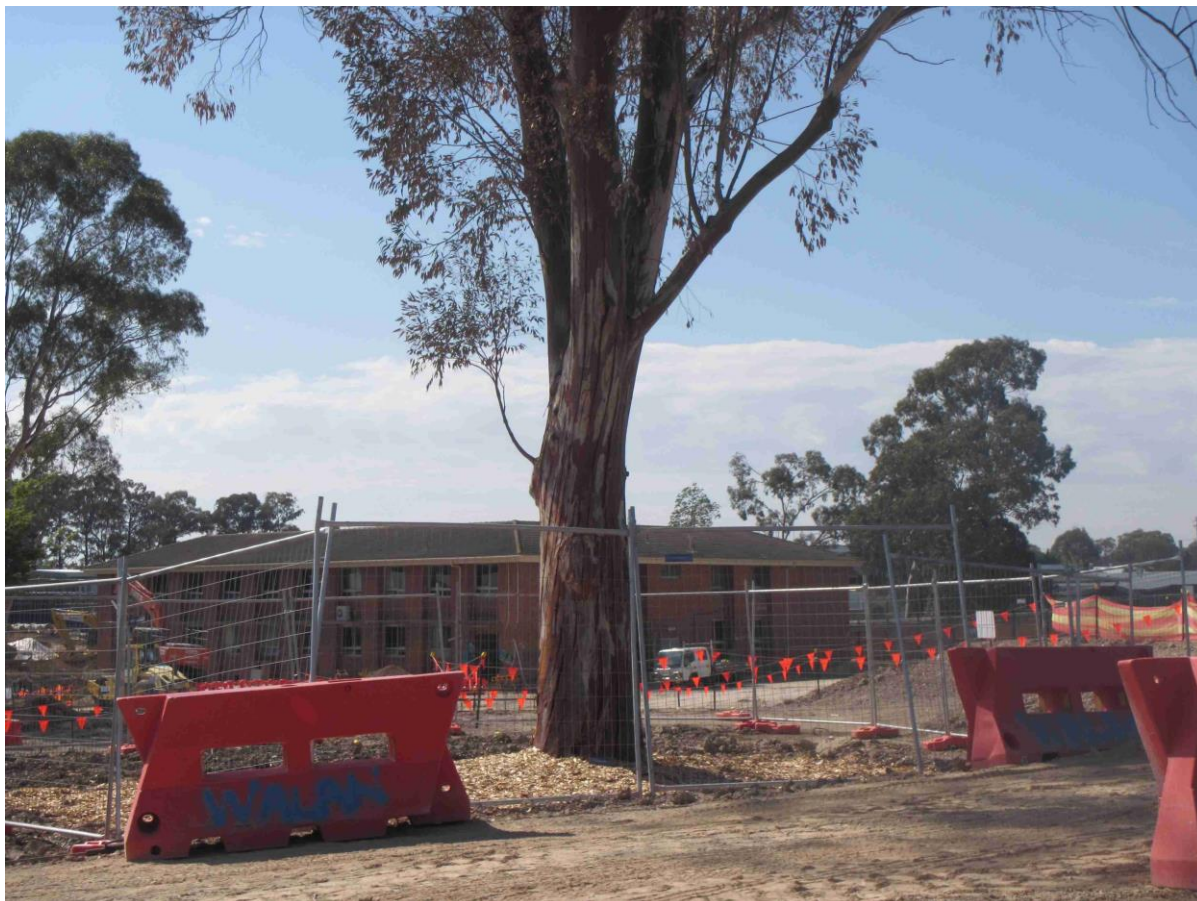
**Figure 3 Shows the trees lower trunk within TPZ from a distance.**

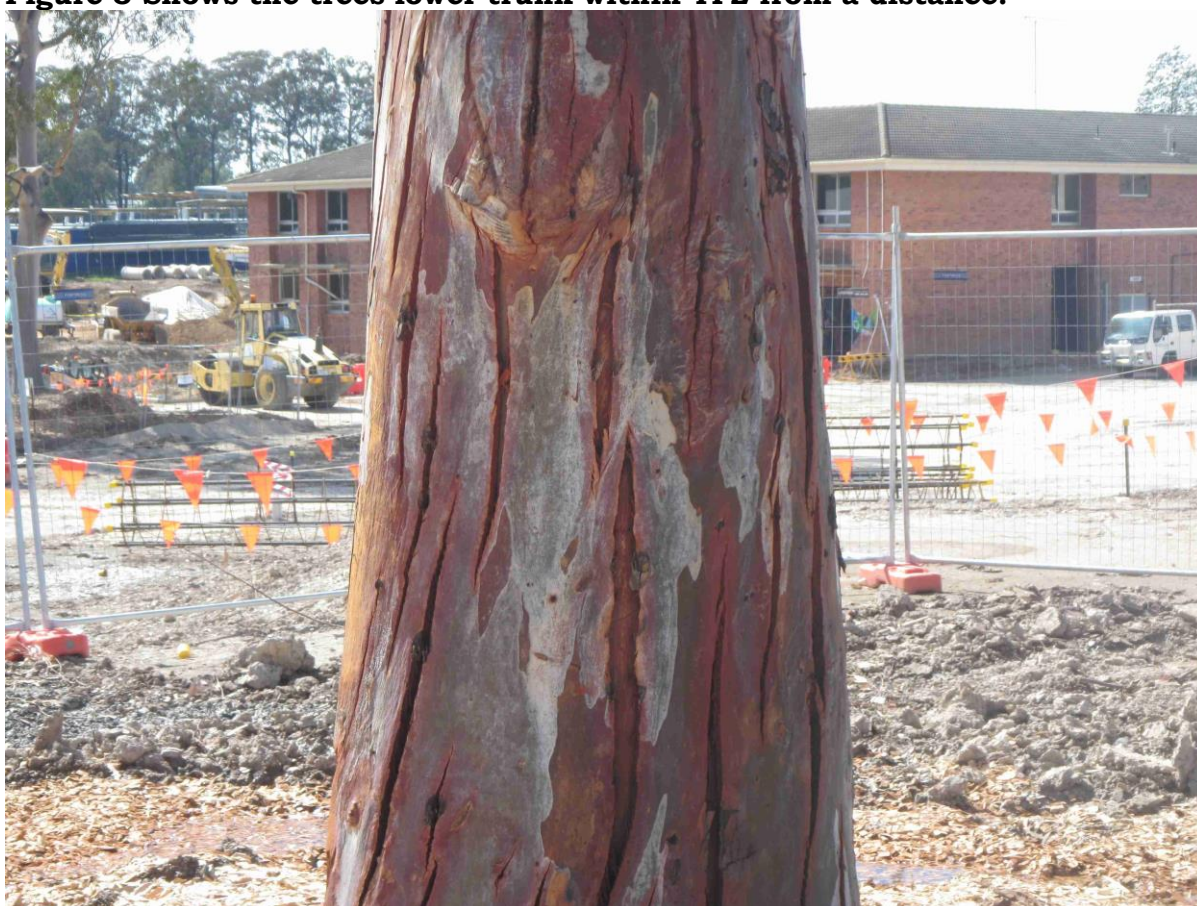
Based upon our inspection, the tree appeared to be in poor health and overall structural condition. The tree appears to have been struck by lightening in recent storm events, this opinion is based on a large scar running vertically down one side of the trunk with additional splitting of the trees outer cambium and rapid decline of the trees canopy.

**Figure 4 Shows the lower trunk from a distance with major splitting from possible lightning strike in poor health and structural condition.**

This tree is required to be removed immediately due to WH&S concerns if retained, as it has the potential to cause death or damage to persons or property within the construction zone.

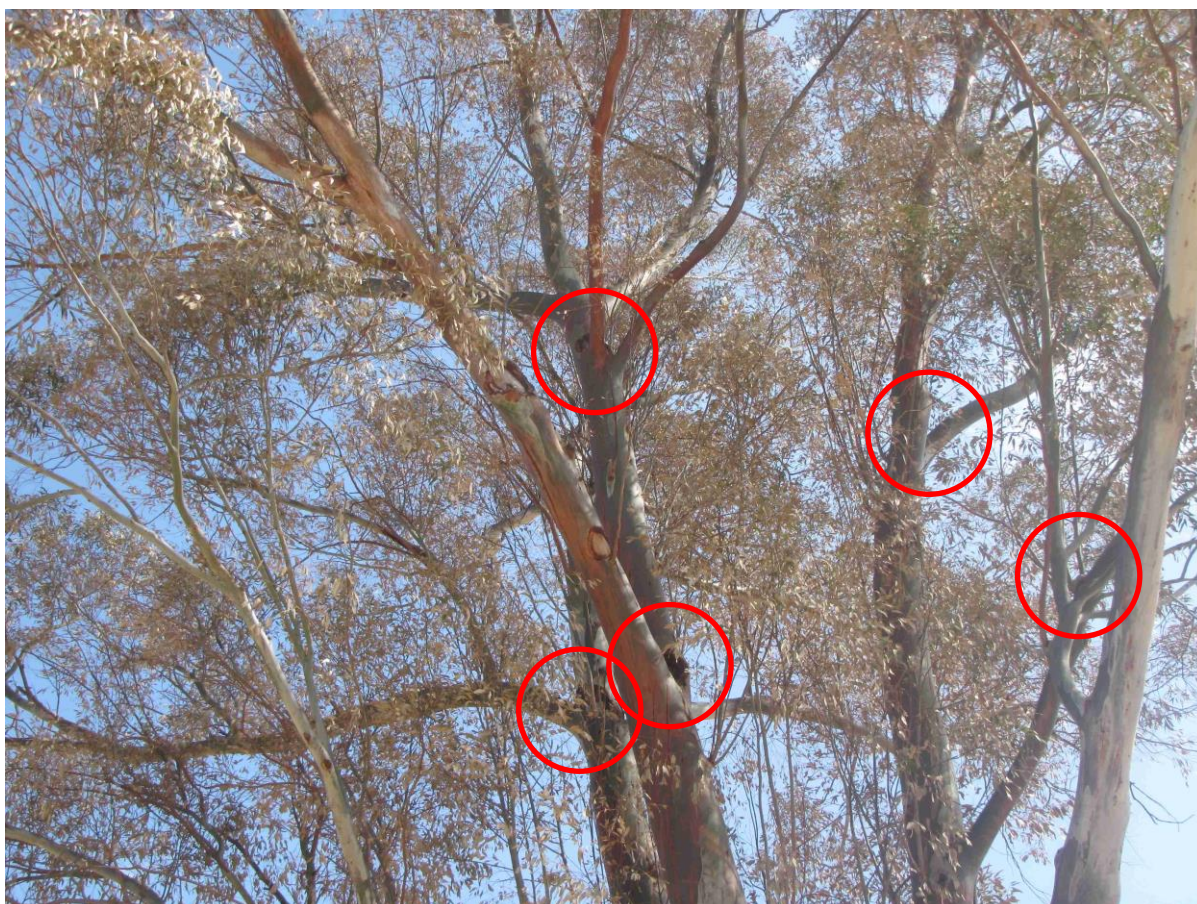
This tree is unable to be safely retained due to its poor health, furthermore, this tree has numerous noted poor branch inclusions from Cockatoo damage that has resulted in large open wounds in the upper scaffold unions and poor weight distribution of the outer limbs/canopy from these structural faults. (See Site Photos attached).

**Figure 5 Shows poor branch inclusions with major cockatoo damage.**

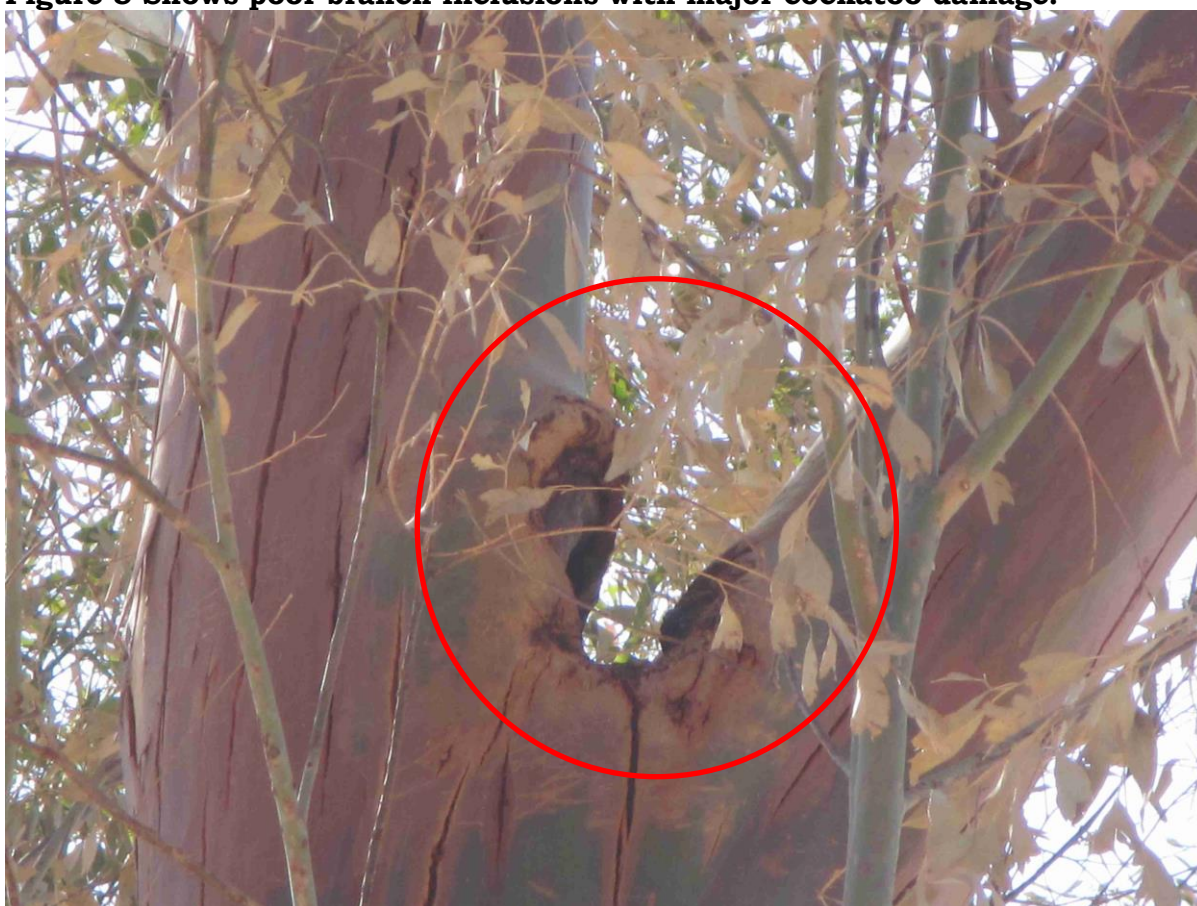
**Figure 6 Shows a close up of a poor branch union.**

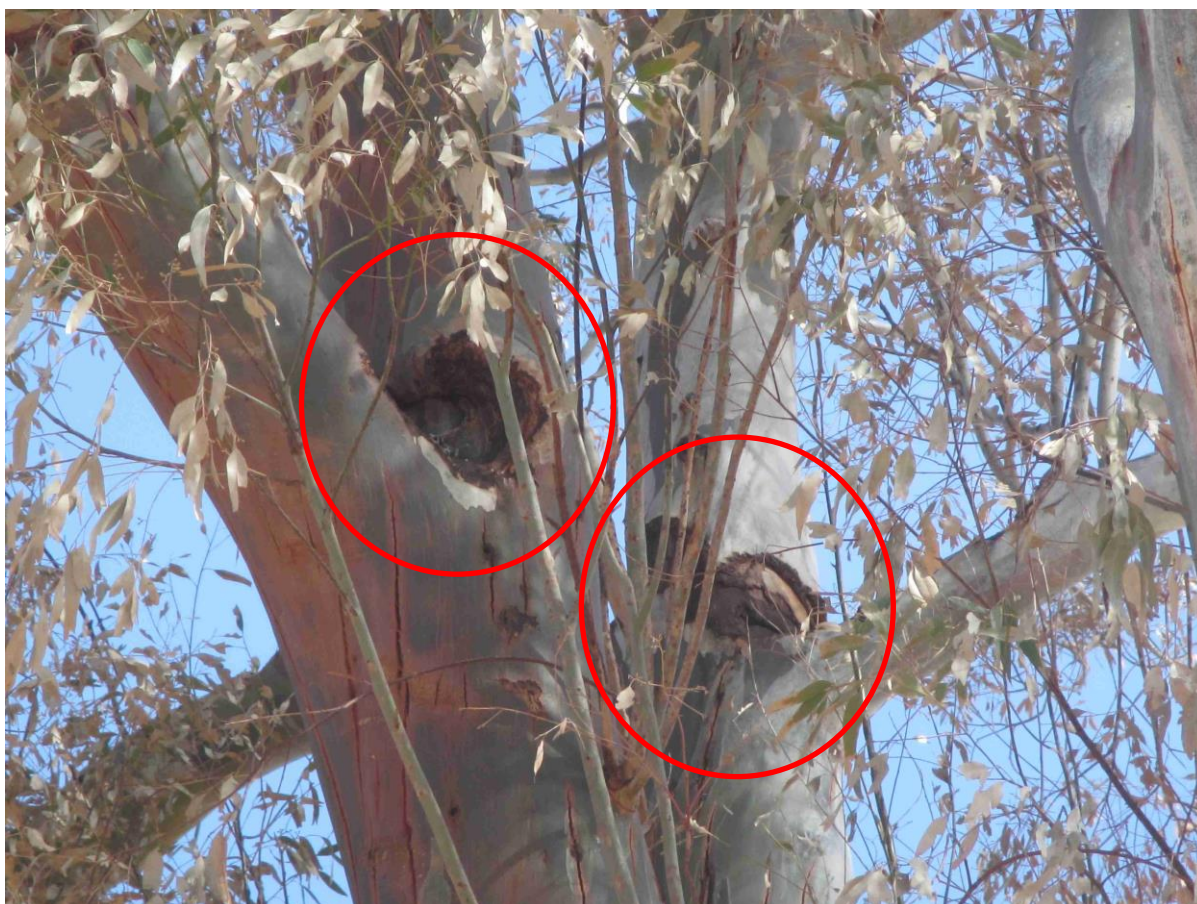
**Figure 7 Shows two more poor branch inclusions that present serious WH&S concerns if retained.**

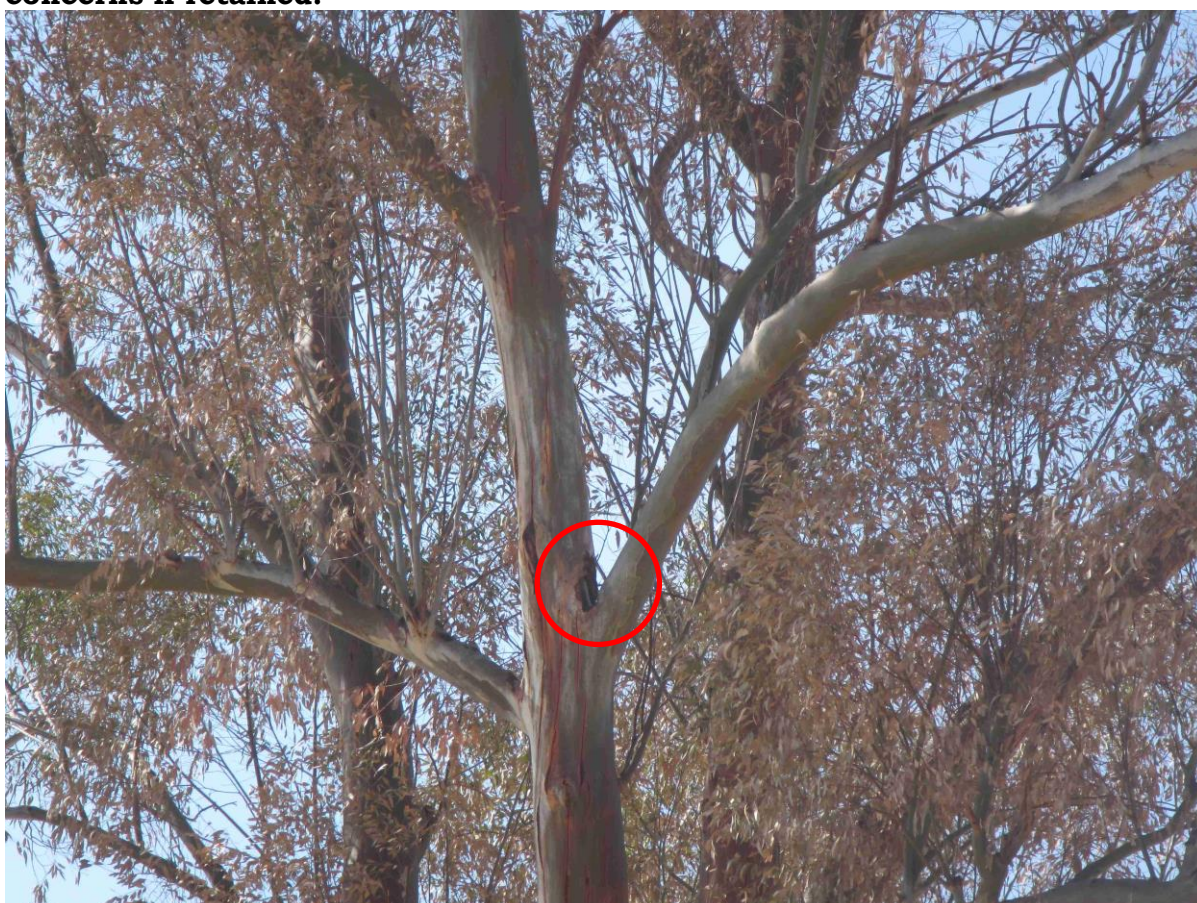
**Figure 8 Shows again the branch structure with poor unions.**
