# SCHEDULE OF CONSERVATION WORKS

*Belmont House - St. John of God Richmond Hospital*  
177 Grose Vale Rd, North Richmond NSW 2753

November 2021 | J3780

**Weir  
Phillips**  
**Heritage  
and Planning**

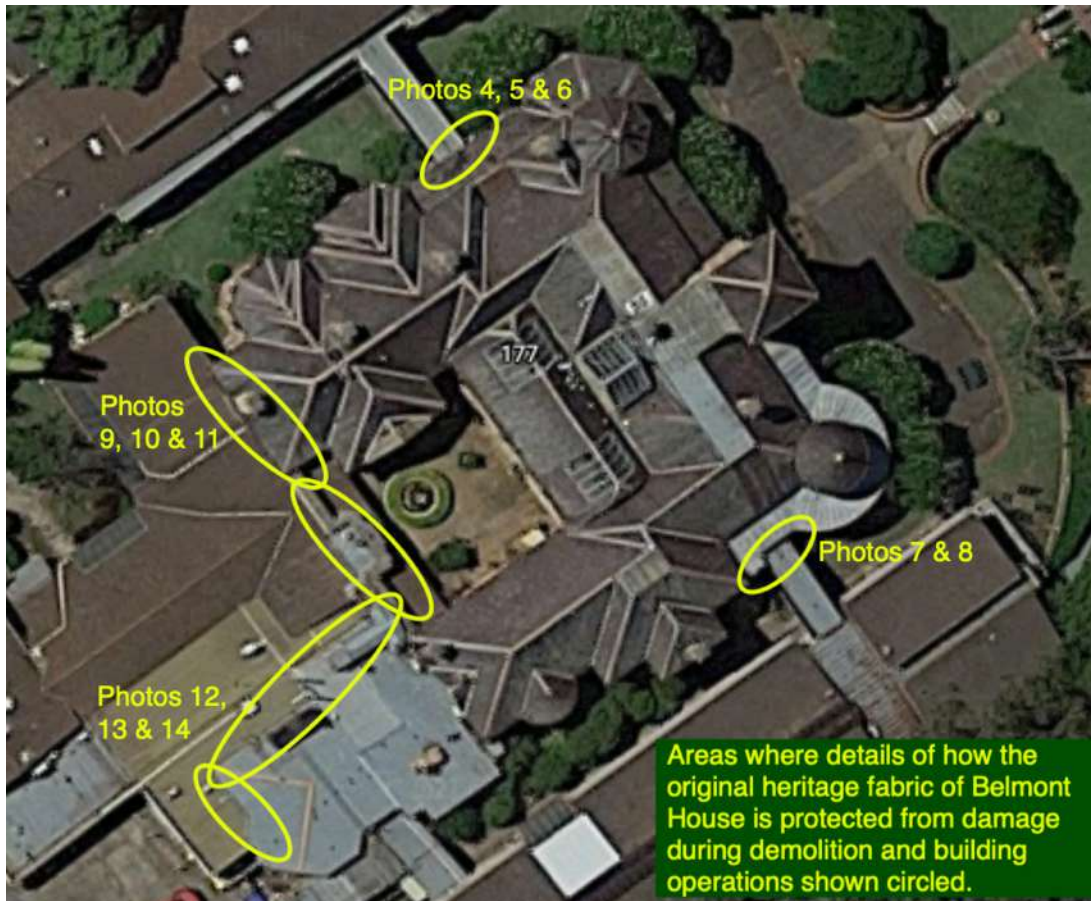
**Photo. 3.** A detailed description is to be provided showing how areas circled above and in photos 4, 5, 6, 7, 8, 9, 10, 11, 12, 13 and 14 are to be protected from damage during demolition and building operations.

- A detailed description is to be provided showing how areas noted in photo 3 and shown in photos 4, 5, 6, 7, 8, 9, 10, 11, 12, 13 and 14 are to be protected from damage during demolition and building operations.

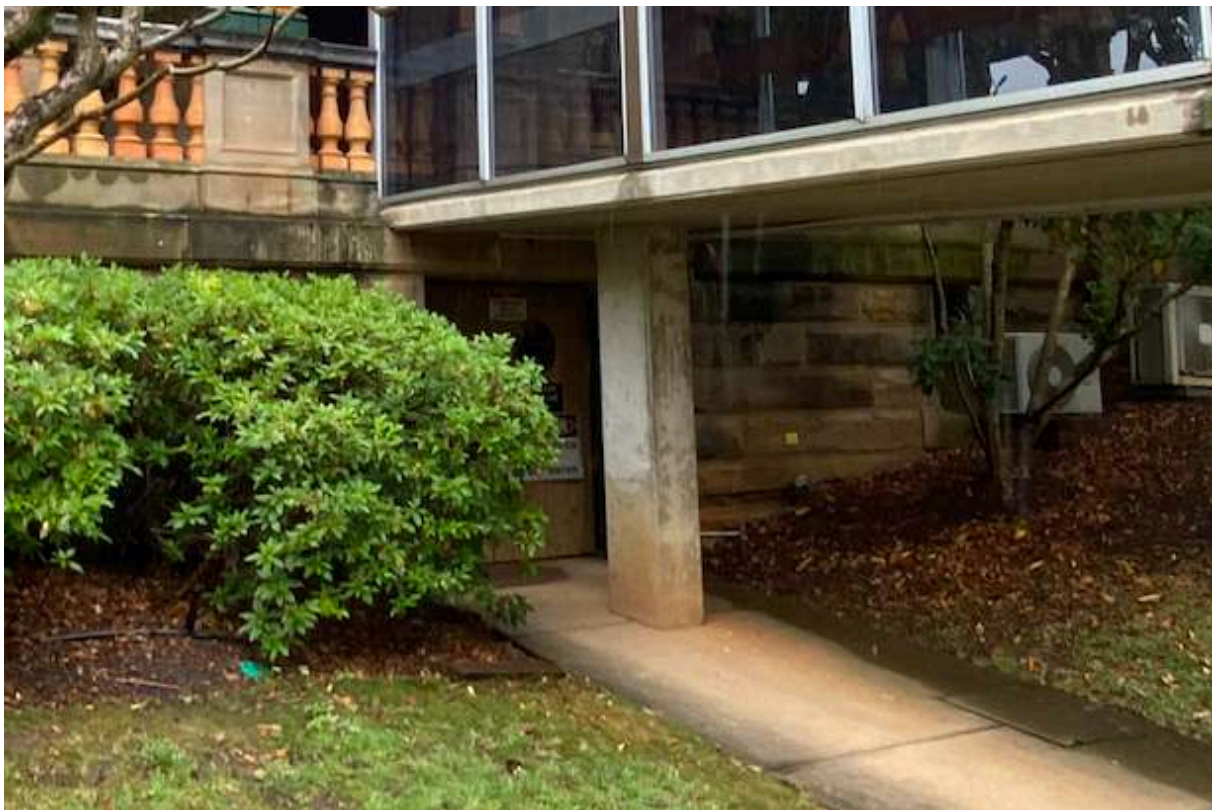
**Photo. 4.** Provide protect to heritage sandstone while walk way is being removed.

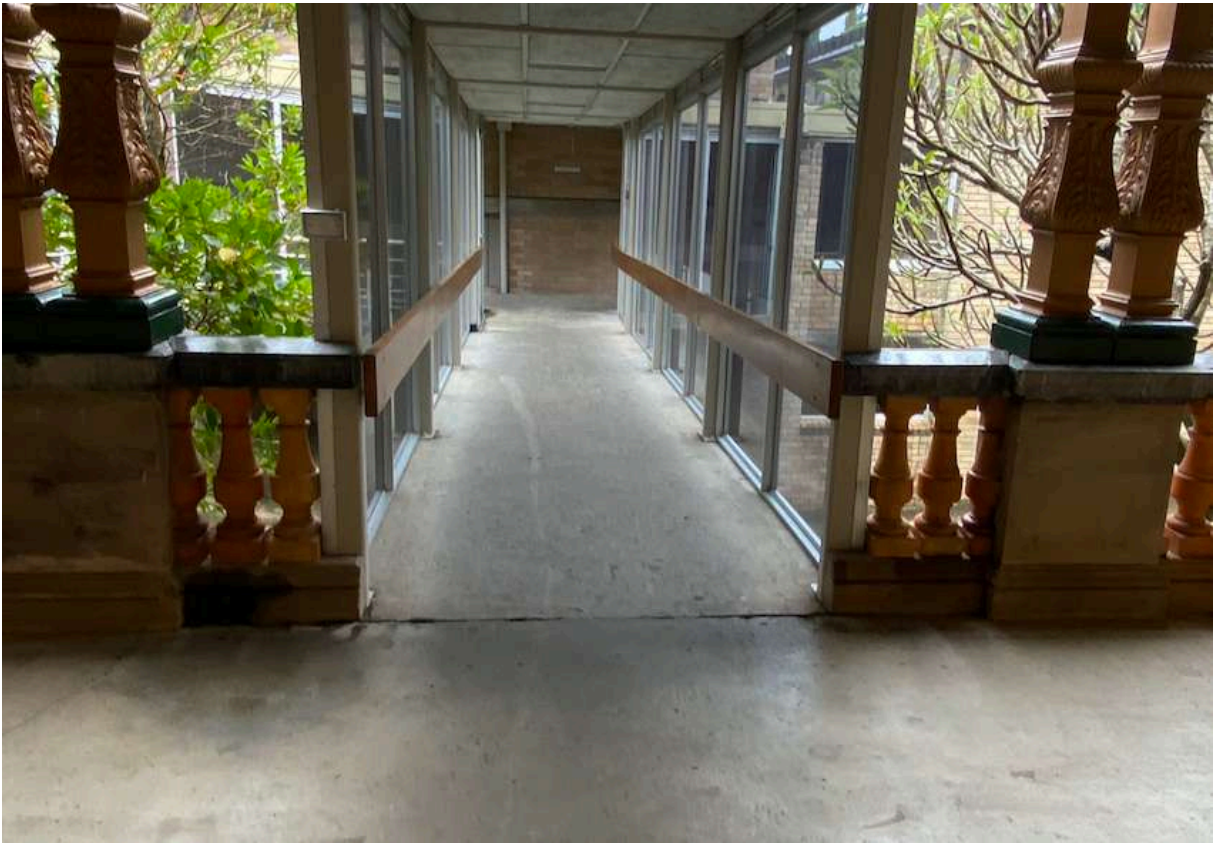
**Photo. 5.** Provide detail and description of how the balustrade is to be reinstated where walkway is being removed.

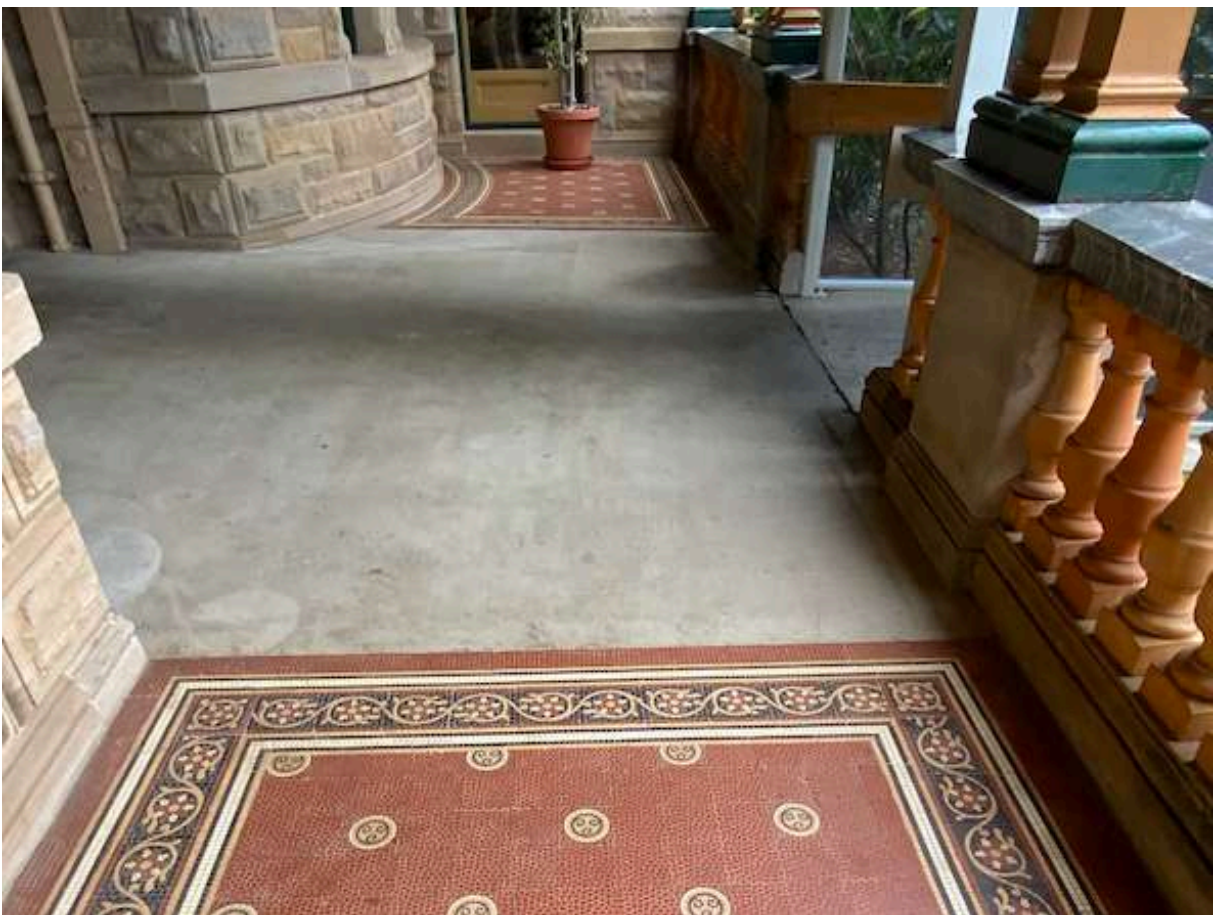
**Photo. 6.** Provide protect to heritage tiles and rendered verandah floor while walk way is being removed.

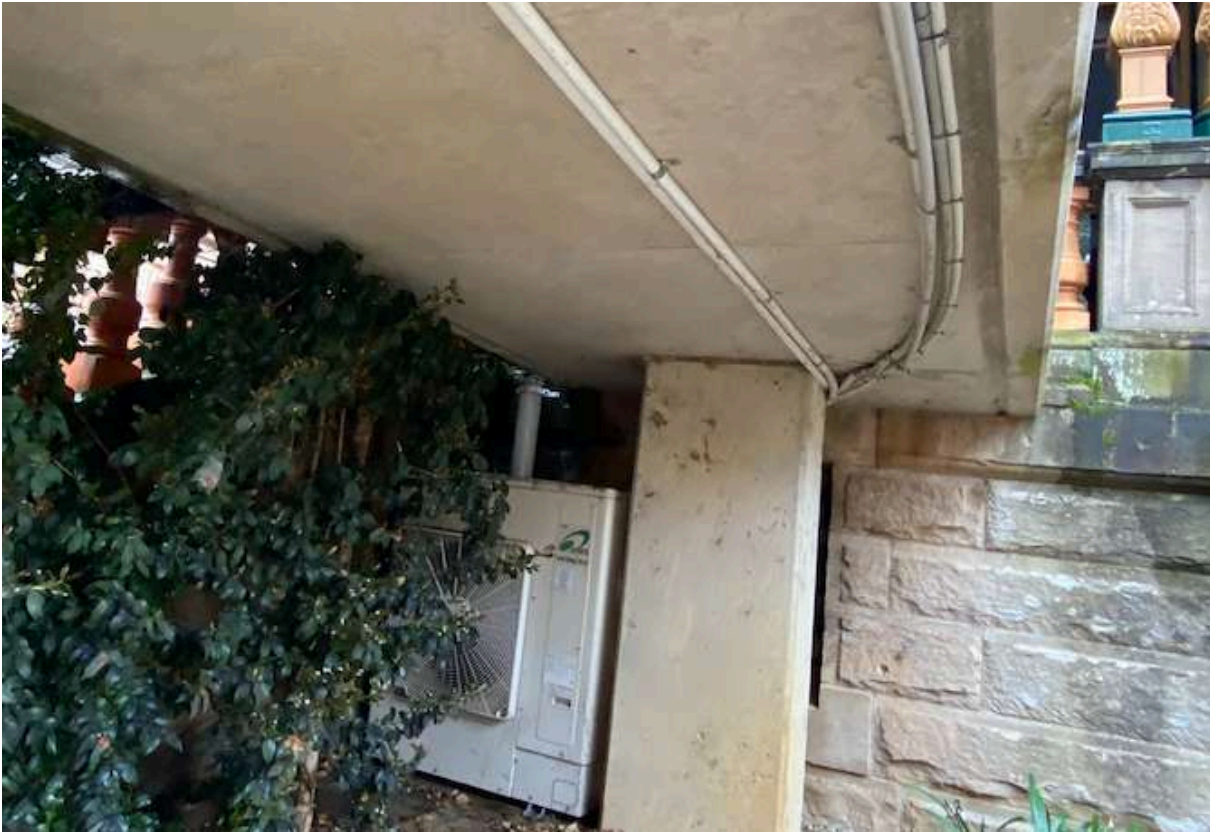
**Photo. 7.** Provide protect to heritage sandstone while walk way is being removed.

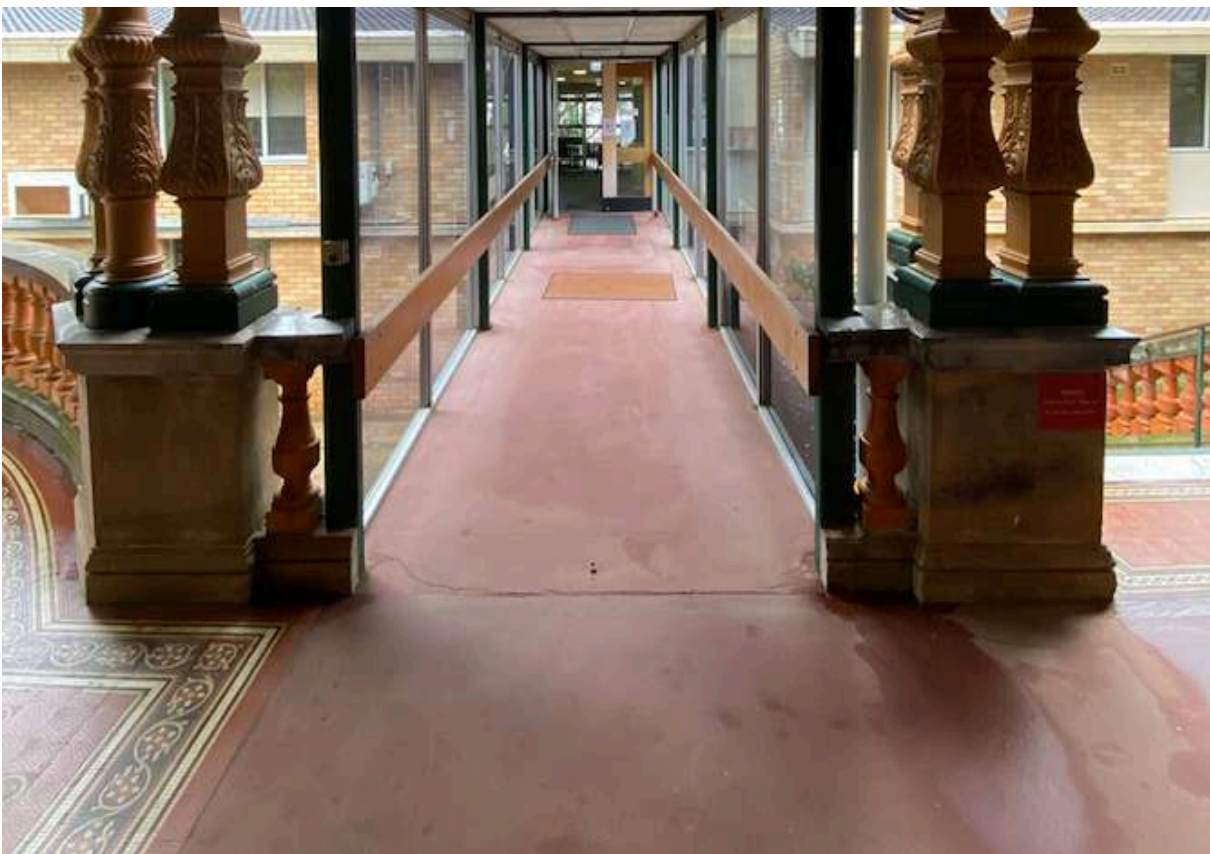
**Photo. 8.** Provide detail and description of how the balustrade is to be reinstated where walkway is being removed. Provide protect to heritage tiles and rendered verandah floor while walk way is being removed.

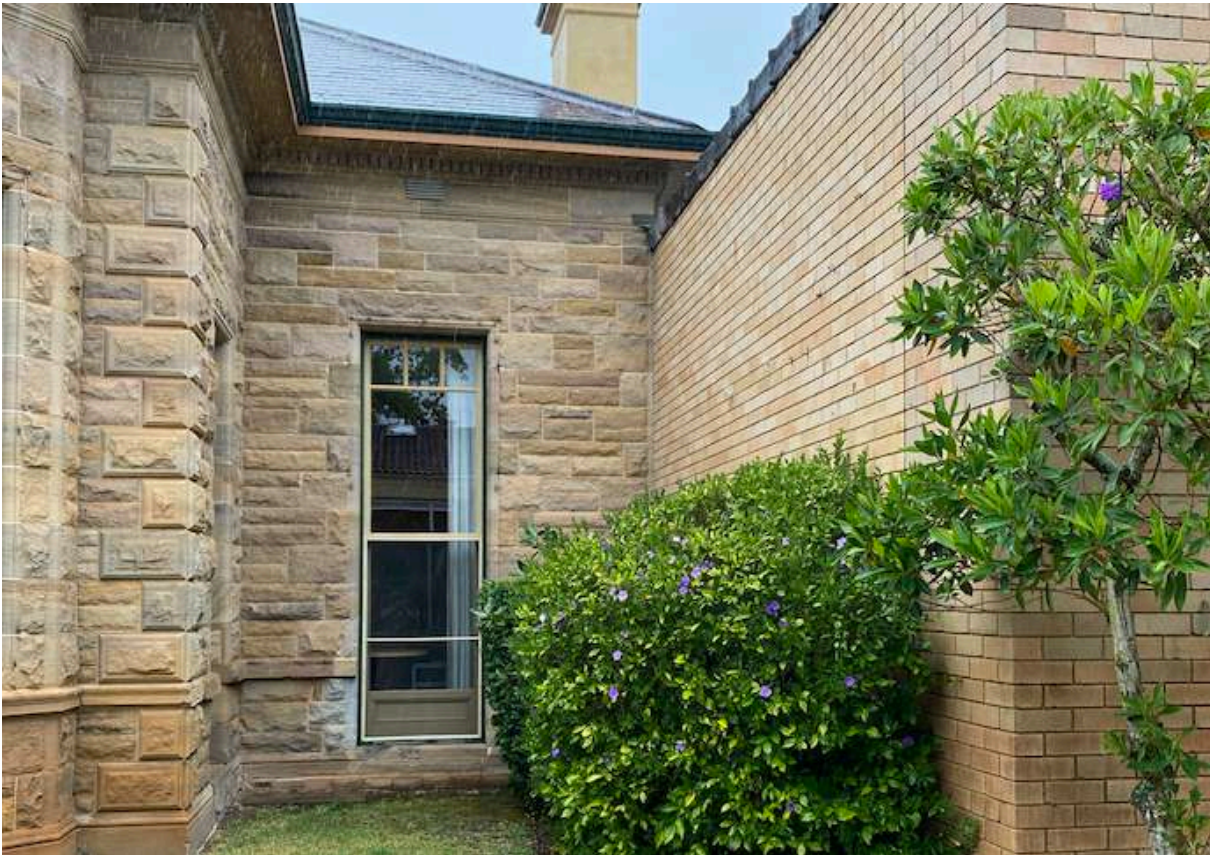
**Photo. 9.** Provide protect to heritage sandstone while adjoining structure is being removed.

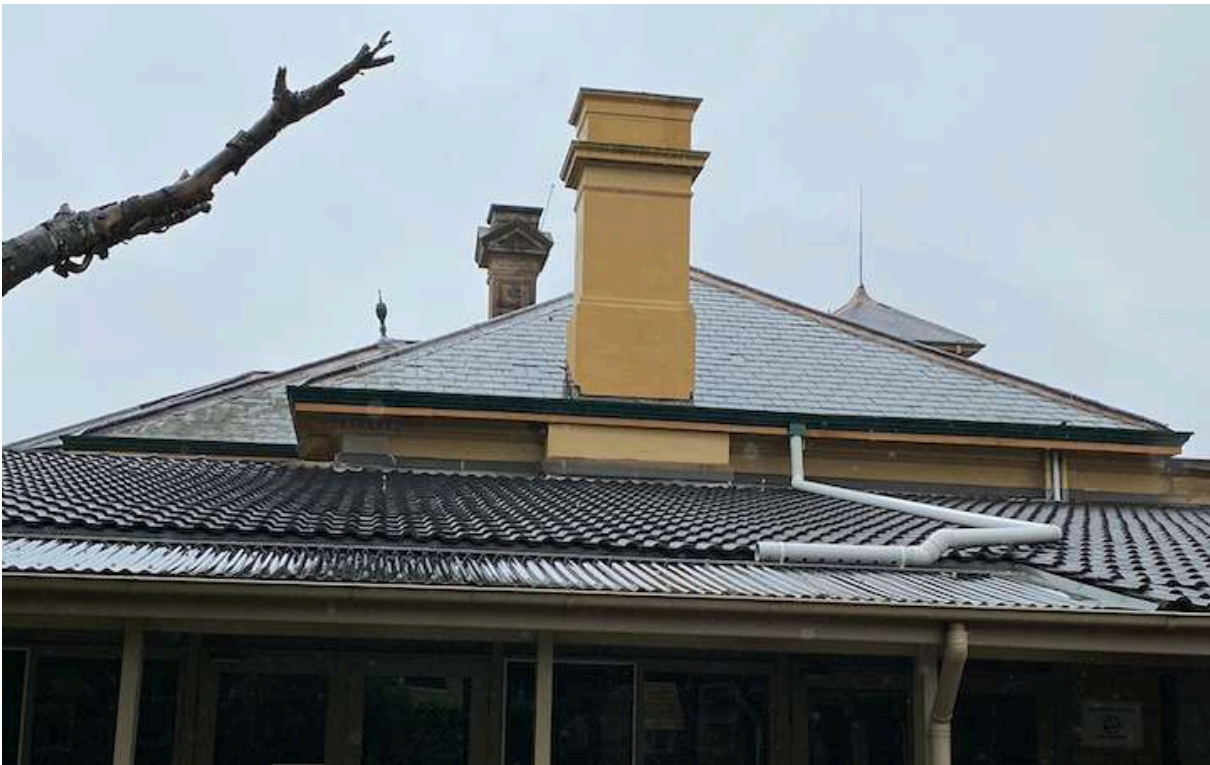
**Photo. 10.** Provide protect to heritage sandstone while adjoining structure is being removed.

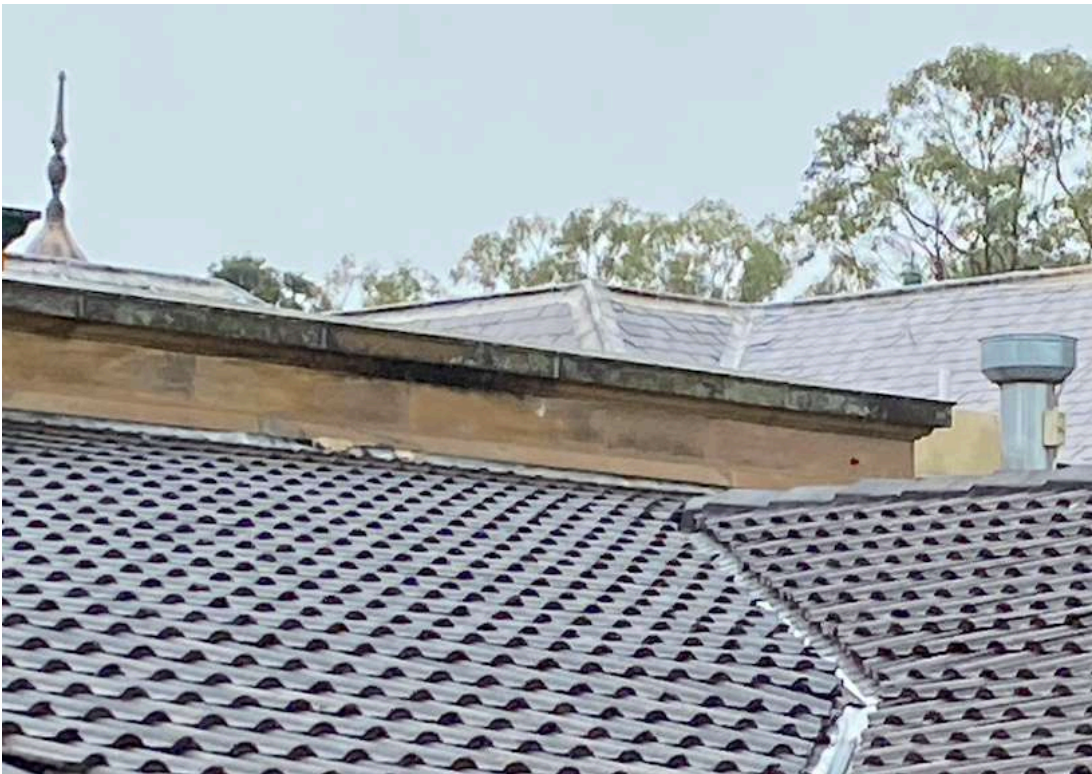
**Photo. 11.** Provide protect to heritage sandstone while adjoining structure is being removed.

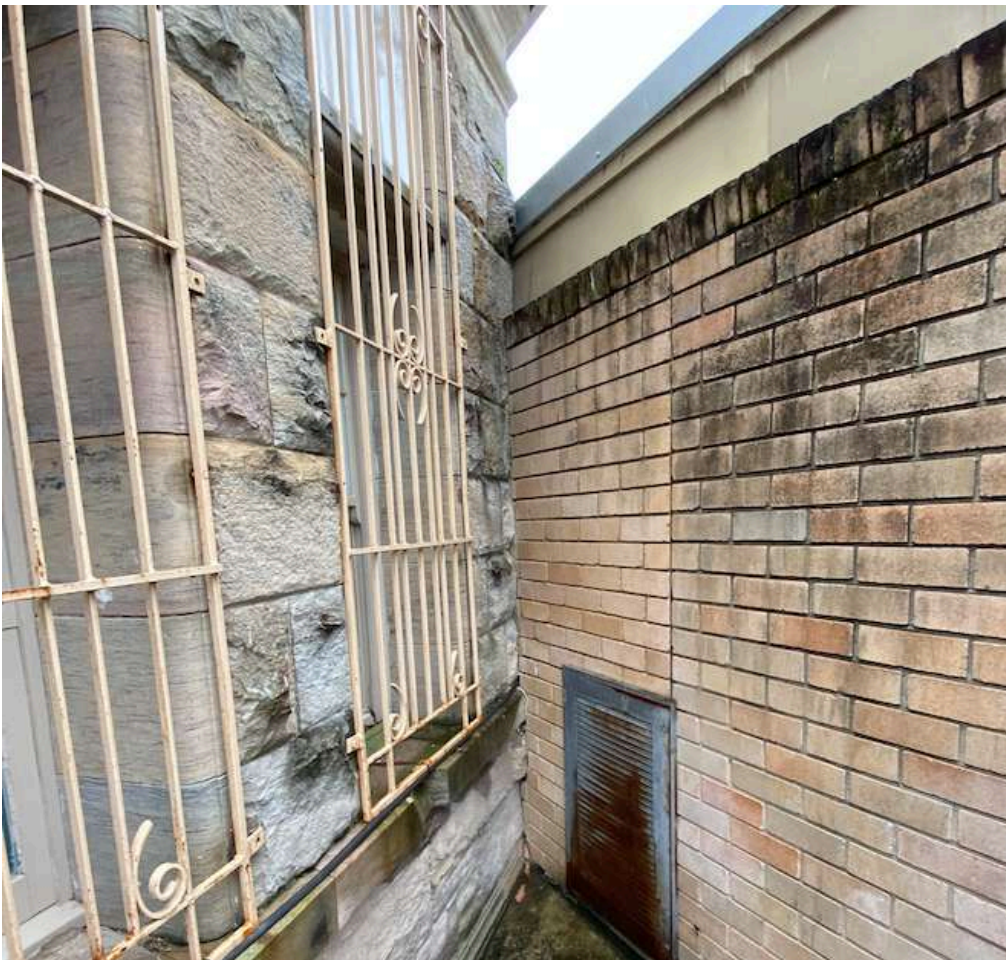
**Photo. 12.** Provide protect to heritage sandstone while adjoining structure is being removed

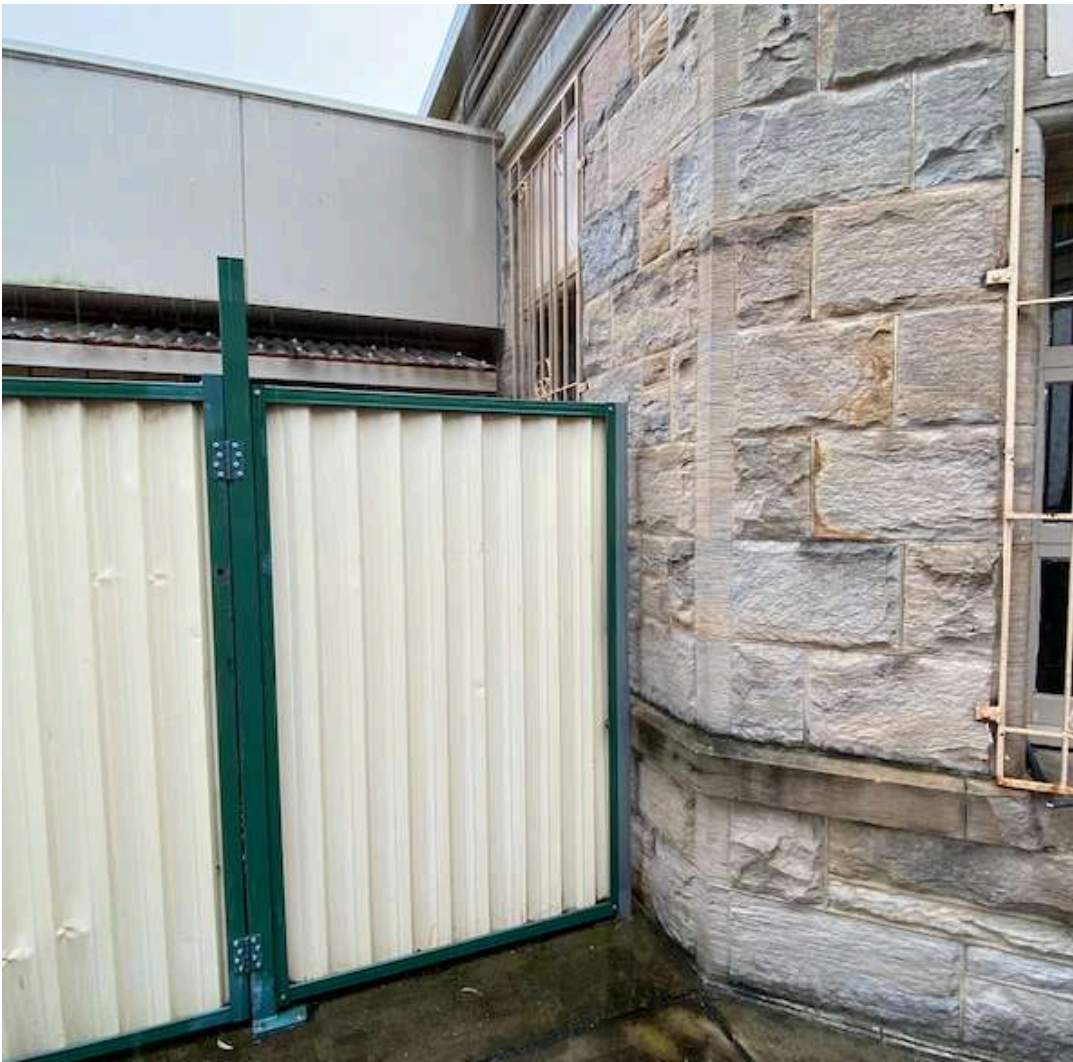
**Photo. 13.** Provide protect to heritage sandstone while adjoining structure is being removed

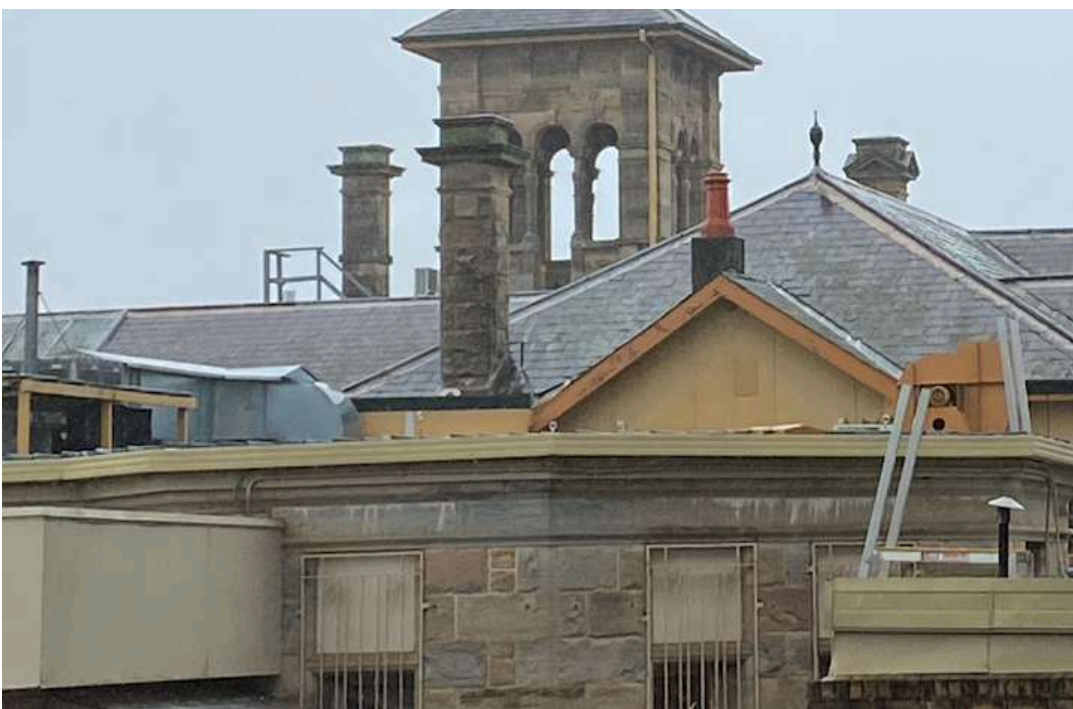
**Photo. 14.** Provide protect to heritage sandstone while adjoining structures are being removed

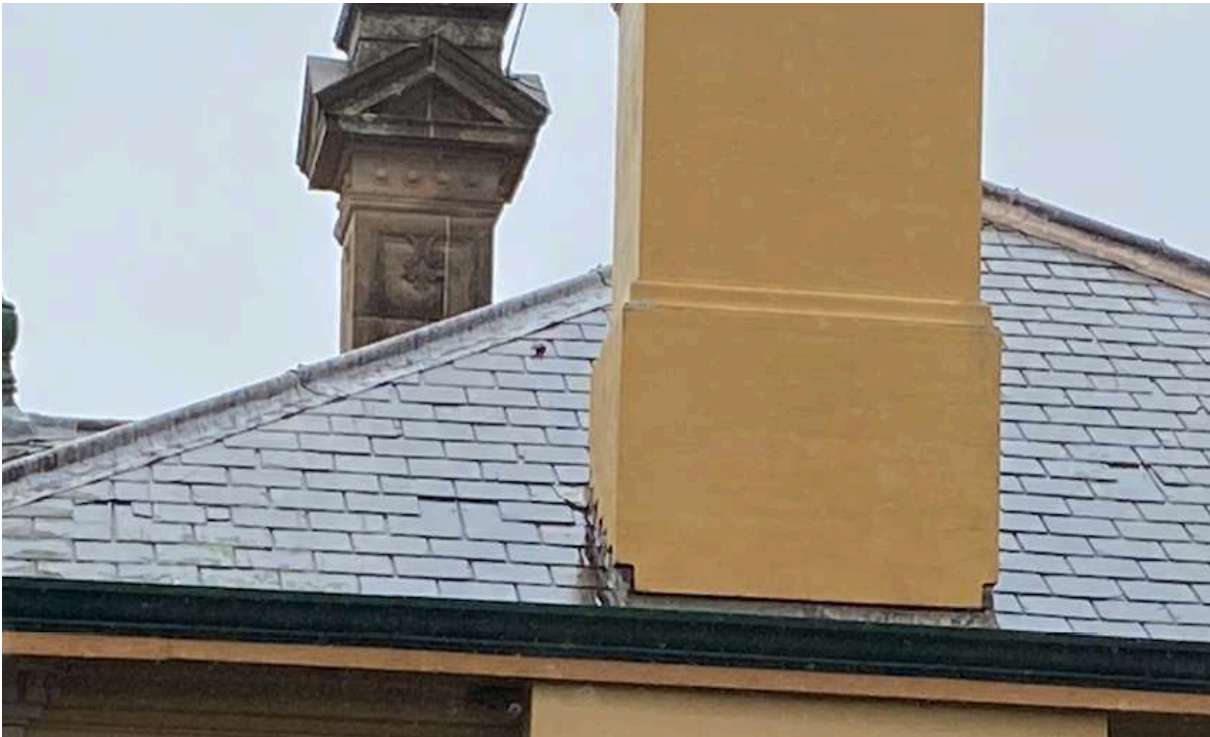
**Photo. 15.** The roof slates are to be inspected by an experienced heritage slate roofing contractor. Missing slates are to be replaced and flashings repaired where required.

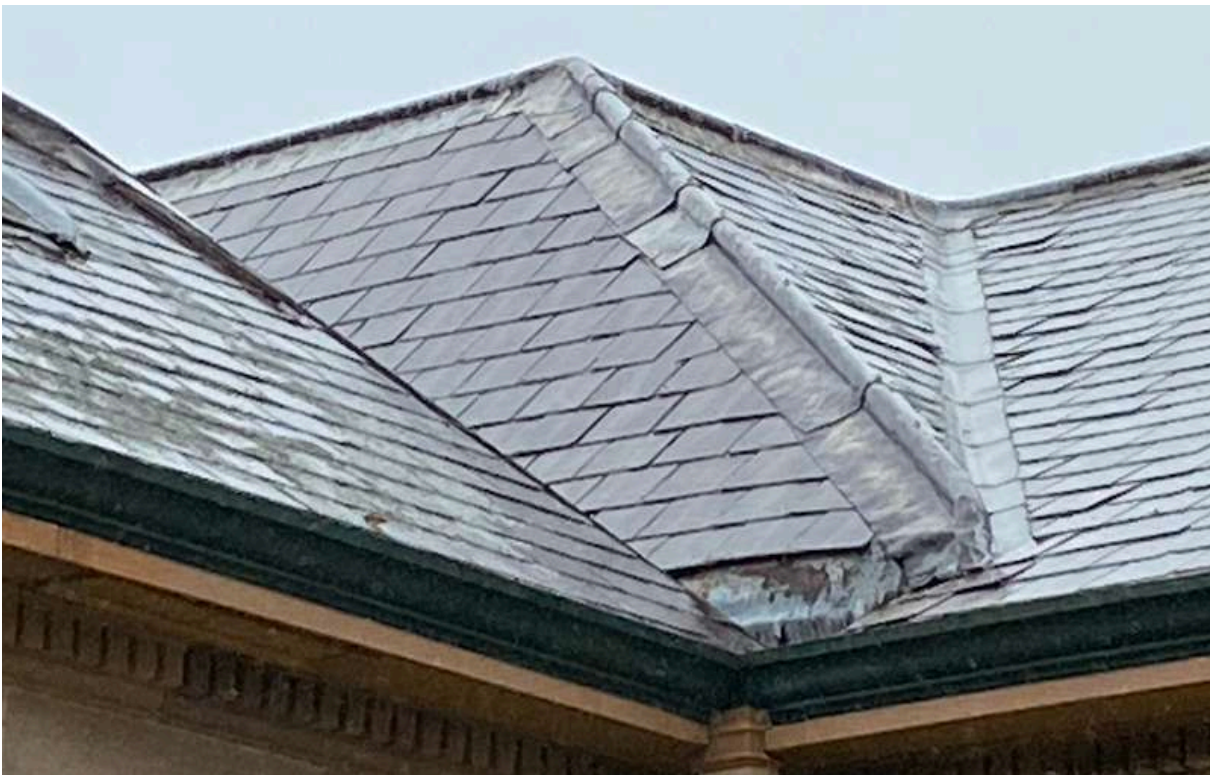
**Photo. 16.** The roof slates are to be inspected by an experienced heritage slate roofing contractor. Missing slates are to be replaced and flashings repaired where required.

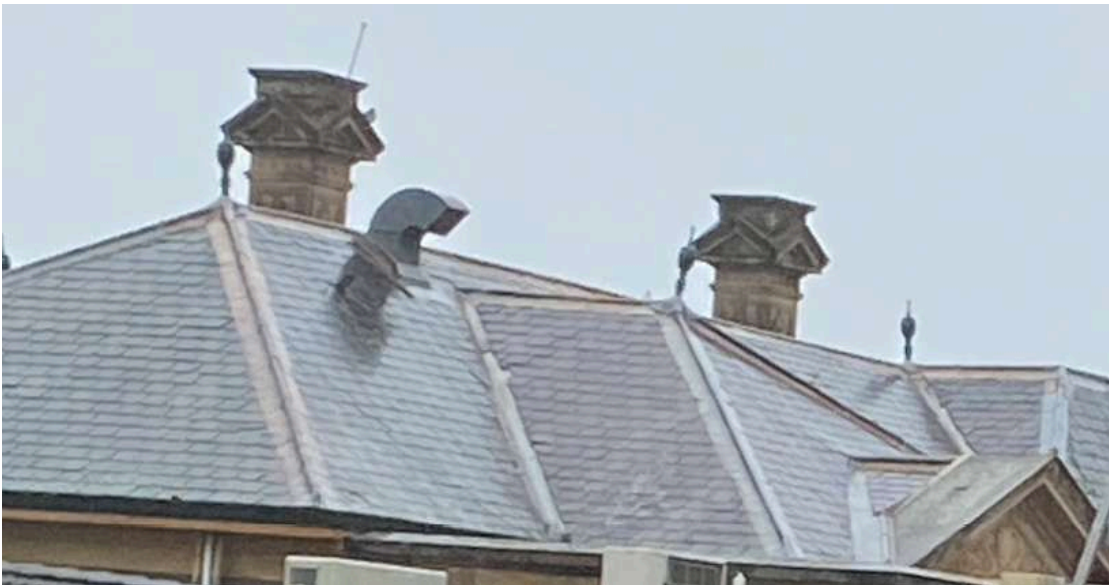
**Photo. 17.** The roof slates are to be inspected by an experienced heritage slate roofing contractor. Missing slates are to be replaced, valley gutters and flashings repaired where required.

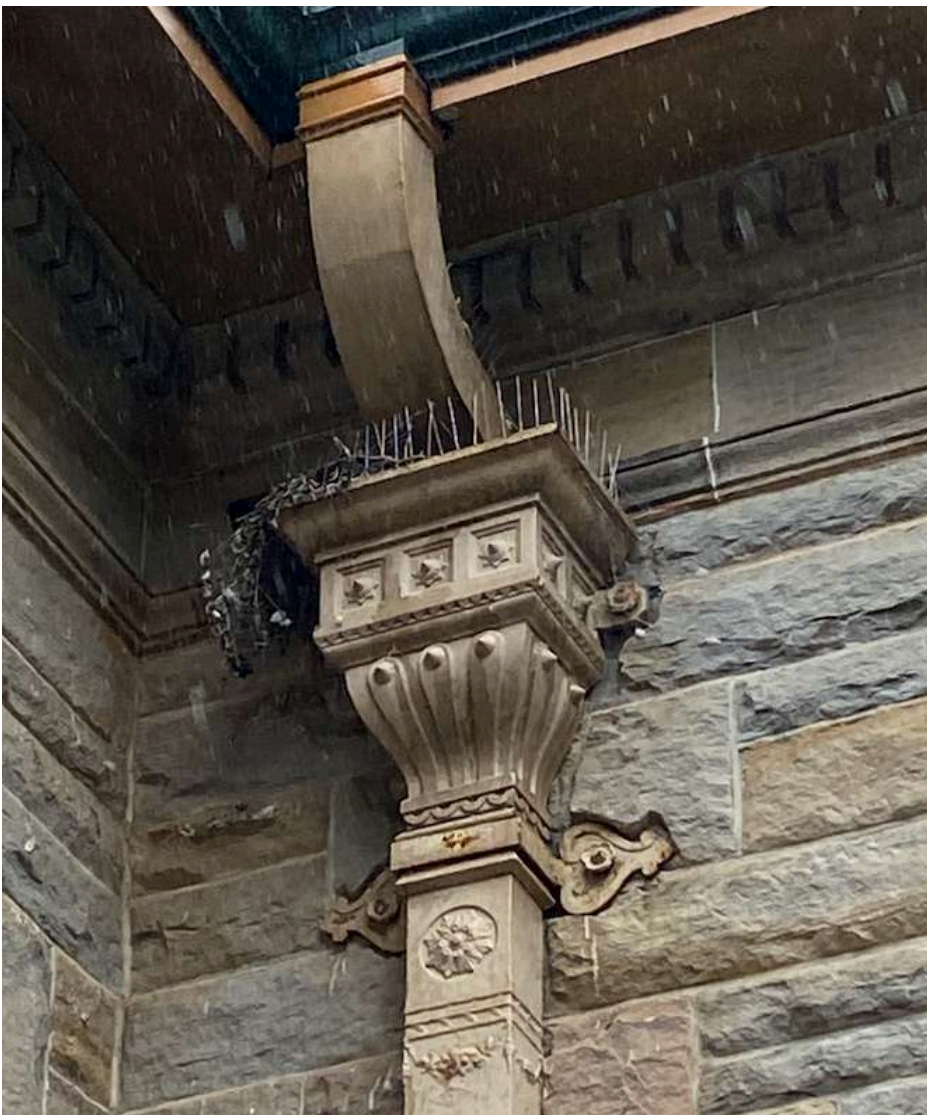
**Photo. 18.** The gutters and down-pipes are to be cleared of debris and any rusting fixings embedded in the sandstone repaired or replaced.

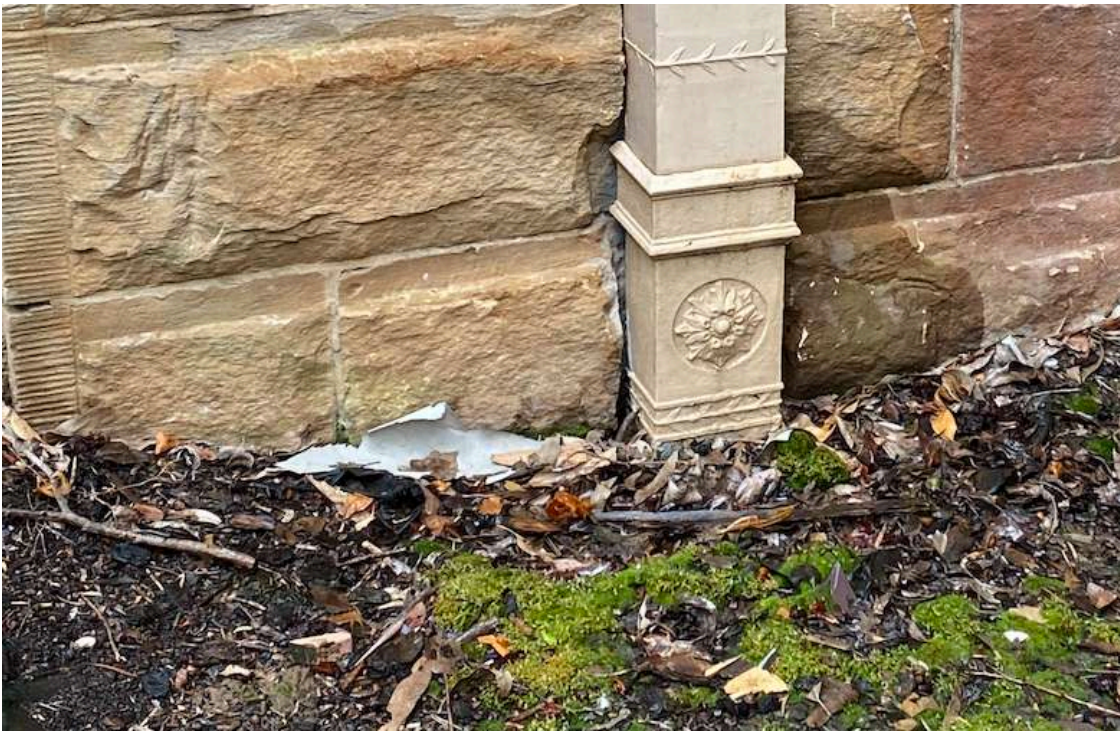
**Photo. 19.** The ground level at the wall at the bottom of the down-pipes should be lowered as the ornate cast iron down-pipes are exposed to accelerated deterioration when buried and clearing the down-pipes is impeded when access to the bottom of the down-pipe is not provided.

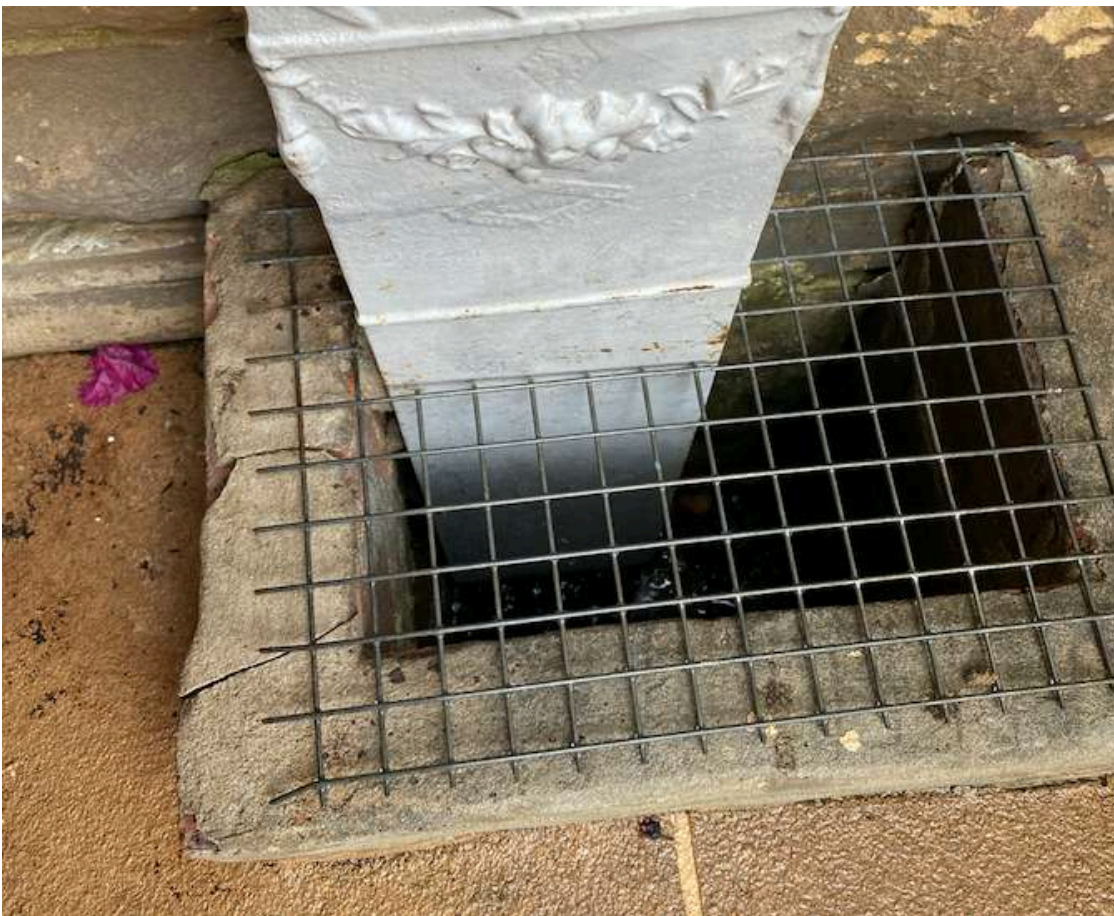
**Photo. 20.** Down-pipes should terminated above a grated stormwater pit.

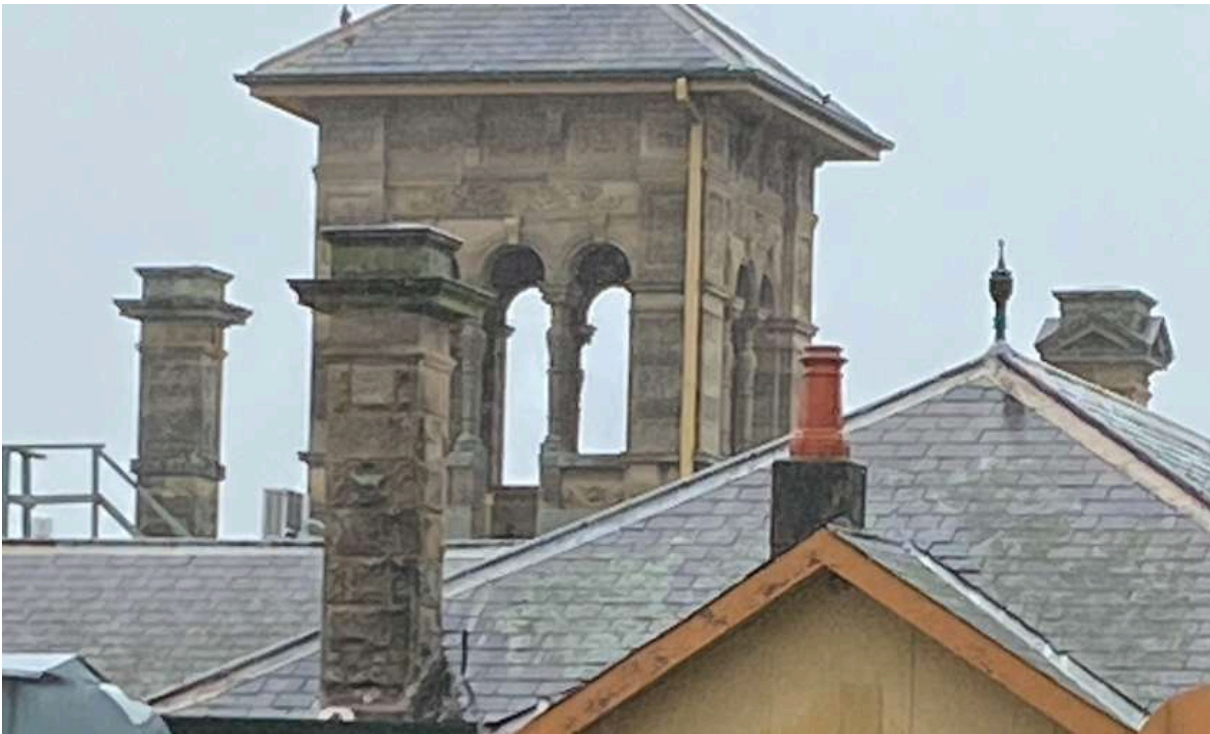
**Photo. 21.** The chimneys and sandstone roof structures are to be inspected by and experienced heritage sandstone contractor. Flashings are to be repaired as required, eroded sandstone mortar is to be re-pointed and the sandstone is to be cleaned where required.

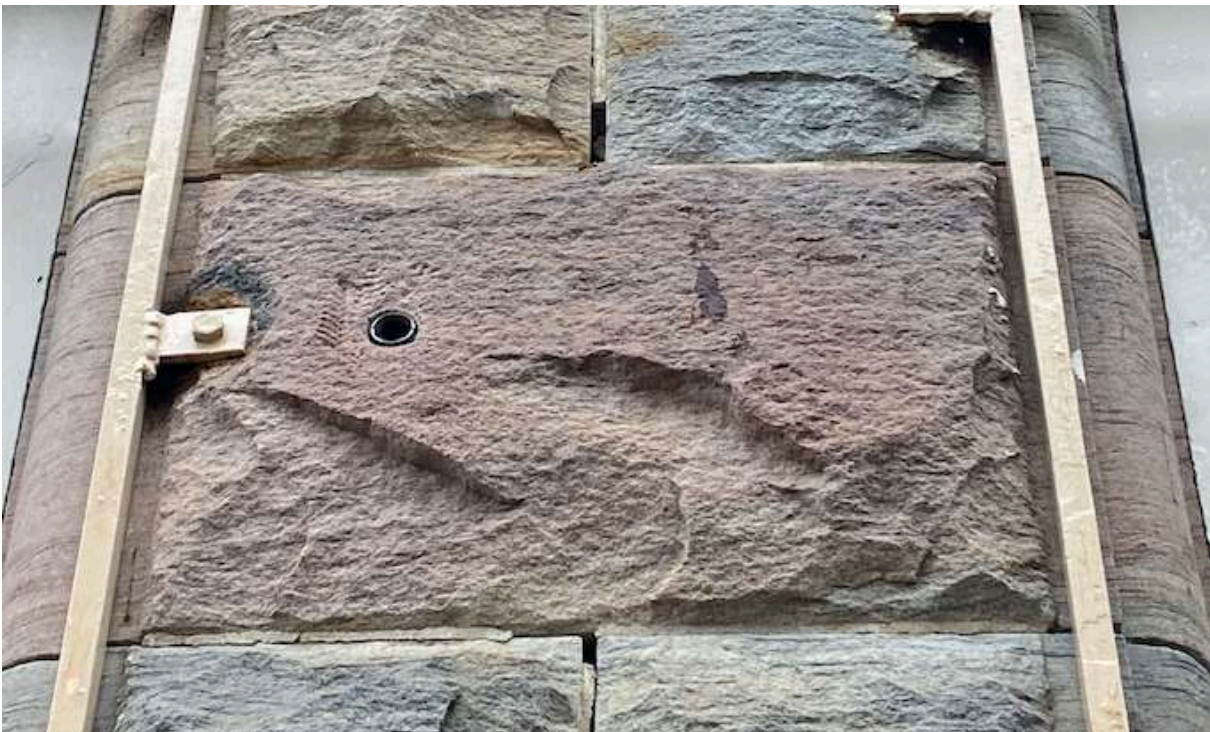
**Photo. 22.** All redundant masonry anchor remnants embedded in the sandstone are to be removed and eroded sandstone mortar is to be re-pointed.

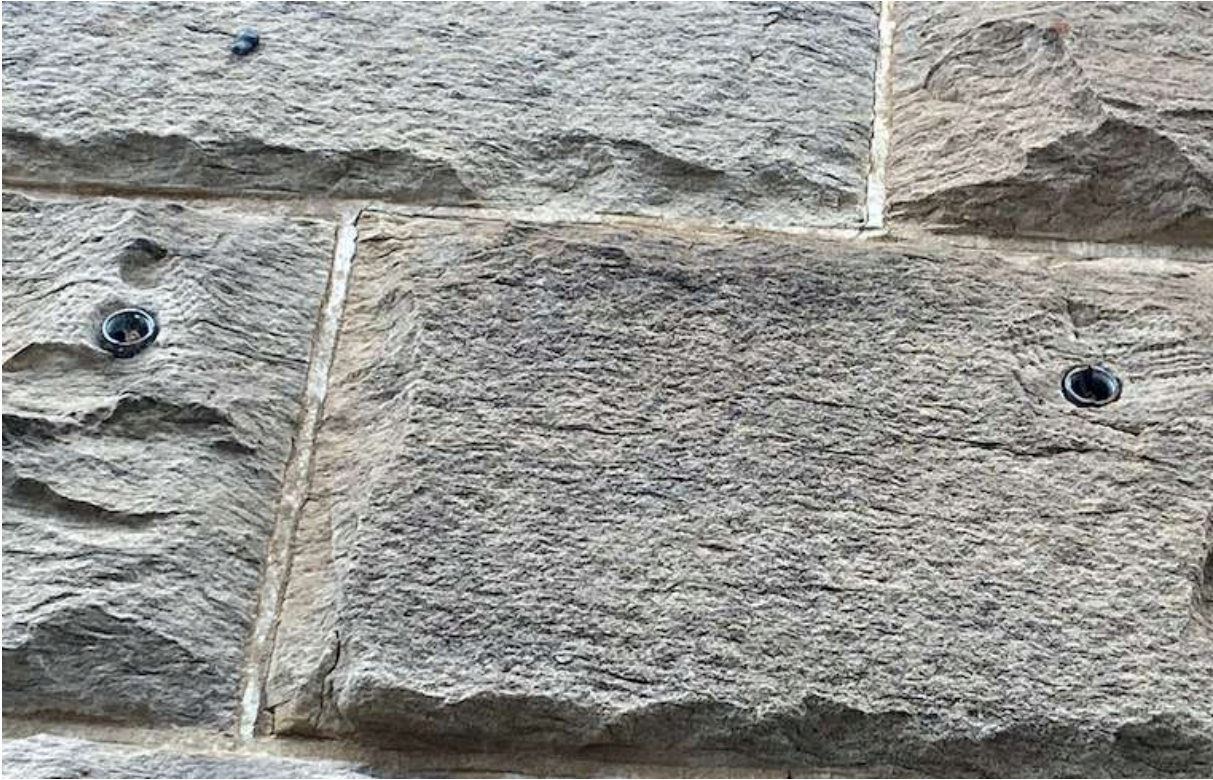
**Photo. 23.** All redundant masonry anchor remnants embedded in the sandstone are to be removed.

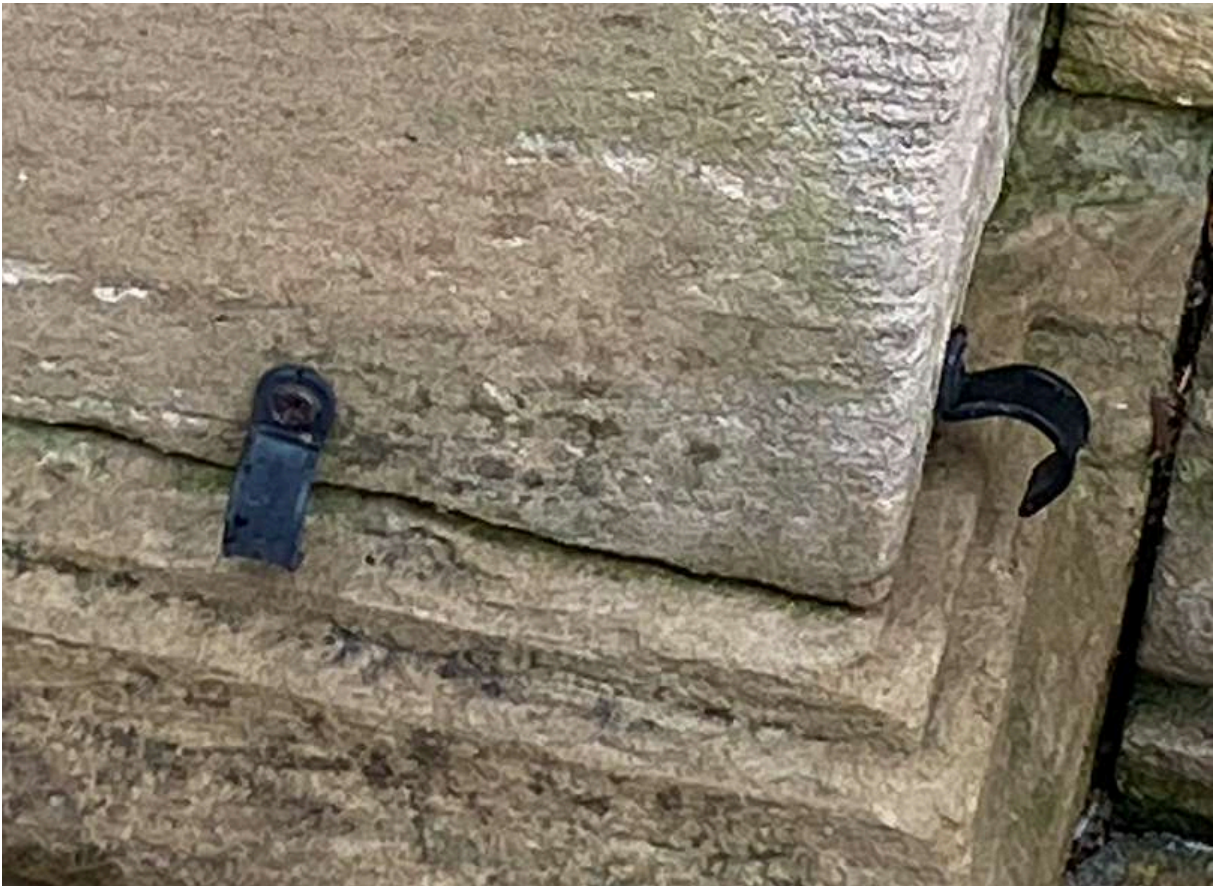
**Photo. 24.** All rusting steel saddles and the like attached and embedded in the sandstone are to be removed.

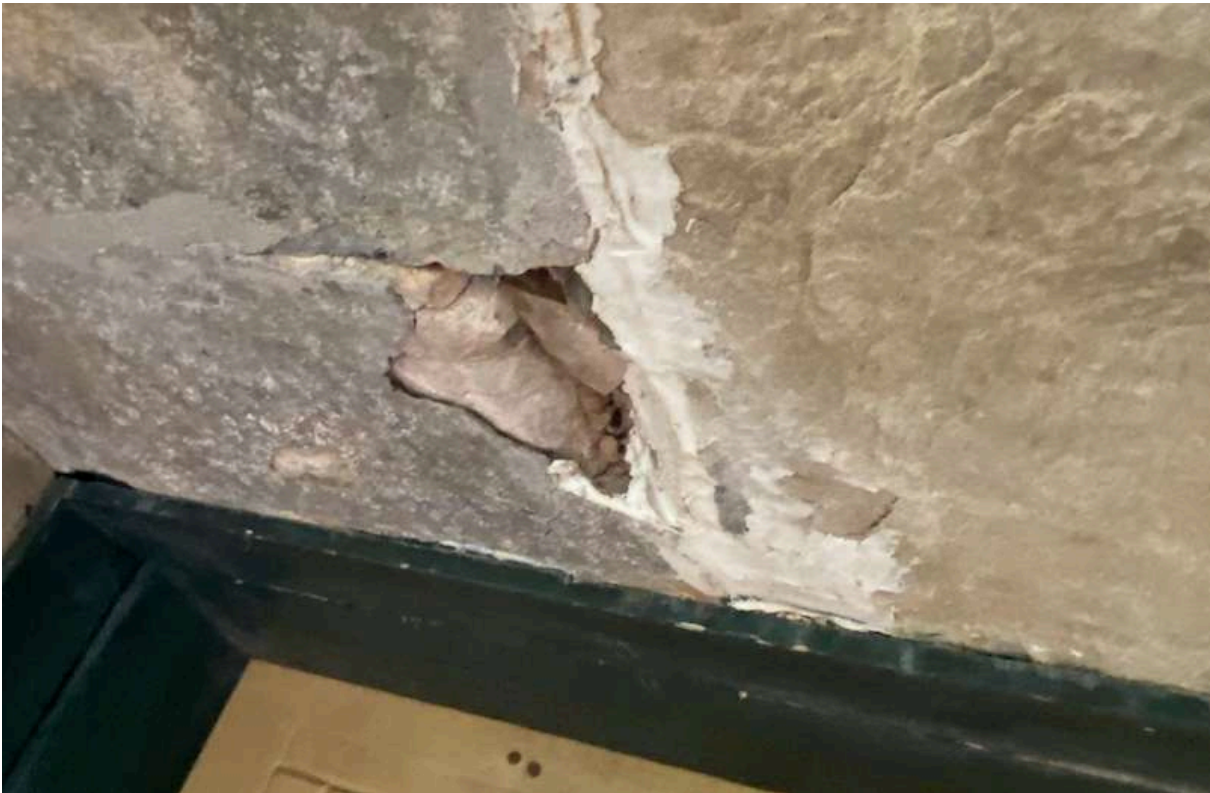
**Photo. 25.** All damaged and missing sandstone mortar is to be inspected by an experienced heritage sandstone contractor and repaired where required.
