# SCHEDULE OF CONSERVATION WORKS

*Belmont House - St. John of God Richmond Hospital*  
177 Grose Vale Rd, North Richmond NSW 2753

November 2021 | J3780

**Weir  
Phillips**  
**Heritage  
and Planning**

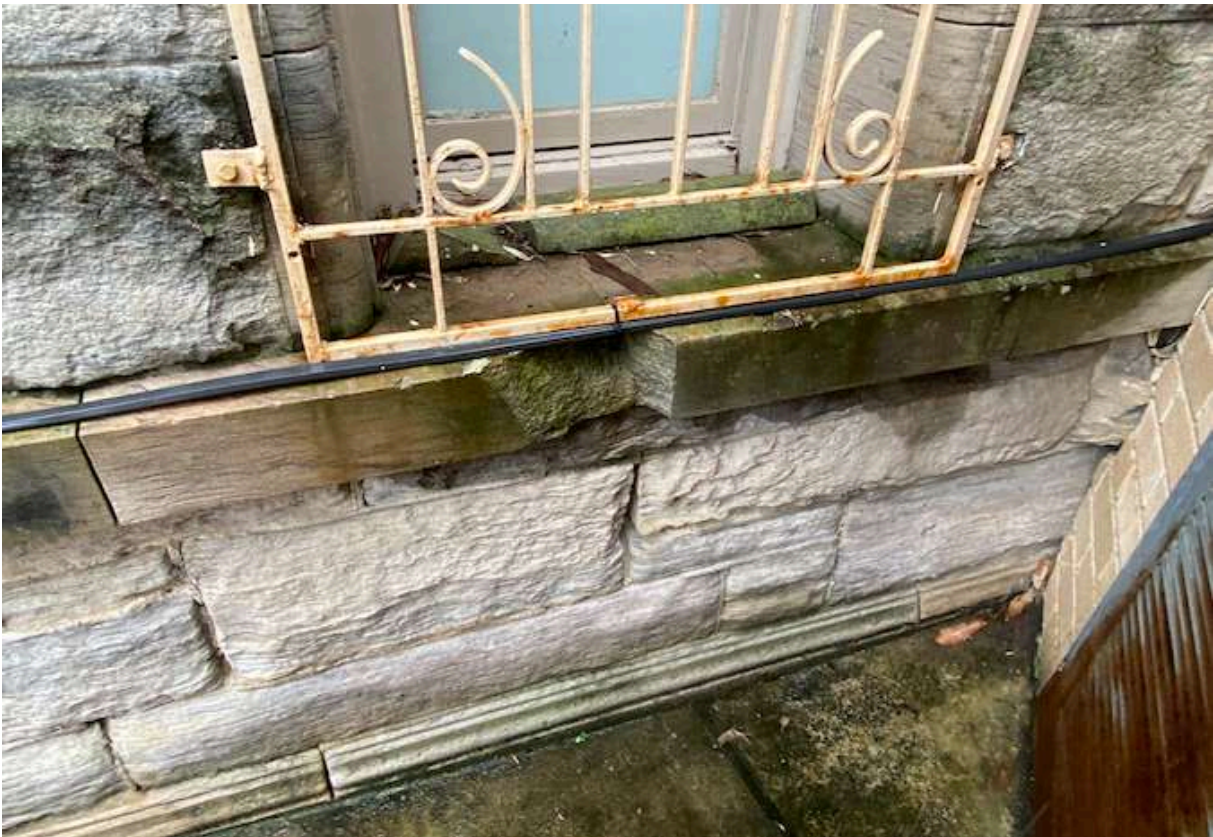
**Photo. 27.** All damaged and missing sandstone mortar is to be inspected by an experienced heritage sandstone contractor and repaired where required

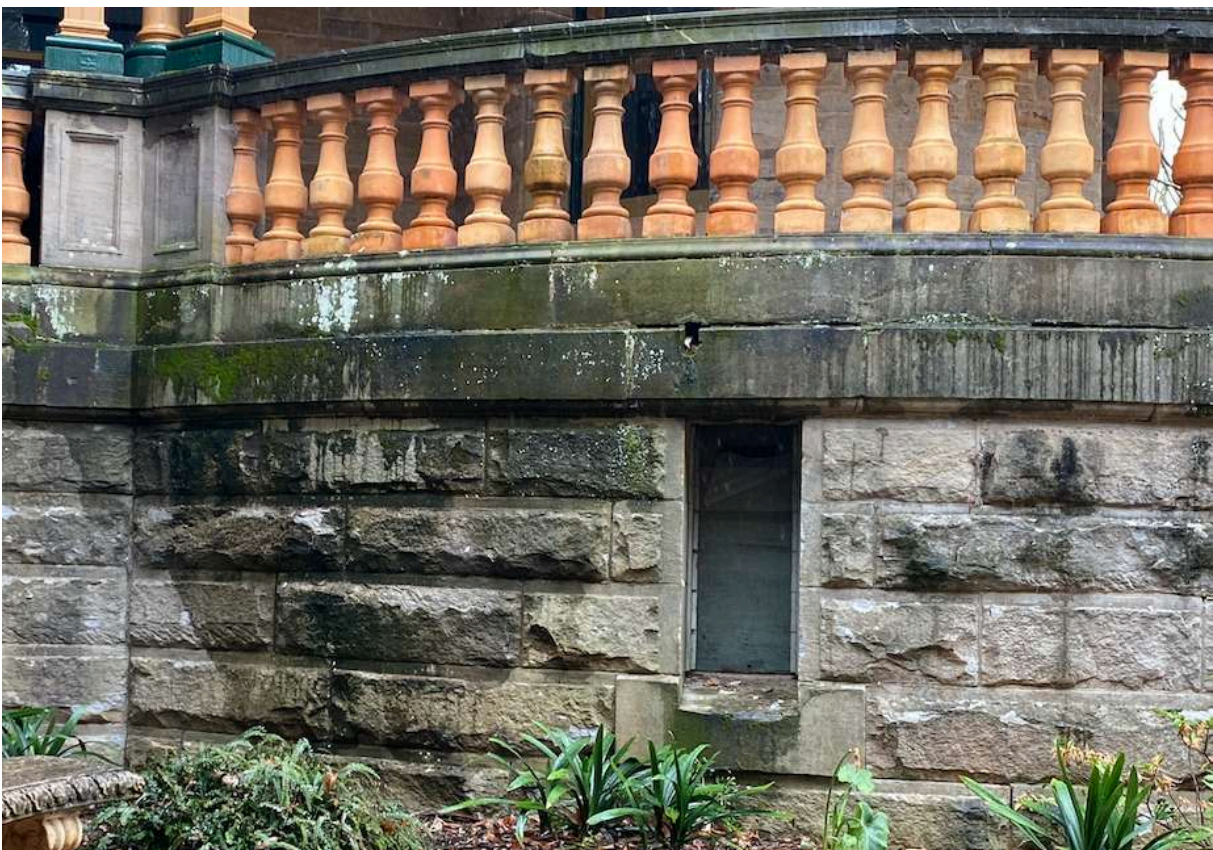
**Photo. 28.** Sandstone is to be cleaned by an experienced heritage sandstone cleaning contractor where required.

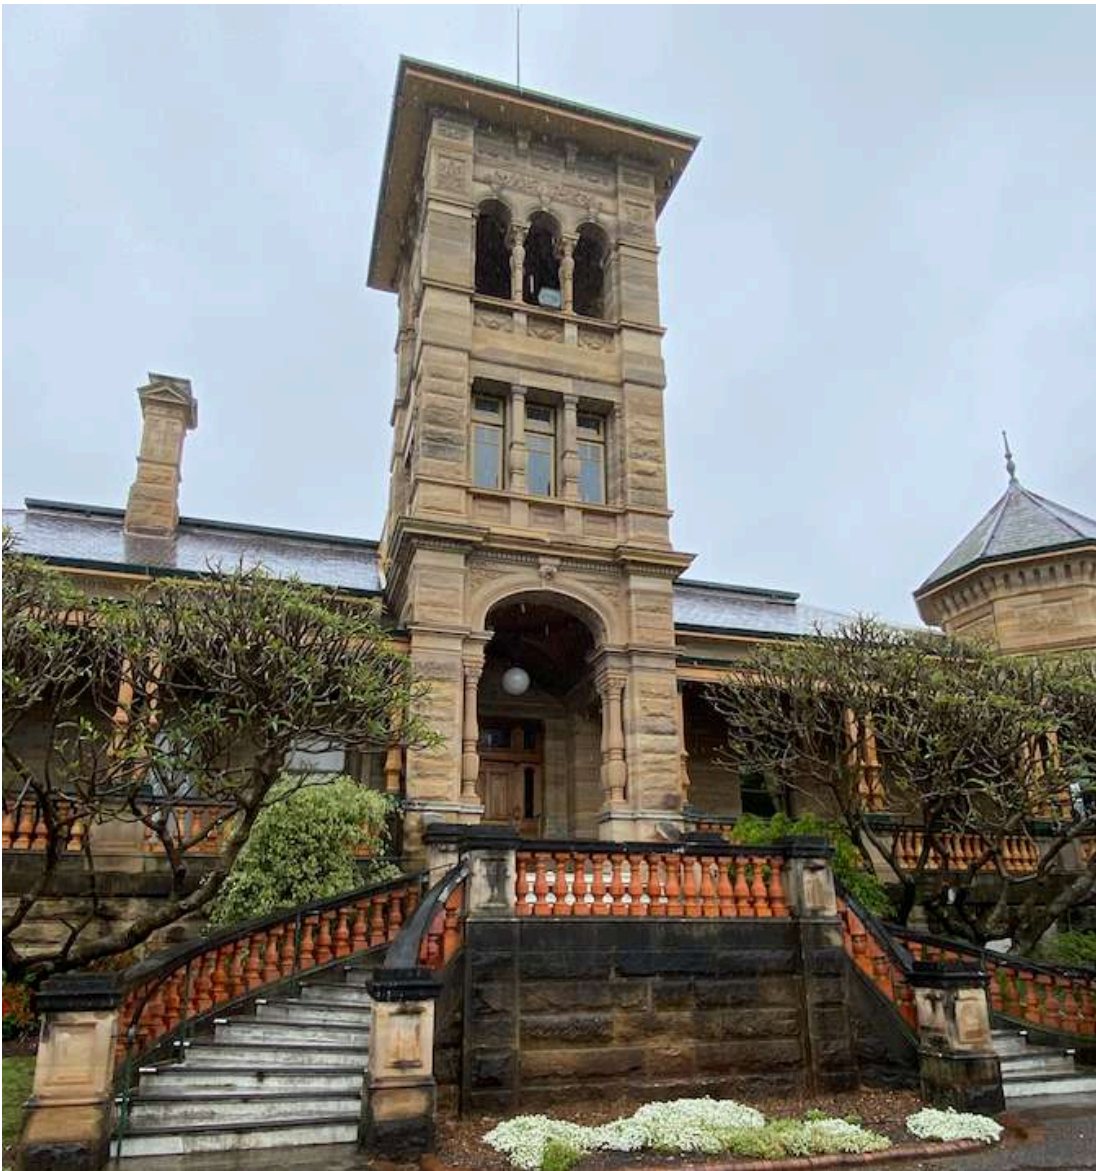
**Photo. 29.** Sandstone is to be cleaned by an experienced heritage sandstone cleaning contractor where required

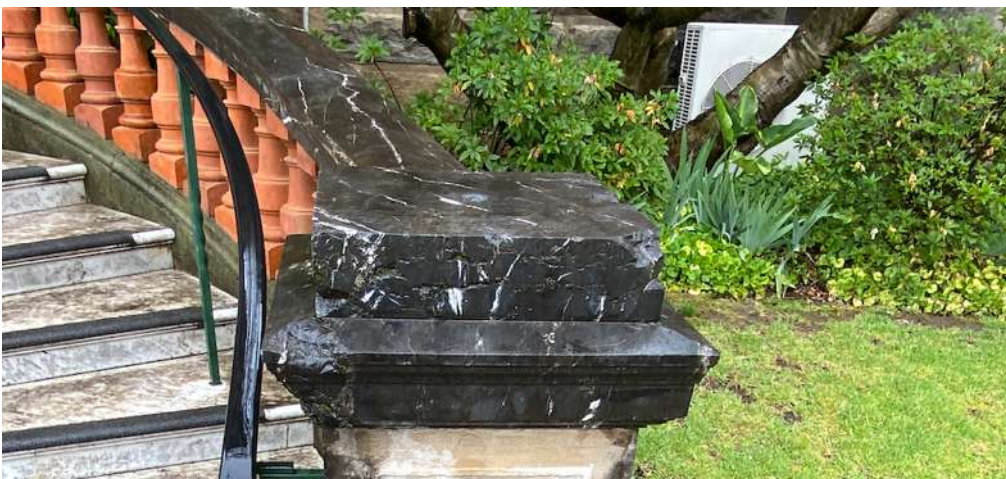
**Photo. 30.** The deterioration to the marble stair balustrade capping of the main entry is to be repaired.

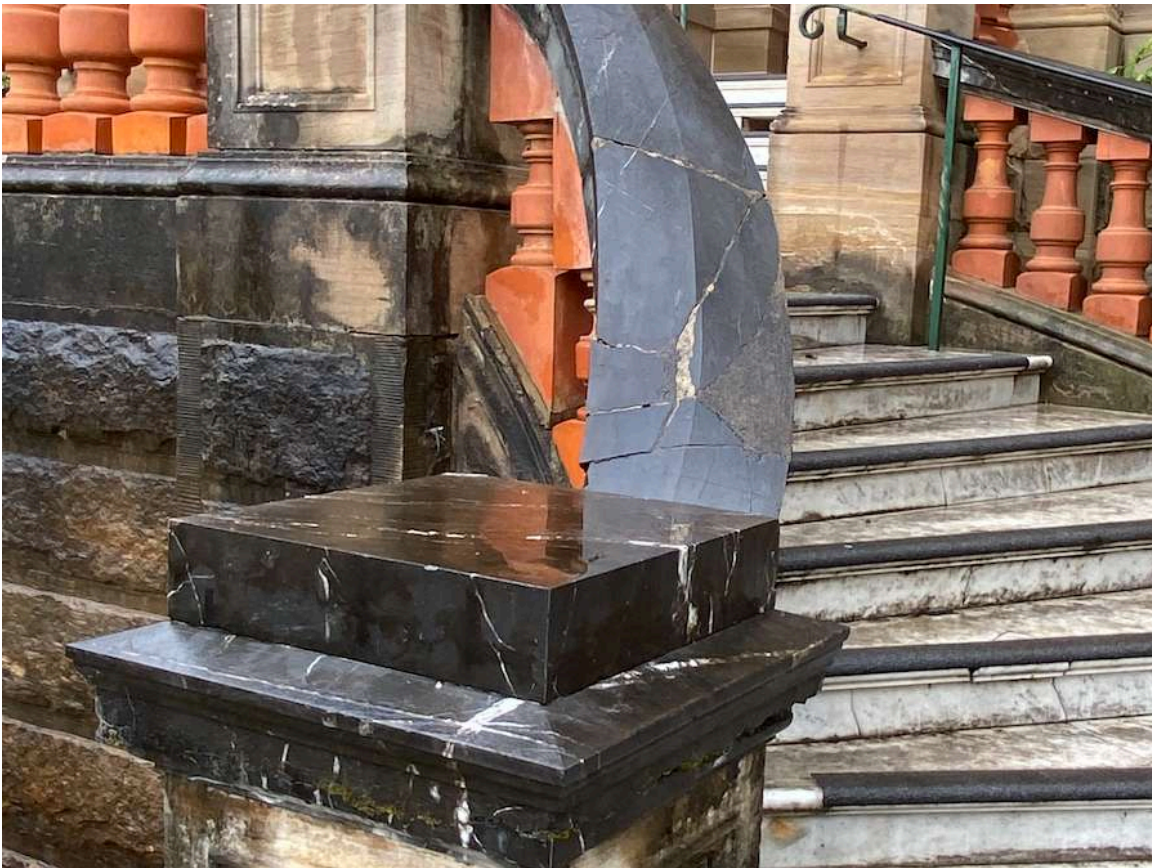
**Photo. 31.** The deterioration to the marble stair balustrade capping of the main entry is to be repaired.

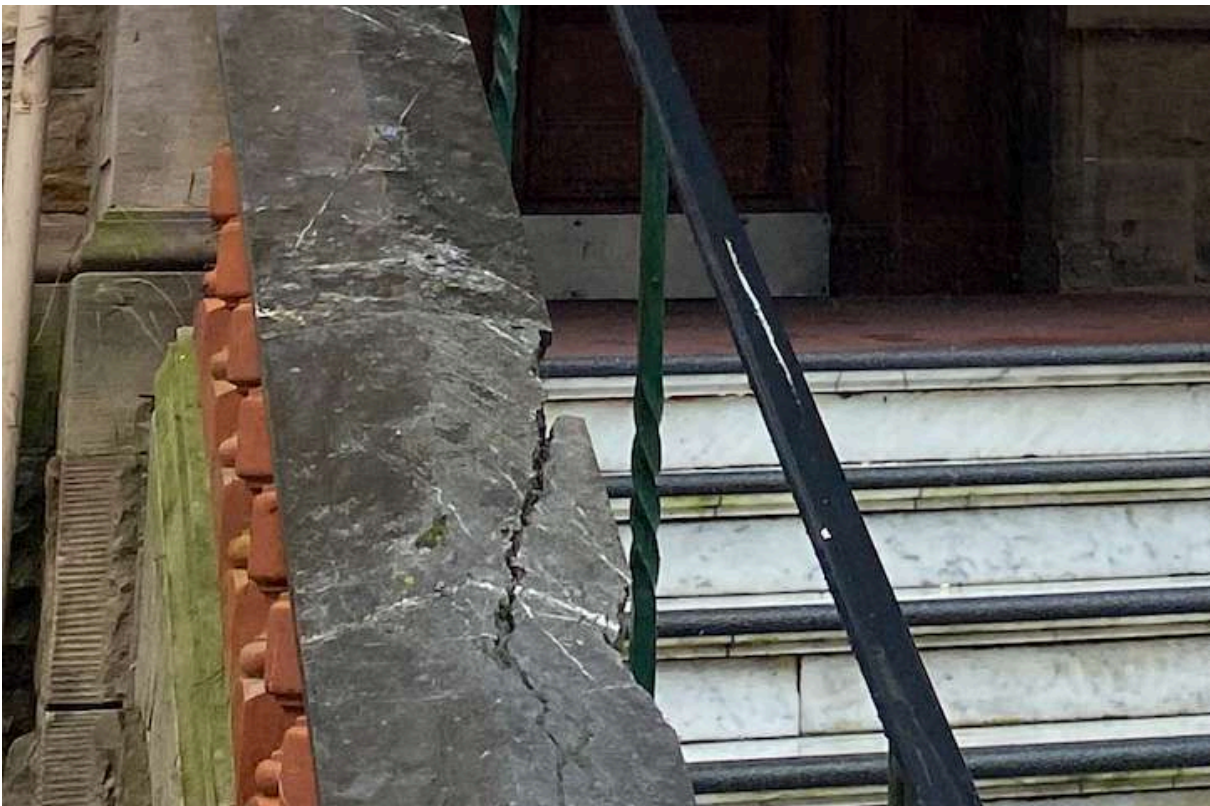
**Photo. 32.** The deteriorated marble stair balustrade of the south-eastern entry is to be repaired.

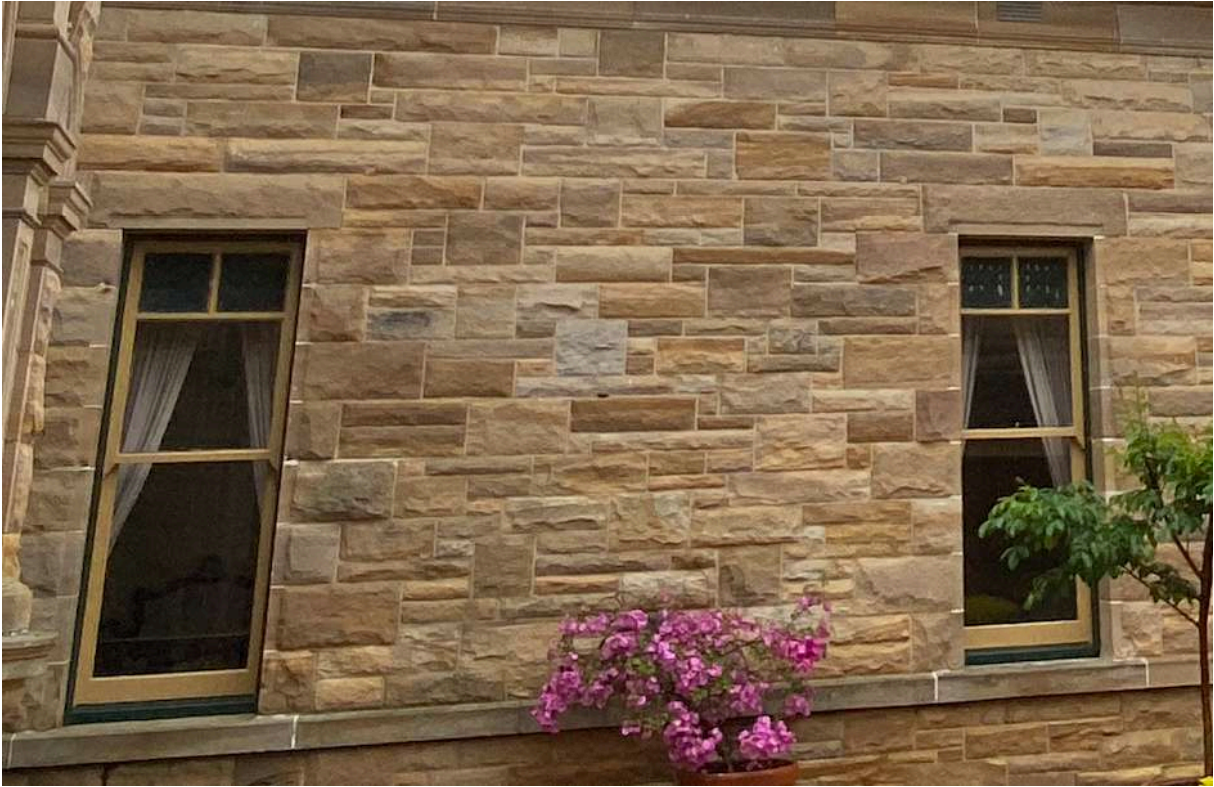
**Photo. 33.** All the windows of Belmont House are to be inspected and serviced to ensure they are in an acceptable condition and operating properly.

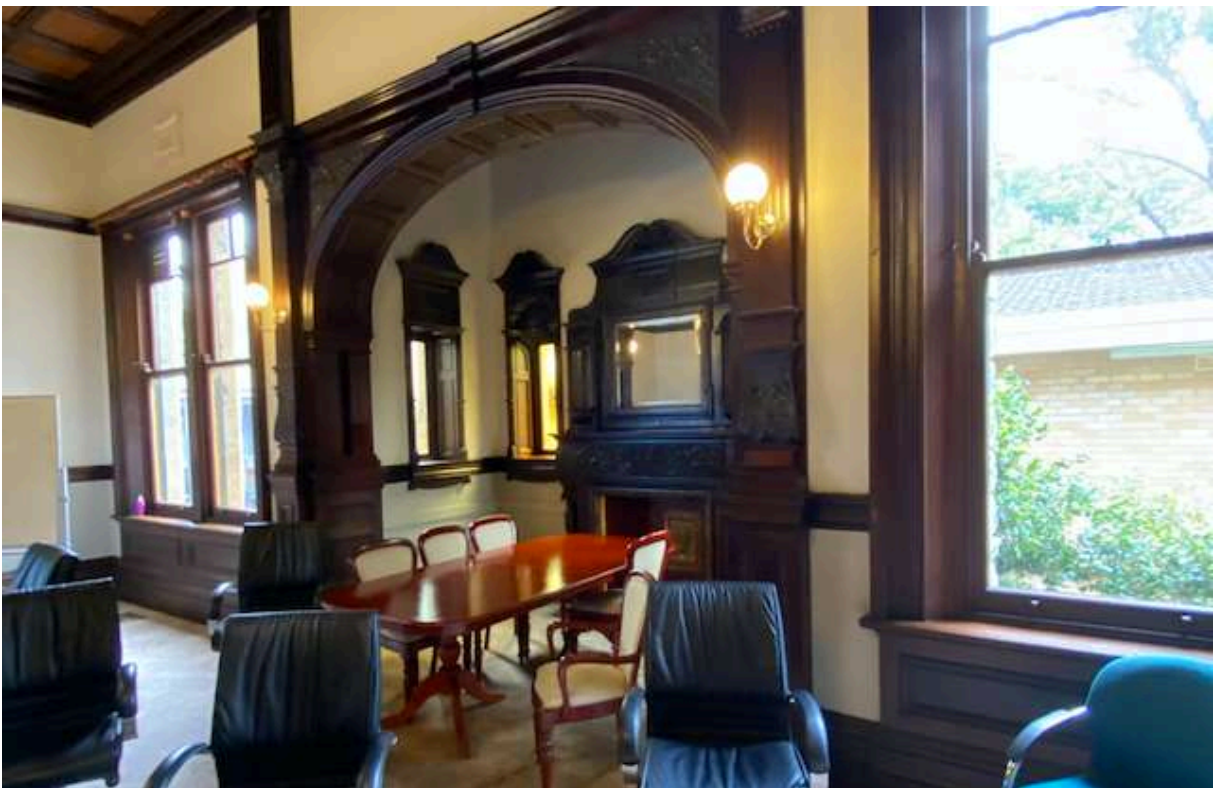
**Photo. 34.** All the windows of Belmont House are to be inspected and serviced to ensure they are in an acceptable condition and operating properly.

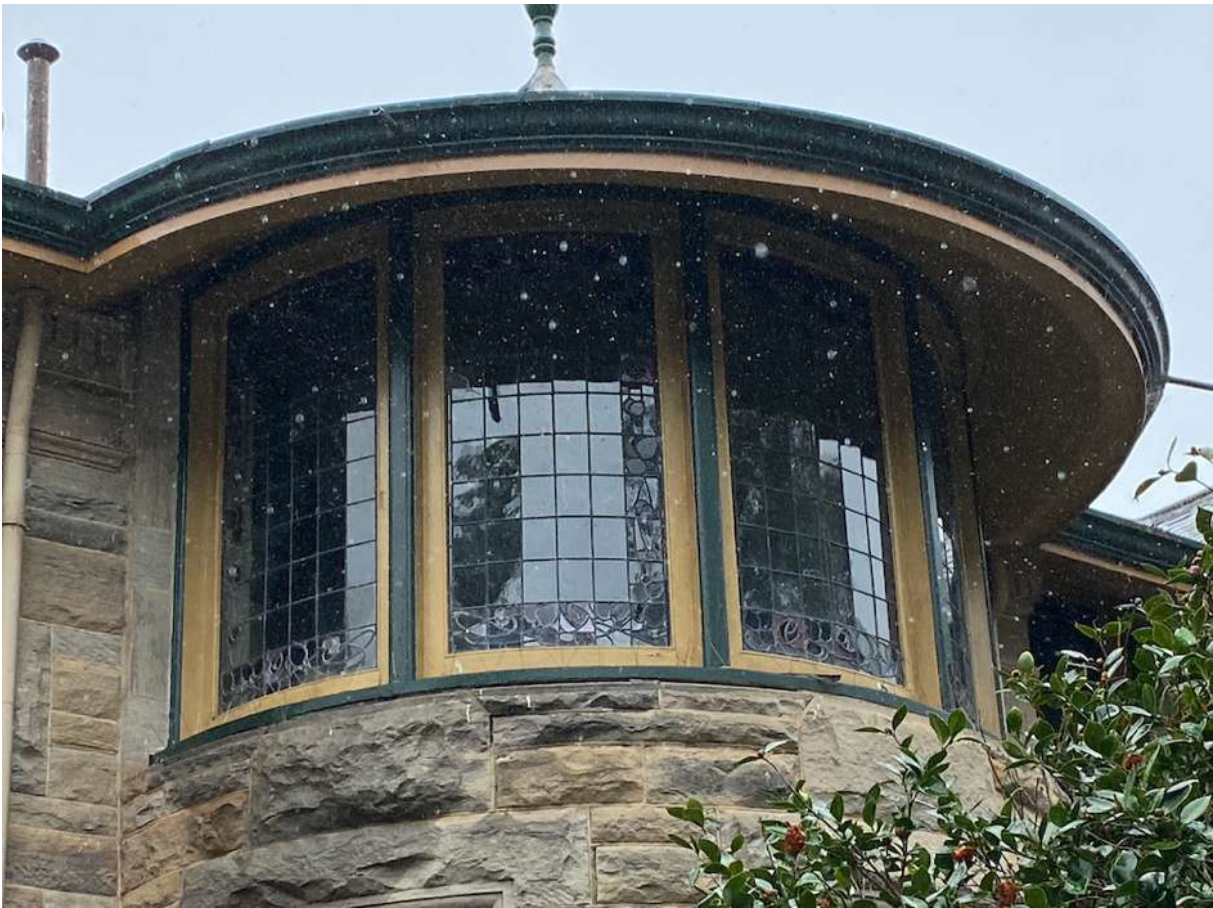
**Photo. 35.** All the windows of Belmont House are to be inspected and serviced to ensure they are in an acceptable condition and operating properly. Lead-light is to be cleaned and serviced by an experienced heritage lead-light contractor.

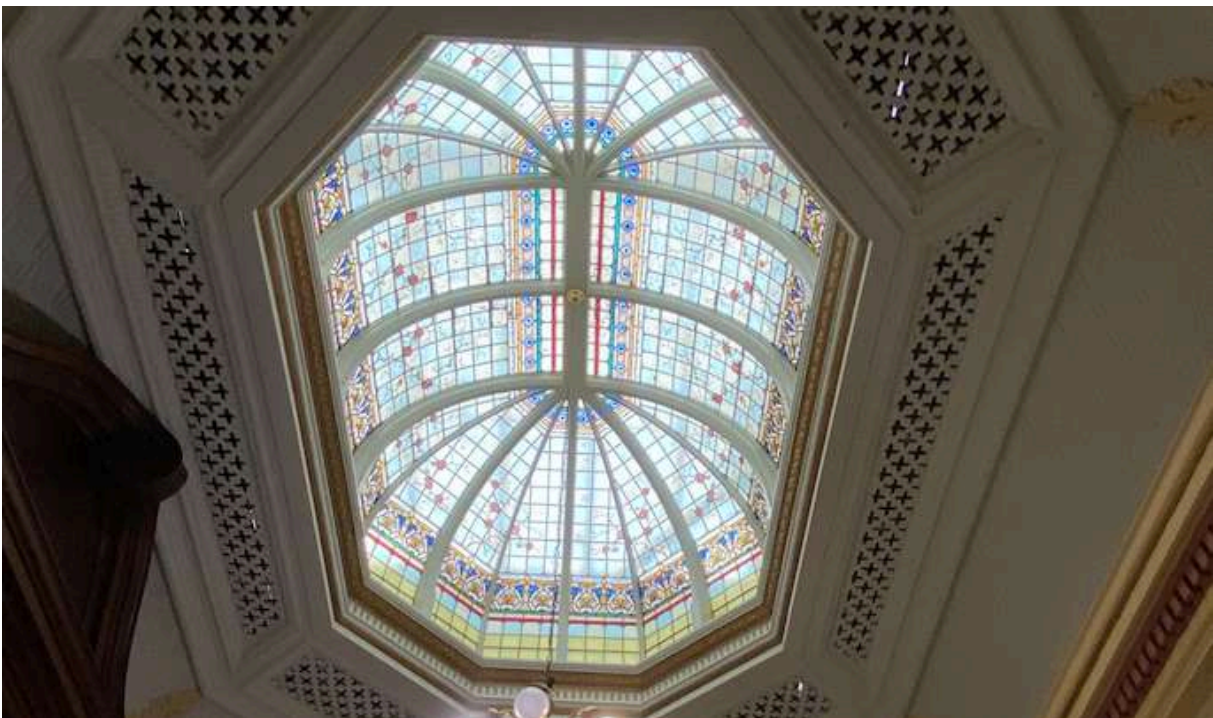
**Photo. 36.** The Lead-light dome is to be inspected cleaned and serviced by an experienced heritage lead-light contractor.

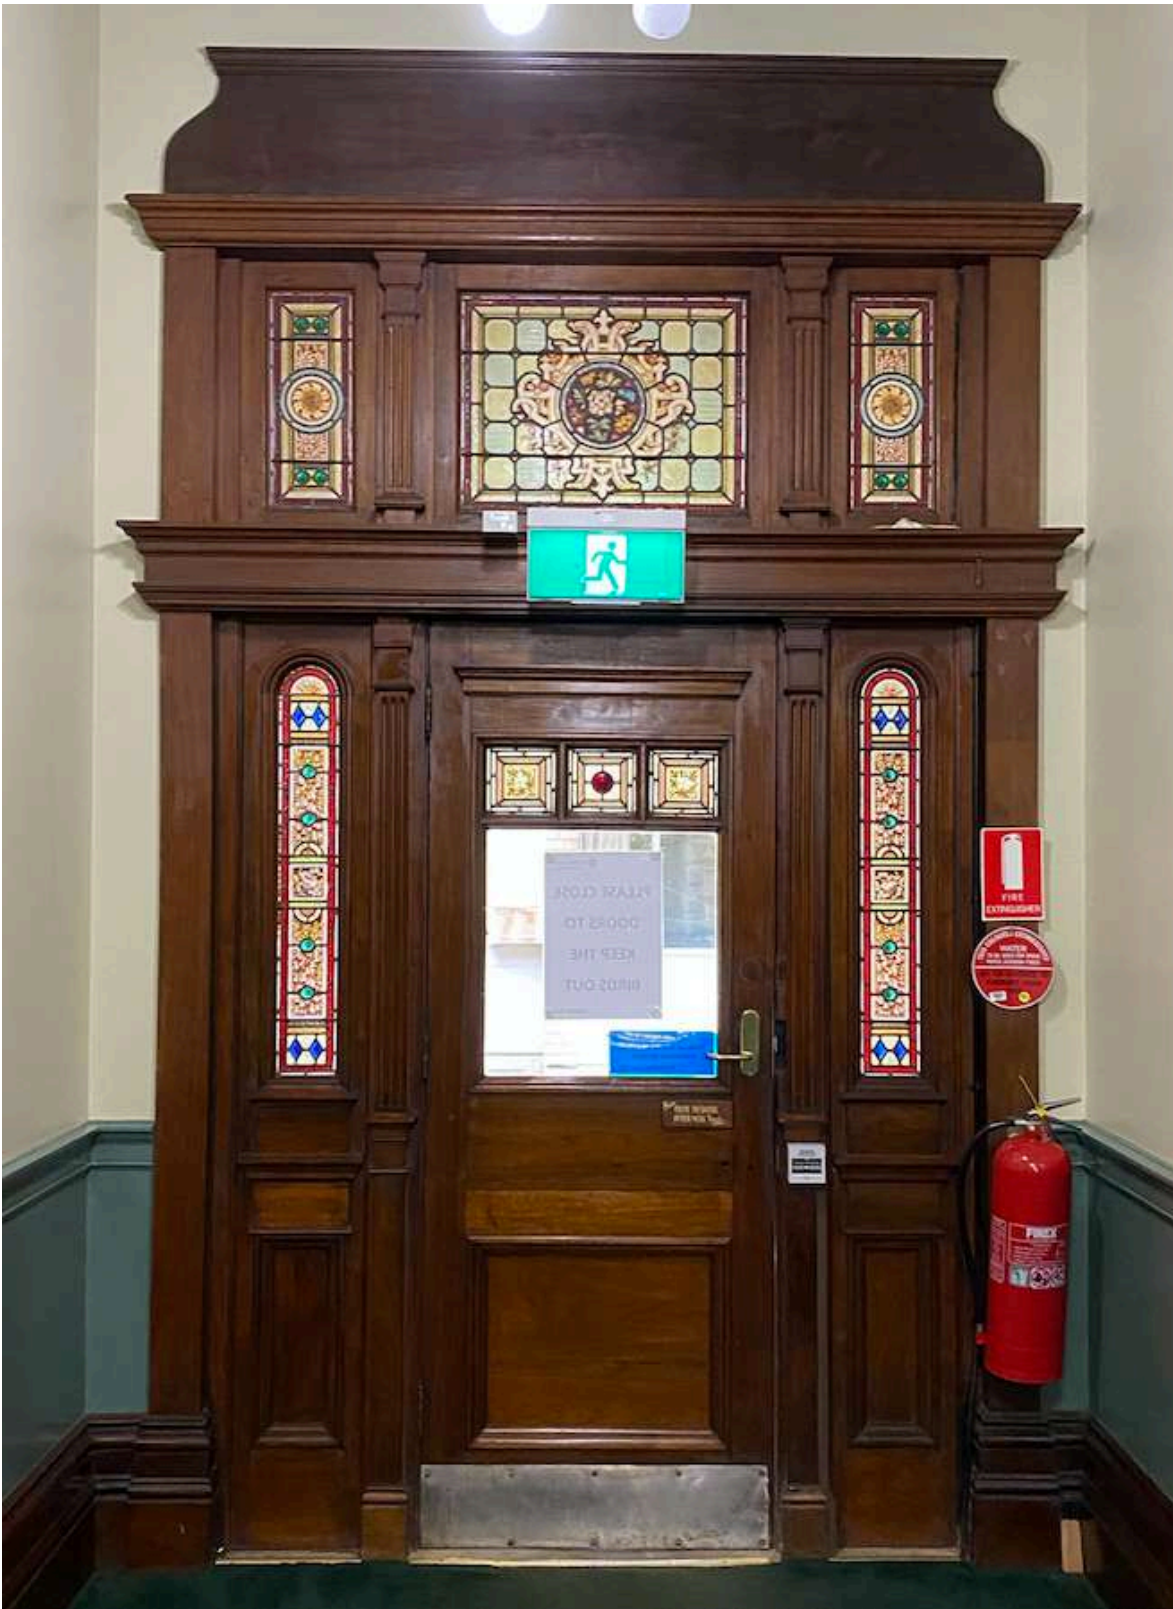
**Photo. 37.** All doors are to be inspected by an experienced heritage carpentry contractor, to ensure they are in a good condition and operating properly.

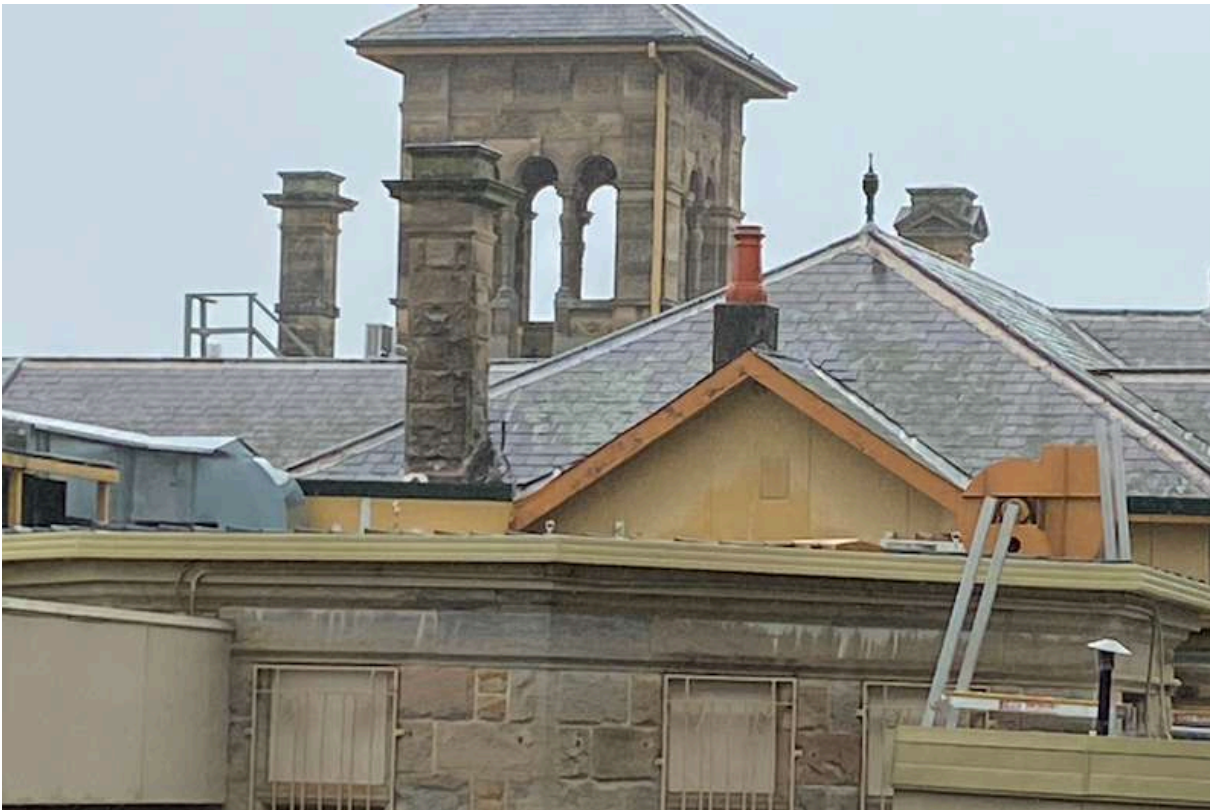
**Photo. 38.** The existing klip-lok style flat roof with sheer line guttering to the south-western wing of Belmont House is inappropriate. This roof and gutter is to be replaced with a more sympathetic roof, one similar in pitch to the original roof. Details of the revised area along with the proposed roofing material are to be determined with assistance of the nominated heritage consultant. A standing seam metal roof would be acceptable.

- The existing klip-lok style flat roof with sheer line guttering to the south-western wing of Belmont House is inappropriate. It is recommended that this roof and gutter be replaced with a more sympathetic roof, one similar in pitch to the original roof. Details of the revised area along with the proposed roofing material are to be determined with assistance of the nominated heritage consultant. A standing seam metal roof would be acceptable, (photo 38).

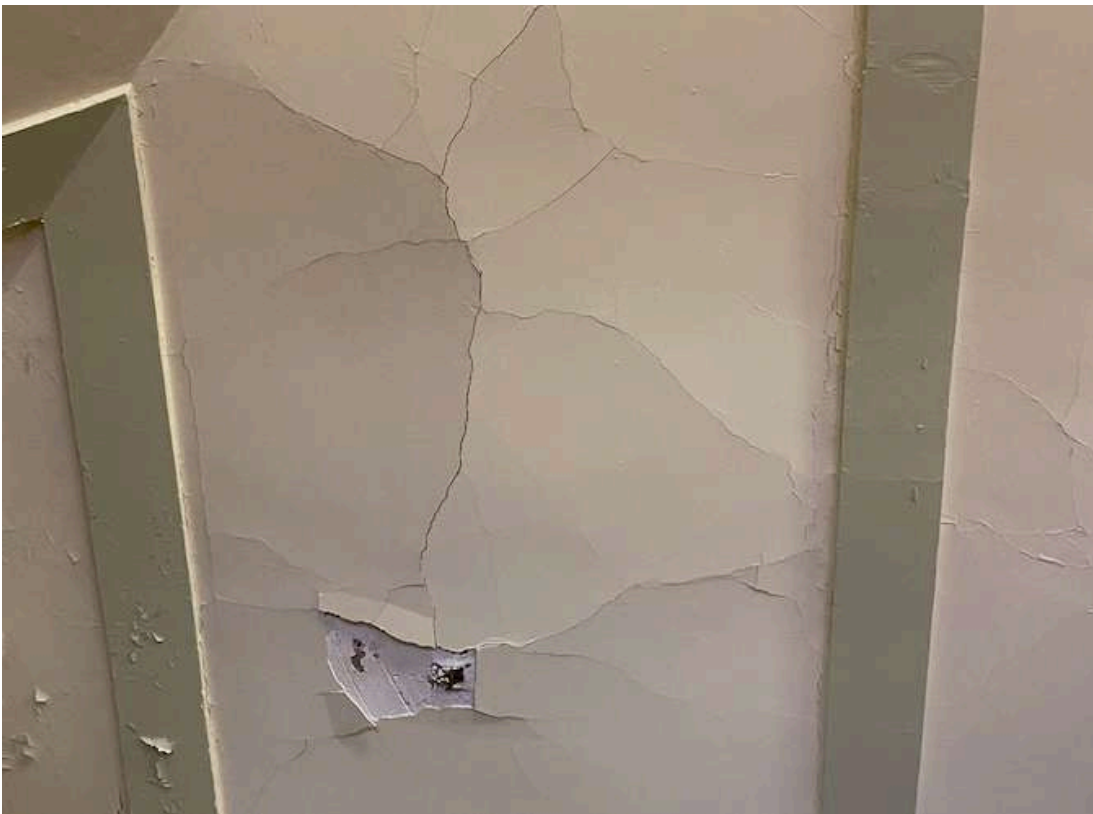
**Photo. 39.** The billiard vaulted ceiling is damaged that requires repair.

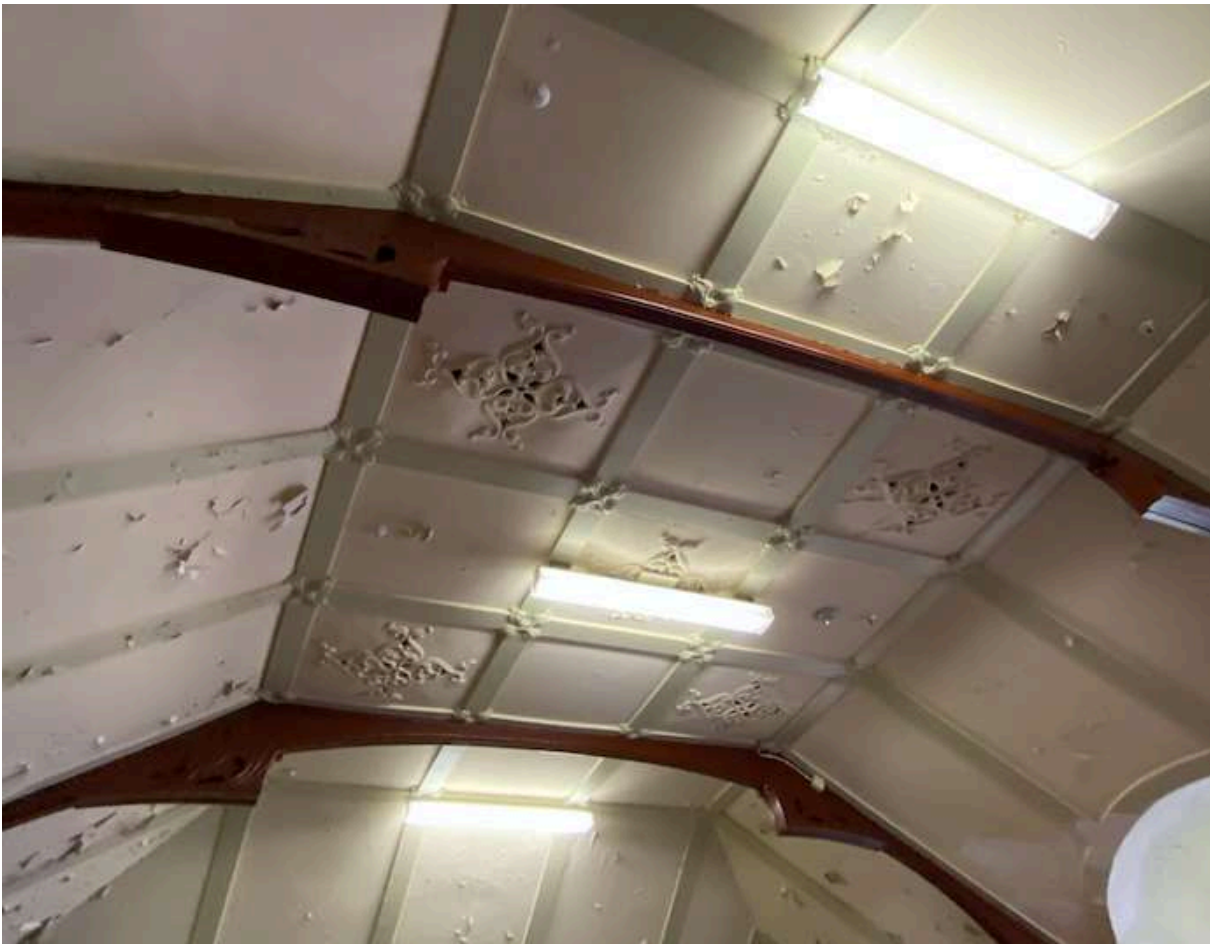
**Photo. 40.** The paint adhesion to the vaulted ceiling in the billiard room is failing. This ceiling is to be properly prepared and repainted.

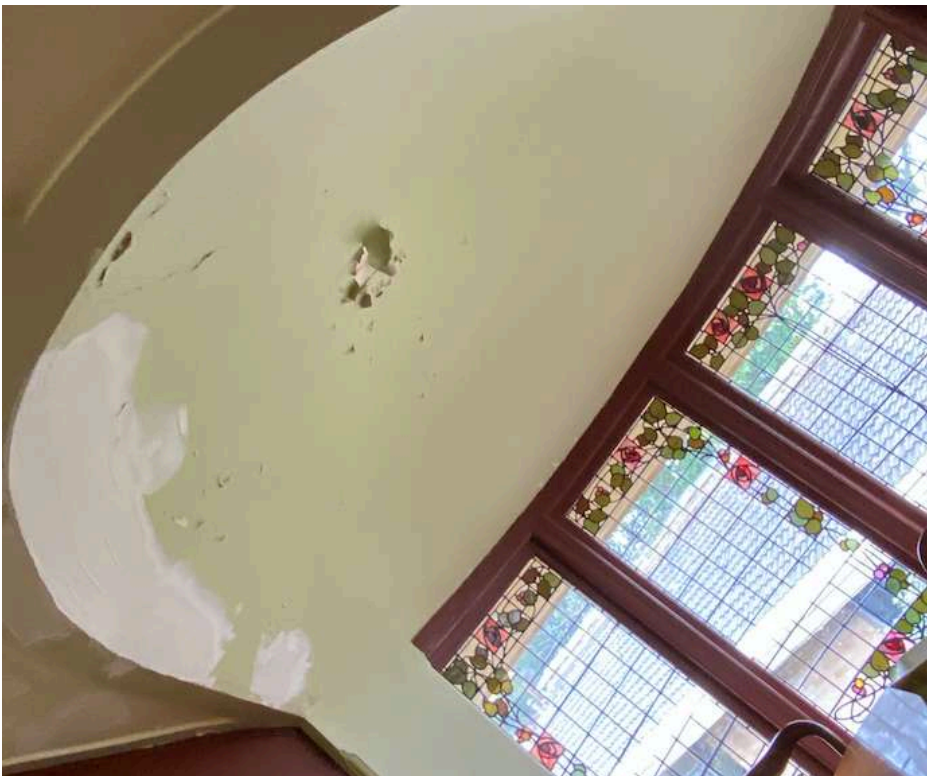
**Photo. 41.** The paint adhesion to the curved window bay ceiling is failing. This ceiling is to be properly prepared and repainted.

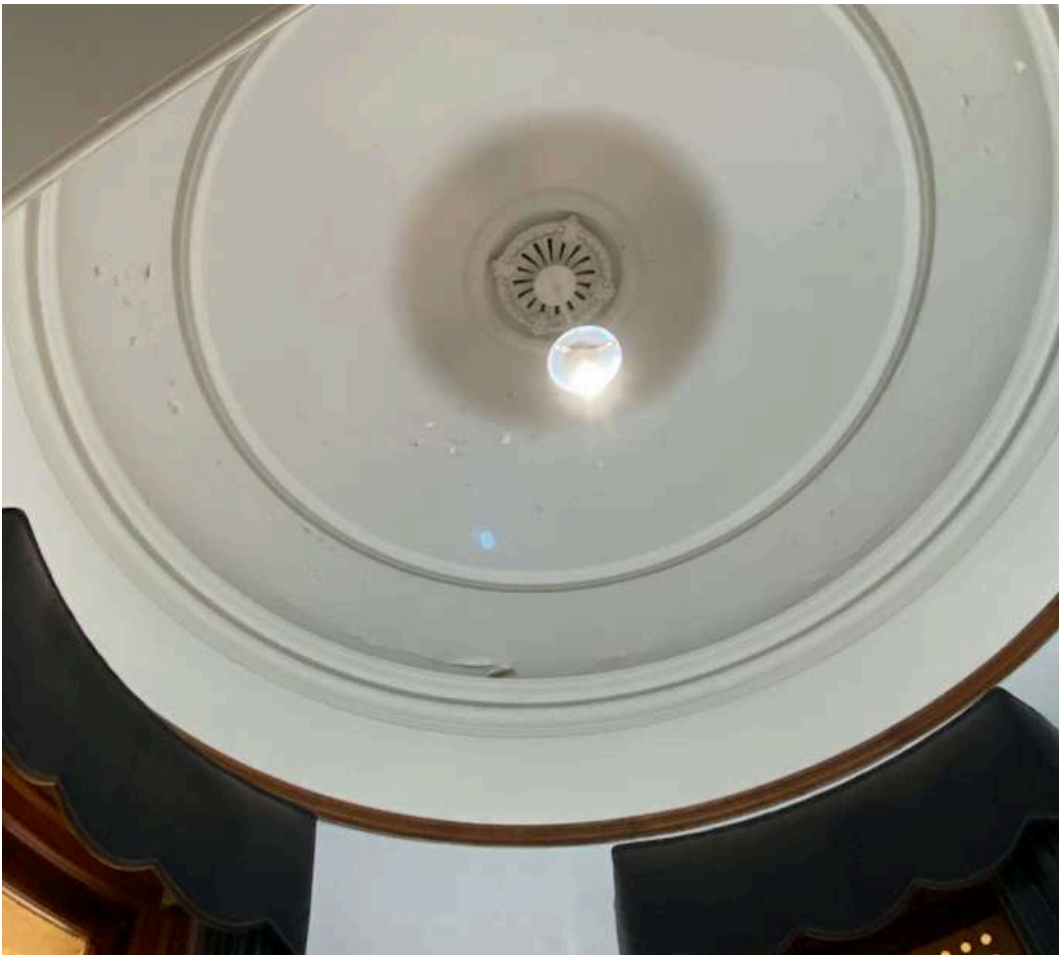
**Photo. 42.** The minor damage to the ceiling is to be repaired and the failing paint adhesion to the area ceiling requires proper preparation and repainting.

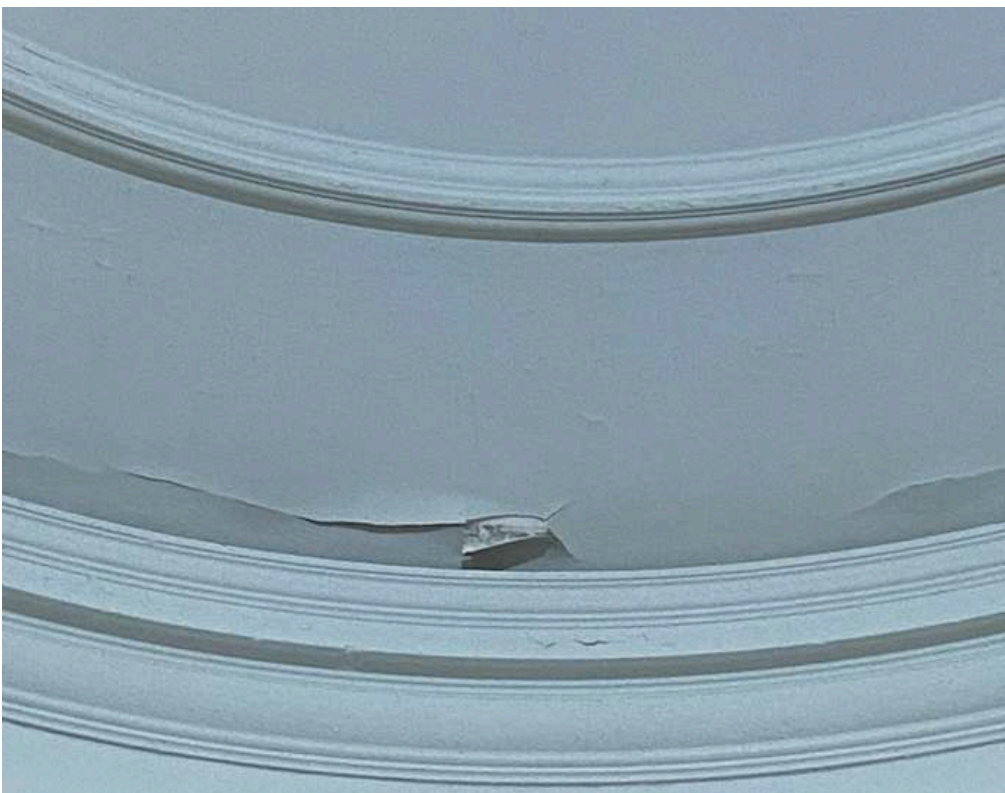
**Photo. 43.** The minor damage to the ceiling is to be repaired and the failing paint adhesion to the area ceiling requires proper preparation and repainting.

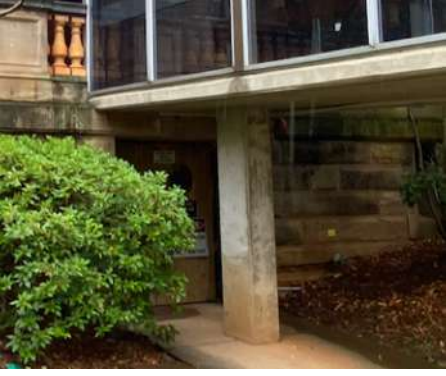
<b>LOCATION:</b> Northern walkway removal  <b>WORK REQUIRED:</b> Provide protect to heritage sandstone while walk way is being removed. This work is to be executed by a licensed contractor with a proven record of satisfactory work to heritage buildings.  Standards: AS 2601-2001 Demolition and AS 4361.2-1998 Guide to lead paint management - Residential and commercial building.

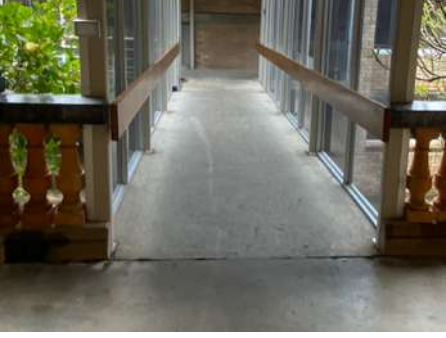
<b>LOCATION:</b> Northern walkway removal  <b>WORK REQUIRED:</b> Provide detail and description of how the balustrade is to be reinstated where walkway is being removed.

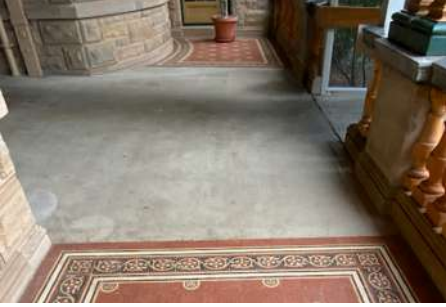
<b>LOCATION:</b> Northern walkway removal  <b>WORK REQUIRED:</b> Provide protect to heritage tiles and rendered verandah floor while walk way is being removed. This work is to be executed by a licensed contractor with a proven record of satisfactory work to heritage buildings. Standards AS 2601-2001 Demolition and AS 4361.2-1998 Guide to lead paint management - Residential and commercial building.

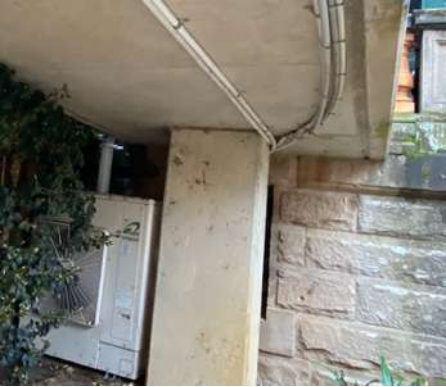
<b>LOCATION:</b> South-eastern walkway removal  <b>WORK REQUIRED:</b> Provide protect to heritage sandstone while walk way is being removed. This work is to be executed by a licensed contractor with a proven record of satisfactory work to heritage buildings.  Standards: AS 2601-2001 Demolition and AS 4361.2-1998 Guide to lead paint management - Residential and commercial building.		
Issue:	October 2021

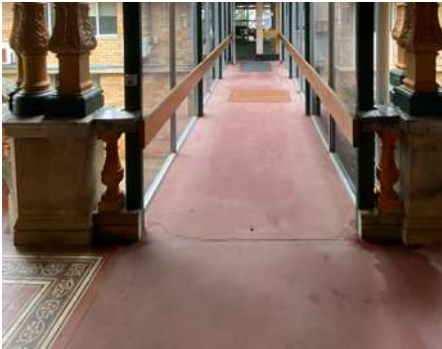
<p><b>LOCATION:</b> South-eastern walkway removal</p> <p><b>WORK REQUIRED:</b>          Provide detail and description of how the balustrade is to be reinstated where walkway is being removed.          Provide protect to heritage tiles and rendered verandah floor while walk way is being removed. This work is to be executed by a licensed contractor with a proven record of satisfactory work to heritage buildings.          Standards AS 2601-2001 Demolition and AS 4361.2-1998 Guide to lead paint management - Residential and commercial building.</p>

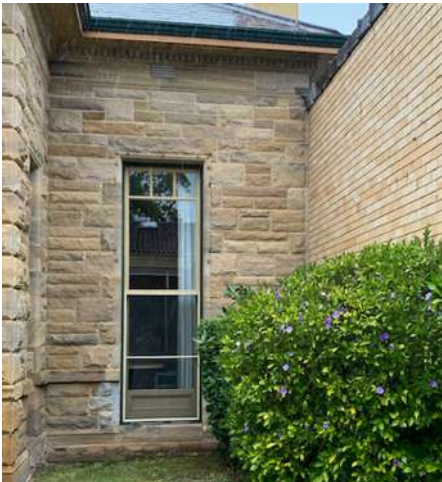
<p><b>LOCATION:</b> North-western corner</p> <p><b>WORK REQUIRED:</b>          Provide protect to heritage sandstone while adjoining structure is being removed.</p> <p>This work is to be executed by a licensed contractor with a proven record of satisfactory work to heritage buildings.</p> <p>Standards: AS 2601-2001 Demolition and AS 4361.2-1998 Guide to lead paint management - Residential and commercial building.</p>

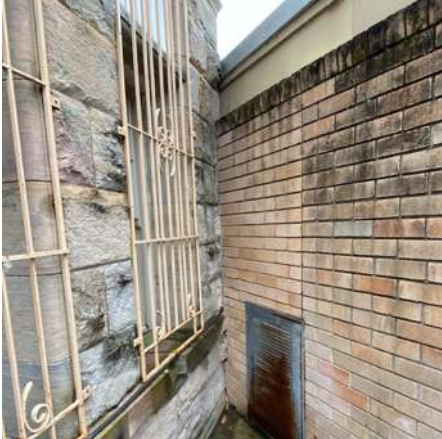
<p><b>LOCATION:</b> South-western wall and southern wing</p> <p><b>WORK REQUIRED:</b>          Provide protect to heritage sandstone while adjoining structure is being removed.</p> <p>This work is to be executed by a licensed contractor with a proven record of satisfactory work to heritage buildings.</p> <p>Standards: AS 2601-2001 Demolition and AS 4361.2-1998 Guide to lead paint management - Residential and commercial building.</p>	
Issue:		October 2021

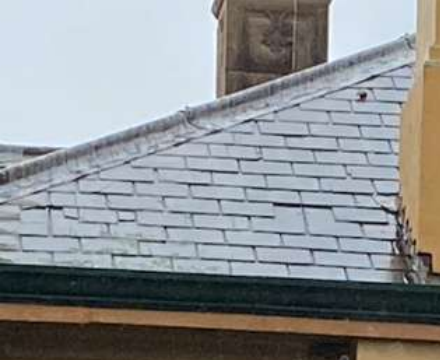
<p><b>LOCATION:</b> Entire Roof</p> <p><b>WORK REQUIRED:</b>          The roof slates are to be inspected by an experienced heritage slate roofing contractor. Missing slates are to be replaced, flashings and valley gutters repaired where required.          This work is to be executed by a licensed heritage slate roofing contractor with a proven record of satisfactory work to heritage buildings.          Standards: AS 2050:2018 Roof Tiles and AS/NZS 2179.1-1994 Metal Rainwater Goods.</p>

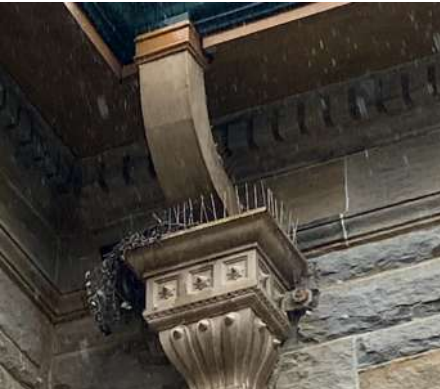
<p><b>LOCATION:</b> All gutter, rain-heads and down-pipes</p> <p><b>WORK REQUIRED:</b>          All gutters, rain-heads and down-pipes are to be cleared of debris and any rusting fixings embedded in the sandstone repaired or replaced</p> <p>This is to be executed by qualified contractor with experience and a proven record of satisfactory work to heritage buildings.</p> <p>Standards AS/NZS 2179.1-1994 Metal Rainwater Goods and AS/NZS 3500 Set - 2018, Plumbing and drainage.</p>

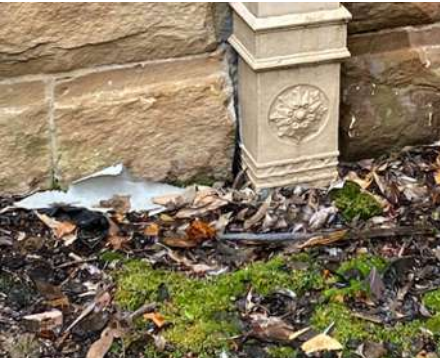
<p><b>LOCATION:</b> All down-pipes</p> <p><b>WORK REQUIRED:</b>          The ground level at the wall at the bottom of the down-pipes should be lowered as the ornate cast iron down-pipes are exposed to accelerated deterioration when buried and clearing the down-pipes is impeded when access to the bottom of the down-pipe is not provided.</p> <p>Standards AS/NZS 2179.1-1994 Metal Rainwater Goods and AS/NZS 3500 Set - 2018, Plumbing and drainage.</p>

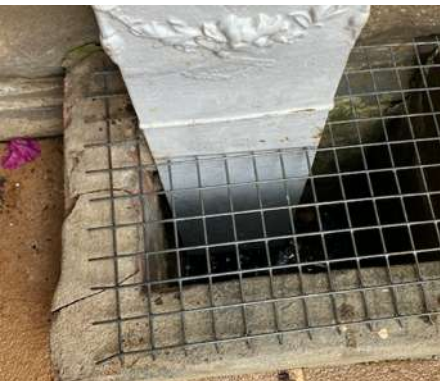
<p><b>LOCATION:</b> All down-pipes</p> <p><b>WORK REQUIRED:</b>          Down-pipes should terminated above a grated stormwater pit.</p> <p>This work is to be executed by a licensed contractor with a proven record of satisfactory work to heritage buildings.</p> <p>Standards AS/NZS 2179.1-1994 Metal Rainwater Goods and AS/NZS 3500 Set - 2018, Plumbing and drainage.</p>		
Issue:	October 2021

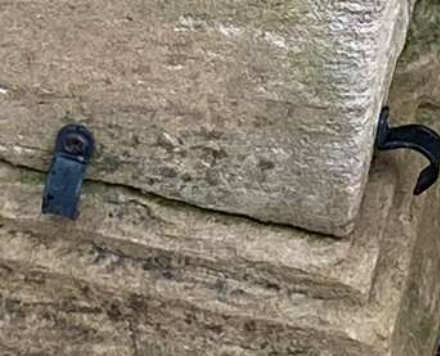
<b>LOCATION:</b> Courtyard  <b>WORK REQUIRED:</b> All rusting steel saddles and the like attached and embedded in the sandstone are to be removed.  This is to be executed by qualified contractor with experience and a proven record of satisfactory work to heritage buildings.  Standard: AS 3700:2018 Masonry

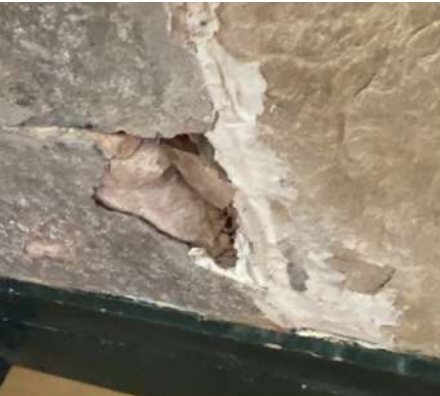
<b>LOCATION:</b> Under north-western walkway  <b>WORK REQUIRED:</b> All damaged and missing sandstone mortar is to be inspected by an experienced heritage sandstone contractor and repaired where required. Mortar is to be lime mortar of the same strength, colour and consistency as the existing mortar. This work is to be executed by qualified contractor with experience and a proven record of satisfactory work with heritage sandstone.  Standard: AS 3700:2018 Masonry		
<b>Issue:</b>	<b>October 2021</b>

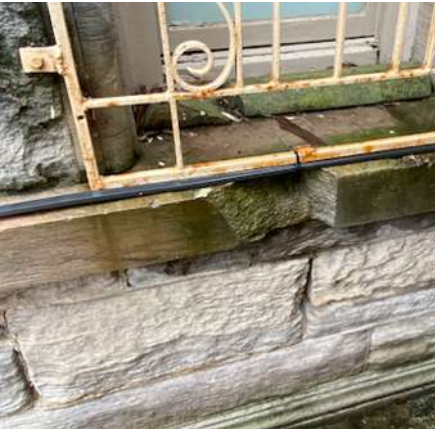
<p><b>LOCATION:</b> Southern wing</p> <p><b>WORK REQUIRED:</b>            Damaged sandstone window sill is to be replaced by an experienced heritage sandstone contractor with experience and a proven record of satisfactory work with heritage sandstone.</p> <p>Sandstone is to match the existing sandstone. Sample of proposed sandstone to be used in repair is to be approved by the nominated heritage consultant.</p> <p>Standard: AS 3700:2018 Masonry</p>

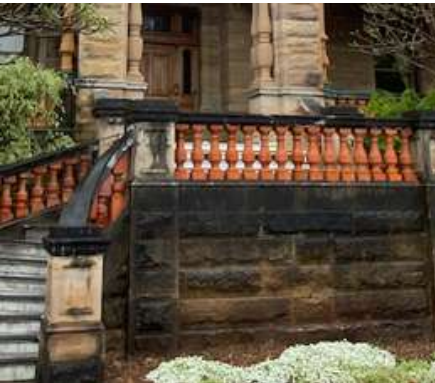
<p><b>LOCATION:</b> All stained sandstone</p> <p><b>WORK REQUIRED:</b>            All stained sandstone is to be cleaned by a by an experienced heritage sandstone cleaning contractor with experience and a proven record of satisfactory cleaning of heritage sandstone.</p> <p>Standard: AS 3700:2018 Masonry</p>

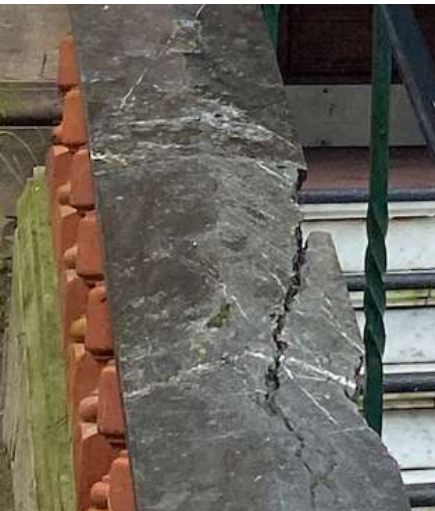
<p><b>LOCATION:</b> South-eastern entry stairs</p> <p><b>WORK REQUIRED:</b>            The deteriorated marble stair balustrade of the south-eastern entry is to be repaired.</p> <p>This is to be executed by qualified marble repair contractor with experience and a proven record of satisfactory marble repairs to heritage buildings.</p> <p>Standard: AS 3700:2018 Masonry</p>

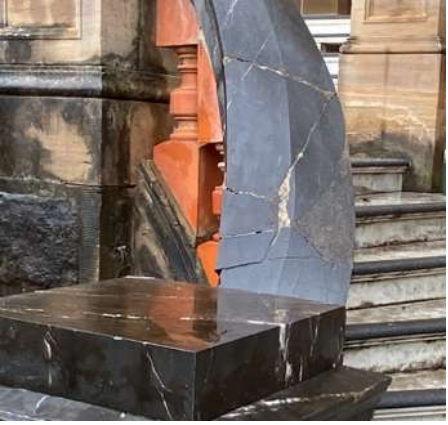
<p><b>LOCATION:</b> North-eastern entry stairs</p> <p><b>WORK REQUIRED:</b> The deteriorated marble stair balustrade of the north-eastern entry is to be repaired.</p> <p>This is to be executed by qualified marble repair contractor with experience and a proven record of satisfactory marble repairs to heritage buildings.</p> <p>Standard: AS 3700:2018 Masonry</p>
