# SCHEDULE OF CONSERVATION WORKS

*Belmont House - St. John of God Richmond Hospital*  
177 Grose Vale Rd, North Richmond NSW 2753

November 2021 | J3780

**Weir  
Phillips**  
**Heritage  
and Planning**

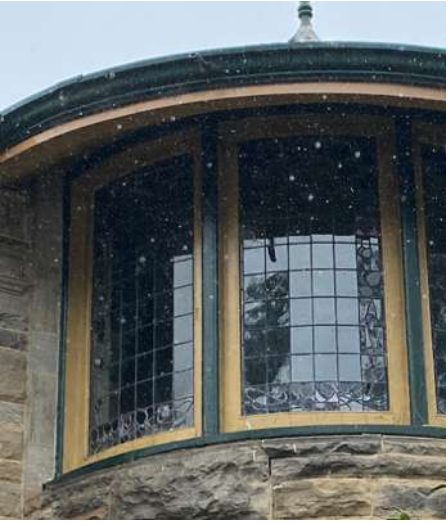
<p><b>LOCATION:</b> All windows</p> <p><b>WORK REQUIRED:</b> All the windows of Belmont House are to be inspected and serviced to ensure they are in an acceptable condition and operating properly.</p> <p>This is to be executed by qualified contractor with experience and a proven record of satisfactory work to heritage buildings.</p> <p>Lead-light is to be cleaned and serviced by an experienced heritage lead-light contractor.</p> <p>Standards: AS 1684.2—2006 Timber framing and AS 2047-2014, Windows and external glazed doors in buildings</p>

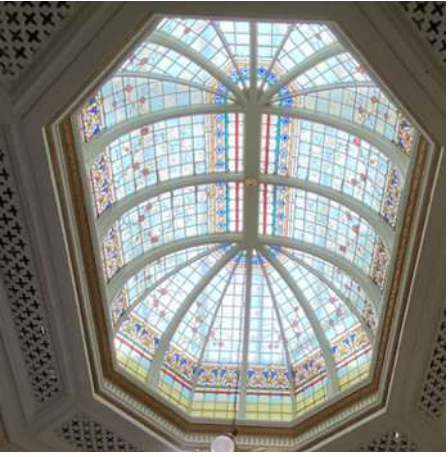
<p><b>LOCATION:</b> Main entry</p> <p><b>WORK REQUIRED:</b> The Lead-light dome is to be inspected cleaned and serviced by an experienced heritage lead-light contractor.</p> <p>Standards: AS 2047-2014, Windows and external glazed doors in buildings</p>		
Issue:	October 2021

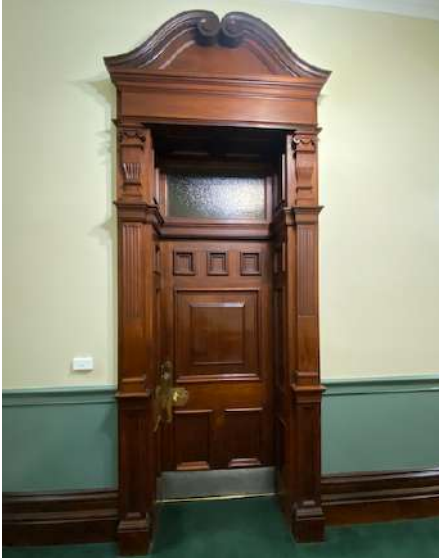
<p><b>LOCATION:</b> All doors</p> <p><b>WORK REQUIRED:</b> All doors are to be inspected by an experienced heritage carpentry contractor, to ensure they are in a good condition and operating properly.</p> <p>This is to be executed by qualified contractor with experience and a proven record of satisfactory work to heritage buildings.</p> <p>Standards: AS 1684.2—2006 Timber framing.</p>

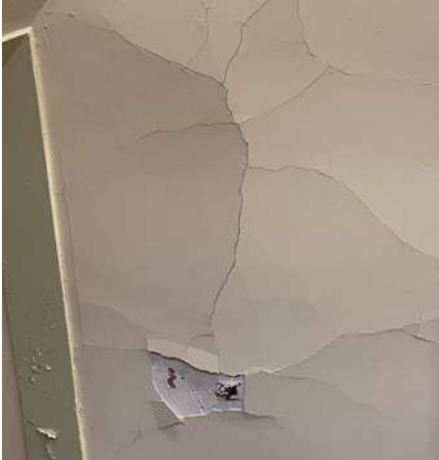
<p><b>LOCATION:</b> Billiard Room</p> <p><b>WORK REQUIRED:</b> The damage to the vaulted ceiling is to be repaired repair</p> <p>This is to be executed by qualified contractor with experience and a proven record of satisfactory work to heritage buildings.</p> <p>Standards: AS/NZS 2908.2:2020 Cellulose-cement products Flat sheets and AS/NZS 2588:2018 Gypsum plasterboard</p>

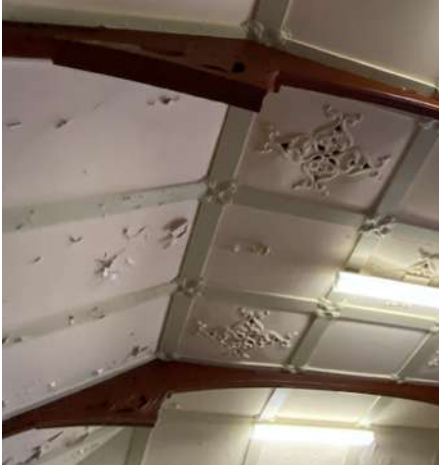
<p><b>LOCATION:</b> Billiard Room</p> <p><b>WORK REQUIRED:</b> The vaulted ceiling is to be properly prepared and painted</p> <p>This is to be executed by qualified contractor with experience and a proven record of satisfactory work to heritage buildings.</p> <p>Standards: AS/NZS 2311-2017 Guide to Painting of Buildings and AS 4361.2-1998 Guide to lead paint management - Residential and commercial building.</p>

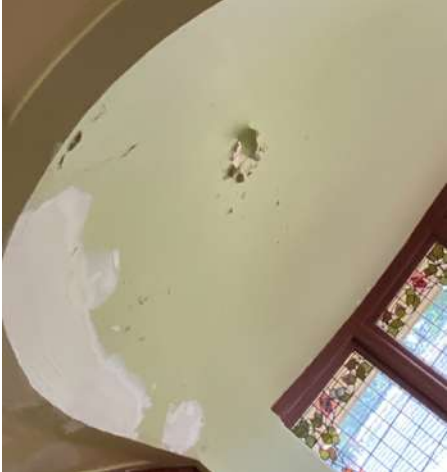
<b>LOCATION:</b> Pantry  <b>WORK REQUIRED:</b> The pantry ceiling is to be properly prepared and painted  This is to be executed by qualified contractor with experience and a proven record of satisfactory work to heritage buildings.  Standards: AS/NZS 2311-2017 Guide to Painting of Buildings and AS 4361.2-1998 Guide to lead paint management - Residential and commercial building.

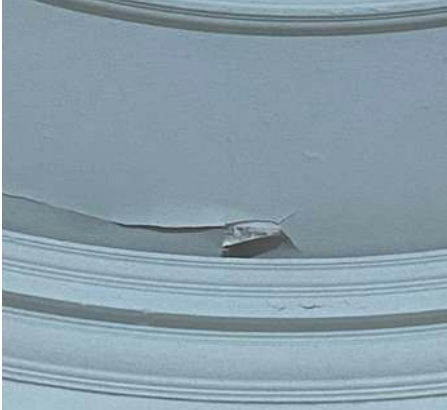
<b>LOCATION:</b> Morning Room  <b>WORK REQUIRED:</b> The minor damage to the ceiling is to be repaired and the failing paint adhesion to the area ceiling requires proper preparation and repainting. This is to be executed by qualified contractor with experience and a proven record of satisfactory work to heritage buildings. Standards: AS/NZS 2908.2:2020 Cellulose-cement products Flat sheets, AS/NZS 2588:2018 Gypsum plasterboard, AS/NZS 2311-2017 Guide to Painting of Buildings and AS 4361.2-1998 Guide to lead paint management - Residential and commercial building.

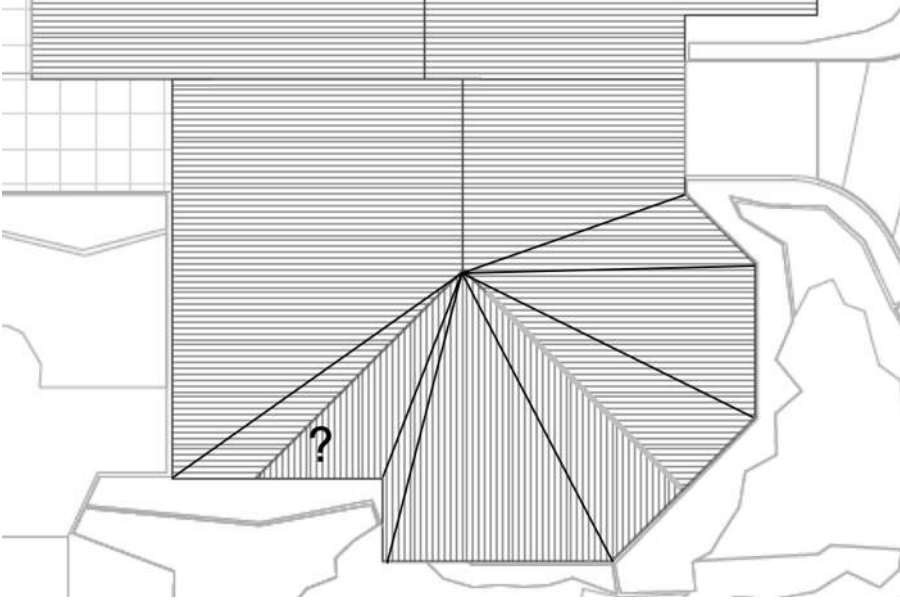
<p>The existing klip-lok style flat roof with sheer line guttering to the south-western wing of Belmont House is inappropriate. It is recommended that this roof and gutter be replaced with a sympathetic roof, one similar to the original roof. Details of the revised roof detail including the proposed eaves and guttering along with the proposed roofing material are to be provide with guidance of the nominated heritage consultant. A standing seam metal roof would be acceptable.</p>			
Issue:		October 2021
