FABRIC SURVEY

St. John of God Hospital
No. 177 Grose Vale Road, Richmond
November 2021| J3780

**Weir
Phillips**
Heritage
and Planning

FABRIC SURVEY: Belmont House, St. John of God Richmond Hospital
Hexagonal stone storage building

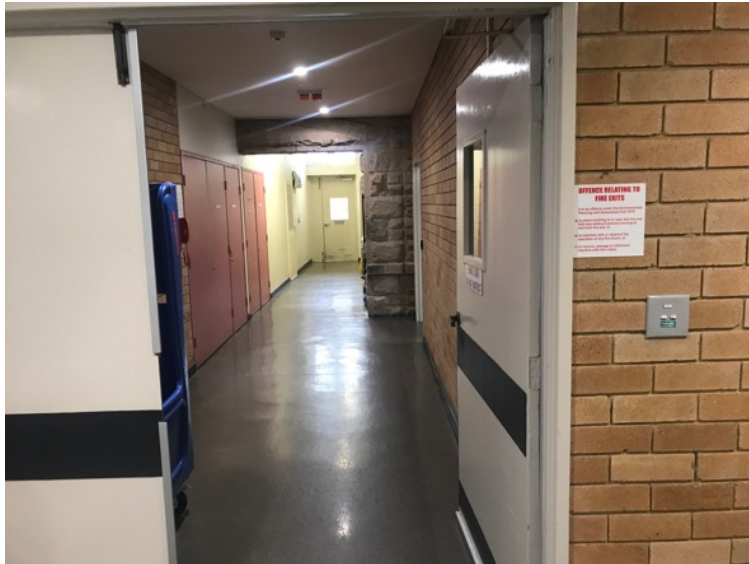
ELEMENT	COMMENT
EXTERNAL	
Hexagonal Shaped Sandstone blockwork Wall	Face Sandstone blocks. In good condition. Rendered and painted internally
Roof	Contemporary kliplok flat roof.
Windows	Original timber framed double hung windows. Good condition.
Door	Contemporary door opening from adjacent hallway.
INTERNAL	
Internal walls	Painted and rendered
Ceiling	Contemporary gyprock
Floor	Contemporary vinyl sheeting and floor tiles
Lighting	Contemporary fluorescent ceiling mounted.
Architrave	Contemporary
Doors	Contemporary
Joinery	Contemporary

Figure 8: Sandstone wall of hexagonal stone building in hallway.

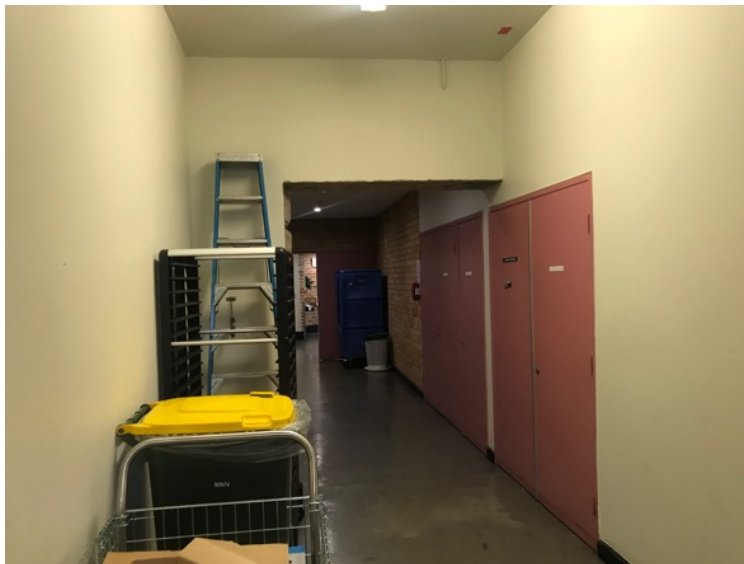
Figure 9: Other side, Sandstone wall of hexagonal stone building in hallway.

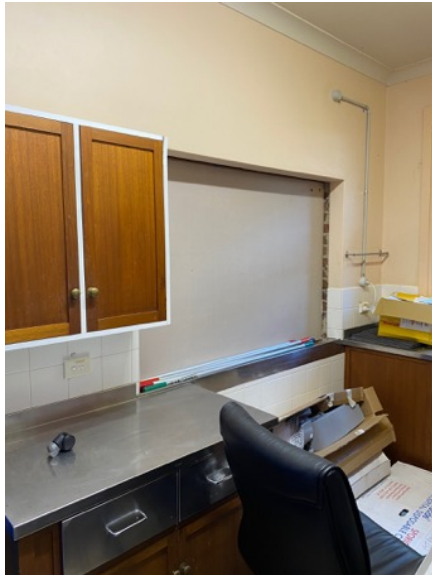
Figure 40: Internal Former Servery. Note former servery window.

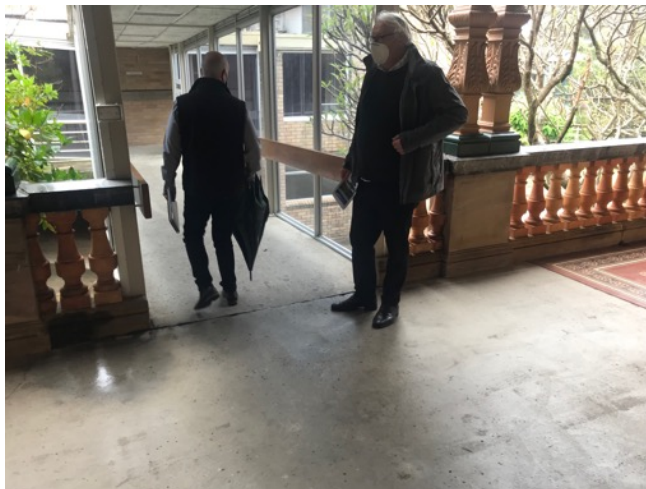
ELEMENT	COMMENT
Stone Handrail	Handrail cut to enable connection to contemporary ramp.
Painted concrete Balusters	Some concrete balusters have been removed to enable connection to contemporary ramp.
Mosaic tiled verandah Floor	The mosaic tile floor adjacent to the contemporary ramp has been covered over with a concrete screed.
Verandah Ceiling	Timber lined tongue n groove ceiling boards.
Fireplace	Rendered and chimney with curved staff moulds on the corners.
Other Notes	Contemporary lighting and hardware unless otherwise noted.

Figure 51: Verandah balustrade, handrail and concrete screed over mosaic tiles.

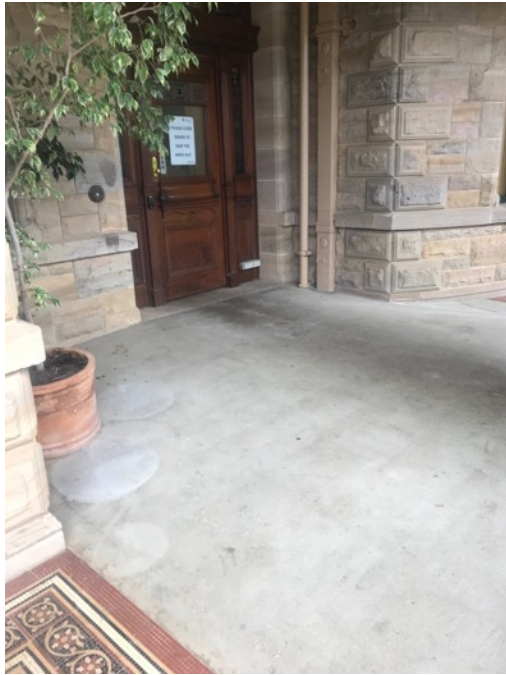
Figure 52: Verandah concrete screed over existing mosaic tiles.

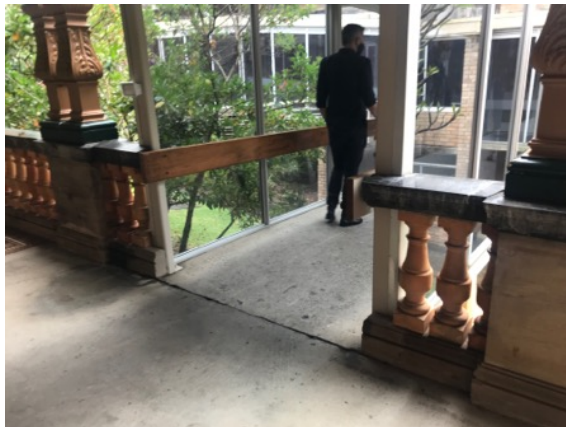
Figure 53: Verandah balustrade, handrail and concrete screed over mosaic tiles.

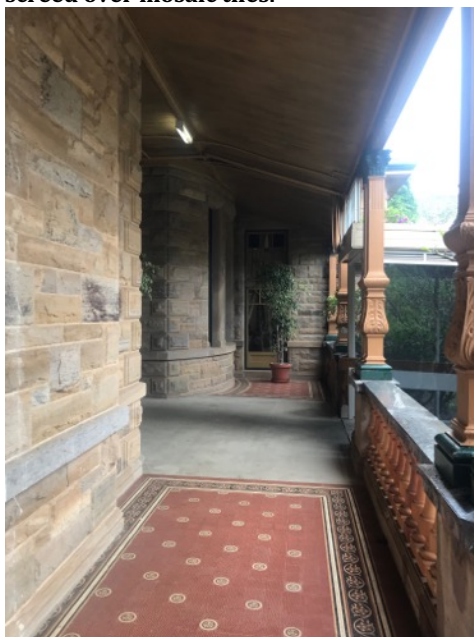
Figure 54: Verandah balustrade, handrail and concrete screed over mosaic tiles.

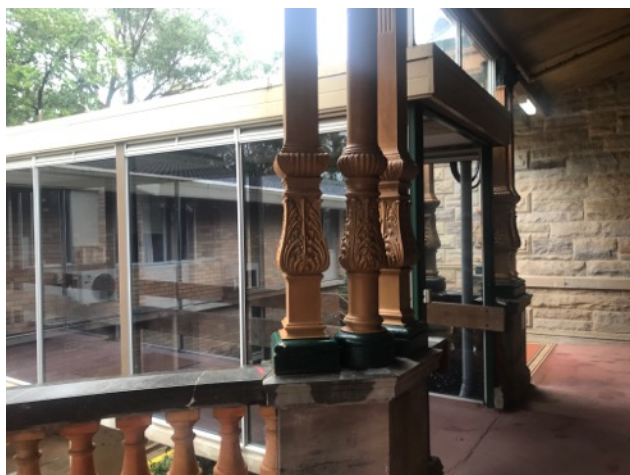
Figure 55: Verandah balustrade, handrail and concrete screed over mosaic tiles.

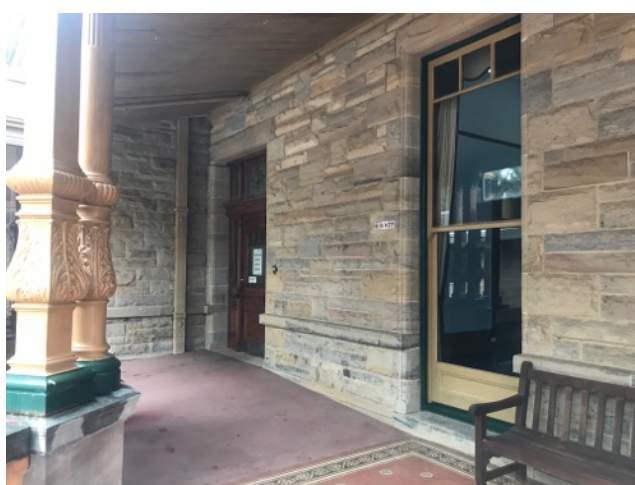
Figure 56: Verandah balustrade, handrail and concrete screed over mosaic tiles.

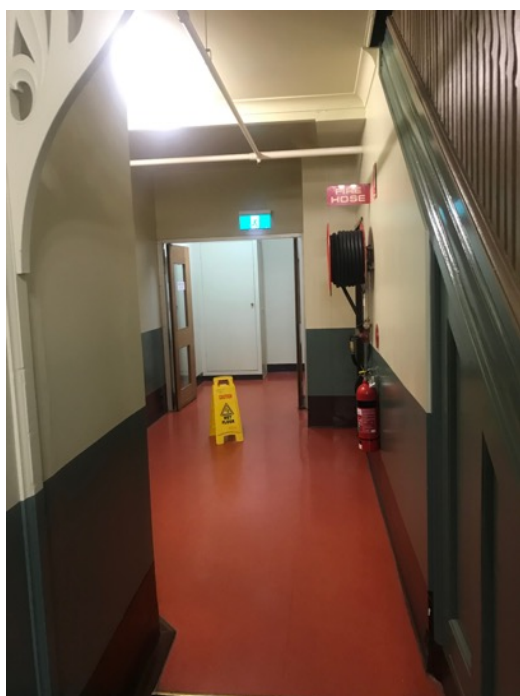
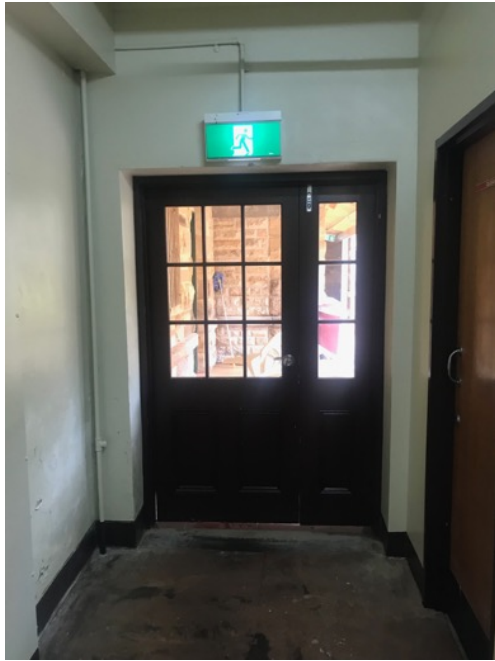
FABRIC SURVEY: Belmont House, St. John of God Hospital	
EXTERNAL: Corridor adaptive reuse for Bathrooms and Storage.	
ELEMENT	COMMENT
Ceiling	Contemporary gyprock ceiling
Cornice	Cove cornice.
Skirting	Upturned vinyl sheet.
Floor	Vinyl sheet
Walls	Render and paint over masonry. Flaking paint. Minor plaster repairs visible.
Windows	Nil.
Doors	Timber framed multi pane door out to courtyard.
Other Notes	Air conditioning unit mounted on fireplace wall.

Figure 58: Existing corridor space to be repurposed as bathrooms and storage.
