# Report

## Improvements in the Operation of the Electrostatic Precipitator

Boral Cement Works, Berrima NSW

Date of report: 30/03/2022  
Prepared by: Cristian Ciornei  
Reviewed by: Gabriel Paicu & Greg Johnson  
Approved by: Gabriel Paicu & Greg Johnson

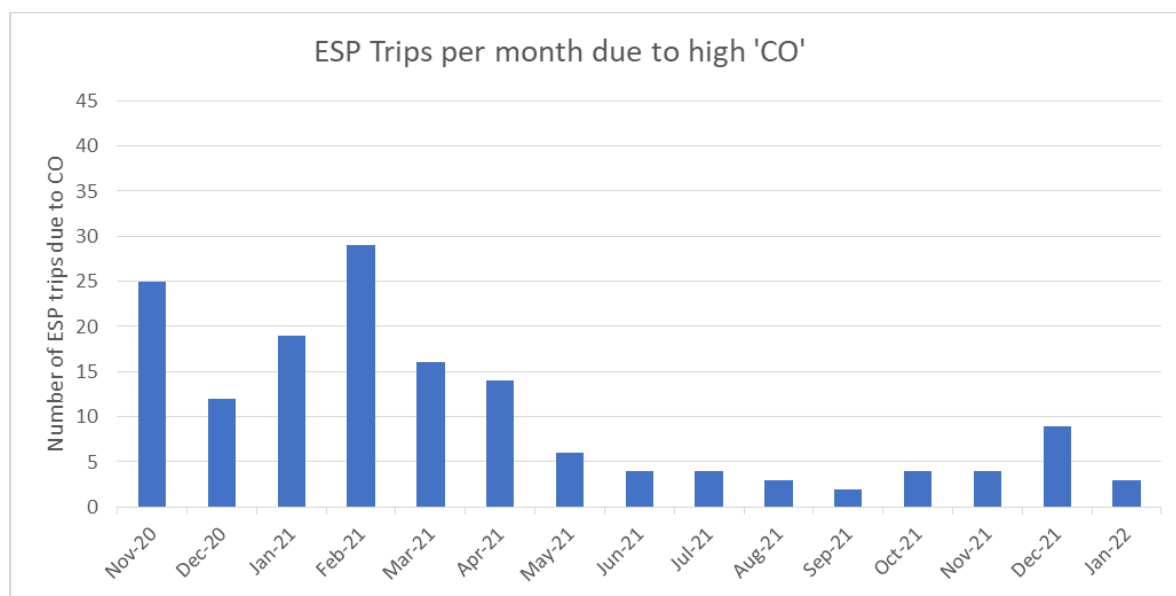
**Figure 2 Recent history of electrostatic precipitator deactivations at Boral Cement – Berrima Works**

A detailed analysis of operations during November and December 2020 (first two columns in Figure 2) was undertaken in February 2021, which revealed different causes for the automated deactivations of electrostatic precipitator.

The measures proved highly effective resulting in a significant improvement in the total number of occurrences from May 2021, as shown in Figure 2.

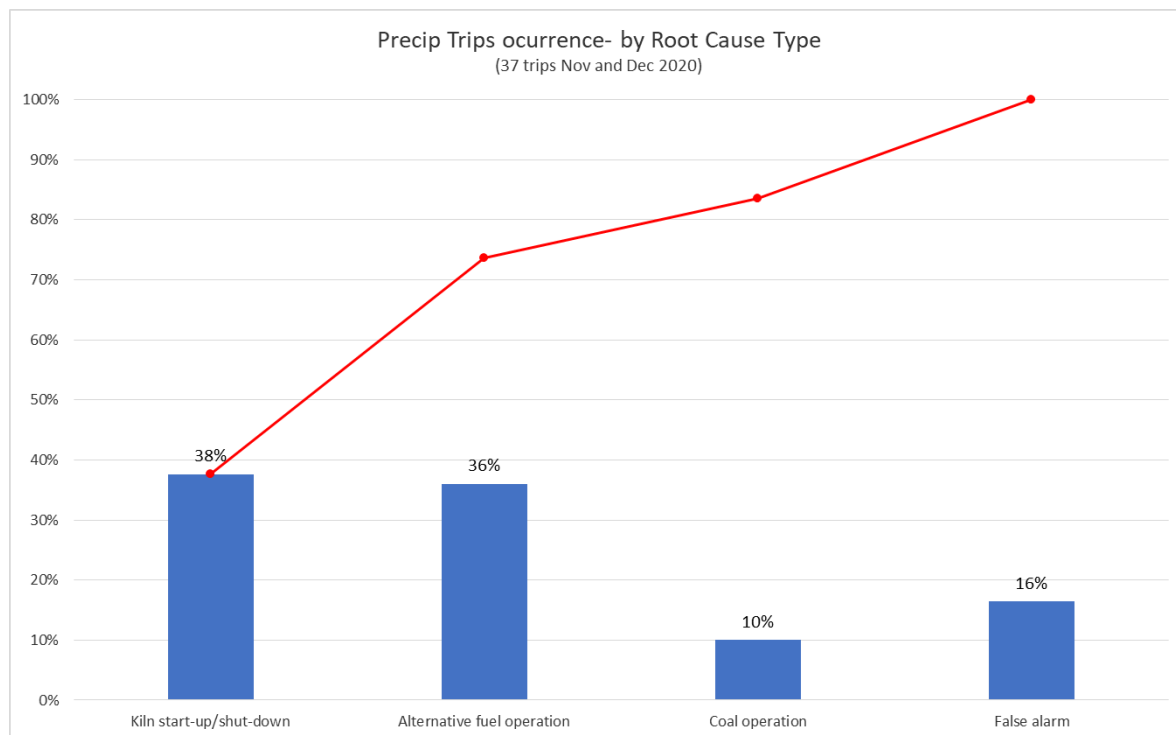
**Figure 3 Distribution of root causes among historical occurrences (Nov 2020 to Dec 2020)**

Figure 3 details that the main causes of ESP trips during November being Kiln Start up/shut down, Alternative Fuel operation, coal operation and false alarms. In response to the identified issues the Plant Management team implemented specific measures to address the particular root causes as described following section in February 2021 and March 2021 during the annual kiln shut down.

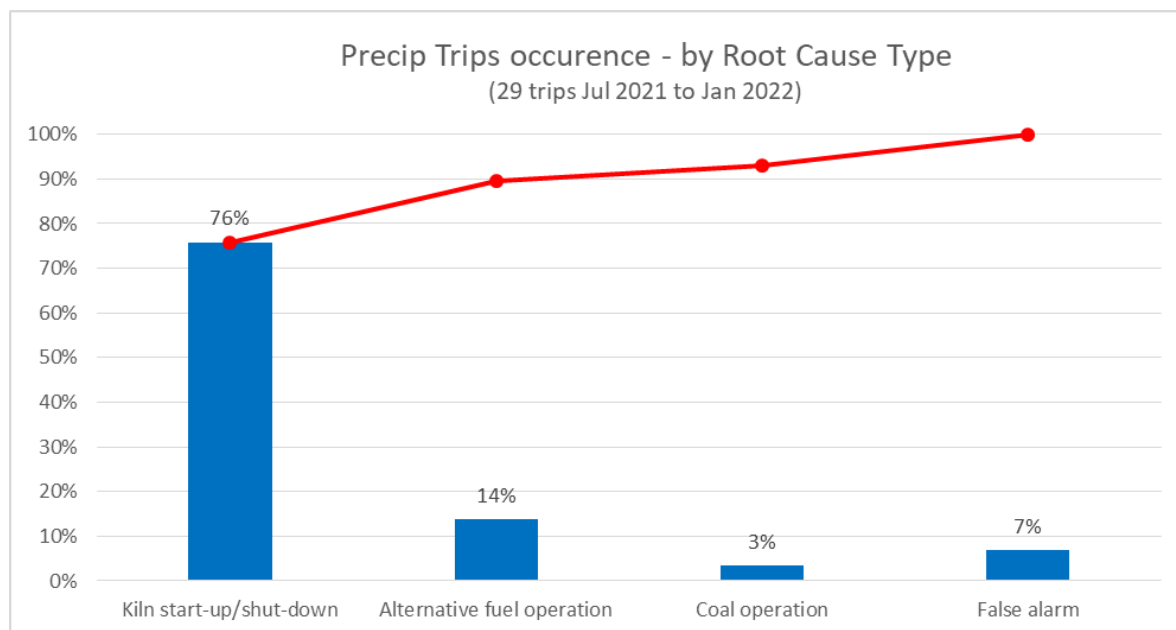
**Figure 4 Distribution of root causes during the reporting period: Jul 2021 to Jan 2022**

Figure 4 shows a significant improvement in the distribution of root causes of the ESP trips during the reporting period: July 2021 to January 2022, with kiln start-up/shut-down representing the main root cause.

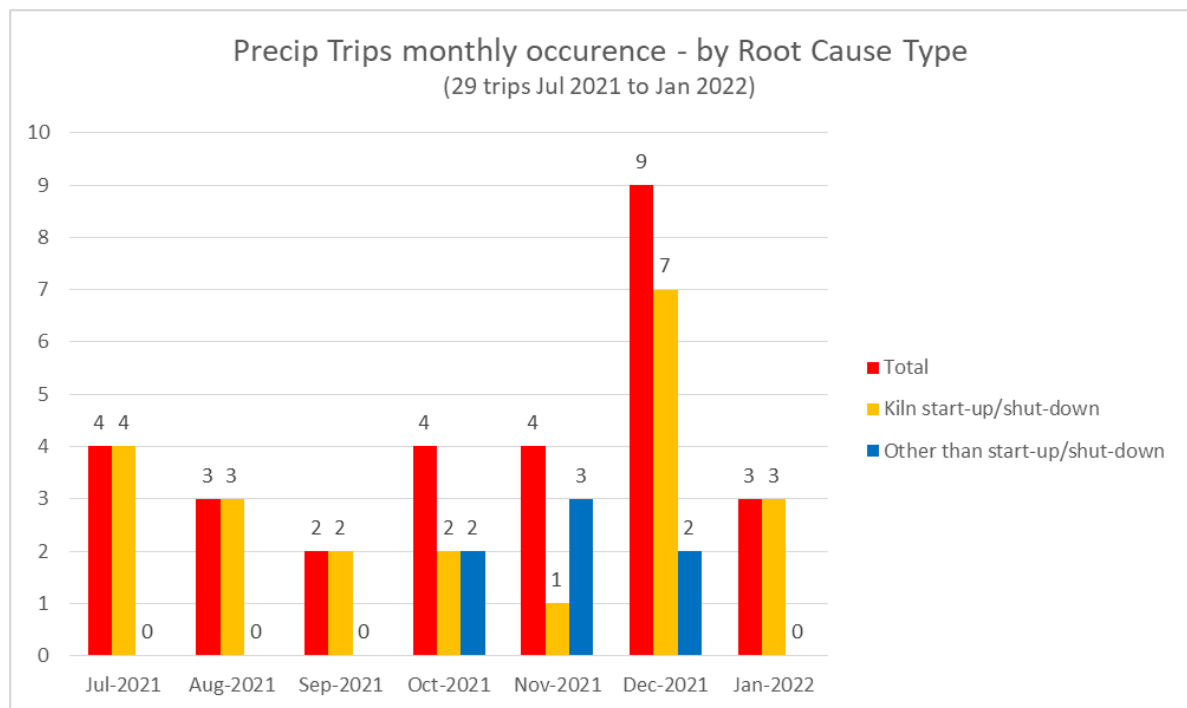
Figure 5 Proportion of root causes during the reporting period: Jul 2021 to Jan 2022

This trend is consistent through each month of the reporting period, as shown in Figure 5.

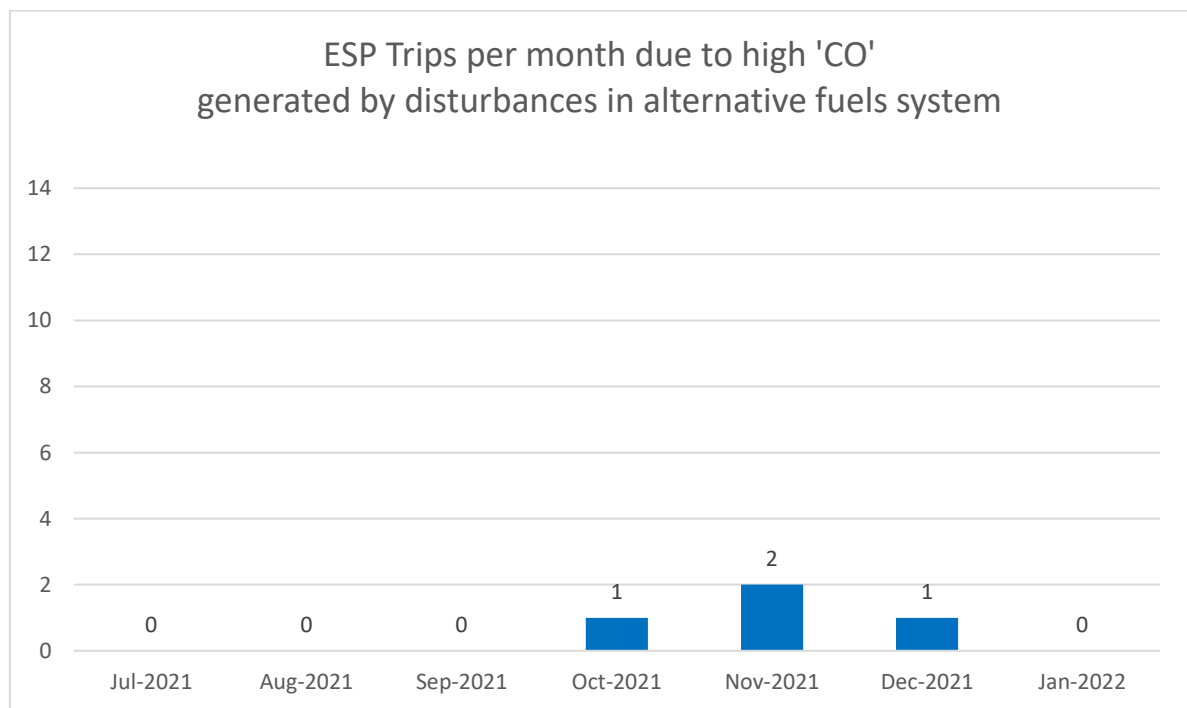
Figure 6: Number of ESP trips per months attributed to the alternative fuels system.

An analysis of historical occurrences of electrostatic precipitator deactivations revealed a direct link between operating issues related to the alternative fuels feeding systems (e.g.: disturbances in the feeding rate leading to improper mixing and localised cooling) and spikes in carbon monoxide.

The management team of Boral Cement – Berrima Works drafted specific plans to mitigate the occurrence of such events and the Maintenance and Operations teams implemented modifications to the feeding system during the March 2021 kiln 6 shut, such as: changing the injection point of alternative fuels; revamping the expansion joints on the screw conveyors and revamping the paddles in the screw conveyors feed bin to tighten the control of the feed rate; new Standard Operating Procedures for starting, stopping and ramping up the injection rate.
