## **Geotechnical Assessment Report**

**200 Aldington Rd, Kemps Creek, NSW 2178**  
**Dam Walls Stability Analysis**

**Prepared for: Fife Kemps Creek Ltd**

A201021.1725.03.v1f\_200 Aldington Rd\_Dam Stability\_JP | 21.03.2022

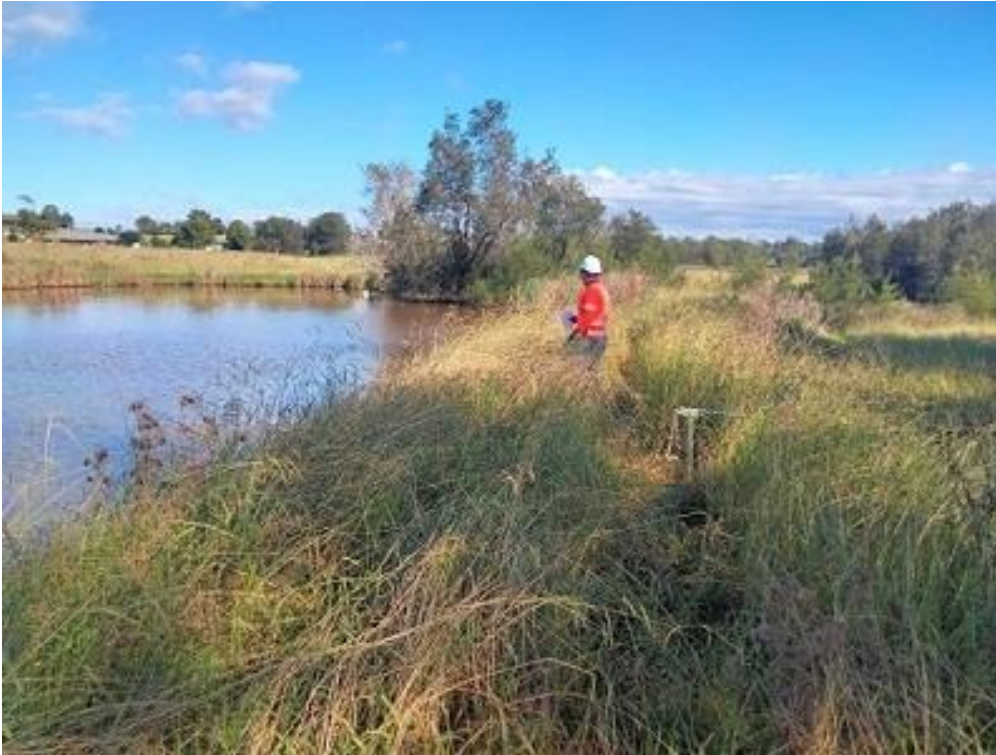
**Photo 1** – Facing west at DCP location 1 - Crest of northern dam wall at Dam 1

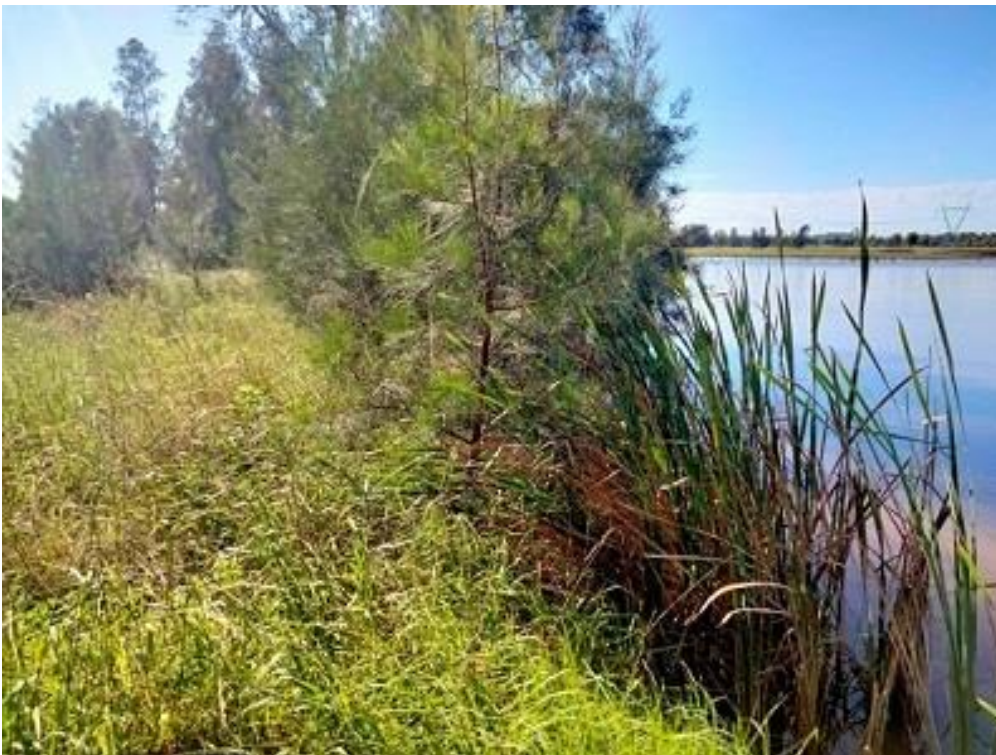
The inclination of embankments at Dam 1 and Dam 2 was generally observed to be between approximately 30 – 45°, however some steeper slopes may have been obscured by vegetation and high dam water levels. The embankments of Dam 1 were covered in vegetation with several small trees observed along the northern and western walls. (see **Photo 2**). The east and west banks of Dam 2 were lined with trees and vegetation.

**Photo 2** – Facing east at DCP location 4 – Crest of northern dam wall at Dam 1

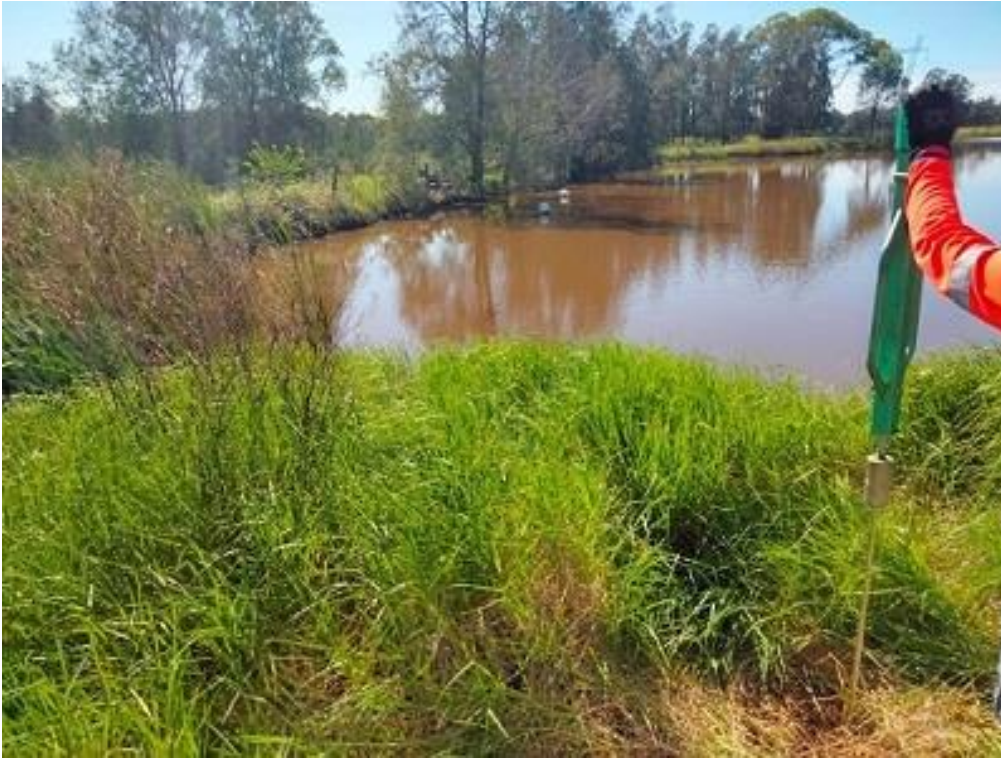
**Photo 3** – Facing east at DCP location 6 – Dam 1 and northern dam wall in background

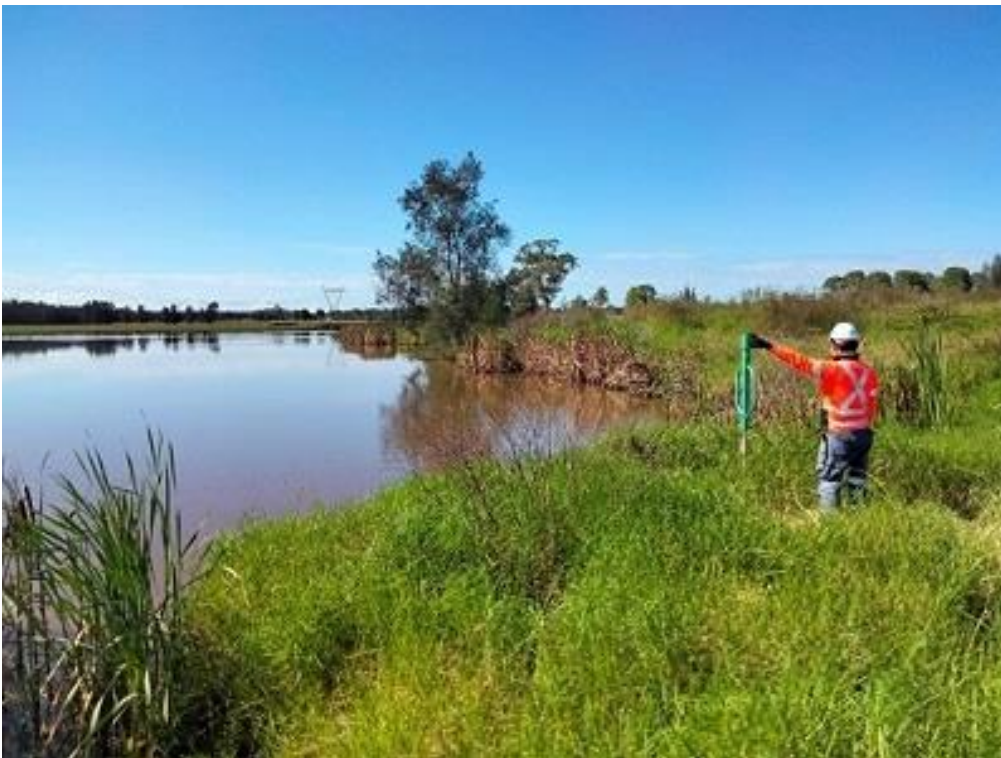
**Photo 4** – Facing south viewing DCP location 6 from northeast corner of Dam 1

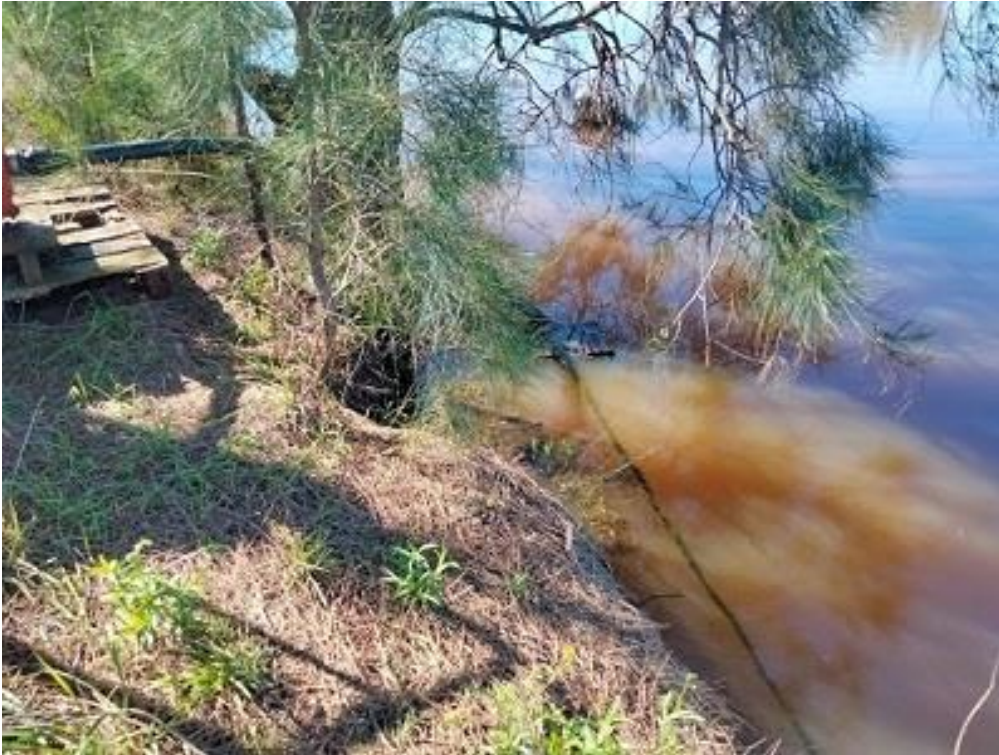
**Photo 5** – Dam water pump and pipe on northern wall of Dam 1

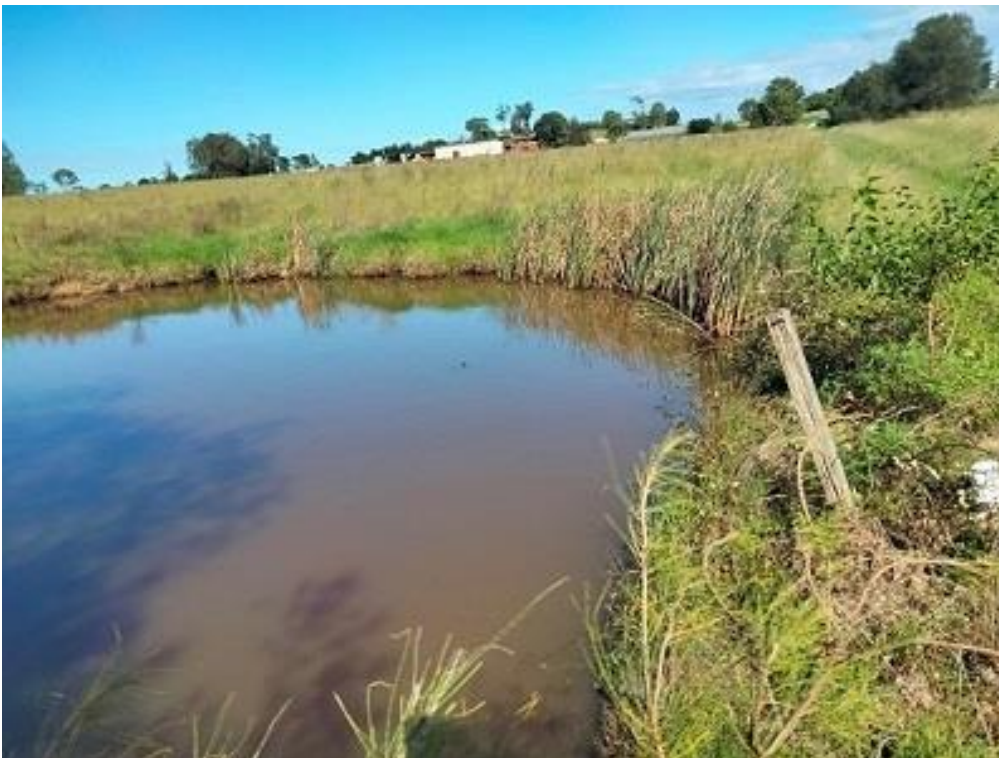
**Photo 6** – Facing west at northeast corner of Dam 1.

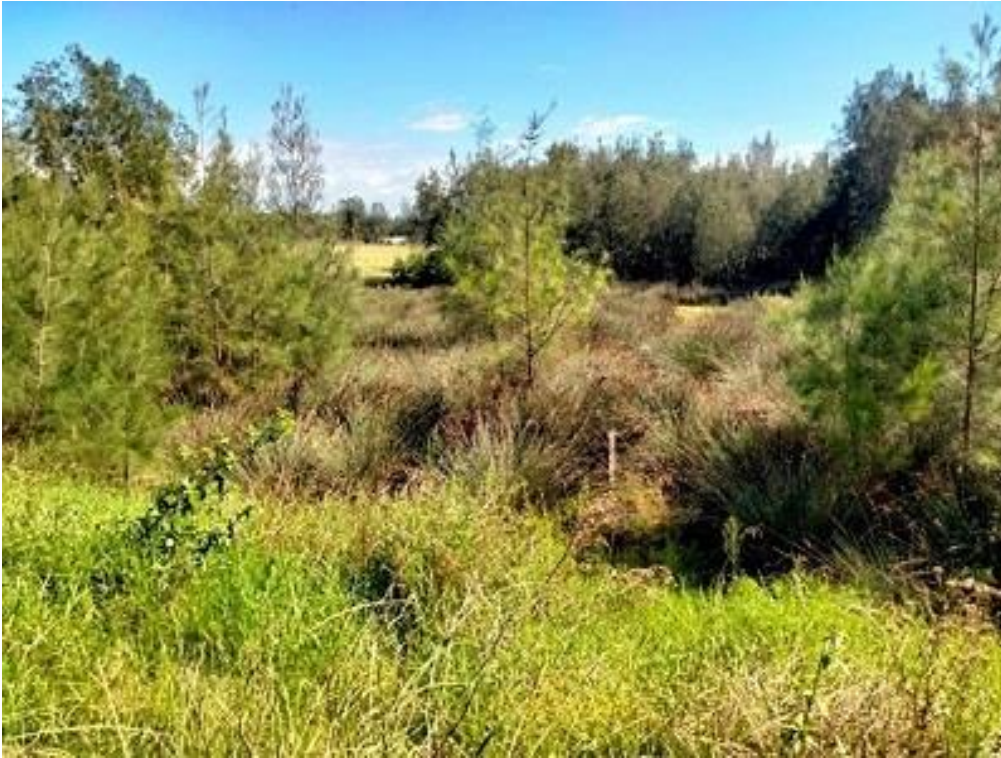
No formal spillway structures were observed at Dam 1. An overland natural spillway (no flow direction was visible at time of inspection) was observed at the northeast corner of the dam, leading north through a forested area towards Dam 2.

**Photo 7** – Facing north from Dam 1 northern wall towards Dam 2 – water overflow path towards Dam 2

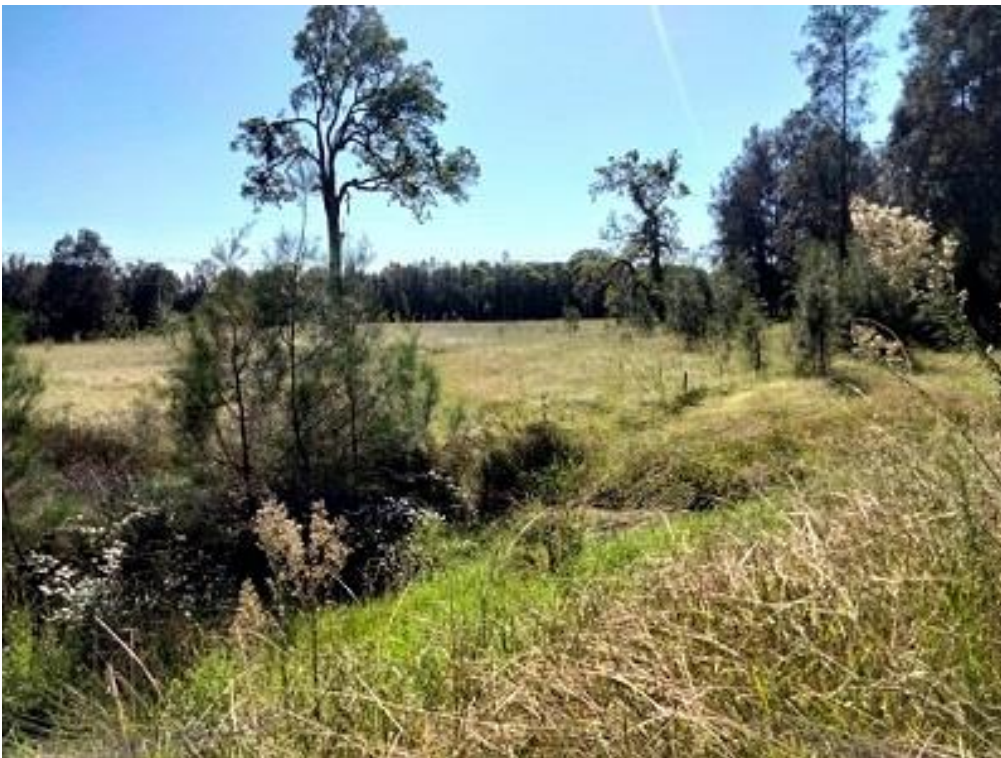
**Photo 8** – Facing northeast from Dam 1 northern wall – water overflow path towards Dam 2.

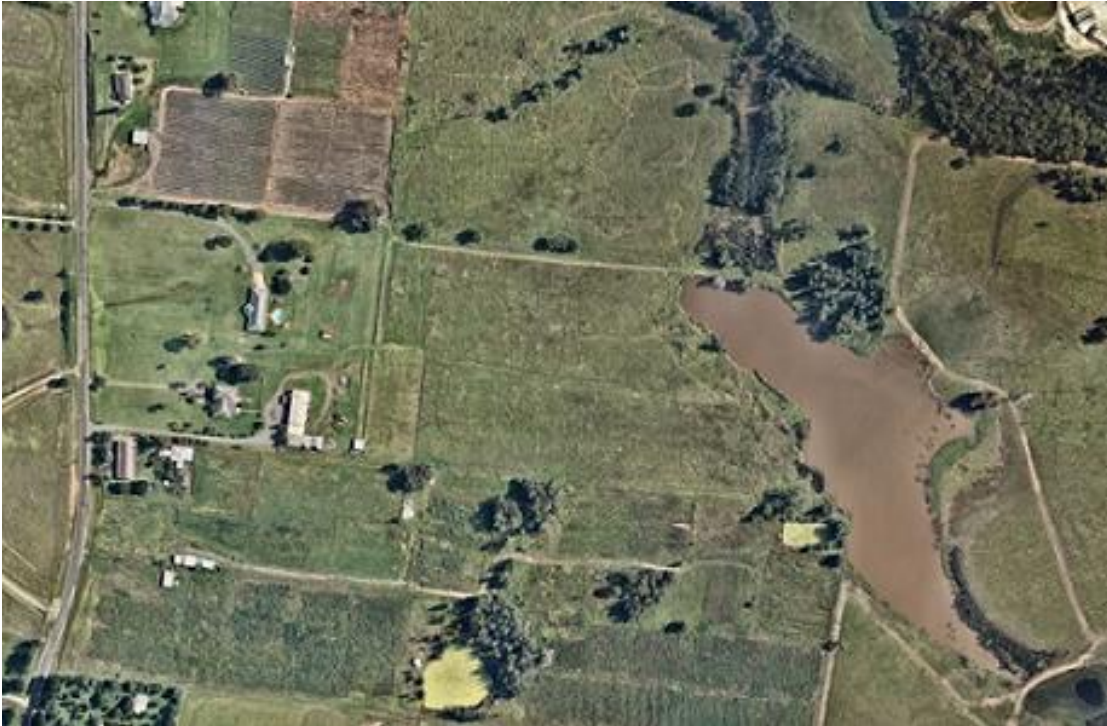
**Photo 9** – Aerial image of dams (February 2022) – Sourced from Nearmap

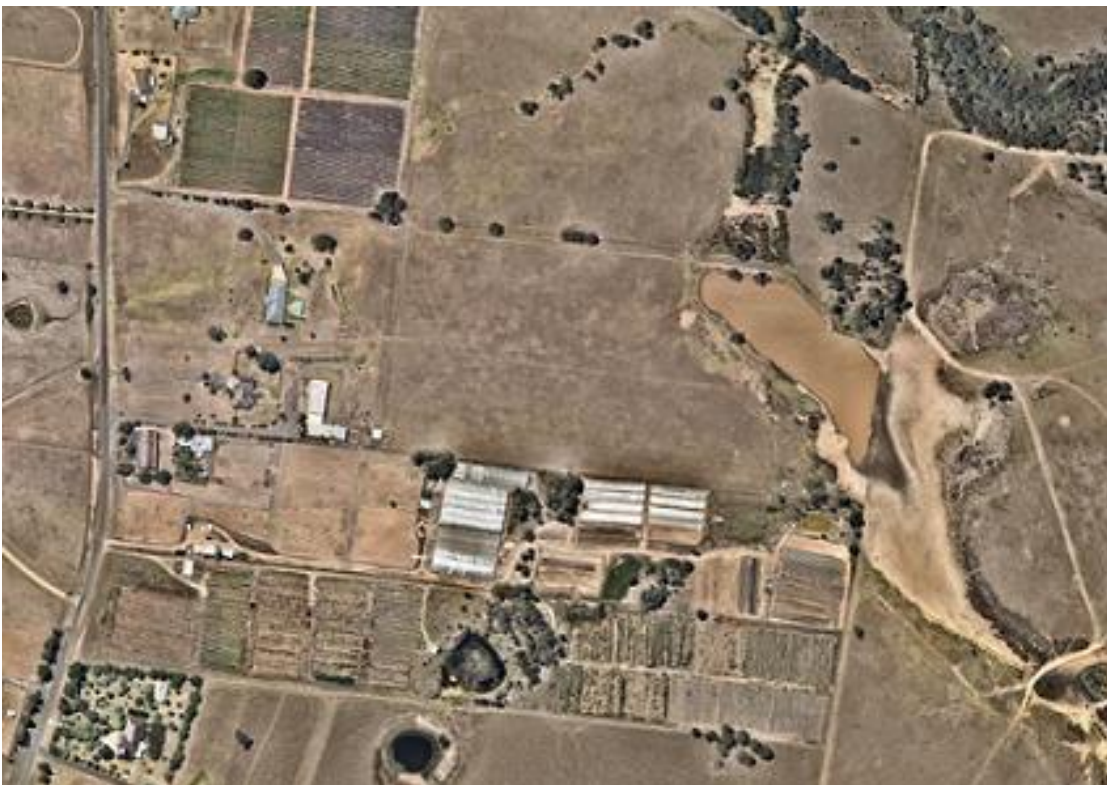
**Photo 10** – Aerial image of dams (January 2018) – Sourced from Nearmap

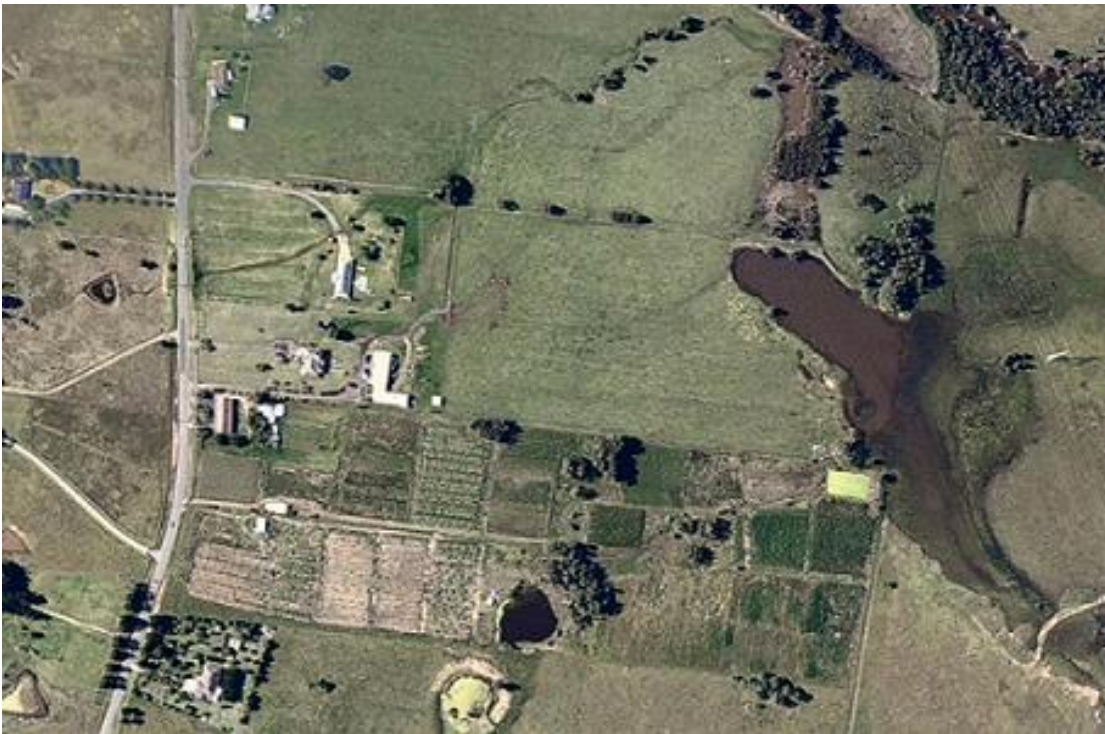
**Photo 11** – Aerial image of dams (February 2012) – Sourced from Nearmap
