Pre-Demolition Hazardous Materials Survey Report

Lot 20, 214 Aldington Road, Kemps Creek NSW

Prepared for: Fife Capital DSI Pty Ltd

21.1994 | HBM1 | Date: 22nd March 2022

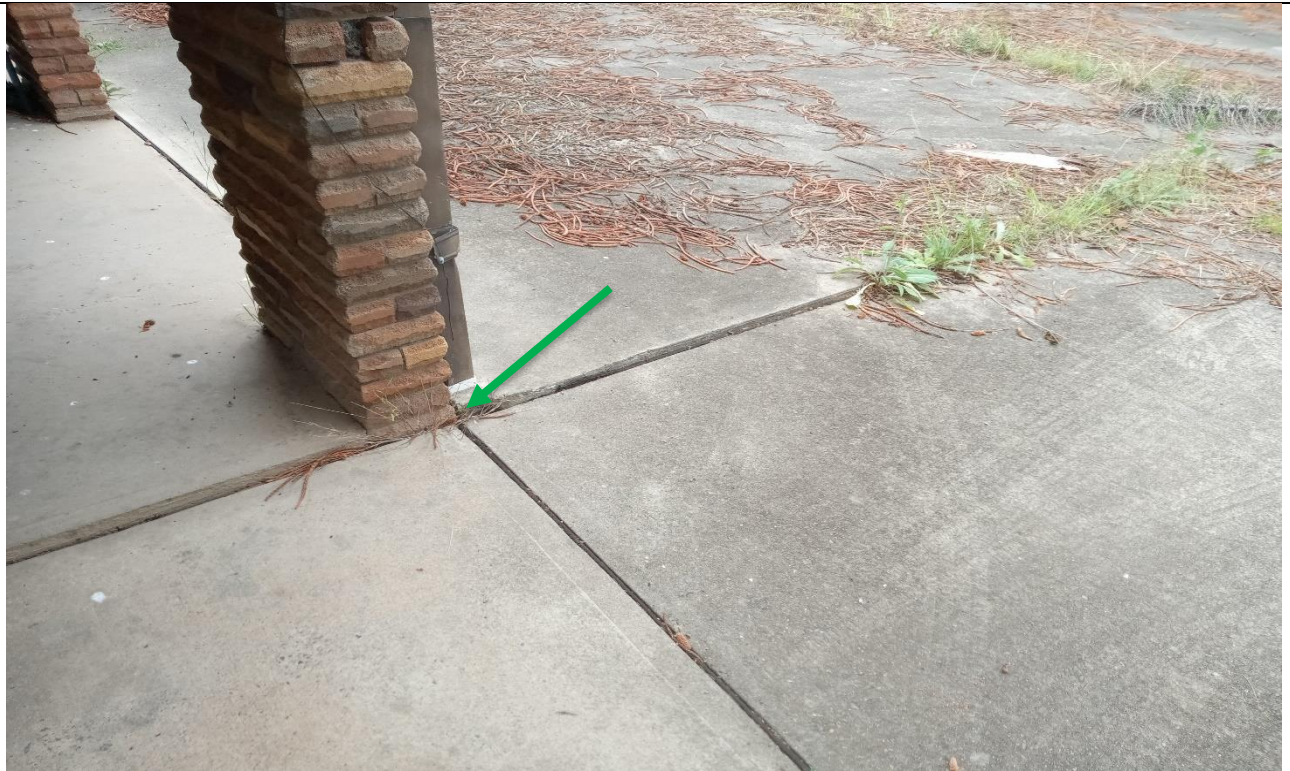
Photograph 1. External surround, non asbestos Bitumen mastic to concrete slab, as observed on 12/01/2022.

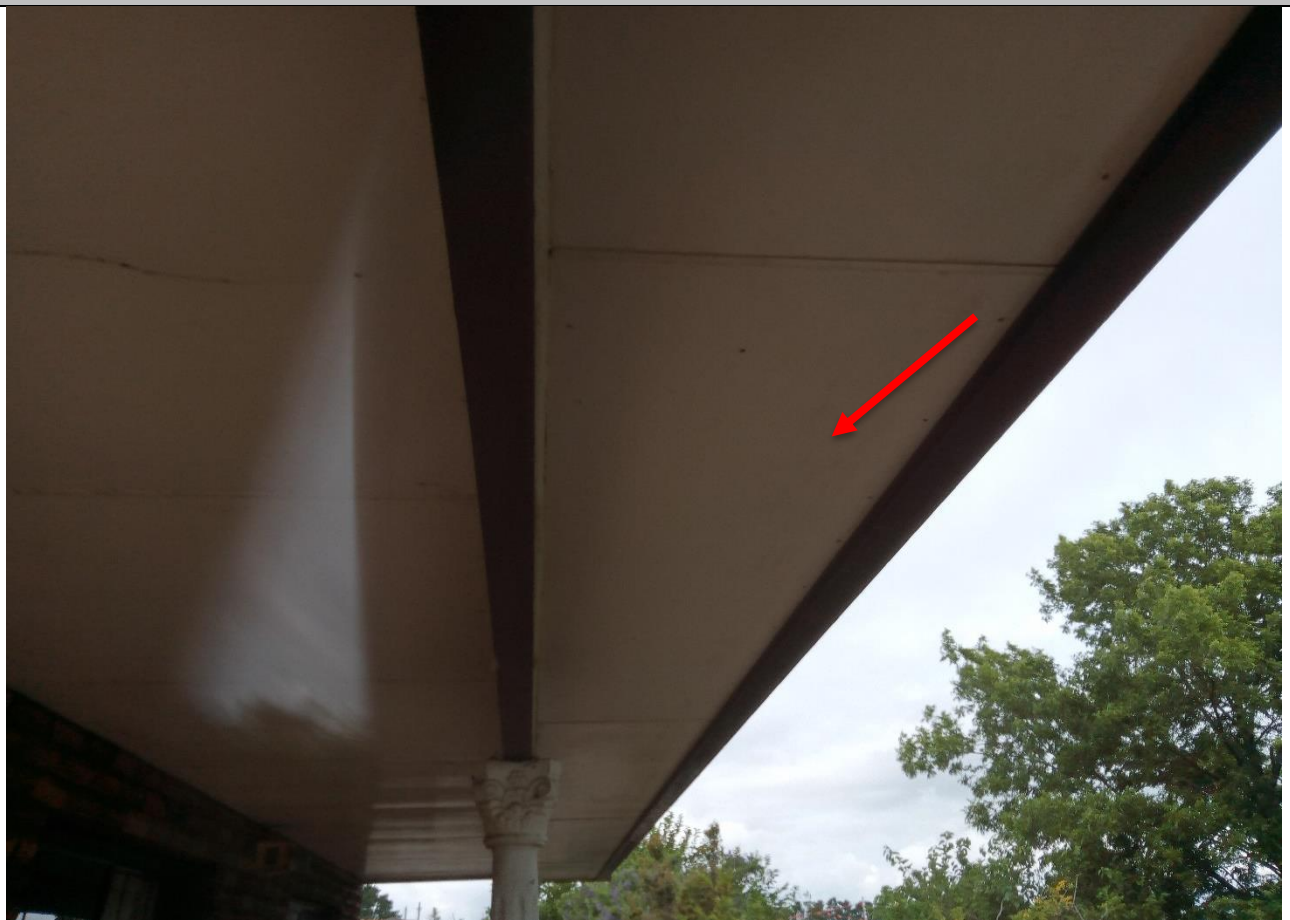
Photograph 2. External eaves, asbestos containing fibre cement, as observed on 12/01/2022.

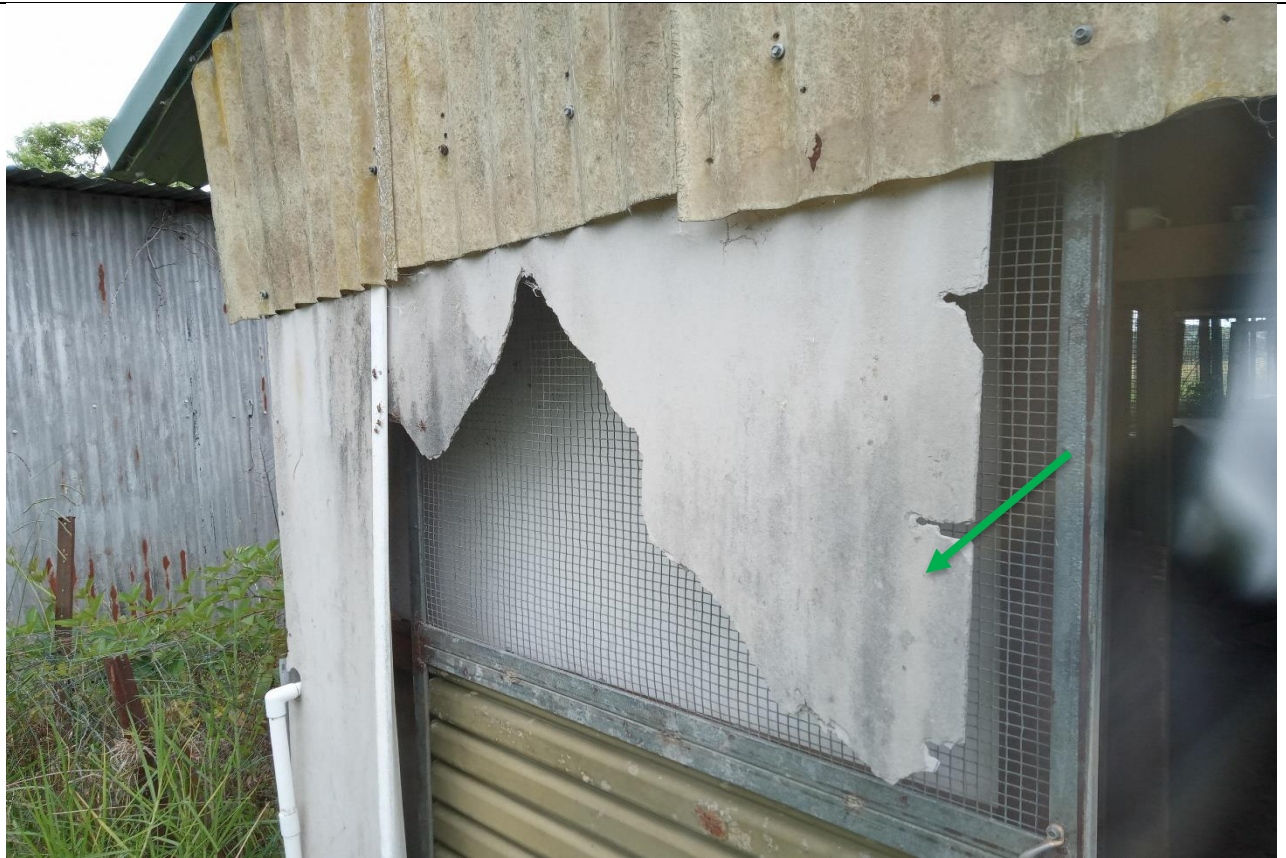
Photograph 3. External, storage and animal cages wall lining and entrance door, non-asbestos containing fibre cement, as observed on 12/01/2022.

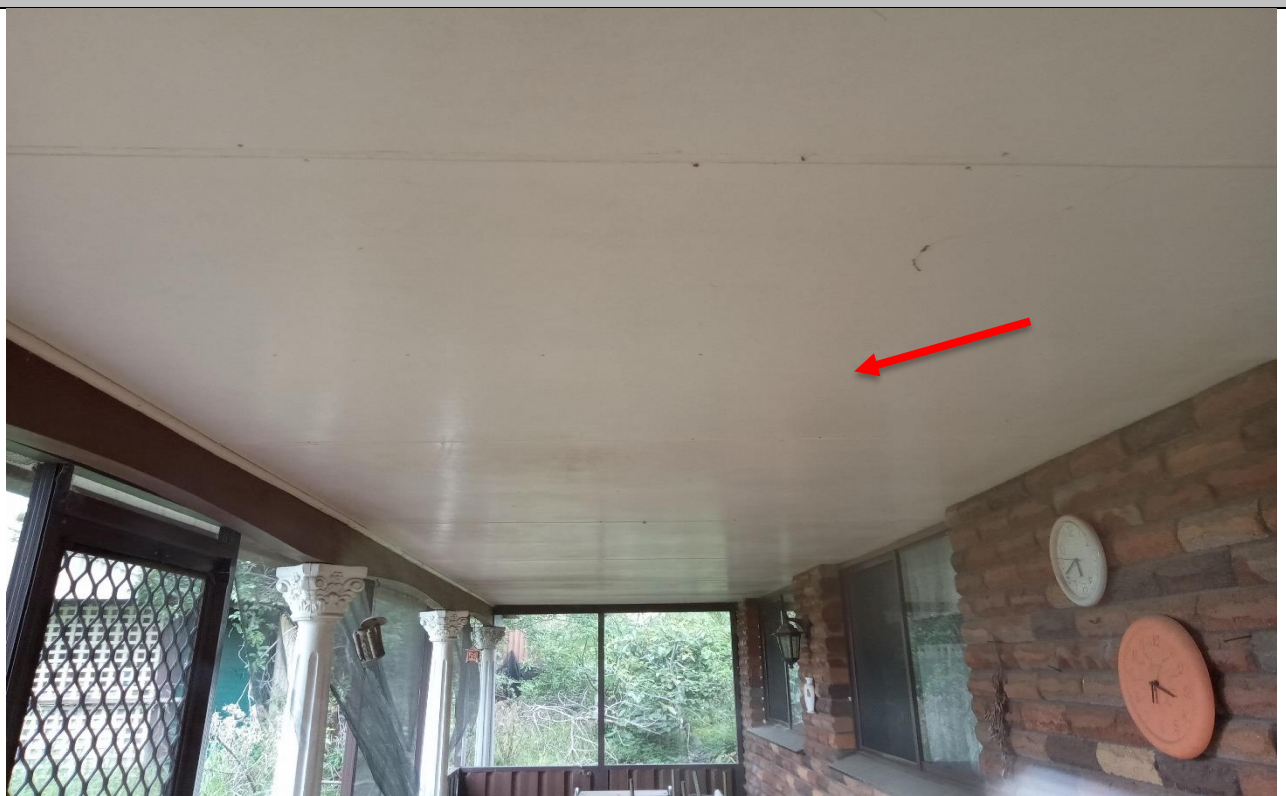
Photograph 4. Internal, front and rear entrance - asbestos containing ceiling lining, as observed on 12/01/2022.

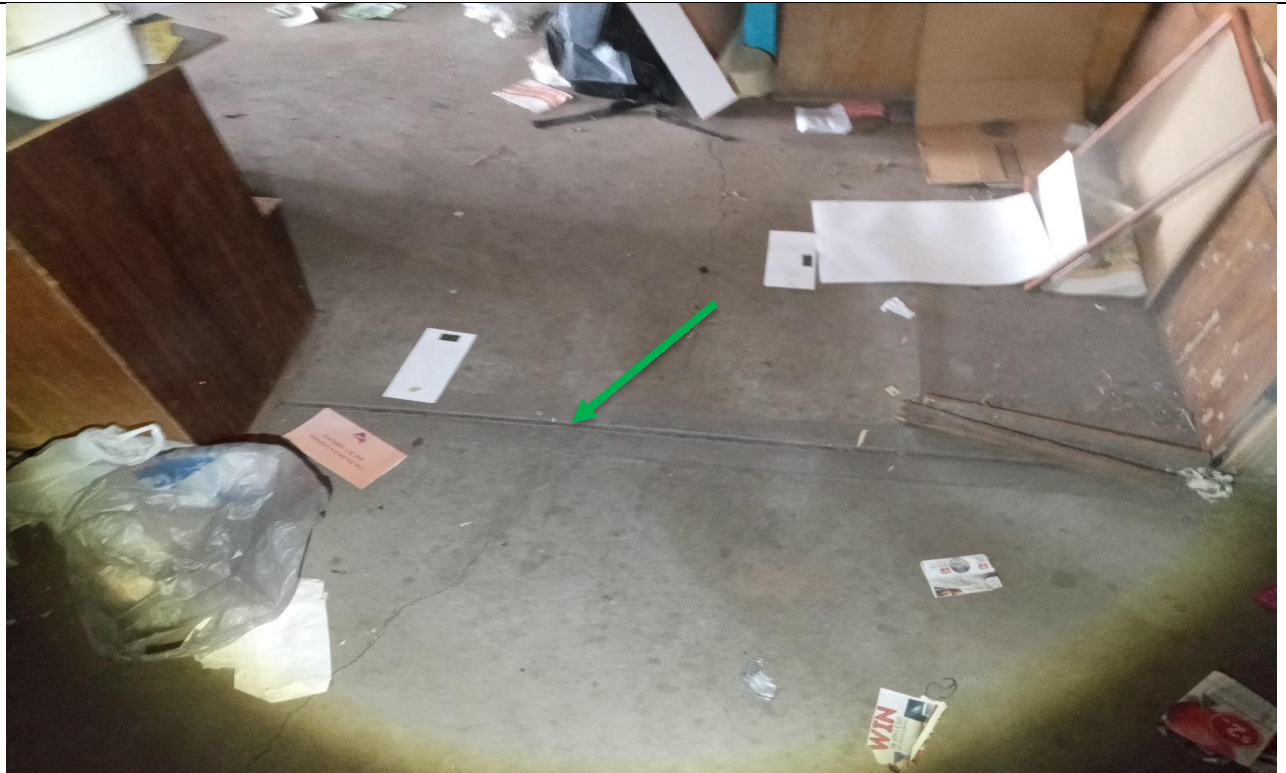
Photograph 5. Internal, ground level, non asbestos bitumen mastic to concrete floor slabs, as observed on 12/01/2022.

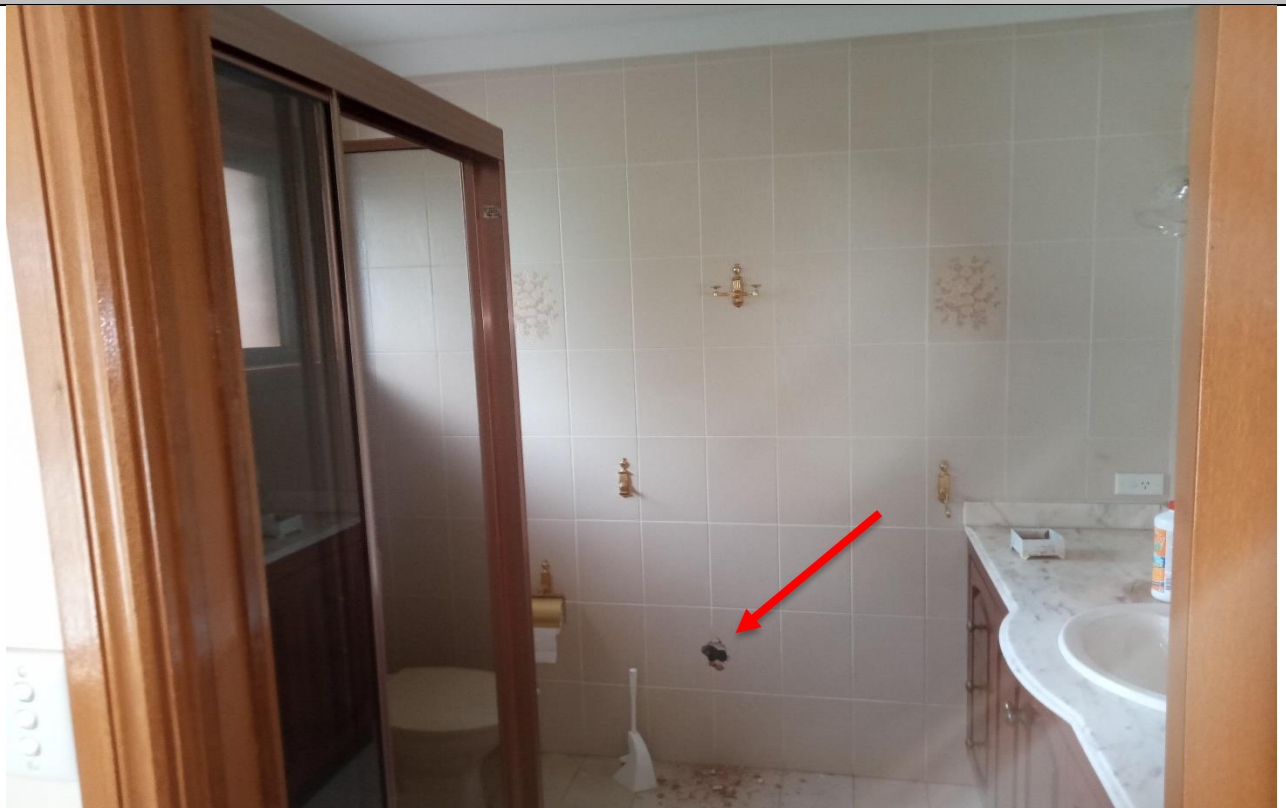
Photograph 6. Internal, bathroom ensuite wall lining, sbestos containing fibre cement, as observed on 12/01/2022.

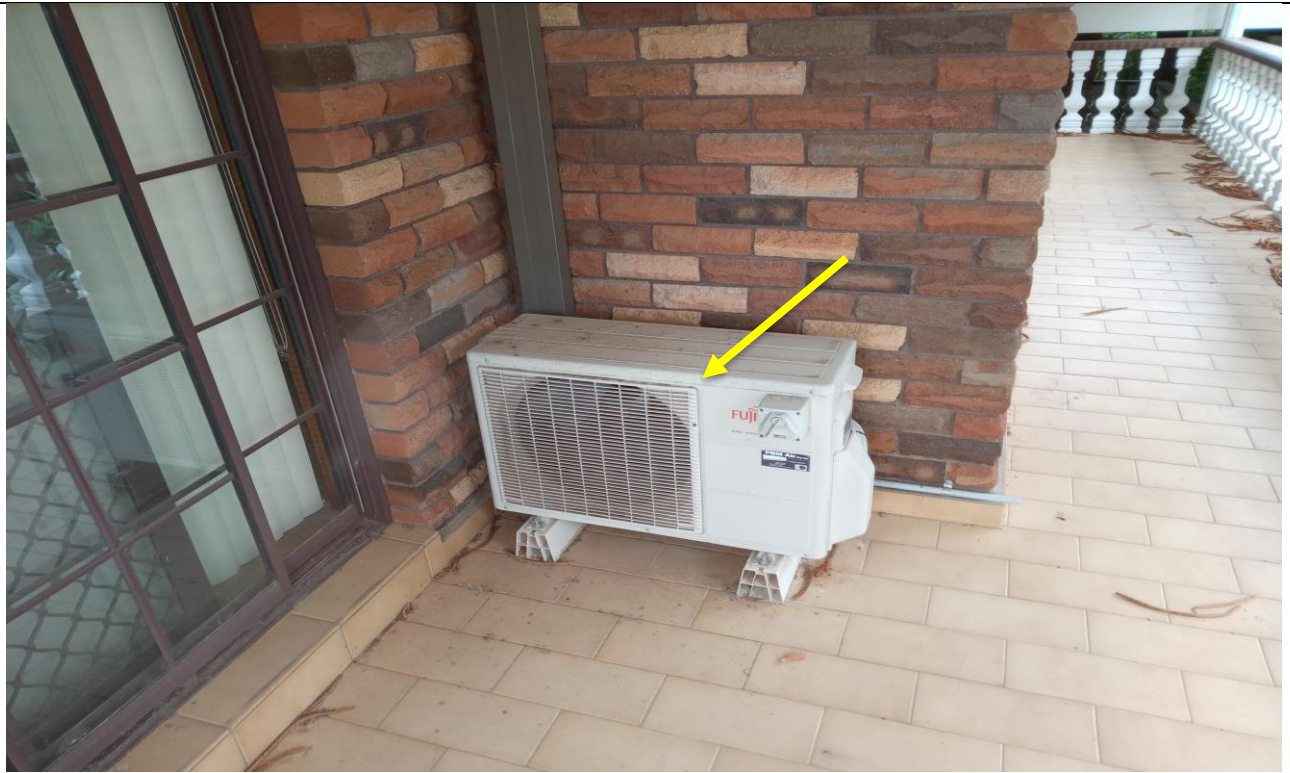
Photograph 7. External front balcony, non ODS gas R32, as observed on 12/01/2022.

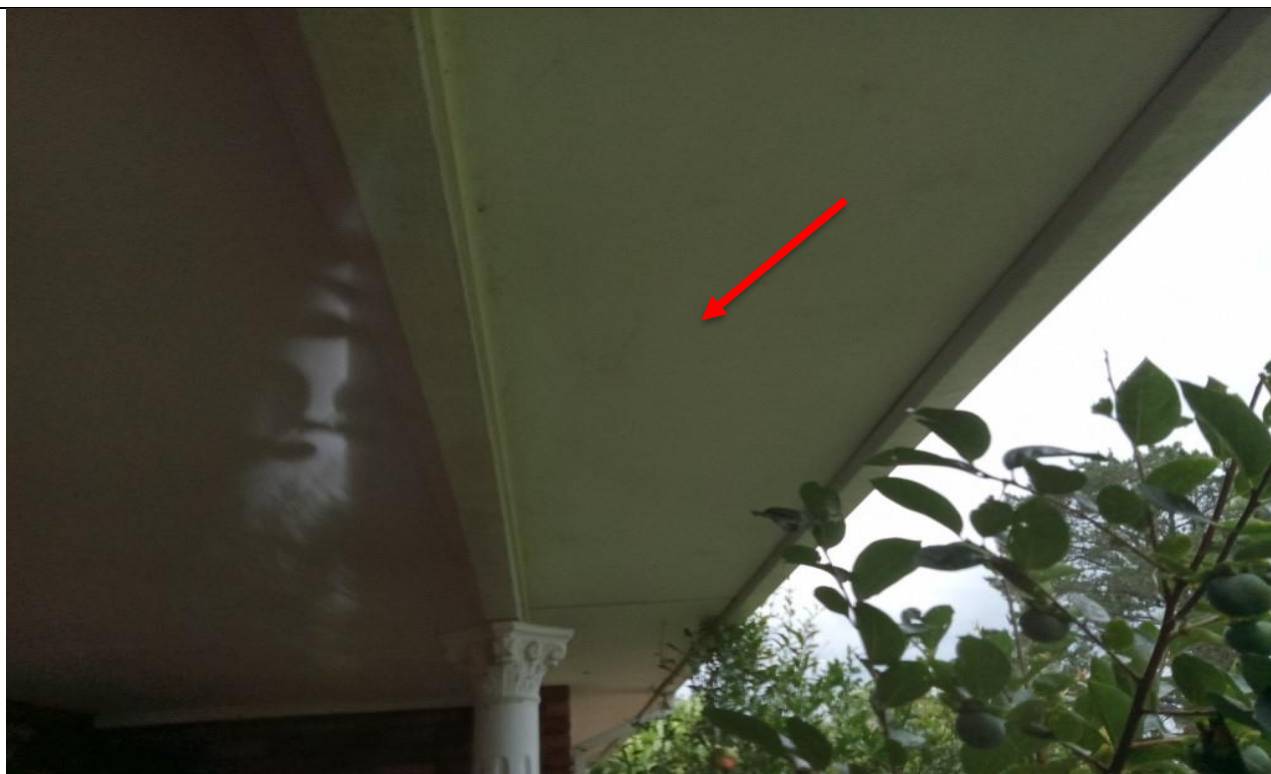
Photograph 1. 198B residence, External surround, asbestos containing eaves lining, as observed on 12/01/2022.

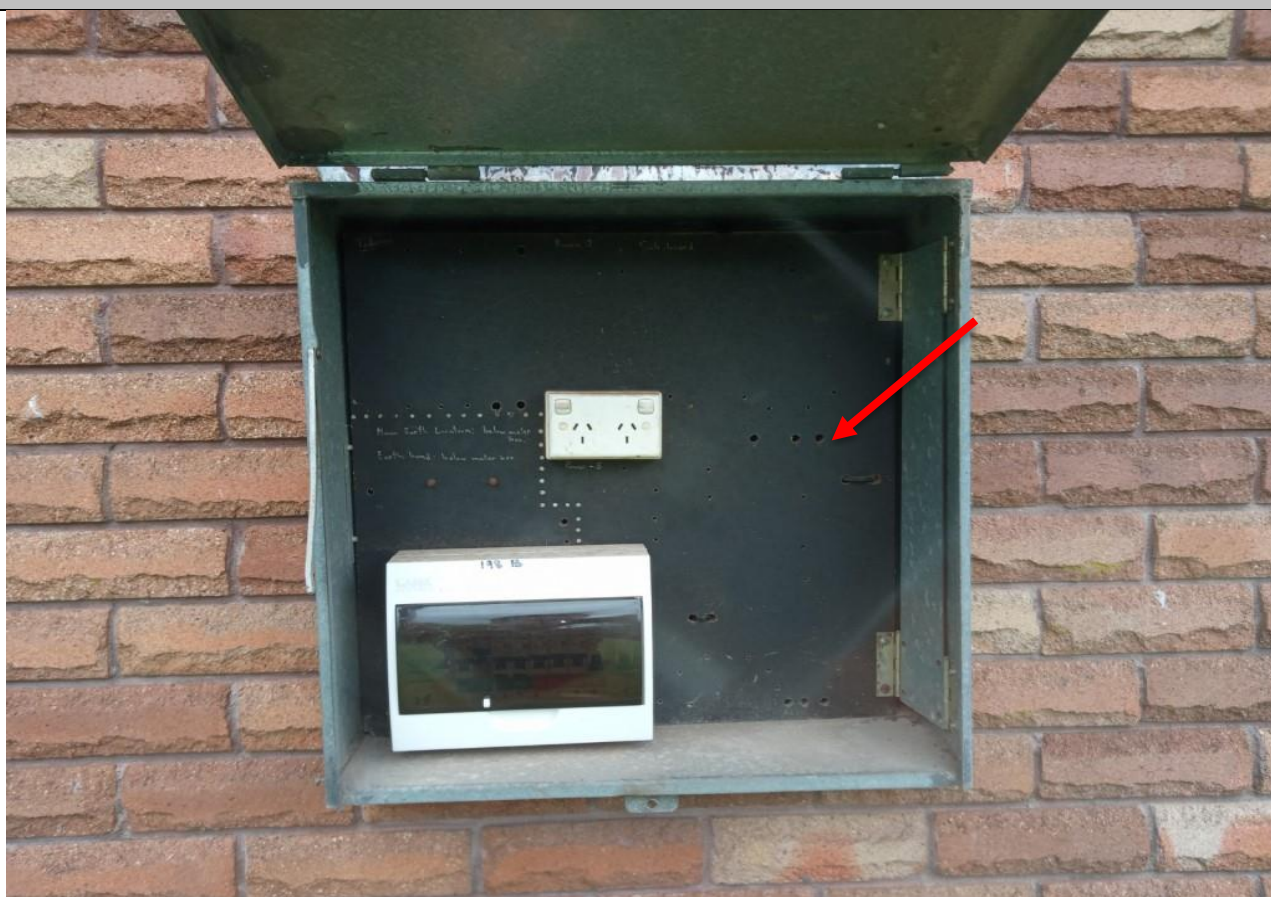
Photograph 2. 198B residence, External, presumed asbestos containing electrical backing board, as observed on 12/01/2022.

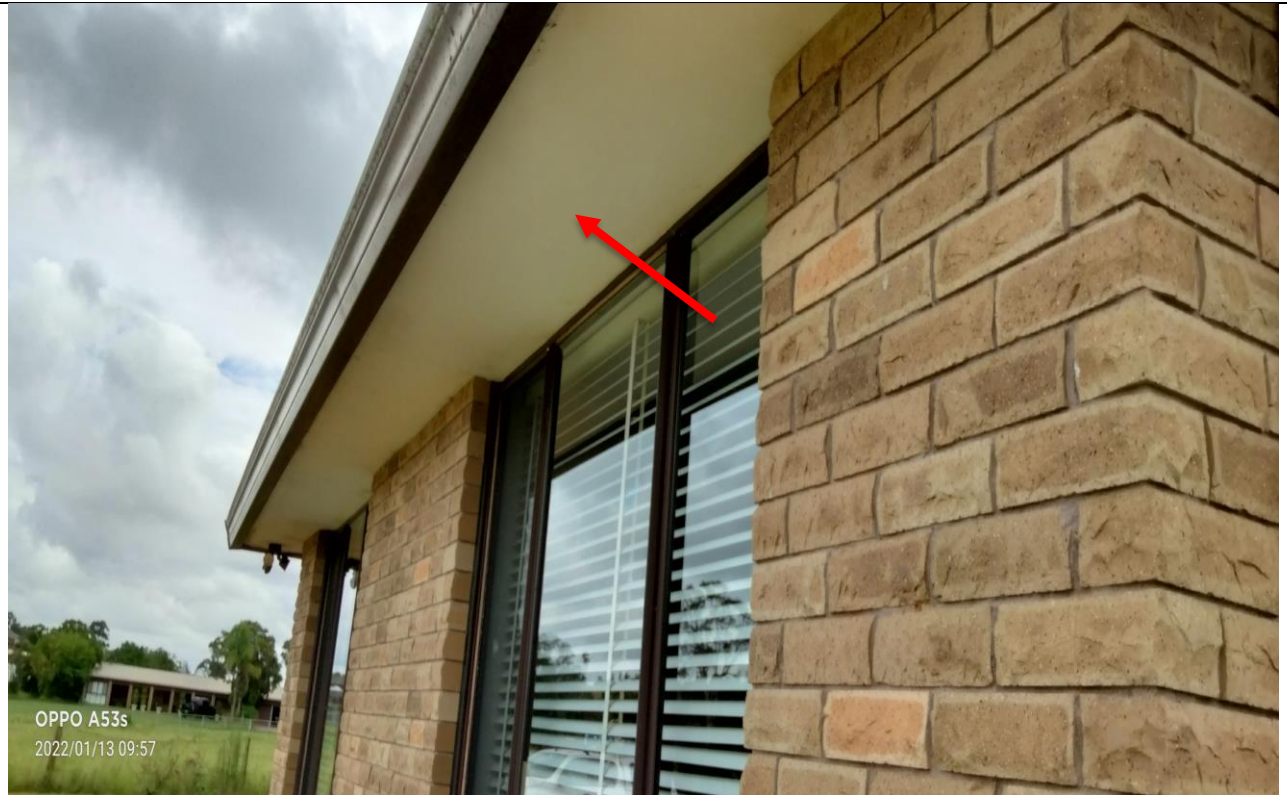
Photograph 3. 198A residence, External surround, asbestos containing eaves lining, as observed on 12/01/2022.

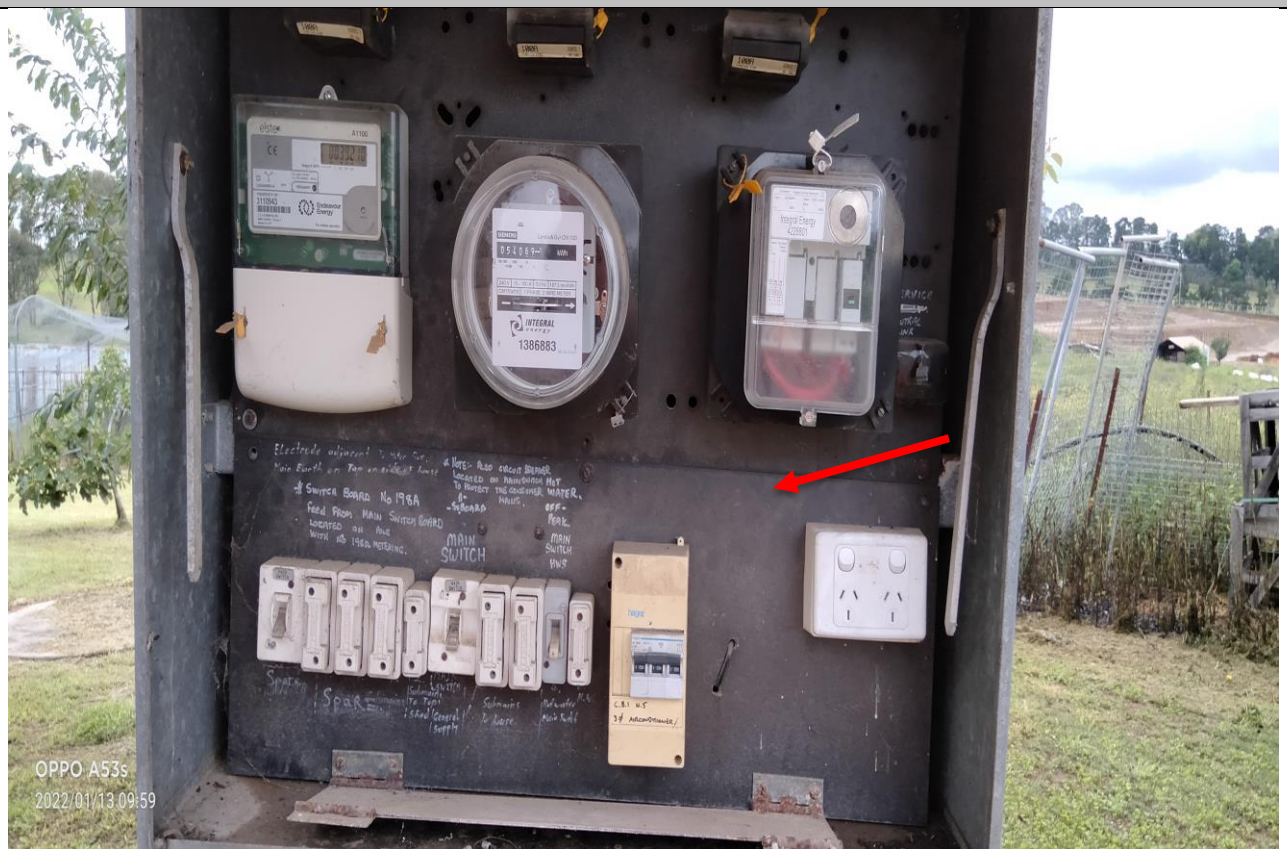
Photograph 4. 198A residence, External, presumed asbestos containing electrical backing board, as observed on 12/01/2022.

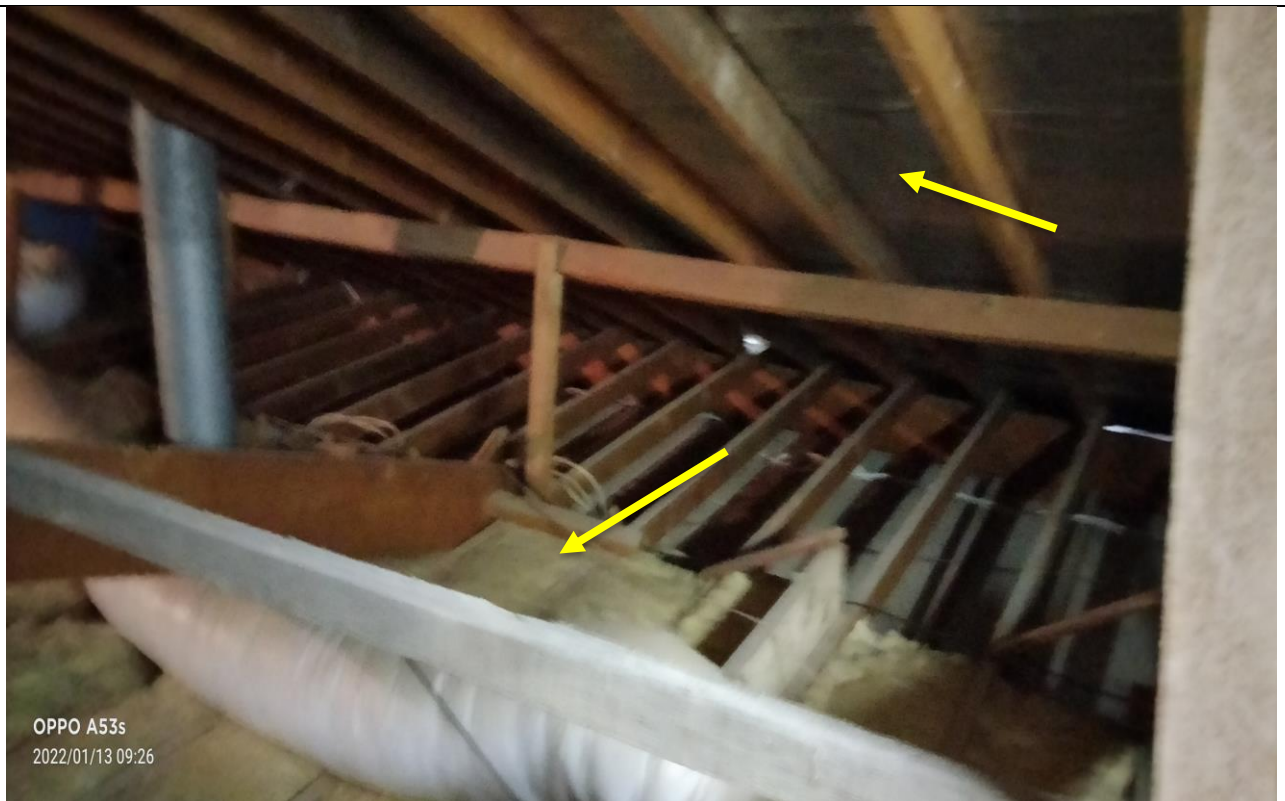
Photograph 5. Internal, main building, ceiling void – presumed SMF sarking and insulation batts as observed on 12/01/2022.

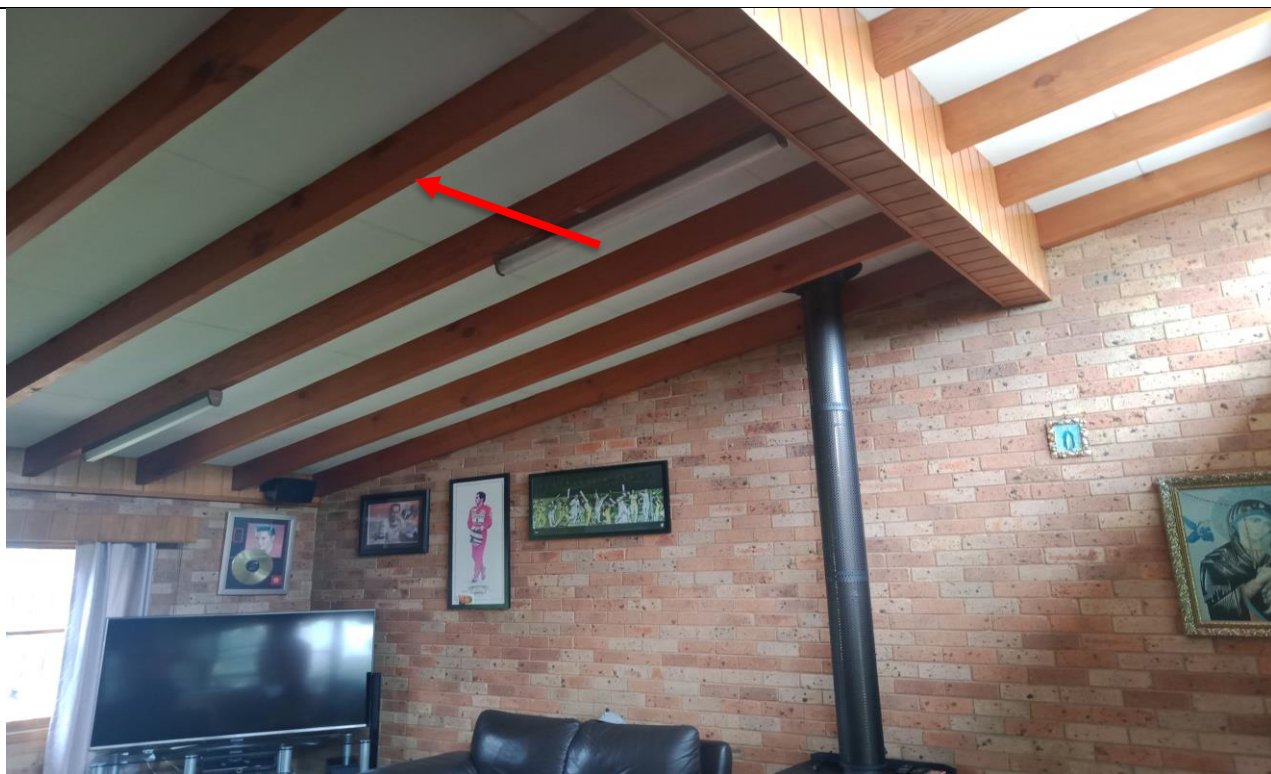
Photograph 1. West building, Internal, ground, living room, asbestos containing FC ceiling lining, as observed on 12/01/2022.

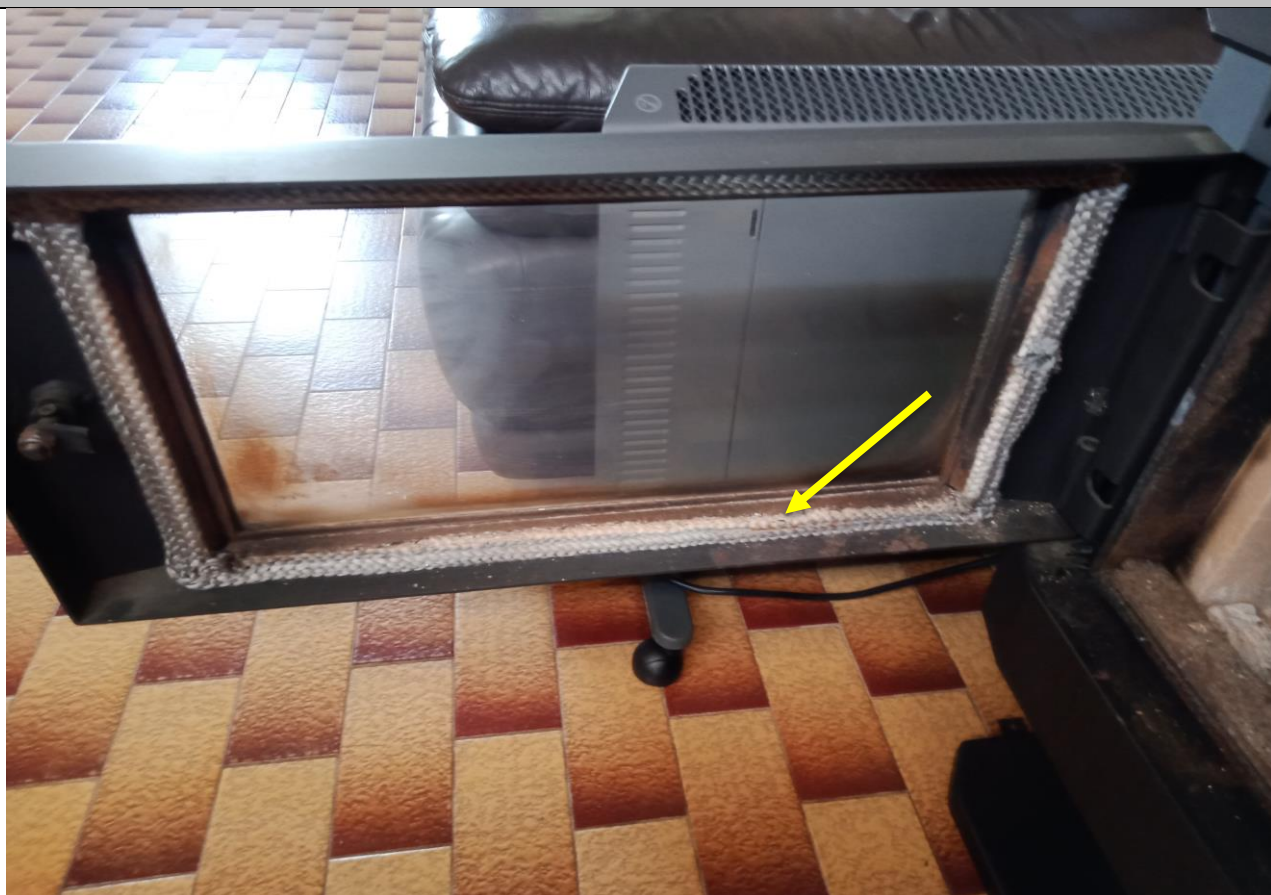
Photograph 2. West building, Internal, ground, living room, non-asbestos containing, SMF fibres detected rope seal to furnace door, as observed on 12/01/2022.

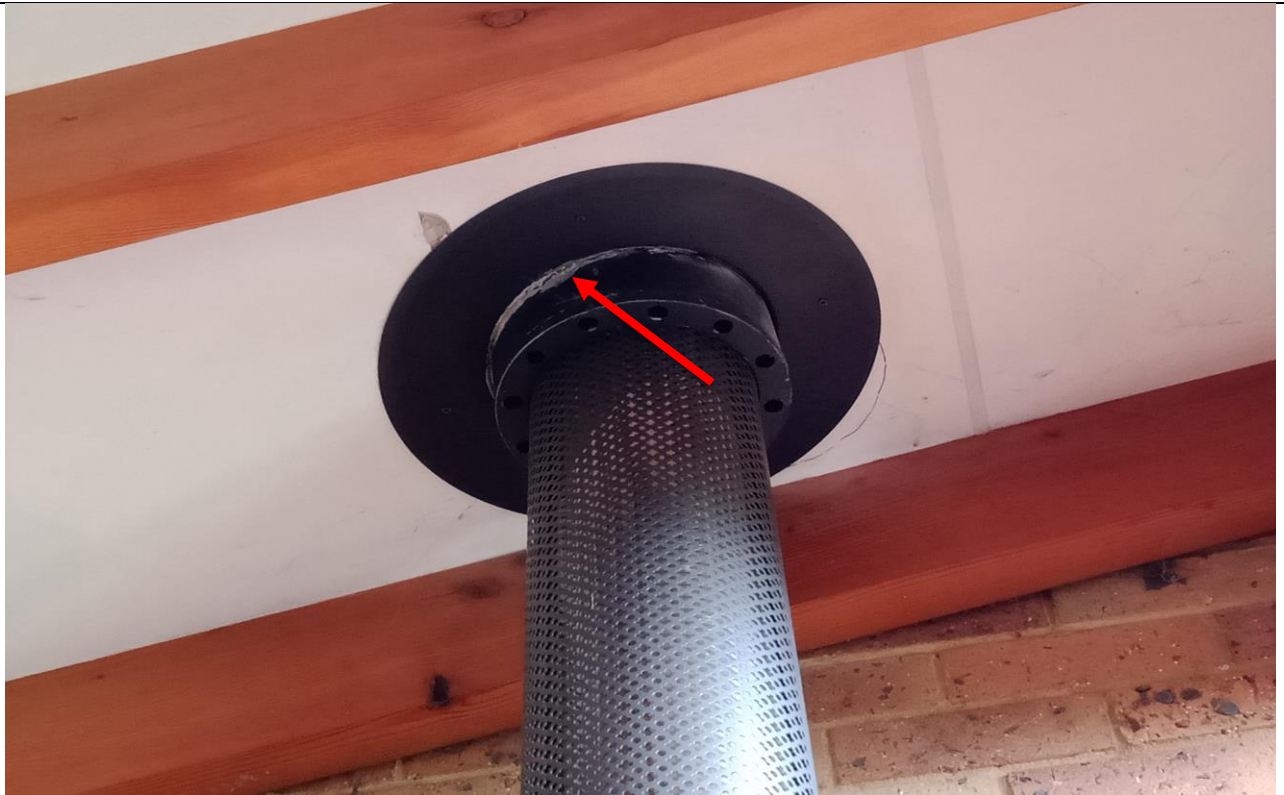
Photograph 3. West building, Internal, ground, living room, asbestos containing mastic to furnace flue pipe, as observed on 12/01/2022.

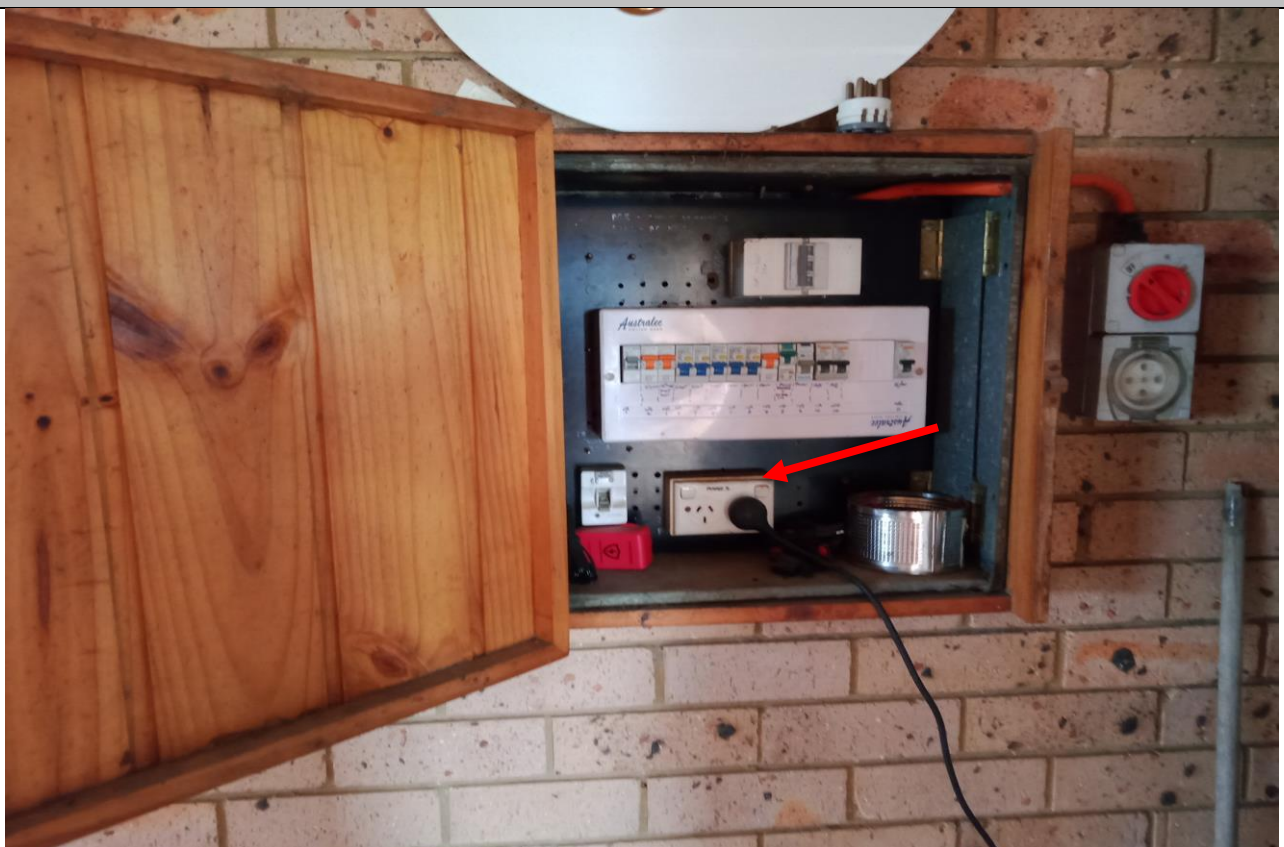
Photograph 4. West building, Internal, ground, presumed asbestos containing electrical backing board, as observed on 12/01/2022.

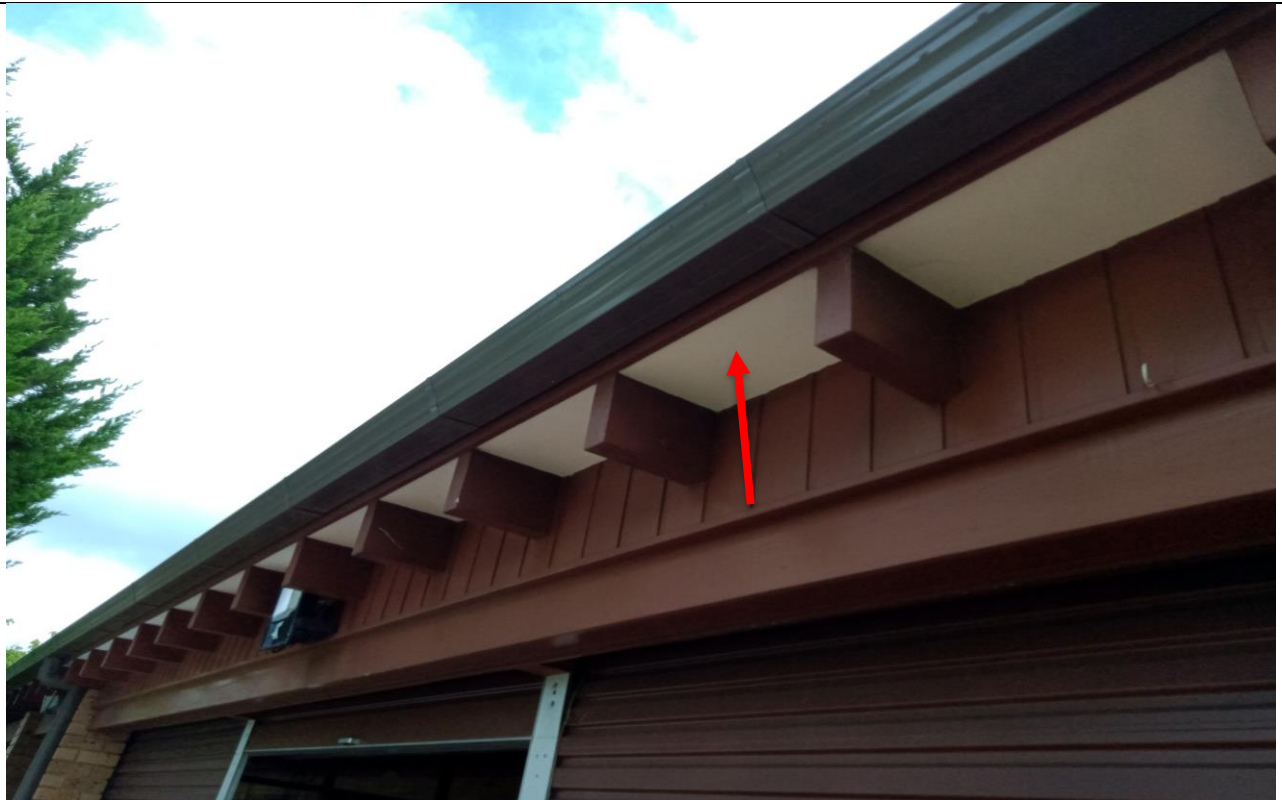
Photograph 5. West building, external, asbestos containing FC eaves lining, as observed on 12/01/2022.

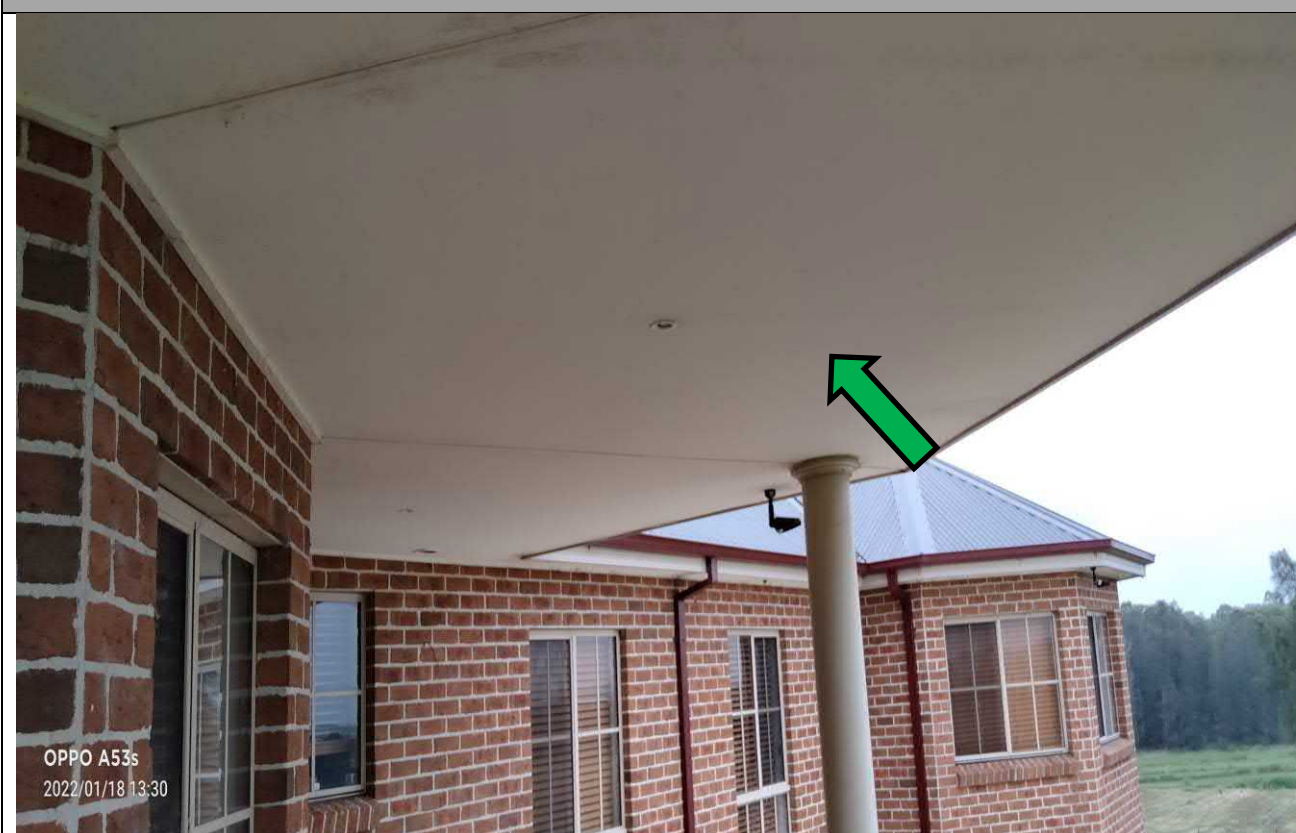
Photo 2: Main building, eaves, non-asbestos containing fibre cement sheeting, as observed on 18/01/2022.

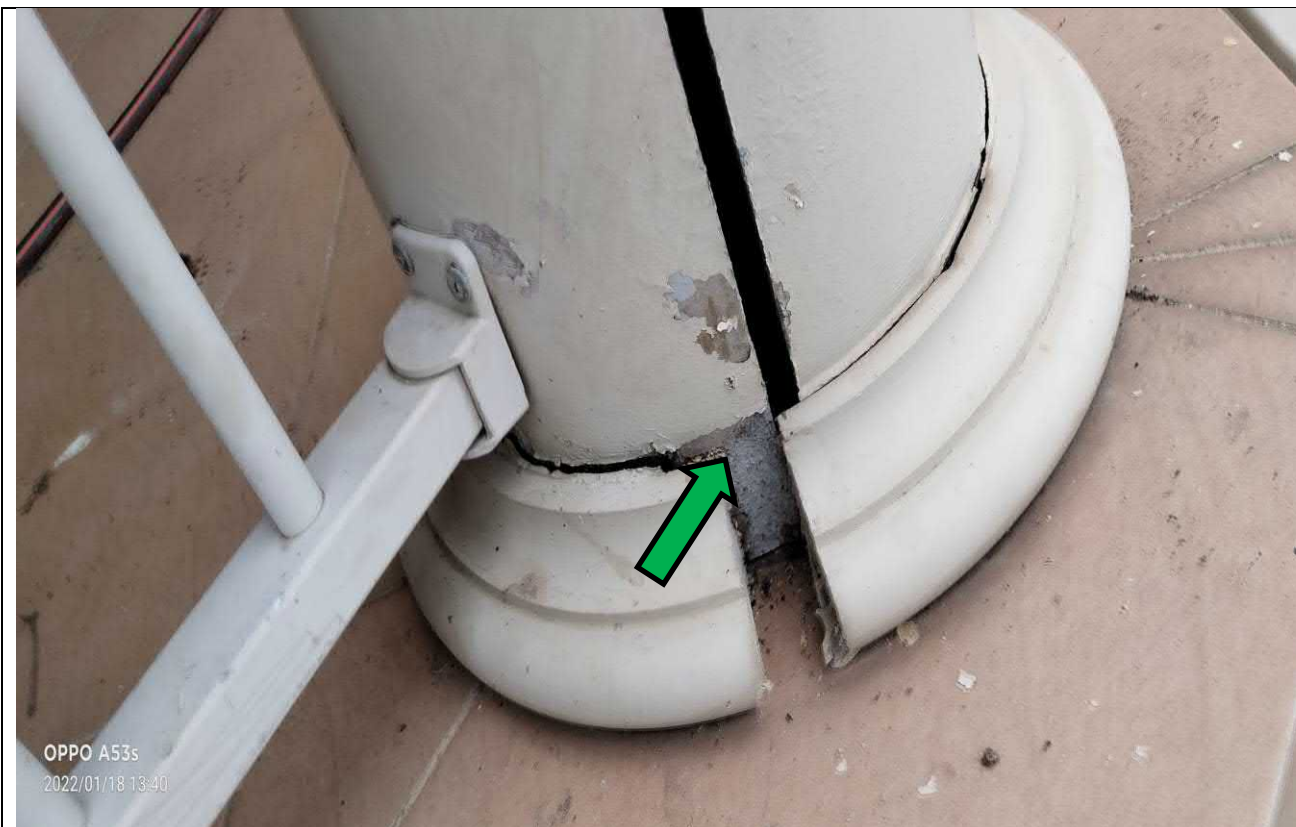
Photo 3: Main building, pillars, non-asbestos containing moulded fibre cement sheeting, as observed on 18/01/2022.

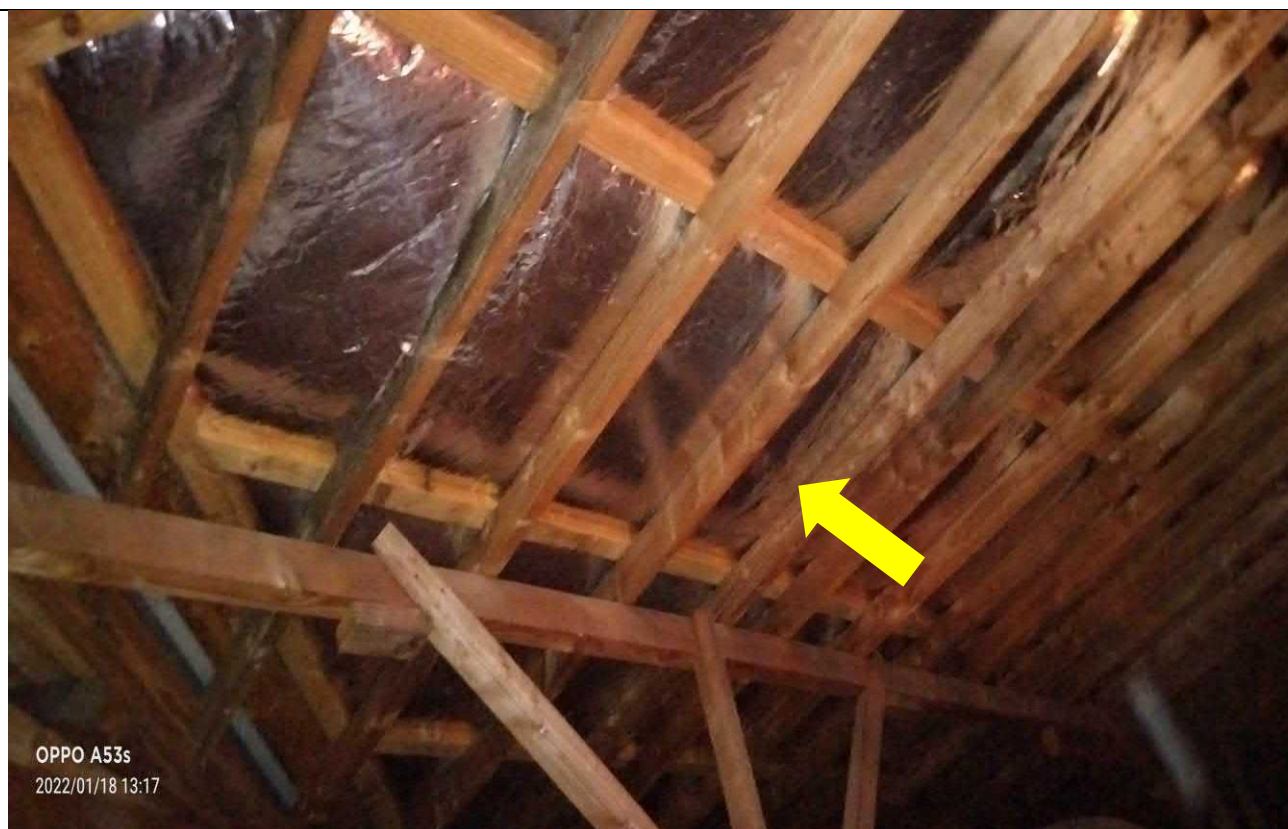
Photo 5: Main building, ceiling, sarking insulation, presumed SMF, as observed on 18/01/2022.

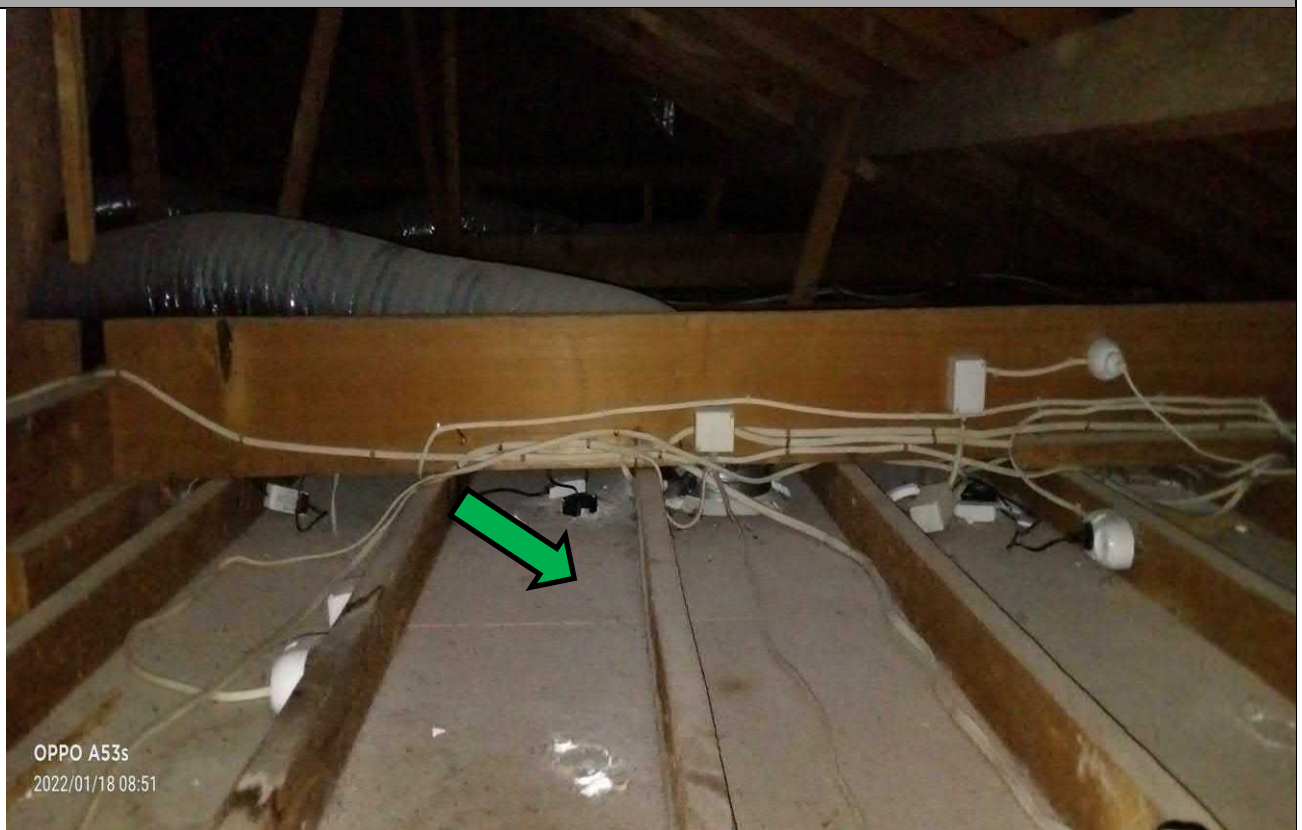
Photo 2: Main building, ceiling space, non-asbestos containing dust, as observed on 18/01.2022.
