Pre-Demolition Hazardous Materials Survey Report

Lot 20, 214 Aldington Road, Kemps Creek NSW

Prepared for: Fife Capital DSI Pty Ltd

21.1994 | HBM1 | Date: 22nd March 2022

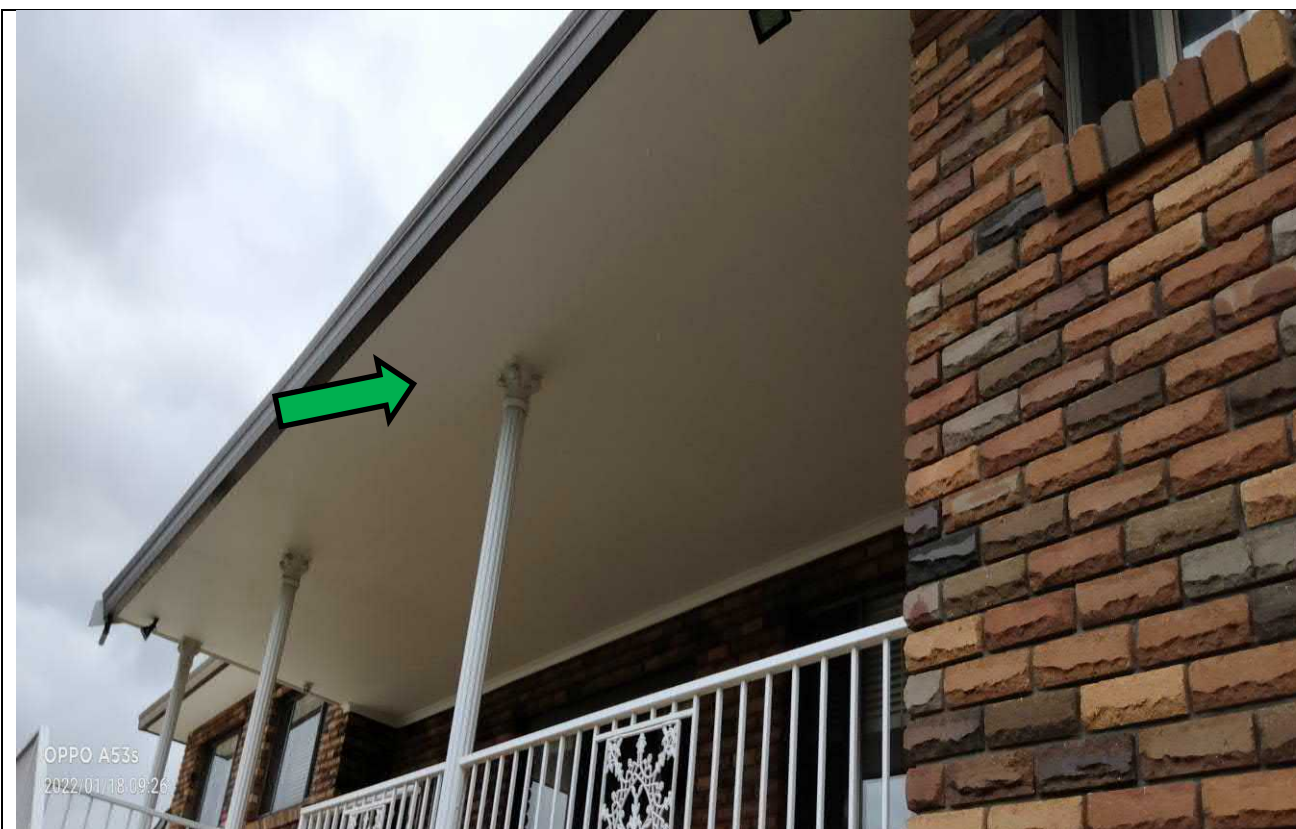
Photo 3: Main building, eaves and awnings, non-asbestos containing fibre cement sheeting, as observed on 18/01/2022.

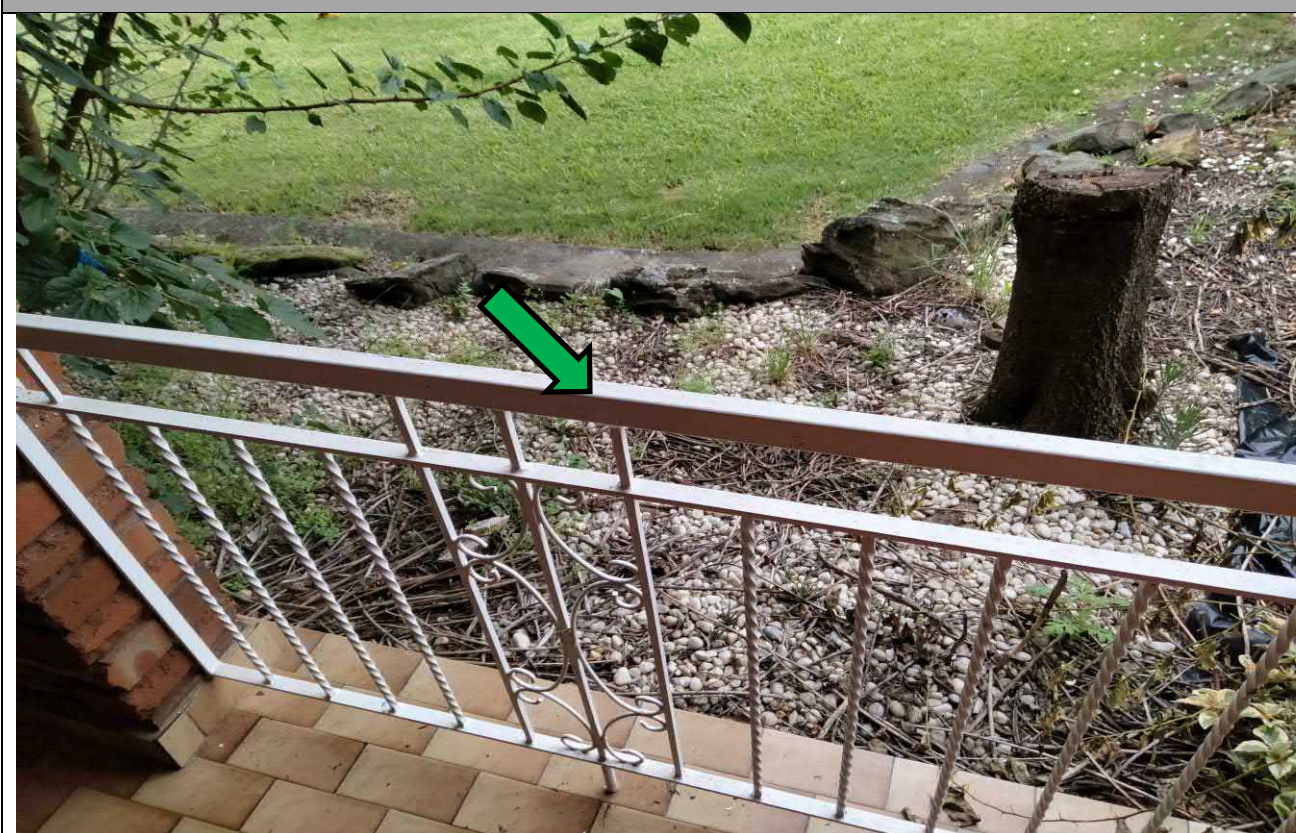
Photo 4: Main building, railings and fences, non-lead containing white paint system, as observed on 18/01/2022.

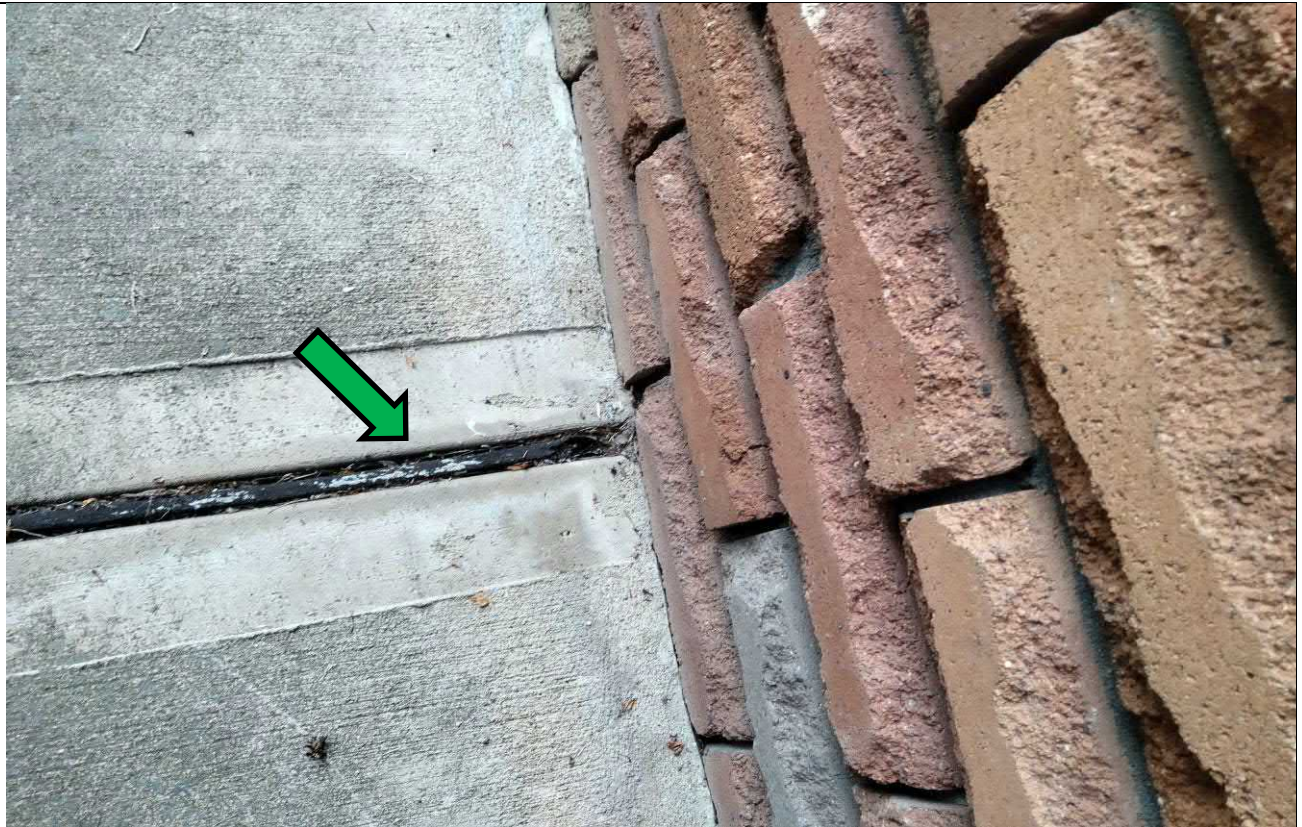
Photo 5: Modern building, expansion joints, non-asbestos containing mastic, as observed on 18/01/2022.

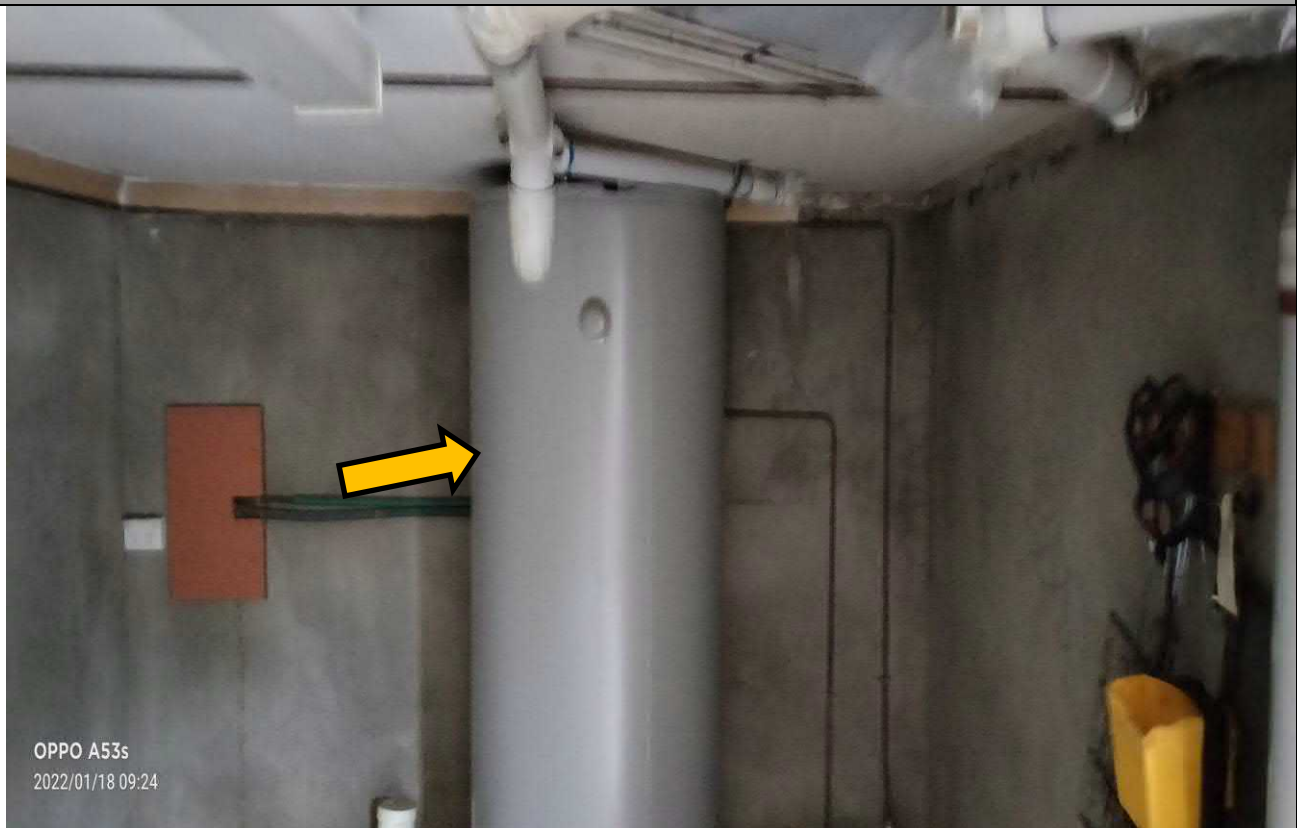
Photo 6: Main building, water heater, presumed SMF, as observed on 18/01/2022.

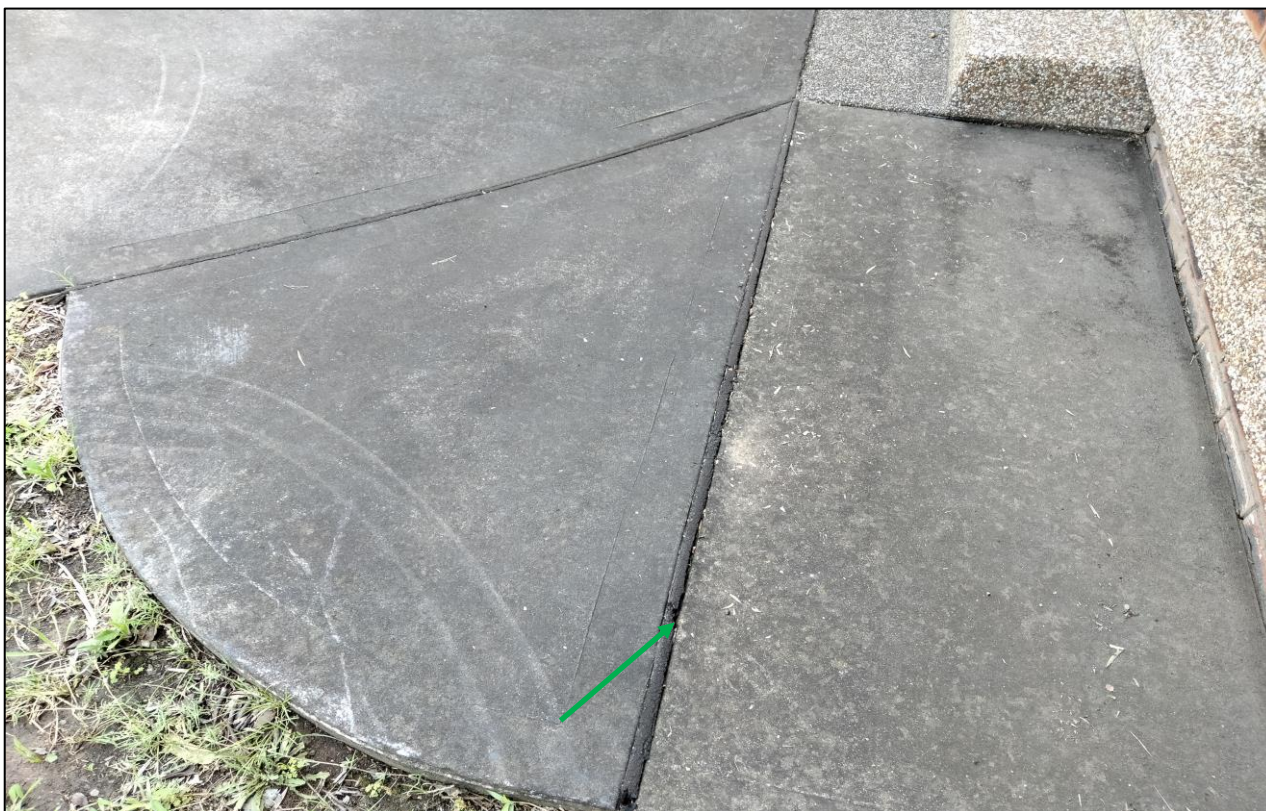
Photograph 2. Building external, bituminous material between concrete joints, no asbestos detected, as observed on 18/01/2022.

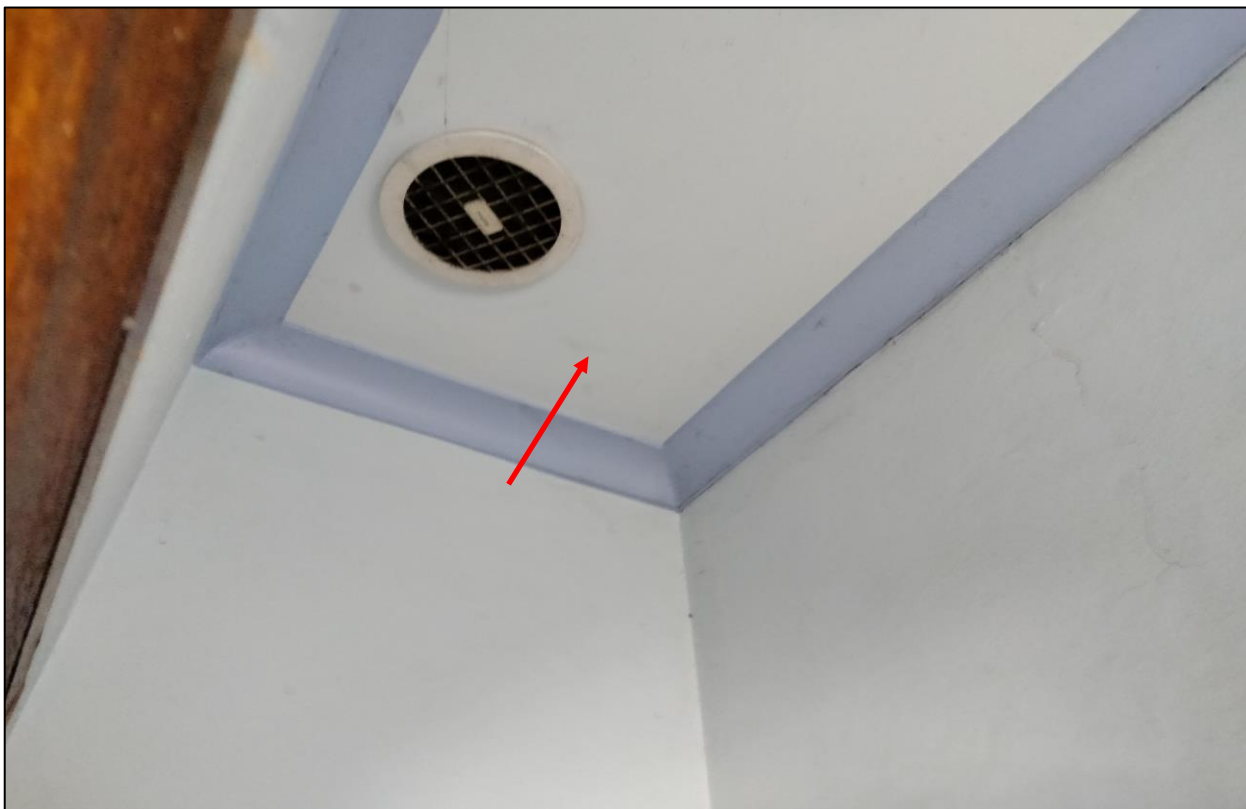
Photograph 3. Building internal, toilet and bathroom, ceiling, chrysotile asbestos containing fibre cement sheeting, as observed on 18/01/2022.

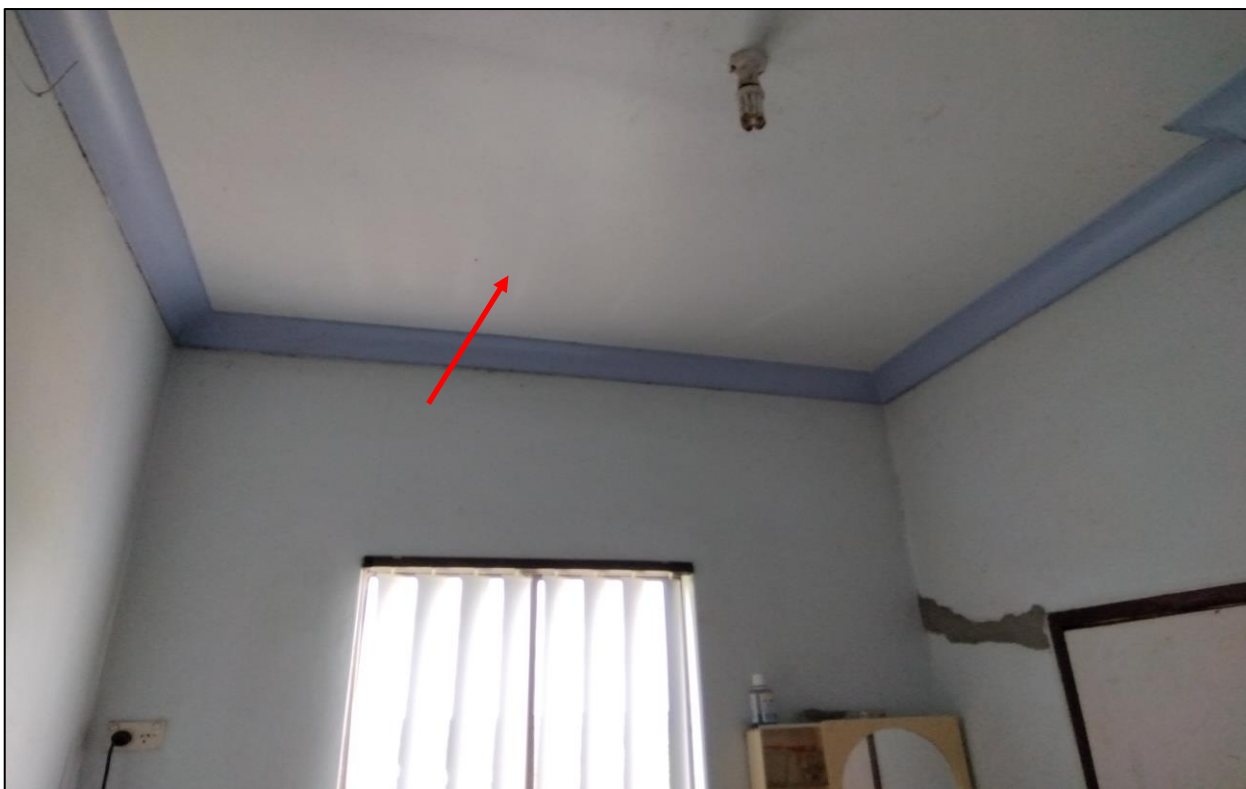
Photograph 4. Building internal, laundry, ceiling, same as toilet and bathroom ceiling, presumed to contain asbestos, as observed on 18/01/2022.

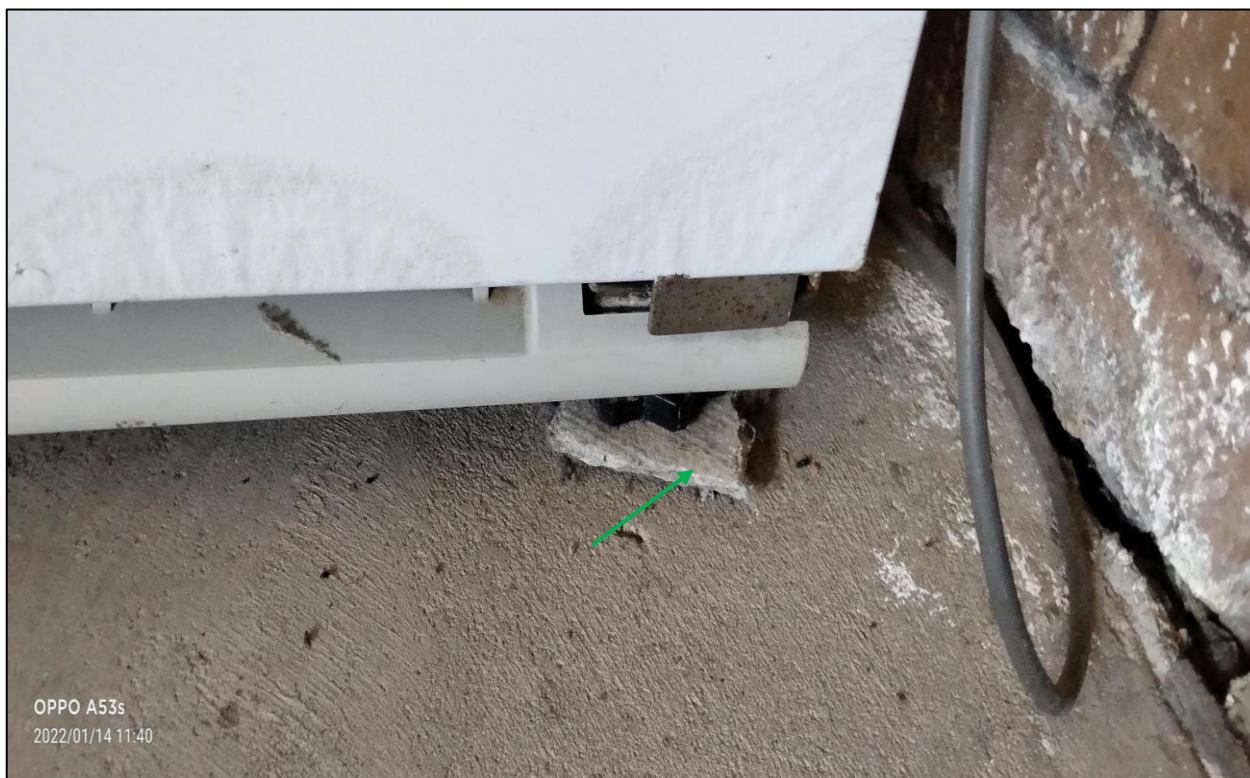
Photograph 5. Building internal, garage, non-asbestos containing independent fibre cement fragment used as part, as observed on 18/01/2022.

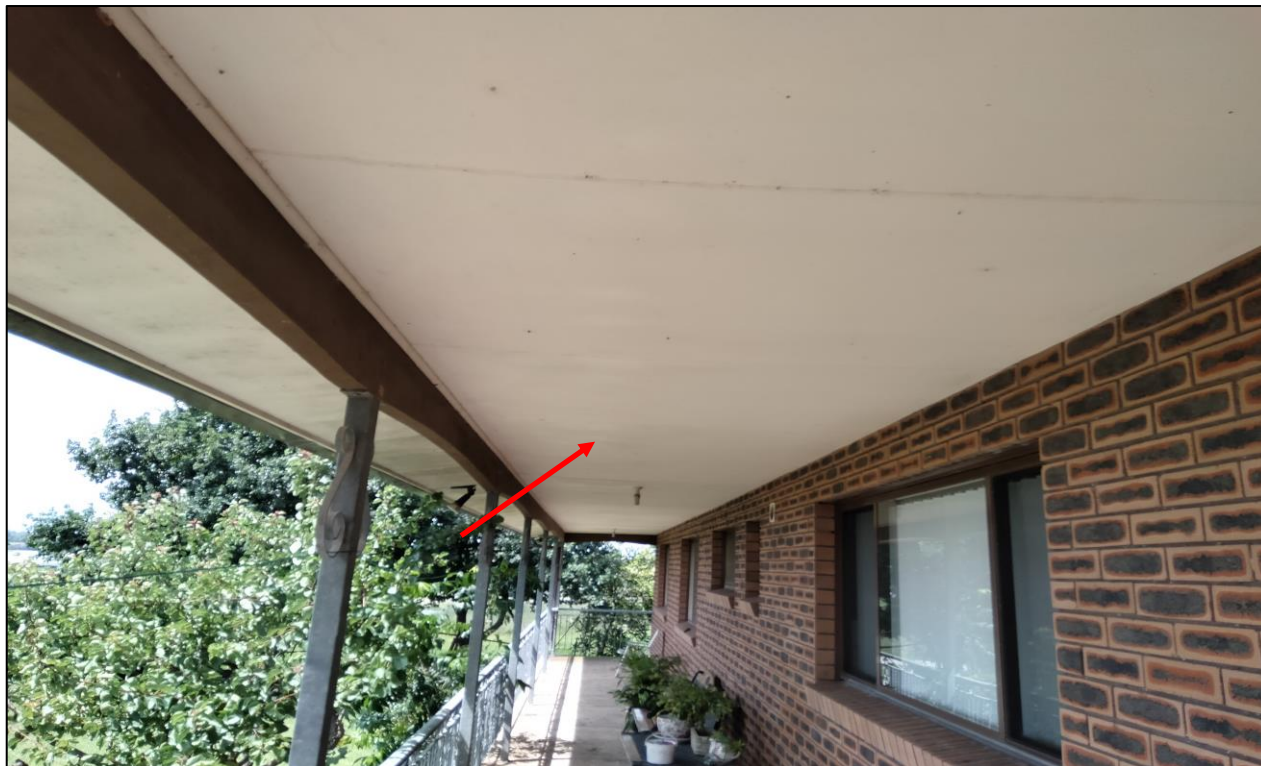
Photograph 6. Building external, all around, eaves and awnings, chrysotile asbestos containing fibre cement sheeting, as observed on 18/01/2022.

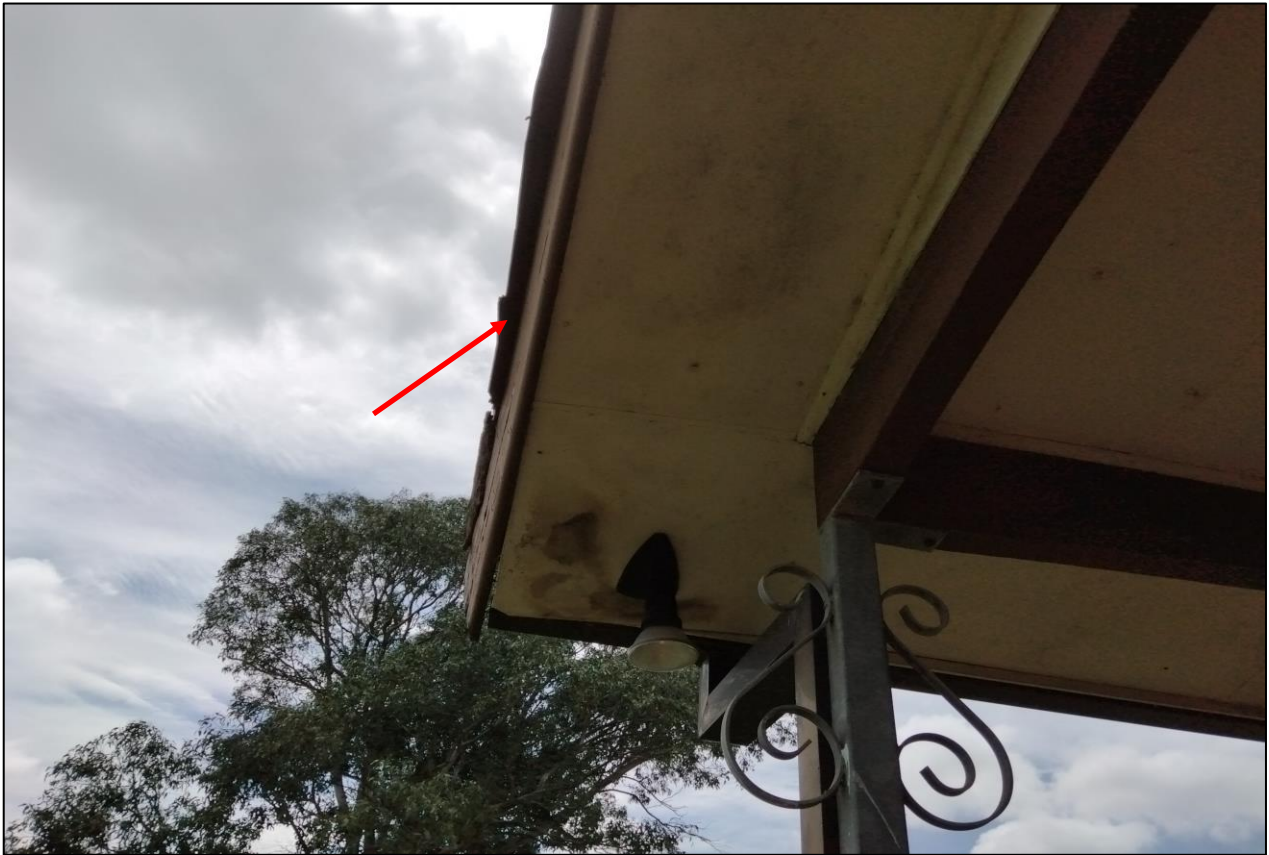
Photograph 7. Building external, panel beneath roof, Chrysotile asbestos containing fibre cement panel, as observed on 18/01/2022.

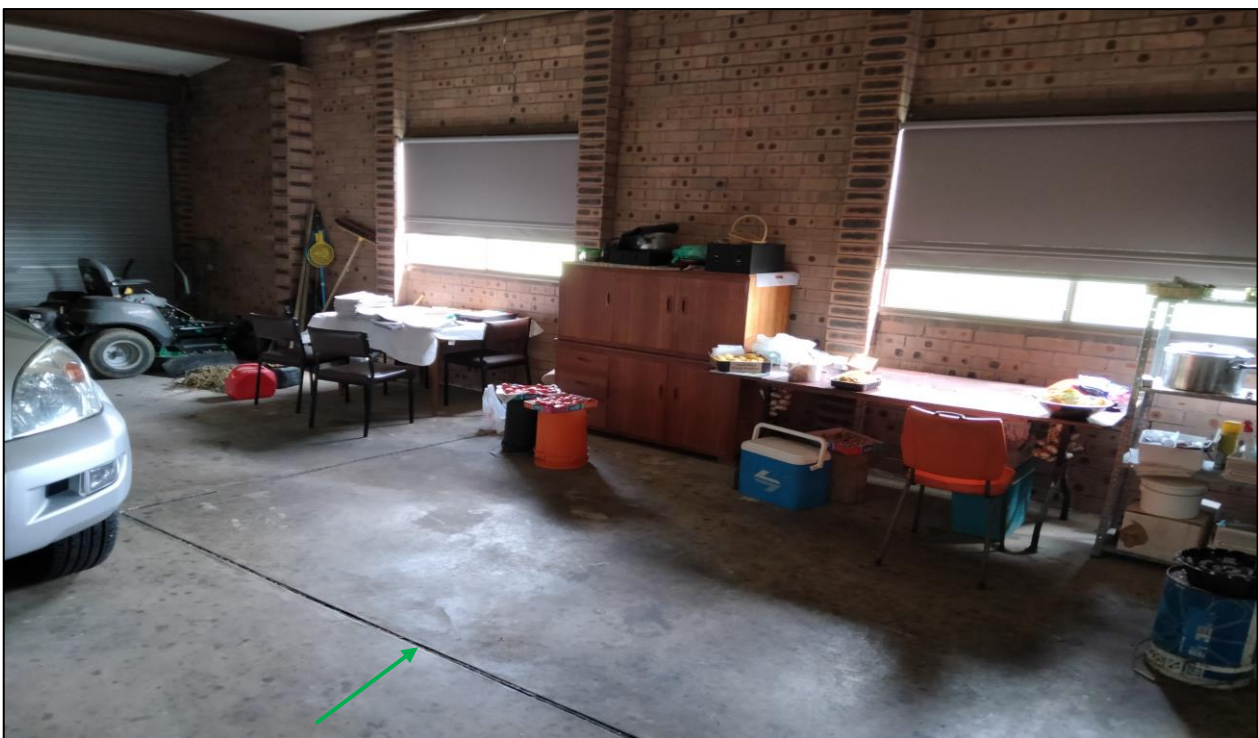
Photograph 8. Garage internal, floor, bituminous material, no asbestos detected, as observed on 18/01/2022.

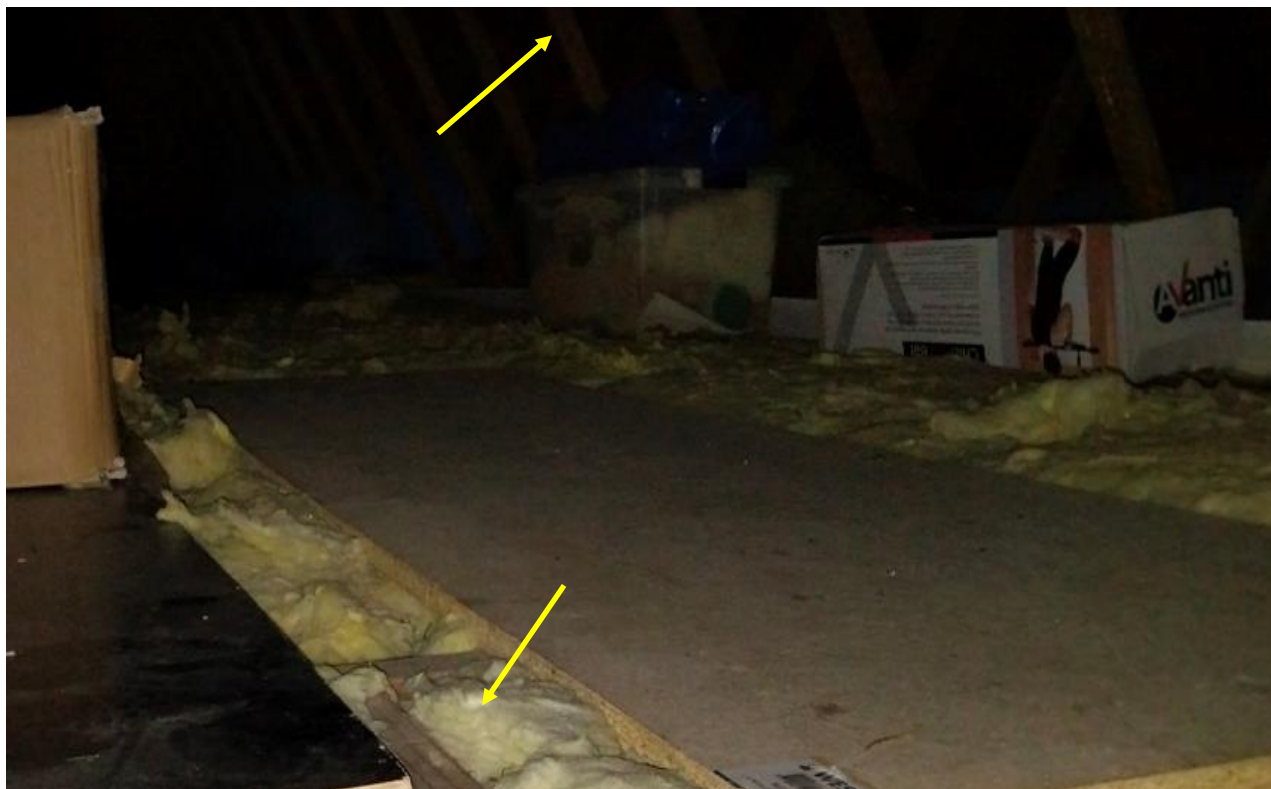
Photograph 2. 31A Main building internal, ceiling space, insulation, no asbestos detected, SMF detected, as observed on 18/01/2022.

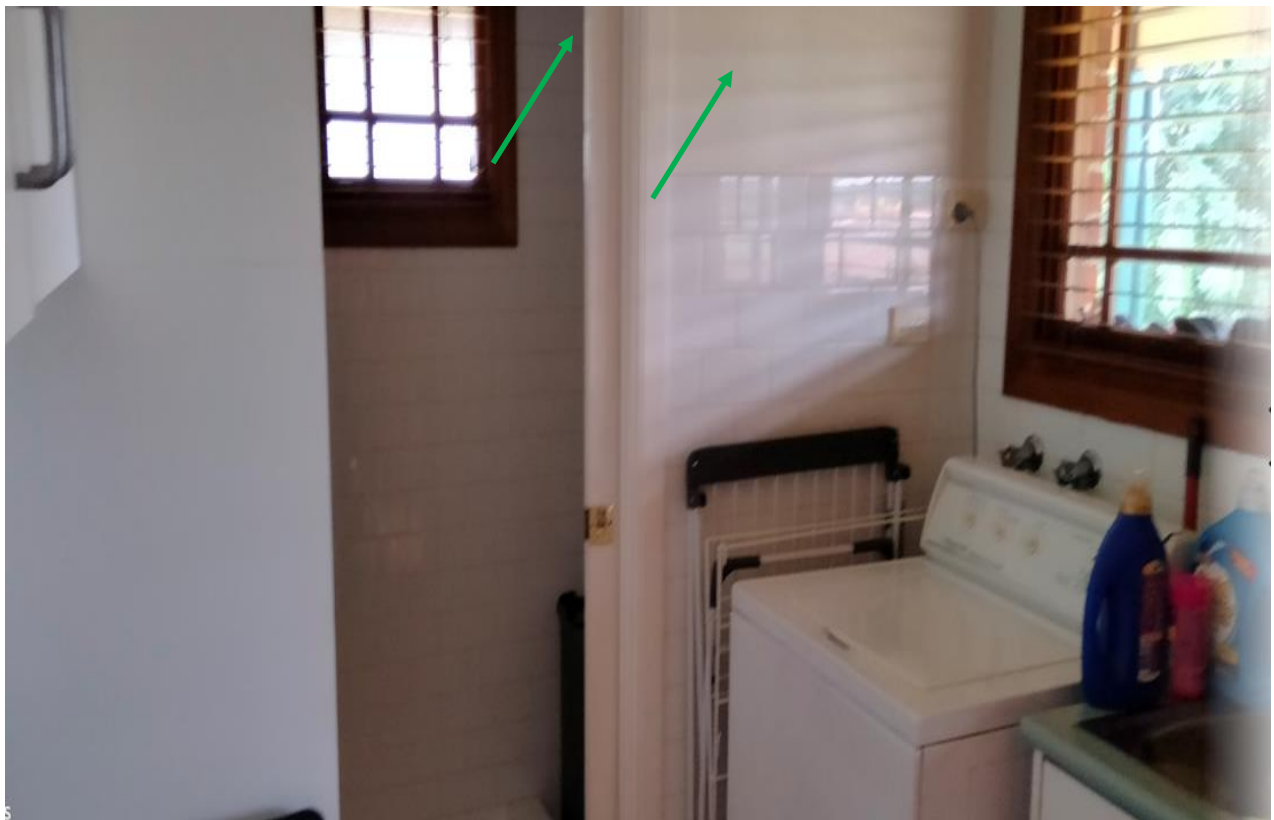
Photograph 3. 31A Main building internal, northeaster bathroom, walls, non-asbestos fibre cement sheeting, as observed on 18/01/2022.

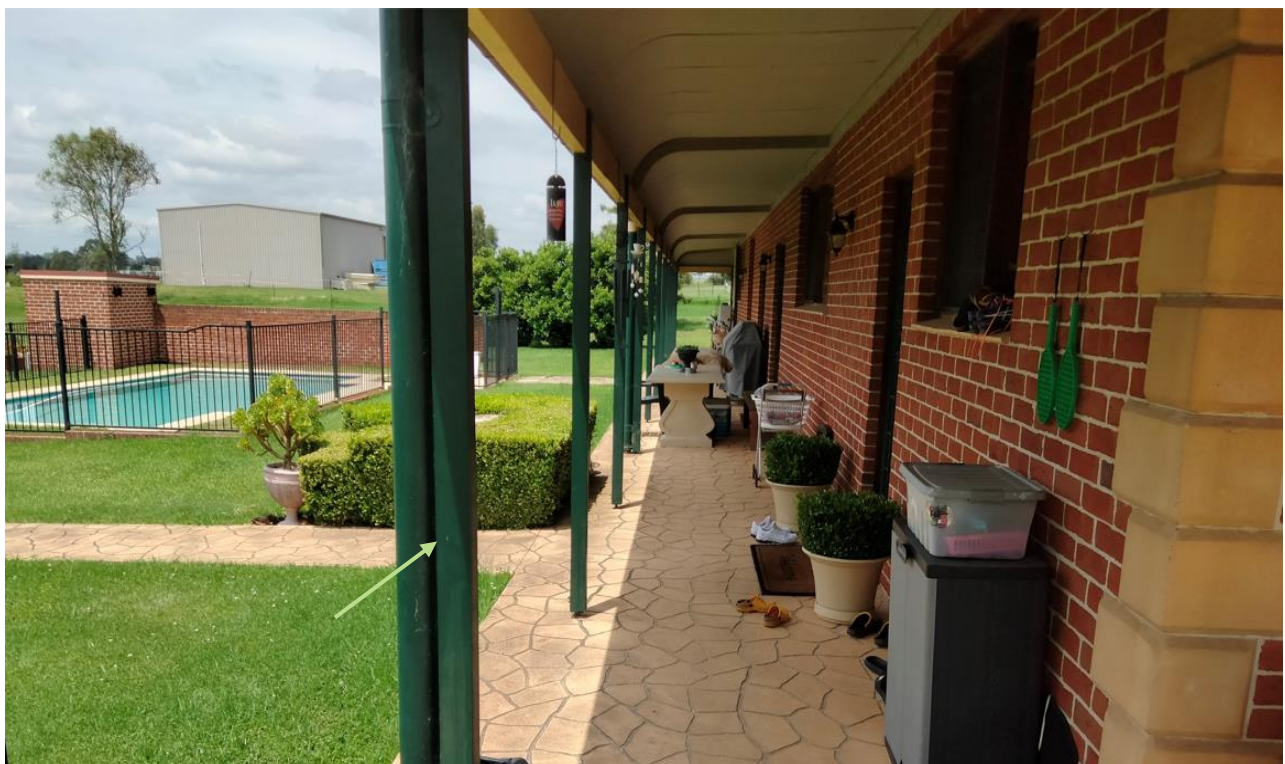
Photograph 4. 31A Main building, northern and eastern side, beams supporting eaves and awnings, non-lead containing green paint system, as observed on 18/01/2022.

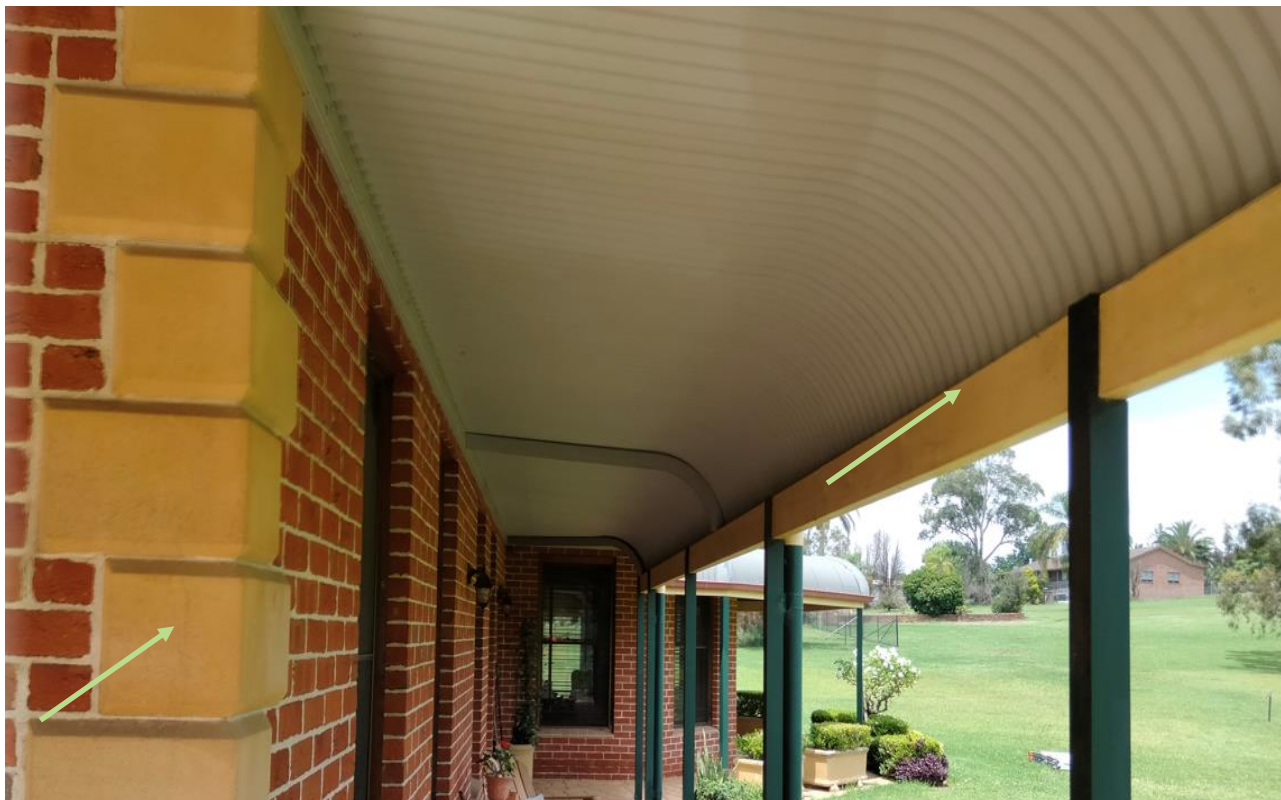
Photograph 5. 31A Main building, northern and eastern side, beams to gutter lining and walls, non-lead containing cream paint system, as observed on 18/01/2022.

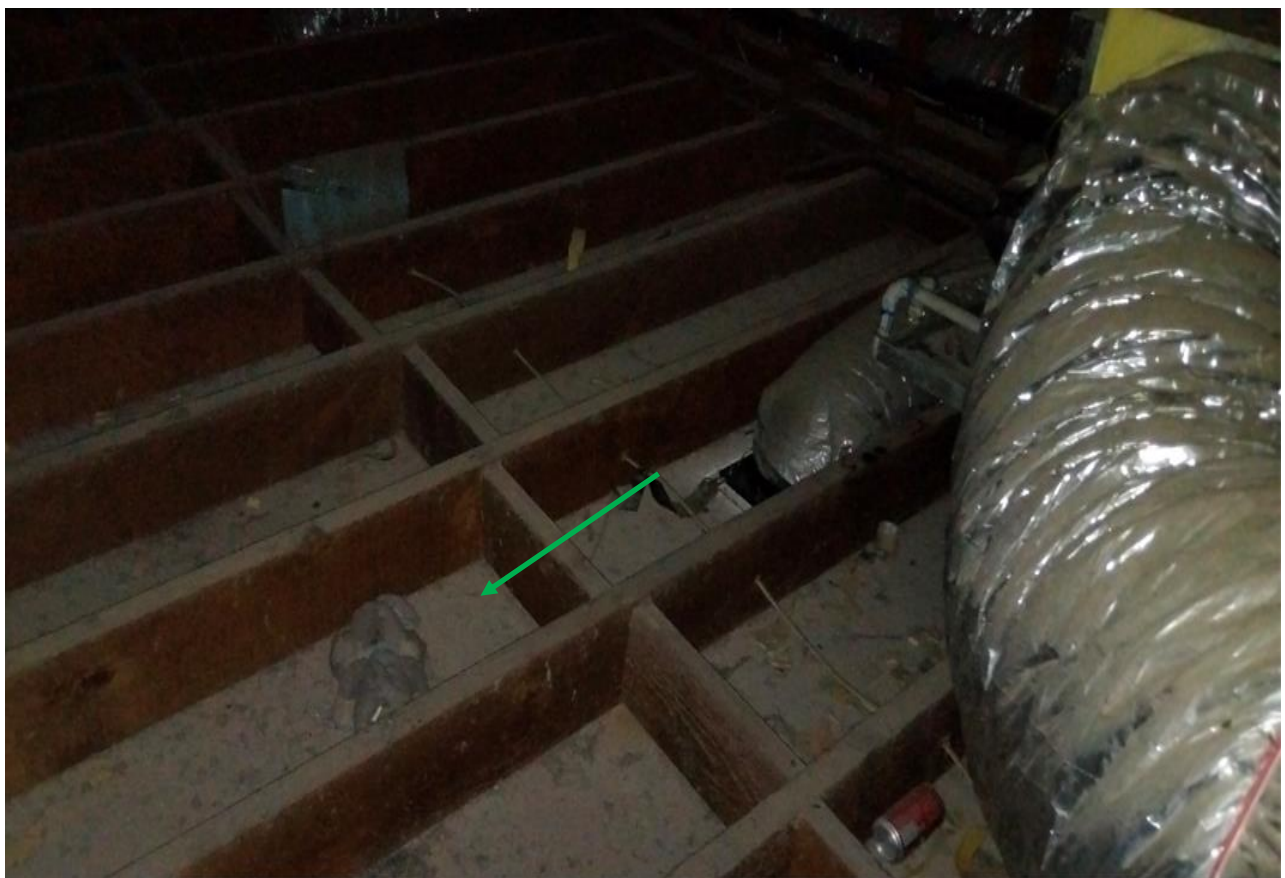
Photograph 8. Internal, Main building , ceiling space, settled dust, no asbestos detected, as observed on 18/01/2022.

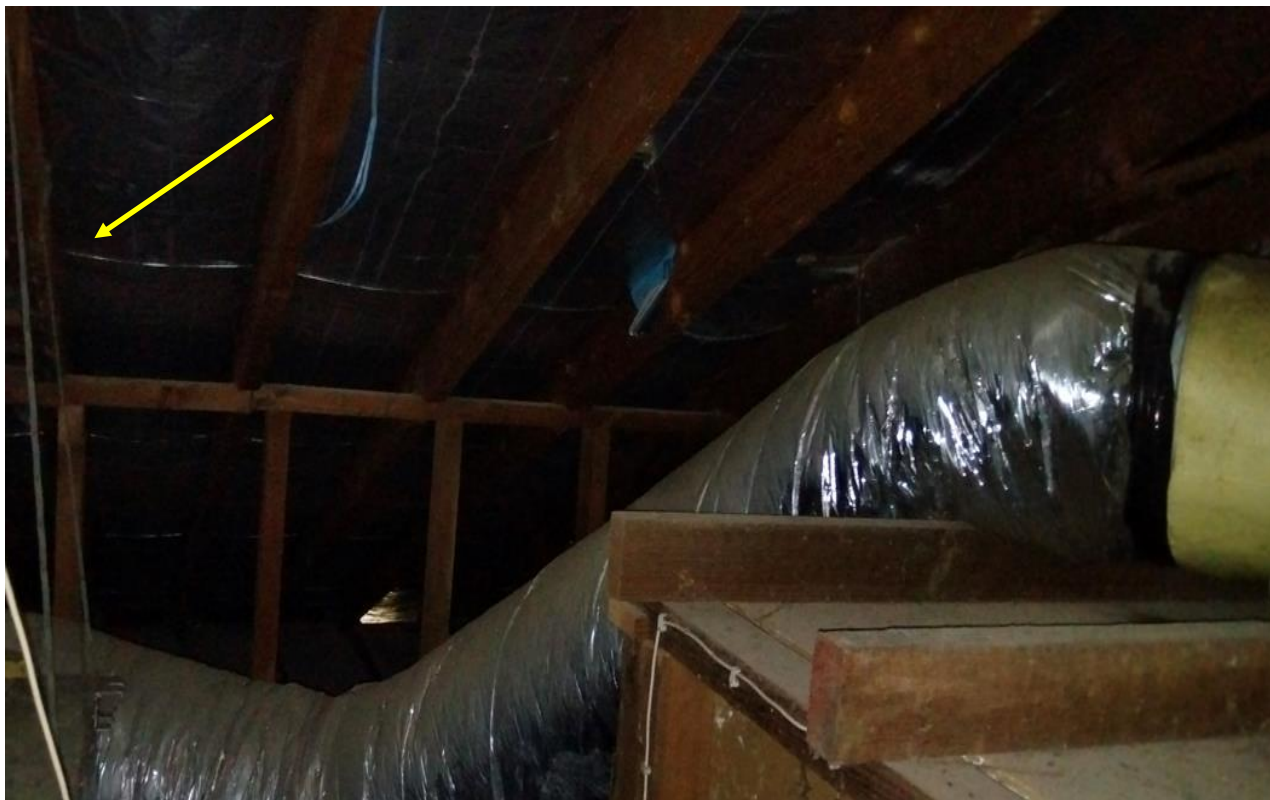
Photograph 9. 31B main building Internal, ceiling void – presumed SMF sarking, as observed 18/01/2022.

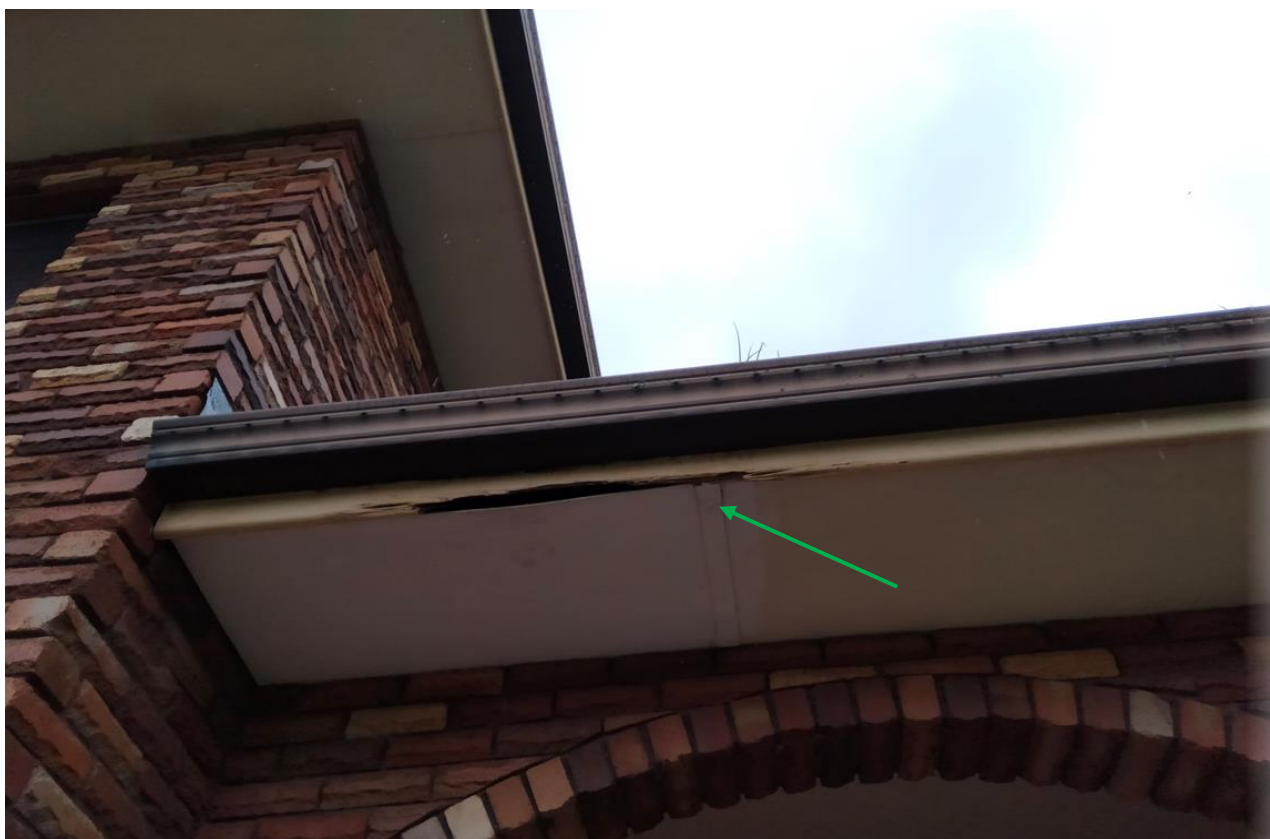
Photograph 10. 31B main building external, eaves and awnings, no asbestos detected, as observed on 18/01/2022.

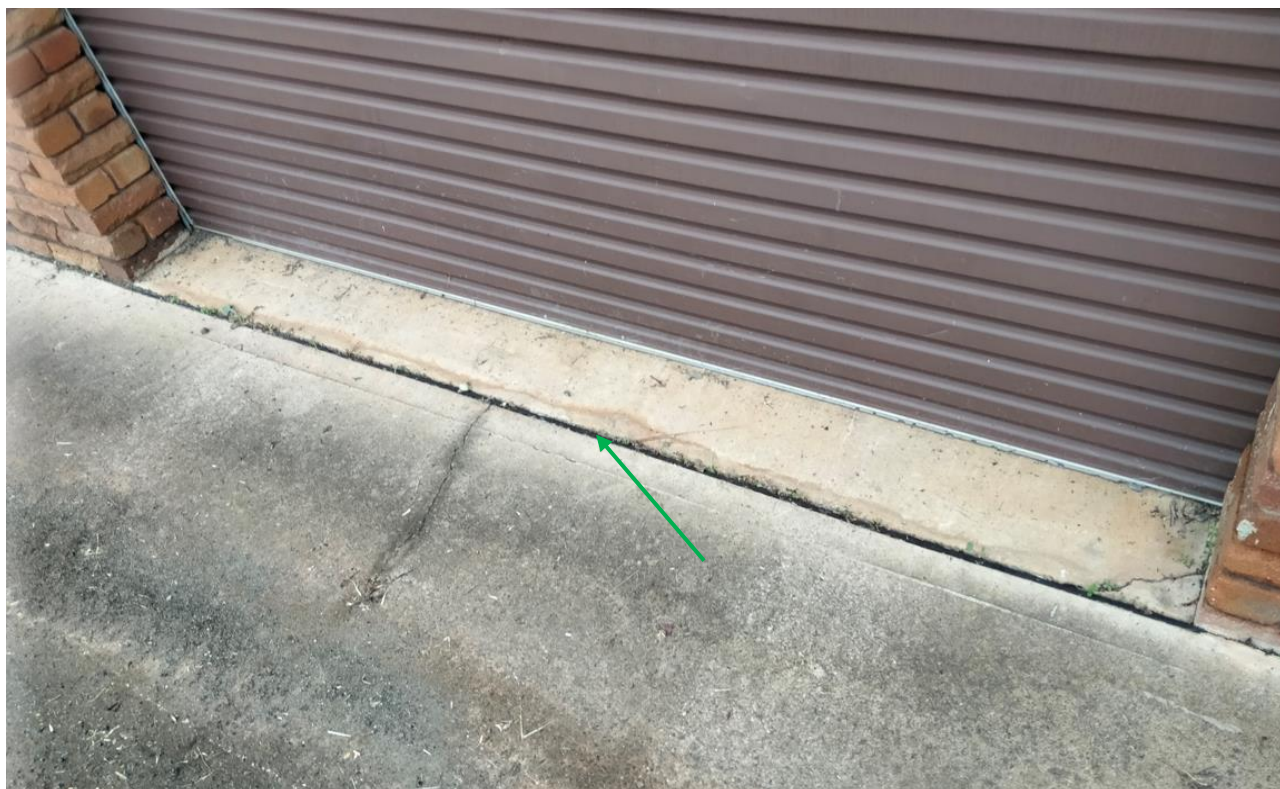
Photograph 11. 31B main building external, bituminous membrane between concrete joints, no asbestos detected, as observed on 18/01/2022.

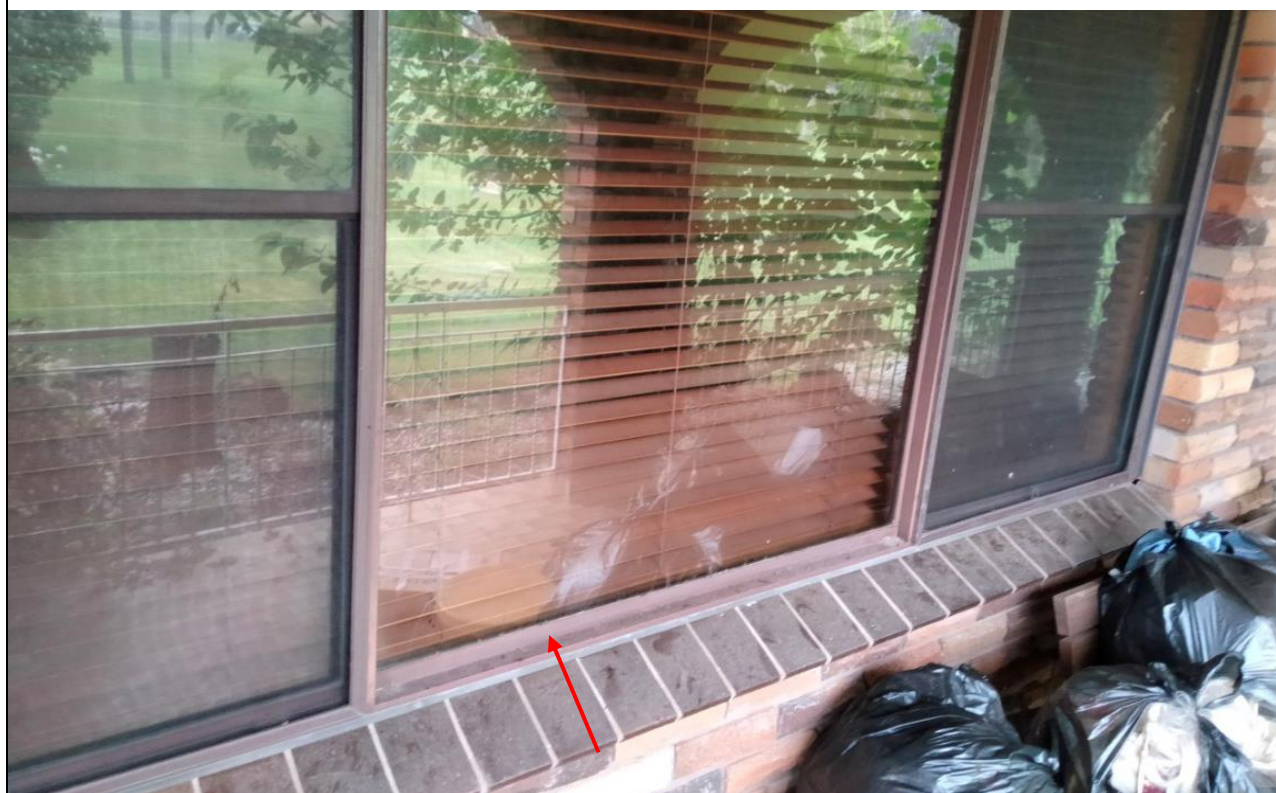
Photograph 12. 31B main building external, asbestos containing window putty, as observed on 18/01/2022.

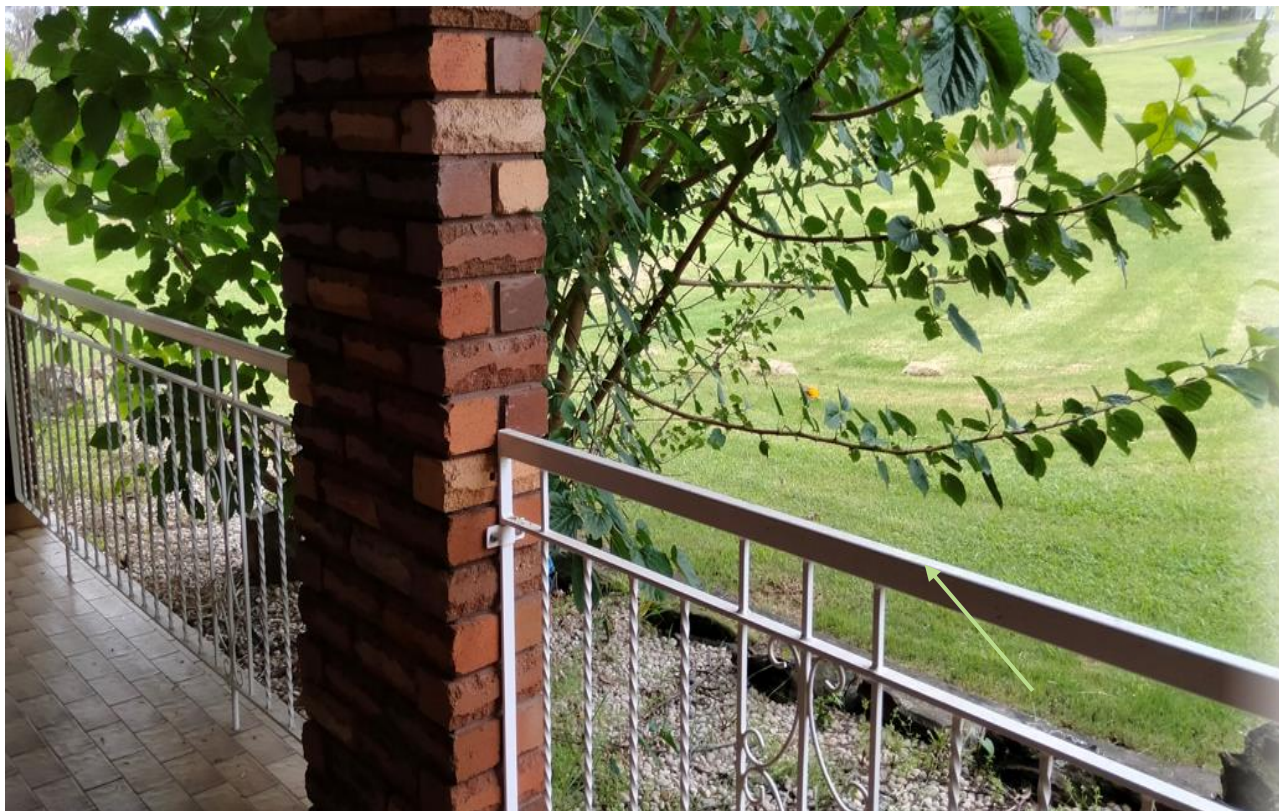
Photograph 13. 31B main building external, white paint system , non lead based paint, as observed on 18/01/2022.
