Pre-Demolition Hazardous Materials Survey Report

Lot 20, 214 Aldington Road, Kemps Creek NSW

Prepared for: Fife Capital DSI Pty Ltd

21.1994 | HBM1 | Date: 22nd March 2022

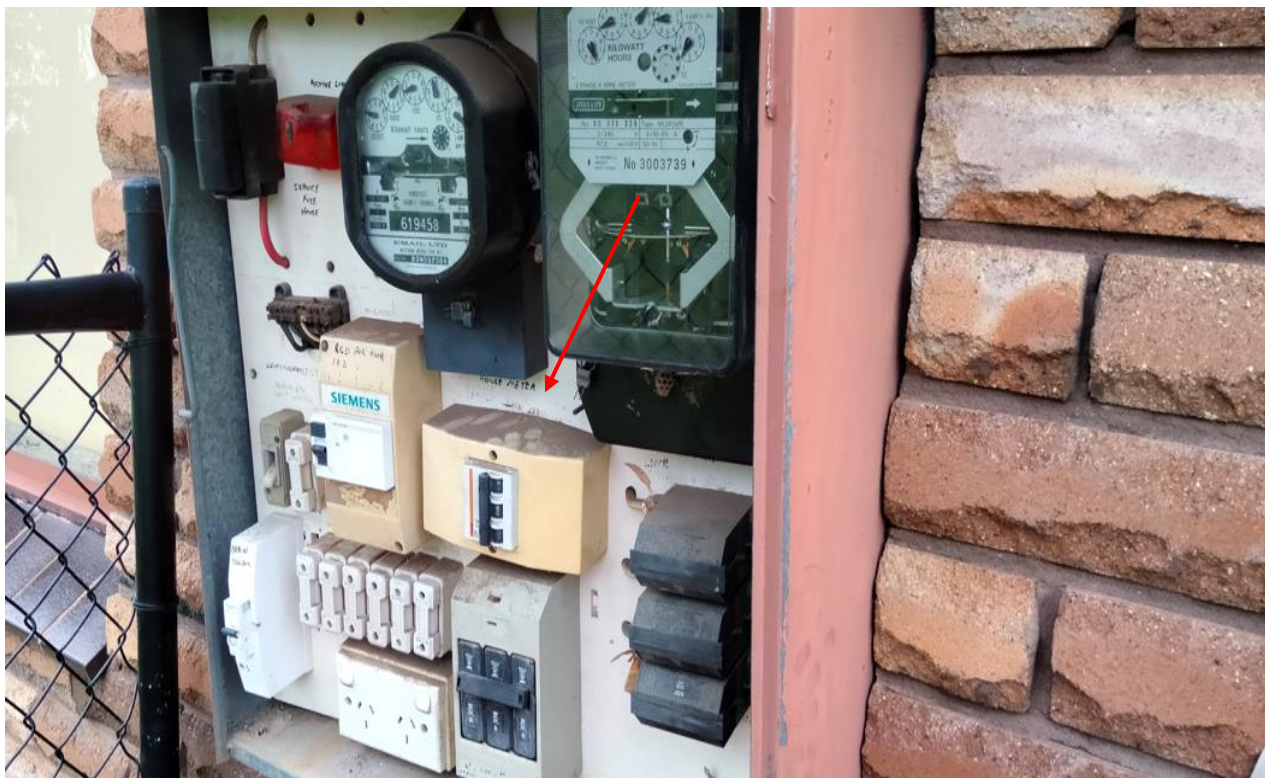
Photograph 14. 31B main building external, north western side, electrical backing panel, presumed to contain asbestos, as observed on 18/01/2022.

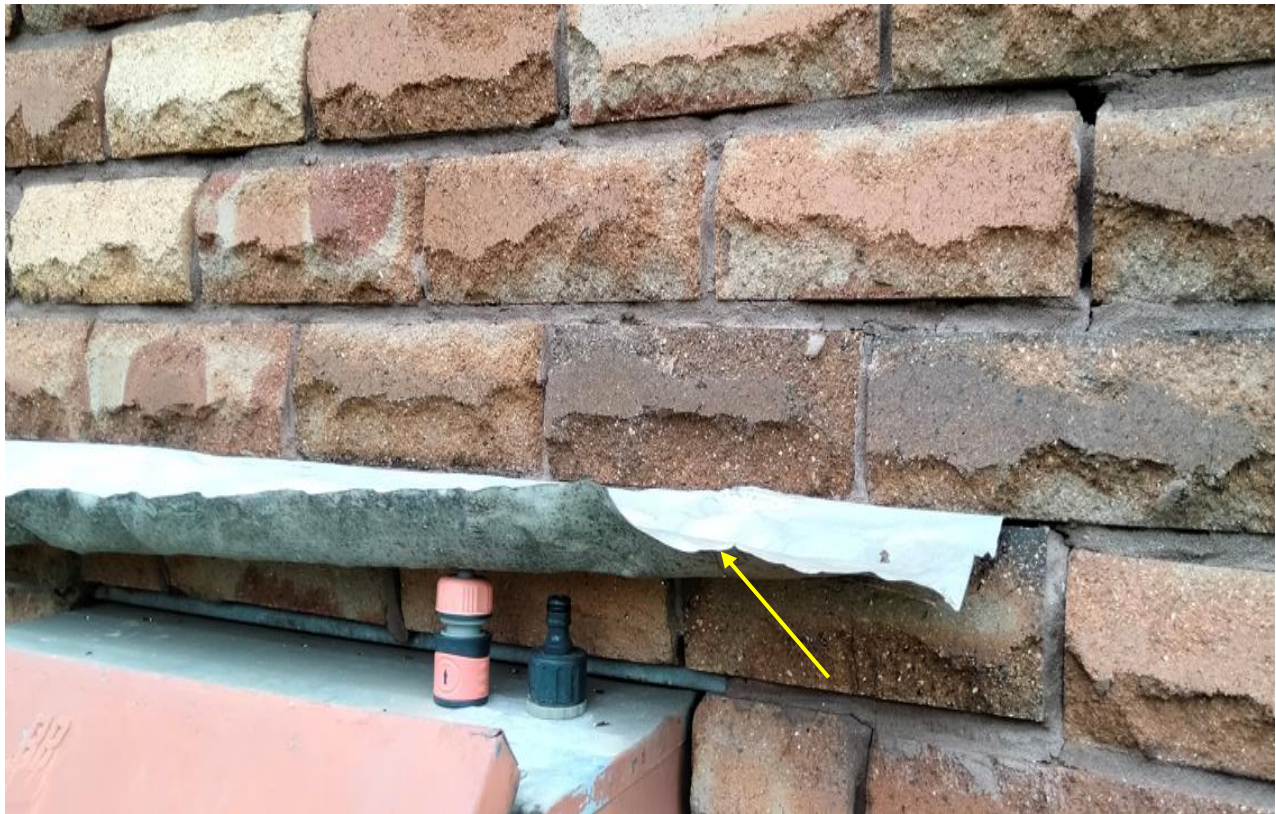
Photograph 15. 31B main building external, north western side, above electrical backing panel, lead flashing, as observed on 18/01/2022.
