**DATE** 09/12/2021  
**TO** Sirius Development  
120B Underwood Street  
Paddington NSW 2021  
**ATTN** John Green  
**RE** Sirius building – Tree 50 and 51 – Options for Basement Rectification Works.

Reference is made to the earlier SCP Report 21/09/2021 and the subsequent submission dated 24/11/2021. This report outlines options to stabilise or replace the existing retaining walls which have failed structurally, are unstable and do not comply to current Australian Standards.

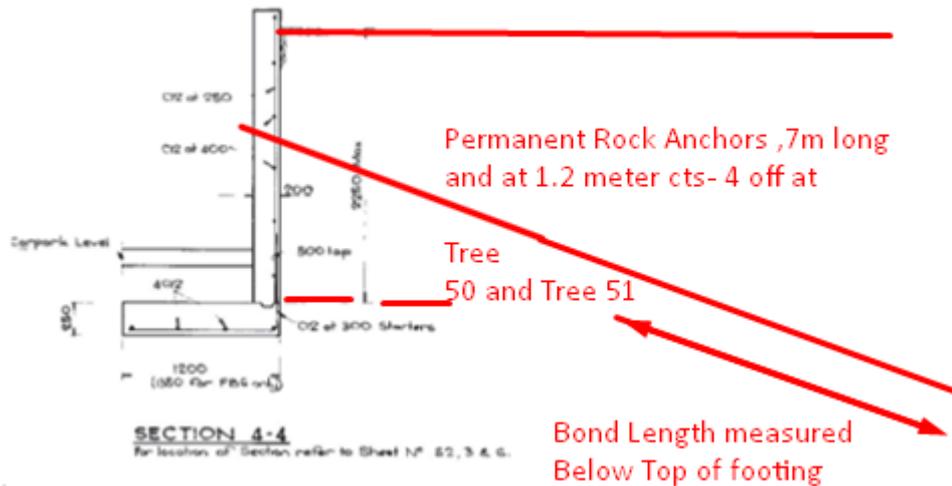
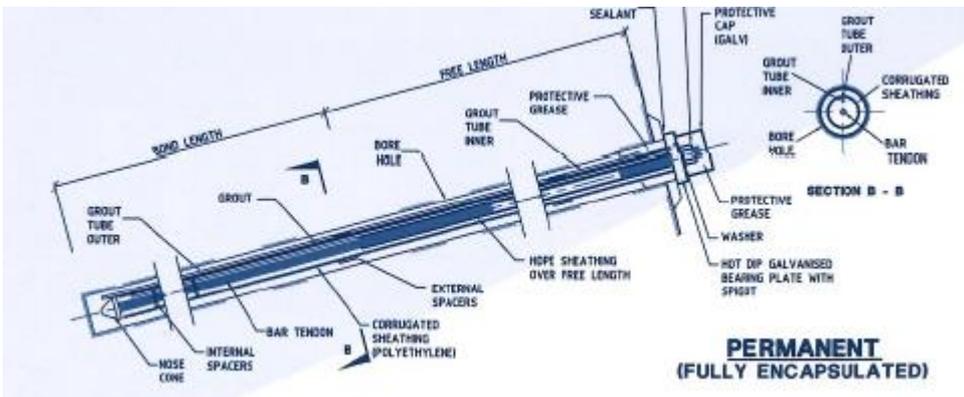
**Option 1: Install Rock Anchors into the Existing Retaining Walls at Tree 50 and 51**

This retention option is proposed to have the wall remain in-situ with the existing restrained by permanent rock anchors behind the wall.

At each tree location permanent rock anchors at 1.2 metre intervals along a length of approximately 4 metres would be required to stabilise the existing retaining wall. Up to 4 permanent rock anchors would be required at each tree location.

Permanent Rock anchors are fully encapsulated and require full bond length to the rock below the footing.

The overall anchor length required to resist the forces imposed on the retaining walls by the tree roots would be 6 to 7m behind the wall based on the bond length of 3.5 to 4.5m required. The length is measured from below the top of the footing. We note Gloucester Walk is bounded along its western edge by the Sirius site and to the east it is a rock cliff face extending down to Atherden Street at 5 to 6m variable width from the face of the retaining wall.

There are a number of geometric and engineering issues in relation to this option that render this option not feasible from an engineering standpoint:

- i) The anchor length required is more than the overall width of Gloucester Walk. That is 6 to 7m of overall horizontal projection length is required and only 5 to 6m is available.
- ii) The existing retaining wall does not have front face reinforcement (only rear face reinforcement is installed) thus stressing of the installed anchor can fail the existing wall at the base on the basement side causing a catastrophic failure of the existing wall.

- Local failure of the rock under Gloucester Walk as a result of the anchor stressing process
- Damage to the tree roots as a result of the above coring and jet washing process.
- Grouting installed under pressure can migrate into the voids in the backfill behind the wall. There is also potential to damage the rock on the eastern side of Gloucester Walk as grout can ingress through rock defects or other voids in Gloucester Walk whilst being installed under pressure, causing potential blow out on the east side of the rock cliff face.

Therefore, it was determined that as a result of the engineering limitations and the potential risks outlined above, this option cannot be considered.

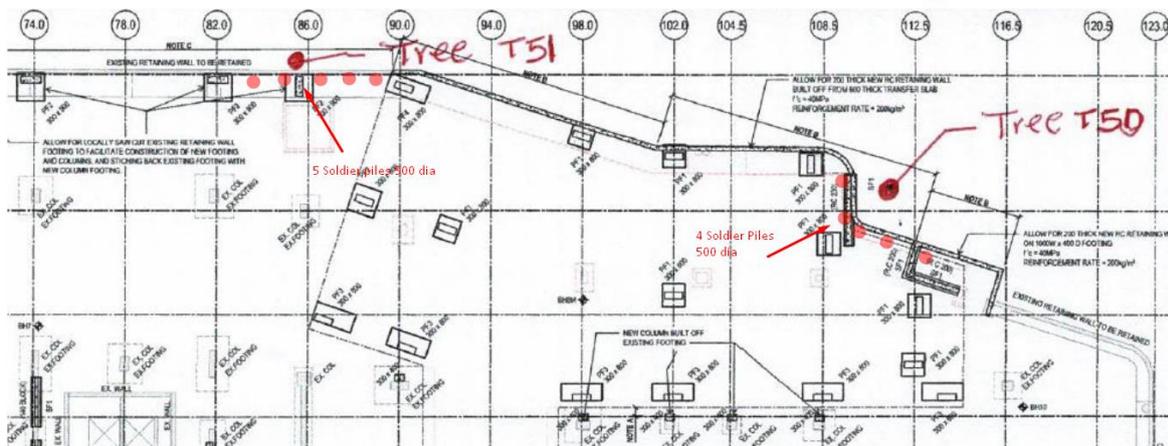
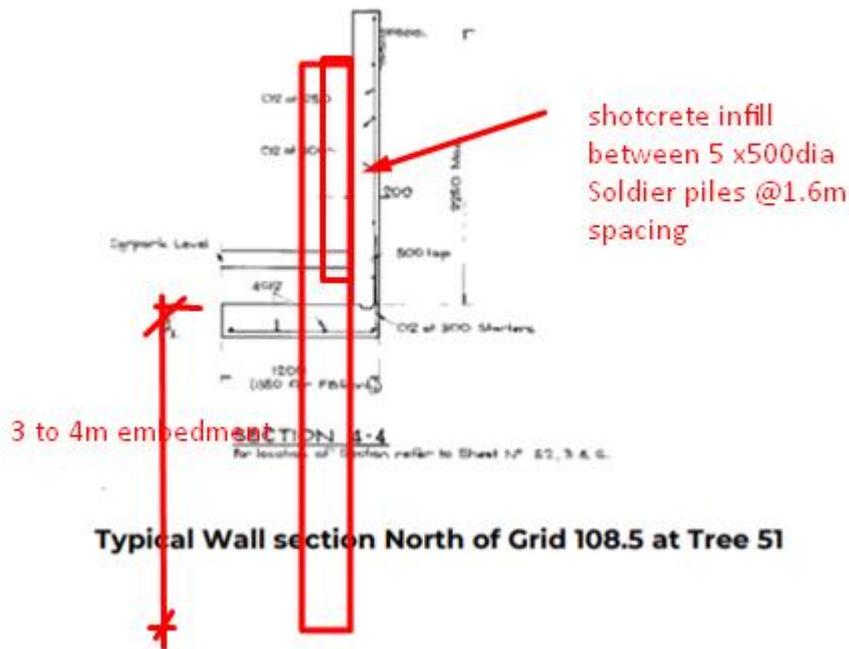
**New Works Plan showing new pad footings clashing with existing RW footings.**

This option involves a soldier pile wall, up to 4.8m long built in front of the existing wall using 4 to 5 soldier piles at 1.6m centres through the existing footing and positioned in front of the existing wall to retain the wall.

The piles would be 500mm diameter and be required to be cored 3 to 4m below the basement level and cantilever above the basement level to the top of the existing wall.

Richard Crookes Construction have provided supporting documentation to indicate that the machinery required to undertake the piling works cannot be positioned in place to undertake the work. There is insufficient room in the existing basement to manoeuvre the machine in place nor drill the piles due to the restricted head height within the existing basement.

Option 2 is not achievable as Richard Crookes Construction have provided supporting documentation to indicate that the machinery required to undertake the piling works cannot be positioned in place to undertake the work. There is insufficient room in the existing basement to manoeuvre the machine in place nor drill the piles due to the restricted head height within the existing basement.

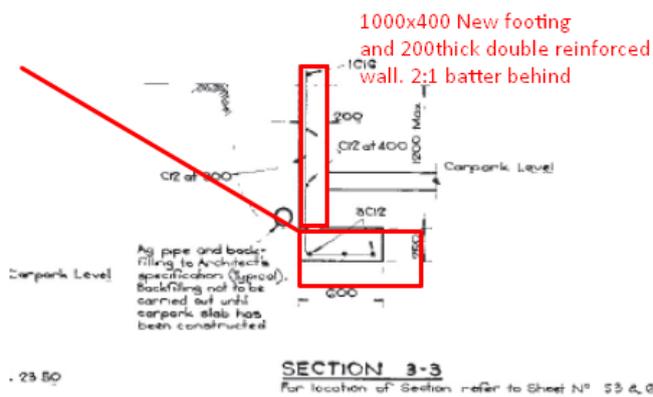
**Typical Wall section South of Grid 108.5 at Tree 50**

SCP discussed this option previously. As the walls are currently unstable to the Australian Standard AS4678-Earth retaining structures, this option would involve the removal of the backfill, create a safe 2:1 working batter and re-construct the walls to current Australian Standards as shown below in red.

The removal of the backfill in order to construct the wall will render the existing trees unstable as per previous Arborist advice.

Option 3: The replacement wall option is feasible and can be implemented using temporary excavation and batters behind the wall. The replacement wall can then be designed to current code requirements and good modern building practice.

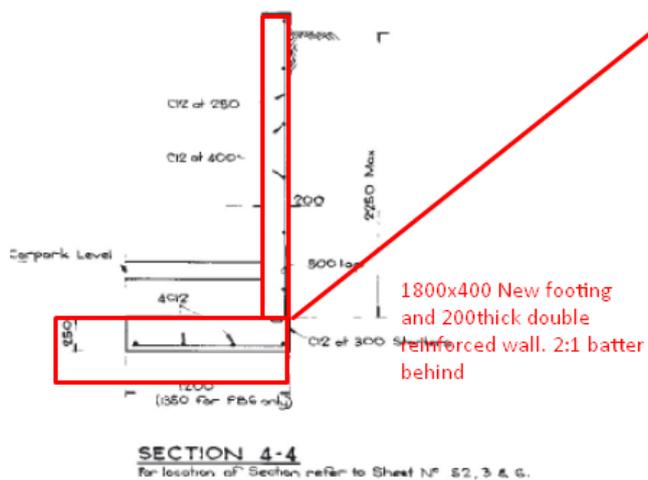
**Typical Wall section North of Grid 108.5 at Tree 51**

The wall in its current state is unstable due to original design, presence of the trees and the evident structural failure at Tree 51. The stabilisation options presented above are required prior to
