**Re: Sirius Building - Tree numbers 50 and 51 - Basement rectification works.**

# Sirius - Tree Removal on Gloucester Walk

This letter is prepared to provide comment on the existing Sirius eastern basement retaining walls design and condition and to also comment on the stability of Trees T50 and T51 on Gloucester walk due to the required basement wall structural upgrade and proposed basement construction works.

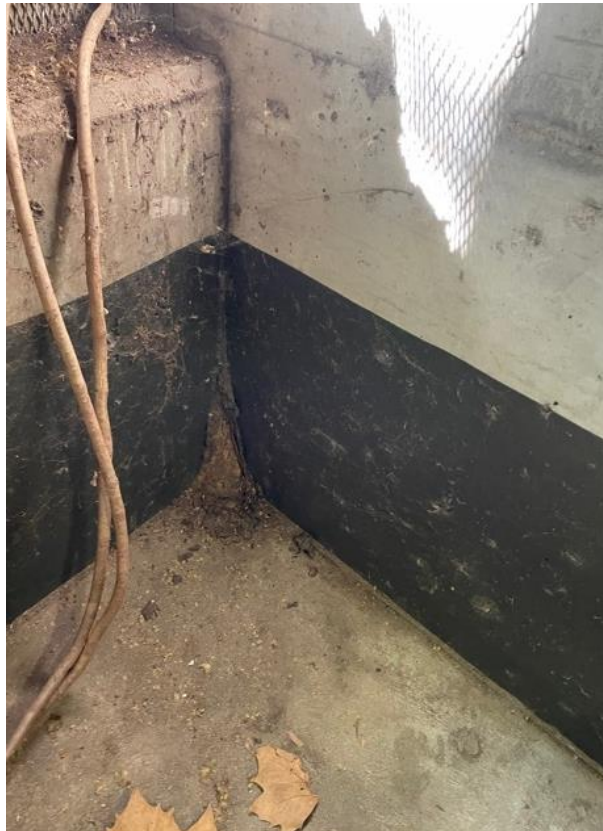
We note the existing retaining walls are of age and have been compromised by Tree 50 and 51. At Tree 50, the tree roots have penetrated the walls inducing forces onto the wall as well as compromising the integrity and waterproofing of the wall. At tree 51, the wall displays a vertical crack at the centre line of the tree trunk indicating the tree has imparted significant lateral pressure on the wall and caused the wall to fail in horizontal bending. This crack in the wall is at least 1 to 1.5mm in width indicating structural failure of the wall. We note the wall at this location also presents a 30mm lean into the basement. The lean is indicative of flexural failure at the base of the wall, or instability of the wall as a result of the added induced lateral pressure of the tree root system.

Tree 50: Plane Tree root penetration at wall floor internal junction

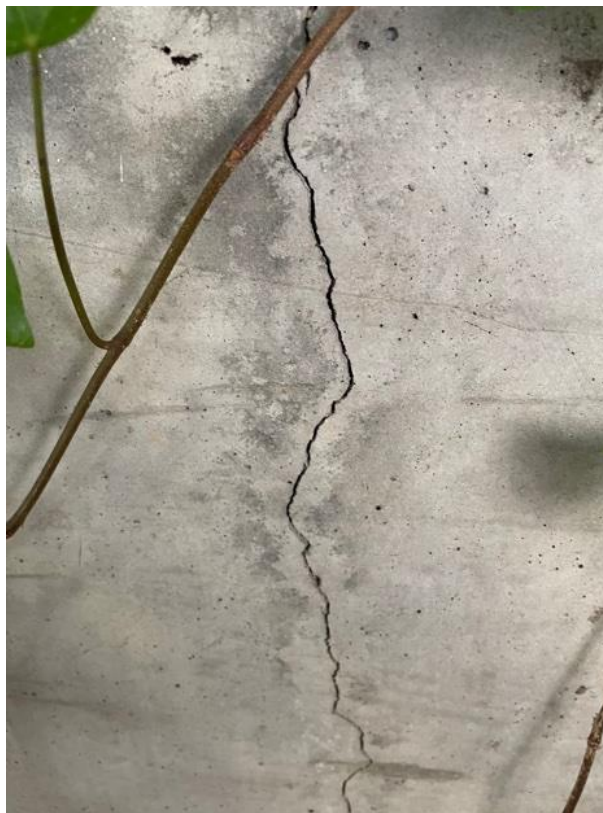
Tree 51: structural crack to retaining wall

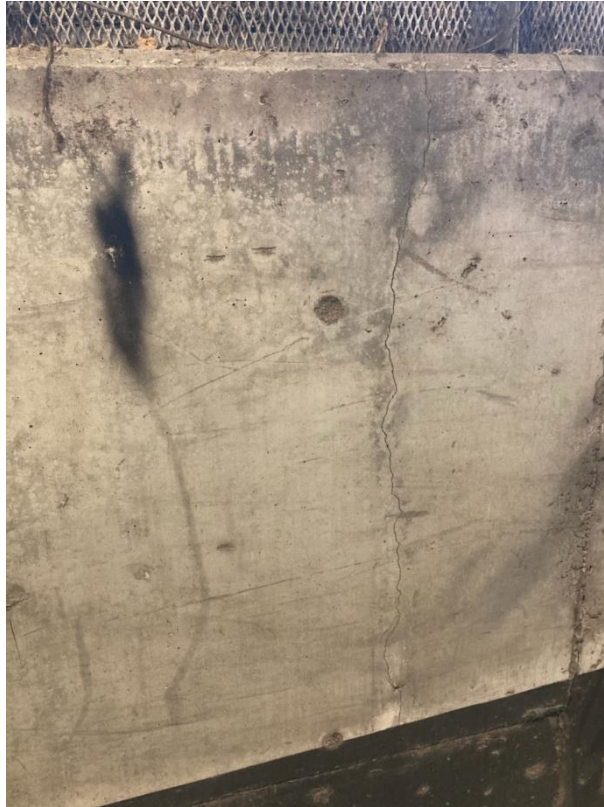
Tree 51: structural crack to retaining wall (top to bottom)

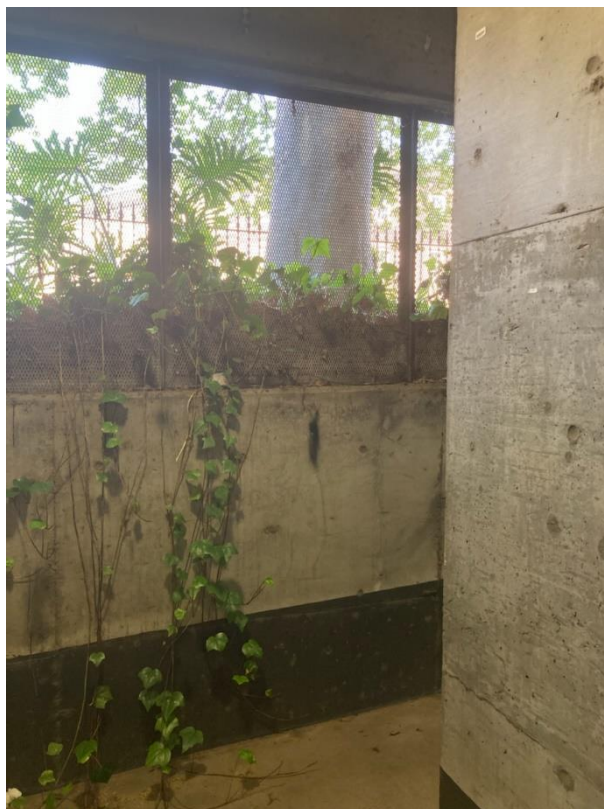
Tree 51: structural crack to retaining wall (top to bottom) at centreline of tree trunk

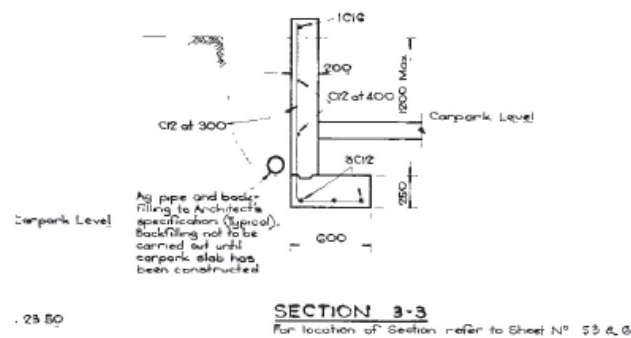
**Typical Wall section South of Grid 108.5 at Tree 50**

The existing retaining walls adjacent to trees 50 and 51 have narrower footings than required as specified in AS4678-2002 Earth Retaining Structures.

Section 4-4 indicates a wall height of 2250mm having a footing of 1200mm wide. In accordance with AS4678-2002 the footing is to have a width of 1700mm minimum. The wall is therefore deemed to be unstable in accordance with the code requirements.

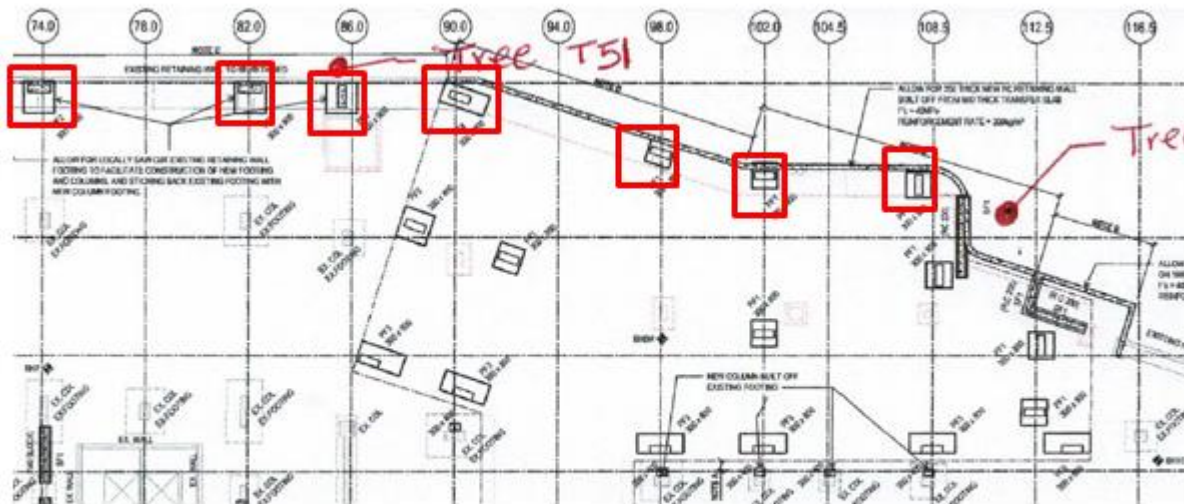
Further as can be seen in the below sketch, pad footings need to be constructed for the future SoHo structure and podium above and these new footings clash with the existing retaining wall footing locations. Therefore, in order to construct the new footing pads the wall footings will need to be demolished, further making the retaining wall unstable.

**New Works Plan showing new pad footings clashing with existing RW footings.**

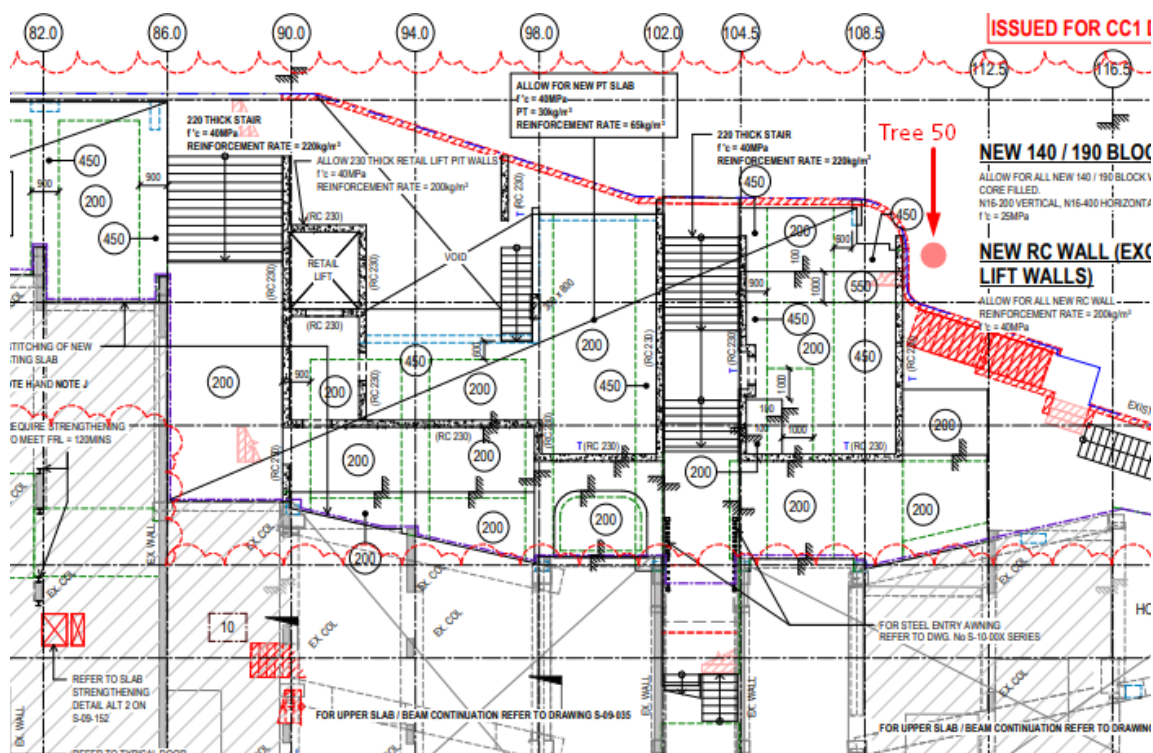
**Tree 50 Updated Podium design showing vertical support structure under clashing with the existing Section 3 Retaining Wall.**
