27th January 2022

Re: Sirius Building - Tree numbers 50 and 51 – Options for basement rectification works – Updated advice 27/1/2022.

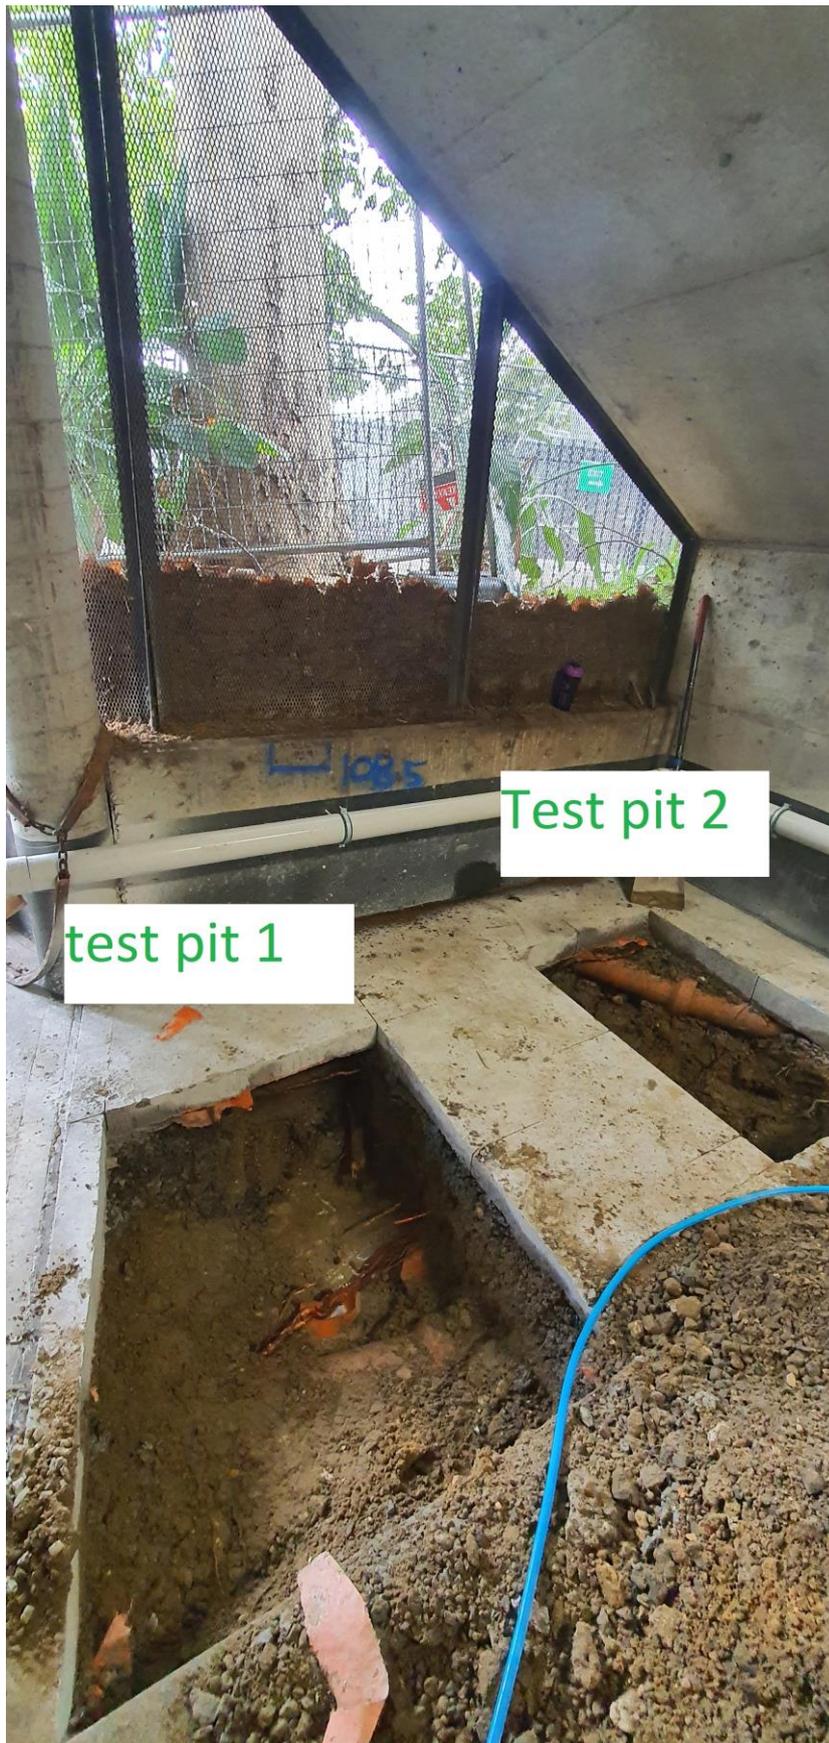
Based on the dimensions, proximity to the trees and bark characteristics the roots depicted in those photographs are from tree number 50. I am advised the roots in question were of 25mm to 70mm diameter and had grown under the existing retaining wall footing. Photographs provided to me depicting the roots are attached in Appendix A. (NB: I am advised that root mapping on the eastern side of the retaining wall adjacent to the trees is not able to be undertaken).

Photograph 1: Illustrating the test pit locations, roots and tree number 50.

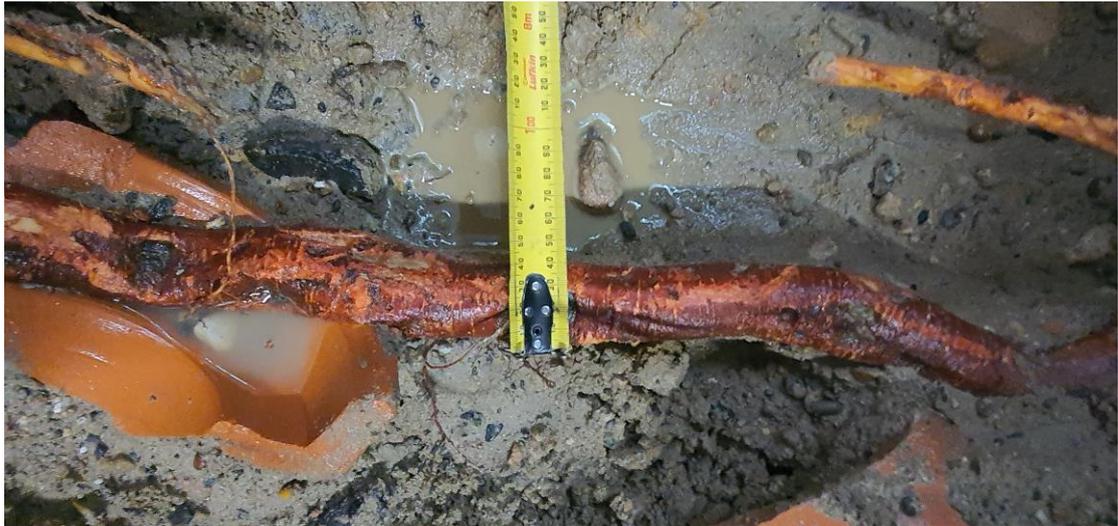
Photograph 2: Illustrating an exposed root in the test pit.

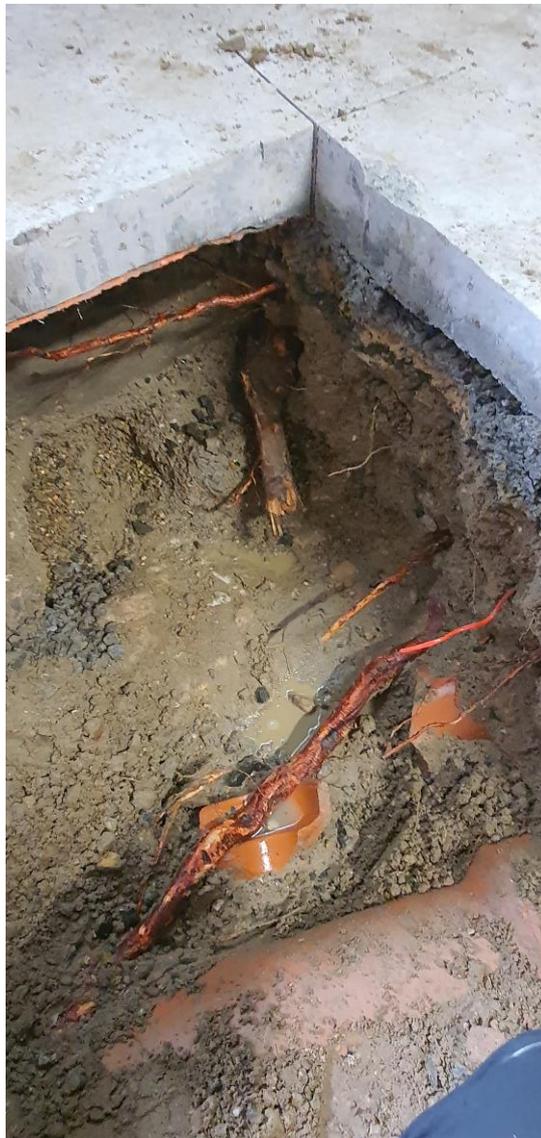
Photograph 3: Illustrating exposed roots in the test pit

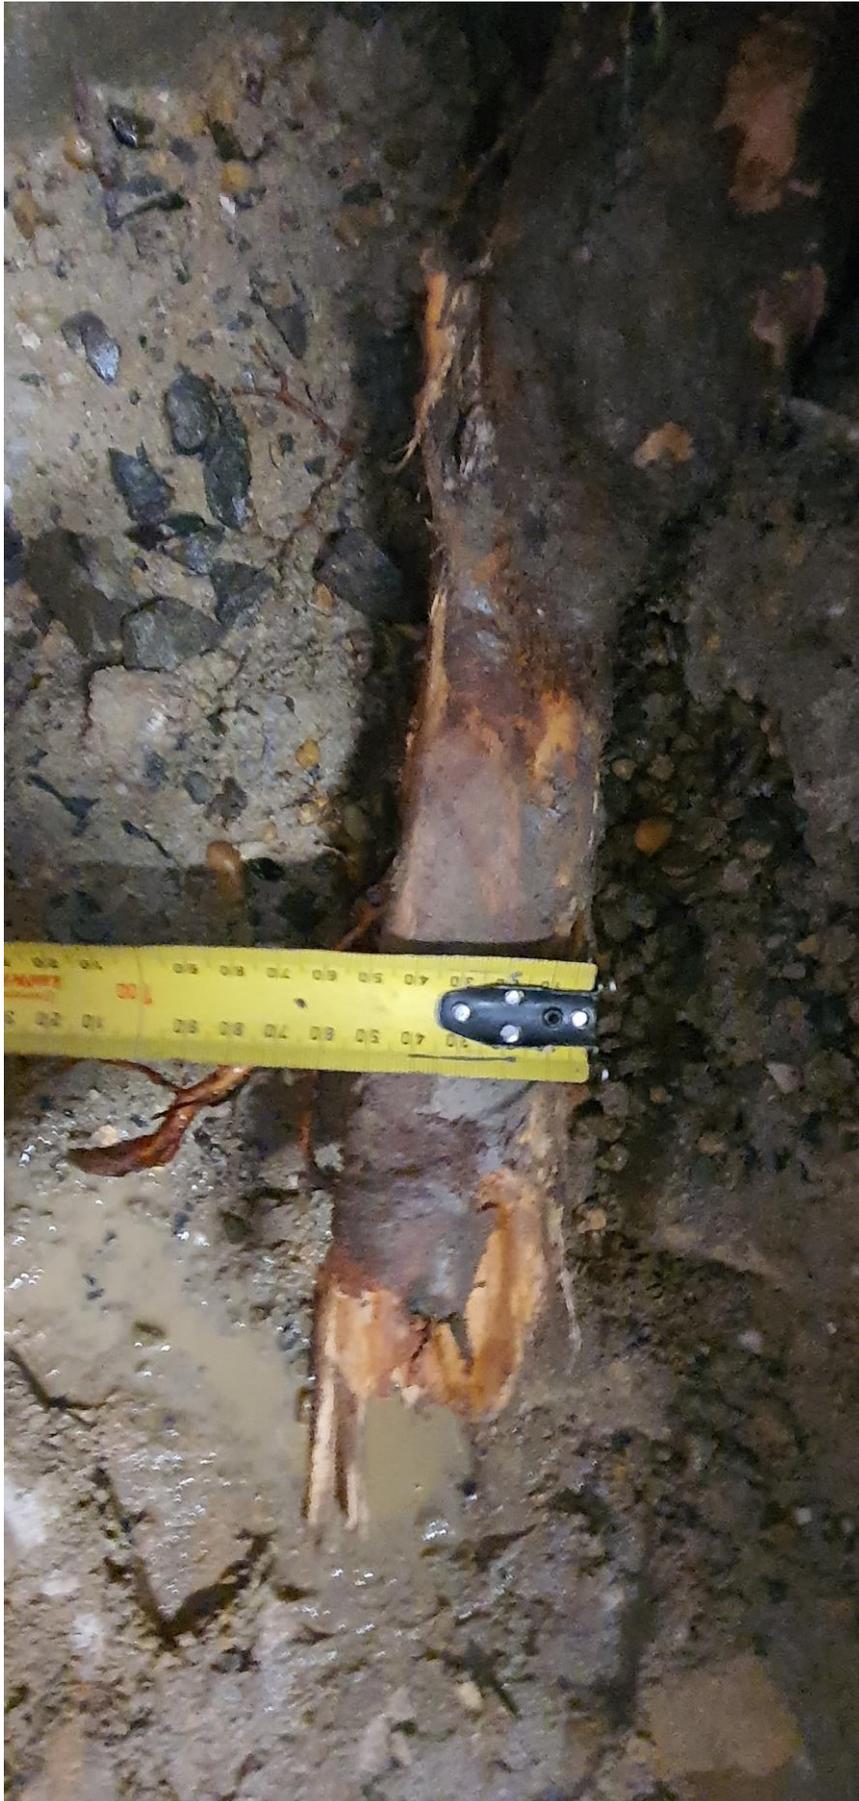
Photograph 4: Illustrating a root dimension.

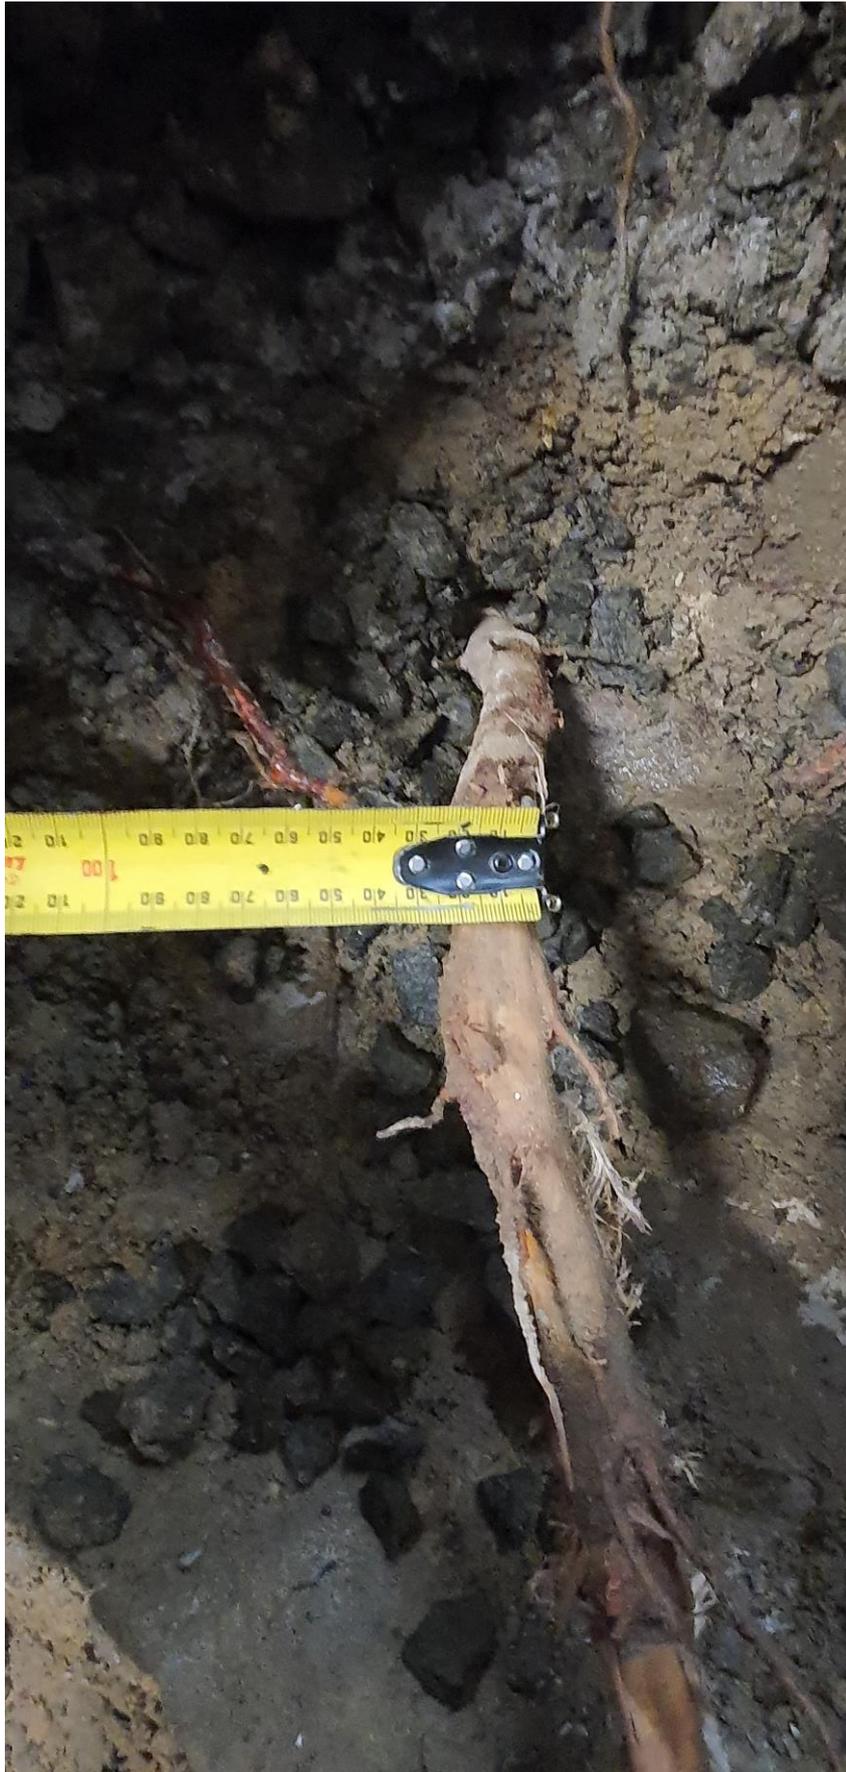
Photograph 5: Illustrating a root dimension.

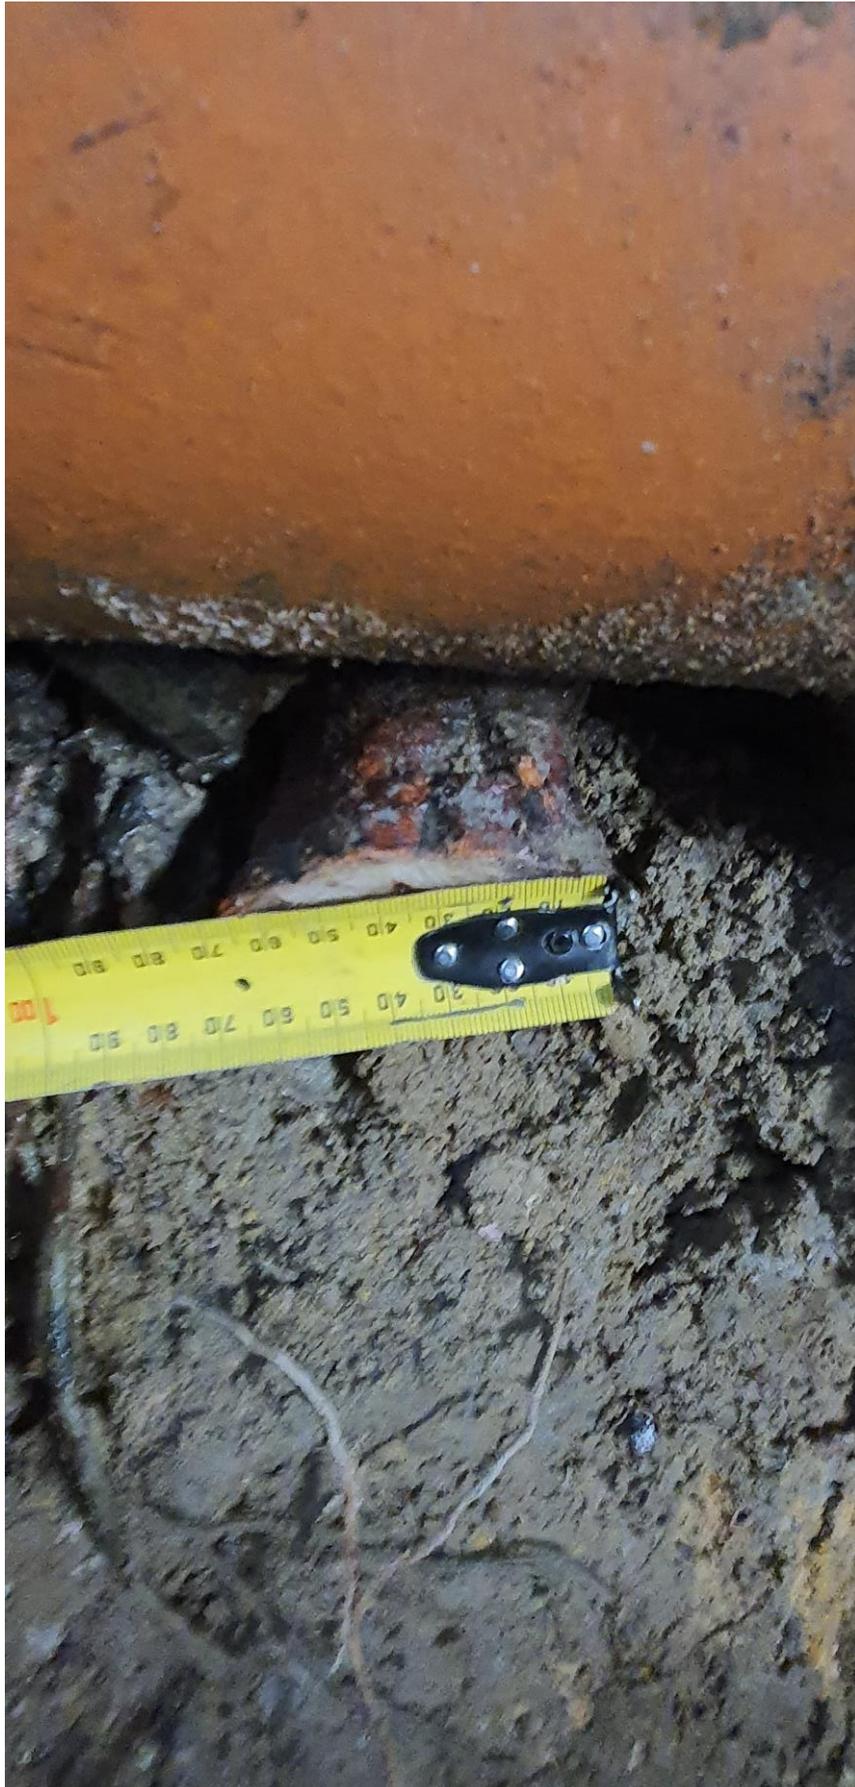
Photograph 6: Illustrating a root dimension.

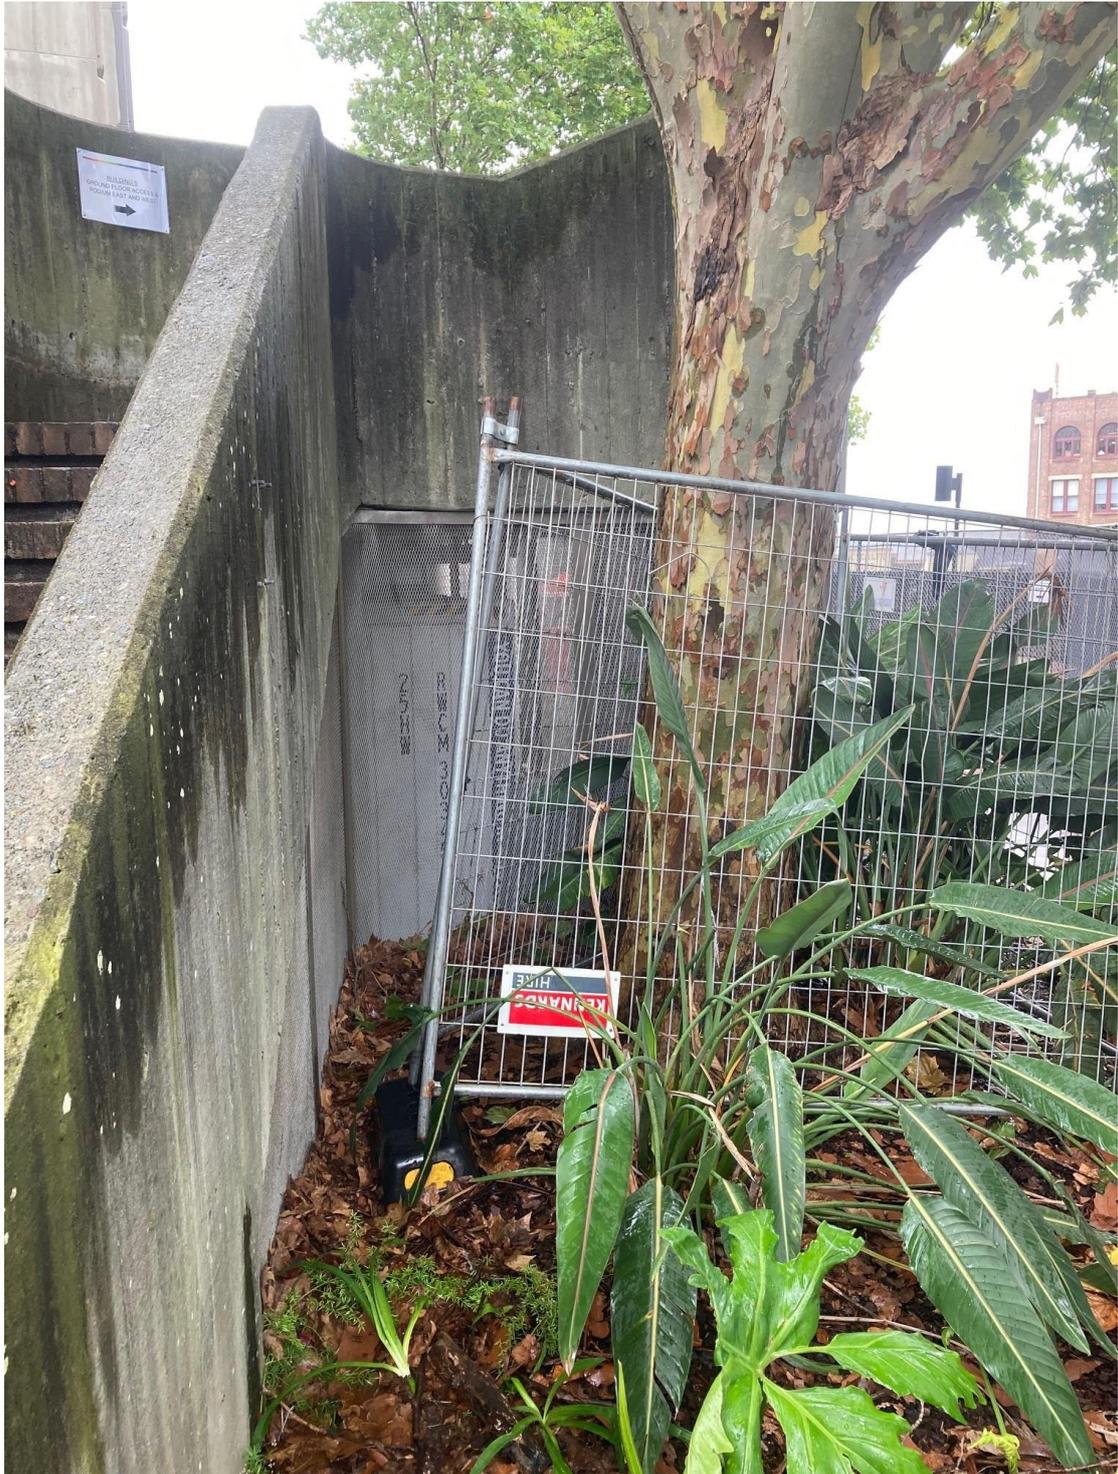
Photograph 7: Illustrating the proximity of tree 50 to the existing structures/basement.

5. The proposed retaining wall works will have a significant impact on the trees and will almost certainly render the trees unstable and at risk of failure in the short term. In this respect, I am of the opinion there is not a practically achievable and arboriculturally acceptable method to stabilise the trees in the short and longer term using mechanic measures such as braces etc.
6. Given the high levels of target (human) activity in the immediate vicinity of the trees their removal, prior to commencement of works, is the only option if the works are to proceed as proposed.

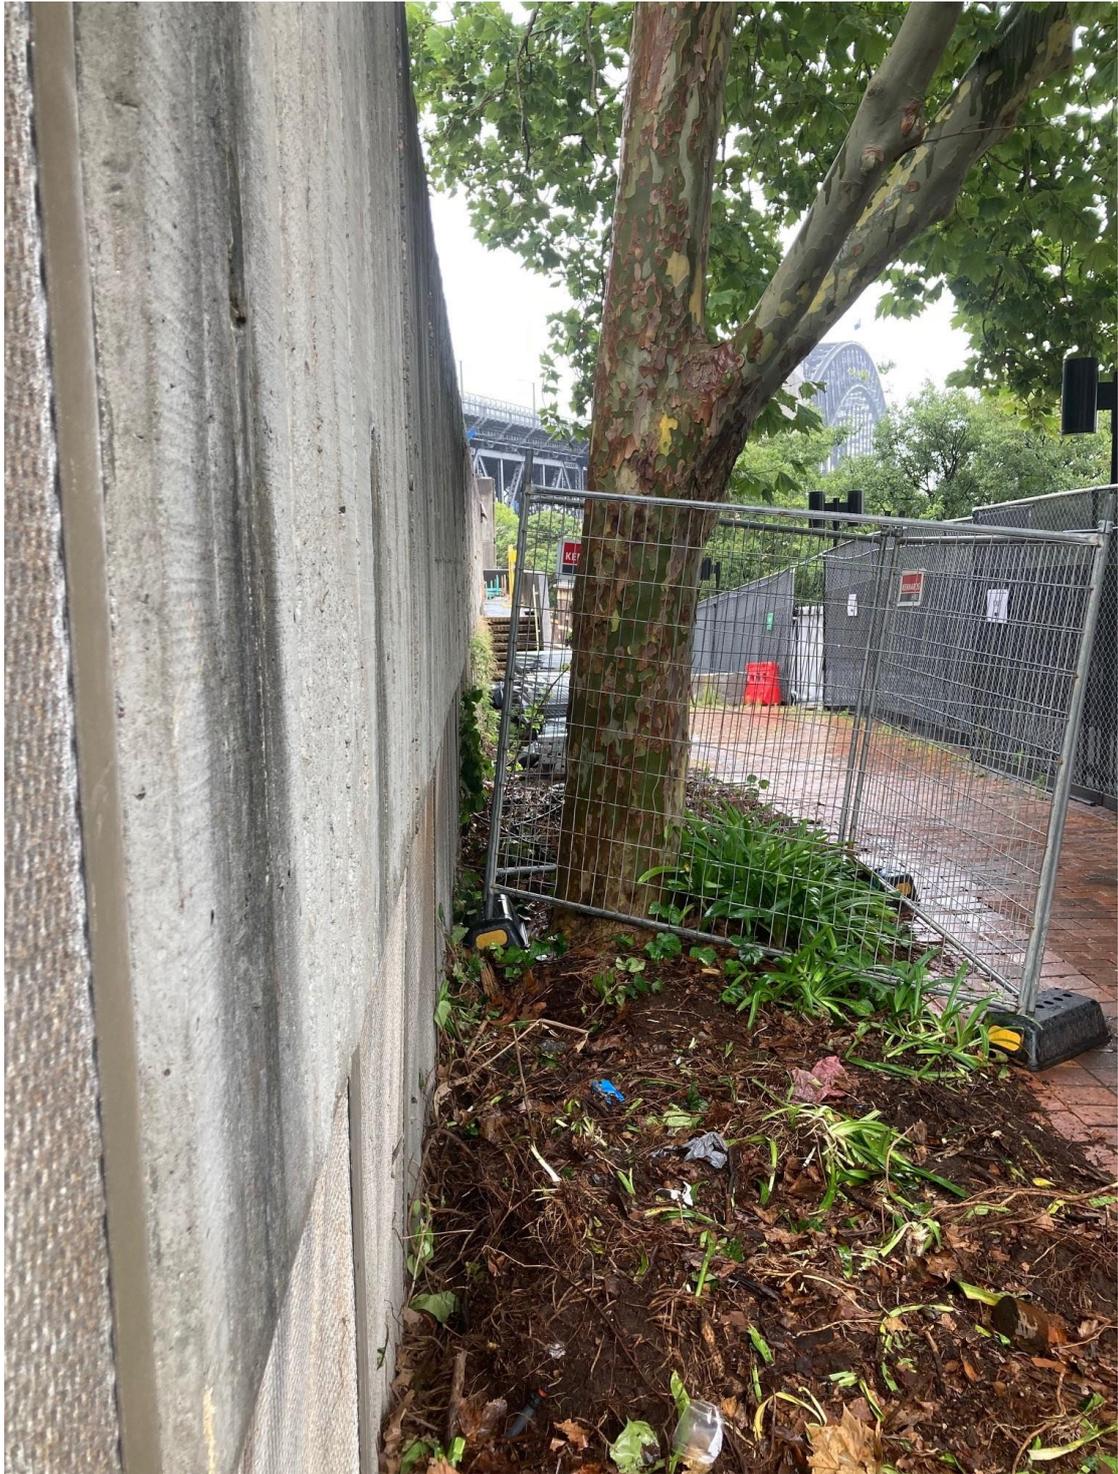
Photograph 8: Illustrating the proximity of tree number 51 to the existing structures/basement
