# Arborist Assessment Report

Department of Education NSW

PROJECT: SSD-21854025 Wee Waa High School

Site Address: 105-107 Mitchel Wee Waa NSW

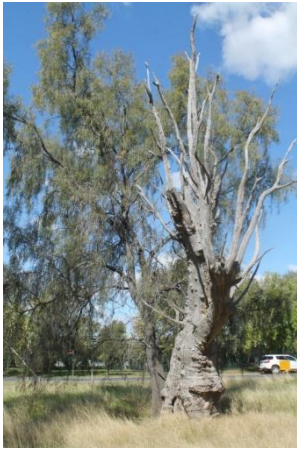
TREE 1 & 1A

- Two (2) significant in sized dead trees (Tree 1 and 46) of indigenous species both contain hollows.  
*(Ecologist required for further information)*

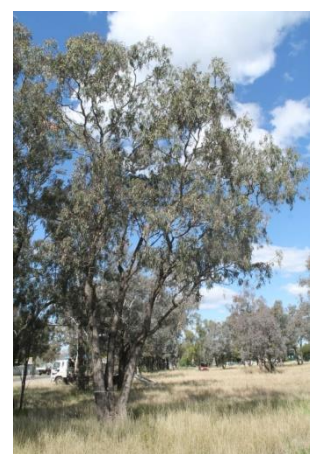
12	Not affected	Eucalyptus <i>microtheca</i> Coolibah	10	30x3	7	Mature good condition but poor form inclusion @ base	80	N/A	N/A	A2 HIGH	Impacted by construction REMOVE TREE
13	In Build Zone	Eucalyptus <i>microtheca</i> Coolibah	10	40/30	7	Mature good condition but poor form Lowest branch section failed	70	N/A	N/A	D2 Medium	Impacted by construction REMOVE TREE
14	In Build Zone	Eucalyptus <i>microtheca</i> Coolibah	10	50/30/15	8	Mature good condition, structure good	80	N/A	N/A	A2 HIGH	Impacted by construction REMOVE TREE
14A-	In Build Zone	Eucalyptus <i>microtheca</i> Coolibah	10	30	5	Mature good condition, structure good	45	N/A	N/A	A2 HIGH	Impacted by construction REMOVE TREE
14B-F	X5 In Build Zone	Eucalyptus <i>microtheca</i> Coolibah	10	30	5	Mature good condition structure good	40	N/A	N/A	A2 HIGH	Impacted by construction REMOVE TREE
15	Not affected	Eucalyptus <i>microtheca</i> Coolibah	12	35	5	Mature good condition, structure good	40	2.2	4.2	A2 HIGH	RETAIN

TREE 12

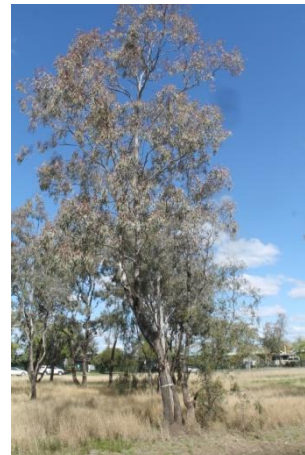
19	Not affected	Eucalyptus <i>microtheca</i> Coolibah	10	40/15	5	Mature good condition damage @ base good tissue response	55	2.5	5.1	A2 HIGH	RETAIN
20	Not affected	Eucalyptus <i>microtheca</i> Coolibah	11	40/15	6	Mature moderate condition, inclusion @ base	50	2.4	5.1	A2 HIGH	RETAIN
21	Not affected	Eucalyptus <i>microtheca</i> Coolibah	9	15x4	4	Mature moderate condition, possible white ant nest @ base	50	2.4	3.6	D2 HIGH	RETAIN
22	Not affected	Eucalyptus <i>microtheca</i> Coolibah	9	30/30/ 20	6	Mature moderate condition poor form, decay in union @ base.	60	2.6	5.6	D2	RETAIN
22A	Not affected	Eucalyptus <i>microtheca</i> Coolibah	11	28	3	Semi mature good condition structure good	35	2.1	5.0	A2 HIGH	RETAIN
23	Not affected	Eucalyptus <i>microtheca</i> Coolibah	10	30/30	7	Mature good condition, structure good	50	2.4	4.2	A2 HIGH	RETAIN
24	Not affected	Eucalyptus <i>microtheca</i> Coolibah	7	15x3	6	Semi mature good condition, poor form damage @ base good tissue response	45	2.3	3.1	D2 HIGH	RETAIN

TREE 19

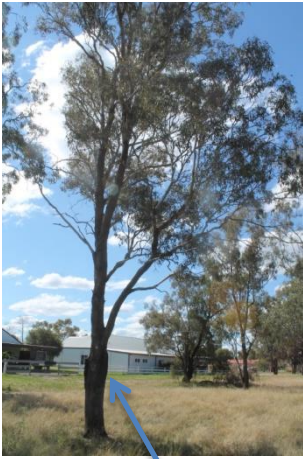
32A	Not affected	Eucalyptus <i>microtheca</i> Coolibah	12	55	8	Mature good condition, inclusion @ 2 m , swelling at site of union	70	N/A	N/A	D3 HIGH	RETAIN
32B	Not affected	Eucalyptus <i>microtheca</i> Coolibah	12	45	6	Mature moderate condition, damage@ 3m	70	N/A	N/A	D3 HIGH	RETAIN
33	In Build Zone	Eucalyptus <i>microtheca</i> Coolibah	10	30/15/ 15	5	Semi mature good condition poor form	50	N/A	N/A	A2 HIGH	Impacted by construction REMOVE TREE
34	In Build Zone	Eucalyptus <i>microtheca</i> Coolibah	12	60	8	Mature good condition, structure good minor dead wood	75	N/A	N/A	A2 HIGH	Impacted by construction REMOVE TREE
35	In Build Zone	Eucalyptus <i>microtheca</i>	12	60	9	Mature good condition, structure good minor dead wood	80	N/A	N/A	A2	Impacted by construction

TREE 32A swelling at union

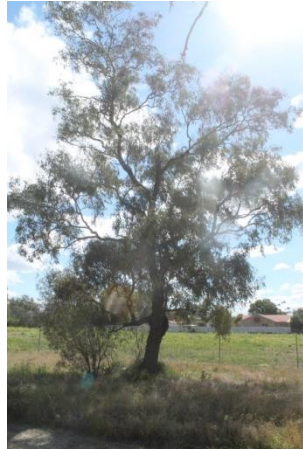
Coolibah								HIGH	REMOVE TREE
35A	In Build Zone	Eucalyptus <i>microtheca</i> Coolibah	10	50	8	Mature good condition, structure fair 3 x branch failures	65	N/A	N/A	D2 HIGH	Impacted by construction REMOVE TREE
36	Not affected	Eucalyptus <i>microtheca</i> Coolibah	8	30/30	6	Mature good condition, structure good tree suppressed by adjacent tree	50	2.4	5.0	A2 HIGH	RETAIN
37	Not affected	Eucalyptus <i>microtheca</i> Coolibah	12	60/30	10	Mature good condition, structure good	80	3.0	8.0	A2 HIGH	RETAIN
37A	Not affected	Eucalyptus <i>microtheca</i> Coolibah	10	30	5	Mature good condition, structure good	40	2.2	3.6	A2 HIGH	RETAIN
37B	Not affected	Eucalyptus <i>microtheca</i> Coolibah	12	60	8	Mature good condition, structure good	75	2.9	7.2	A2 HIGH	RETAIN
37C	REF' works	Eucalyptus <i>microtheca</i> Coolibah	10	40	6	Mature good condition, structure good	55	2.6	4.8	A2 HIGH	Tree to be removed under separate approval (if not removed retain)

TREE 35A

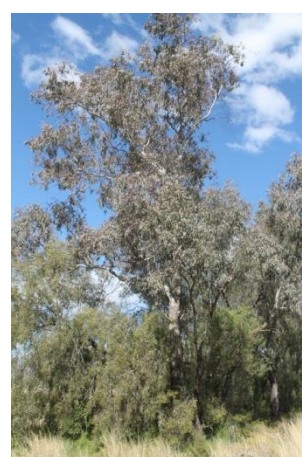
TREE 49

49	REF' works	Eucalyptus <i>microtheca</i> Coolibah	12	40	5	Mature poor condition borer attack, failed section	50	2.4	4.8	D3 HIGH	Tree to be removed under separate approval (if not removed retain)
49A	REF' works	Geijera <i>parviflora</i> Wilga	9	30	7	Mature good condition, structure good	40	2.2	3.6	D3 HIGH	Tree to be removed under separate approval (if not removed retain)
50	REF' works	Eucalyptus <i>microtheca</i> Coolibah	12	30	6	Mature good condition, structure good	50	2.4	3.6	A2 HIGH	Tree to be removed under separate approval (if not removed retain)
51	REF' works	Eucalyptus <i>microtheca</i> Coolibah	12	30	6	Mature good condition, structure good	50	2.4	6.0	A2 HIGH	Tree to be removed under separate approval (if not removed retain)
51A	REF' works	Eucalyptus <i>microtheca</i> Coolibah	12	30	6	Mature good condition, structure good	50	2.4	6.0	A2 HIGH	Tree to be removed under separate approval (if not removed retain)

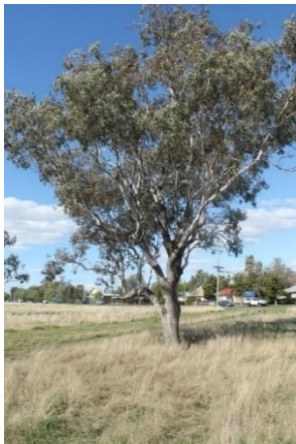
TREE 55

55	Not affected	Eucalyptus <i>microtheca</i> Coolibah	10	60	8	Mature good condition, structure poor, fracture in union West side	80	3.0	7.2	D3 Medium	RETAIN
56	REF' works	Eucalyptus <i>microtheca</i> Coolibah	10	35	7	Mature good condition, structure good	50	N/A	N/A	A2 HIGH	Tree to be removed under separate approval (if not removed retain)
57	Not affected	Eucalyptus <i>microtheca</i> Coolibah	10	40	7	Mature moderate condition	48	2.4	4.2	A2 HIGH	RETAIN
58	REF' works	Eucalyptus <i>microtheca</i> Coolibah	10	20x4	6	Mature good condition, poor form structure good.	80	3.0	4.8	A2 HIGH	Tree to be removed under separate approval (if not removed retain)
59	REF' works	Eucalyptus <i>microtheca</i> Coolibah	10	40	6	Mature good condition, structure good	50	2.4	4.2	A2 HIGH	Tree to be removed under separate approval (if not removed retain)
60	REF' works	Eucalyptus <i>microtheca</i> Coolibah	12	40	6	Mature moderate condition, structure ok	50	2.4	4.2	D3 HIGH	Tree to be removed under separate approval (if not removed retain)
