Harbourside Development

Maritime Heritage Dilapidation Survey Report

Darling Harbour
NSW

July 2022

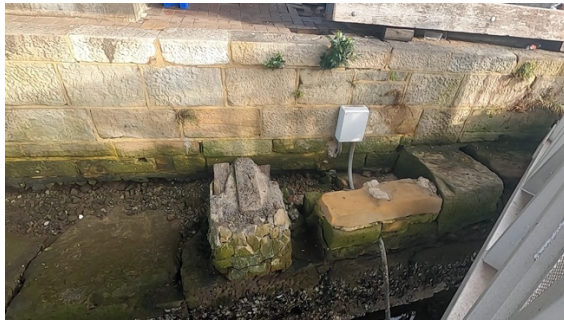
Approximately 1 metre south there appears to be the remains of a landing or wharf footing immediately adjacent to a stone block carrying a modern cable conduit (Figure 5). Moving southward, the section of stone seawall underneath the Bridge appears to have a more modern section of sandstone built on a base of older, larger, more rounded stone blocks (Figure 6). Drain outlets have been built into the wall at various points along its length (Figure 7). There is evidence of 'quickfix' repairs such as a hole fixed using house bricks (Figure 8) and some evidence of mortar loss, lower down the wall in the splash zone (Figure 9). The tide levels are indicated by the mollusc growth on the seawall (Figure 10).

Figure 5: Possible wharf footing (Image 220624 Harbourside stone wall above water_linear, 00:04).

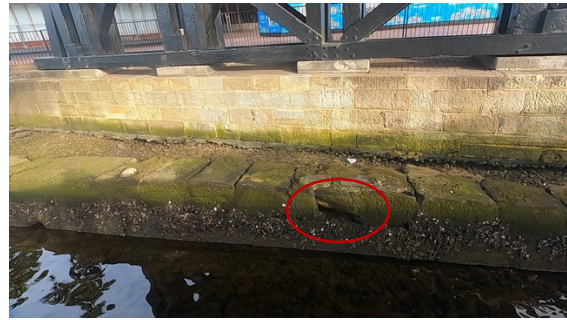
Figure 6: Stone seawall underneath the Pymont Bridge. Note mortar loss. (Image 220624 Harbourside stone wall above water_linear, 00:13).

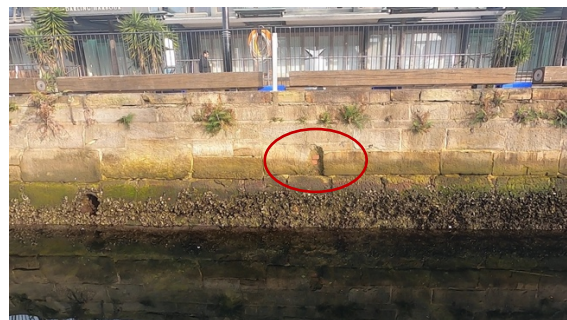
Figure 8: Some evidence of a repair using bricks. (Image 220624 Harbourside stone wall above water_linear, 01:28).

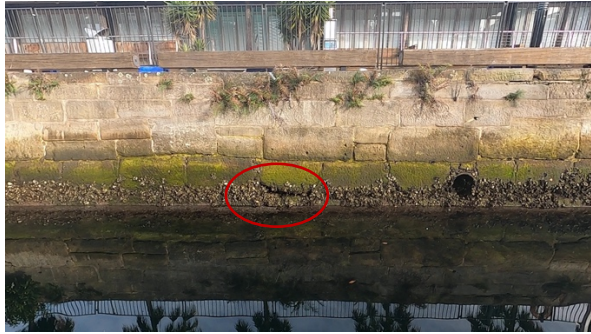
Figure 9: Example of mortar loss above water. (Image 220624 Harbourside stone wall above water_linear, 01:41).

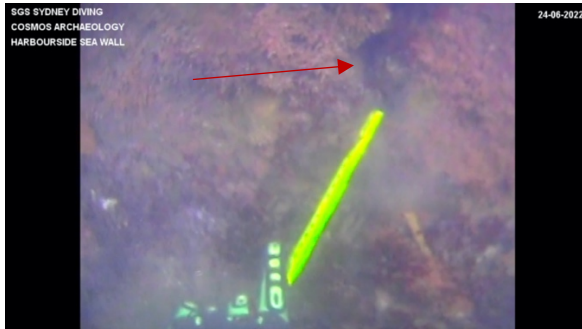
Below water, the seabed against the stone seawall is a silty mud. The lower courses of stone had small gaps consistent with mortar loss along the length of the wall (Figure 11).

Figure 11: Example of gaps between blocks indicating mortar loss. (Image 220624_Stone seawall dilapidation_1, 04:18)

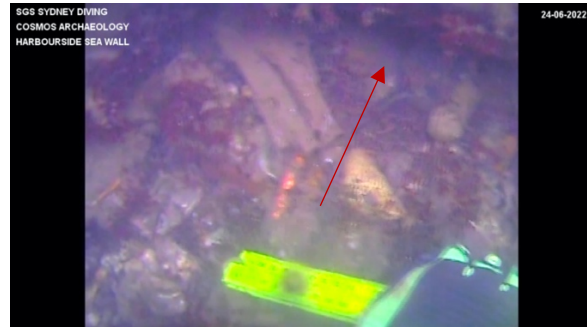
Approximately 12 m from the start of the diver survey, a cavity along the base of the seawall was noted. This cavity was 800 mm long, 120 mm wide and 250 mm deep in sections. It appears the seabed has come through this section at the base (Figure 12).

Figure 12: Cavity at base of stone wall 12 m along survey line, indicated by red arrow. (Image 220624_Stone seawall dilapidation_1, 04:18)

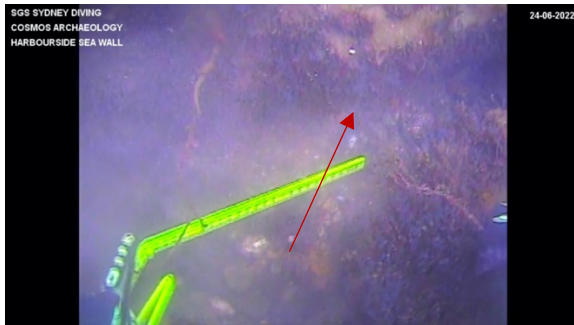
At 16 m along the stone sea wall, there is a section of undermining up to 500 mm in depth, likely up to the course of blocks behind it (Figure 13). The length of undermining is 500 mm up to a height of 80 mm. Another cavity was found at 22.5 m from the northern corner measuring 450 mm long by 50 mm high and 500 mm deep (Figure 14). Another area of undermining was noted at 24 m, measuring 400 mm long, 250 mm wide and up to 800 mm deep in sections. At 25 m some material loss at the base of the stone wall was noted measuring 300 mm long x 250 mm high and 250 mm deep. More undermining at 31.3 m of 1000 mm in length and up to 1000 mm deep and 250 mm high.

Figure 13: Section of undermining at base of stone wall 16 m along survey line, indicated by red arrow. (Image 220624_Stone seawall dilapidation_1, 06:43)

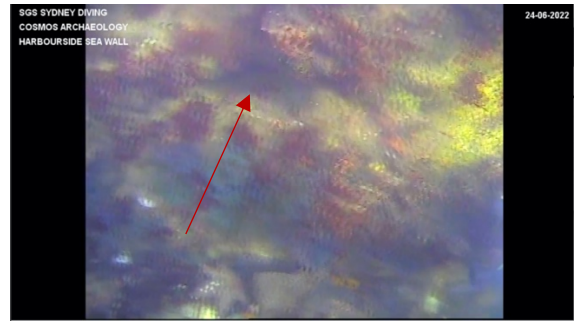
Figure 14: Section of undermining at base of stone wall 22.5 m along survey line, indicated by red arrow. (Image 220624_Stone seawall dilapidation_2, 00:52)

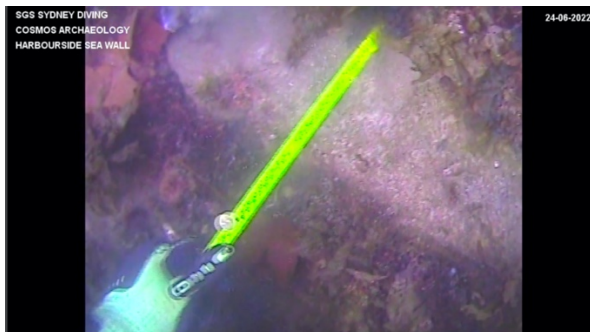
A longer section of undermining at 39 m was recorded measuring approximately 1500 mm long, 200 mm high and 900 mm deep (Figure 15).

Figure 15: Section of undermining at base of stone wall 39 m along survey line. (Image 220624_Stone seawall dilapidation_3, 00:03)

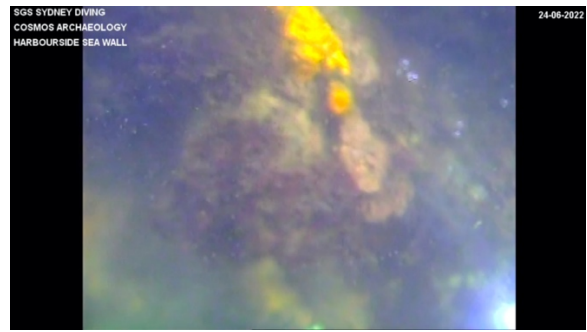
At 45 m, there appeared to be a potential damaged drainage pipe with broken bricks and jumbled rocks. The length of damage in the seawall measured 1000 mm wide, 800 mm high and at least 1000 mm deep (Figure 16).

Figure 16: Possible damaged drainage pipe. (Image 220624_Stone seawall dilapidation_4, 02:49)

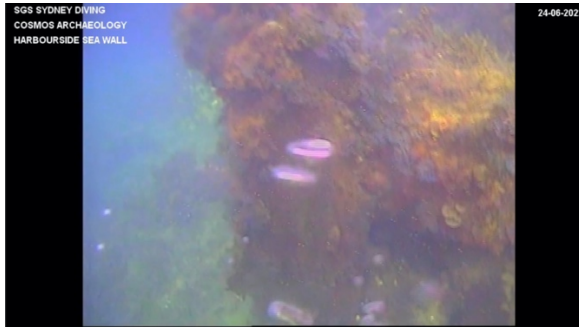
Just to the north of the public walkway (at 63 m), a cut-off timber pile was located, measuring 250 mm in diameter and 650 mm high. This is likely part of an old wharf structure (Figure 17).

Figure 17: Cut-off timber pile, located 1 m north of steel pile of public walkway. (Image 220624_Stone seawall dilapidation_4, 02.49)

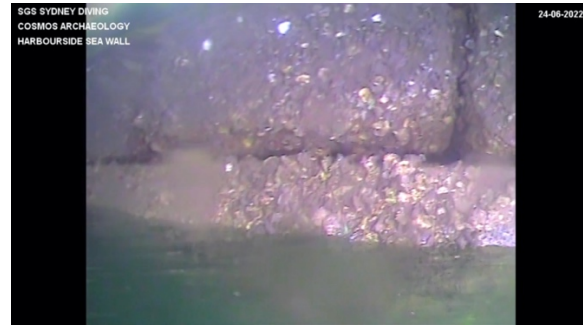
Underneath the public walkway, the stone seawall is in good condition. The stone blocks above the water line have experienced some mortar loss (Figure 18). While the blocks below the water line show some minor cavities and material loss. The silt has built up underneath the walkway making it difficult to determine if there is any significant undermining in this area.

Figure 18: Underneath public walkway, the stones have experienced mortar loss above water. (Image 220624_Stone seawall dilapidation_S_walkway, 00.44)

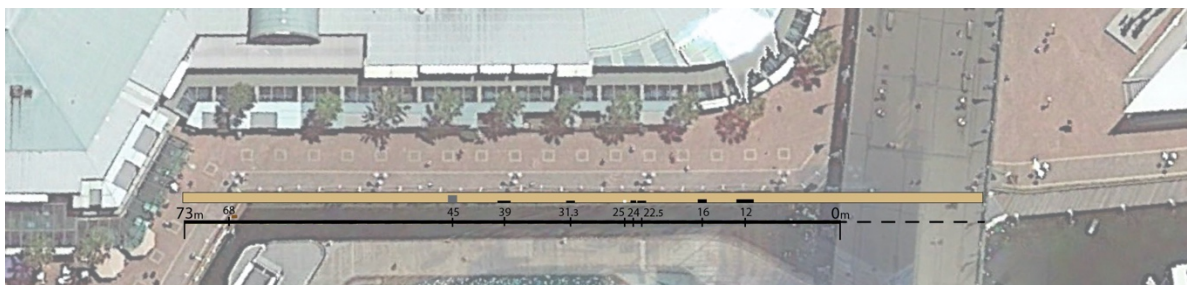
Figure 19: Digital representation of locations of areas of undermining.

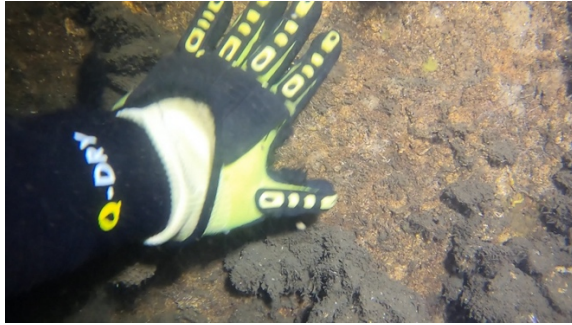
Figure 25: External concrete wall of intake entrance. (Image 220624_Intake conduit, 00:11).

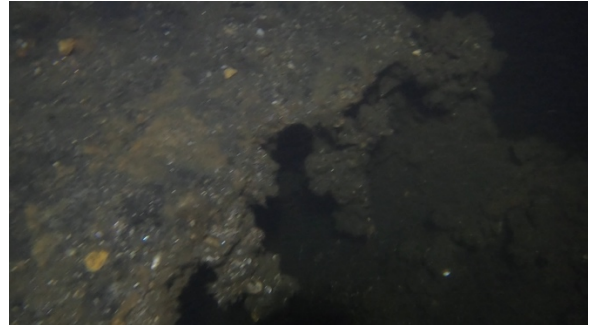
The intake entrance has a square profile entrance made of concrete (Figure 25). Where visible, this concrete appeared in good condition. At the northern entrance gate there was what appeared to be construction debris that had fallen partway into the entrance (Figure 26). This was not touched or examined due to safety concerns of it falling on the diver. There was a build-up of silt and marine growth on the gates within each of the 'entrances' (Figure 27) and the silty seabed had build-up in front of each bottom gate to a level just below the opening mechanism (Figure 28). This silt build-up is likely due to the pull of the water as it is sucked into the intake entrance.

Figure 26: Construction debris at base of northern entrance. (Image 220624_Intake conduit, 00:18).

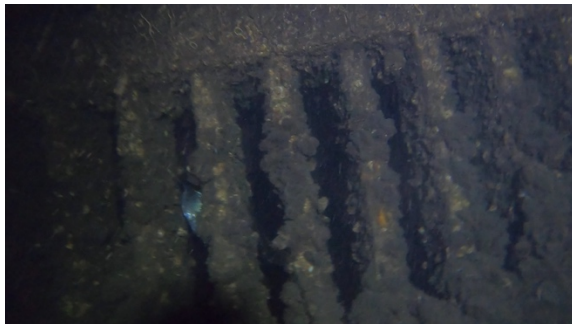
Figure 27: Example of growth build-up on intake gates. (Image 220624_Intake conduit, 03:34).
