**Manildra – Port Kembla Bulk Liquid Terminal**

# Remedial Action Plan

Reference No. 30013038-R02

Prepared for Manildra Group Pty Ltd

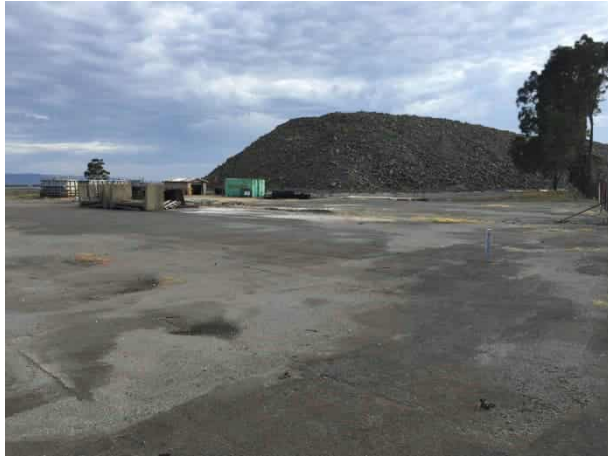
Photo 2-1 Looking north east towards stockpile (March 2021)

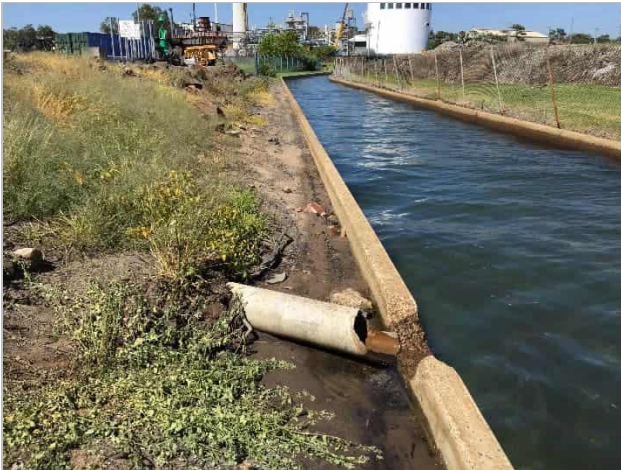
| Location and description | Date observed (Document reference) | Current Status |
|---|---|---|
| Central portion - Buried ACM pipe was observed at the stormwater channel bank (Photo 2-9) | March 2021 (SMEC, 2021a) | Remains onsite<br>(identified by Clearsafe Environmental Solutions on 22/10/2022) |

Photo 2-9 Buried ACM pipe observed on channel bank (March 2021)

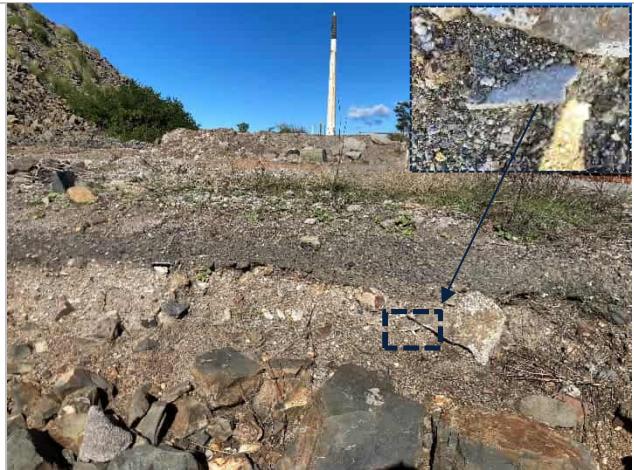
Photo 2-10 Evidence of ACM observed along eroded bank near stormwater outlet (April 2022)

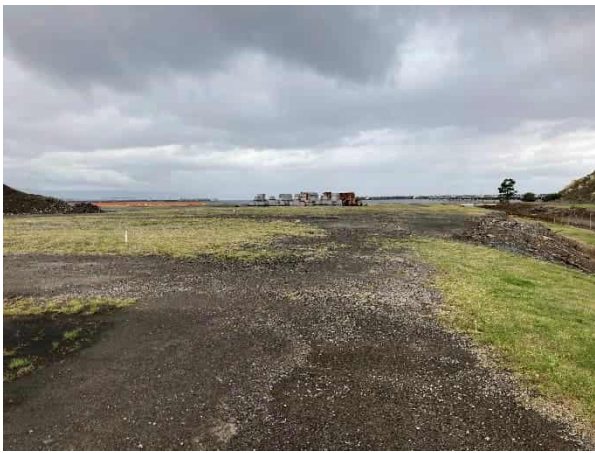
Photo 2-11 Areas west of the channel facing north-east towards harbour (October 2021)-

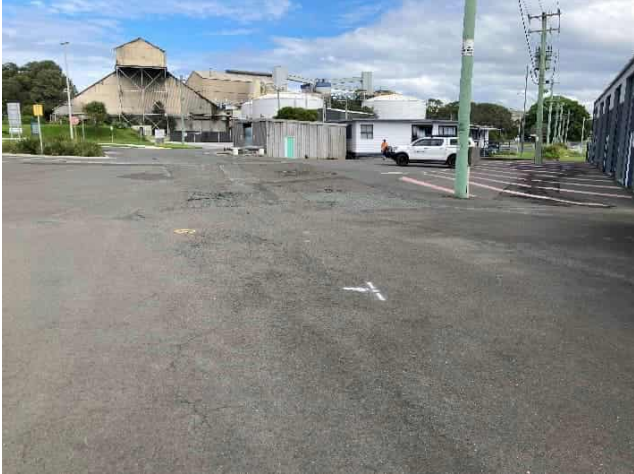
Photo 2-13 Looking south across asphalt carparking area near BH02 (Chainage 380m)

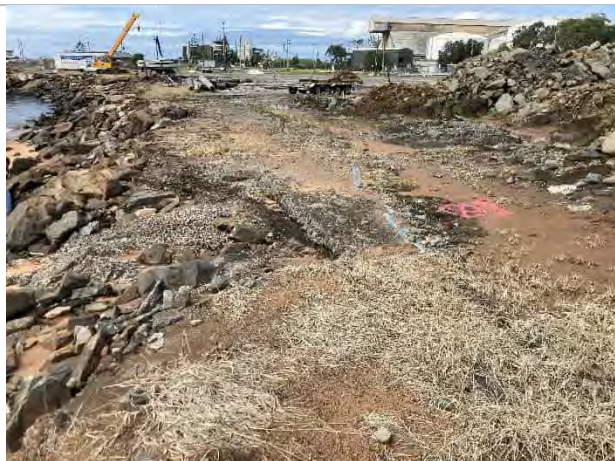
| Location and description | Date observed (Document reference) | Current Status |
|---|---|---|
| Pipeline route (Chainage 70m to 100m) - Multiple surface fragments on ground surface in good condition over an area of approximately 30m length by 4m wide area (Photo 2-17). Protruding fragments were also observed on walls of heavily eroded embankment along the harbour foreshore (Photo 2-18 and Photo 2-19), and several fragments were noted to have fallen amongst break wall boulders. | April 2022 (SMEC, 2022) | Removed and clearance issued (Clearsafe Environmental Solutions on 5/04/2022) |

Photo 2-17 ACM observed across area immediately north of Site near BH08 (Chainage 70m to 100m)

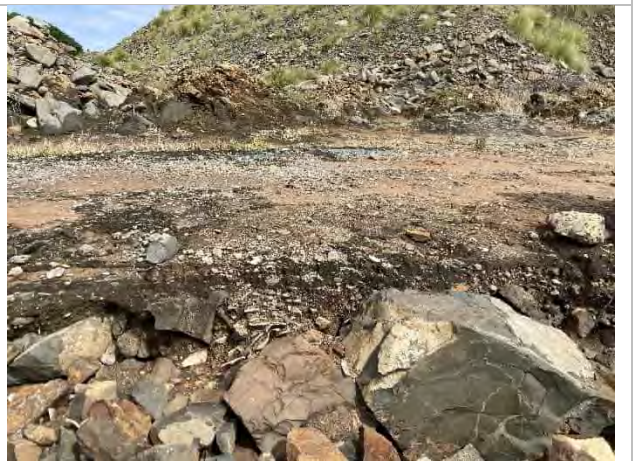
Photo 2-18 ACM observed within eroded embankment wall north of BH08 (Chainage 80m)

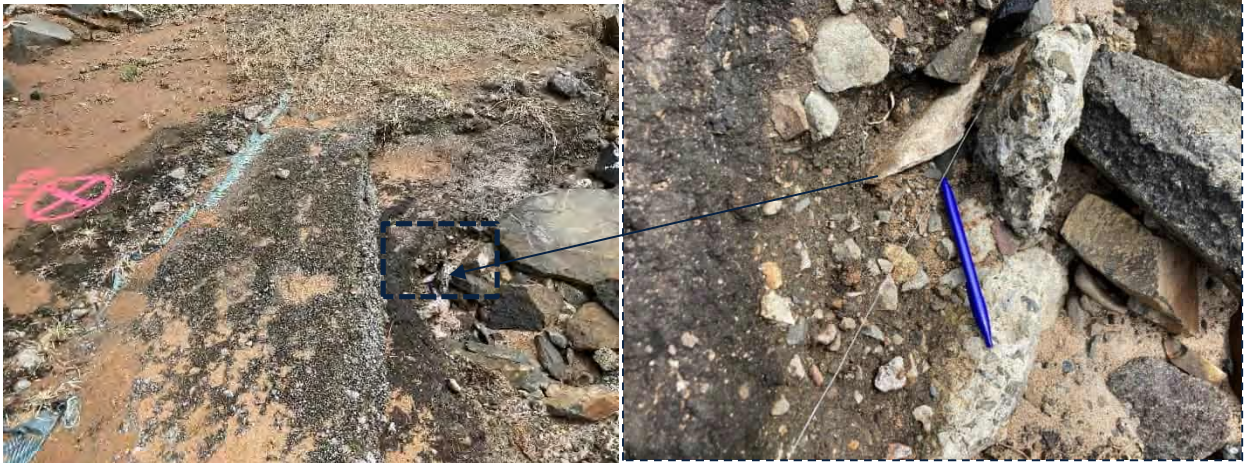
Photo 2-19 Example of ACM fragment observed protruding from eroded embankment wall near BH08 (Chainage 80m)

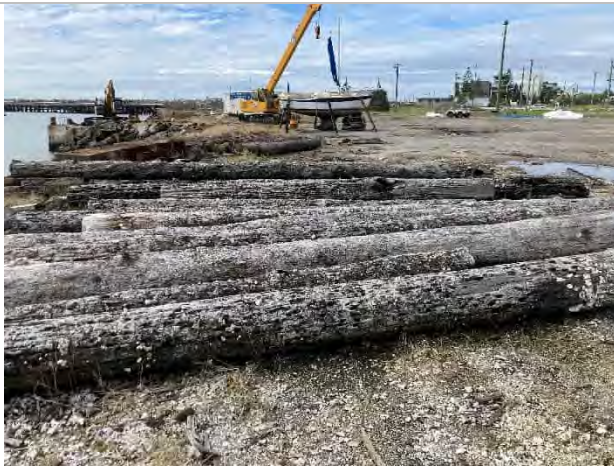
- Multiple timber poles were observed to be stockpiled in the vacant parcel of Lot 6 between Chainage 90 m and Chainage 150m (Photo 2-20). The timber poles were covered with shells and had been removed from marine timber structures associated with the former harbour jetty. Evidence of stockpiles of shredded timber were noted (Photo 2-21).

Photo 2-20 Timber poles stockpiled near BH07 (Chainage 110m)
