Hazardous Building Materials Assessment Staff Car Park King Street Nth (SYDPKN-P) Jet Base Mascot NSW 2020

November 2014

Qantas Facility ID: SYDPKN-P

Job No: 52602-026: Client No: J0013

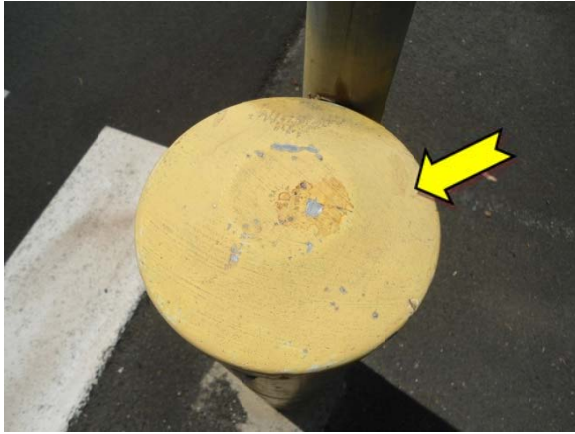
- LCP was identified in the yellow upper coloured paint system to the bollards in various areas throughout the car park during the assessment.

Photo 1. Ground level, various areas throughout car park, steel bollards – lead-containing yellow upper coloured paint system

- Any works that are likely to disturb LCP surfaces should be conducted in accordance with the AS4361.2-1998 *Guide to Lead paint Management* and Part 7.2 of the *NSW Work Health & Safety Regulation, 2011*.
- Please refer to the HMMP for this site for overarching recommendations for lead-based paints at this site.

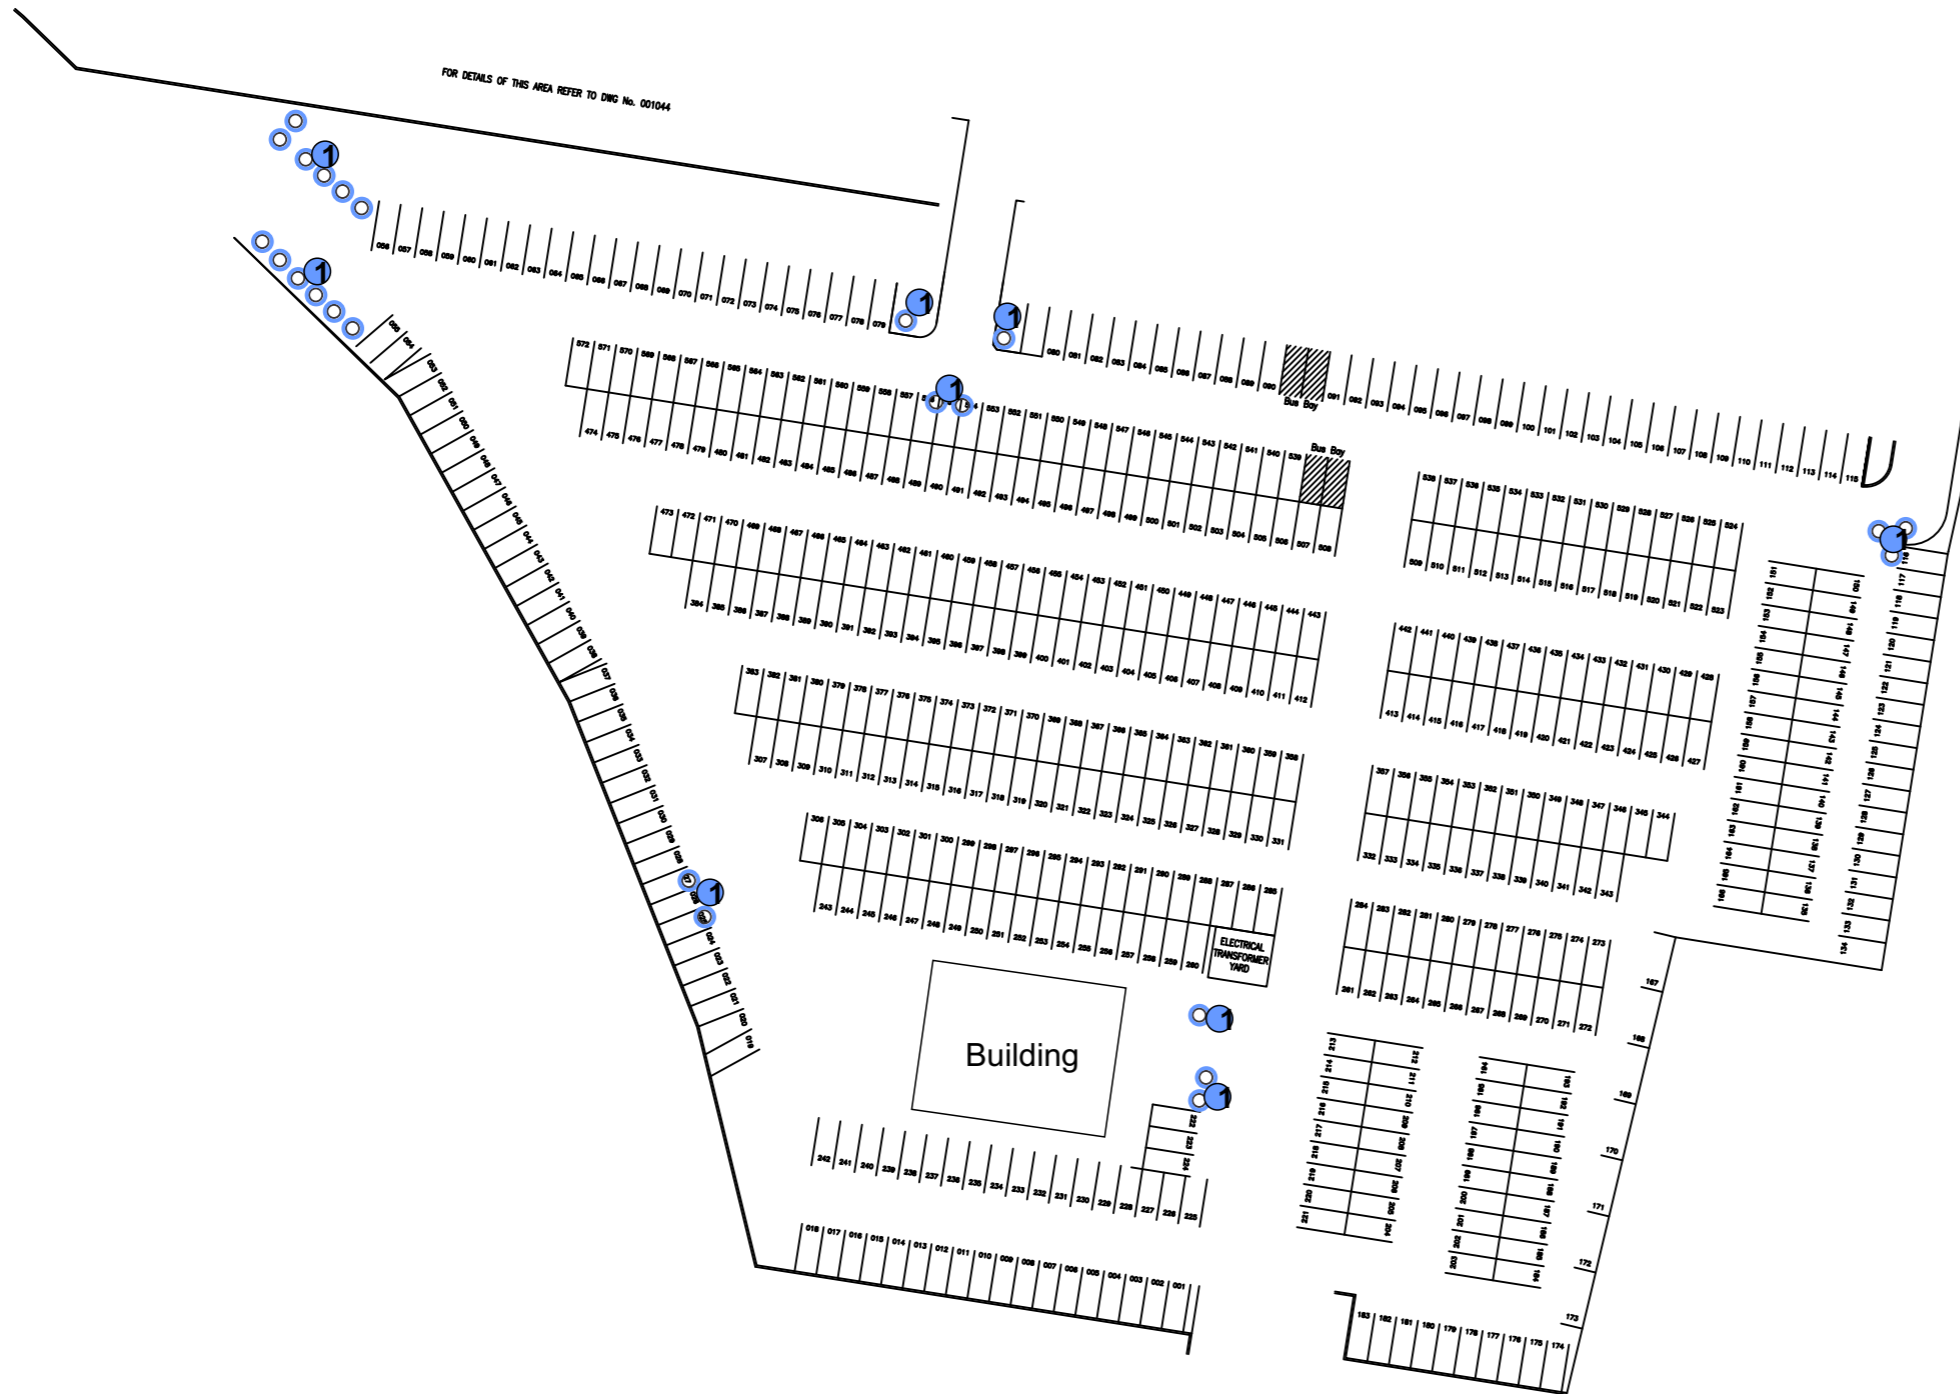
Drawing Title: Hazardous Materials Locations Plan

- Lead Containing Paint
- Paint
