# DILAPIDATION REPORT

## Yiribana Logistics Estaste East – Stage 1 Works (754-786 Mamre Road, Kemps Creek NSW 2178)

**Report Date:**

1 Nov 2023

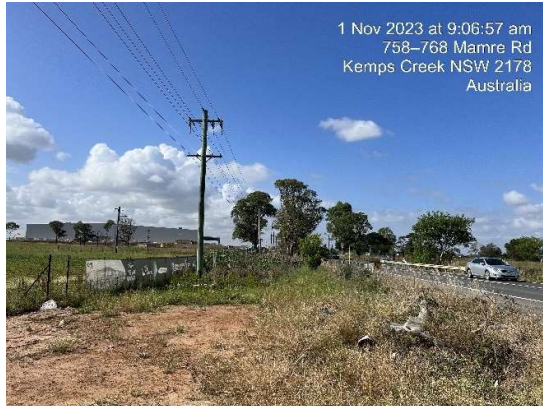
Photo 1.jpg

| Item | Description | Photo no. |
|---|---|---|
| 4.2.1 | North of site gate entry and photo taken facing south - Southbound verge had overgrown vegetation. | 1 |

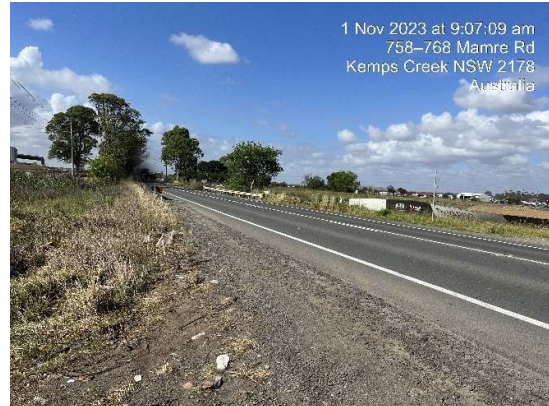
Photo 2.jpg

| Item | Description | Photo no. |
|---|---|---|
| 4.2.2 | North of site gate entry and photo taken facing south - Spray seal stripped on shoulder. Road pavement and line marking in general condition. | 2 |

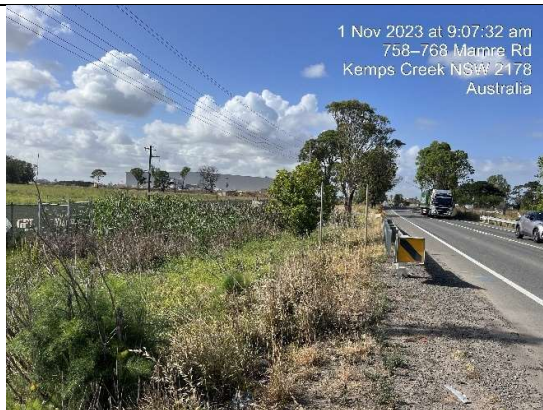
Photo 3.jpg

| Item | Description | Photo no. |
|---|---|---|
| 4.2.3 | North of site gate entry and photo taken facing south - Two signage poles with missing signage plate. | 3 |

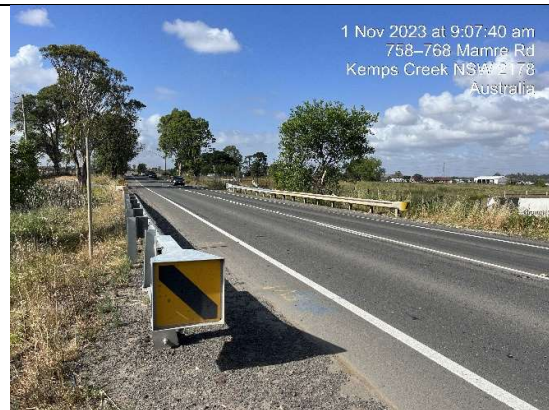
Photo 4.jpg

| Item | Description | Photo no. |
|---|---|---|
| 4.2.4 | North of site gate entry and photo taken facing south – Section of guardrail adjacent to northbound lane has been previously replaced. Road pavement and line marking in general condition. Median Raised Road Pavement Marker (RRPM) missing. | 4 |

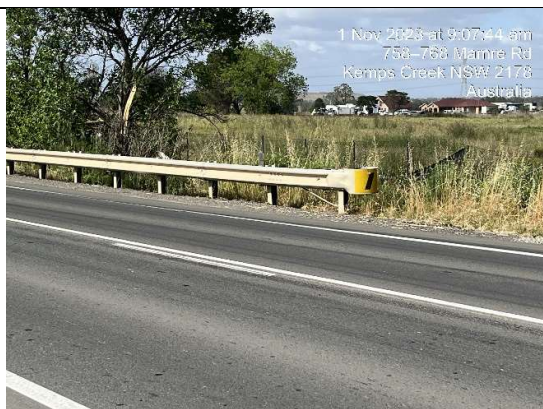
Photo 5.jpg

| Item | Description | Photo no. |
|---|---|---|
| 4.2.5 | North of site gate entry and photo taken facing south – Guardrail adjacent to northbound lane. | 5 |

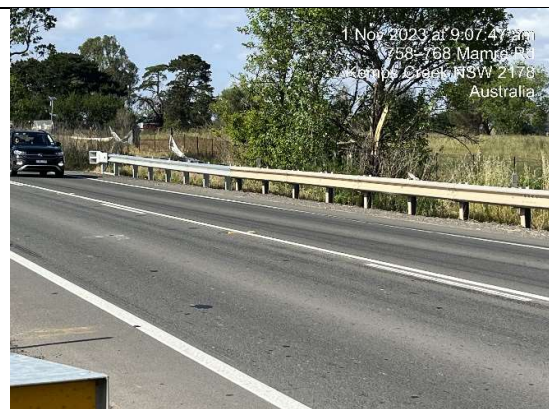
Photo 6.jpg

| Item | Description | Photo no. |
|---|---|---|
| 4.2.6 | North of site gate entry and photo taken facing south – Guardrail adjacent to northbound lane. Road pavement and line marking in general condition. | 6 |

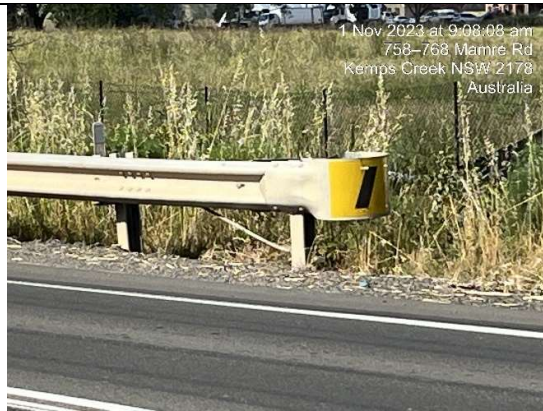
Photo 7.jpg

| Item | Description | Photo no. |
|---|---|---|
| 4.2.7 | North of site gate entry and photo taken facing south – Northern guardrail end terminal adjacent to northbound lane. | 7 |

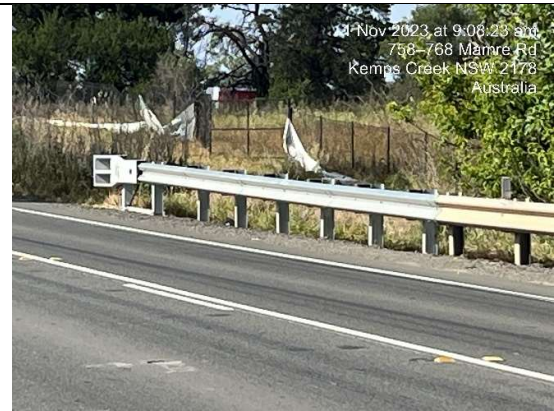
Photo 8.jpg

| Item | Description | Photo no. |
|---|---|---|
| 4.2.8 | North of site gate entry and photo taken facing south – Southern guardrail end terminal adjacent to northbound lane. | 8 |

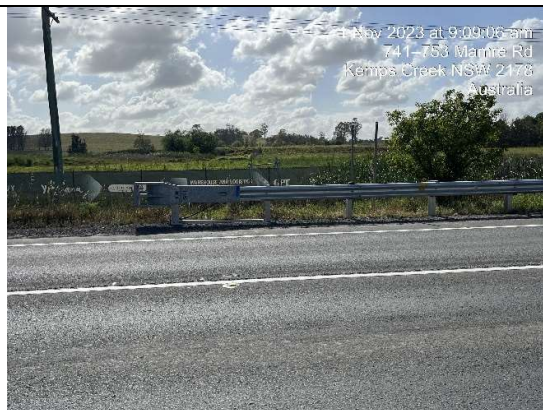
Photo 9.jpg

| Item | Description | Photo no. |
|---|---|---|
| 4.2.9 | North of site gate entry and photo taken facing south – Northern guardrail end terminal adjacent to southbound lane. | 9 |

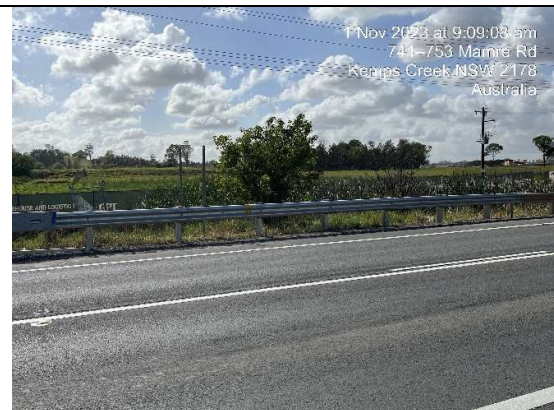
Photo 10.jpg

| Item | Description | Photo no. |
|---|---|---|
| 4.2.10 | North of site gate entry and photo taken facing south – Section of guardrail adjacent to southbound lane has been previously replaced. Also, damaged post at the guardrail connection between old and new. | 10 |

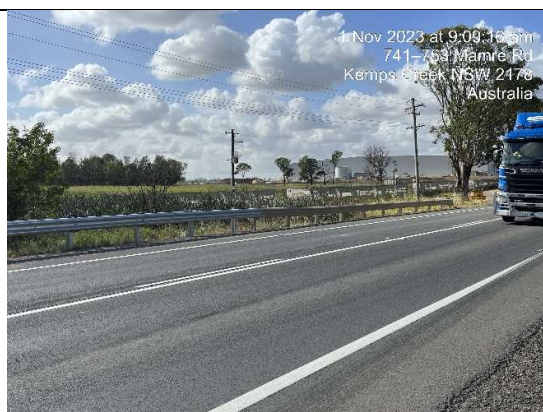
Photo 11.jpg

| Item | Description | Photo no. |
|---|---|---|
| 4.2.11 | North of site gate entry and photo taken facing south – Guardrail adjacent to southbound lane. | 11 |

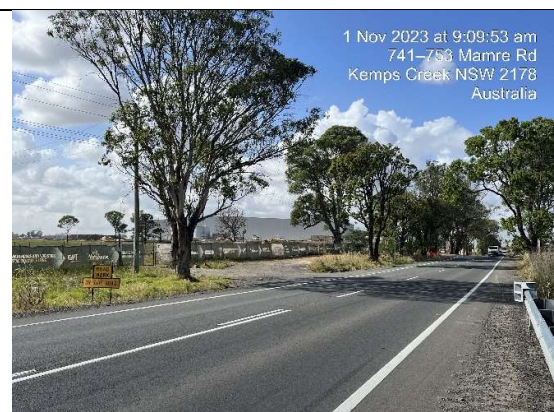
Photo 12.jpg

| Item | Description | Photo no. |
|---|---|---|
| 4.2.12 | North of site gate entry and photo taken facing south – Driveway between northbound lane and gate. | 12 |

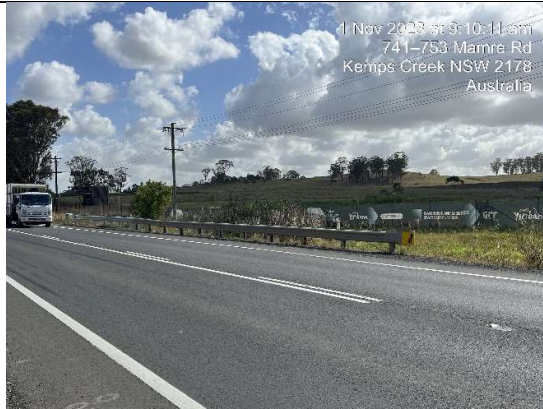
Photo 13.jpg

| Item | Description | Photo no. |
|---|---|---|
| 4.2.13 | North of site gate entry and photo taken facing north – Southern guardrail end terminal adjacent to southbound lane. | 13 |

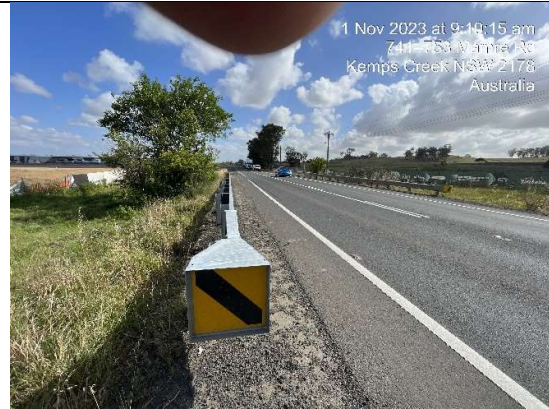
Photo 14.jpg

| 4.2.14 | North of site gate entry and photo taken facing north – Northern guardrail end terminal adjacent to northbound lane. Stripping of spray seal. | 14 |

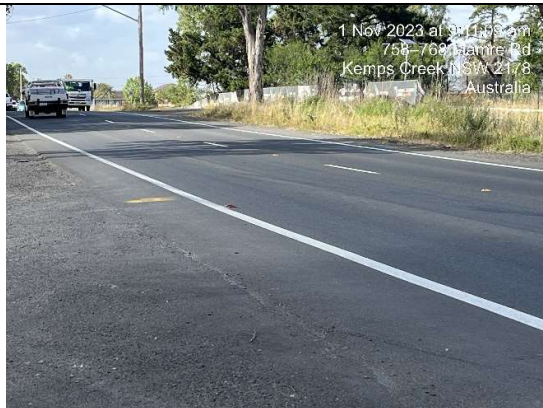
Photo 15.jpg

| 4.2.15 | North of site gate entry and photo taken facing south – Road pavement and line marking in general condition. | 15 |

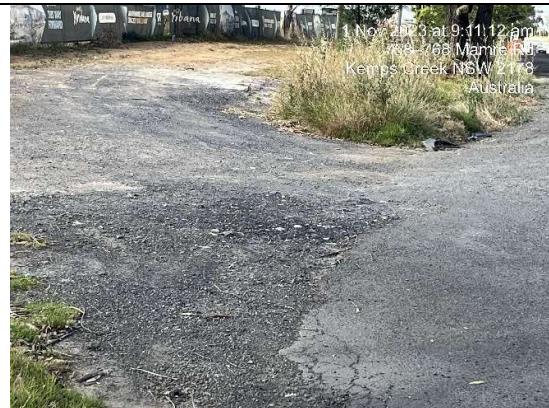
Photo 16.jpg

| 4.2.16 | North of site gate entry and photo taken facing south – Driveway pavement between southbound lane and gate in poor condition. No grass in verge. | 16 |

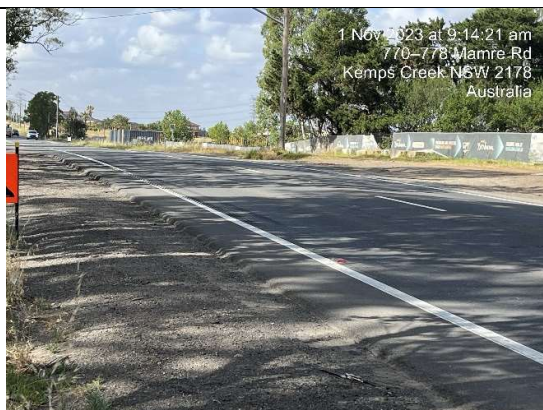
Photo 17.jpg

| 4.2.17 | North of site gate entry and photo taken facing south – Road pavement and line marking in general condition. | 17 |

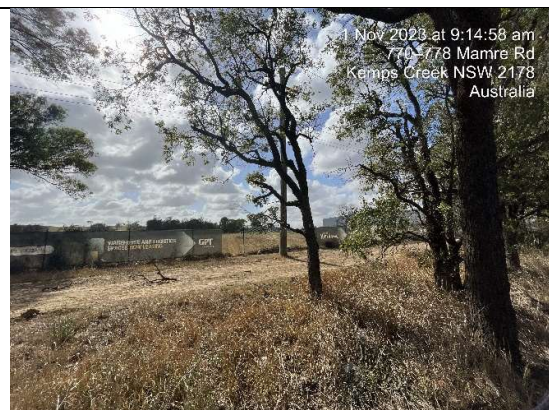
Photo 18.jpg

| 4.2.18 | North of site gate entry and photo taken facing south – No grass in verge adjacent to southbound lane. | 18 |

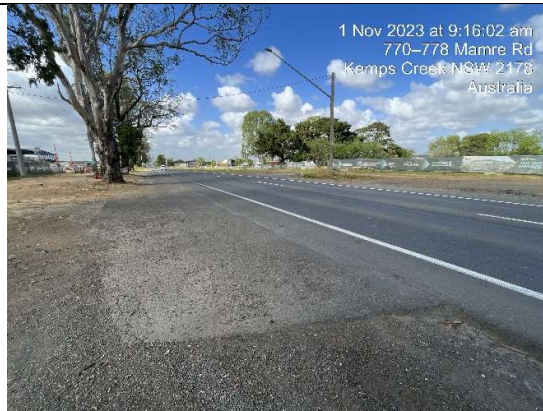
Photo 19.jpg

| 4.2.19 | North of site gate entry and photo taken facing south – Road pavement and line marking in general condition. | 19 |

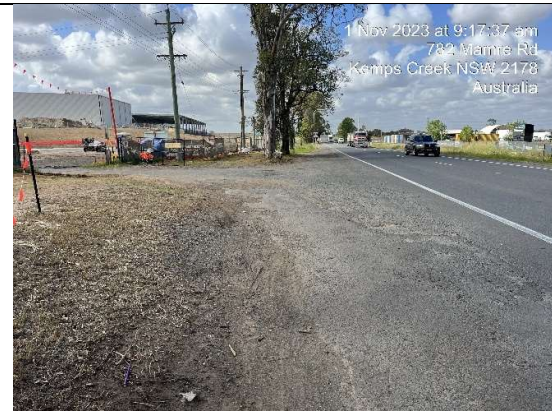
Photo 20.jpg

| 4.2.20 | North of site gate entry and photo taken facing south – Driveway pavement between southbound lane and gate in poor condition. No grass in verge. | 20 |

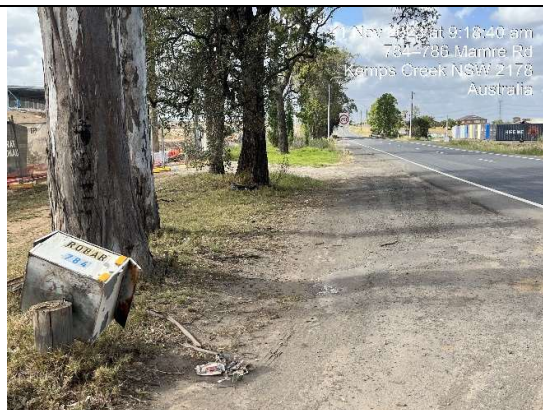
Photo 21.jpg

| 4.2.21 | South of site gate entry and photo taken facing south – Robar letter box fallen. Spray seal stripped in shoulder. Road pavement and line marking in general condition. | 21 |

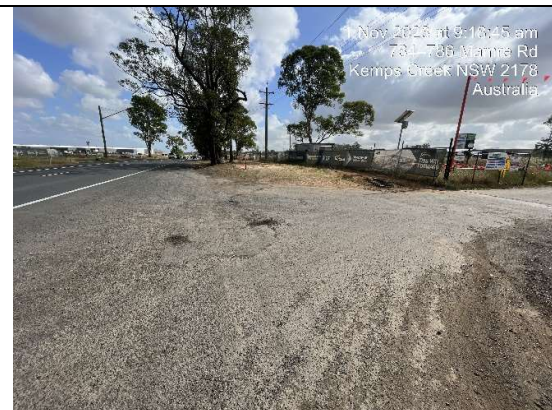
Photo 22.jpg

| 4.2.22 | South of site gate entry and photo taken facing south – Driveway pavement between southbound lane and gate in poor condition. No grass in verge. | 22 |

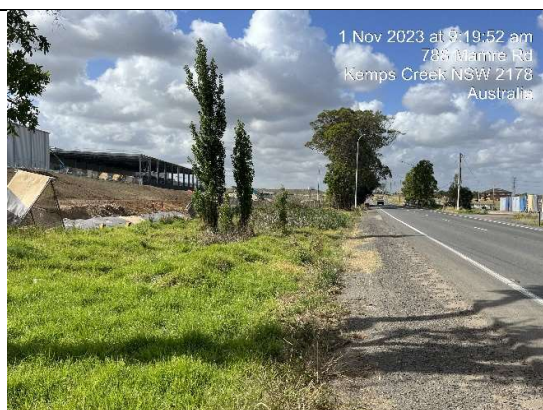
Photo 23.jpg

| 4.2.23 | South of site gate entry and photo taken facing south – Spray seal stripped in shoulder. | 23 |

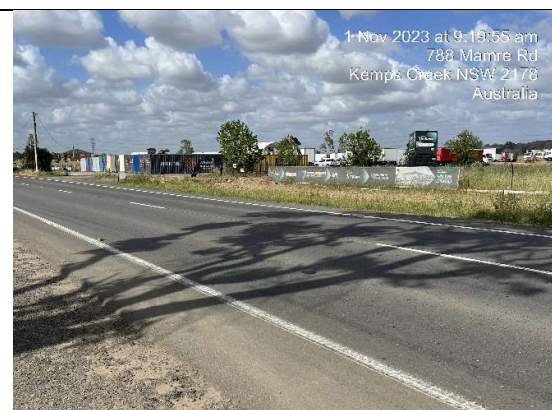
Photo 24.jpg

| 4.2.24 | South of site gate entry and photo taken facing south – Road pavement and line marking in general condition. | 24 |

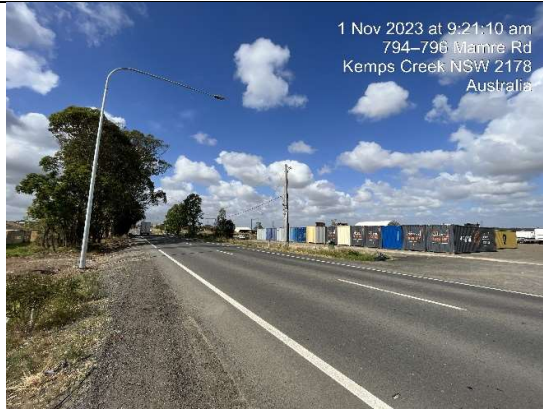
Photo 25.jpg

| 4.2.25 | South of site gate entry and photo taken facing south – Road pavement and line marking in general condition. | 25 |

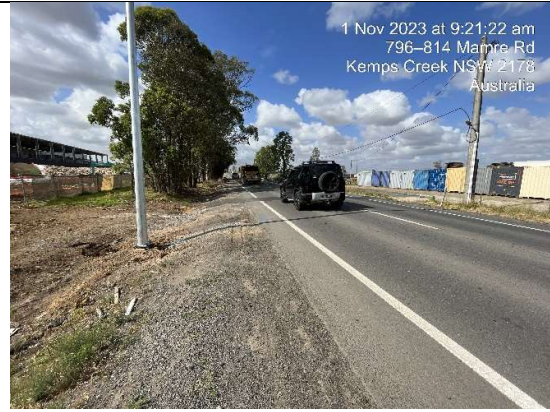
Photo 26.jpg

| 4.2.26 | South of site gate entry and photo taken facing south – Trench through existing road pavement. | 26 |

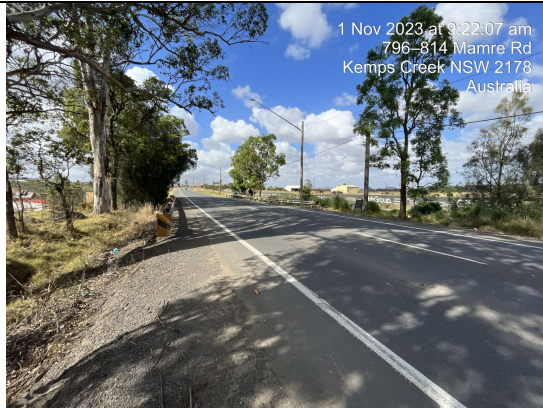
Photo 27.jpg

| 4.2.27 | South of site gate entry and photo taken facing south – Guardrail adjacent to southbound and northbound lanes. | 27 |

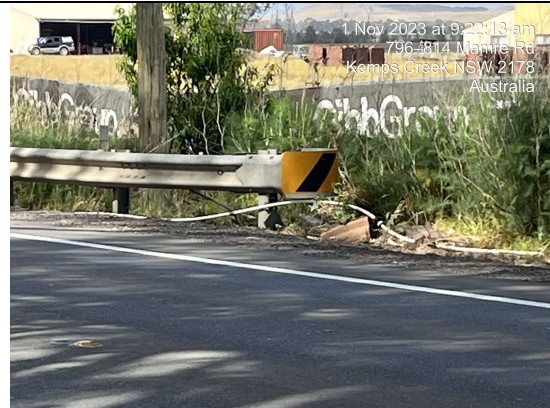
Photo 28.jpg

| 4.2.28 | South of site gate entry and photo taken facing south – Northern guardrail end terminal adjacent to northbound lane. | 28 |

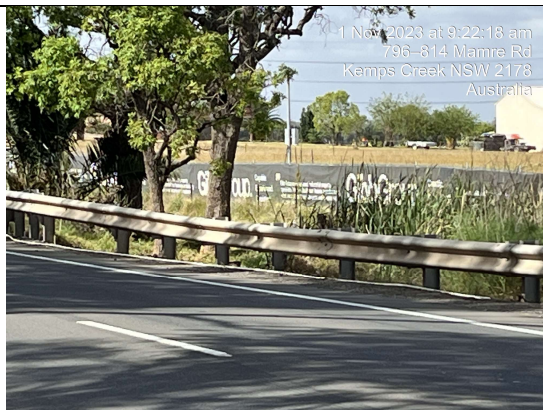
Photo 29.jpg

| 4.2.29 | South of site gate entry and photo taken facing south – Guardrail adjacent to northbound lane. | 29 |

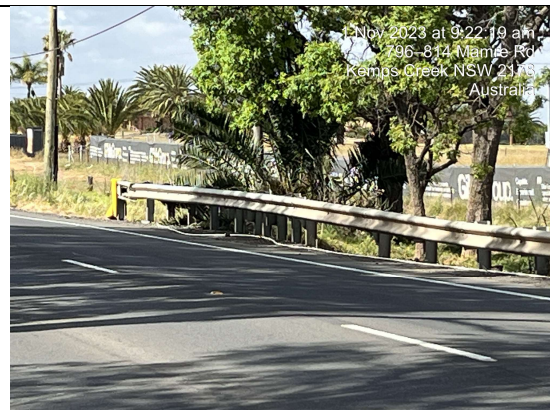
Photo 30.jpg

| 4.2.30 | South of site gate entry and photo taken facing south – Southern end terminal guardrail adjacent to northbound lane. | 30 |

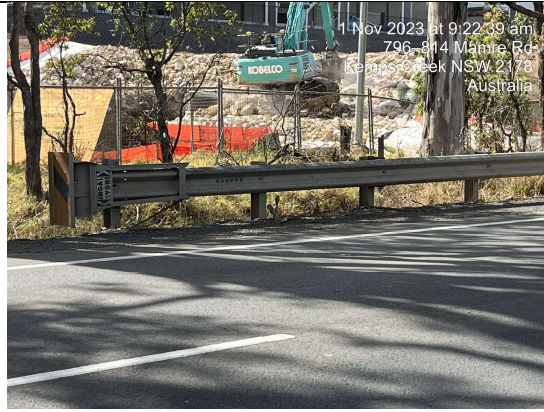
Photo 31.jpg

| 4.2.31 | South of site gate entry and photo taken facing south – Northern guardrail end terminal adjacent to southbound lane. | 31 |

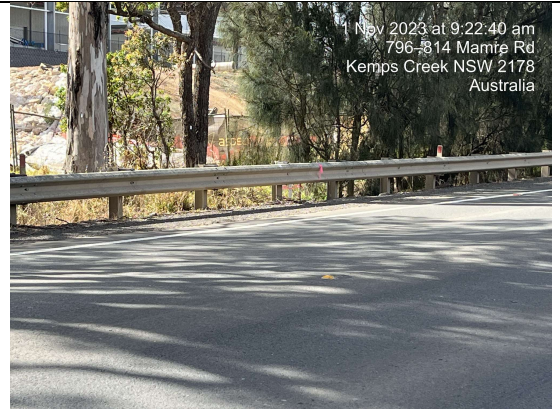
Photo 32.jpg

| 4.2.32 | South of site gate entry and photo taken facing south – Guardrail adjacent to southbound lane. | 32 |

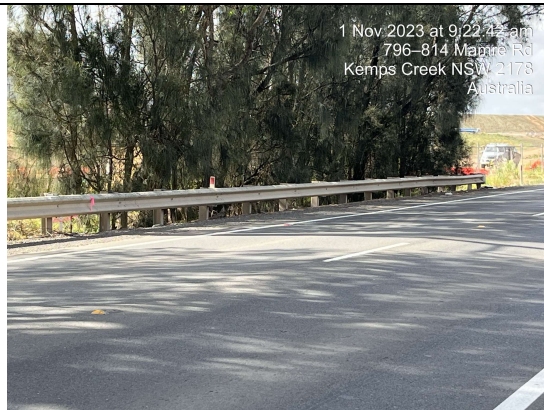
Photo 33.jpg

| 4.2.33 | South of site gate entry and photo taken facing south – Guardrail adjacent to southbound lane. | 33 |

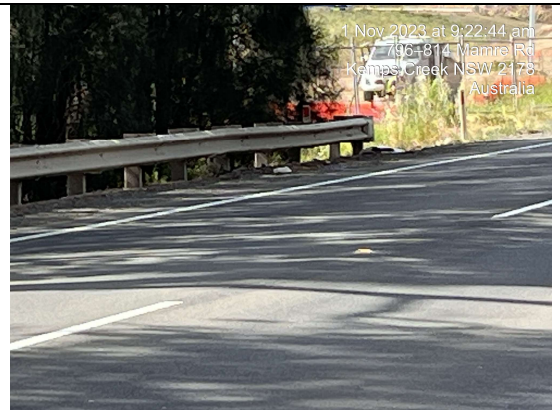
Photo 34.jpg

| 4.2.34 | South of site gate entry and photo taken facing south – Southern guardrail end terminal adjacent to southbound lane. | 34 |

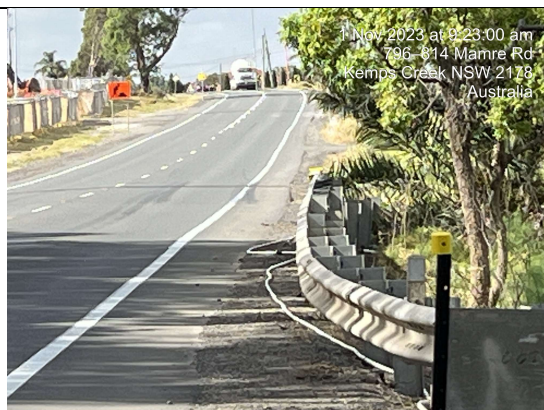
Photo 35.jpg

| 4.2.35 | South of site gate entry and photo taken facing south – Southern guardrail end terminal adjacent to northbound lane. | 35 |

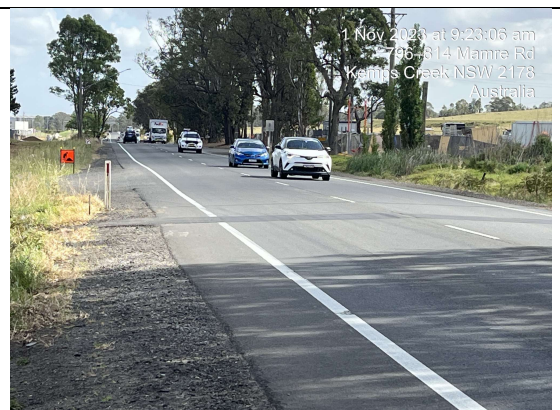
Photo 36.jpg

| 4.2.36 | South of site gate entry and photo taken facing north – Trench through exiting road pavement. | 36 |

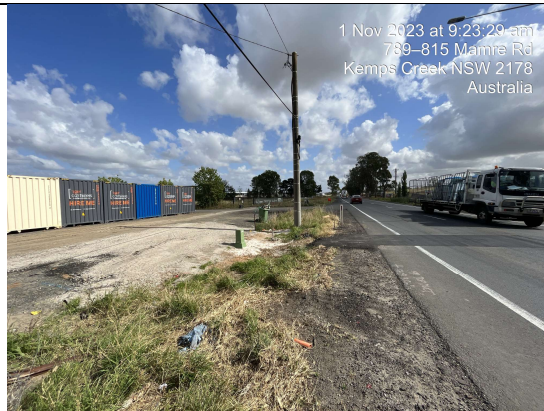
Photo 37.jpg

| 4.2.37 | South of site gate entry and photo taken facing north – Shoulder and verge adjacent to northbound lane. Trench through exiting road pavement. | 37 |

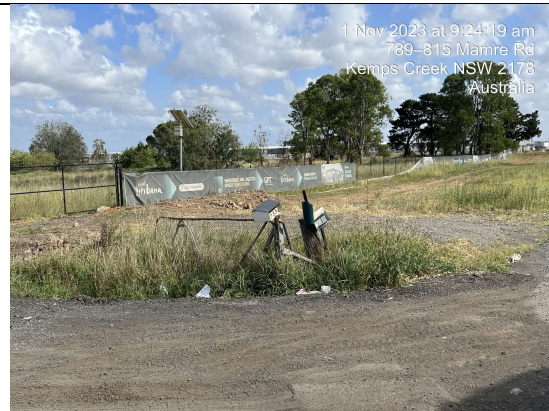
Photo 38.jpg

| 4.2.38 | South of site gate entry and photo taken facing north – Driveway pavement off northbound lane in poor condition and gate damaged. | 38 |

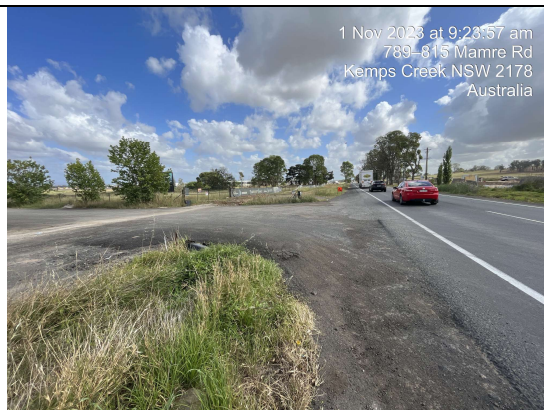
Photo 39.jpg

| 4.2.39 | South of site gate entry and photo taken facing north – Driveway pavement off northbound lane in poor condition. | 39 |
