# Arboricultural Impact Assessment

**St Luke's Grammar School – New Senior Campus  
Midson Group  
800 Pittwater Road  
Dee Why NSW 2099**

**1 November 2019**

**Arboricultural Impact Assessment for sixty-two (62) trees located within the vicinity of the proposed redevelopment of 800 Pittwater Road, Dee Why and 224 Headland Rd, North Curl Curl**

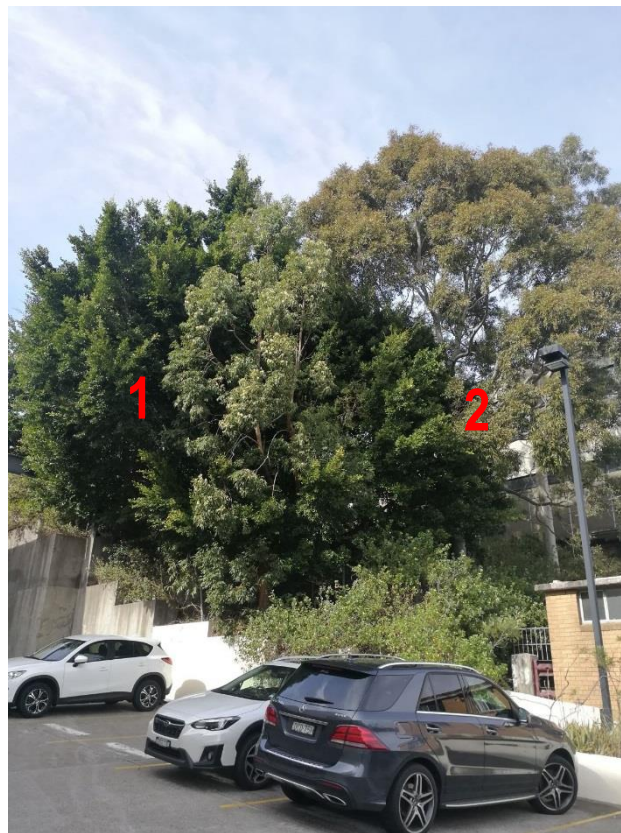
- 5.7.3 Tree 1 is a *Ficus microcarpa* var. *hillii* (Hill's Weeping Fig). The tree is a prominent local feature in an otherwise heavily urbanised landscape and provides screening to and from 800 Pittwater Road and is shown in Figure 7.

- 5.7.6 Tree 2 is a *Corymbia maculata* (Spotted Gum). The tree is a prominent local feature in an otherwise heavily urbanised landscape and provides screening to and from 800 Pittwater Road and is shown in Figure 7.

- 5.7.7 Tree 2 is of good health and structure and has a life expectancy of >50 years.
- 5.7.8 The TPZ for Tree 2 is 4.8m measured at a radial distance from the centre of the trunk.

Figure 7. View to south-east of Tree 1 (Hill's Weeping Fig) and 2 (Spotted Gum) in their growing environment as shown by red numbering. (Kane Hollstein, 26 July 2019).

- 7.2.1 Two (2) trees, numbered 1 and 2 are recommended for retention and require specific protection measures during construction to ensure they remain viable following the completion of works pending whether the existing retaining wall to the south of the site can be retained *in-situ*. It is recommended the retaining wall is maintained to minimise the potential for root disturbance and further encroachment in these TPZ's.

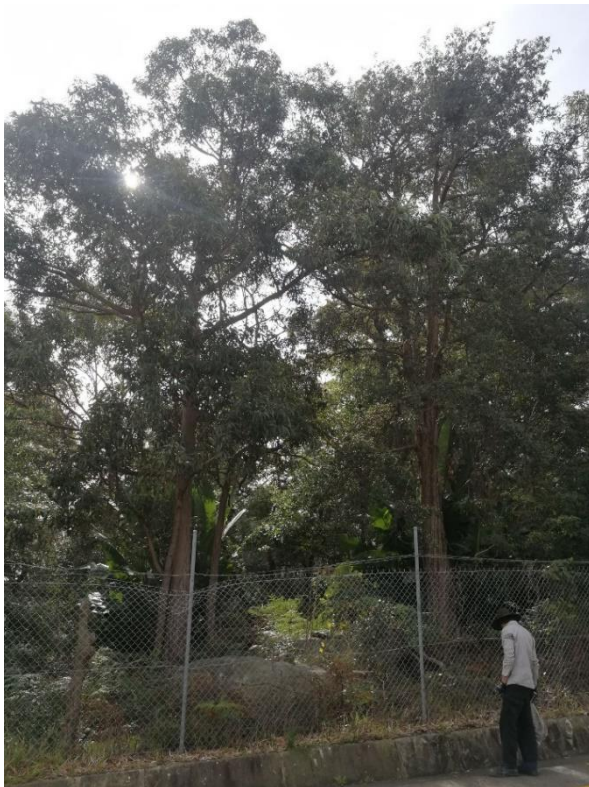
- 5.8.3 Tree 19 is a *Eucalyptus acmenoides* (White Mahogany) and Tree 20 a *Syncarpia glomulifera* (Turpentine) located to the north of the site shown in Figure 9.
- 5.8.4 Tree 19 is of moderate size and in good health and structure with an estimated life expectancy of >50 years.
- 5.8.5 Tree 20 is of moderate size and in good health with fair structure and an estimated life expectancy of 25–50 years.
- 5.8.6 Both trees have been downgraded from Category A due to small dimensions and lack of visual prominence.
- 5.8.7 The TPZ for Tree 19 is 4.1m measured at a radial distance from the centre trunk.
- 5.8.8 The TPZ for Tree 20 is 6.5m measured at a radial distance from the centre trunk.
- 5.8.9 However, root growth and development have likely been influence by hard surfaces to the south. It is expected the volume of significant roots south of the fence line would be limited.

Figure 9. View to north of Tree 19 (left) (White Mahogany) and Tree 20 (right) (Turpentine) in their growing environment. (Kane Hollstein, 26 July 2019).

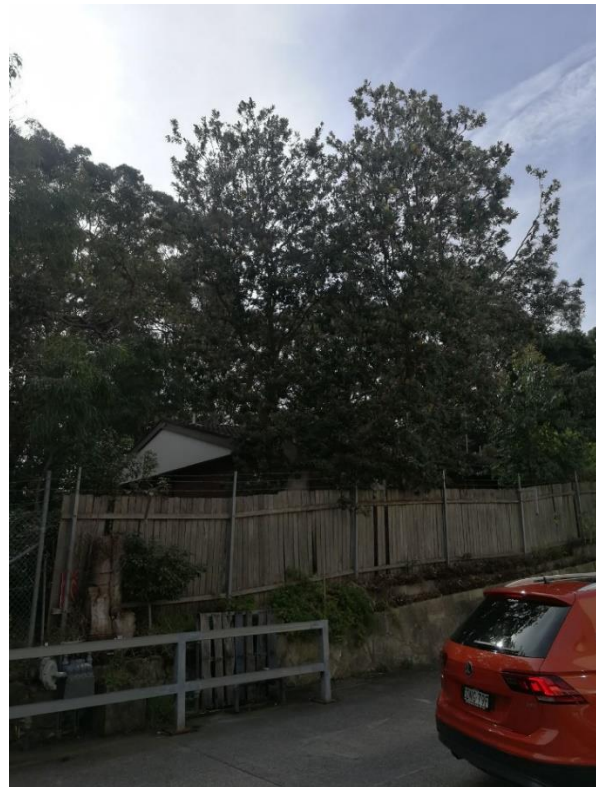
Figure 10. View to north of Tree 22 (Coast Banksia) in its growing environment. (Kane Hollstein, 26 July 2019).

- 5.8.10 Tree 22 is a *Banksia integrifolia* (Coast Banksia) tree located north of the site within Stony Range Botanic Gardens as shown in Figure 10. The tree is of good health and fair structure with an estimated life expectancy of 15–25 years.
- 5.8.11 The TPZ for Tree 22 is 4.2m measured at a radial distance from the centre trunk. However, root growth and development have likely been influence by hard surfaces and a retaining wall to the south. It is expected the volume of significant roots south of the fence line would be limited.

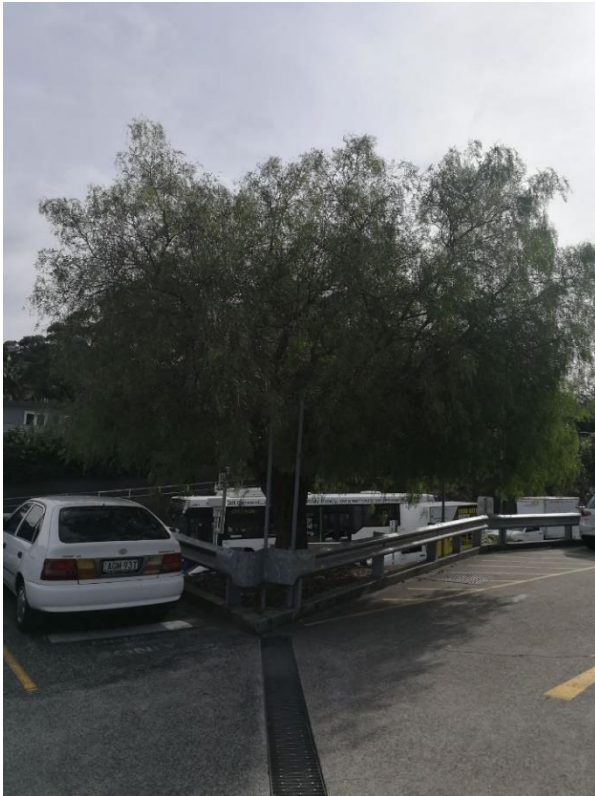
- 5.9.3 Tree 11 is a *Schinus areira* (Peppercorn) tree located along the western frontage of Pittwater Road as shown in Figure 12. The tree is in a visually prominent location and provides low to moderate amenity and screening. It has been downgraded from a Category B due to past poor pruning (lopping) practices (Standards Australia, 2007) which have resulted in a form not true to type and an estimated life expectancy of 10-15 years.

- 5.9.4 The TPZ for Tree 11 is 6.7m measured at a radial distance from the centre trunk.
- 5.9.5 Tree 33 is a *Banksia serrata* (Saw-toothed Banksia) tree located along the eastern property boundary within Stony Range Botanic Garden and is shown in Figure 13. The tree is an endemic species but possesses a highly asymmetrical crown towards 800 Pittwater Road due to phototropism. The tree has no visual prominence but may provide a forage source for local fauna.

Figure 12. View to west of Tree 11 (Peppercorn) in its growing environment. (Kane Hollstein, 26 July 2019).

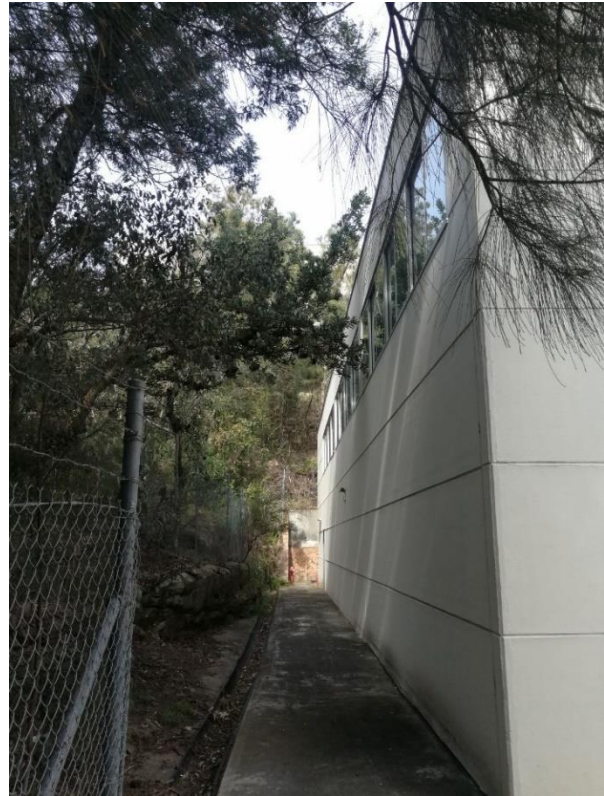
- 5.9.6 The TPZ for Tree 33 is 3.8m measured at a radial distance from the centre trunk. However, root growth and development have likely been influence by a natural sandstone shelf and hard surfaces to the west. It is expected the volume of significant roots west of this would be limited.

Figure 13. View to south of Tree 33 (Saw-toothed Banksia) in its growing environment. (Kane Hollstein, 26 July 2019).

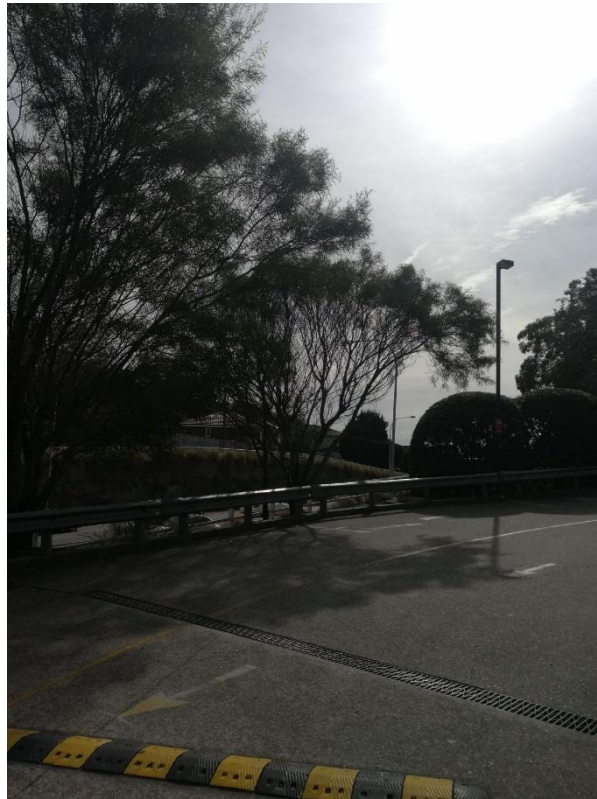
- 5.10.3 Trees 13–18 are *Acacia saligna* (Golden Wreath Wattle) located in the north-western corner of the site along the Pittwater Road frontage. These trees are listed as an exempt species in the Warringah Development Control Plan (DCP), 2011, are naturally short lived and are all either dead or in decline.

Figure 15. View to north of Trees 17 and 18 (Golden Wreath Wattle) in their growing environment. (Kane Hollstein, 26 July 2019).
