Asbestos Survey 2016

224 Headland Road
Dee Why NSW 2099

Strata Plan 45082

INSPECTION SUMMARY REPORT

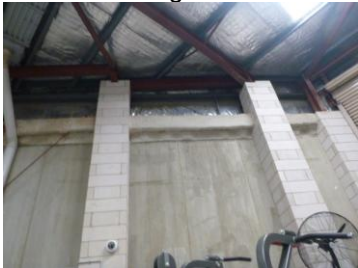
Photo	Location	Asbestos Item and Description	Condition	Work in adjacent areas	Current Controls	Risk Level	Control Measure	Sample
				What work is likely to be conducted in the adjacent areas?	What controls are currently in place (including labeling)?		- Elimination - Substitution - Engineering/Isolation - Administrative - Behaviour - PPE	
Photo 1: Structural beam coating Unit 1

Internal Inspection	Item: Fire-retardant material on supporting steel work No asbestos containing materials (ACM) identified.						Asbestos Sample 1 - NAD, ORF - 11/2016
Photo 2: Main electrical switch room ceiling sheet

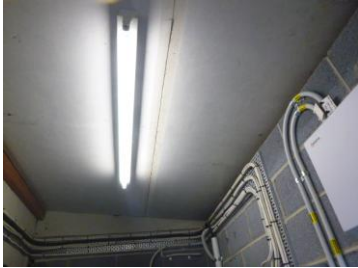
Common Property	Item: Asbestos cement sheeting No asbestos containing materials (ACM) identified.						Asbestos Sample 2 - NAD, ORF - 11/2016

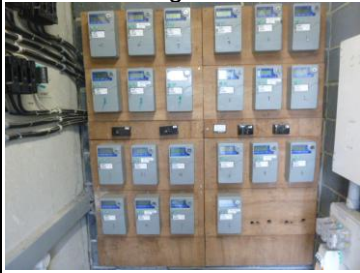
Photo	Location	Asbestos Item and Description	Condition	Work in adjacent areas	Current Controls	Risk Level	Control Measure	Sample
<p>Photo 3: Electrical meter backing boards</p>

<p>Common Property</p>	<p>No asbestos containing materials (ACM) identified.</p>						
<p>Photo 4: Electrical meter and fuse backing boards</p>

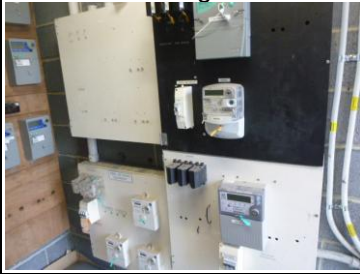
<p>Common Property</p>	<p>No asbestos containing materials (ACM) identified.</p>						
<p>Photo 5: External wall finishes</p>

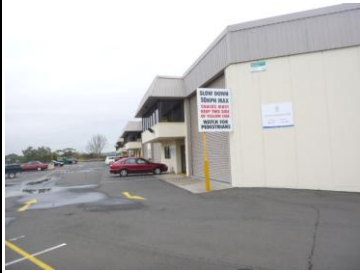
<p>Common Property</p>	<p>No asbestos containing materials (ACM) identified.</p>

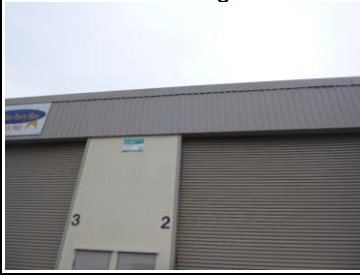
Photo	Location	Asbestos Item and Description	Condition	Work in adjacent areas	Current Controls	Risk Level	Control Measure	Sample
<p>Photo 6: External roof / wall cladding</p>

<p>Common Property</p>	<p>No asbestos containing materials (ACM) identified.</p>						
<p>Photo 7: External wall finishes</p>

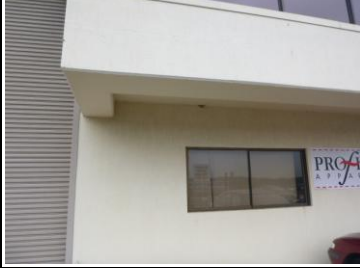
<p>Common Property</p>	<p>No asbestos containing materials (ACM) identified.</p>						
<p>Photo 8: External underside of mezzanine floor</p>

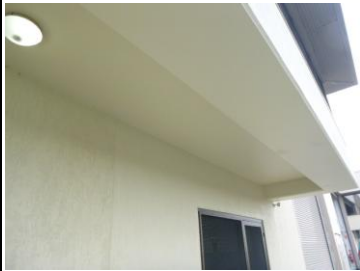
<p>Common Property</p>	<p>No asbestos containing materials (ACM) identified.</p>

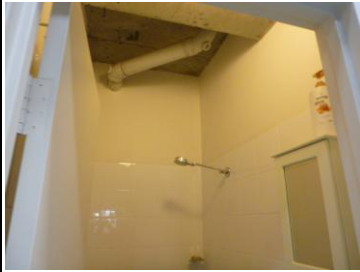
Photo	Location	Asbestos Item and Description	Condition	Work in adjacent areas	Current Controls	Risk Level	Control Measure	Sample
<p>Photo 9: Unit 1 common shower</p>

<p>Internal Inspection</p>	<p>No asbestos containing materials (ACM) identified.</p>						
<p>Photo 10: Unit 1 common toilet</p>

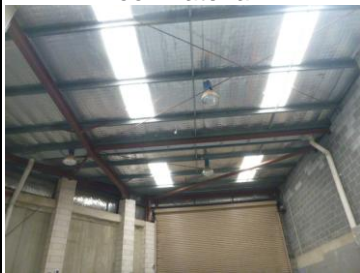
<p>Internal Inspection</p>	<p>No asbestos containing materials (ACM) identified.</p>						
<p>Photo 11: Unit 1 underside of roof material</p>

<p>Internal Inspection</p>	<p>No asbestos containing materials (ACM) identified.</p>

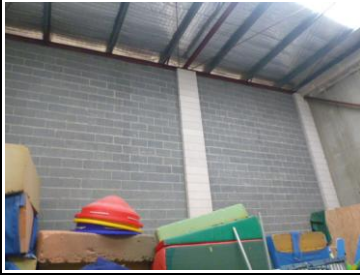
Photo	Location	Asbestos Item and Description	Condition	Work in adjacent areas	Current Controls	Risk Level	Control Measure	Sample
<p>Photo 12: Unit 1 internal wall finishes</p>

Internal Inspection	No asbestos containing materials (ACM) identified.						
<p>Photo 13: Unit 1 upper level shop ceilings</p>

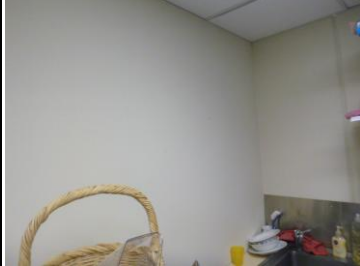
Internal Inspection	No asbestos containing materials (ACM) identified.						
<p>Photo 14: Unit 1 upper level shop partition walls</p>

Internal Inspection	No asbestos containing materials (ACM) identified.

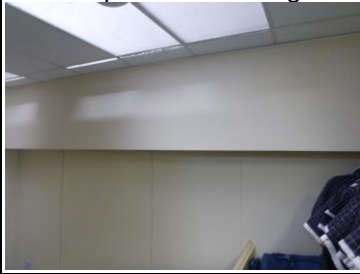
Photo	Location	Asbestos Item and Description	Condition	Work in adjacent areas	Current Controls	Risk Level	Control Measure	Sample
<p>Photo 15: Unit 1 upper level shop beam covering</p>

<p>Internal Inspection</p>	<p>No asbestos containing materials (ACM) identified.</p>						
<p>Photo 16: Unit 1 upper level shop toilet</p>

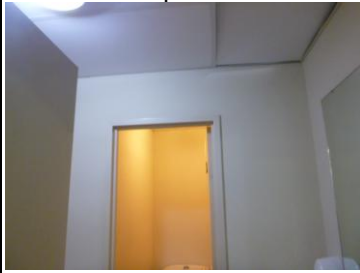
<p>Internal Inspection</p>	<p>No asbestos containing materials (ACM) identified.</p>
