# *Asbestos Register and Management Plan*

**800 Pittwater Road  
Dee Why  
New South Wales**

Asbestos Register and Management Plan  
800 Pittwater Road, Dee Why, NSW  
St Luke's Grammar School  
6 October 2015

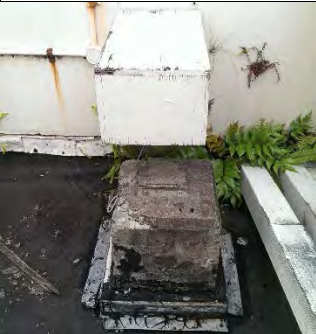
<b>DUE September 2020</b>  NAME  DATE  NOTE
2	Chrysotile Asbestos  Black bituminous sealant  Clock Tower roof top area Material around concrete pillar on the floor	No	Poor	Low	Ensure labelled as containing asbestos.  Manage in accordance with NSW WorkCover (2011) – Code of Practice – <i>How to Manage and Control Asbestos in the Workplace</i> .  Consider licensed asbestos removal contractor to remove material in accordance with NSW WorkCover (2011) – Code of Practice – <i>How to Safely Remove Asbestos</i> if maintenance or refurbishment works will disturb.  Re-inspect within 5 years or prior if the material is removed, disturbed, sealed or enclosed

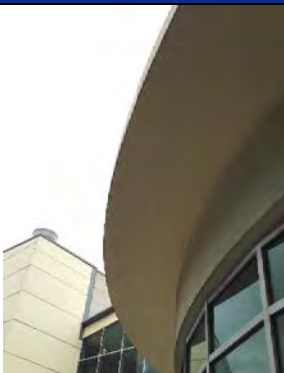
Item No.	Description	Friable	Condition	Risk	Management/Removal	Photograph 1	Photograph 2	Reinspection Notes
3	Potential Asbestos  Fibre Cement Sheet  Soffits within eaves around the curved heritage part of the building  Fitness First tenancy	No	Poor	Low	Repairs to parts of the eave structure are required. If disturbance is planned engage environmental consultant to sample and confirm the presence/absence of asbestos within the identified material.  In interim ensure labelled as containing asbestos.  Manage in accordance with NSW WorkCover (2011) – Code of Practice – <i>How to Manage and Control Asbestos in the Workplace</i> .  Consider licensed asbestos removal contractor to remove material in accordance with NSW WorkCover (2011) – Code of Practice – <i>How to Safely Remove Asbestos</i> if maintenance or refurbishment works will disturb.  Re-inspect within 5 years or prior if the material is removed, disturbed, sealed or enclosed

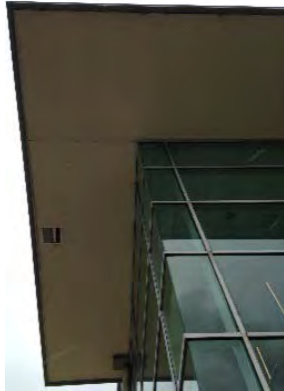
4	Potential Asbestos  Fibre Cement Sheet  Soffits within eaves around the building facade	No	Good	Low	Ensure labelled as containing asbestos. If disturbance is planned engage environmental consultant to sample and confirm the presence/absence of asbestos within the identified material.  Manage in accordance with NSW WorkCover (2011) – Code of Practice – <i>How to Manage and Control Asbestos in the Workplace</i> .  Consider licensed asbestos removal contractor to remove material in accordance with NSW WorkCover (2011) – Code of Practice – <i>How to Safely Remove Asbestos</i> if maintenance or refurbishment works will disturb.  Re-inspect within 5 years or prior if the material is removed, disturbed, sealed or enclosed
