## PRE CONSTRUCTION CONDITION SURVEY

Fort Street Public School, Millers Point NSW

Upper Fort Street Public School  
MILLERS POINT NSW 2000

19 January 2021

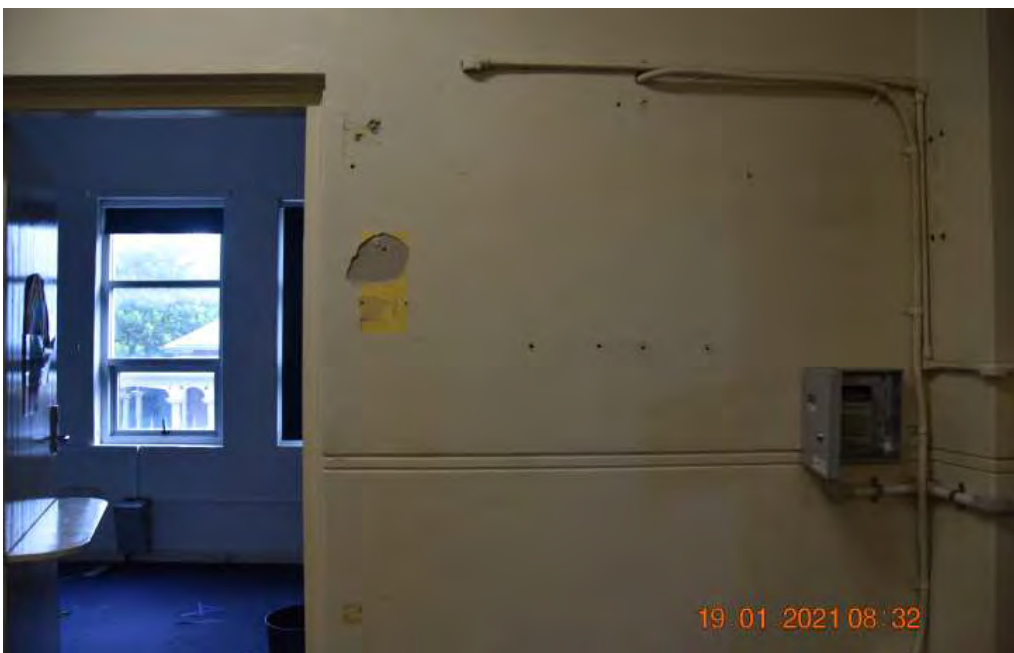
Figure: 0014

South wall in the entrance lobby. Showing nailing marks and damage.

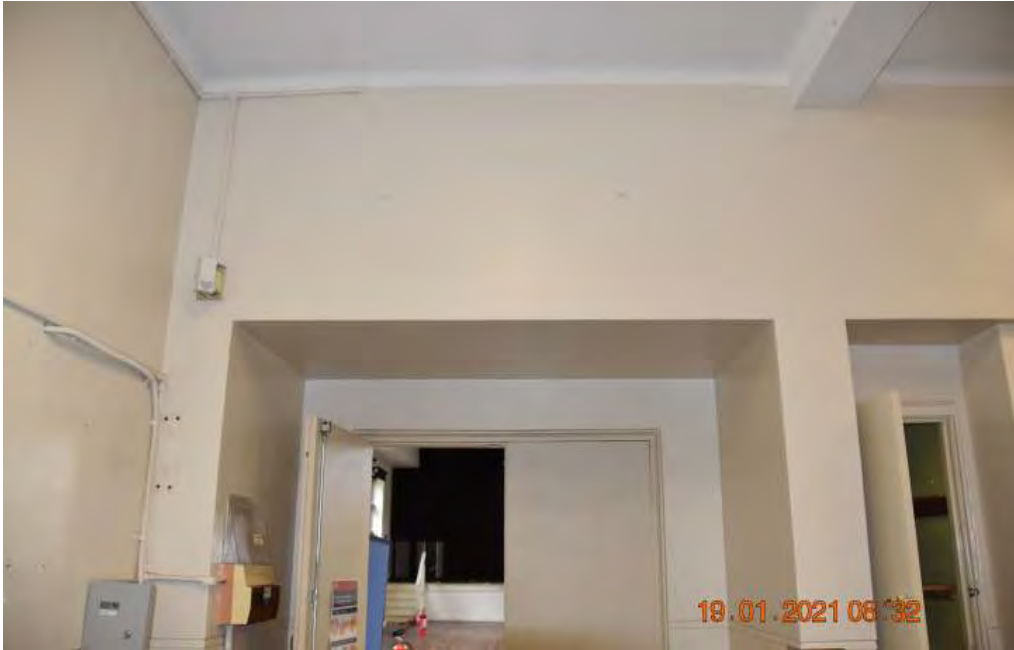
Figure: 0015

South wall in the entrance lobby. Showing nailing marks and damage.

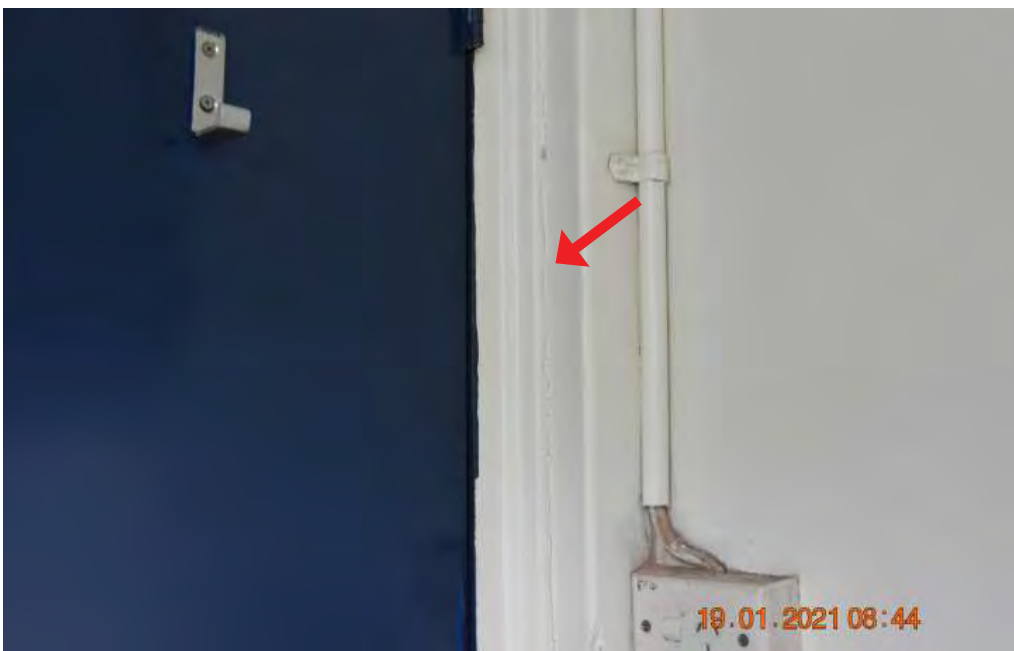
Figure: 0092

Chipping above the door in the east wall in the auditorium kitchenette. Also showing cracking.

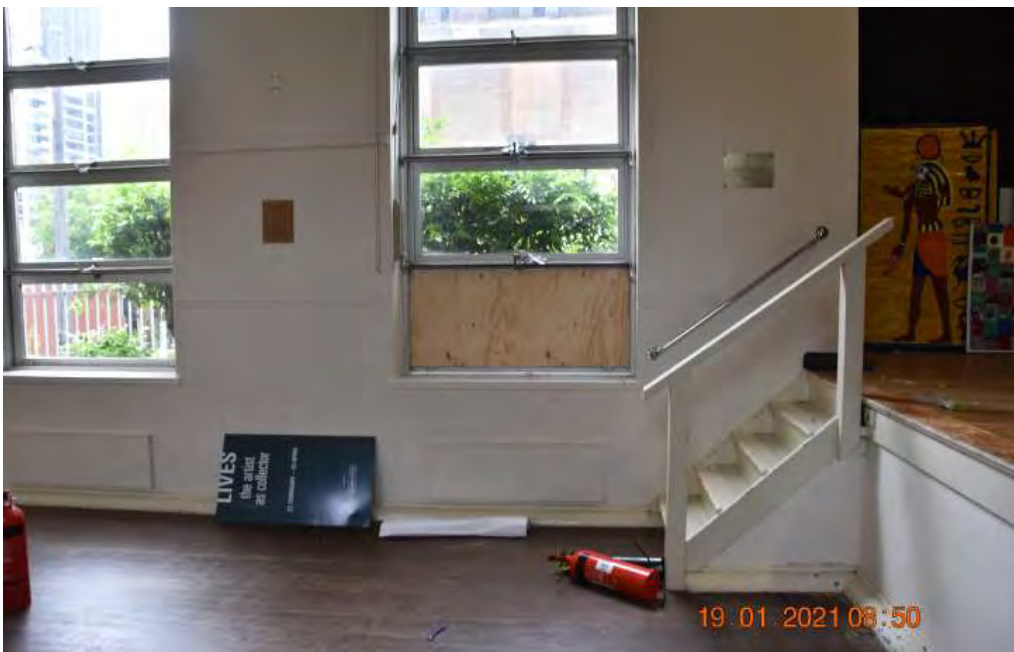
Figure: 0121

South wall in the auditorium. Showing cracking.

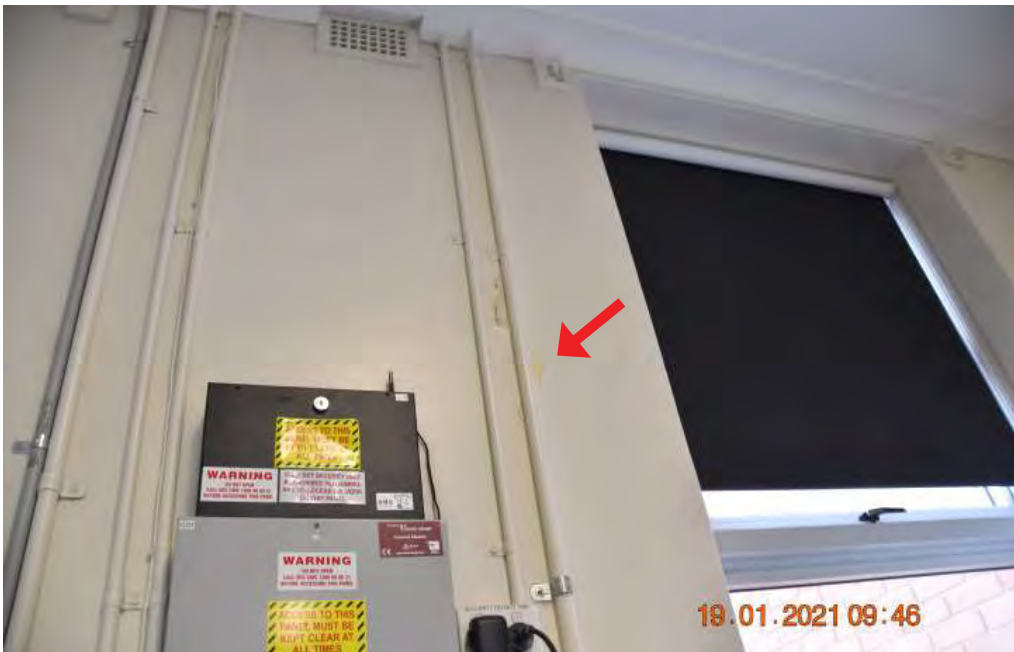
Figure: 0448

Fine cracking in the east wall in the citrine classroom.

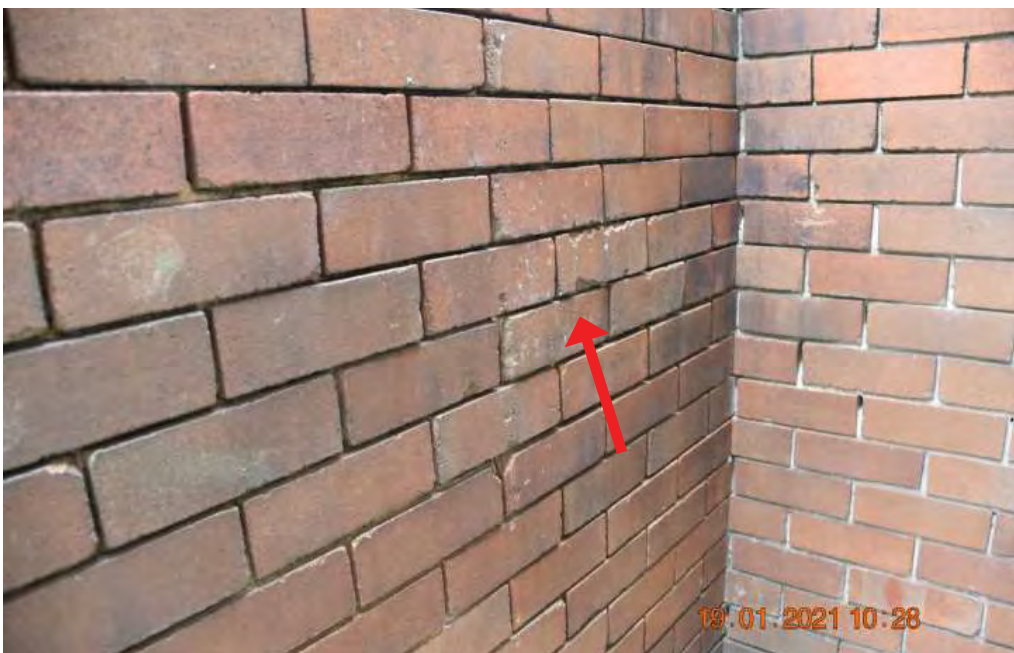
Figure: 0713

Wide cracking in the wall on the north side of room 14.

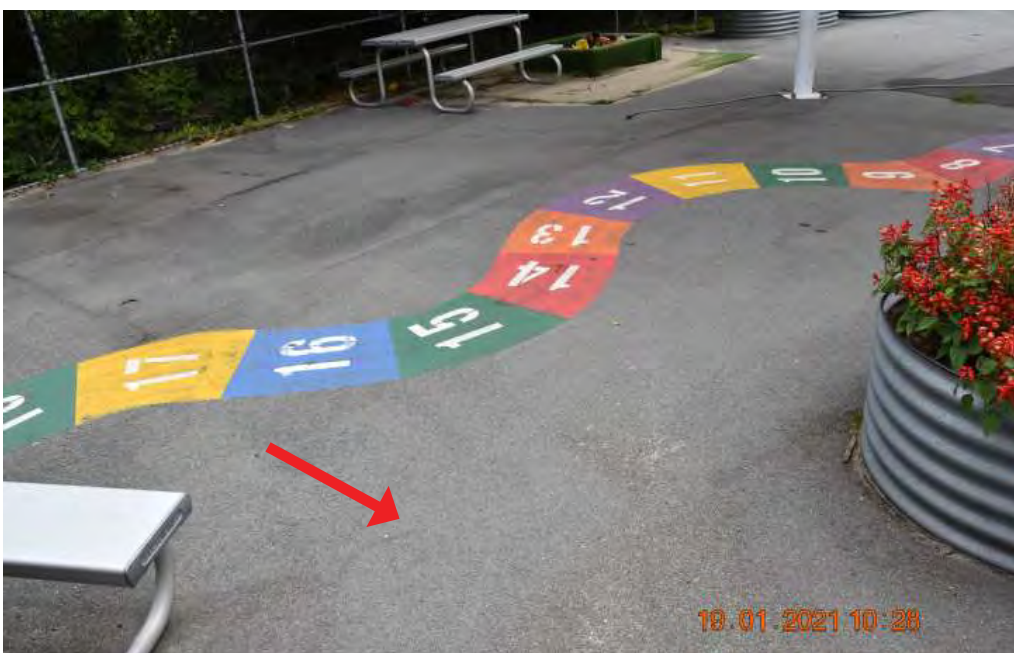
Figure: 0716

Cracking in the paving on the north side of room 14.

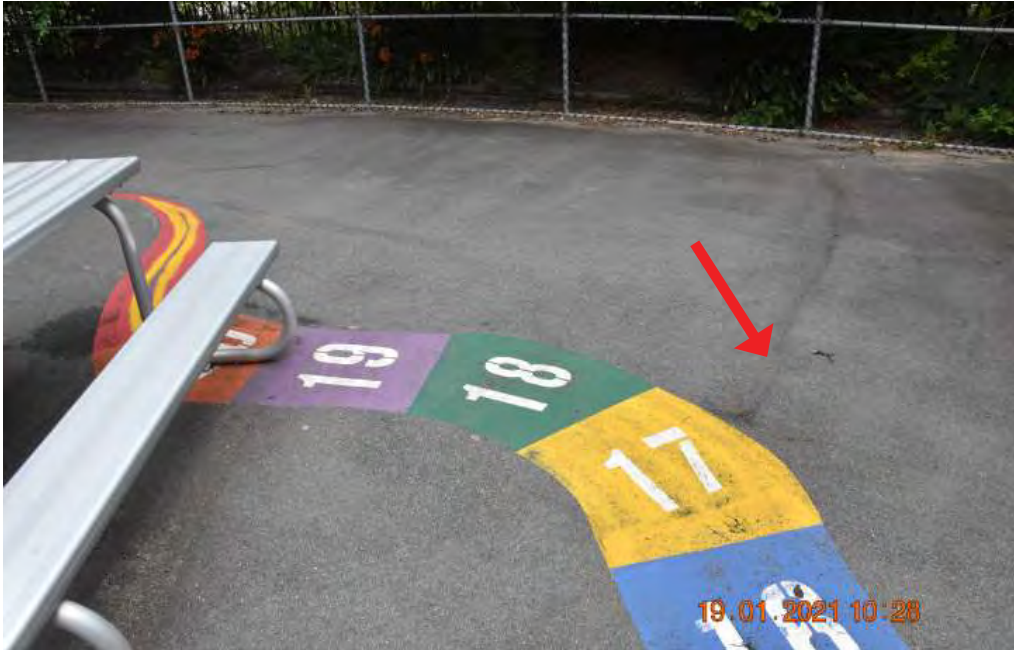
Figure: 0717

Cracking in the paving on the north side of room 14.

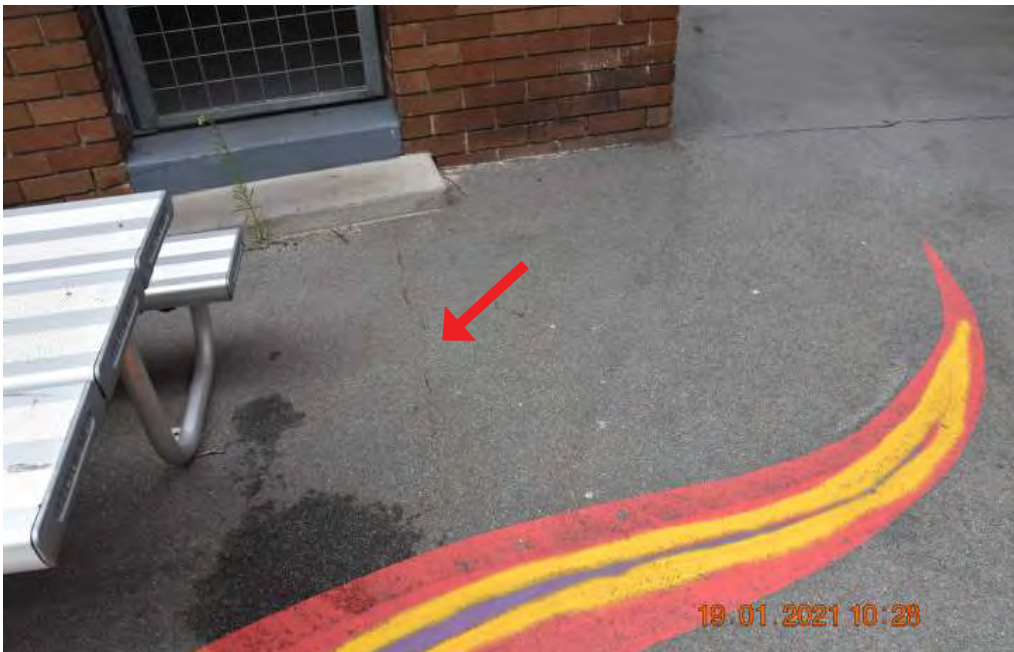
Figure: 0718

Cracking in the paving on the north side of room 14.

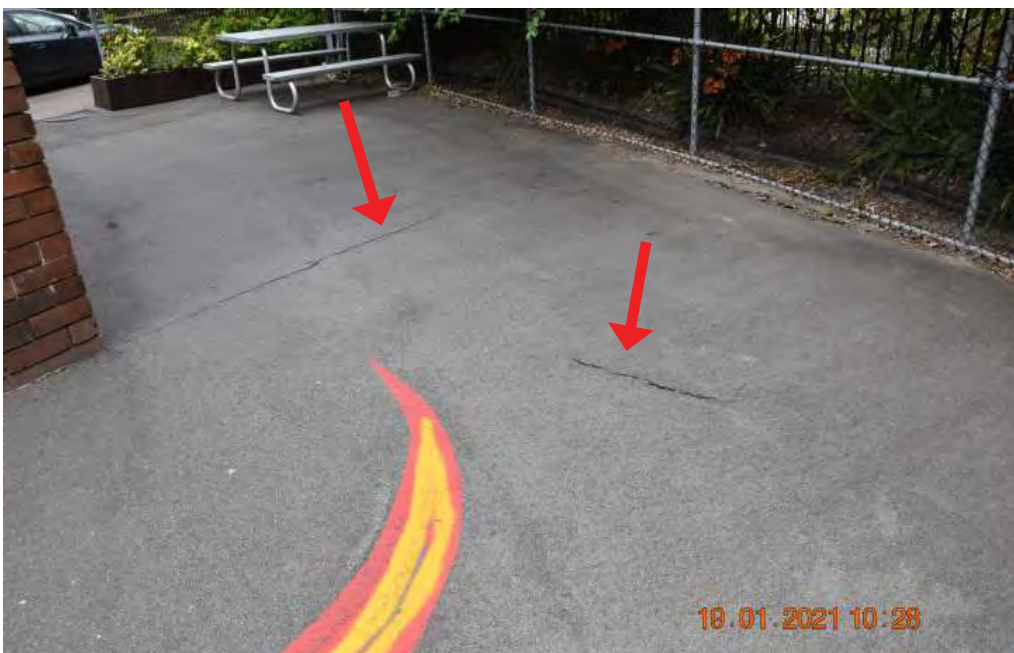
Figure: 0719

Cracking in the paving on the north side of room 15.

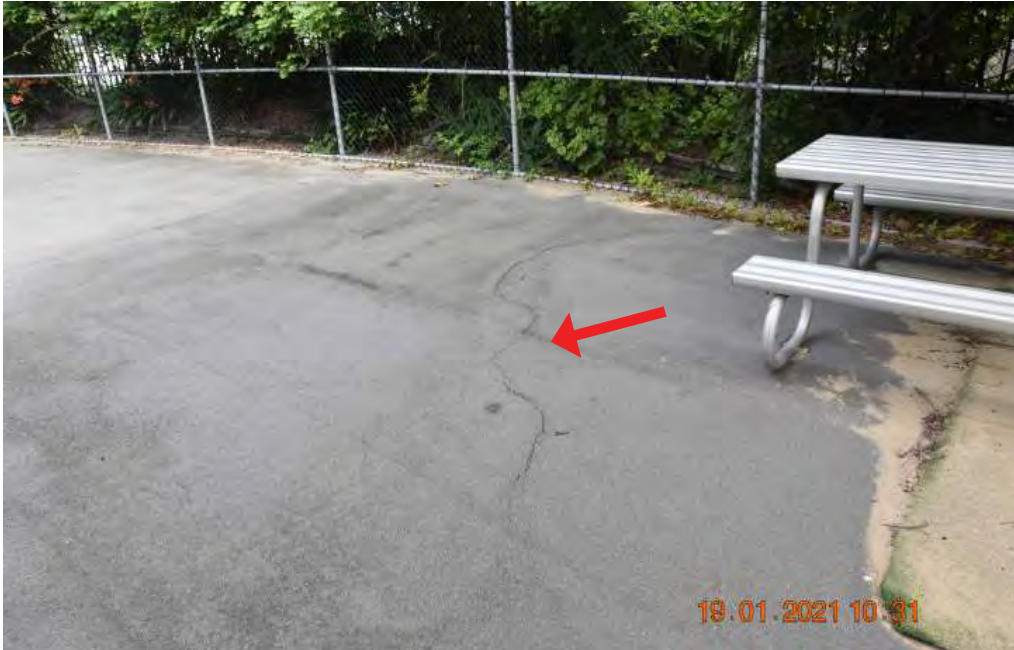
Figure: 0741

General view of the paving on the north side of building A. Showing cracking.

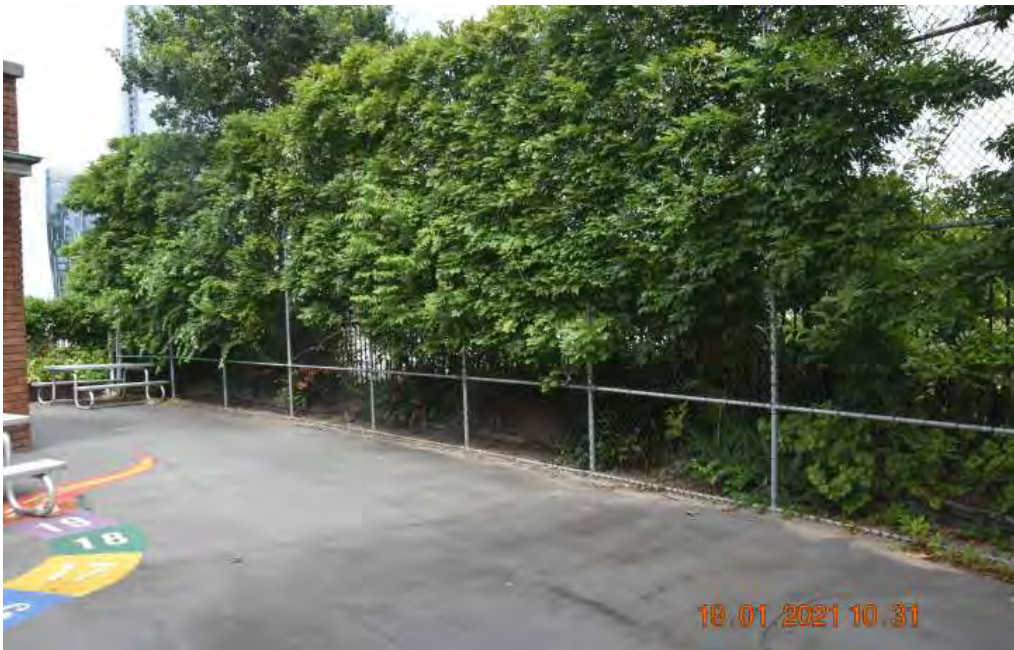
Figure: 0742

General view of the paving on the north side of building A. Showing cracking.

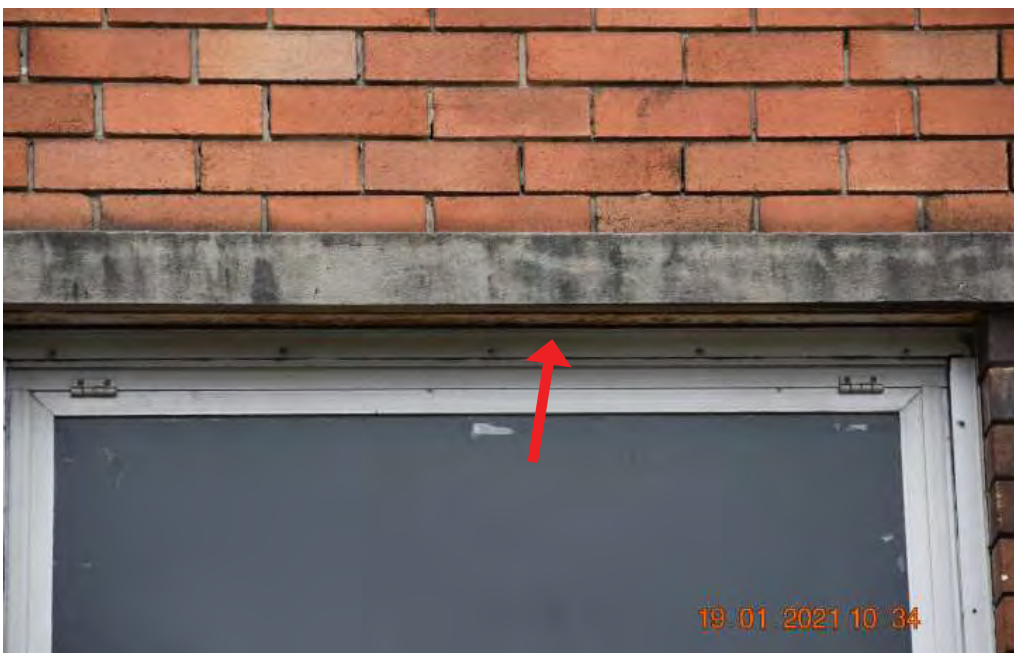
Figure: 0770

Rusting above the window in the north wall of building A.

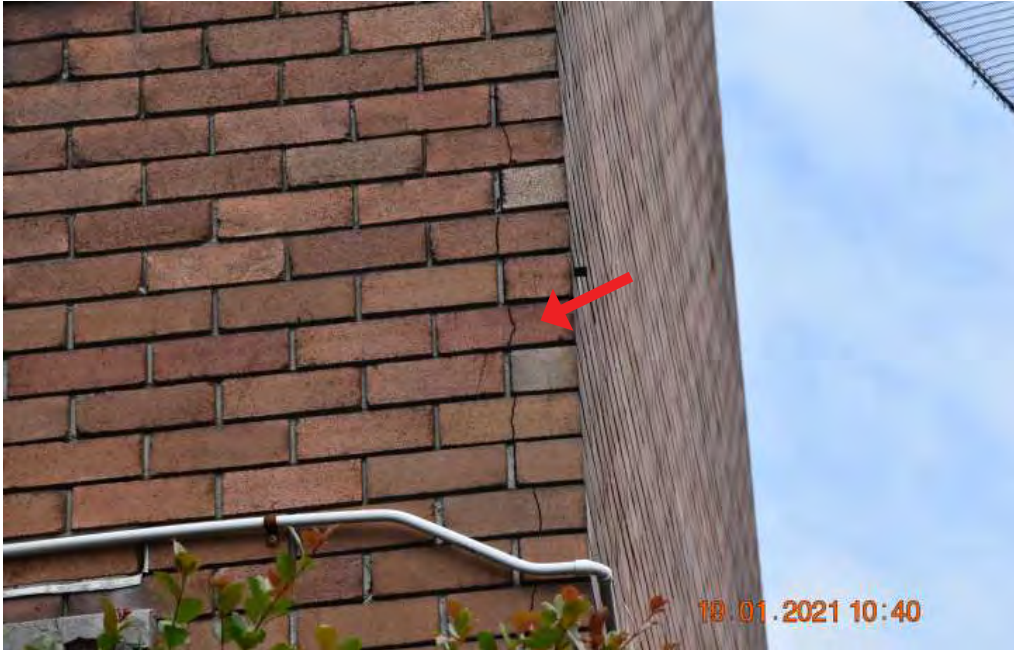
Figure: 0843

Slight, vertical cracking in the east wall of building A, north side

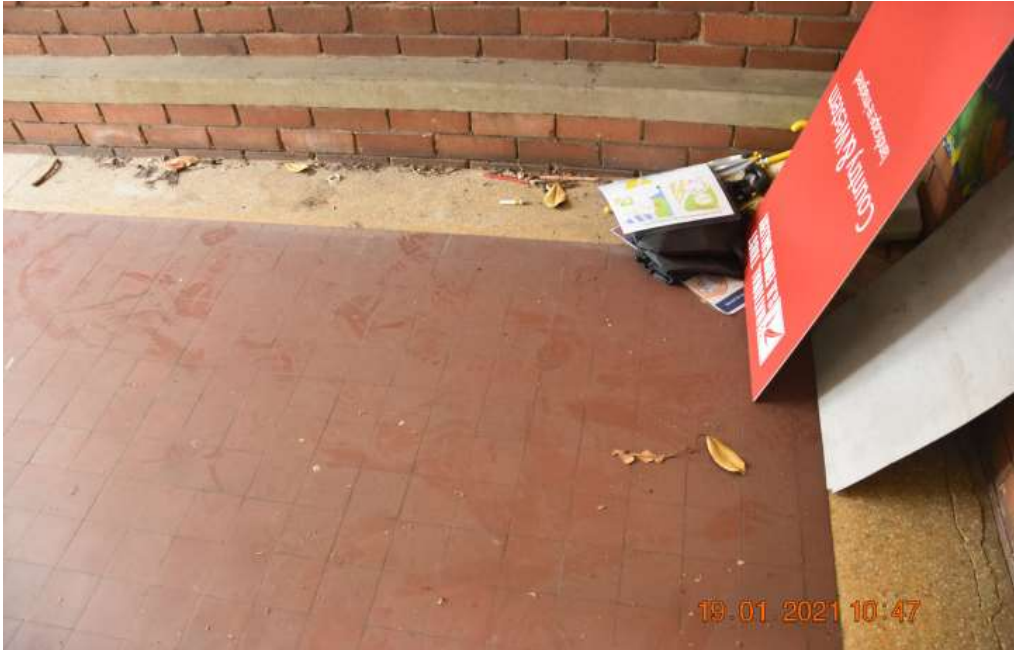
Figure: 0933

Slight cracking in the paving at the entrance.

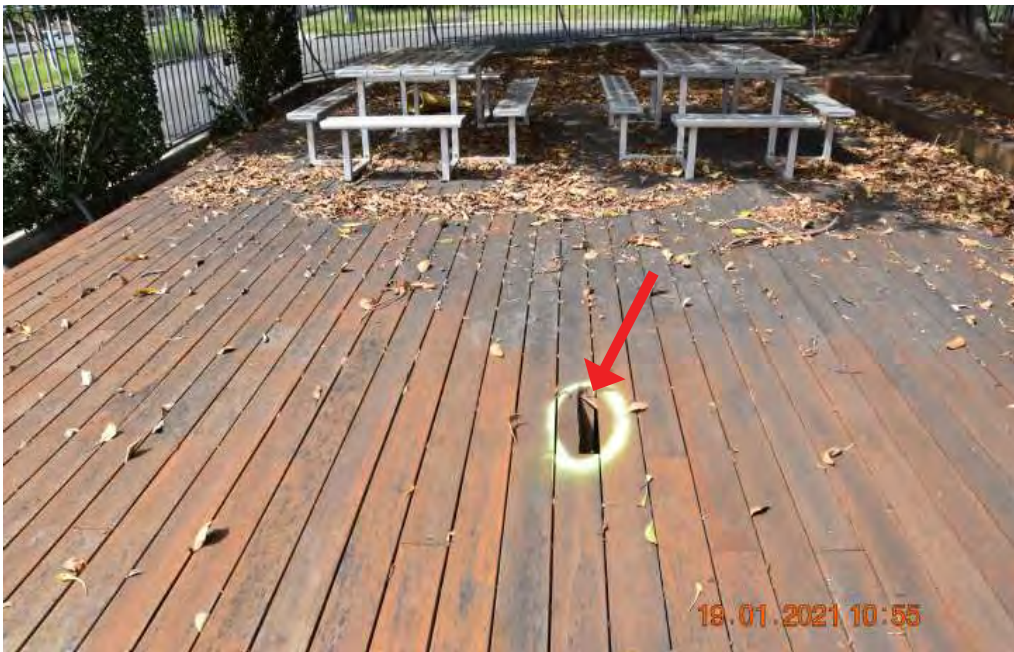
Figure: 0985

General view of the timber deck on the east side of the property. Showing damage.

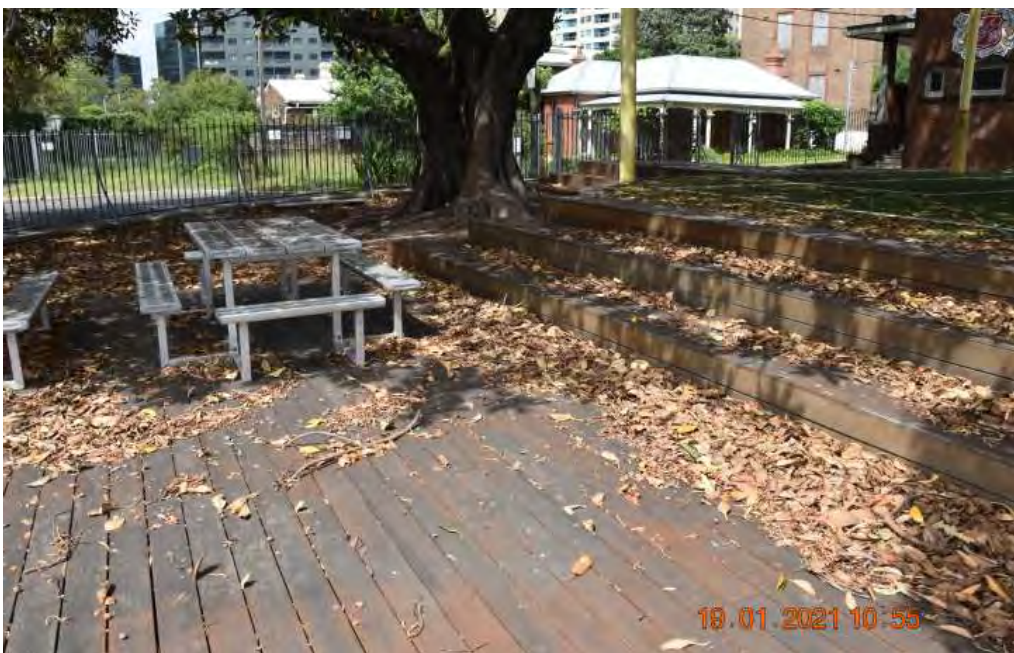
Figure: 0986

General view of the timber deck on the east side of the property. Showing damage.

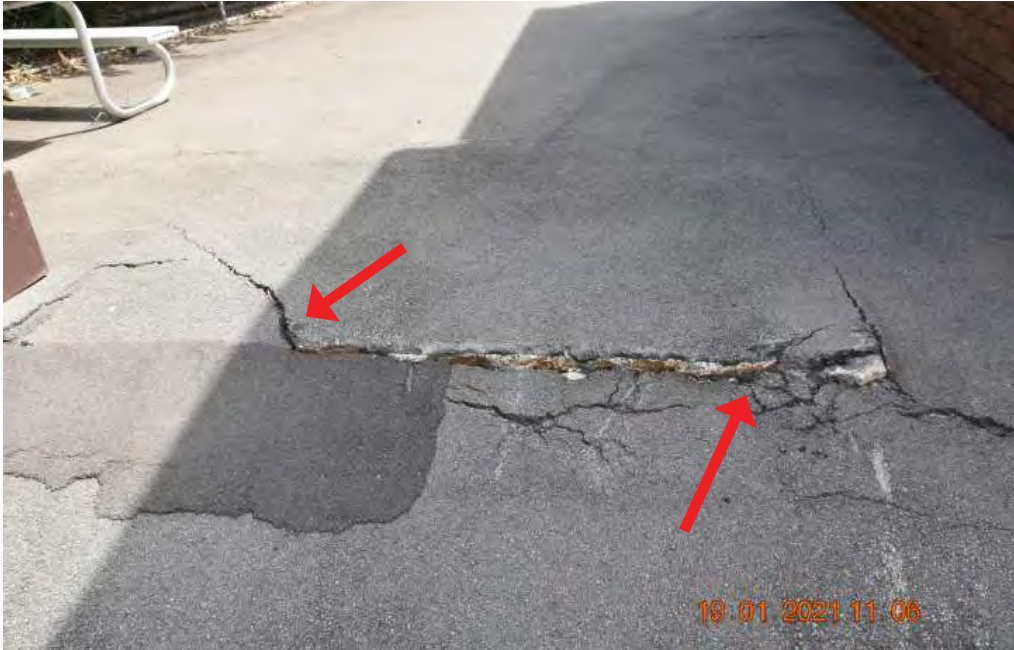
Figure: 1146

Wide cracking and movement in the paving at the southwest corner of building A.

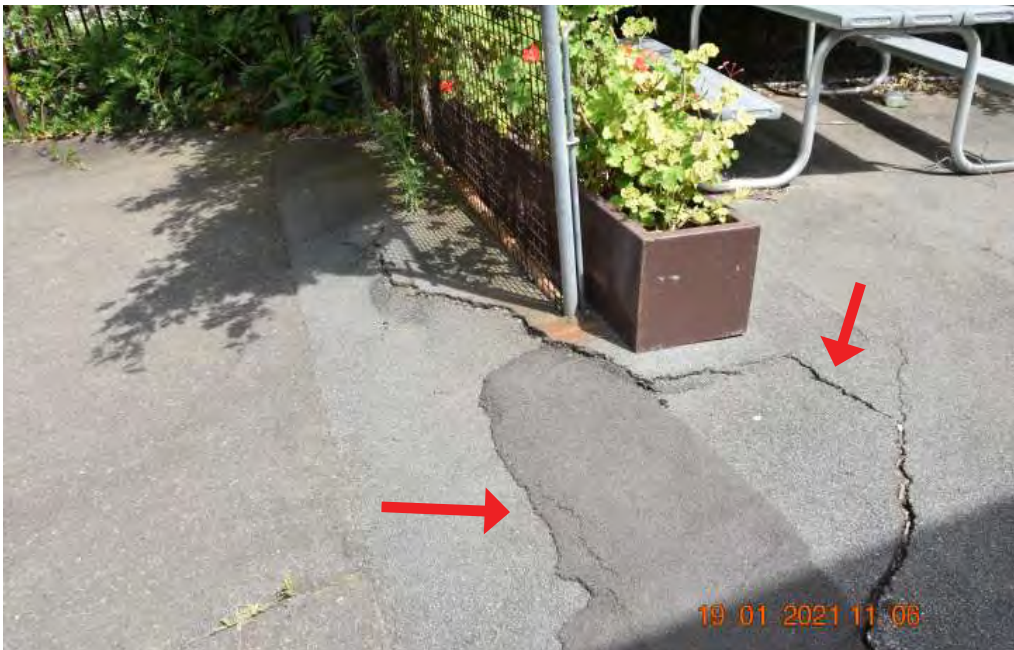
Figure: 1147

Wide cracking and movement in the paving at the southwest corner of building A.

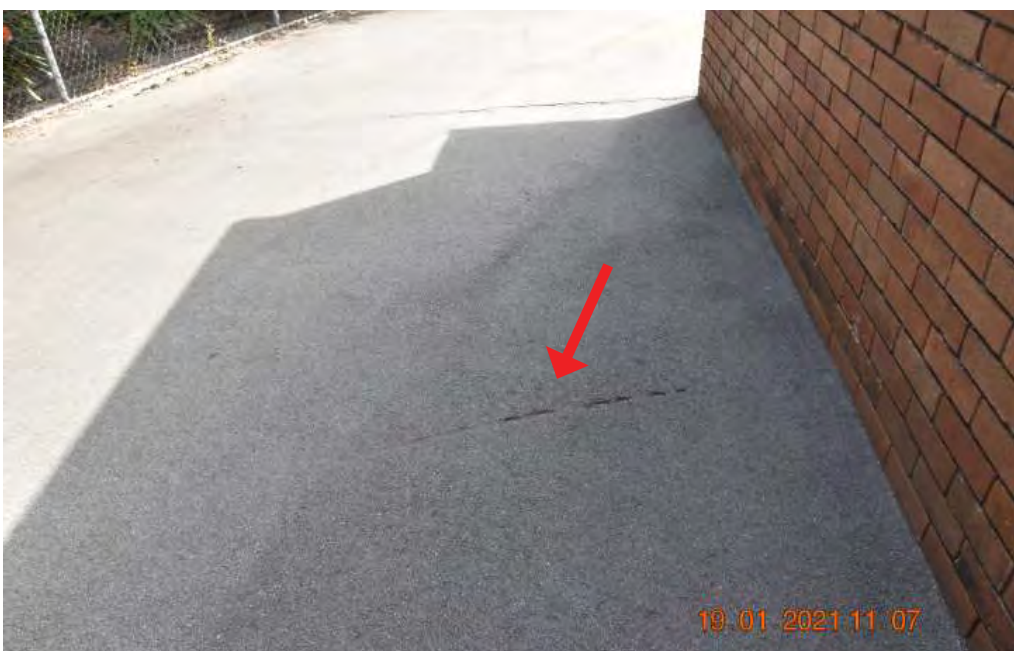
Figure: 1148

Wide cracking and movement in the paving at the southwest corner of building A.

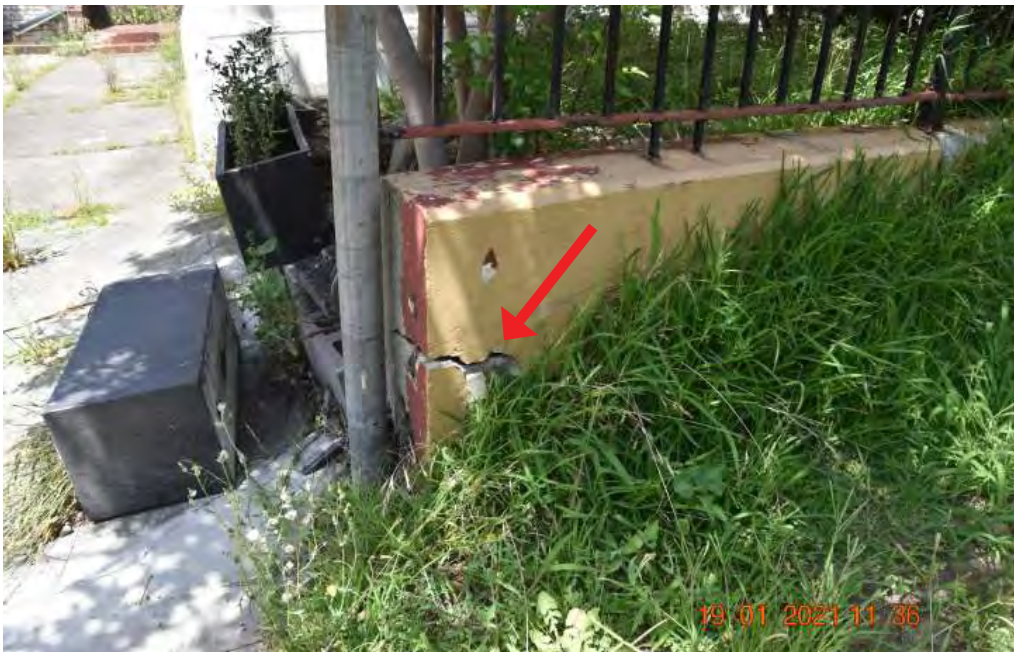
Figure: 1293

General view of the garden bed on the north side of building B. Showing cracking.

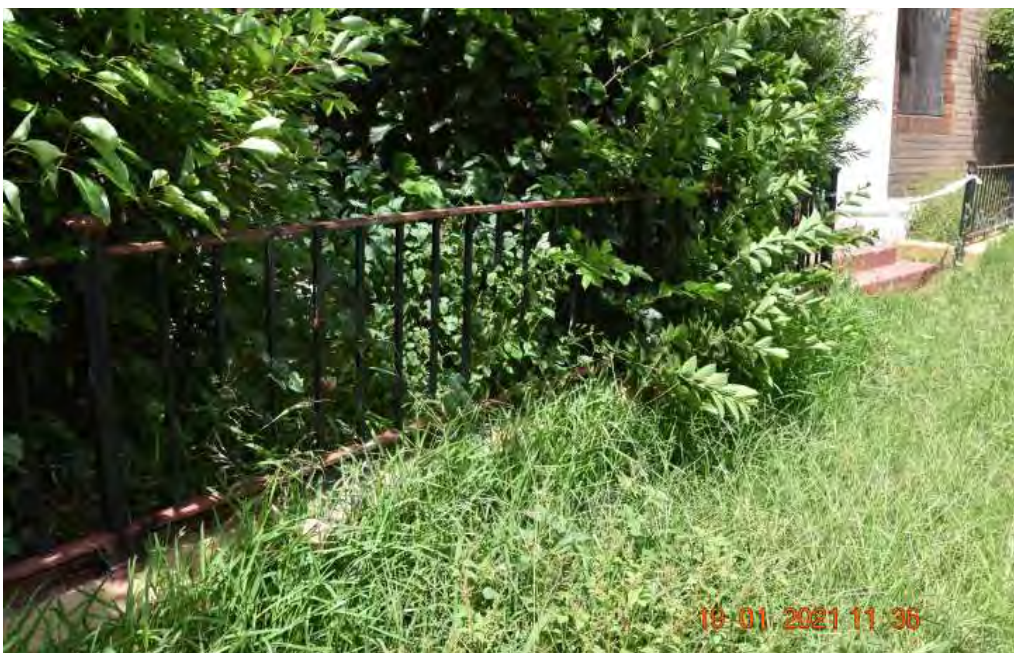
Figure: 1294

General view of the garden bed on the north side of building B. Showing wide cracking.

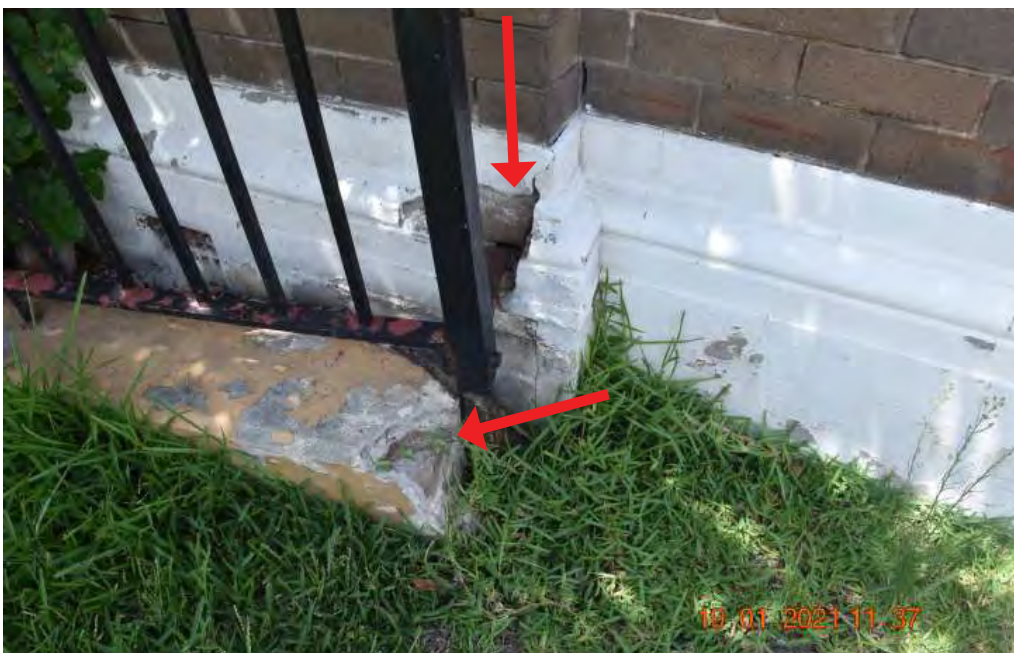
Figure: 1303

General view of the garden bed on the north side of building B. Showing damage in the garden bed and the north wall.

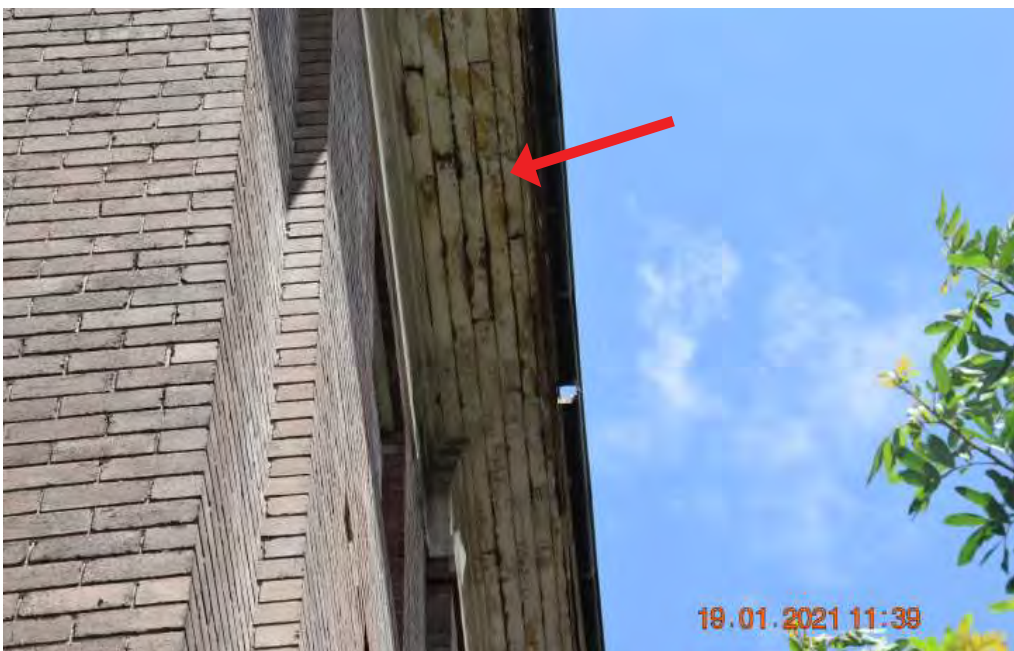
Figure: 1318

General view of the soffit on the north side of building B. Showing weathering and damage.

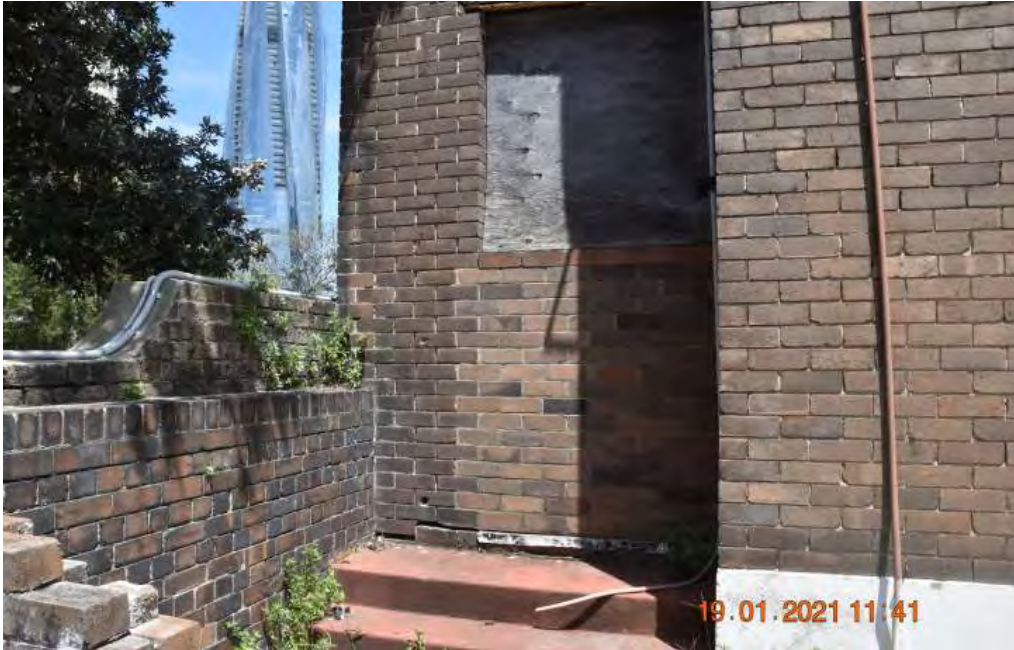
Figure: 1340

Slight stepped cracking in the mortar joints in the east wall of building B, south side. Also showing missing bricks.

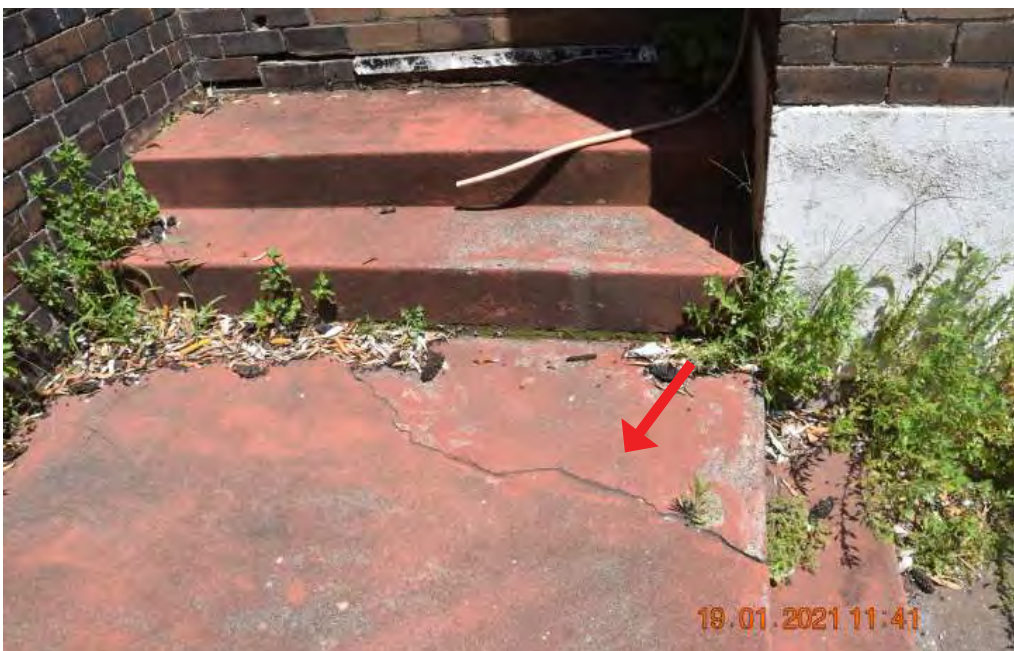
Figure: 1342

Slight cracking in the mortar joints in the east wall of the building, south side. Also showing movement.

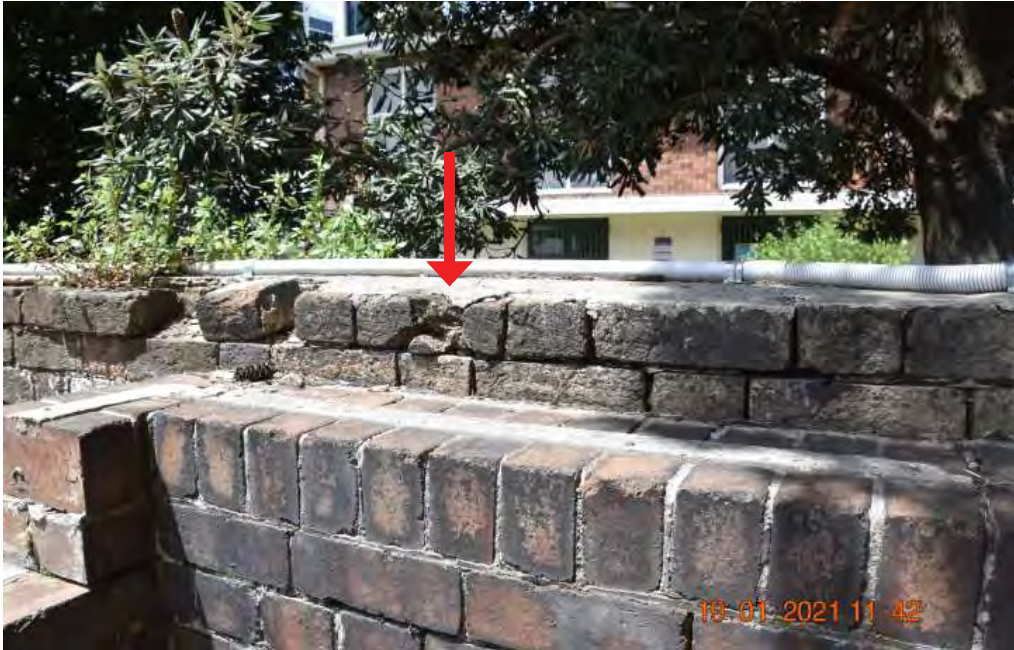
Figure: 1349

Cracking in the heritage wall, looking from the southeast corner of building B. Also showing erosion in the mortar joints.

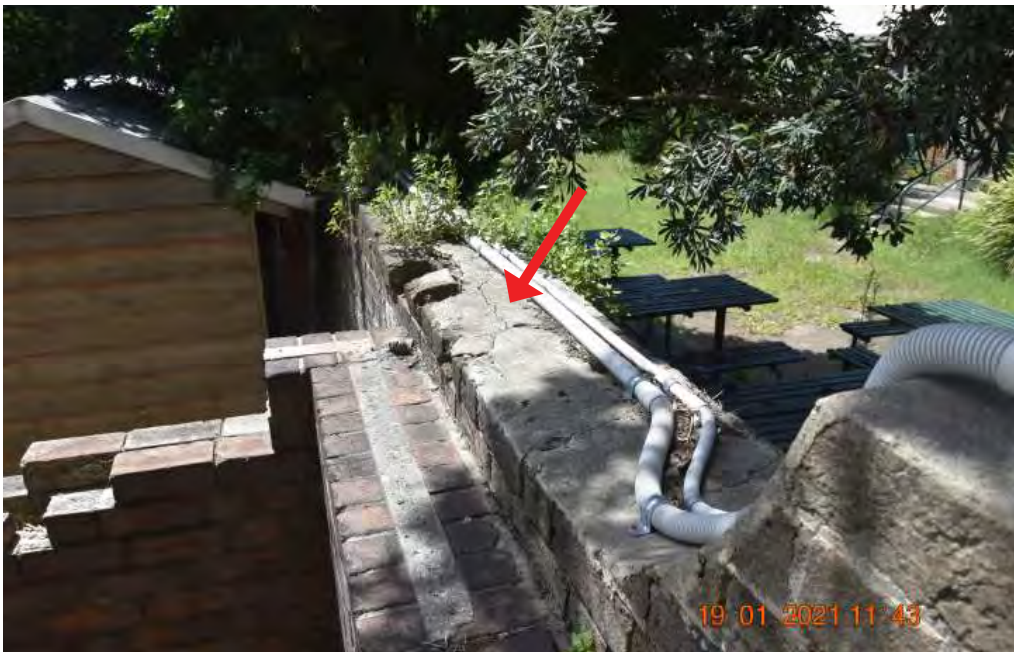
Figure: 1350

Erosion in the mortar joints the heritage wall, looking from the southeast corner of building B. Also showing movement.

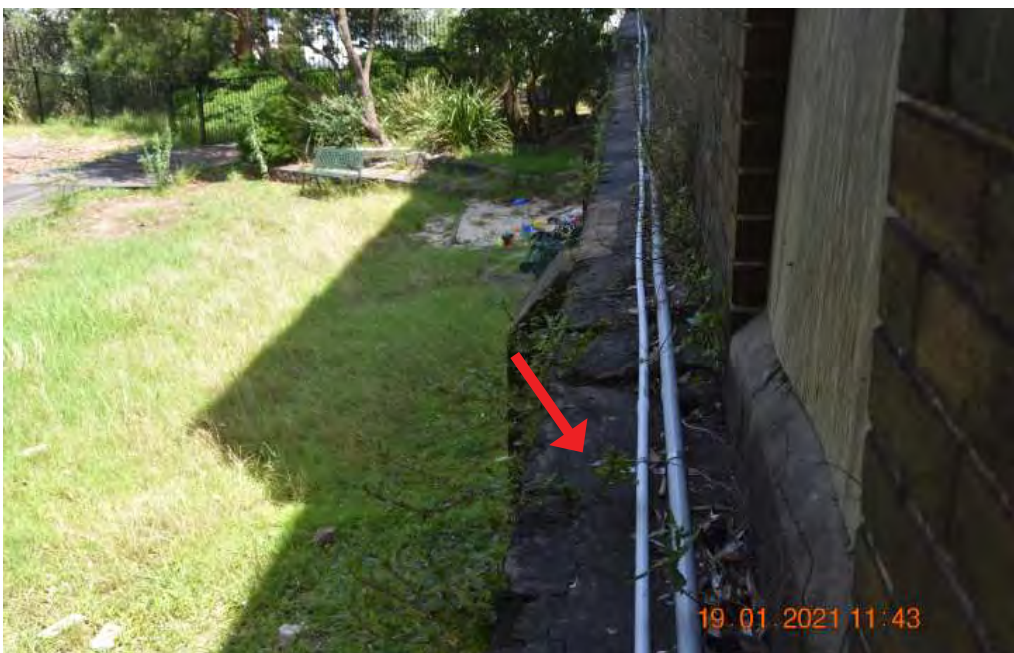
Figure: 1351

Cracking in the top of the heritage wall, looking from the southeast corner of building B.

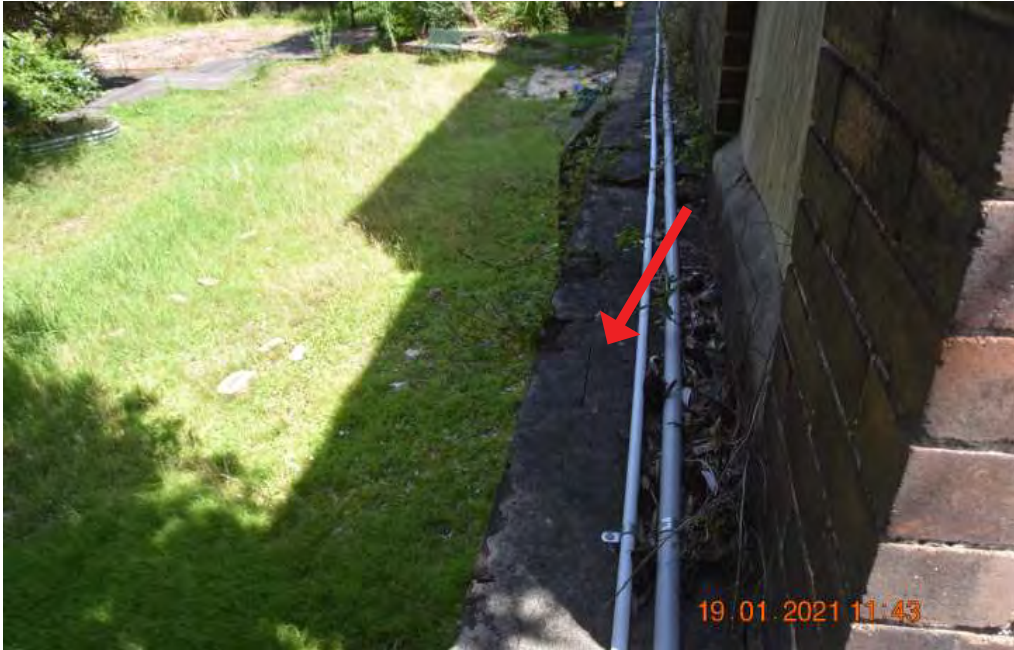
Figure: 1352

Cracking and erosion in the top of the heritage wall, looking from the southeast corner of building B.

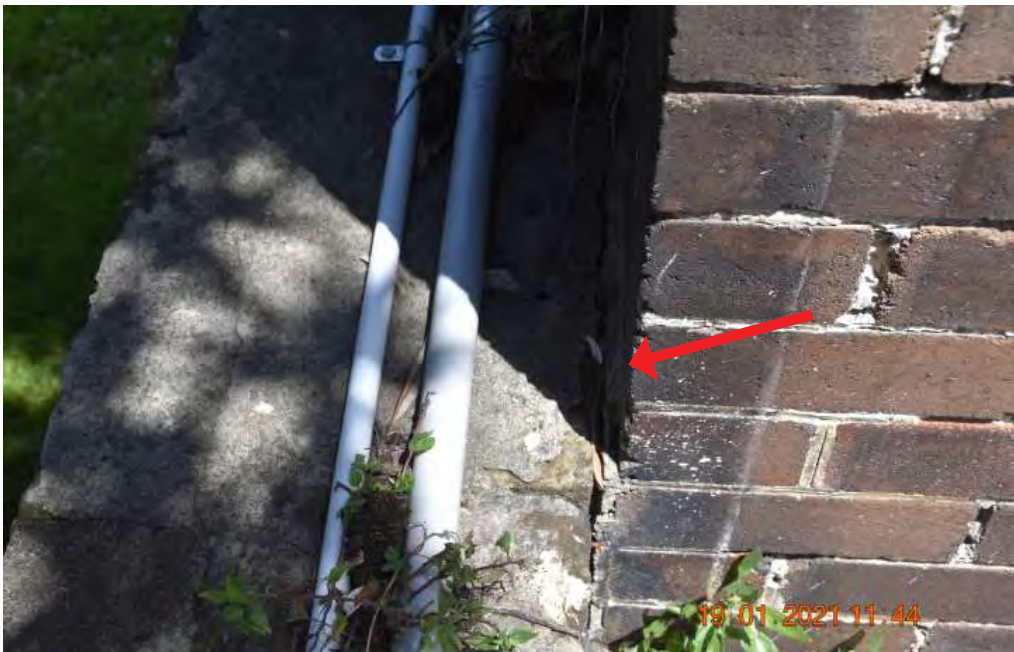
Figure: 1353

Cracking and erosion in the top of the heritage wall, looking from the southeast corner of building B.

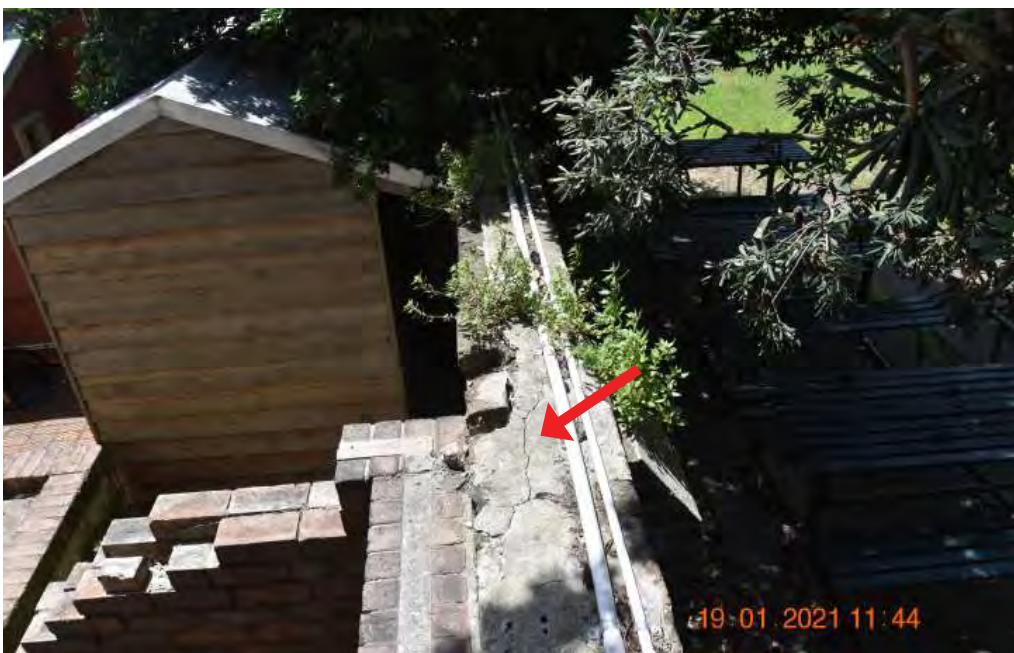
Figure: 1354

Separation between the heritage wall and the south wall of building B.

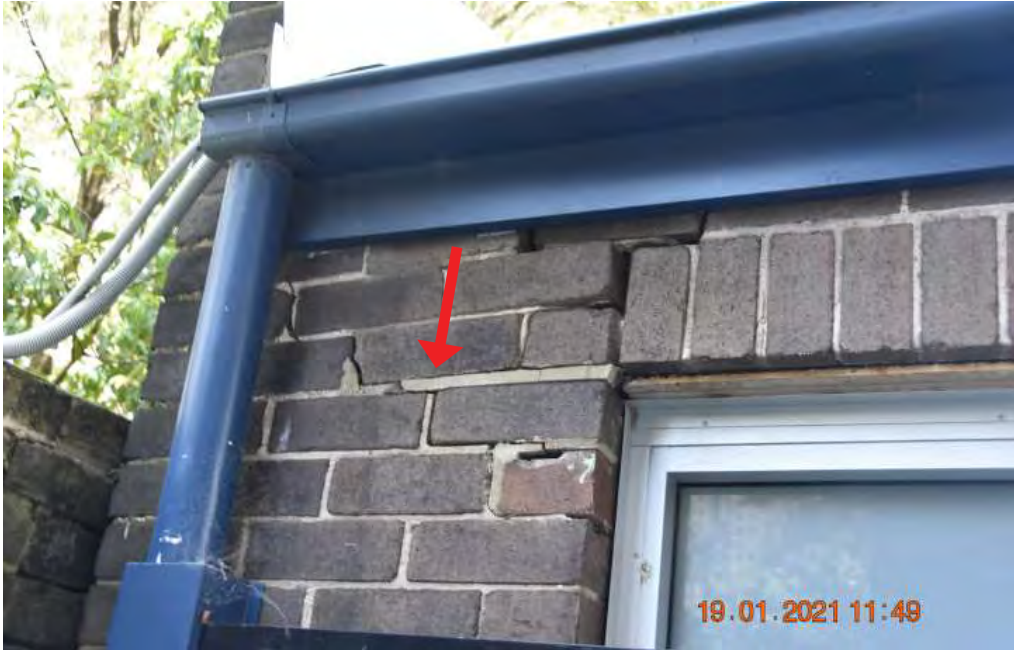
Figure: 1385

Slight stepped cracking in the east wall of building F.

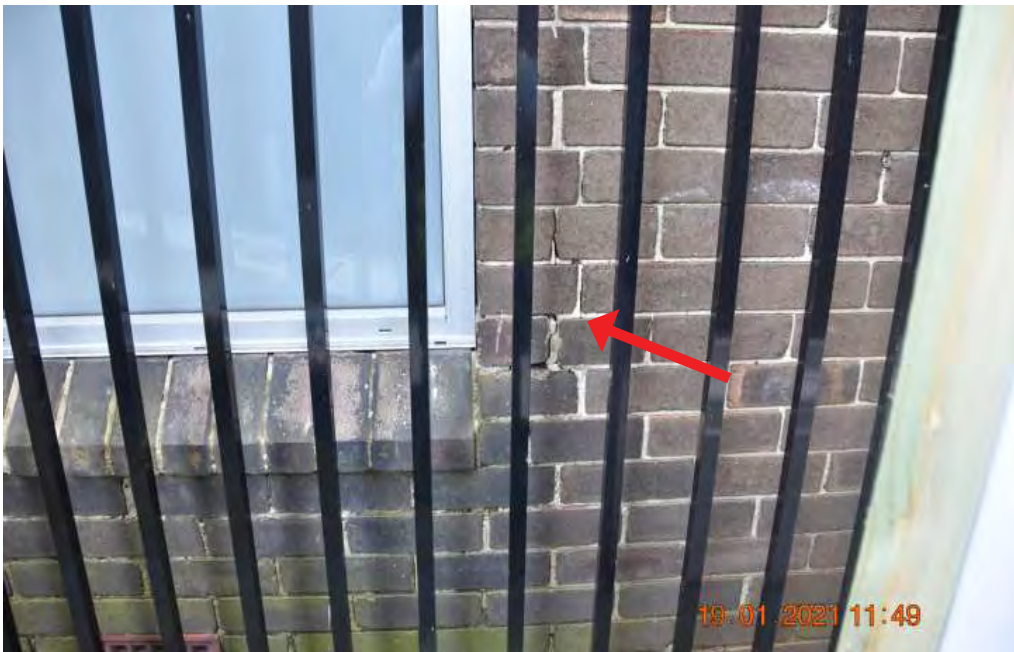
Figure: 1386

Slight stepped cracking in the east wall of building F. Also showing movement.
