## PRE CONSTRUCTION CONDITION SURVEY

Fort Street Public School, Millers Point NSW

Upper Fort Street Public School  
MILLERS POINT NSW 2000

19 January 2021

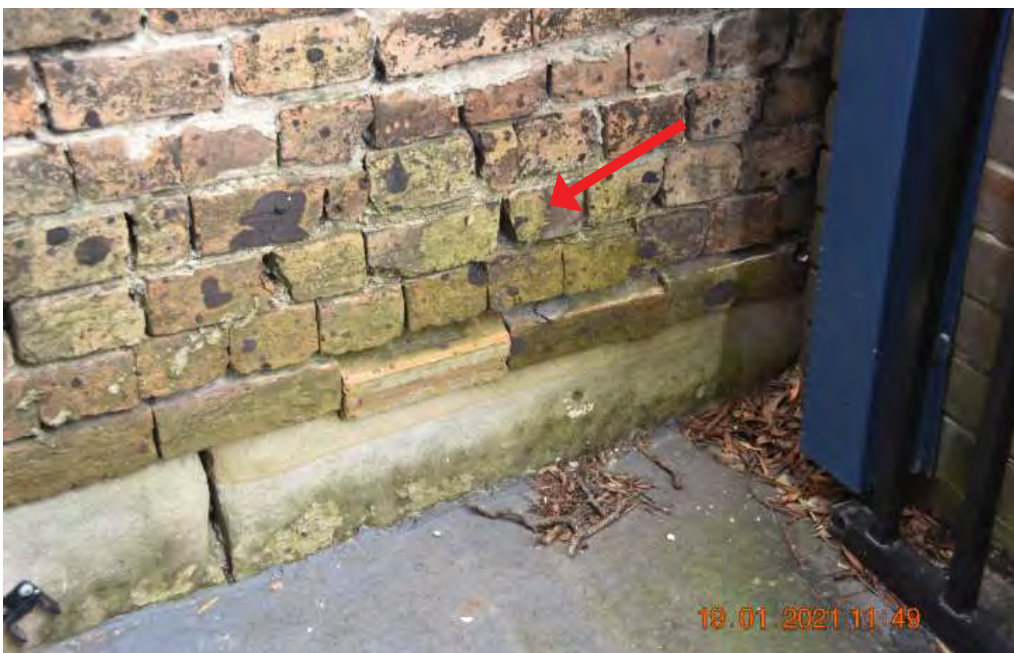
Figure: 1387

Slight stepped cracking in the east wall of building F.

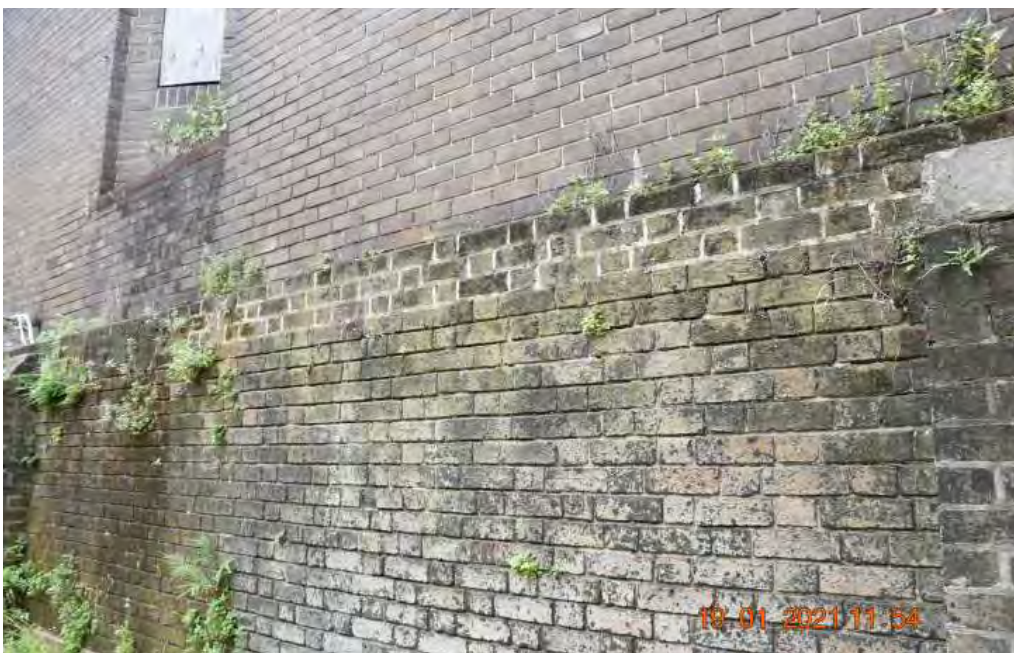
Figure: 1447

Stepped cracking and erosion in the mortar joints in the south wall of building B.

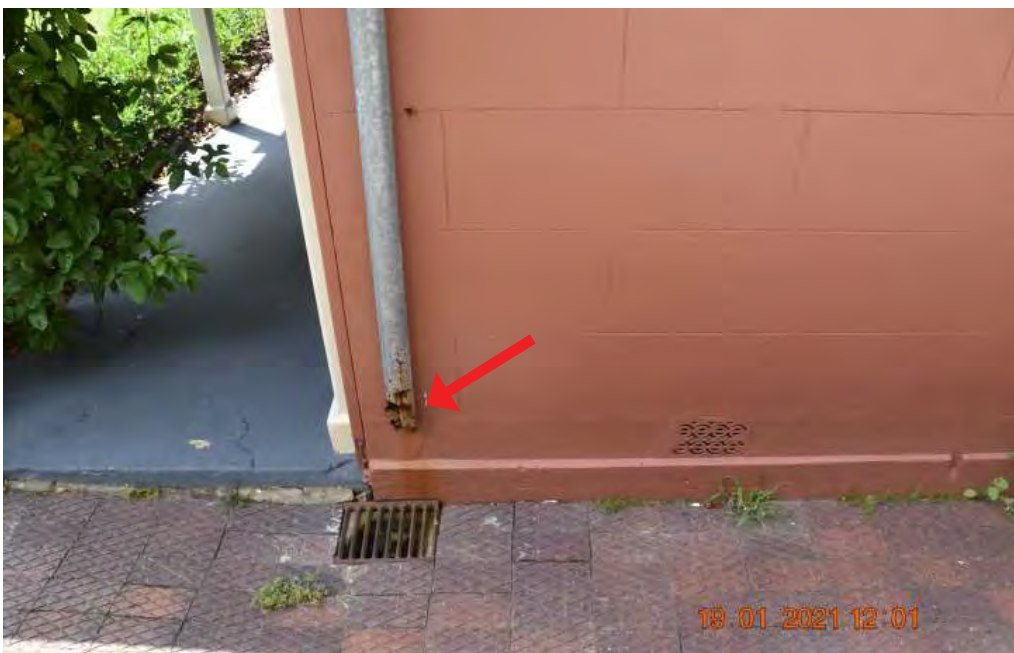
Figure: 1531

Cracking in the west wall of building C, north side.

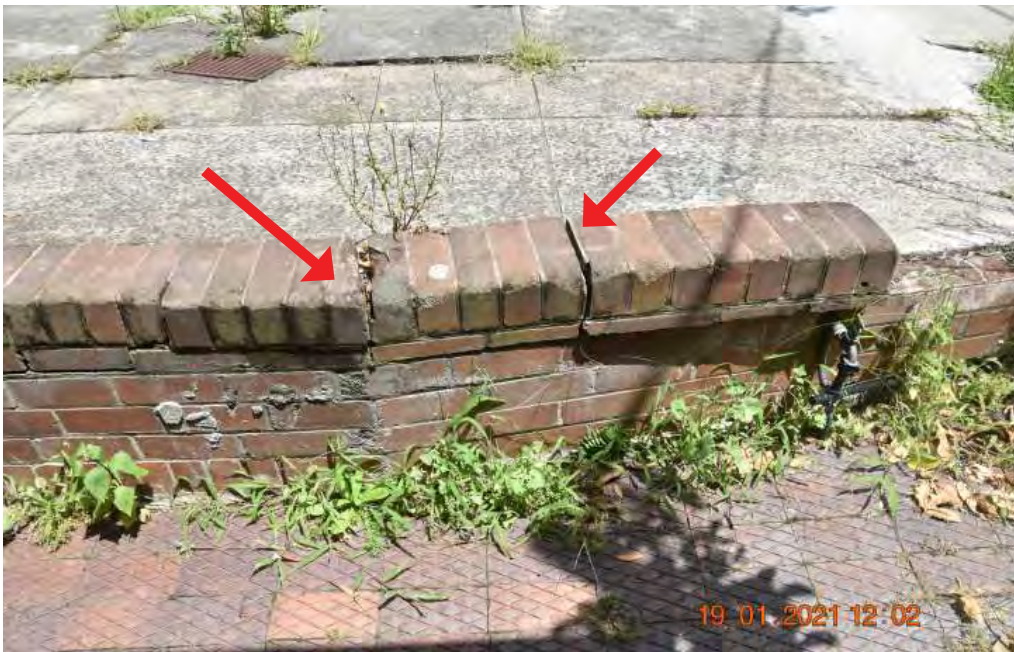
Figure: 1533

Movement in the retaining wall at the northwest corner of building C.

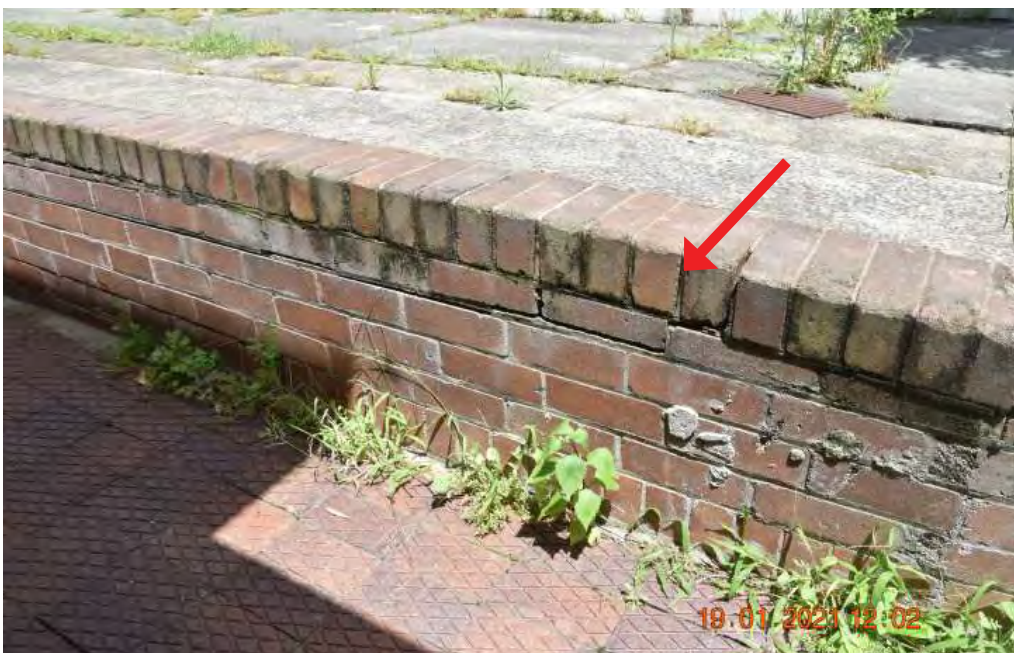
Figure: 1534

Movement in the retaining wall at the northwest corner of building C. Also showing wide cracking.

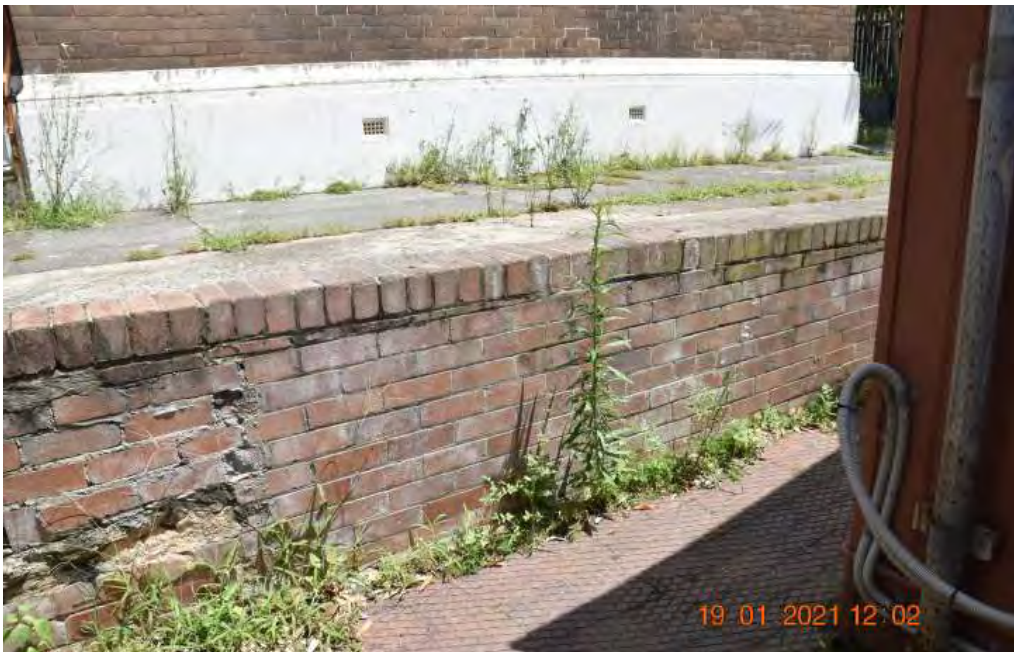
Figure: 1542

General view of the retaining wall on the west side of building C. Showing damage.

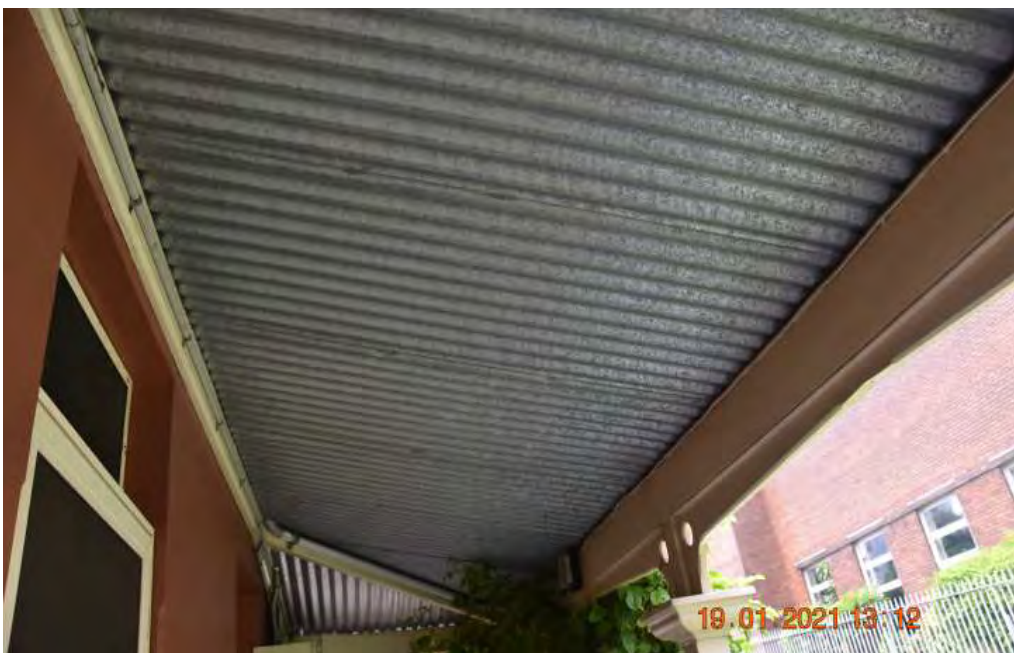
Figure: 1717

General view of the ceiling on the north porch on building C. Showing cracking.
