# Fort Street Public School

## ARBORICULTURAL DEVELOPMENT IMPACT ASSESSMENT REPORT

SSD 10340

Prepared by Birds Tree Consultancy

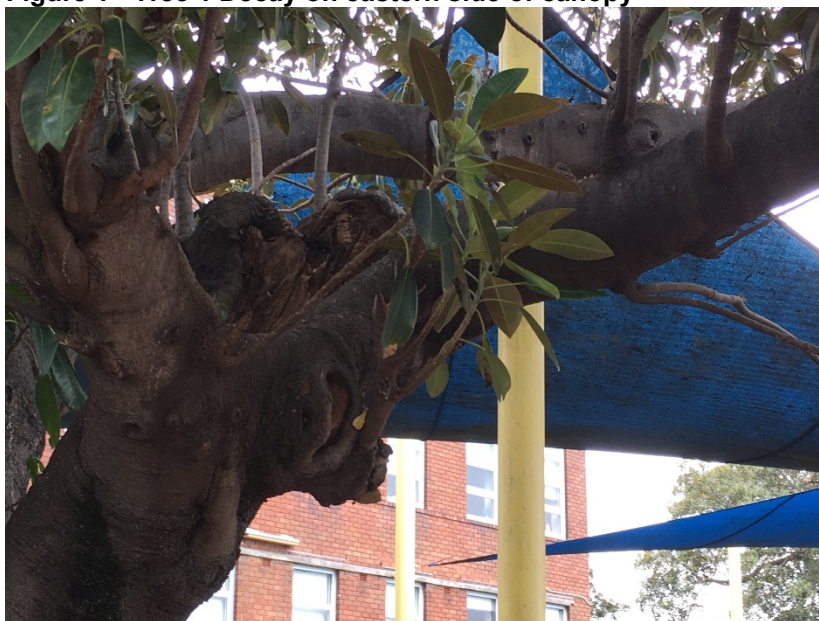
**Figure 2 - Decay in secondary branch north of Tree 1**

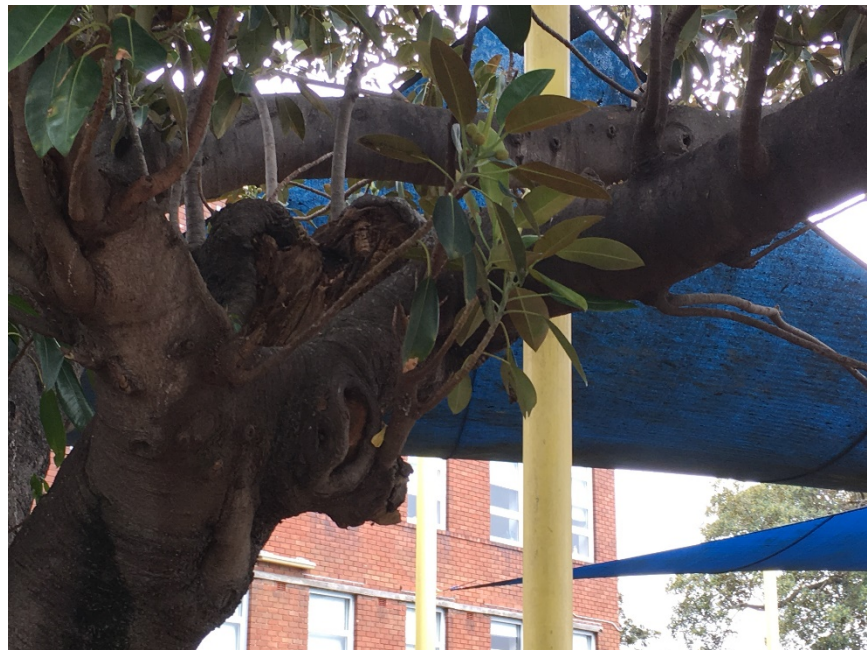
This mature tree is approximately 21m tall with a canopy spread of 24m. It has a single trunk with a diameter at breast height (DBH) of 1750mm. This tree is in good health and condition with minimal deadwood and epicormic growth. There is evidence of decay in a secondary junction on the eastern side at point of high lever arm stress 1.5m from junction in long horizontal end weighted branch at a height of approximately 3m. There is also decay in a secondary branch on the northern side of canopy, approximately 1.5m from the secondary junction at a height of approximately 9m.

Figure 2 - Decay at Location 1

Tree 1 is found to have a moderate risk rating for failure of the branch at Location 1 and accordingly poses a significant hazard to life. In order to remove the risk posed by this branch, we recommend the removal of this branch at the secondary junction.
