Report on
Hazardous Building Materials (HBM) Survey

Cricket NSW Centre of Excellence
Newington Road, Silverwater NSW

Prepared for
COX Architecture Pty Ltd

Project 86694.06
May 2020

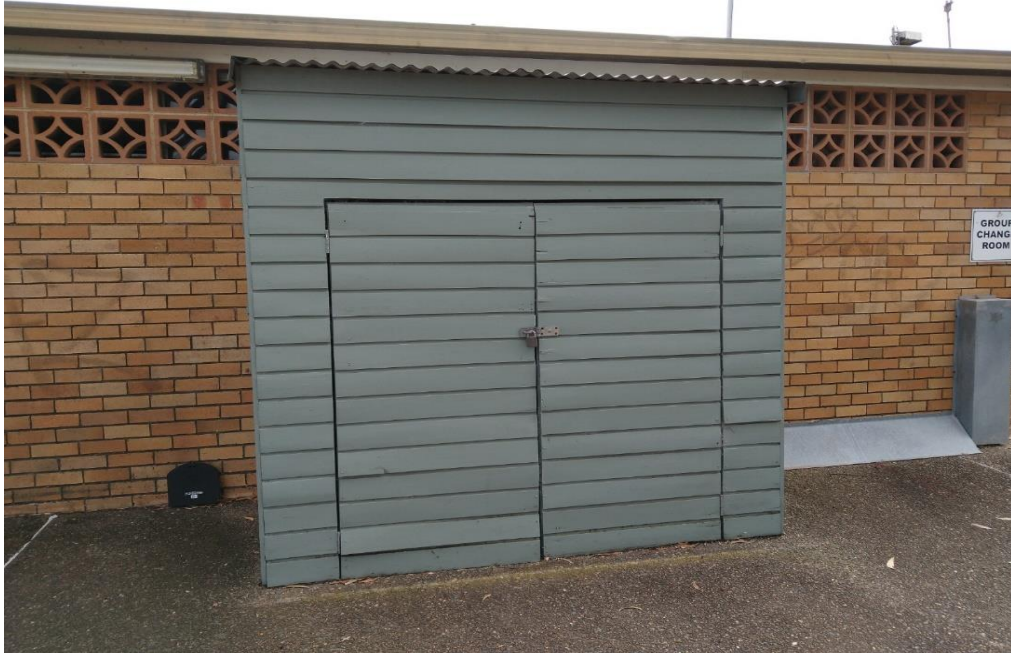
Photograph 1: Foreshore amenities block, southern side of building, locked store room, materials in general, inaccessible.

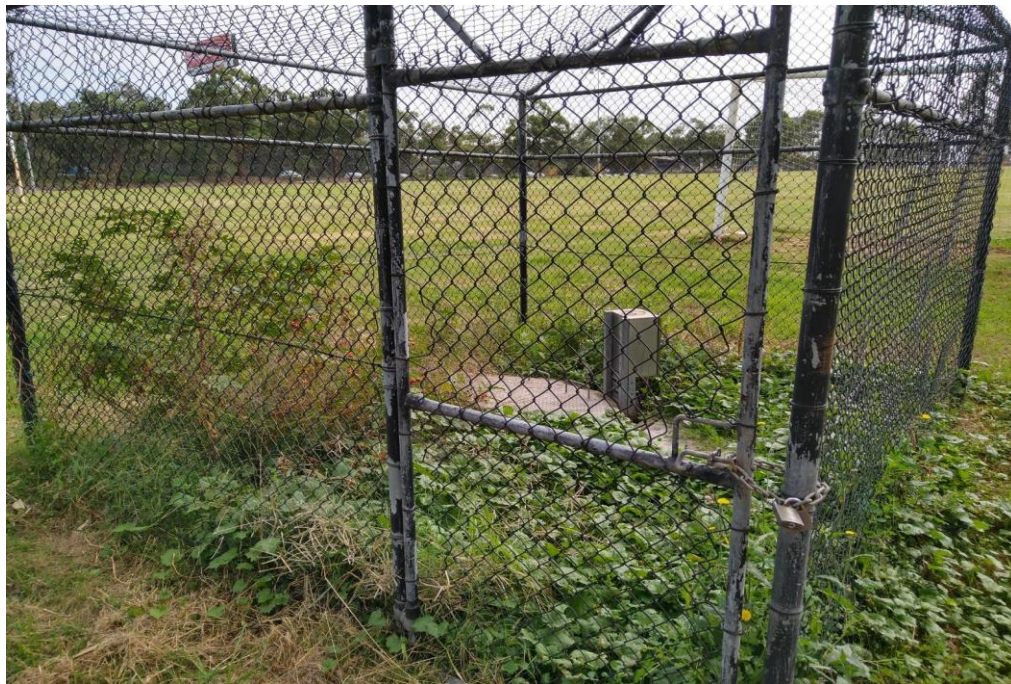
Photograph 2: Grandstand to main rugby oval, southeastern corner, interception and valve pit, materials in general, inaccessible.

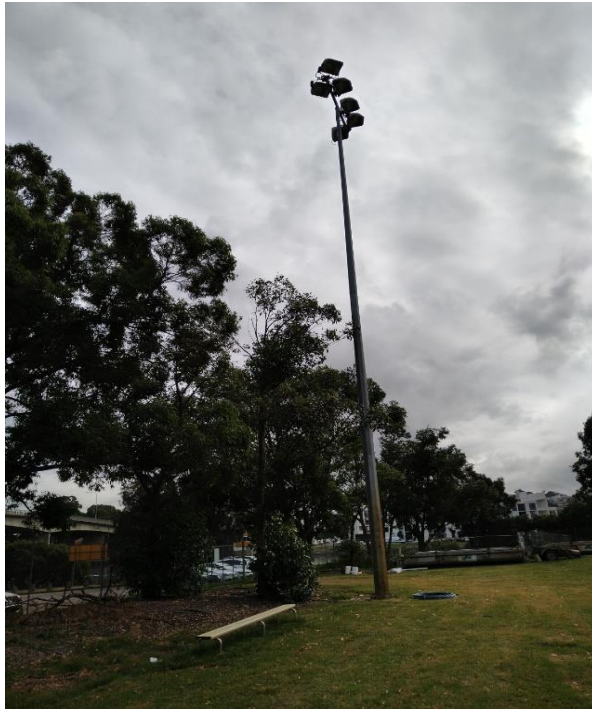
Photograph 3: Main rugby oval, perimeter, field lights x 4 (approx.), internal components (e.g. capacitors, ballasts), insulating oil, PCB (assumed).

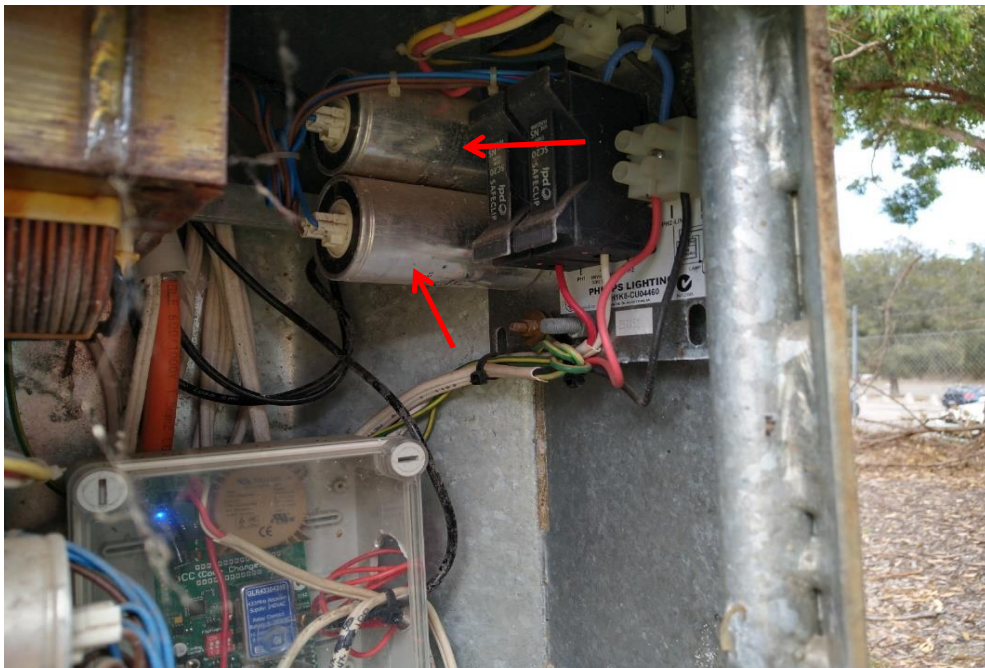
Photograph 4: Main rugby oval, perimeter, field lights x 4 (approx.), internal components (e.g. capacitors, ballasts), insulating oil, PCB (assumed).

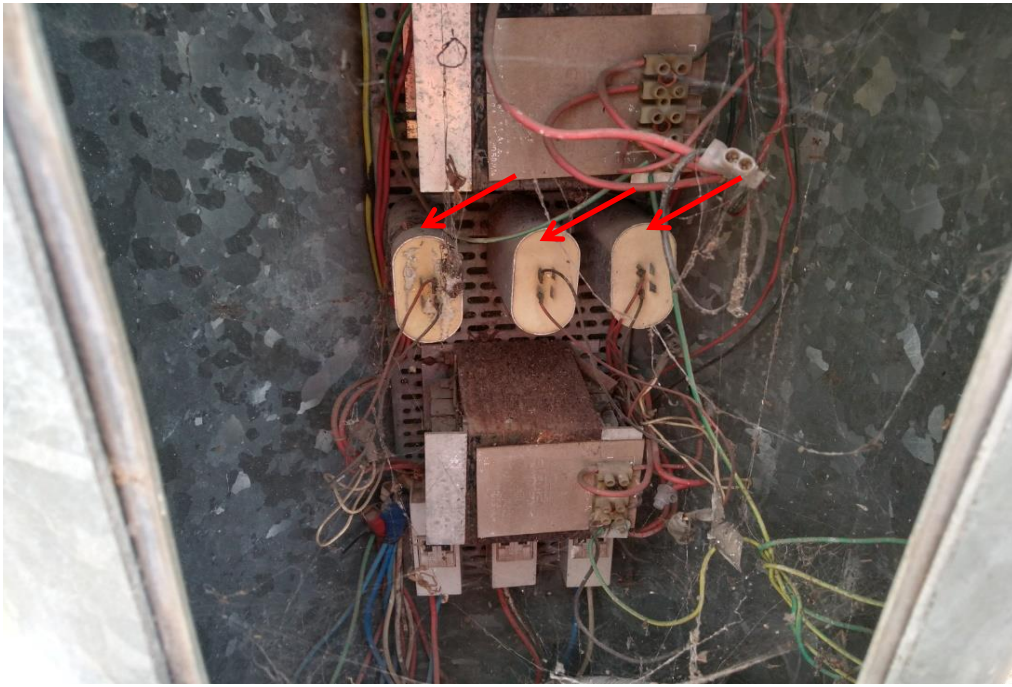
Photograph 5: Southern sports field, perimeter, field lights x 8 (approx.), internal components (e.g. capacitors, ballasts), insulating oil, PCB (assumed).

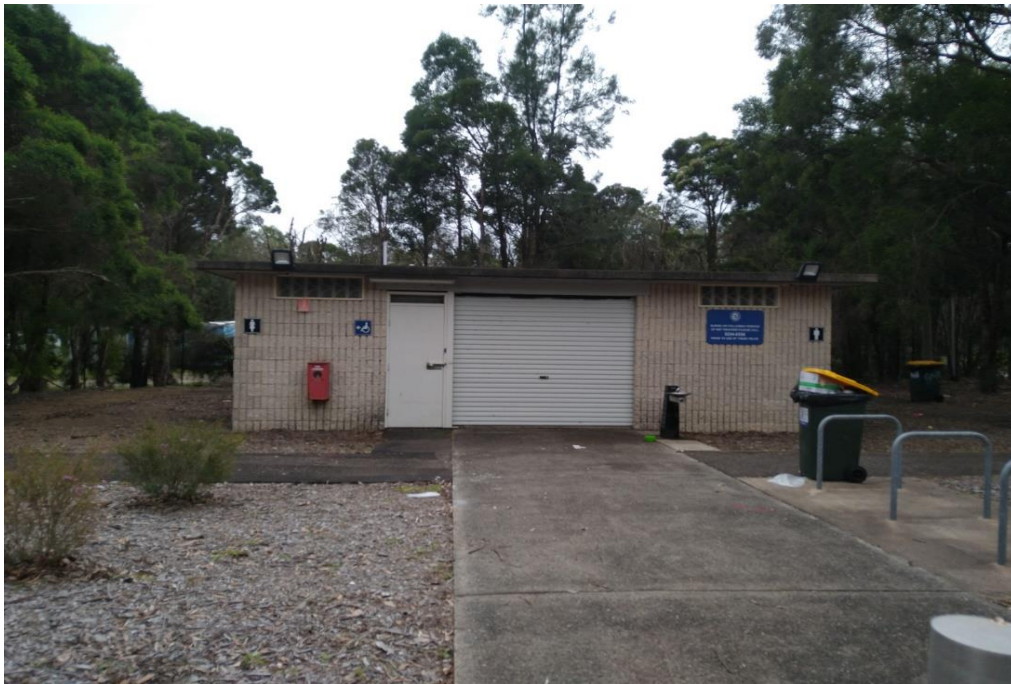
Central amenities block	Interior	throughout	materials in general	N/A	inaccessible	N/A	N/A	N/A	N/A	N/A	N/A	N/A	N/A	6	Inaccessible area/material - Confirm status of hazardous material(s) when safe access available and prior to any disturbance.
Exterior boundary	throughout	fences	typical black paint	spot test 10	negative for lead	N/A	N/A	N/A	N/A	N/A	N/A	N/A	N/A	N/A	No asbestos/hazardous material identified.
Eastern side of the main oval grandstand	behind fence	ground surface	stored field lights and materials	N/A	inaccessible	N/A	N/A	N/A	N/A	N/A	N/A	N/A	N/A	7	Inaccessible area/material - Confirm status of hazardous material(s) when safe access available and prior to any disturbance.

Photograph 6: Central amenities block, Interior, throughout, materials in general, inaccessible.

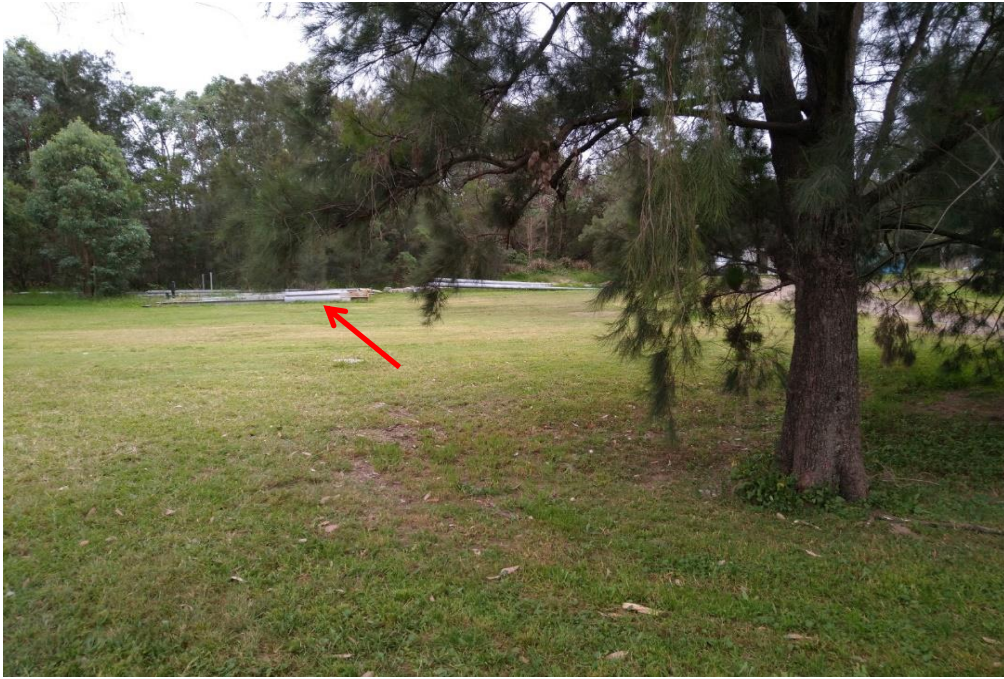
Photograph 7: Eastern side of the main oval grandstand, behind fence, ground surface, stored field lights and materials, inaccessible.

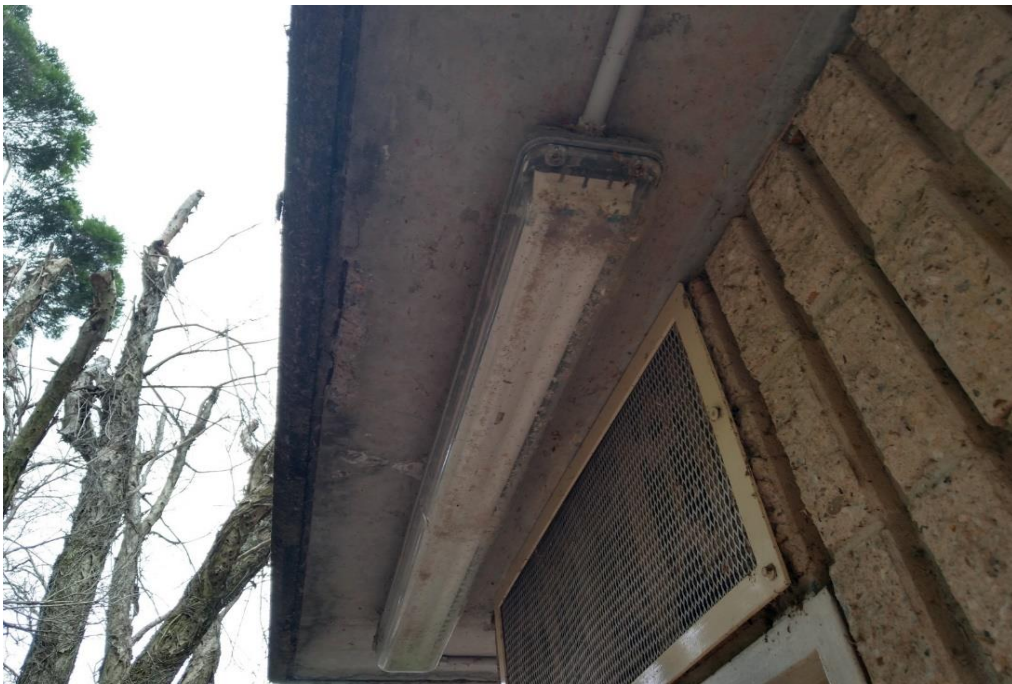
Central amenities block	exterior	fluorescent light fitting(s)	internal components (e.g. capacitors, ballasts), insulating oil	N/A	PCB (assumed)	N/A	N/A	N/A	N/A	N/A	N/A	N/A	N/A	8	Confirm status of hazardous material when safe access available and prior to any disturbance. Reinspect condition of hazardous material on a regular basis. Remove hazardous material prior to any significant disturbance (e.g. renovation, demolition or maintenance work).
Central amenities block	exterior	expansion joints to concrete on ground	black bituminous mastic	S3	no asbestos detected by analysis	N/A	N/A	N/A	N/A	N/A	N/A	N/A	N/A	N/A	No asbestos/hazardous material identified.

Photograph 8: Central amenities block, exterior, fluorescent light fitting(s), internal components (e.g. capacitors, ballasts), insulating oil, PCB (assumed).
