**Interim Site Audit Advice (Site Audit Memo 07) Site Audit FM121 – Cricket NSW – Summary of Site Inspection 10 May 2021**

FJM Consulting Pty Ltd was engaged by MostynCopper on behalf of NSW Cricket Association (Cricket NSW) to provide Frank Mohen as a NSW EPA Accredited Contaminated Site Auditor (the Site Auditor) under the Contaminated Land Management (CLM) Act 1997, for the investigation and remediation of Wilson Park, where Cricket NSW propose to build the Western Sydney Cricket and Community Centre.

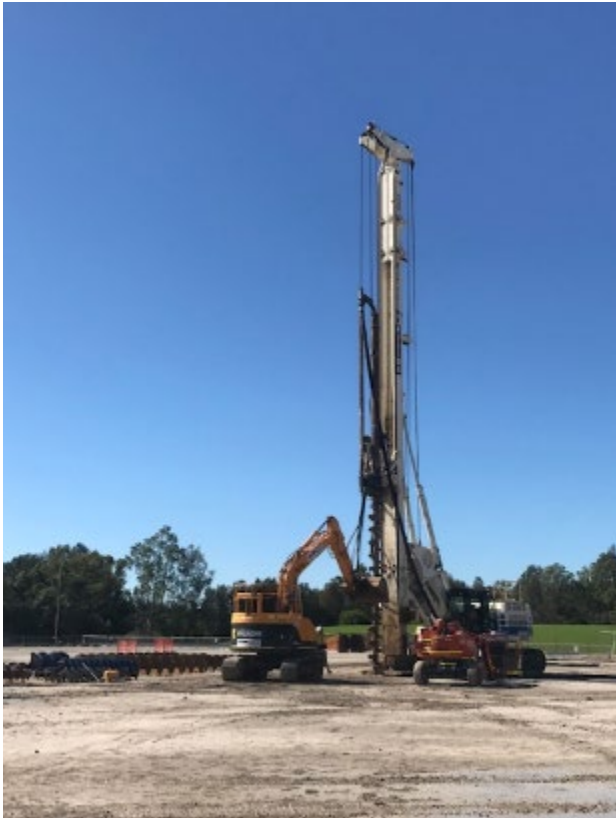
- The piling rig did not commence drilling while the Auditor was on site due to mobilization issues. Buildcorp confirmed that when the piling did commence Douglas partners would be on site monitoring at all times and that the Auditor and SOPA would be notified when piling commences and photographs would be provided.

Piling Rig

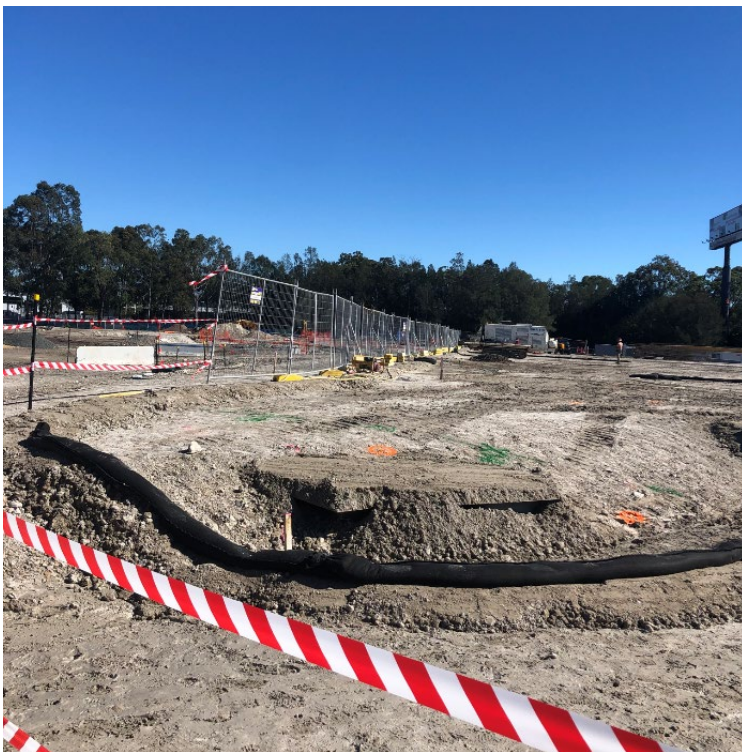
- Buildcorp Area
  - The piling was scheduled to commence at the south east extremity of the building footprint.
  - Preparation for the piling included the placement of earth bunds (naturally formed and also some within geotextile 'socks') to contain any groundwater/leachate that may eventuate from the piling or subsequent rainfall. A transfer pump and holding tank were also in place.

First Piling site hole prepared

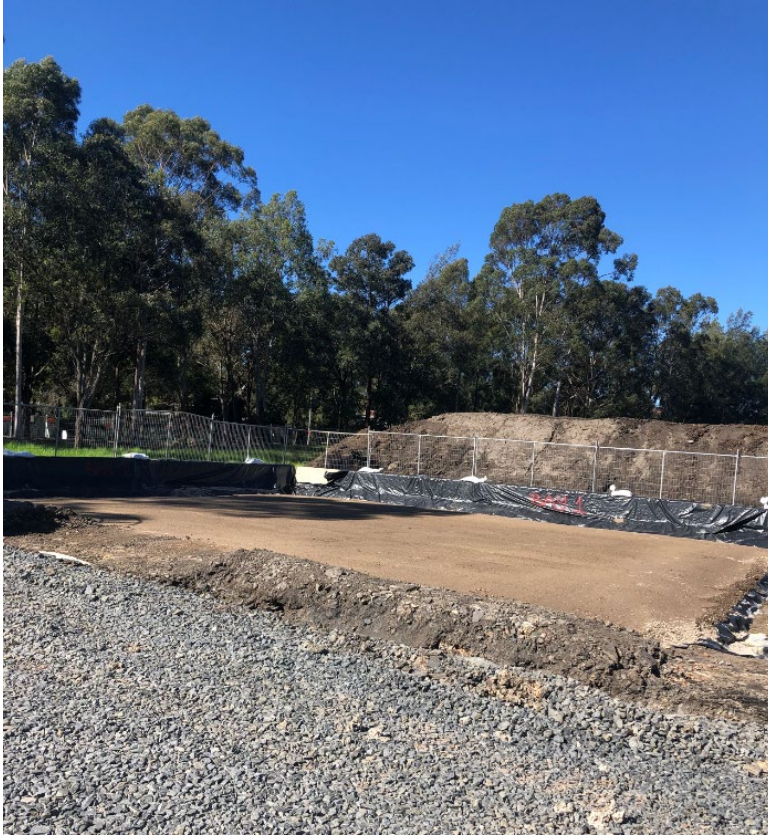
- A placement area for spoil eventuating from the piling was constructed within the Ford Civil area. This included three placement pads with bunding and drainage collection. A transfer pump and holding tank for leachate was also present. Each pad was designed to hold approximately 100 m<sup>3</sup>. At the time of the inspection there were some gaps in the bunding. This was brought to the attention of Ford Civil for rectification.

Spoil area pad

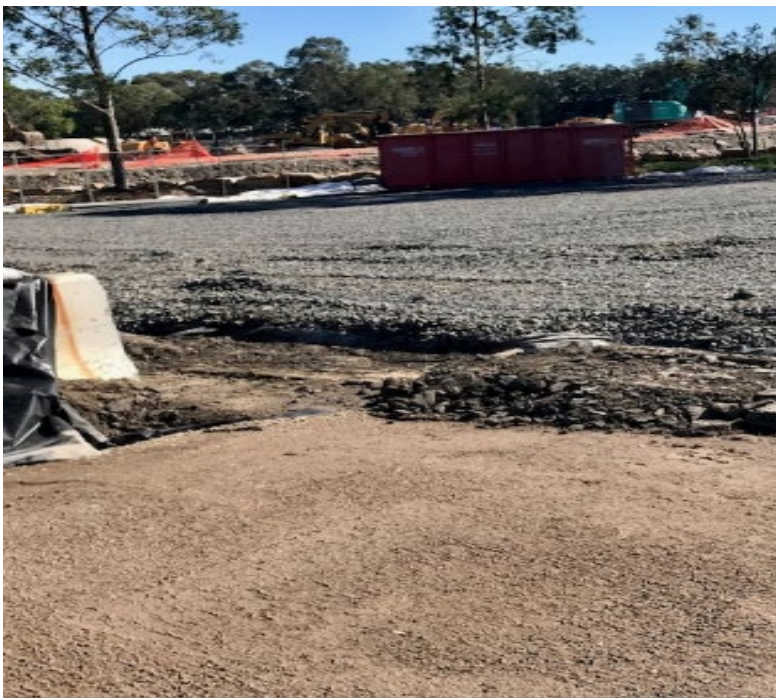
Example of gap in bunding (leachate holding tank in background)

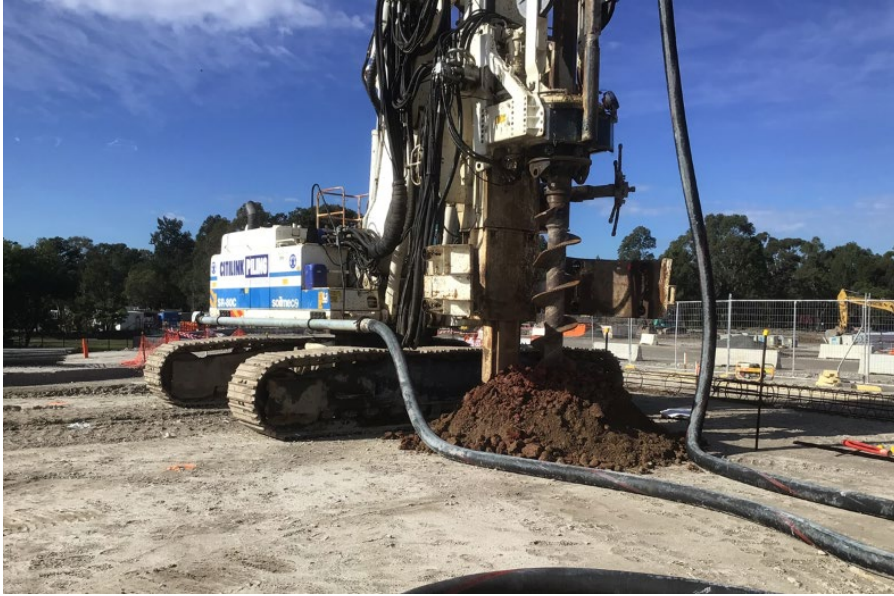
- Subsequently piling commenced on Tuesday 11 May and Andy Mack (Buildcorp) provided an email with a description and photos. No vapour or groundwater were encountered.

First piling hole

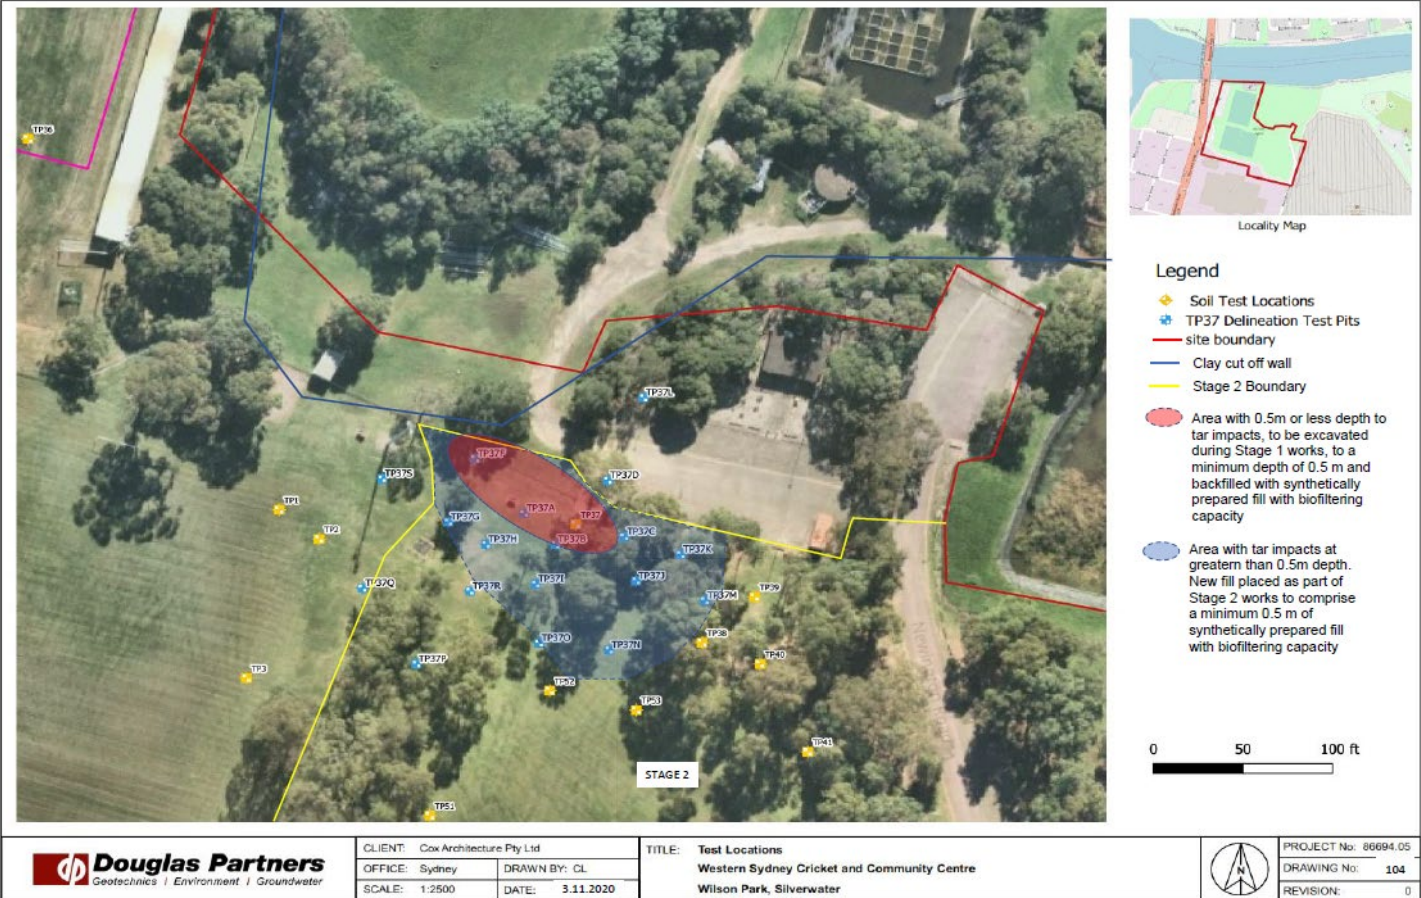
Attachment 2 TP37 works from CMP/RAP

- Discussion with Paul Gorman and Ben Ryan regarding the schedule and plan for the stripping and placement of material from the TP37 Area into placement area within Stage 1 oval identified that this had not been scheduled into the current works. These works are outline in the CMP/RAP (page 36 and shaded red in Drawing 104 (Attachment 2) and are required to allow the reopening to the public of the Stage 2 Area.

- Mostyn Copper/ Ford Civil to provide a schedule and plan for the works outlined in the CMP/RAP for the TP37 area. Confirming actual placement area and depth within the Stage 1 area.
