HAZARDOUS MATERIALS SURVEY

**Sutherland
Entertainment Centre –
30 Eton Street,
Sutherland NSW 2232**

**Prepared for:
Sutherland Shire
Council**

**Project No.
46702**

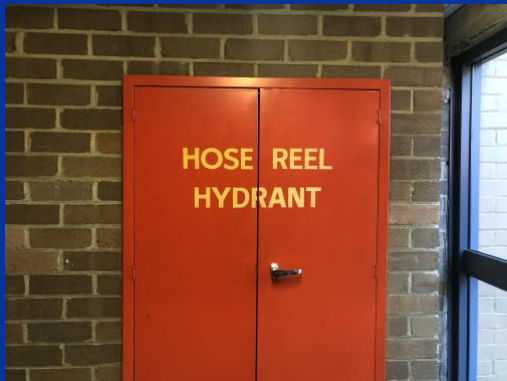
Photo No.
8

Throughout Building

Fire Hose Reel Casing – Positive for lead paint

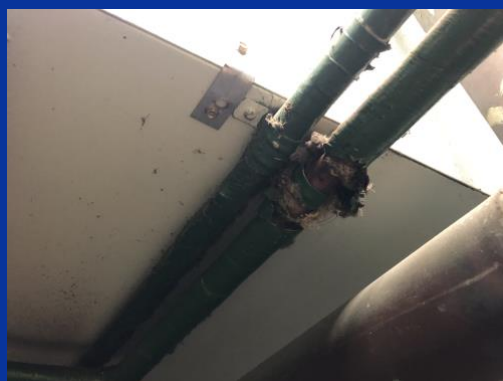
Photo No.
9

Second Level – Plant Room

Pipe lagging to water heater – Positive for SMF

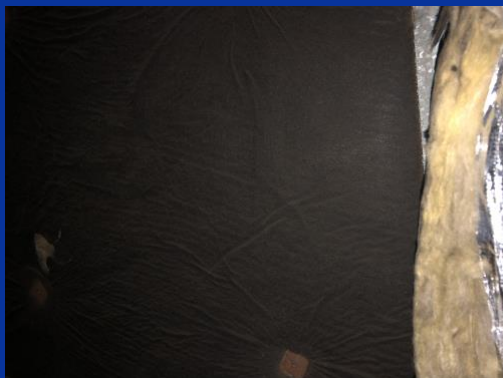
Photo No.
10

Throughout Building

Vent Internal - Fibrous Insulation – Positive for SMF

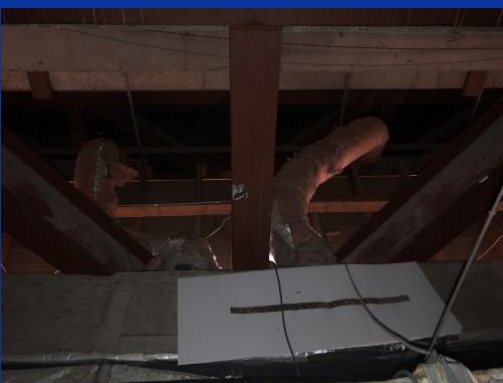
Photo No.
11

Throughout Building
