# ARBORIST'S REPORT

| PROPERTY: | 157 Maitland Street, Muswellbrook |
| DATE OF REPORT: | 16 April 2020 |
| PREPARED FOR: | Stanton Dahl Architects |

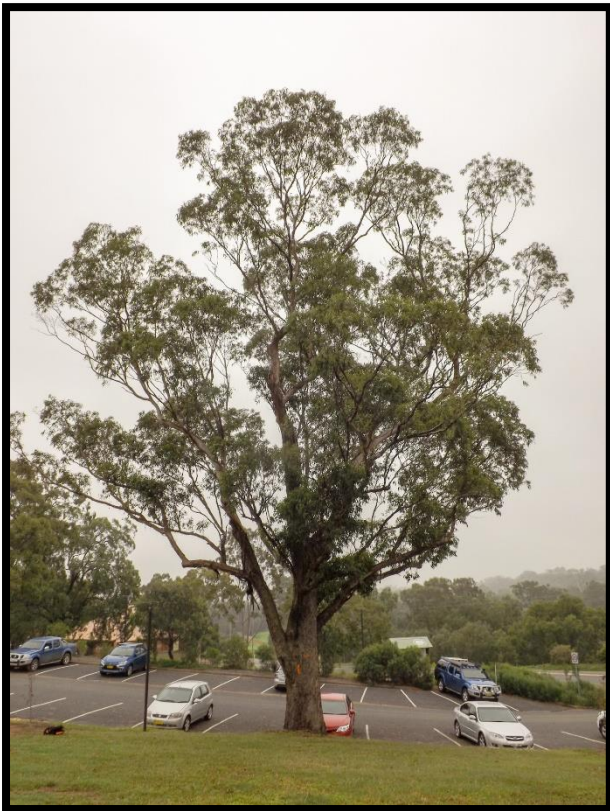
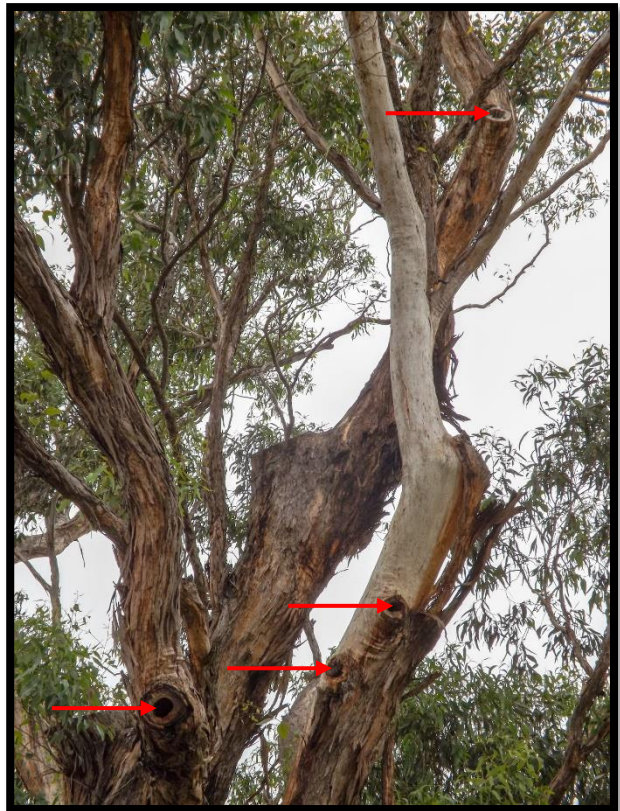
Tree 1 – *Eucalyptus microcarpa* – Green Leaved Box – ULE: 4C

- Leaf density 80% coverage
- Co - dominant stems from 5 metres high with some old cockatoo damage
- Slight deadwood to 50 mm diameter
- Remedial pruning has been carried out which shows hollow branches throughout from extensive subterranean termite activity
- Cavity (south) at 7 metres high 400 mm x 100 mm with recent cockatoo damage

- High (loss of structural integrity of branches – more frequent branch drop expected)

Tree 1 viewed from the south.

Examples of hollow branches in Tree 1.

- Remove tree before use [underneath] increases

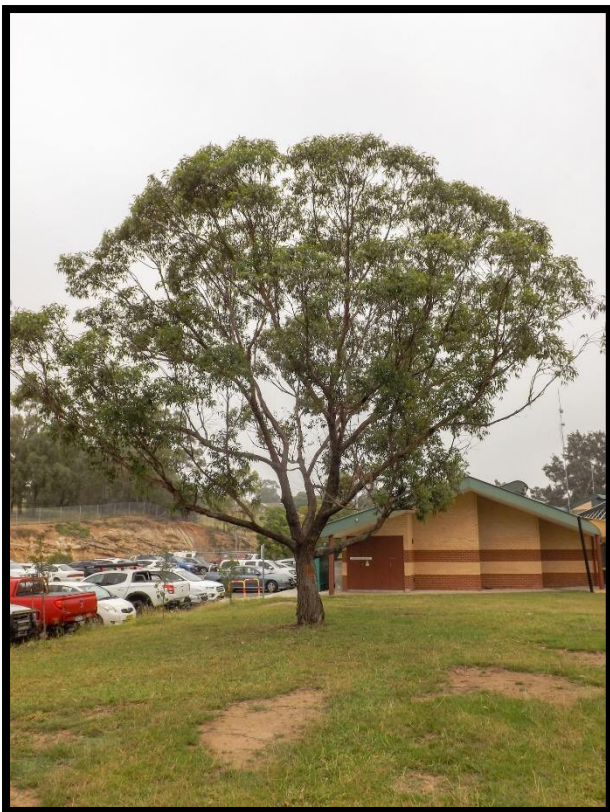
Tree 2 – *Eucalyptus botryoides* – Bangalay – ULE: 2B

- Leaf density of 70% coverage
- Slight deadwood to 50 mm diameter

- Low (minor deadwood)

Tree 2 viewed from the east.

- Monitor every 3 – 5 years

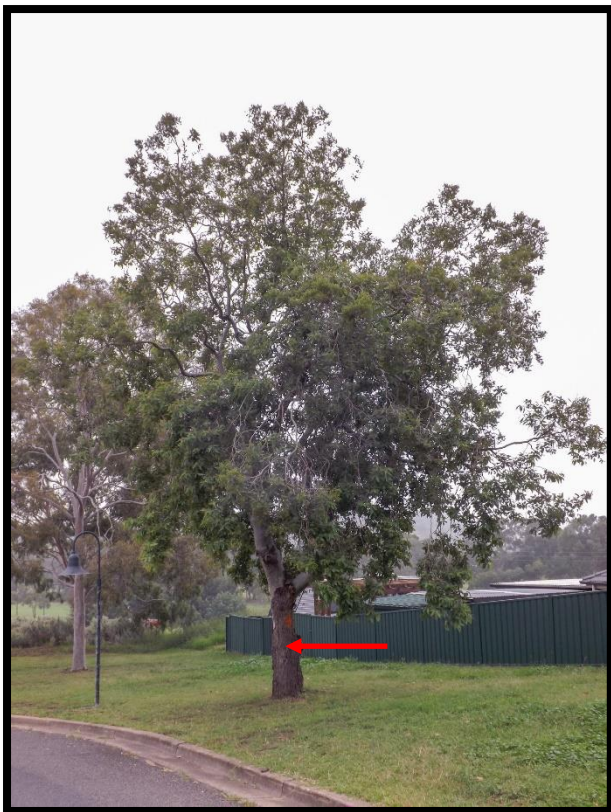
Tree 3 – *Corymbia torelliana* – Cadaghi – ULE: 2B

- Leaf density of 80% coverage
- Slight deadwood to 70 mm diameter

- Low (minor deadwood over low use area)

Tree 3 viewed from the south.

- Monitor every 3 – 5 years

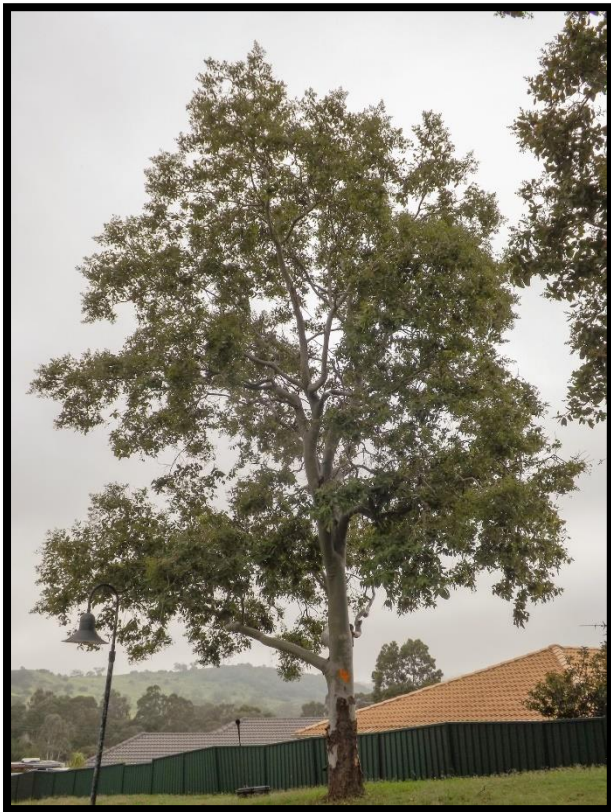
Tree 4 – *Corymbia torelliana* – Cadaghi – ULE: 2B

- Leaf density of 80% coverage
- Slight deadwood to 50 mm diameter
- Slight deadwood stubs to 250 mm long x 100 mm diameter

- Low (minor deadwood over low use area)

Tree 4 viewed from the south.

- Monitor every 3 – 5 years

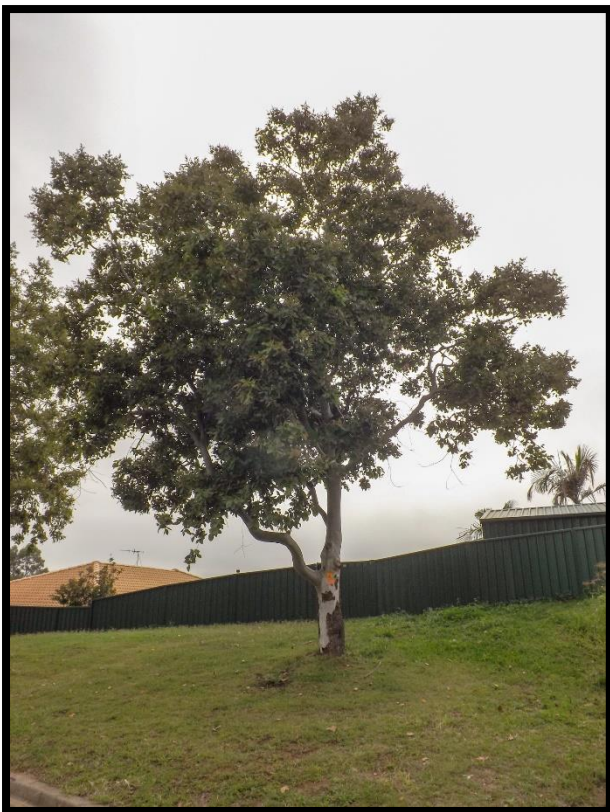
Tree 5 – *Corymbia torelliana* – Cadaghi – ULE: 2B

- Leaf density of 90% coverage
- Slight deadwood to 80 mm diameter

- Low (minor deadwood over low use area)

Tree 5 viewed from the south.

- Monitor every 3 – 5 years

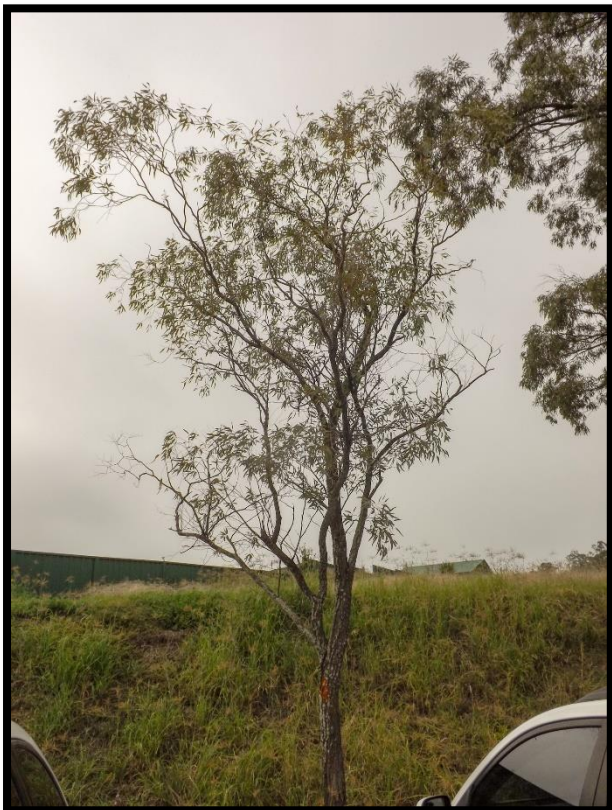
Tree 6 – *Eucalyptus sideroxylon* – Mugga Ironbark – ULE: 2B

- Leaf density 60% coverage
- Some tip dieback
- Co – dominant stems from 1.8 metres high with some included bark
- Some deadwood to 60 mm diameter

- Low (small tree in low use area)

Tree 6 viewed from the north.

- Monitor every 3 – 5 years

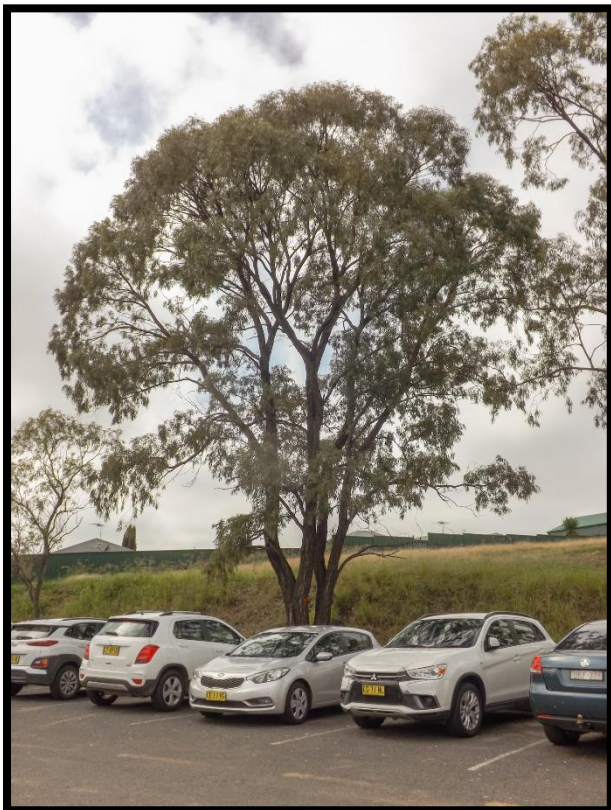
Tree 7 – *Eucalyptus crebra* – Narrow Leaved Ironbark – ULE: 2B

- Leaf density 80% coverage
- Slight deadwood to 80 mm diameter
- Co – dominant stems from 900 mm high (stem union appears stable)

- Some (minor deadwood over car park)

Tree 7 viewed from the NW.

- Prune deadwood over 50 mm diameter within 12 months at property owner's determination
- Monitor every 3 – 5 years

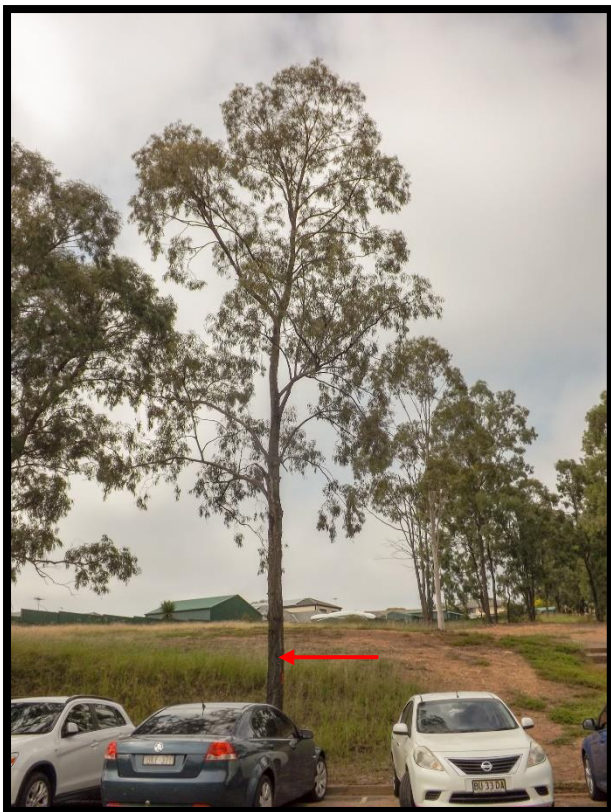
Tree 8 – *Eucalyptus crebra* – Narrow Leaved Ironbark – ULE: 2B

- Leaf density 60% coverage
- Slight deadwood to 50 mm diameter

- Low (50 mm or less diameter deadwood over car park)

Tree 8 viewed from the north.

- Monitor every 3 – 5 years

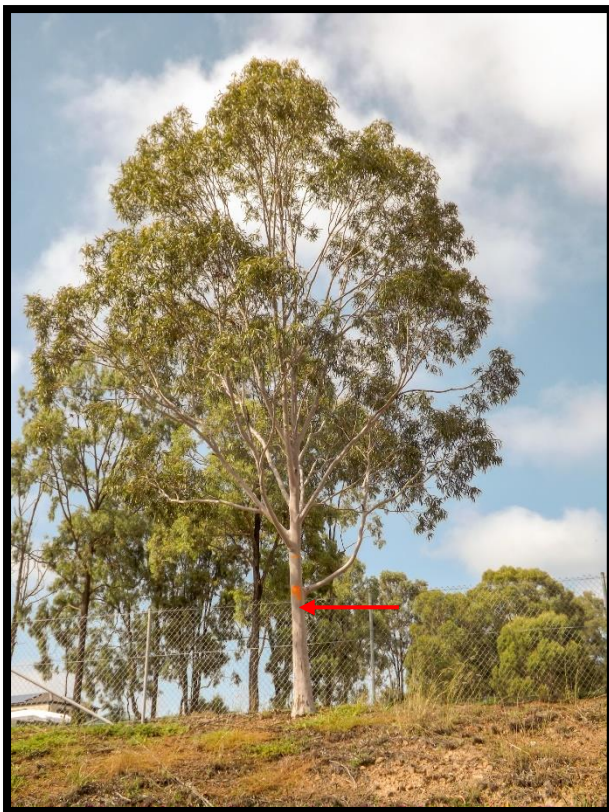
Tree 9 – *Corymbia citriodora* – Lemon Scented Gum – ULE: 2B

- Leaf density 60% coverage
- Slight deadwood to 10 mm diameter

- Low (minor deadwood over low use area)

Tree 9 viewed from the north.

- Monitor every 3 – 5 years

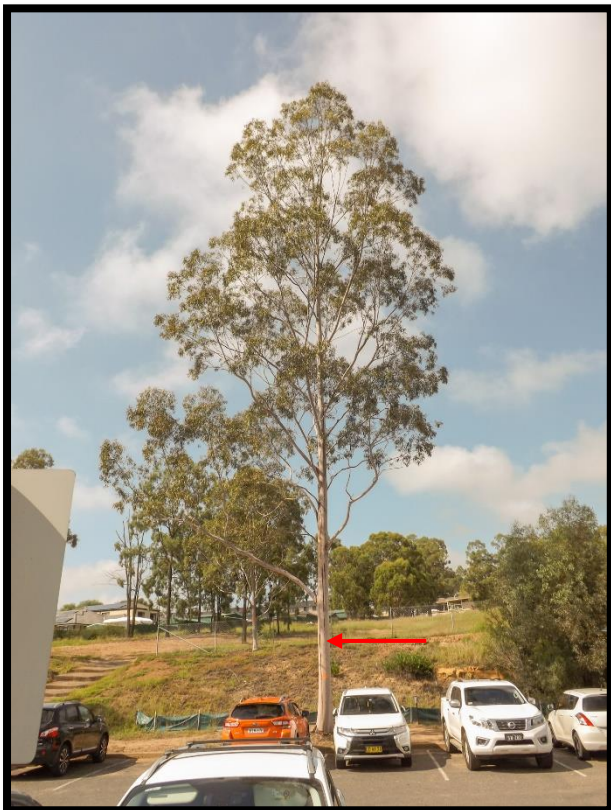
Tree 10 – *Corymbia citriodora* – Lemon Scented Gum – ULE: 2B

- Leaf density 60% coverage
- Slight deadwood to 20 mm diameter
- Slight bark splitting on trunk (possibly stress from drought and surface root damage)
- Some cockatoo damage in branch union at 8 metres high

- Low (minor deadwood over low use area)

Tree 10 viewed from the north.

- Monitor every 3 – 5 years

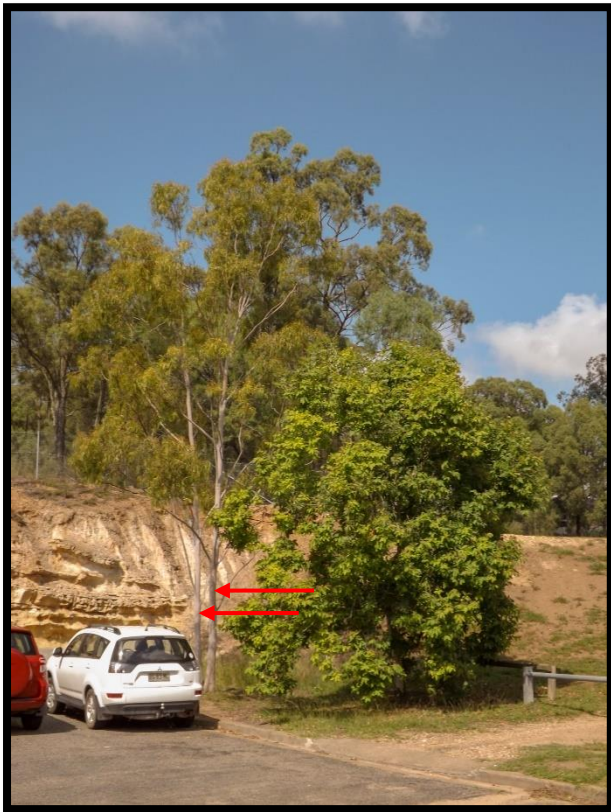
Tree 11 – *Corymbia citriodora* – Lemon Scented Gum – ULE: 4C

- Leaf density 60% coverage
- Slight deadwood to 10 mm diameter
- Co – dominant stems from ground level with active termites (early stages of damage)

- Some (stem union will eventually fail)

Tree 11 viewed from the north.

- Remove tree within 5 years

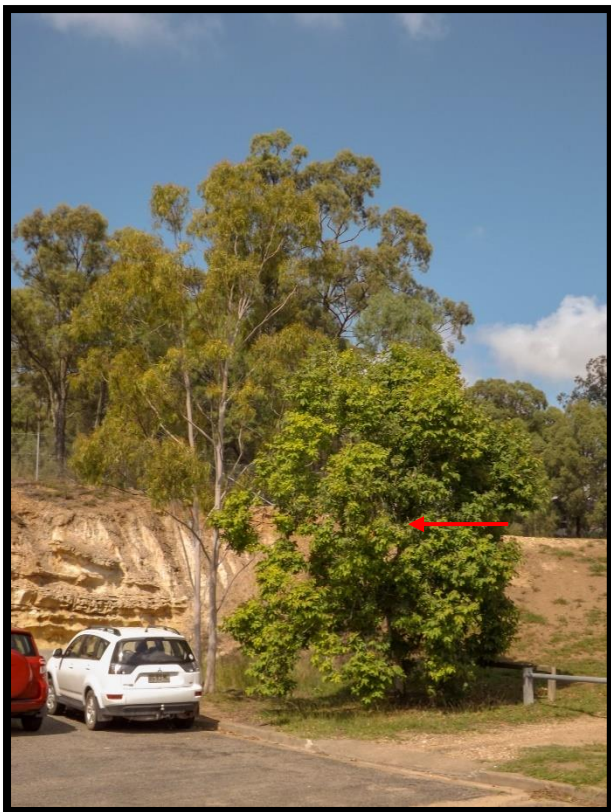
Tree 12 – *Corymbia torelliana* – Cadaghi – ULE: 2B

- Leaf density of 90% coverage
- Slight deadwood to 10 mm diameter

- Low (small tree adjacent to car park)

Tree 12 viewed from the NE.

- Monitor every 3 – 5 years

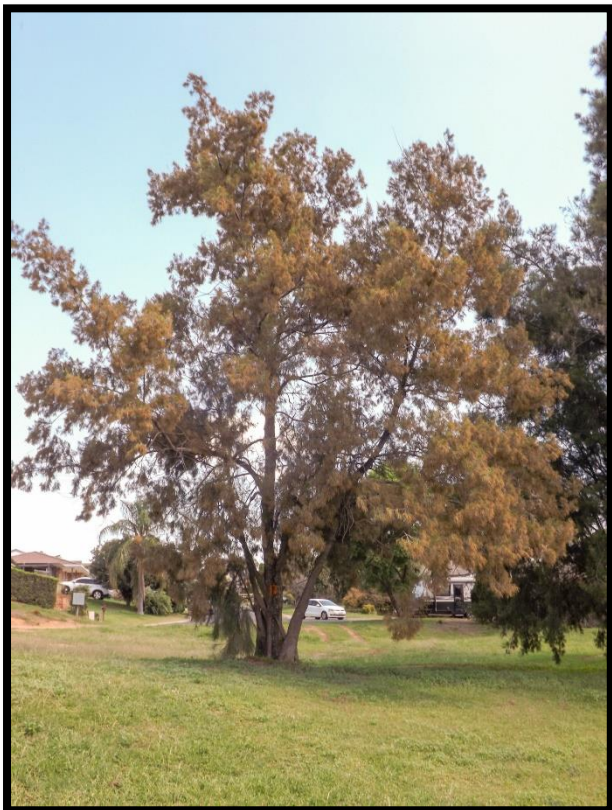
Tree 13 – *Casuarina cunninghamiana* – River Oak – ULE: 2B

- Leaf density 90% coverage
- Slight deadwood to 50 mm diameter
- Three dominant stems from 300 mm high (stem union appears stable)
- Epicormic shoot 8 metres long x 120 mm diameter at the base

- Low (minor deadwood over low use area)

Tree 13 viewed from the east.

- Monitor every 3 – 5 years

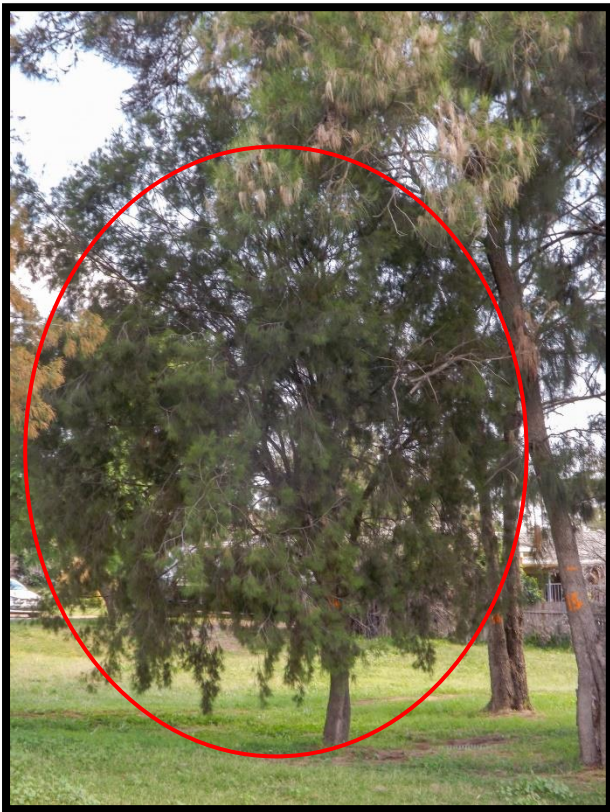
Tree 14 – *Casuarina cunninghamiana* – River Oak – ULE: 2B

- Leaf density 90% coverage
- Slight deadwood to 20 mm diameter
- Co – dominant stems from 500 mm high (stem union appears stable)

- Low (minor deadwood over low use area)

Tree 14 viewed from the east.

- Monitor every 3 – 5 years

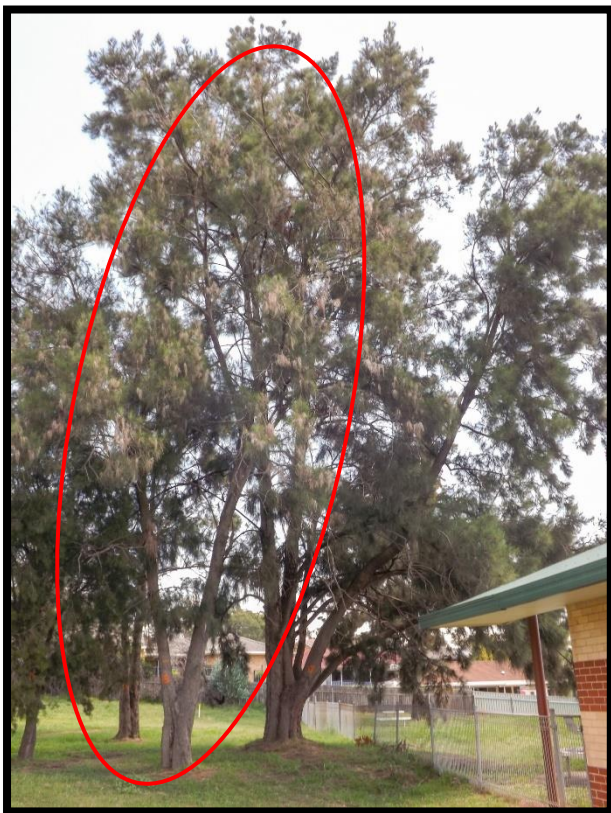
Tree 15 – *Casuarina cunninghamiana* – River Oak – ULE: 2B

- Leaf density 90% coverage
- Slight deadwood to 50 mm diameter
- Co – dominant stems from 1.3 metres high (stem union appears stable)
- Partial occlusion base (900 mm long x 100 mm wide – termite damage, resonates solid)
- Partial occlusion at 3 metres high (300 mm long x 50 mm wide, resonates solid)

Tree 15 viewed from the east.

- Monitor every 3 – 5 years

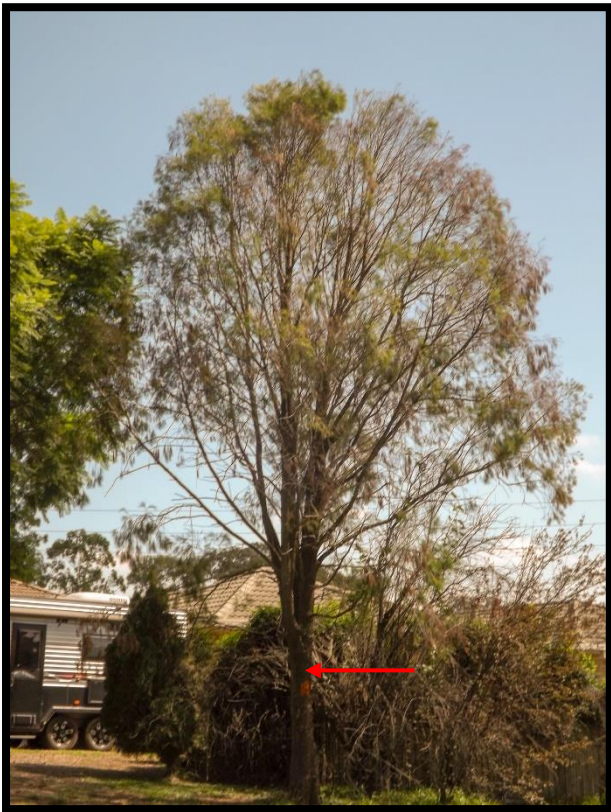
Tree 18 – *Casuarina cunninghamiana* – River Oak – ULE: 4C

- Some (minor deadwood over low use area, some structural defects)

Tree 18 viewed from the east.

- Remove within 5 years

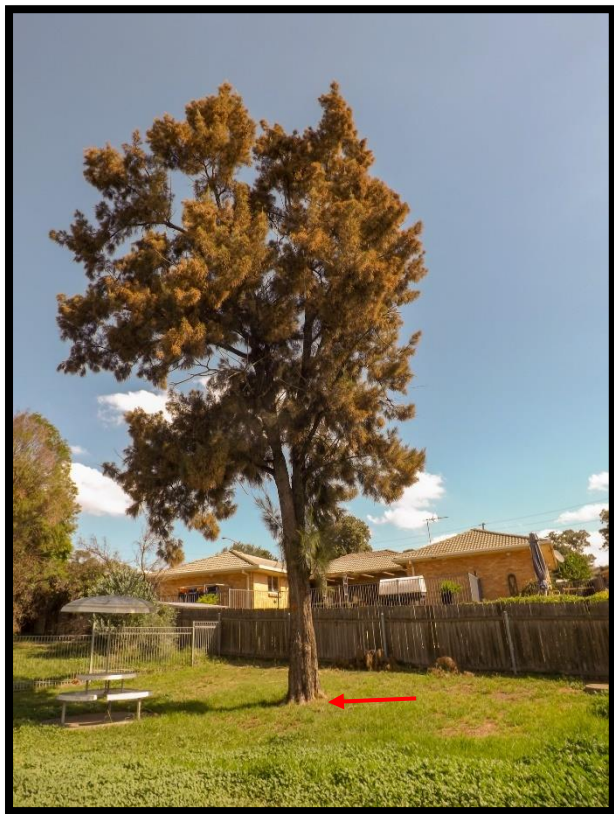
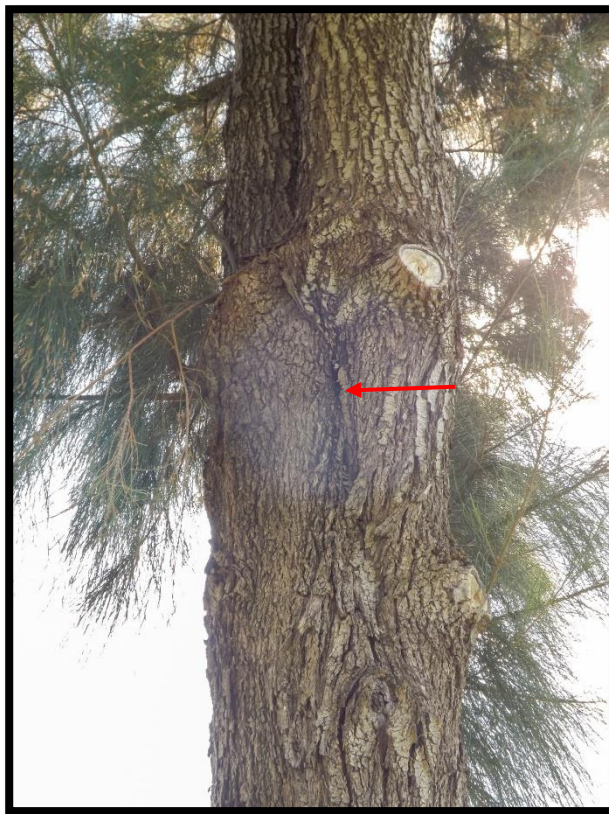
Tree 19 – *Casuarina cunninghamiana* – River Oak – ULE: 4C

- Some (structural defect over low use area)

Tree 19 viewed from the NW.

Included bark on Tree 19.

- Remove within 5 years

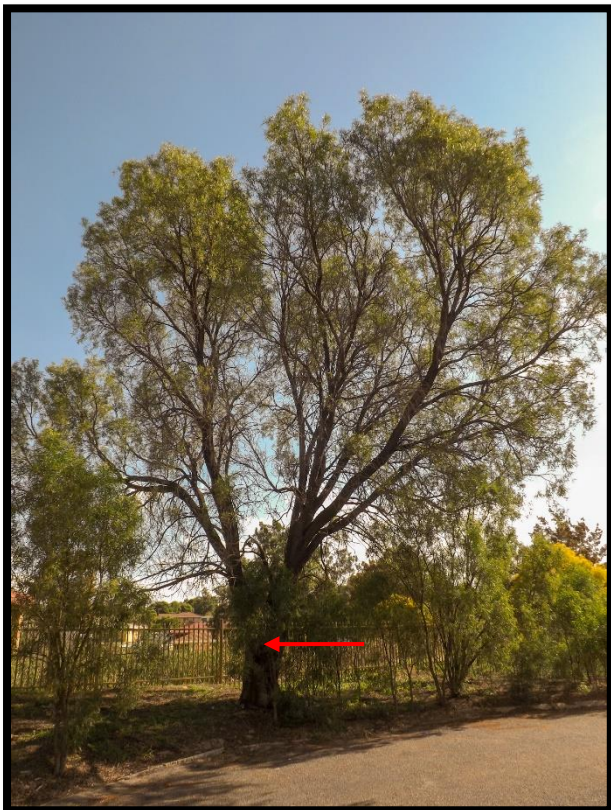
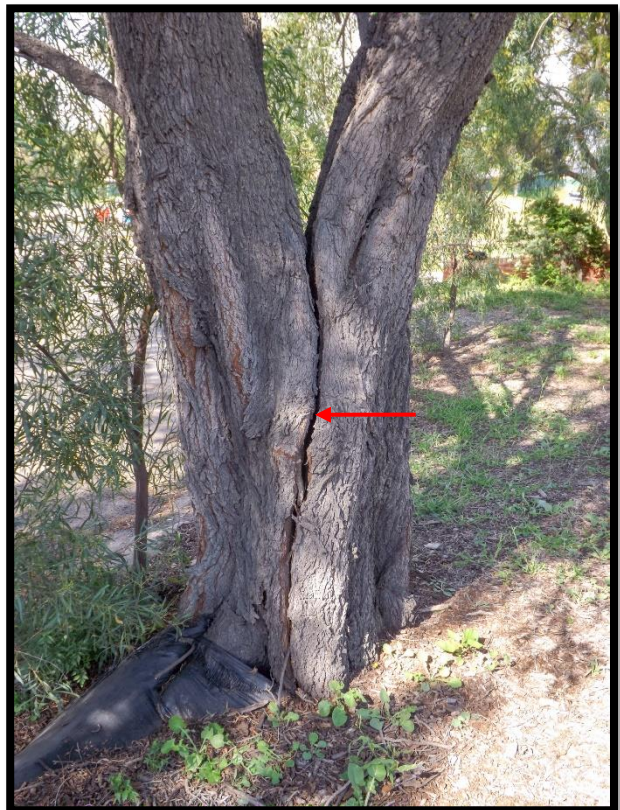
Tree 32 – *Acacia salicina* – Native Willow – ULE: 4C

- Moderate (structurally defective stem union adjacent to vehicular turning area)

Tree 32 viewed from the NW.

Split in stem union of Tree 32.

- Remove within 12 months
