# Preliminary Site Investigation Richard Gill Music Academy, Muswellbrook

Prepared for  
Richard Gill National Music Academy Ltd

7 May 2020

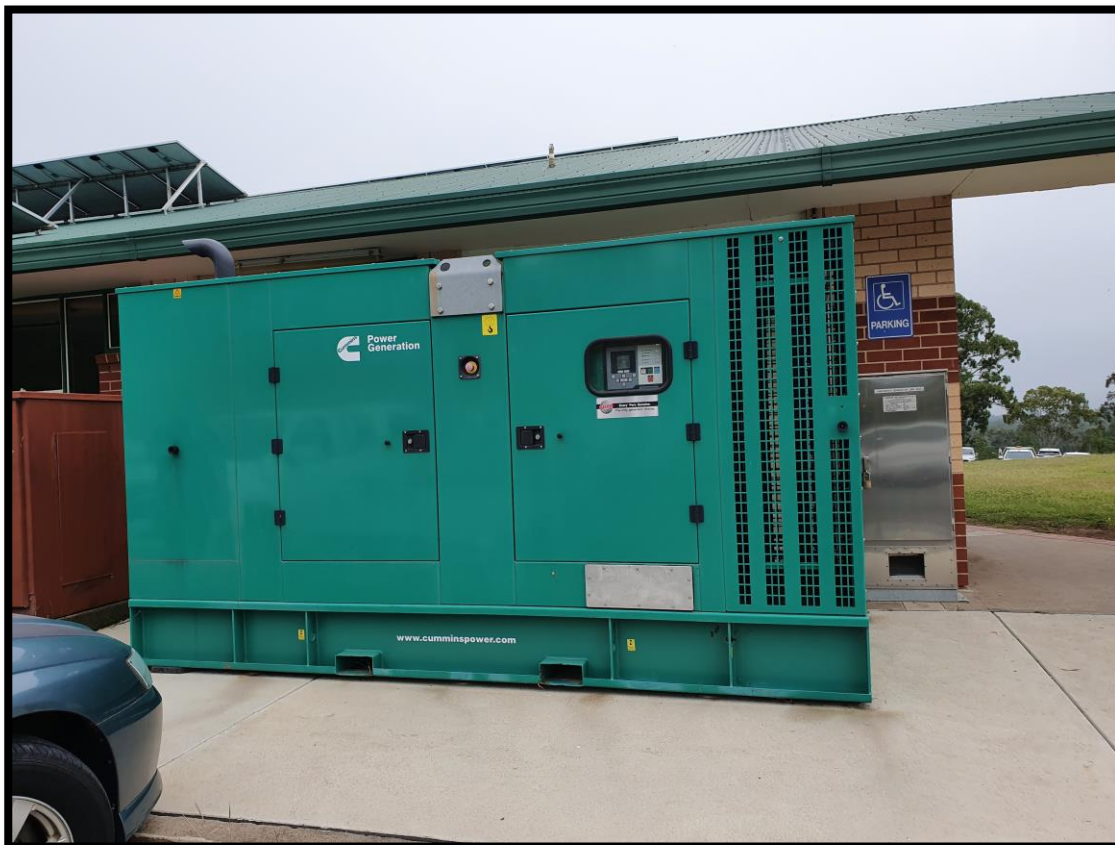
Figure 8-1 Diesel Generator

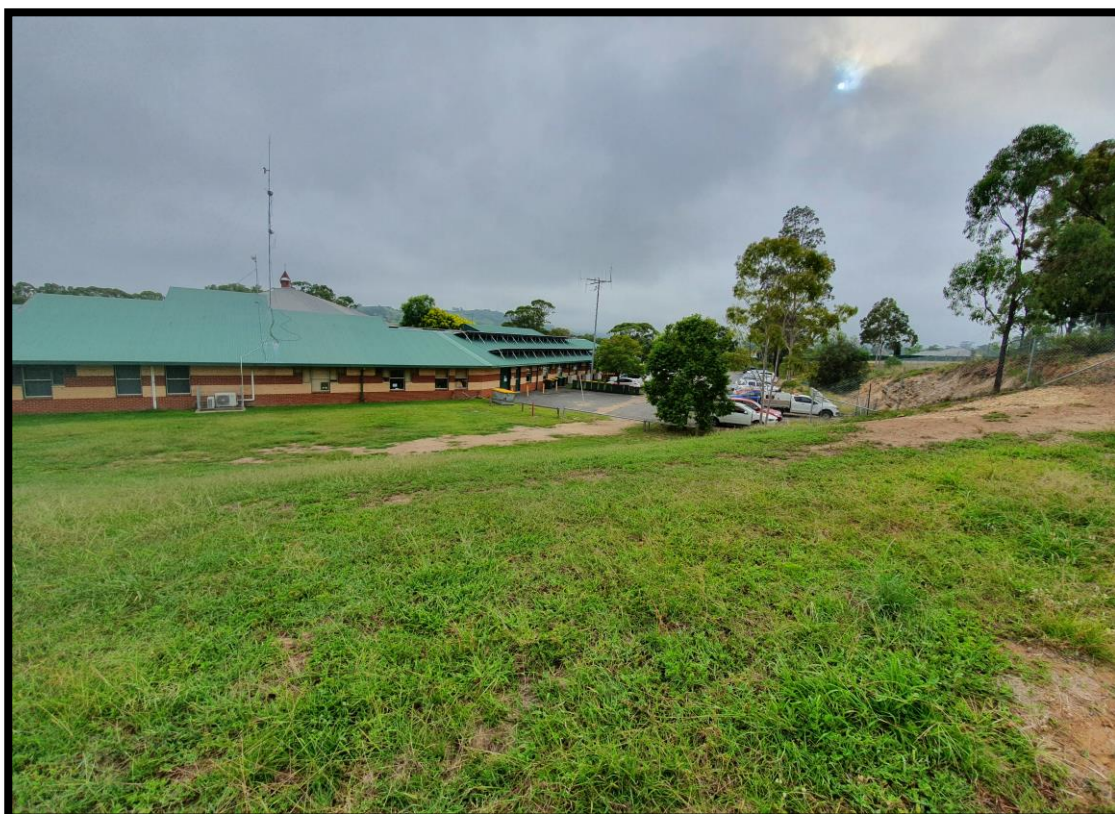
Figure 8-2 Site topography indicative of local regarding

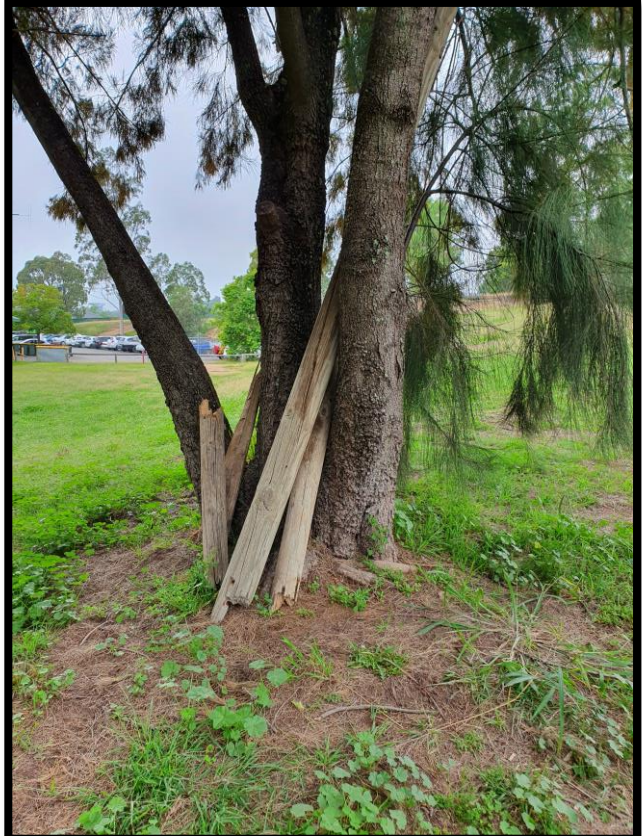
Figure 8-4 Illegally disposed material

- > Due diligence should be employed during construction work and ensure materials exhibiting signs of contaminations (stains, odours etc.) are separated and assessed.

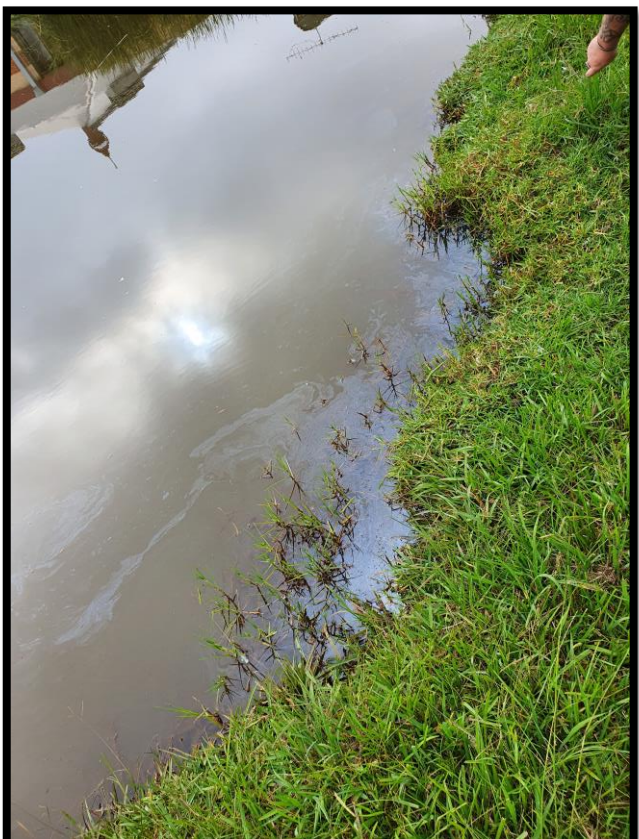
Figure 8-6 Evidence of iron oxidation

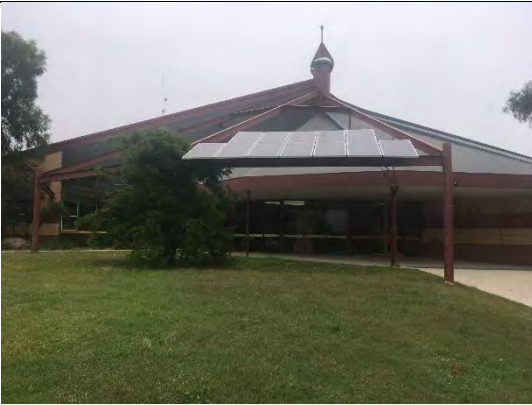
**Photo 1**  
Council offices – 157 Maitland St  
Muswellbrook  
No asbestos detected or observed

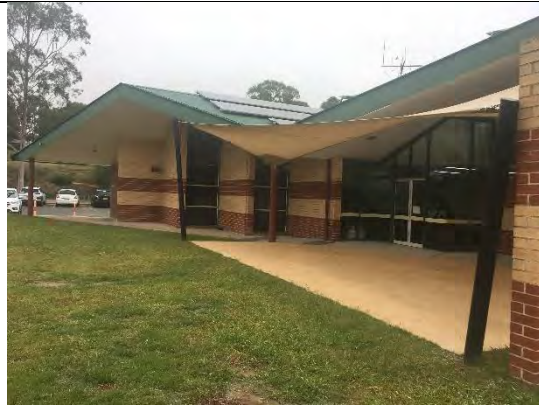
**Photo 2**  
Council offices – 157 Maitland St  
Muswellbrook  
No asbestos detected or observed

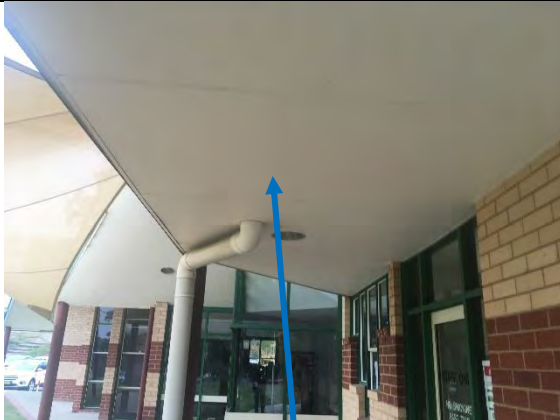
**Photo 3**  
Eave linings - Villaboard  
No asbestos detected  
Sample No: E73071

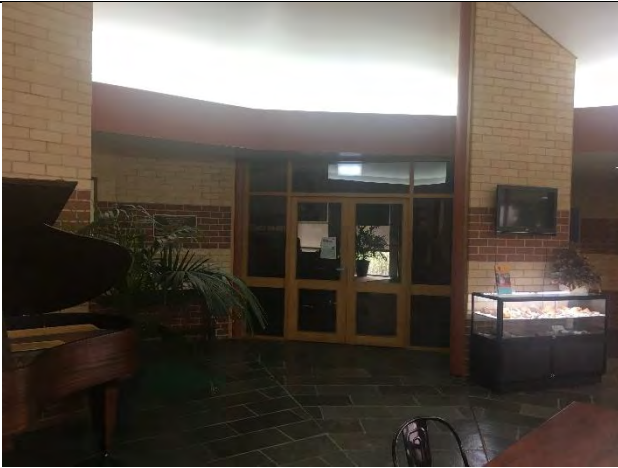
**Photo 7**  
**Internal foyer**  
**No asbestos observed**

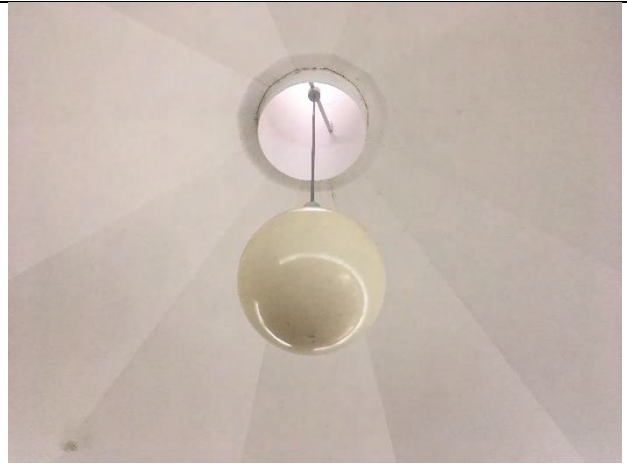
**Photo 8**  
**Internal foyer – ceiling - plaster**  
**No asbestos observed**

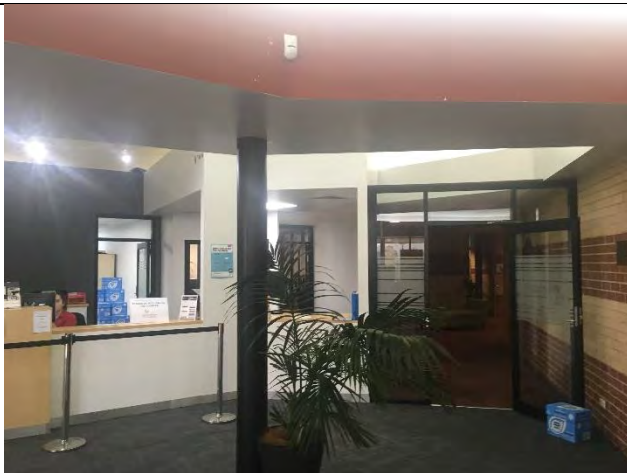
**Photo 9**  
**Internal foyer**  
**No asbestos observed**

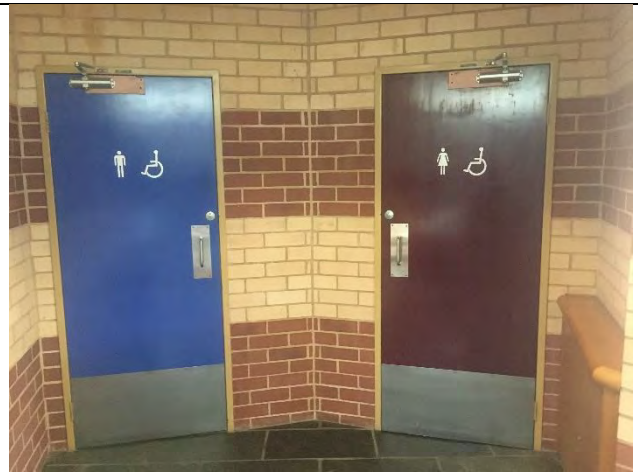
**Photo 10**  
**Internal wet areas**  
**No asbestos observed**

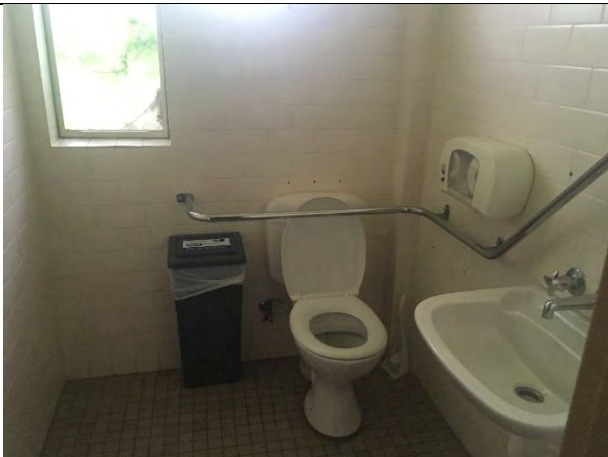
**Photo 11**  
**Internal wet areas**  
**No asbestos observed**

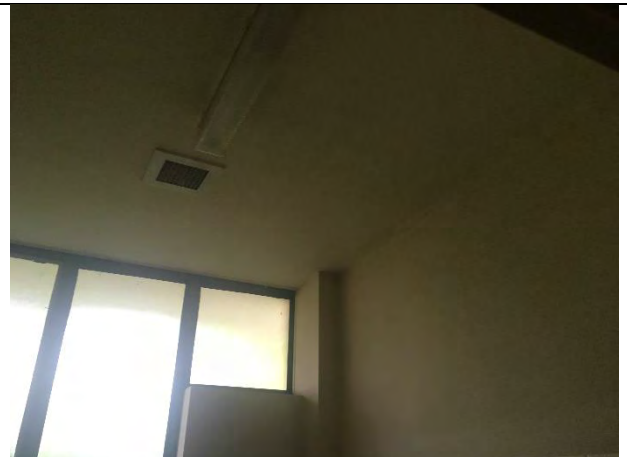
**Photo 12**  
**Internal wet areas**  
**No asbestos observed**

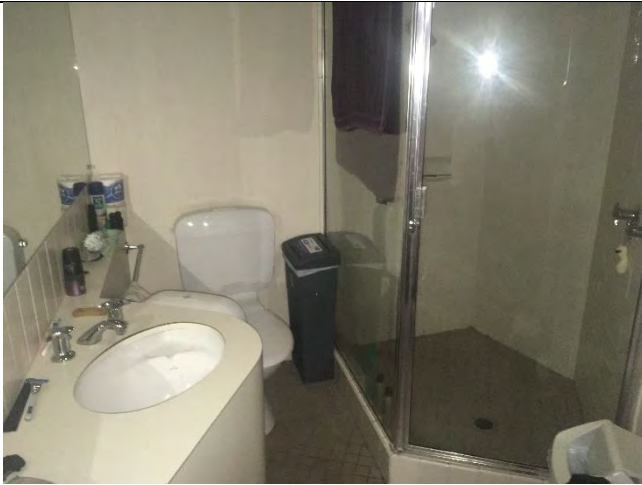
**Photo 13**  
**Internal wet areas**  
**No asbestos observed**

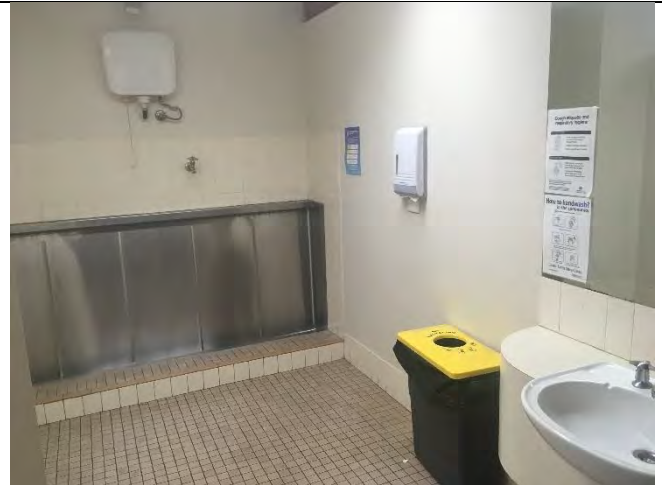
**Photo 14**  
**Internal wet areas**  
**No asbestos observed**

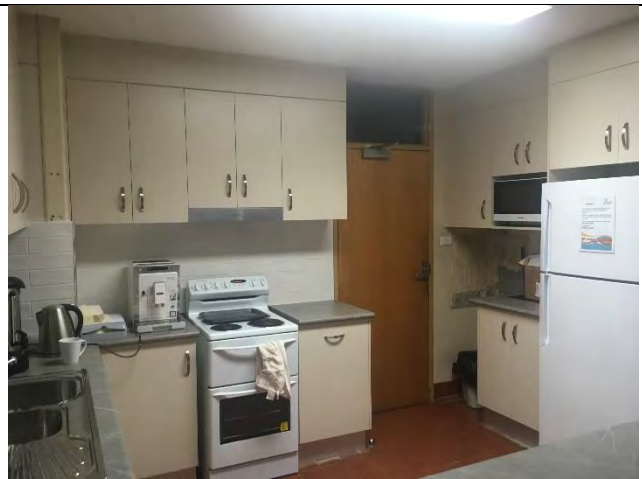
**Photo 15**  
**Internal Kitchen areas**  
**No asbestos observed**

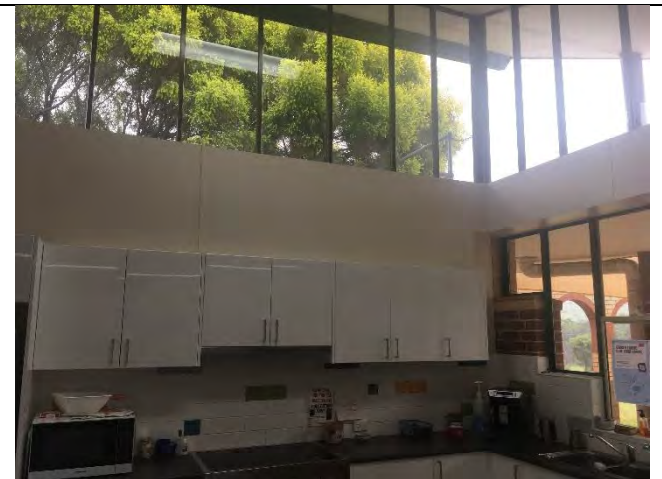
**Photo 16**  
**Internal Kitchen areas**  
**No asbestos observed**

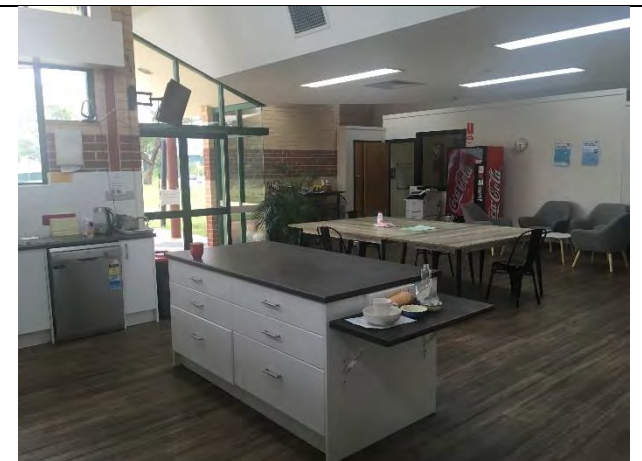
**Photo 17**  
**Internal Kitchen areas**  
**No asbestos observed**

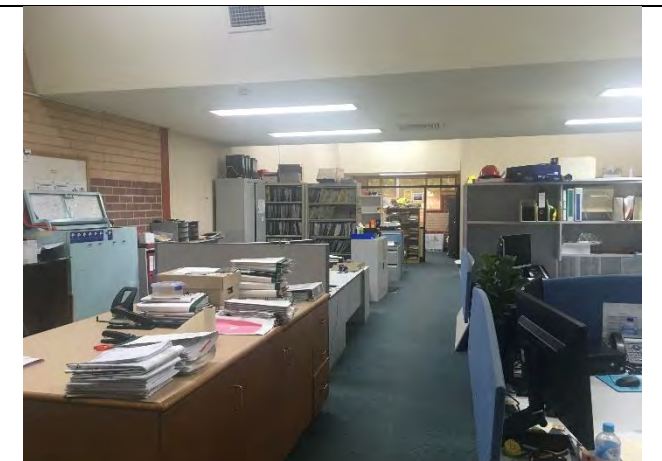
**Photo 18**  
**All office spaces**  
**No asbestos observed**

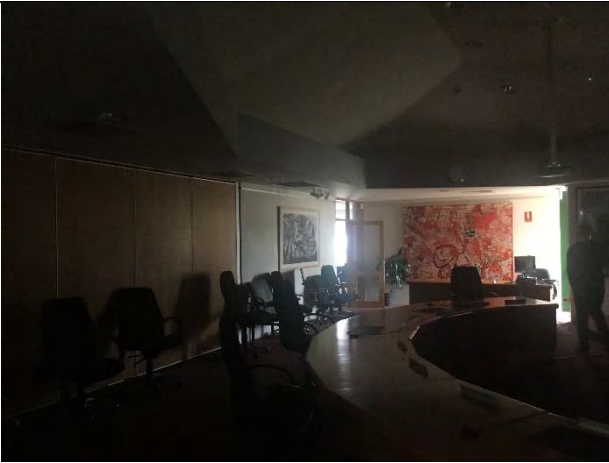
**Photo 19**  
**All office spaces – Council Chambers**  
**No asbestos observed**

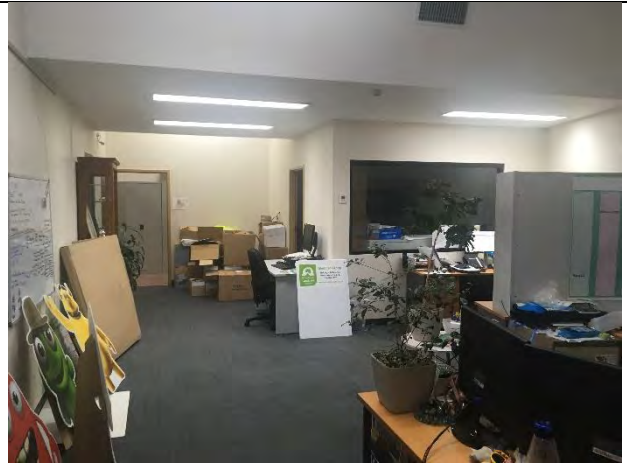
**Photo 20**  
**All office spaces**  
**No asbestos observed**

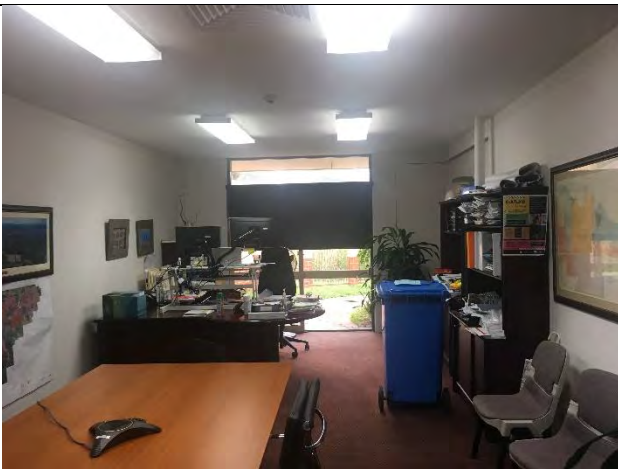
**Photo 21**  
**All office spaces**  
**No asbestos observed**

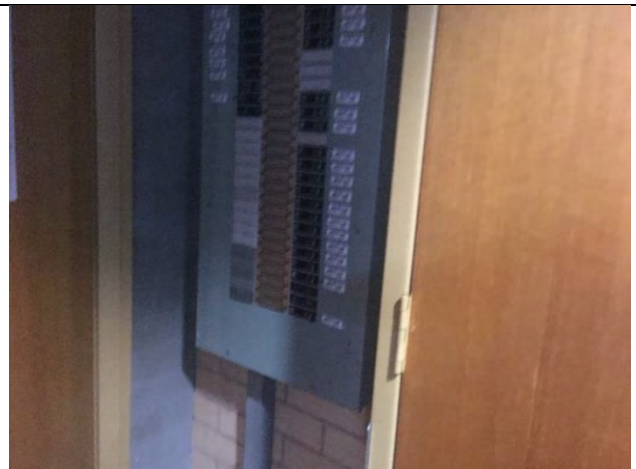
**Photo 22**  
**Internal Electrical Boards**  
**No asbestos observed**

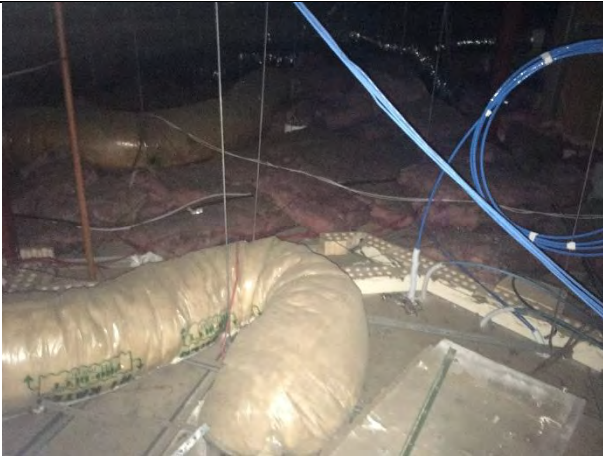
**Photo 25**

**Plant room ceiling space access – SMF batts  
No asbestos observed**

- > During demolition or refurbishment, any works involving SMF should comply with the SWA/NOHSC (1990) Synthetic Mineral Fibres; National Standard for SMF; and the National Code of Practice for the Safe Use of SMFs. All contractors working in areas where SMF is identified and may be impacted should wear appropriate Personal Protective Equipment (PPE) as outlined in the above NOHSC Code.

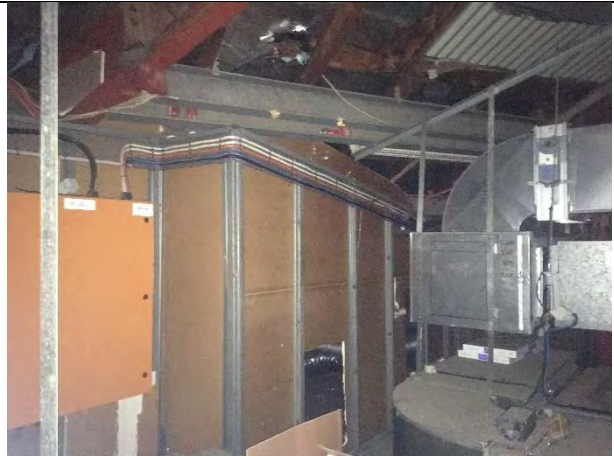
**Photo 26**

**Plant room ceiling space access – metal duct work – Masonite divides  
No asbestos observed**

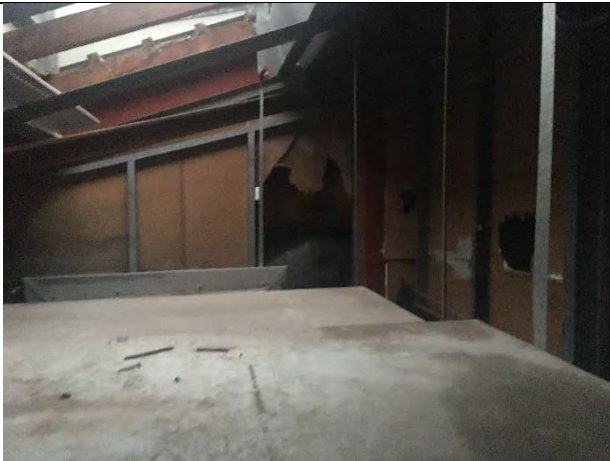
**Photo 27**

**Plant room access – metal duct work –  
Masonite divides  
No asbestos observed**

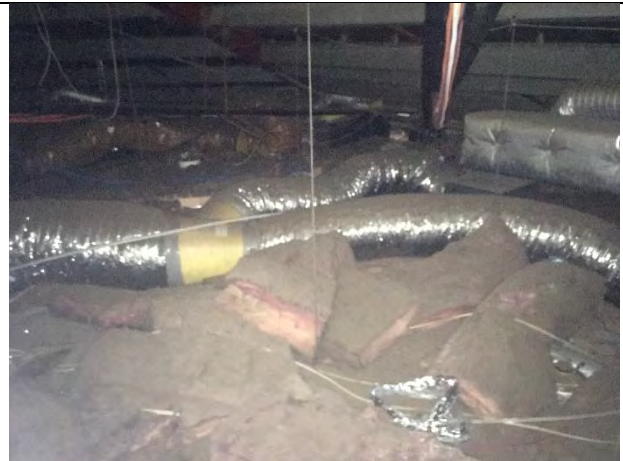
**Photo 28**

**Plant room ceiling space access – SMF batts  
No asbestos observed**

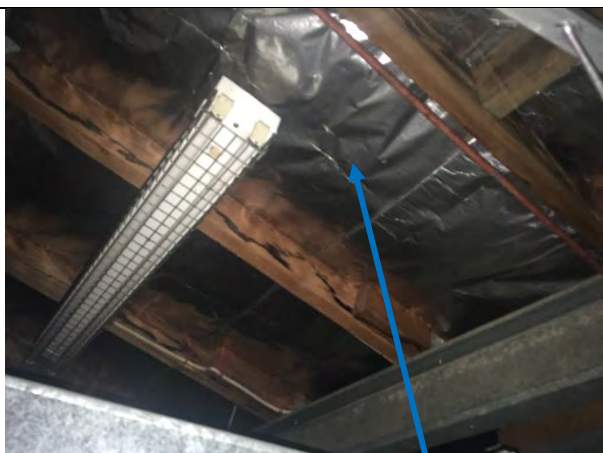
**Photo 29**

**Plant room access – foil clad SMF insulation  
No asbestos observed**

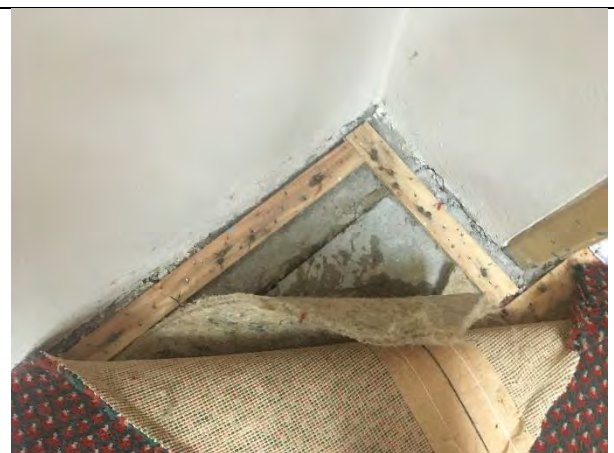
**Photo 30**

**Floor beneath carpets - Concrete  
No asbestos observed**
