Hazardous Materials Survey

2-60 Cumberland St, The Rocks NSW

Report Title: Hazardous Materials Survey - 2-60 Cumberland St, The Rocks NSW
Report No: E24614.E10_Rev1

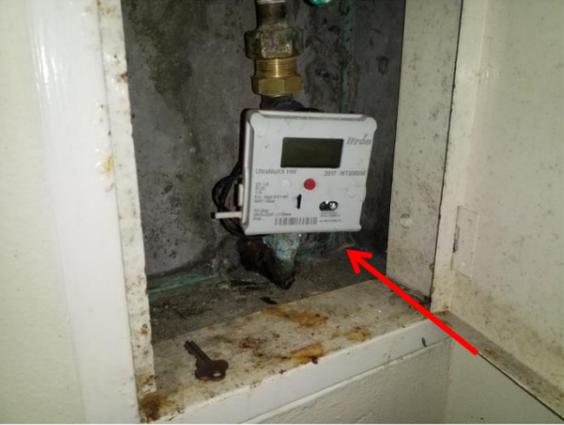
Basement level, outside unit 1, water meter cupboard, redundant gaskets	Gaskets	Friable	Similar to A38	Assume positive	Not determined	Fair Maintenance only	Priority 4: Negligible Risk Level	Remove prior to refurbishment works

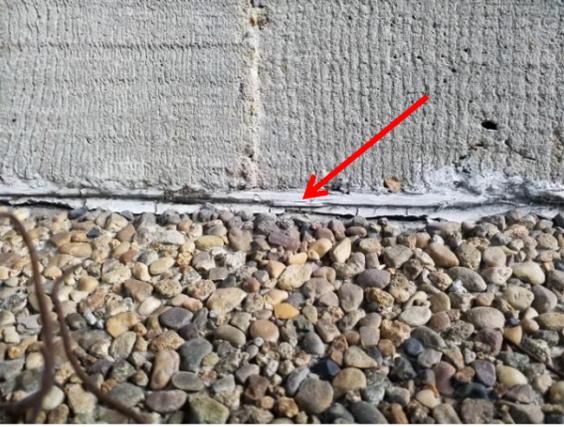
Unit 6, balcony, between pebble surface and wall	Sealant	Non-friable	A49	Chrysotile Asbestos Detected	Not determined	Good Maintenance only	Priority 4: Negligible Risk Level	Remove prior to refurbishment works

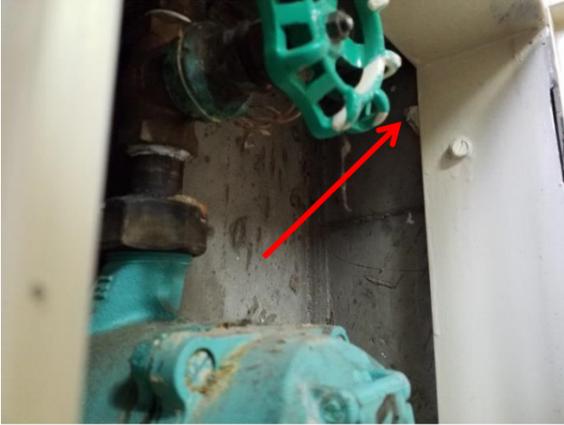
Common area, outside unit 2, water meter riser, packing to frame	Asbestos cement sheeting	Non-friable	Similar to A47	Assume positive	Not determined	Good Maintenance only	Priority 4: Negligible Risk Level	Remove prior to refurbishment works

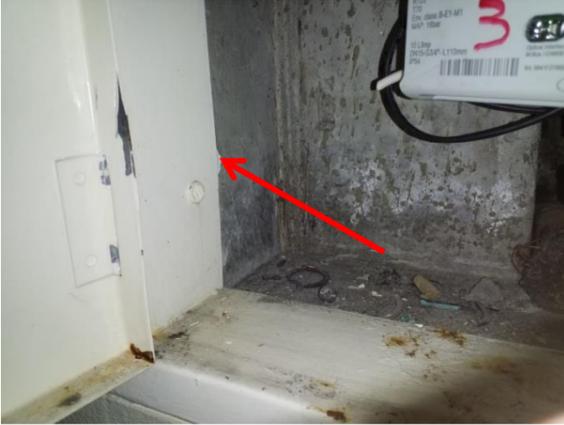
Common area, outside unit 3, water meter riser, packing to frame	Asbestos cement sheeting	Non-friable	Similar to A47	Assume positive	Not determined	Good Maintenance only	Priority 4: Negligible Risk Level	Remove prior to refurbishment works

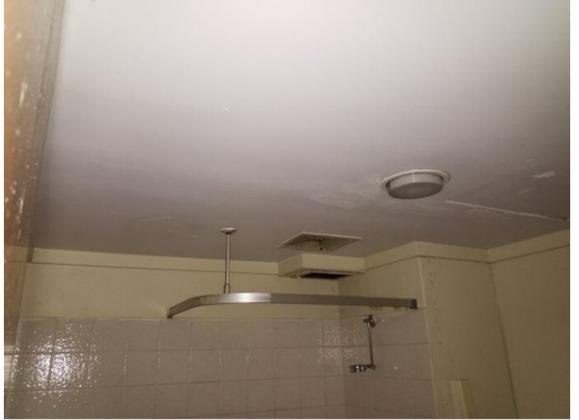
Unit 3 bathroom	Asbestos cement sheeting	Non-friable	Similar to A47	Assume positive	6m ²	Good Maintenance only	Priority 4: Negligible Risk Level	Remove prior to refurbishment works

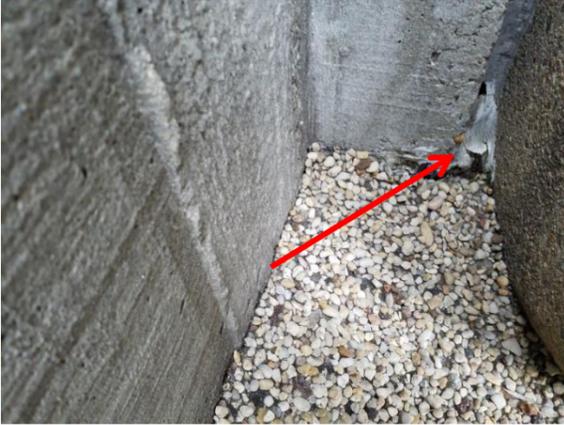
Unit 4, outdoor area, waterproofing to pebble surface and concrete wall	Sealant	Non-friable	Similar to A54	Assume positive	Not determined	Fair Maintenance only	Priority 4: Negligible Risk Level	Remove prior to refurbishment works

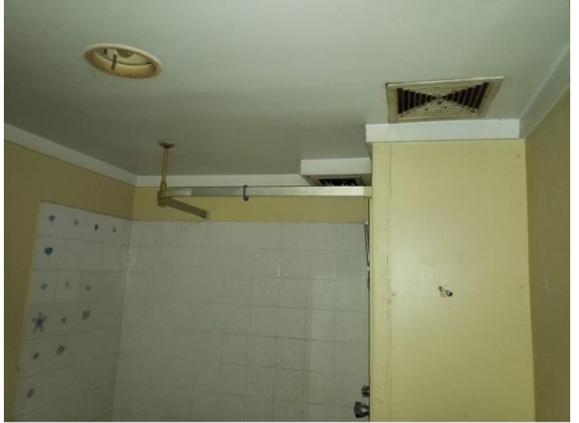
Unit 5 bathroom ceiling	Asbestos cement sheeting	Non-friable	Similar to A47	Assume positive	6m ²	Good Maintenance only	Priority 4: Negligible Risk Level	Remove prior to refurbishment works

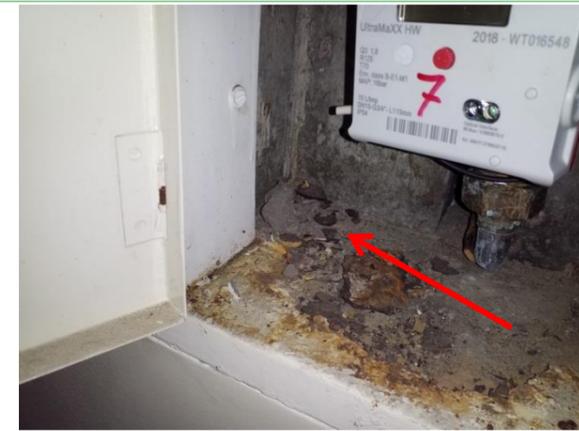
Common area, outside unit 7, water meter risers, redundant gaskets	Gaskets	Friable	Similar to A38	Assume positive	Not determined	Fair Maintenance only	Priority 4: Negligible Risk Level	Remove prior to refurbishment works

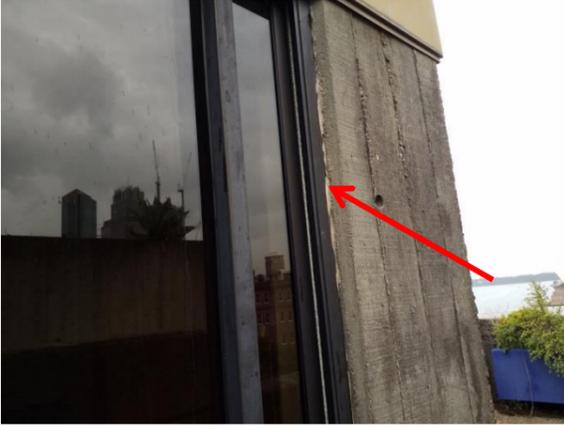
Unit 7, rooftop terrace door, sealant between frame and wall	Sealant	Non-friable	A52	Chrysotile Asbestos Detected	Not determined	Good Maintenance only	Priority 4: Negligible Risk Level	Remove prior to refurbishment works

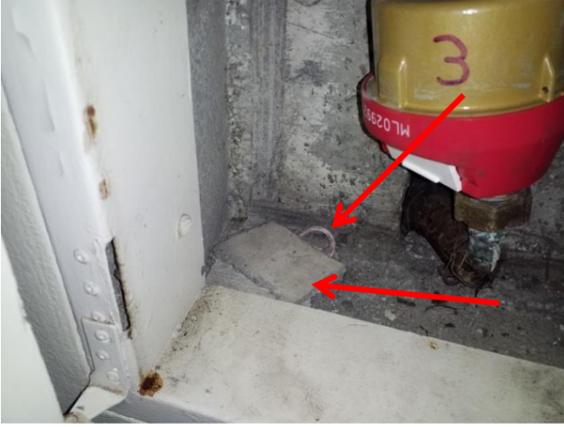
Common are, outside unit 3, water meter riser, redundant gaskets	Gaskets	Friable	Similar to A38	Assume positive	Not determined	Fair Maintenance only	Priority 4: Negligible Risk Level	Remove prior to refurbishment works

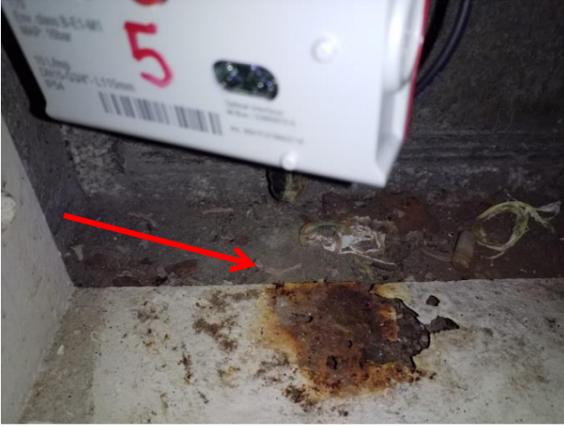
Common are, outside unit 5, water meter riser, redundant gaskets	Gaskets	Friable	Similar to A38	Assume positive	Not determined	Fair Maintenance only	Priority 4: Negligible Risk Level	Remove prior to refurbishment works

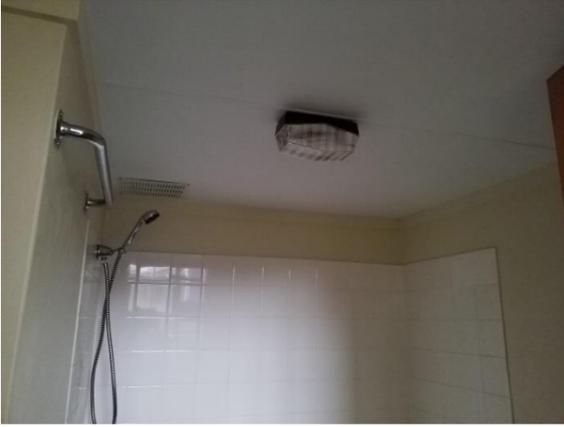
Unit 6 bathroom, ceiling	Asbestos cement sheeting	Non-friable	A58	Chrysotile Asbestos Detected Organic Fibres Detected	6m ²	Good Maintenance only	Priority 4: Negligible Risk Level	Remove prior to refurbishment works

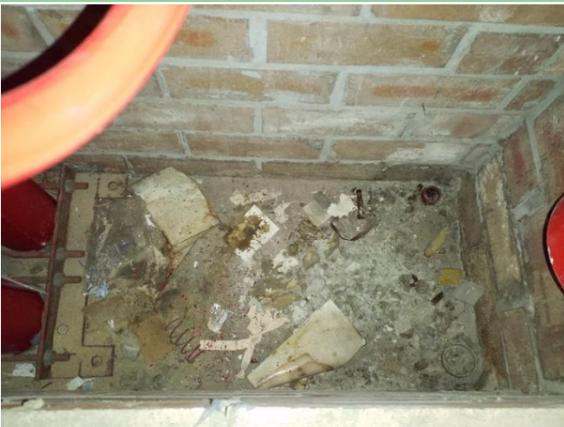
All floors, fire hydrant cupboards, floor surfaces dusts	Asbestos containing dusts	Friable	Similar to A09	Assume positive	Not determined	Poor Maintenance only	Priority 3: Low Risk Level	Restrict access to hydrant cupboards to essential services only. Remove material prior to undertaking any works on hydrant lines.

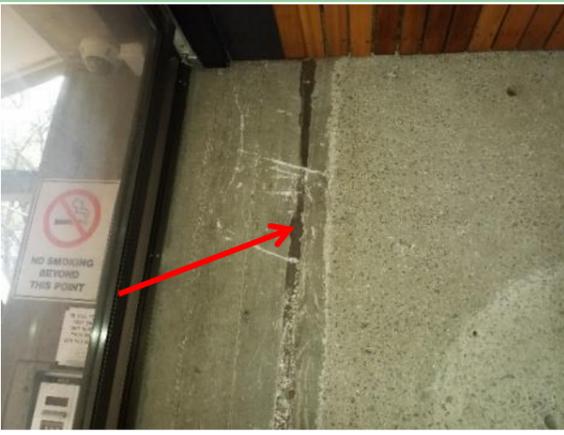
Ground floor, adjacent to main door residual material to north wall	Sealant	Non-friable	A07	Chrysotile Asbestos Detected	Not determined	Good Maintenance only	Priority 4: Negligible Risk Level	Remove prior to refurbishment works

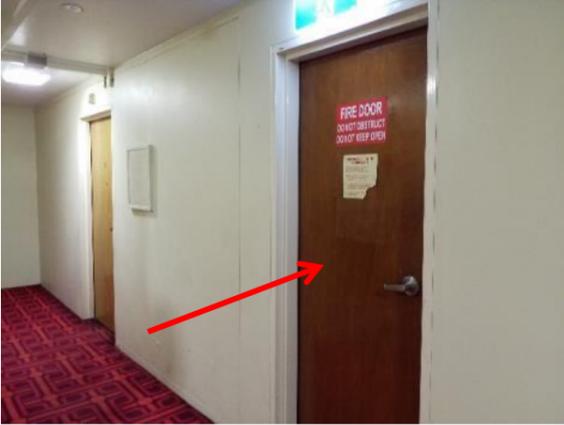
First floor, western fire stairs, door "Padde"	Fire door	Friable	Similar to A10	Assume positive	1 door	Good Maintenance only	Priority 4: Negligible Risk Level	Remove prior to refurbishment works

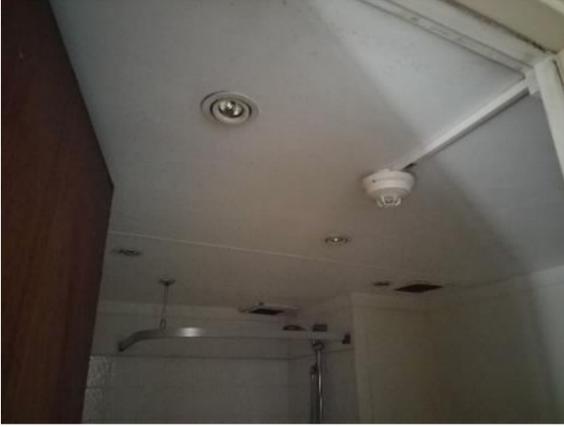
First floor, unit 13, bathroom, ceiling	Asbestos cement sheeting	Non-friable	Similar to A17	Assume positive	6m ²	Good Maintenance only	Priority 4: Negligible Risk Level	Remove prior to refurbishment works

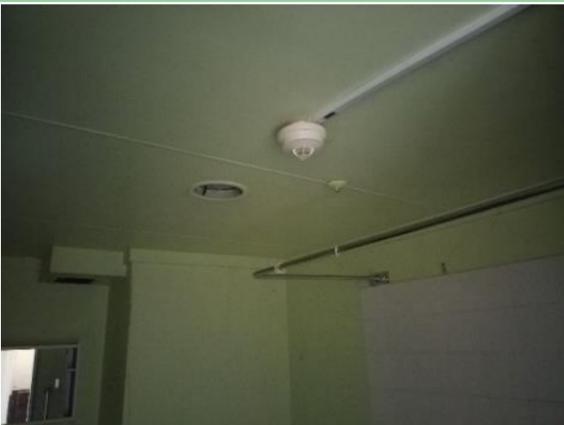
Second floor, unit 21 bathroom, ceiling	Asbestos cement sheeting	Non-friable	Similar to A17	Assume positive	6m ²	Good Maintenance only	Priority 4: Negligible Risk Level	Remove prior to refurbishment works

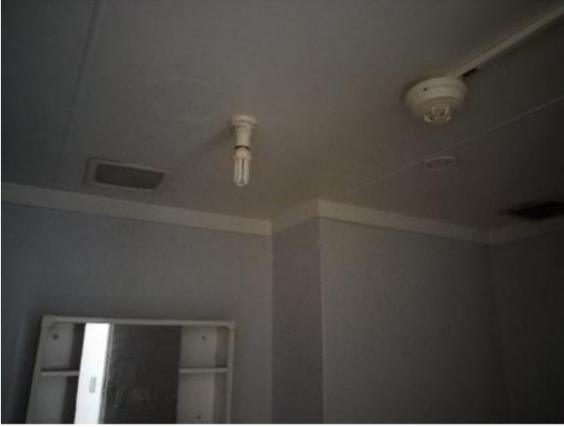
Second floor, unit 24 bathroom ceiling	Asbestos cement sheeting	Non-friable	Similar to A17	Assume positive	6m ²	Good Maintenance only	Priority 4: Negligible Risk Level	Remove prior to refurbishment works

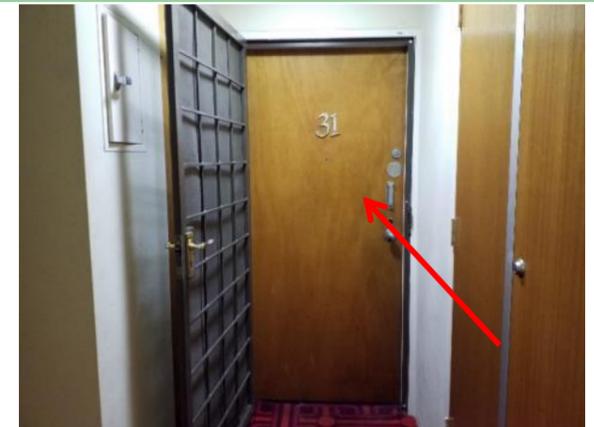
Third floor, unit 31, entry door "Padde" Fire door Friable Similar to A10 **Assume positive** 1 door Good Maintenance only Priority 4: Negligible Risk Level Remove prior to refurbishment works

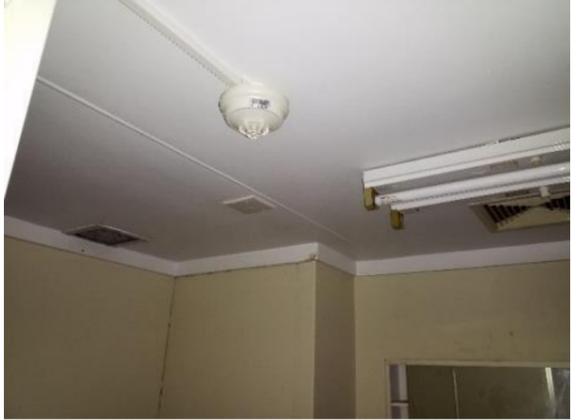
Third floor, unit 33, bathroom, ceiling	Asbestos cement sheeting	Non-friable	Similar to A31	Assume positive	6m ²	Good Maintenance only	Priority 4: Negligible Risk Level	Remove prior to refurbishment works

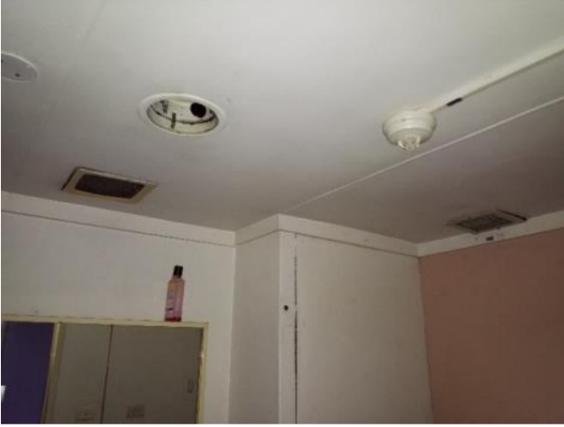
Fourth floor, unit 44, bathroom ceiling	Asbestos cement sheeting	Non-friable	Similar to A25	Assume positive	6m ²	Good Maintenance only	Priority 4: Negligible Risk Level	Remove prior to refurbishment works

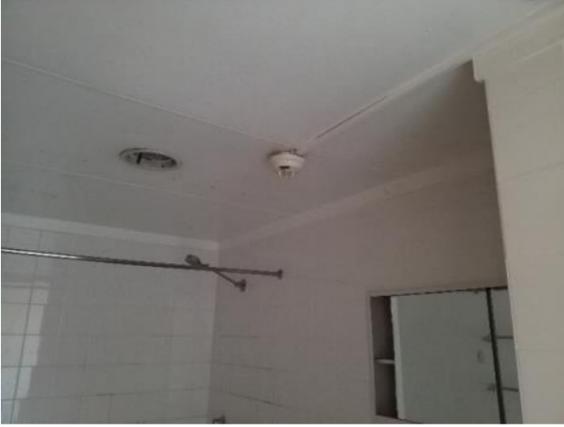
Fourth floor, unit 45, bathroom ceiling	Asbestos cement sheeting	Non-friable	Similar to A25	Assume positive	6m ²	Good Maintenance only	Priority 4: Negligible Risk Level	Remove prior to refurbishment works

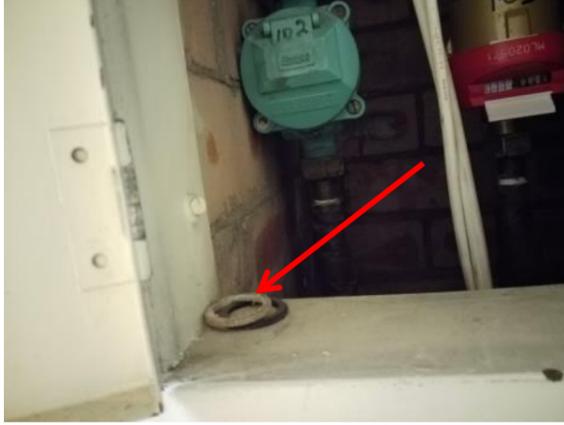
Tenth floor, common area, water meter riser, packing between metal frame and brick walls, redundant gasket (red)	Gasket	Friable	A38	Chrysotile Asbestos Detected	Not determined	Fair Maintenance only	Priority 4: Negligible Risk Level	Remove prior to refurbishment works Gaskets are likely to be found on each floor within water meter risers

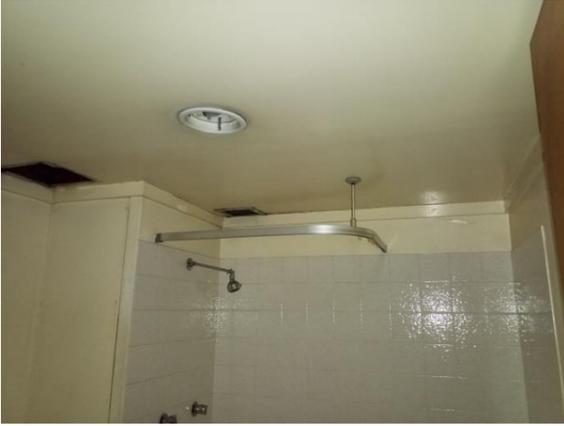
Bathroom ceiling	Asbestos cement sheeting	Non-friable	Similar to A47	Assume positive	6m ²	Good Maintenance only	Priority 4: Negligible Risk Level	Remove prior to refurbishment works
