# Sirius - Tree Removal on Gloucester Walk

**DATE** 21/09/2021  
**TO** Richard Crookes Constructions Pty Ltd  
**ATTN** Ben Wilderink  
**PROJECT** Sirius Building

This letter is prepared to provide comment on the existing Sirius eastern basement retaining walls design and condition and to also comment on the stability of Trees T50 and T51 on Gloucester walk due to the required basement wall structural upgrade and proposed basement construction works.

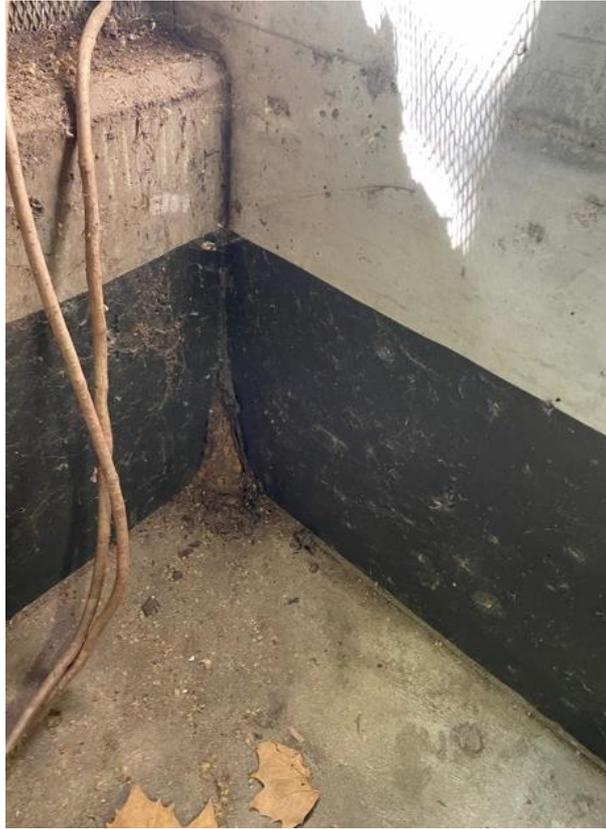
We note the existing retaining walls are of age and have been compromised by Tree 50 and 51. At Tree 50, the tree roots have penetrated the walls inducing forces onto the wall as well as compromising the integrity and waterproofing of the wall. At tree 51, the wall displays a vertical crack at the centre line of the tree trunk indicating the tree has imparted significant lateral pressure on the wall and caused the wall to fail in horizontal bending. This crack in the wall is at least 1 to 1.5mm in width indicating structural failure of the wall. We note the wall at this location also presents a 30mm lean into the basement. The lean is indicative of flexural failure at the base of the wall, or instability of the wall as a result of the added induced lateral pressure of the tree root system.

Tree 50: Plane Tree root penetration at wall floor internal junction

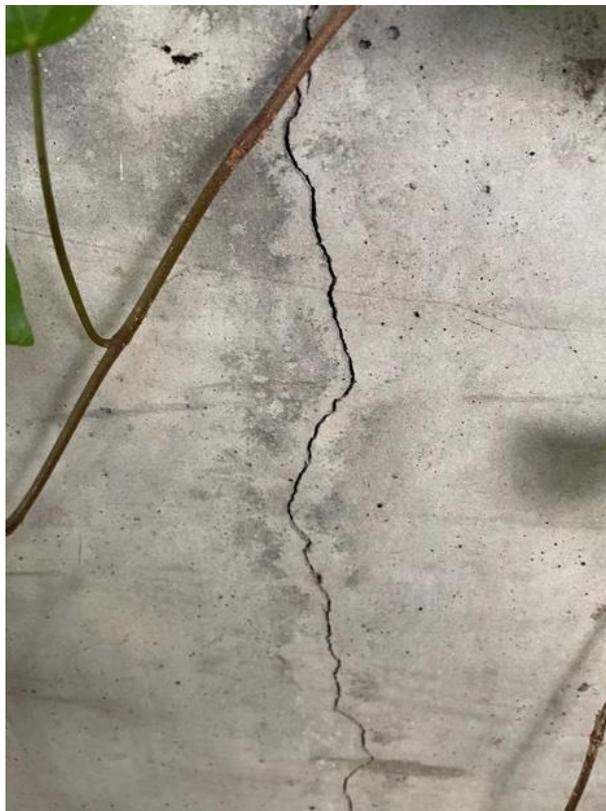
Tree 51: structural crack to retaining wall

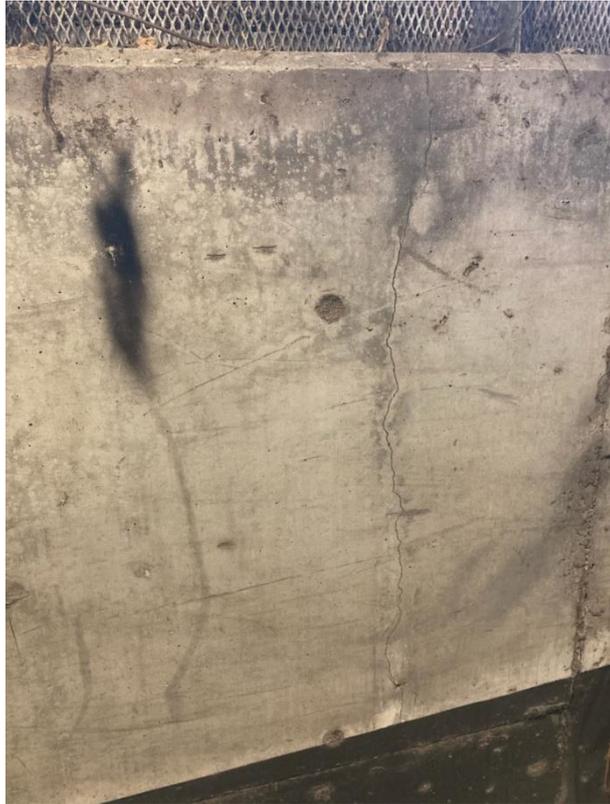
Tree 51: structural crack to retaining wall (top to bottom)

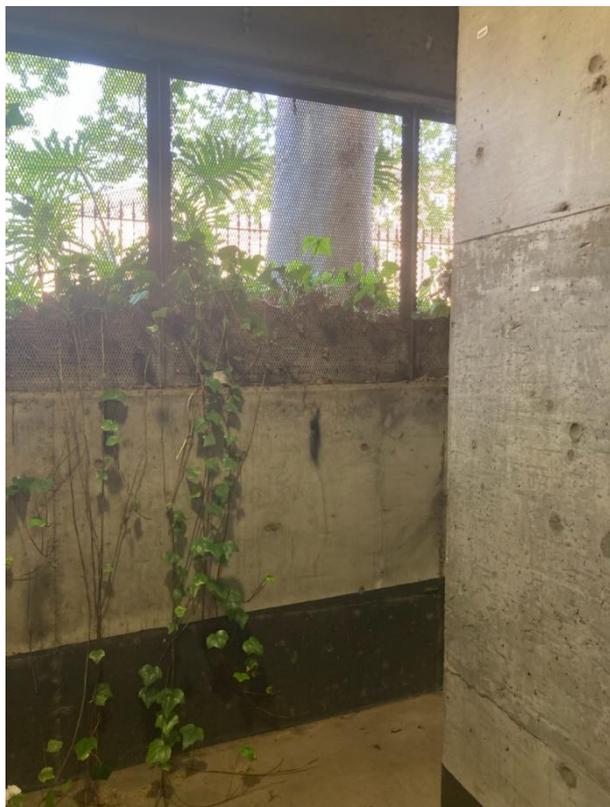
Tree 51: structural crack to retaining wall (top to bottom) at centreline of tree trunk

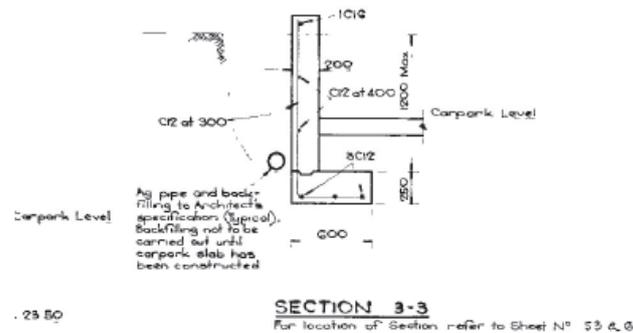
**Typical Wall section South of Grid 108.5 at Tree 50**

The existing retaining walls adjacent to trees 50 and 51 have narrower footings than required as specified in AS4678-2002 Earth Retaining Structures.

Section 4-4 indicates a wall height of 2250mm having a footing of 1200mm wide. In accordance with AS4678-2002 the footing is to have a width of 1700mm minimum. The wall is therefore deemed to be unstable in accordance with the code requirements.

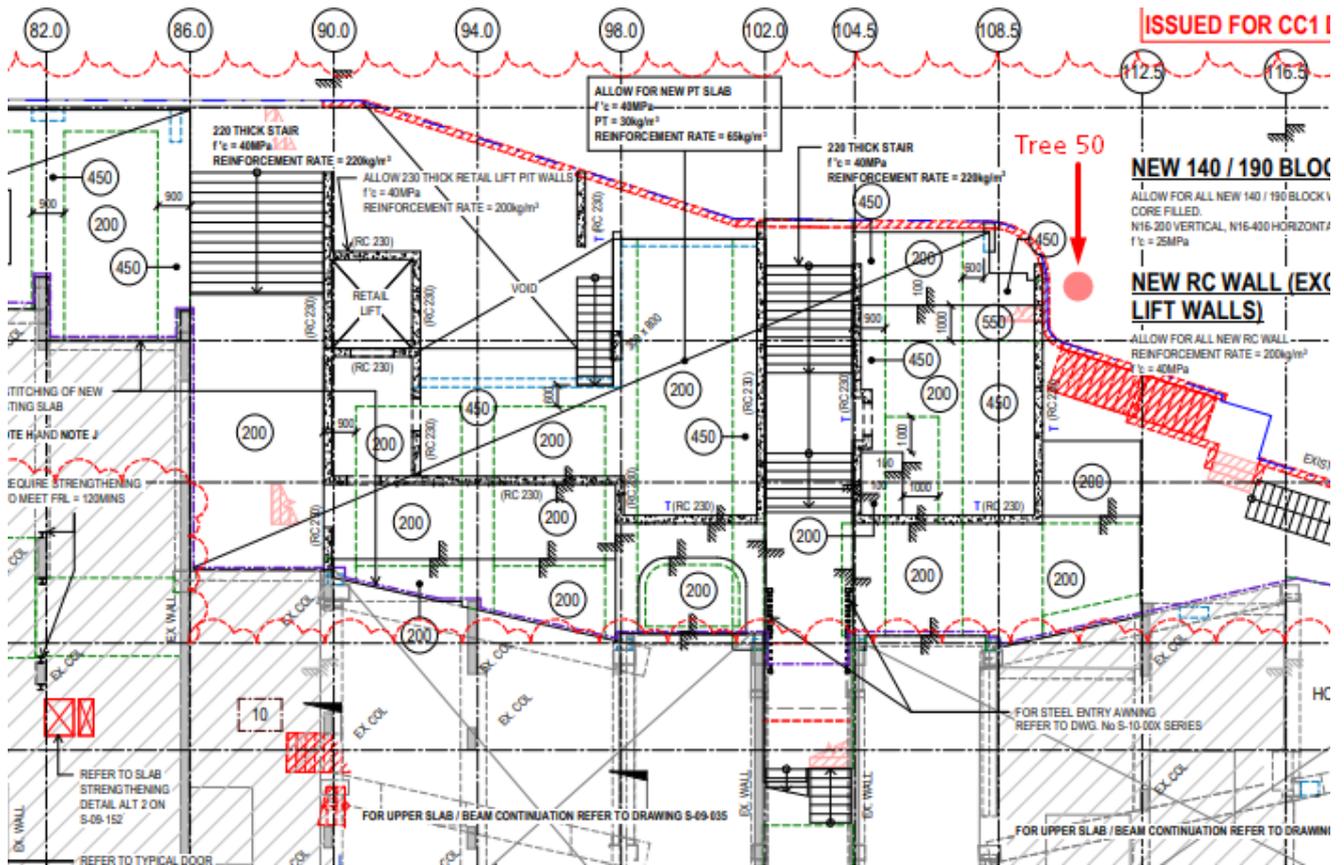
**Tree 50 Updated Podium design showing vertical support structure under clashing with the existing Section 3 Retaining Wall.**

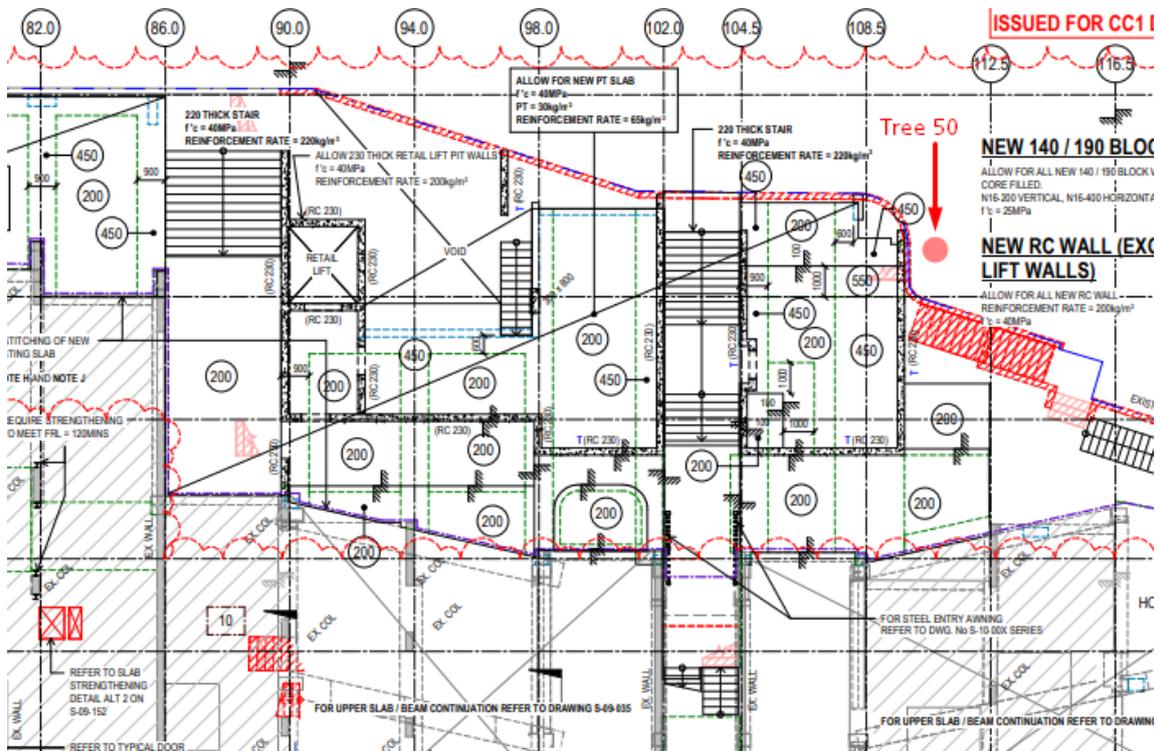
**Tree 50 Updated Podium design showing vertical support structure under clashing with the existing Section 3 Retaining Wall.**
