Re: Sirius Building - Tree numbers 50 and 51 - Basement rectification works.

Sirius - Tree Removal on Gloucester Walk

DATE 21/09/2021
TO Richard Crookes Constructions Pty Ltd
ATTN Ben Wilderink
PROJECT Sirius Building

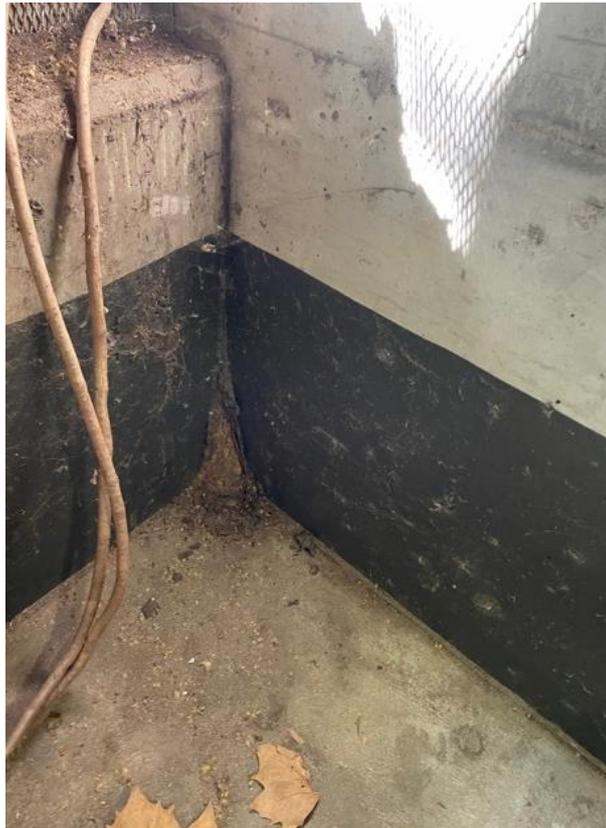
We note the existing retaining walls are of age and have been compromised by Tree 50 and 51. At Tree 50, the tree roots have penetrated the walls inducing forces onto the wall as well as compromising the integrity and waterproofing of the wall. At tree 51, the wall displays a vertical crack at the centre line of the tree trunk indicating the tree has imparted significant lateral pressure on the wall and caused the wall to fail in horizontal bending. This crack in the wall is at least 1 to 1.5mm in width indicating structural failure of the wall. We note the wall at this location also presents a 30mm lean into the basement. The lean is indicative of flexural failure at the base of the wall, or instability of the wall as a result of the added induced lateral pressure of the tree root system.

Tree 50: Plane Tree root penetration at wall floor internal junction

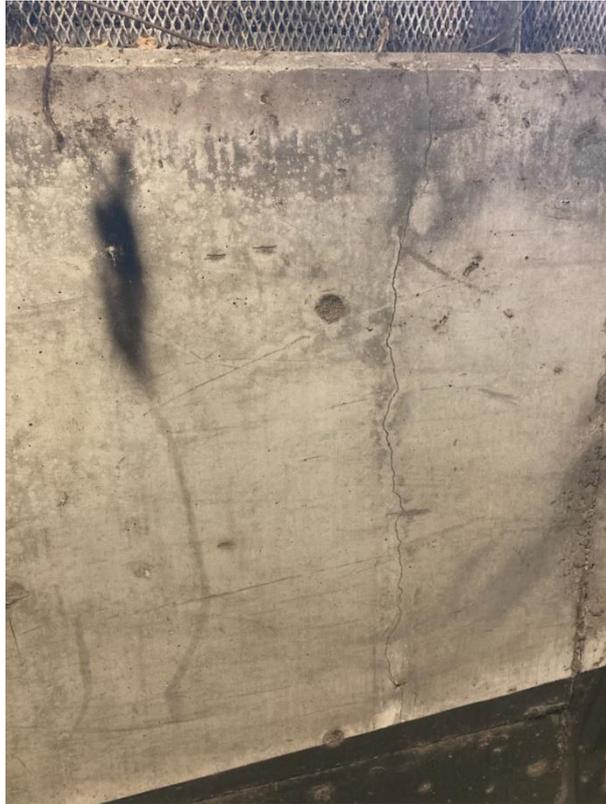
Tree 51: structural crack to retaining wall (top to bottom)

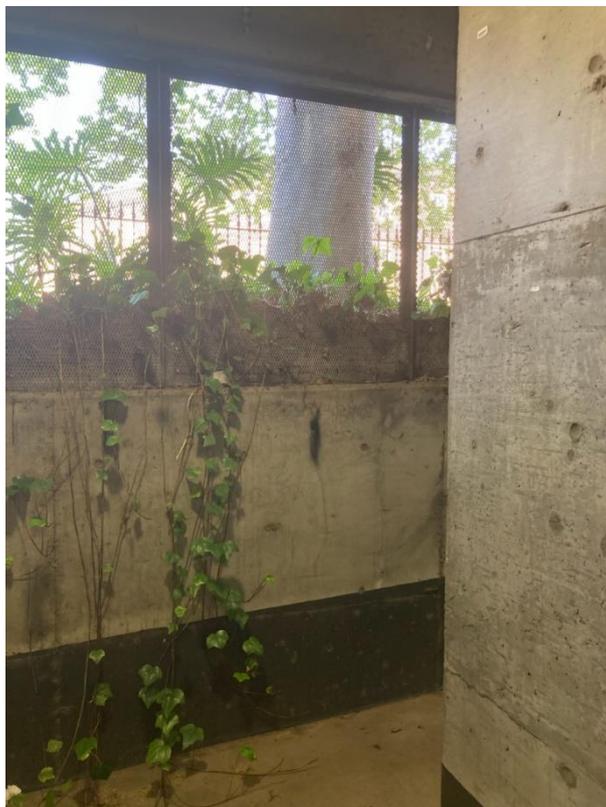
Tree 51: structural crack to retaining wall (top to bottom) at centreline of tree trunk
