Sirius SSD Modification 1 (SSD 10384_Mod 1): proposed tree removal

Sirius - Tree Removal on Gloucester Walk

Re: Sirius Building - Tree numbers 50 and 51 - Basement rectification works.

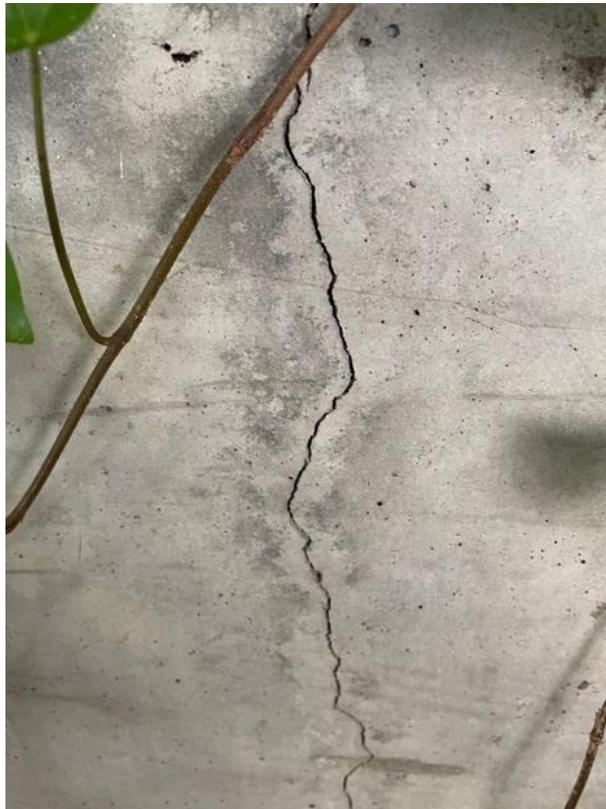
We note the existing retaining walls are of age and have been compromised by Tree 50 and 51. At Tree 50, the tree roots have penetrated the walls inducing forces onto the wall as well as compromising the integrity and waterproofing of the wall. At tree 51, the wall displays a vertical crack at the centre line of the tree trunk indicating the tree has imparted significant lateral pressure on the wall and caused the wall to fail in horizontal bending. This crack in the wall is at least 1 to 1.5mm in width indicating structural failure of the wall. We note the wall at this location also presents a 30mm lean into the basement. The lean is indicative of flexural failure at the base of the wall, or instability of the wall as a result of the added induced lateral pressure of the tree root system.

Tree 51: structural crack to retaining wall

To upgrade the building to meet current standards and good building practice (waterproofing, stability etc), which is required in order to structurally certify the completed project, the retaining walls will require removal and re-construction which will impact on the stability of tree 50 and 51.

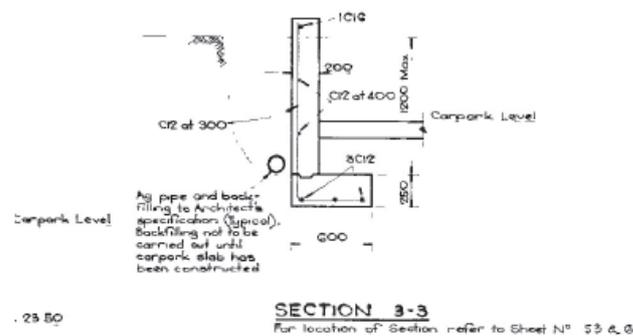
Typical Wall section South of Grid 108.5 at Tree 50

The existing retaining walls adjacent to trees 50 and 51 have narrower footings than required as specified in AS4678-2002 Earth Retaining Structures.

Section 4-4 indicates a wall height of 2250mm having a footing of 1200mm wide. In accordance with AS4678-2002 the footing is to have a width of 1700mm minimum. The wall is therefore deemed to be unstable in accordance with the code requirements.

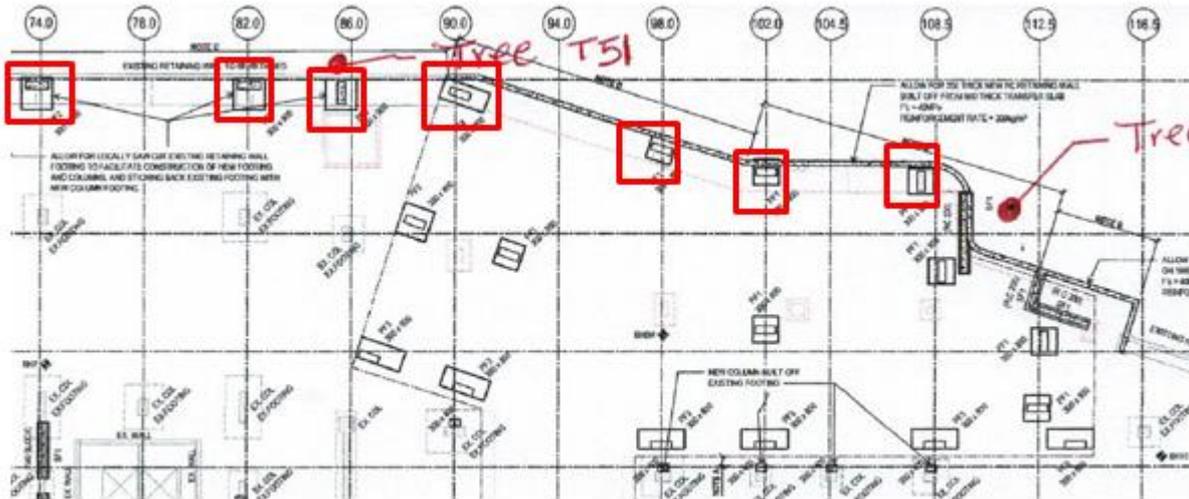
Further as can be seen in the below sketch, pad footings need to be constructed for the future SoHo structure and podium above and these new footings clash with the existing retaining wall footing locations. Therefore, in order to construct the new footing pads the wall footings will need to be demolished, further making the retaining wall unstable.

New Works Plan showing new pad footings clashing with existing RW footings.

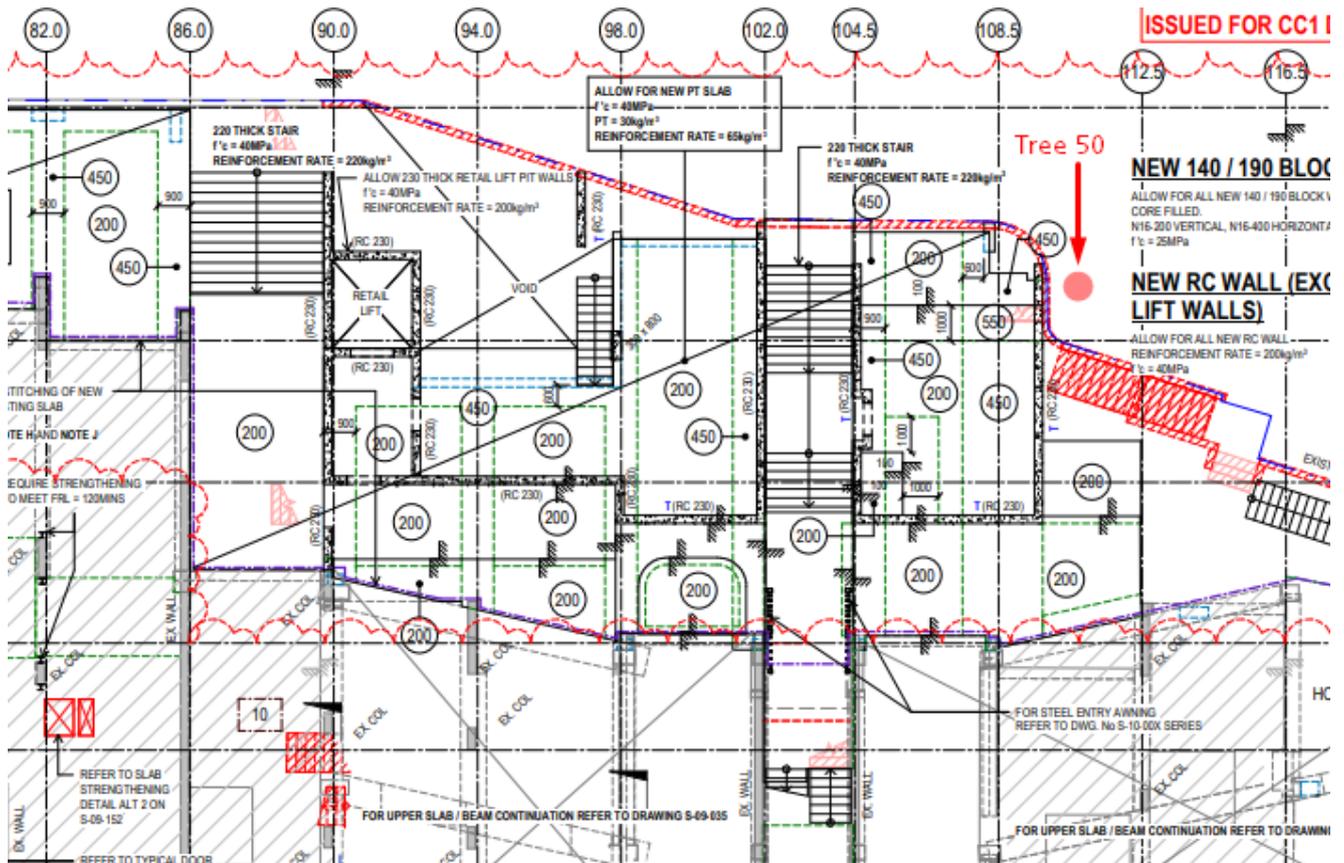
Tree 50 Updated Podium design showing vertical support structure under clashing with the existing Section 3 Retaining Wall.
