Our Ref: PSM3759-005L

**RE: KAMBALA GIRLS HIGH, ROSE BAY, NSW
ADDITIONAL GEOTECHNICAL INVESTIGATION**

Carmichael Tompkins Property Group Pty Ltd
Kambala Girls School
794 New South Head Rd, Rose Bay
BOREHOLE LOCALITY
SITE PLAN

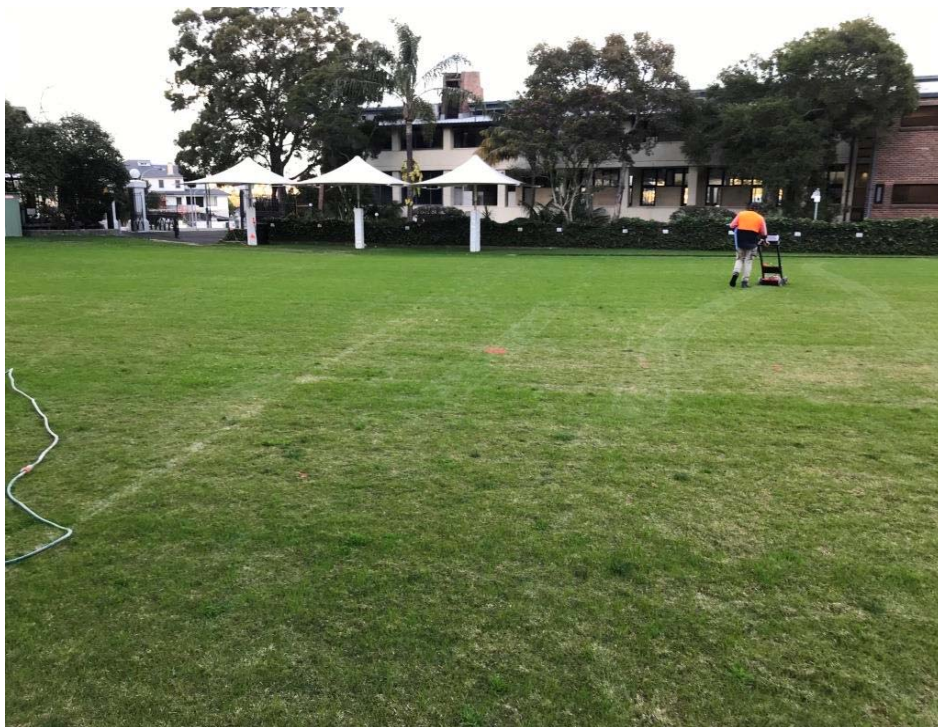
Photo 1 - General site conditions and service locating (11/07/2019)

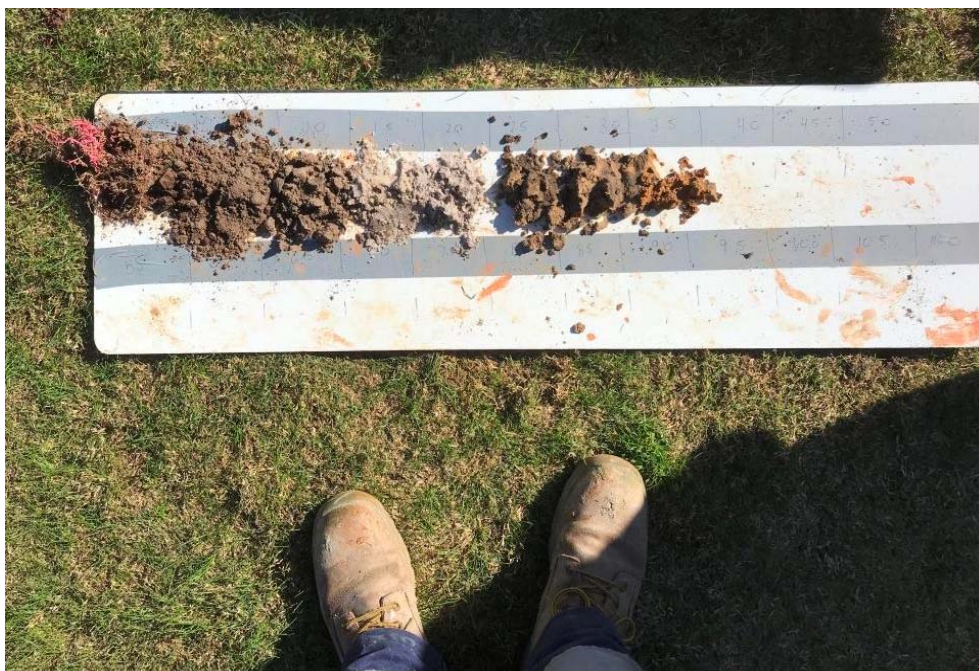
Photo 2 - Soil profile of BH105 (11/07/2019)

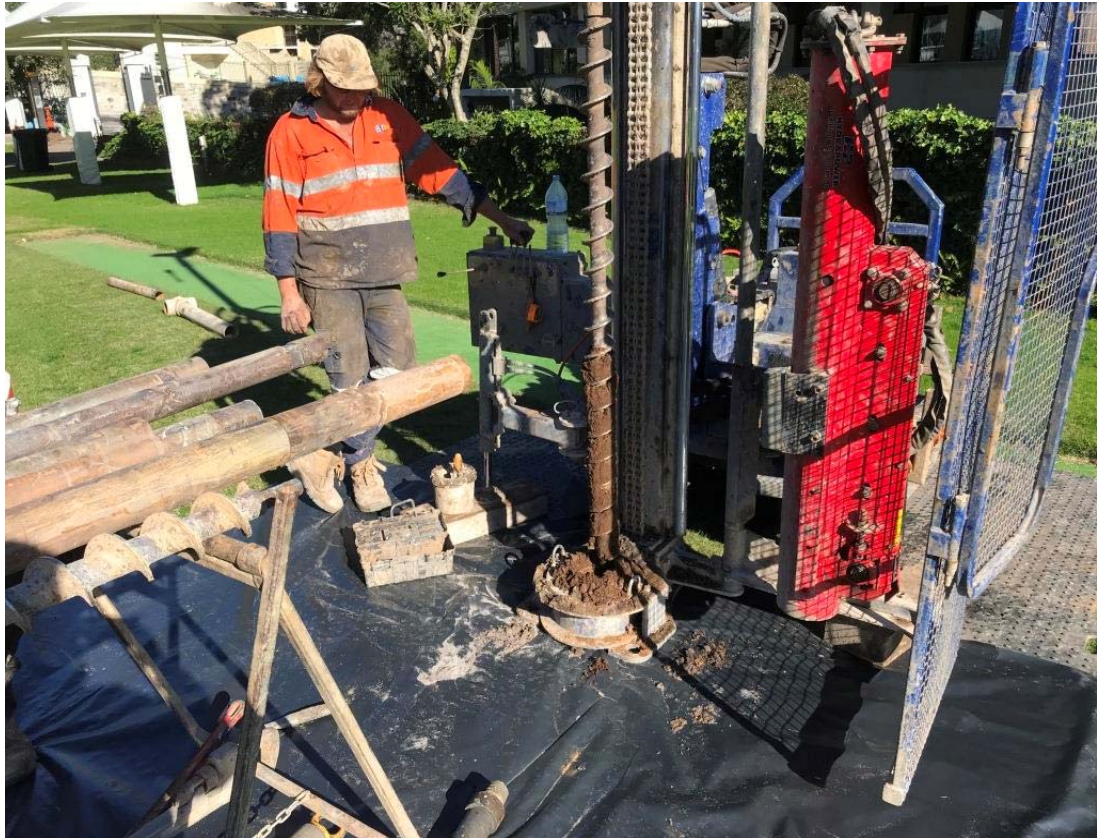
Photo 3 - Fill from BH106, rig set-up with track mats (11/07/2019)

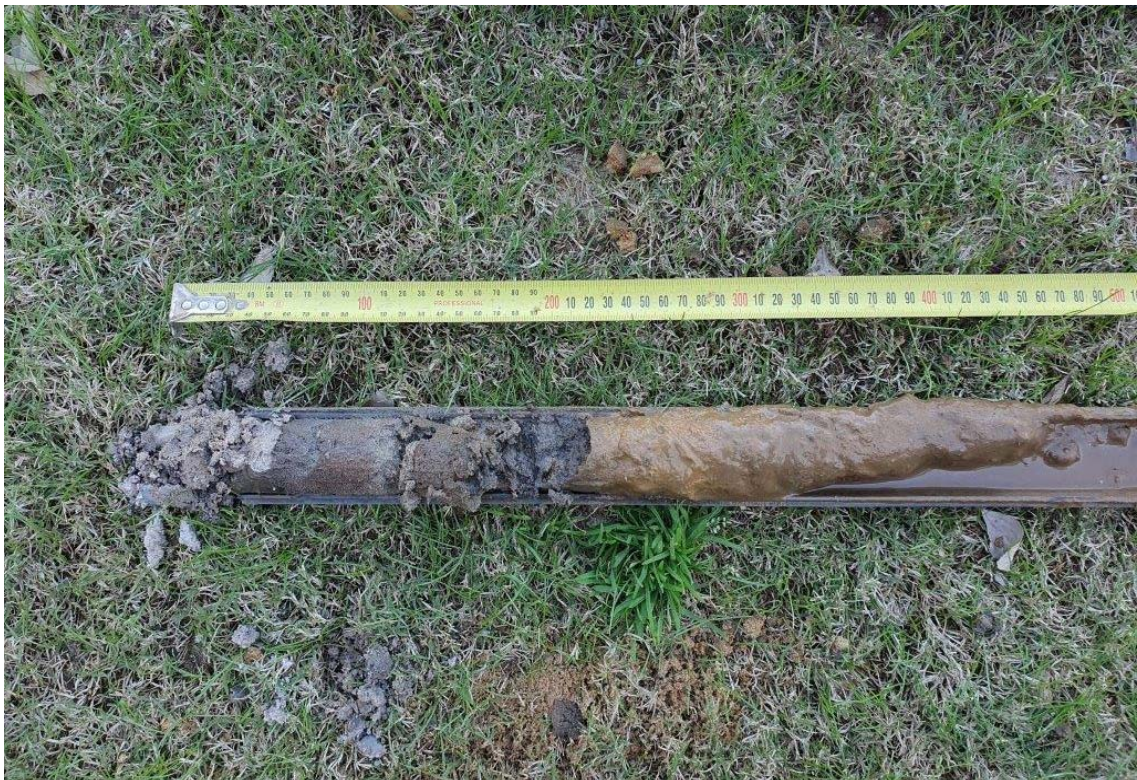
Water ponding was observed at the base of BH104 prior to rock coring. Water within the soil layers was further observed within SPT samples, refer to Figure 3 photo 4. This is consistent with our previous investigation on 8 and 9 November 2018 in which water was observed in four different holes at depths of 0.8 m to 5.2 m from the ground surface (Ref. PSM3759-002L).

Photo 4 - Standard Penetration Test displaying groundwater in BH103 (12/07/2019)

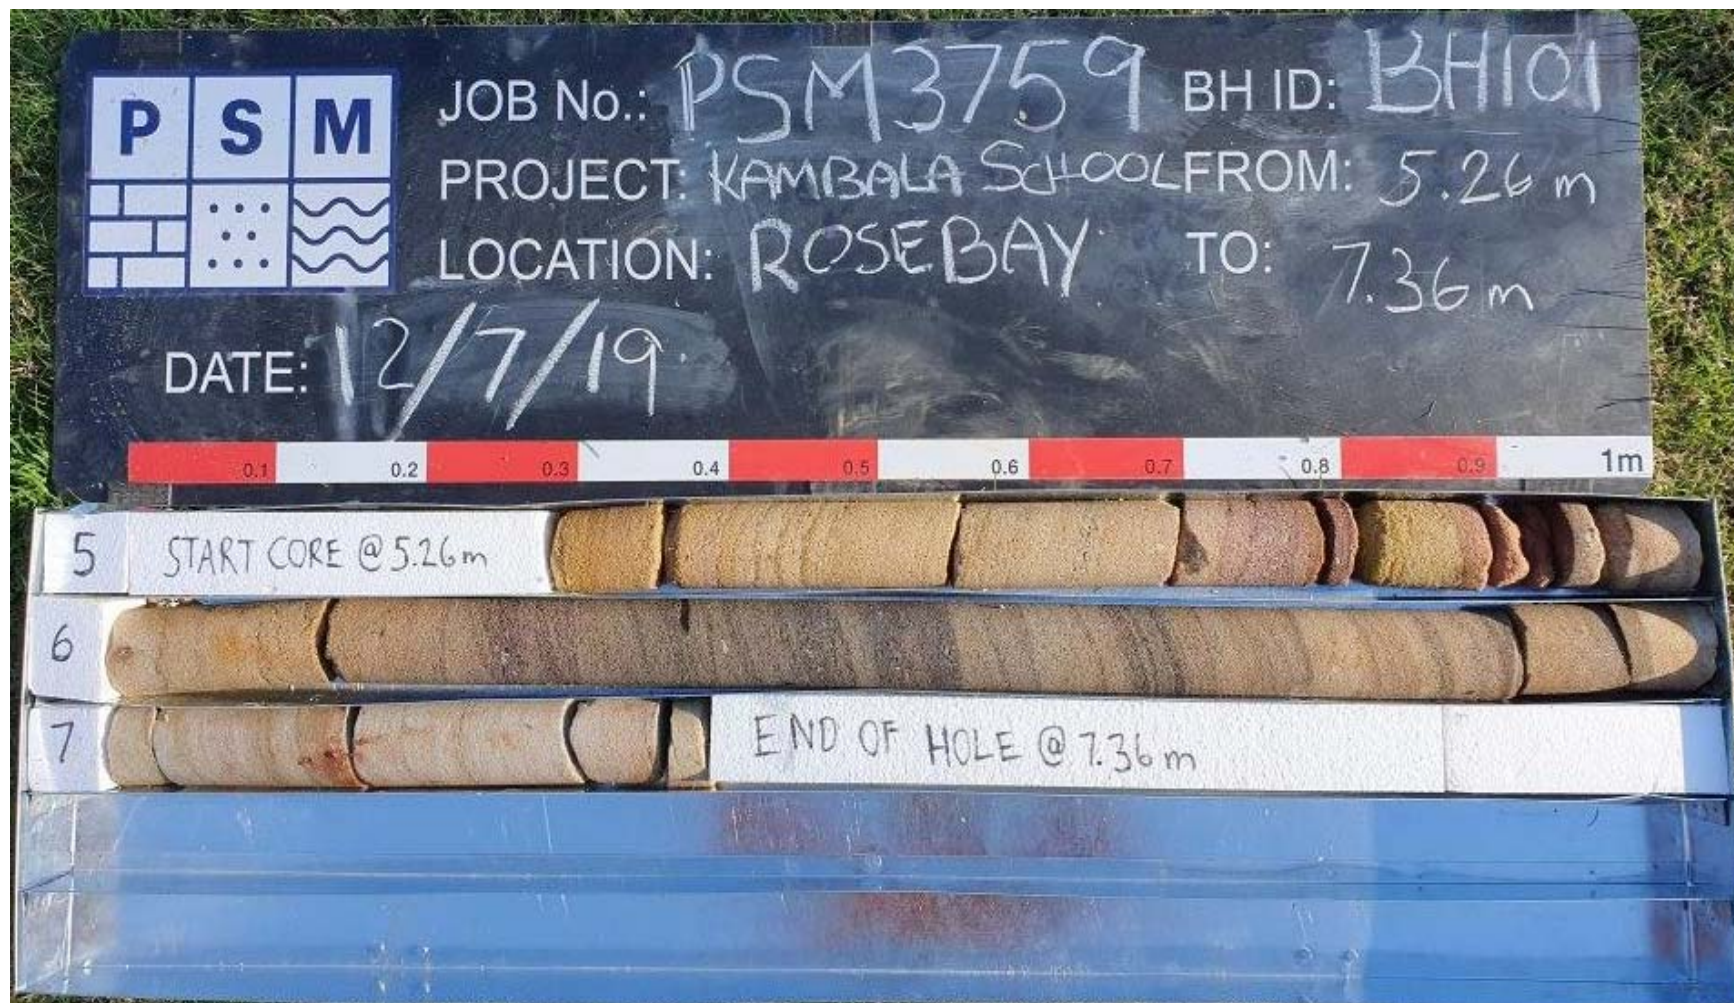
Figure A1

CORE PHOTO BH101

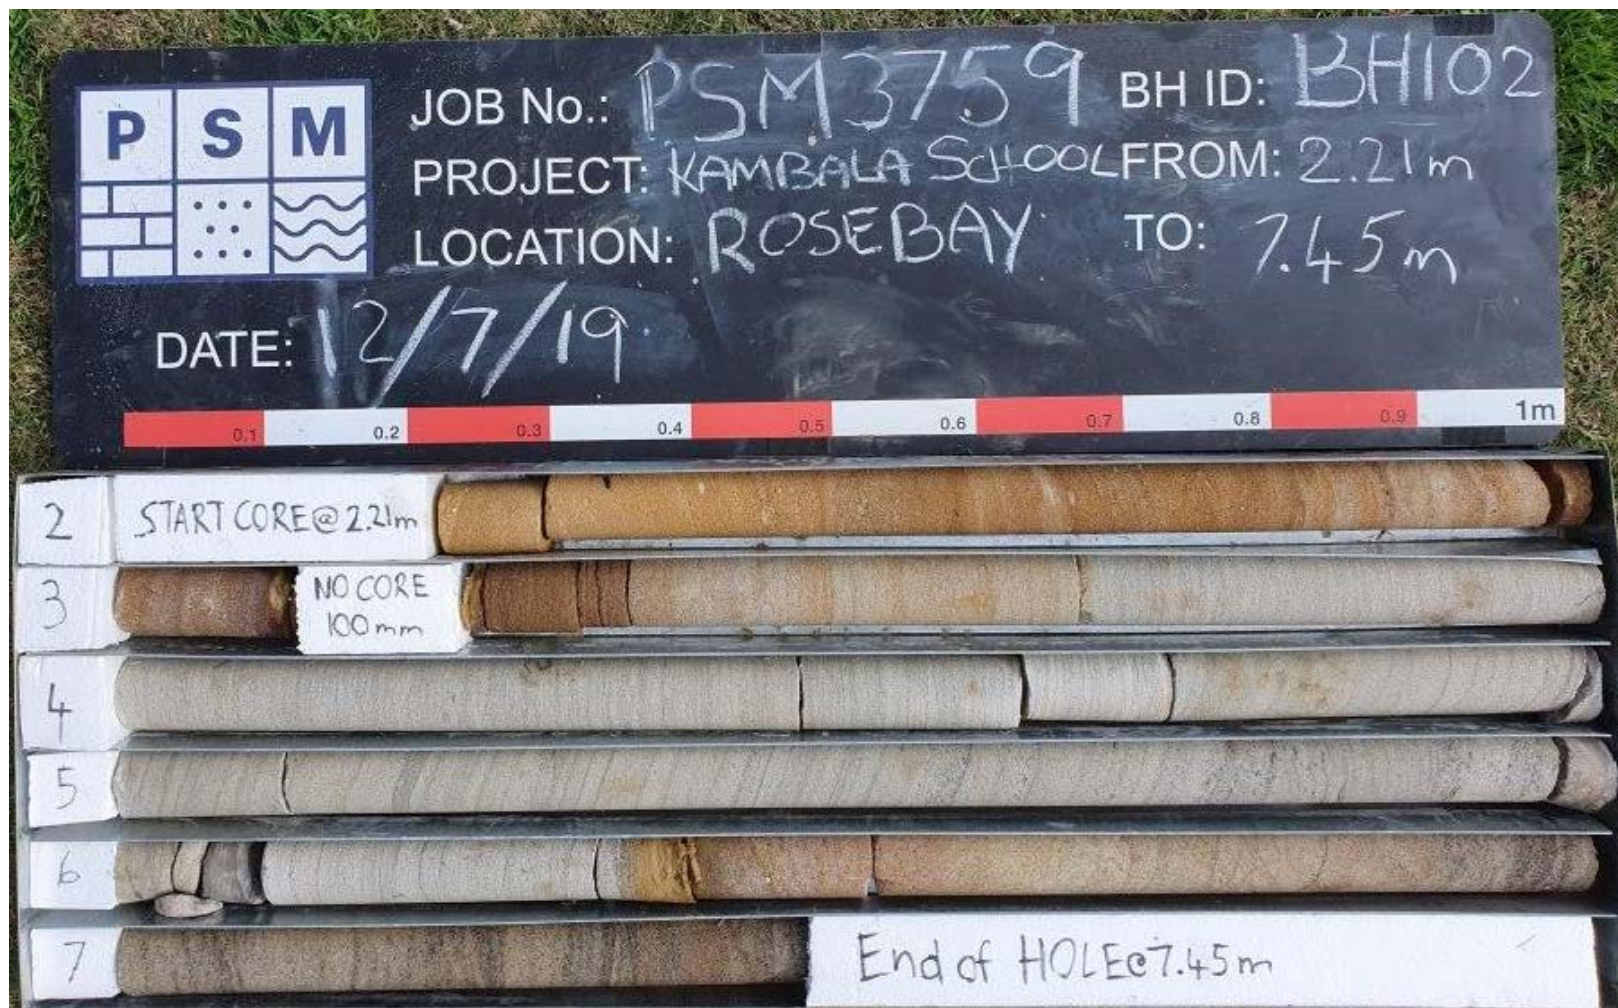
Figure A2

CORE PHOTO BH102

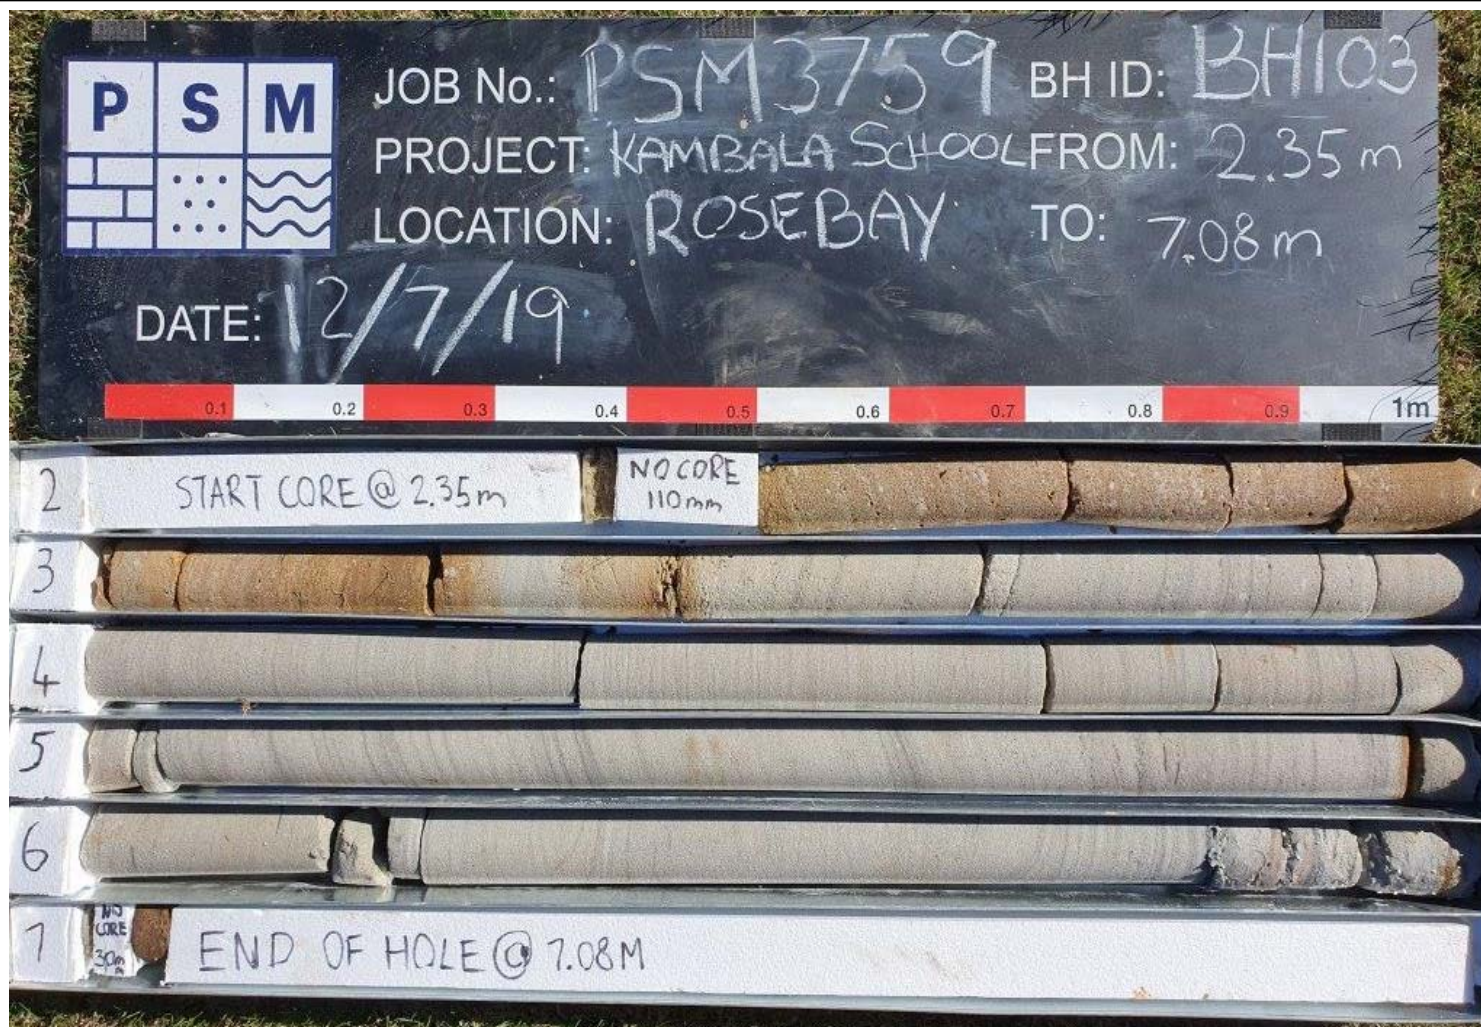
Figure A3

CORE PHOTO BH103

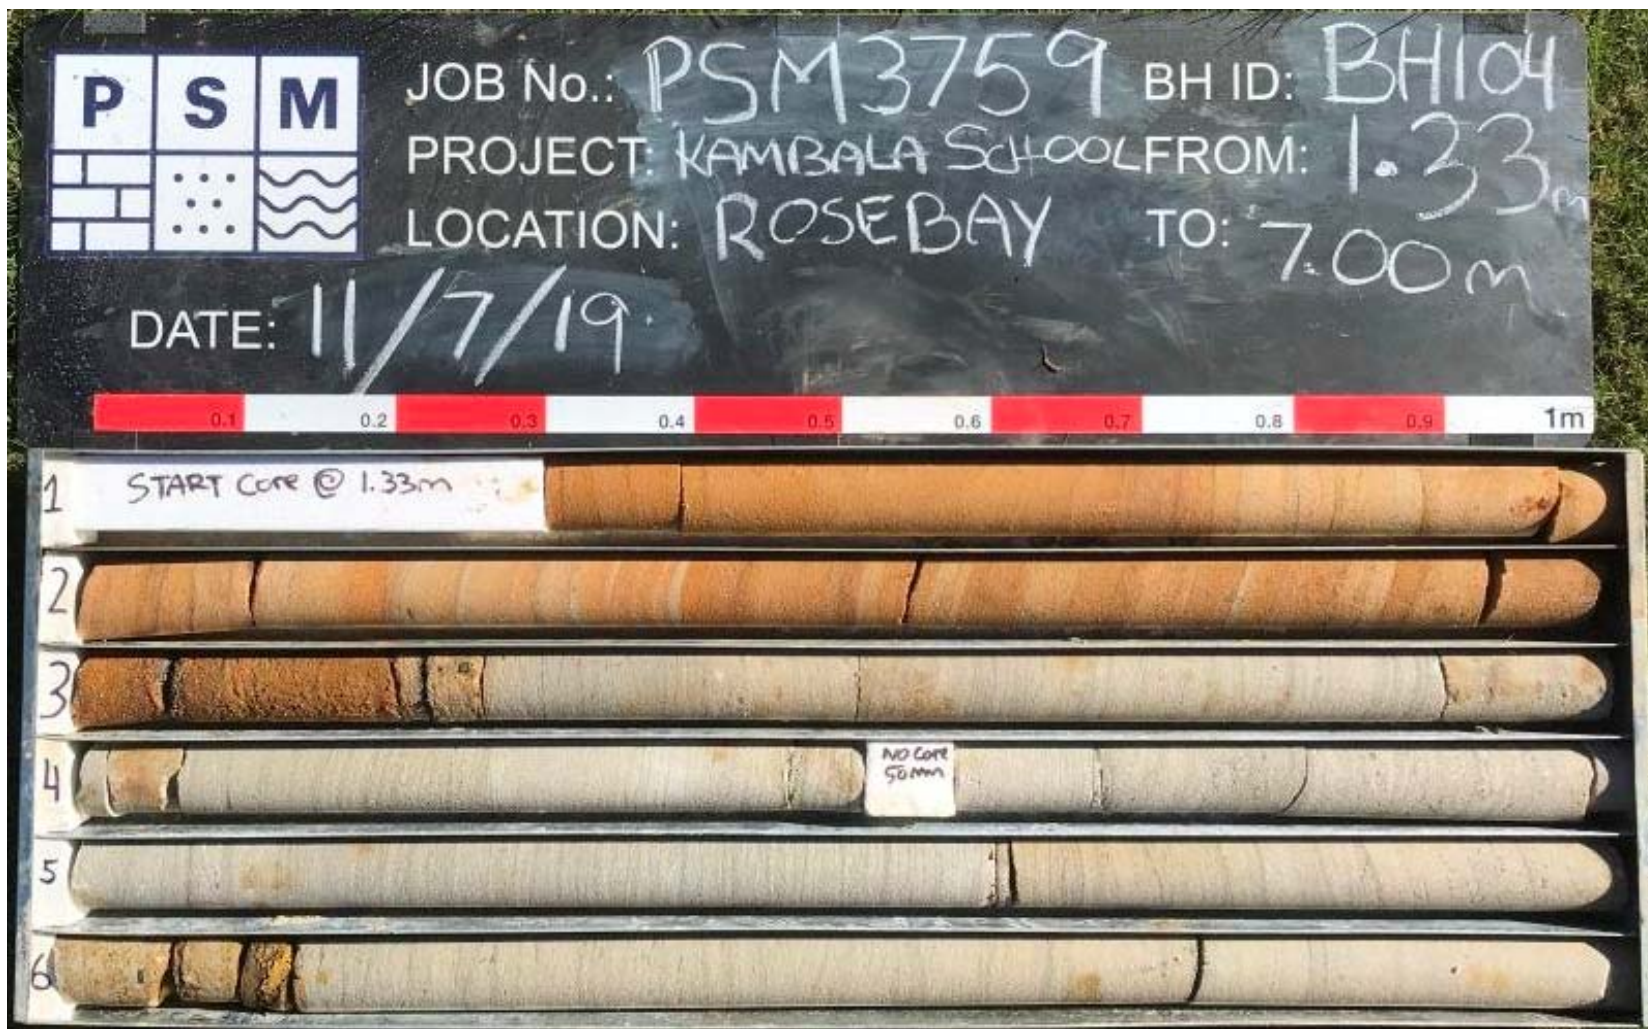
Figure A4

CORE PHOTO BH104

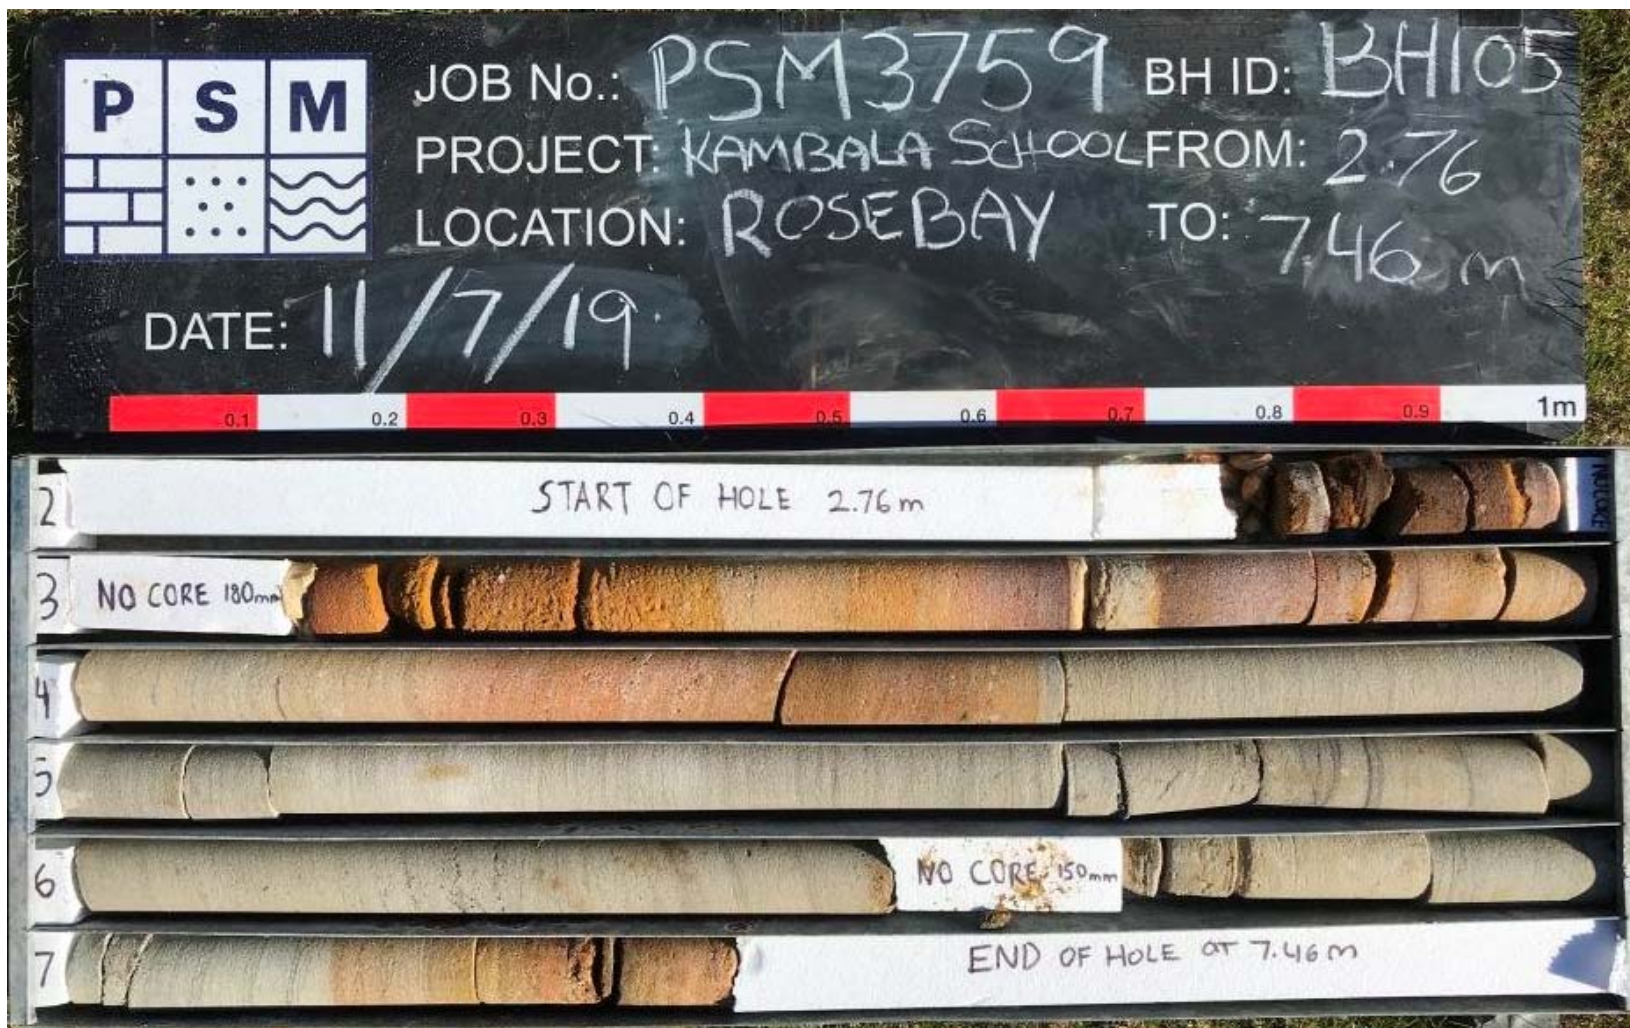
Figure A5

CORE PHOTO BH105
