Carmichael Tompkins Property Group Pty Ltd  
Hazardous Building Materials Survey

Kambala School  
794 New South Head Road,  
Rose Bay, NSW

7 April 2020

58081/127691 (Rev 1)  
JBS&G Australia Pty Ltd

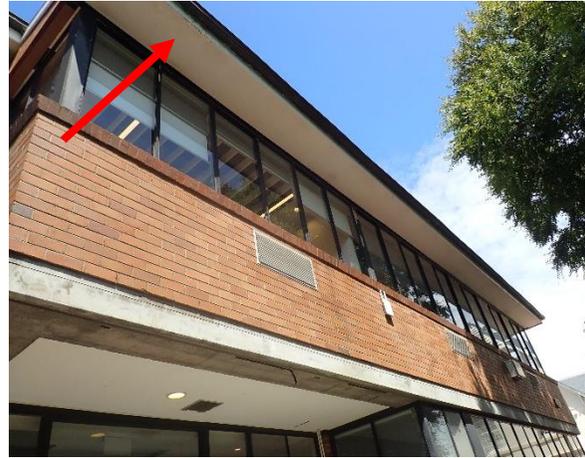
- Suspected asbestos containing fibre cement eaves and undercloak verge were identified to the external northern aspect. Representative samples were unable to be collected due to height safety hazards.
- Non-asbestos containing fibre cement sheeting (A-01) was identified to the reception entry soffit.
- Non-asbestos containing fibre cement sheeting (A-02) was identified to the west entry soffit.
- Non-asbestos containing fibre cement sheeting (A-03) was identified to the northeast entry soffit.
- Non-asbestos containing settled dust (AD-01) was identified to the floor surface of the ground floor comms room. This dust also contained lead concentrations below the adopted site criteria (LD-01, 25 mg/kg).

-	External northern aspect - Eaves and undercloak verge	Fibre cement sheeting	2	No	Non-Friable	<b>Assumed Asbestos</b>	Good	40 m <sup>2</sup>	Remove prior to demolition. Works to be completed under controlled conditions by Class A or B licensed removal contractor in accordance with SWNSW 2019a	11/2/2020 JBS&G SL	
Refer KPMG SGA 2015	First floor corridor, ceiling	Fibre cement sheeting	3	Yes	Non-Friable	<b>Assumed Asbestos</b>	Good	100 m <sup>2</sup>	Manage in accordance with Code of Practice: How to manage and control asbestos in the workplace	21/1/2015 KPMG SGA	Material could not be located during JBS&G 2020 inspection. Assumed to have been removed. No clearance report available at the time of inspection
<b>No Asbestos Detected (NAD)</b>											
A-01	Reception entry soffit	Fibre cement sheeting	4	Yes	-	No Asbestos Detected	-	-	No further action required	11/2/2020 JBS&G SL	
A-02	West entry soffit	Fibre cement sheeting	-	Yes	-	No Asbestos Detected	-	-	No further action required	11/2/2020 JBS&G SL

Photo 2: Hawthorne Building – Northern Aspect – Assumed asbestos containing eaves and undercloak verge

- A Class A or B licensed asbestos removalist shall be engaged to remove all asbestos containing materials as identified in the Hazardous Materials Register (**Appendix A**). Removal and disposal of non-friable asbestos materials shall be undertaken in accordance with the *Work Health and Safety Act (2011)*, *Work Health and Safety Regulation (2017)* and *SWNSW 2019a*.

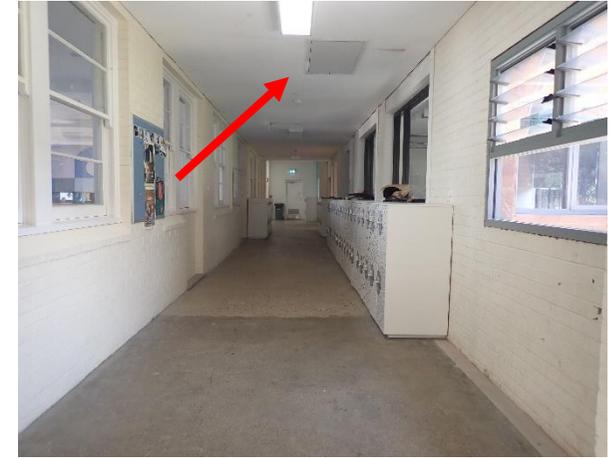
Photo 3: Hawthorne Building – previously identified asbestos containing fibre cement sheeting to the first floor corridor was unable to be located

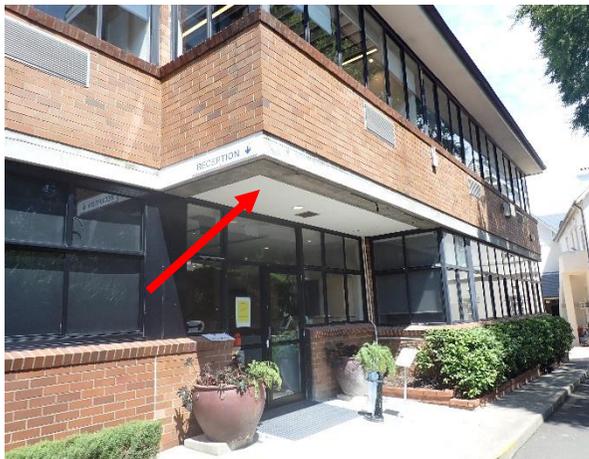
Photo 4: Hawthorne Building – non-asbestos containing fibre cement sheeting to reception entry soffit

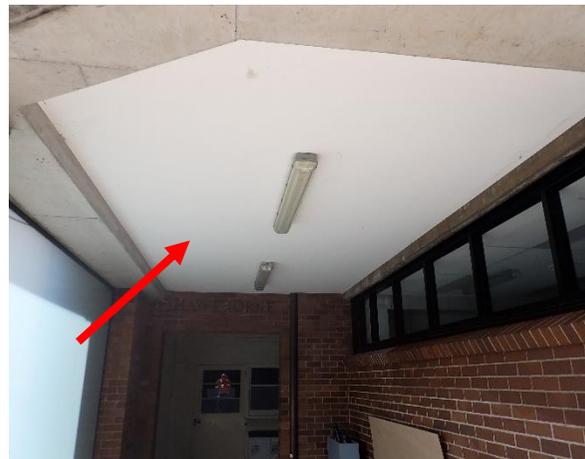
Photo 5: Hawthorne Building – non-asbestos containing fibre cement sheeting to northeast entry soffit

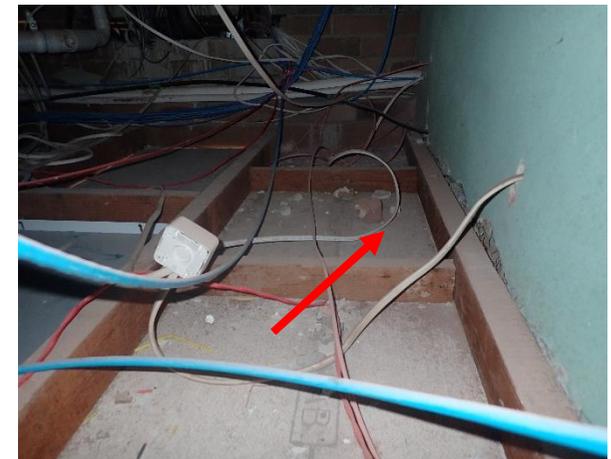
- Lead concentrations within settled dust within the roof void (LD-02, 330 mg/kg) were slightly elevated above the adopted site criteria. This dust was also found not to contain asbestos (AD-02).

Levels of lead in dust were identified slightly above the adopted site criteria within the roof void of the Hawthorne Building. A conservative approach is recommended to be implemented to manage this identified hazard during demolition and refurbishment works.

Photo 6: Hawthorne Building – Roof void – Lead containing dust

A suitably experienced hazardous materials removal contractor should be engaged to remove the lead containing dust prior to demolition. Lead dust waste removed from education facilities is pre-classified as General Solid Waste (non-putrescible) in accordance with the NSW Environmental Protection Authority (2014) *Waste Classification Guidelines – Part 1: Classifying Waste* (EPA 2014).

The roof void should remain restricted from general access until the lead dust hazard is removed.

Should the lead containing dust remain on site for an extended period of time, a lead management plan or similar should be prepared detailing the procedures and requirements to reduce the potential for lead dust exposure if site workers are required to access the hazardous area.

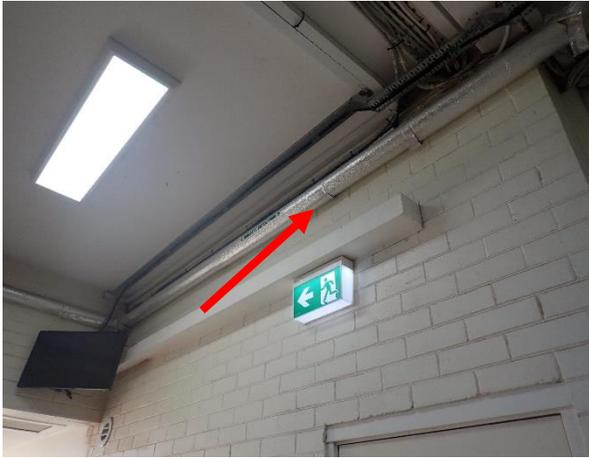
Photo 7: Hawthorne Building – Ground floor corridor – Suspected SMF pipe lagging

The synthetic mineral fibres encountered during this inspection were generally contained and deemed to be low risk. These SMF materials can be removed with the building and demolition waste with care taken not to generate fibres. Appropriate PPE is recommended including the use of P2 respirator as minimum and appropriate removal methodology as outlined in [NOHSC: 1004(1990)] and [NOHSC: 2006(1990)].

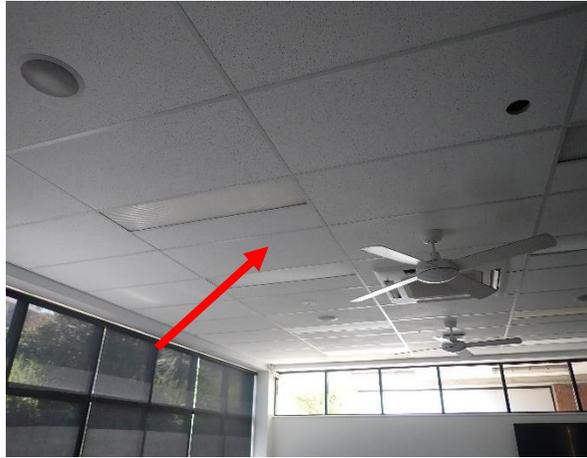
Photo 8: Hawthorne Building – Ground and first floor classroom and administration offices – Suspected SMF ceiling tiles

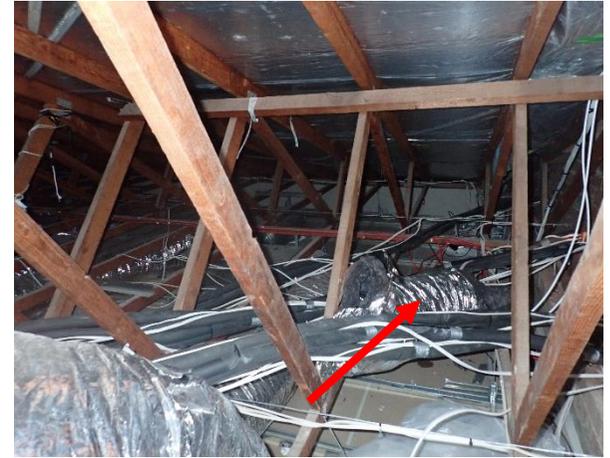
- Suspected SMF insulation was identified to the air conditioning ducting throughout the roof void.
- Suspected SMF insulation batts were identified to the east wall of the roof void.

-	Roof void - air conditioning ducting	Insulation	9	Yes	-	<b>Assumed SMF</b>	Good	50 m <sup>2</sup>	Remove in accordance with NOHSC:2006 (1990)	11/2/2020 JBS&G SL

Photo 9: Hawthorne Building – Roof void air conditioning ducts – Suspected SMF insulation

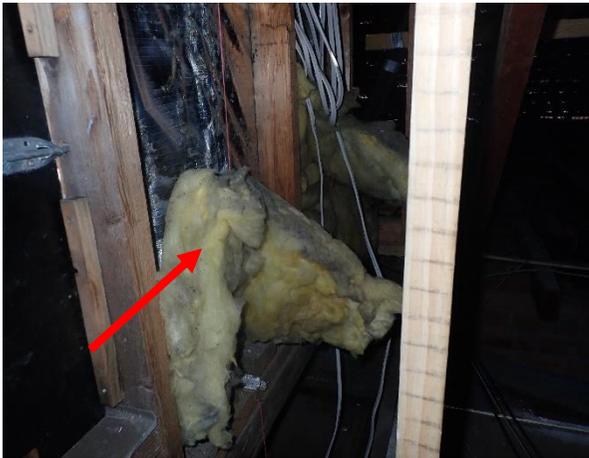
Photo 10: Hawthorne Building – Roof void east wall – Suspected SMF insulation batts

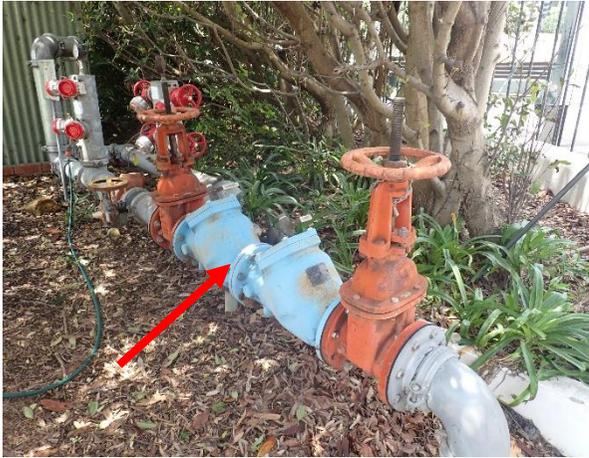
Photo 13: Hydrant Booster – non-asbestos containing gaskets to external pipework

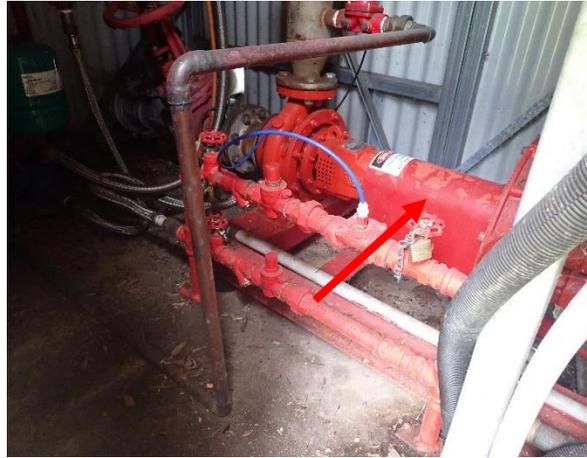
- Non-asbestos containing gaskets (A-04) were identified to the external pipework. Similar gaskets were also identified to the internal pipework.
- Lead based red/orange paint (LP-05, 3.0% w/w) was identified to the external pipework, internal pipework, motor and pump. This paint system was observed to be in fair condition with minor deterioration.

Photo 14: Hydrant Booster – lead based red/orange paint to internal pipework

Lead based paints identified in Hazardous Materials Register (**Appendix A**) should be managed in accordance with the AS4361.2-2017. If peeling or deteriorated they should be removed under controlled conditions by an experienced contractor prior to demolition. Stable lead based paints adhered to building fabric can be removed as general solid waste provided care is taken to minimise any potential for paint flakes to be dispersed onto ground surfaces.

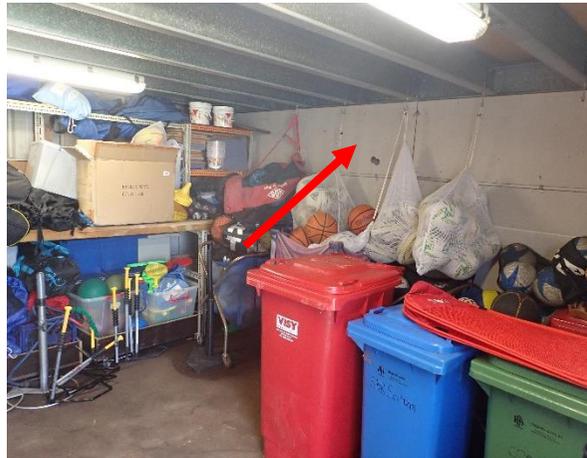
Photo 17: Sports Equipment Store – non-asbestos containing fibre cement sheeting to internal partition walls

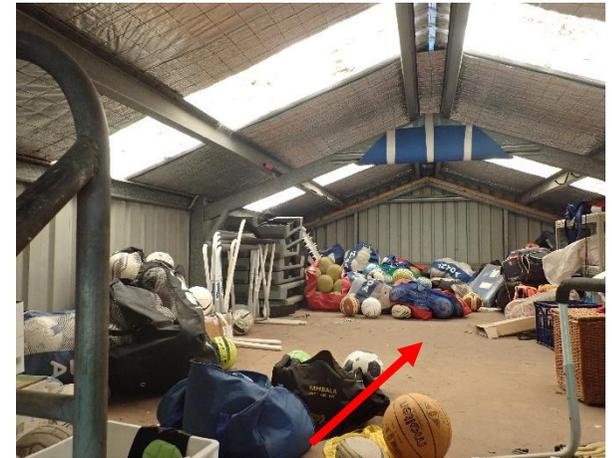
Photo 18: Sports Equipment Store – lead containing dust below the site criteria to the mezzanine floor

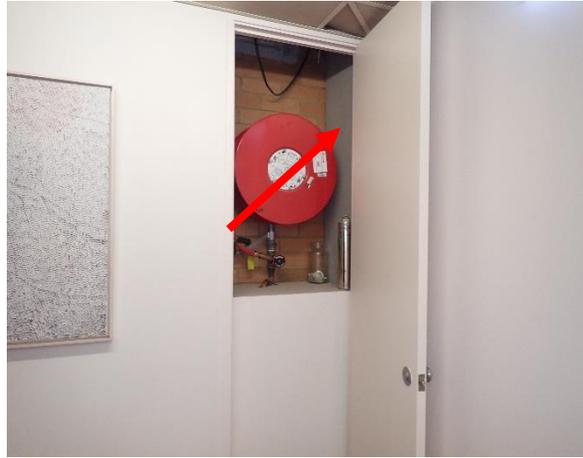
Photo 20: Music Building, asbestos containing fibre cement sheeting to the internal lining of the fire hose reel cupboard

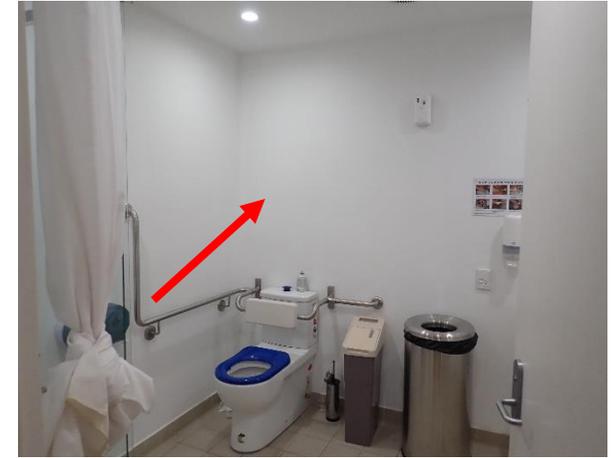
Photo 21: Music Building, asbestos containing fibre cement sheeting to the staff room toilet walls

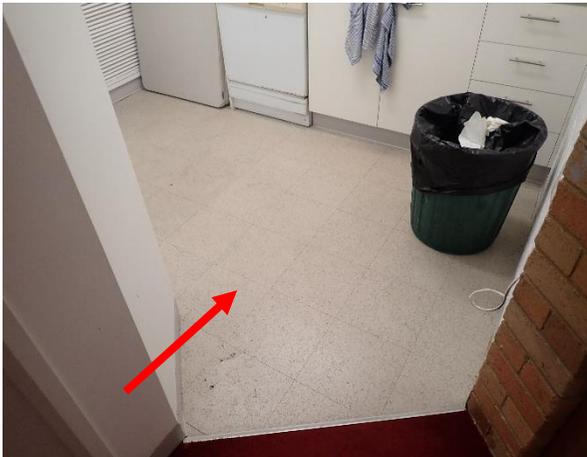
Photo 22: Music Building, non-asbestos containing cream vinyl floor tiles to the staff kitchen

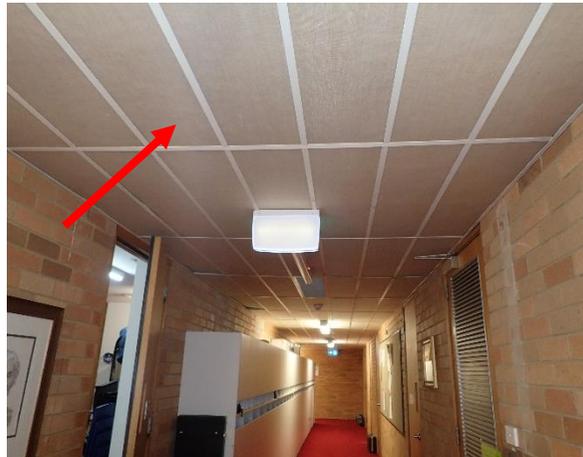
Photo 23: Music Building, assumed SMF ceiling tiles throughout the eastern portion main hallway

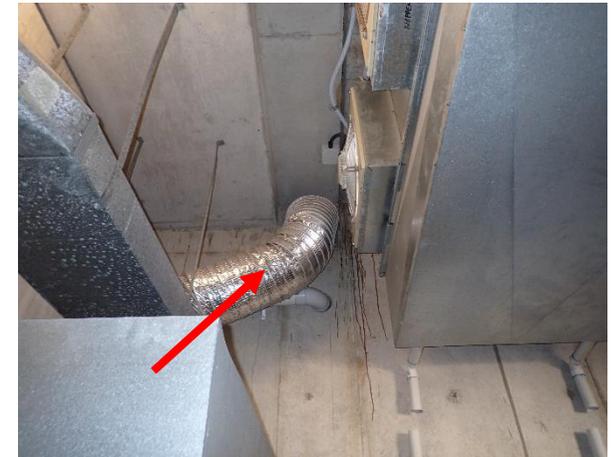
- Suspected SMF insulation was identified to the air conditioning plant and ducting within the plant room.
- An instant hot and cold water system was identified in the kitchen of the Ann & John Lewis Wing.

Photo 24: Music Building, assumed SMF insulation to air conditioning plant and ducting

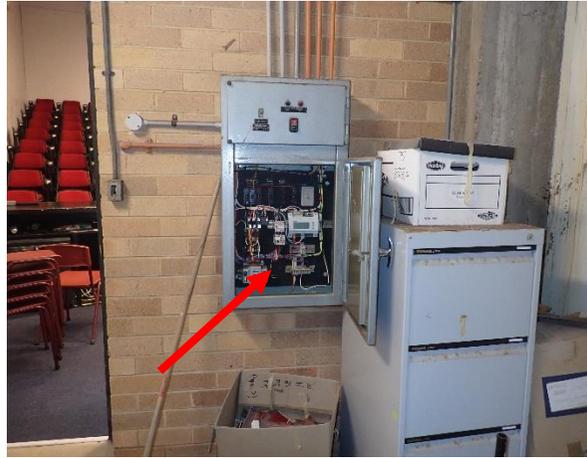
Photo 26: Arts Building, assumed asbestos containing electrical mounting board in lecture theatre plant room

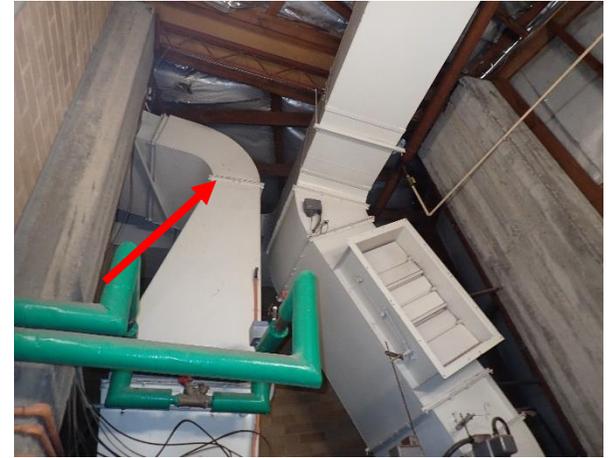
- Suspected asbestos containing mastic was identified to the flange joints of the air conditioning ducting within the lecture theatre plant room. A sample was unable to be collected due to height safety hazards.

Photo 27: Arts Building, assumed asbestos containing mastic to air conditioning ducting in lecture theatre plant room

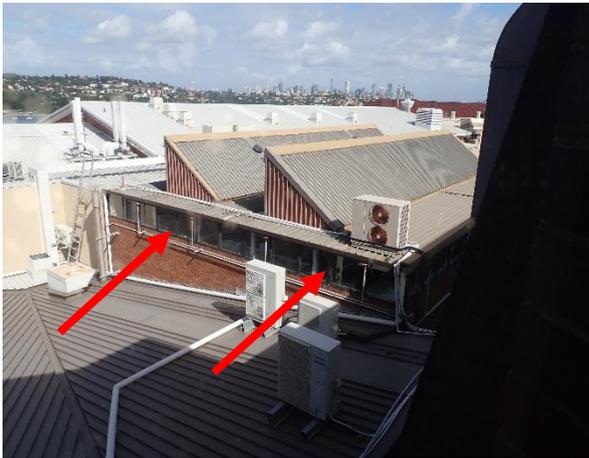
- Suspected asbestos containing mastic was identified to the metal framed windows to the western portion. A sample was unable to be collected due to height safety hazards.

Photo 28: Arts Building, assumed asbestos containing mastic to external windows

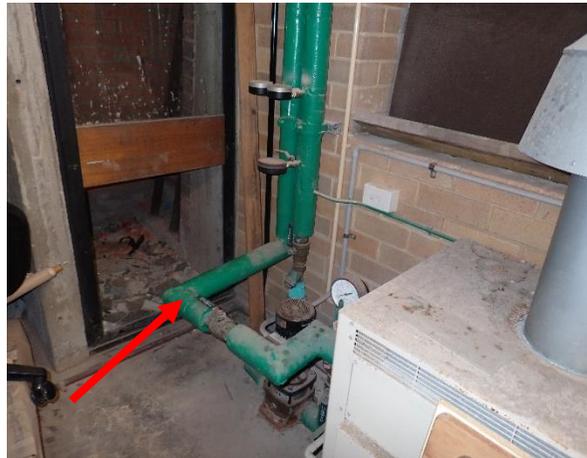
Photo 29: Arts Building, assumed SMF insulation lagging to pipework in lecture theatre plant room

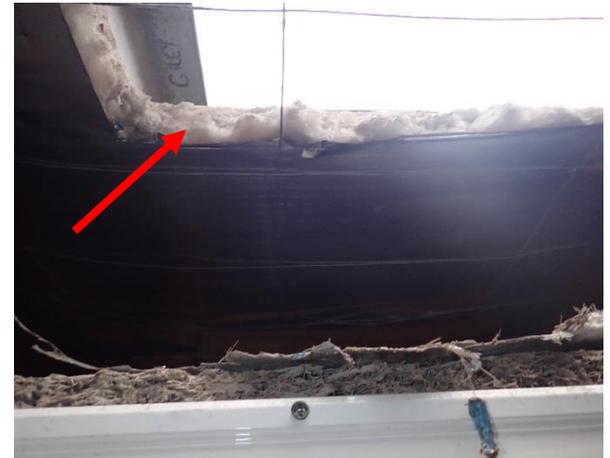
- Suspected SMF insulation was identified to the air conditioning ducting within the south hallway ceiling cavities.
- Suspected SMF insulation sarking was identified to the roof of the western portion.

Photo 30: Arts Building, assumed SMF insulation to the roof sarking throughout

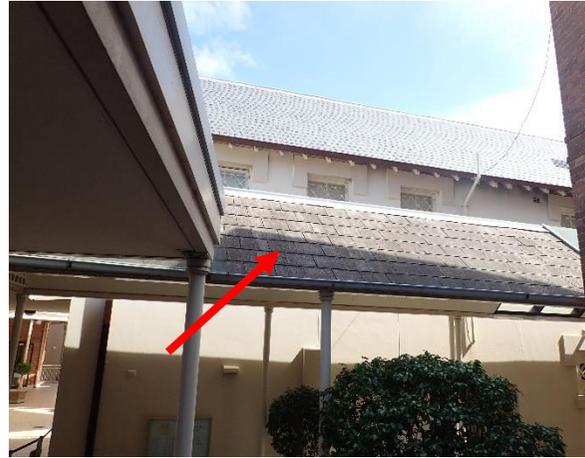
Photo 32: Tivoli Building, non-asbestos containing fibre cement roof shingles to the eastern covered walkway

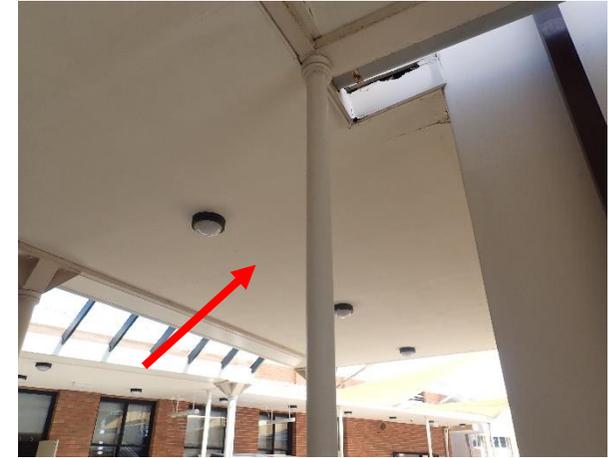
Photo 33: Tivoli Building, non-asbestos containing fibre cement sheeting to the soffits of the canteen courtyard

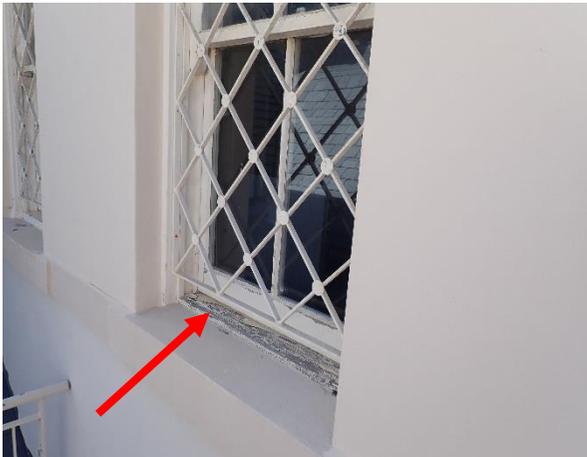
Photo 34: Tivoli Building, lead based cream paint to the external timber windows

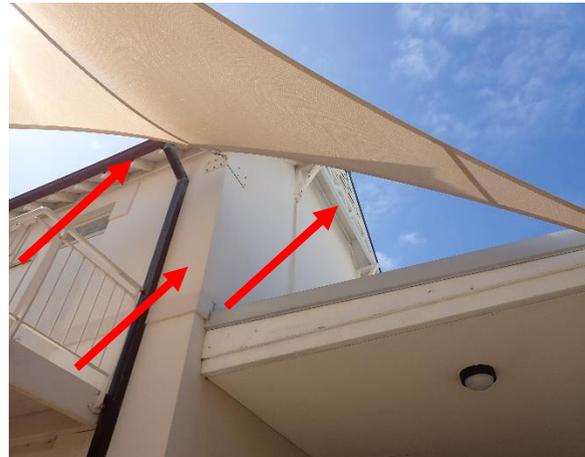
Photo 35: Tivoli Building, assumed lead based external paint systems

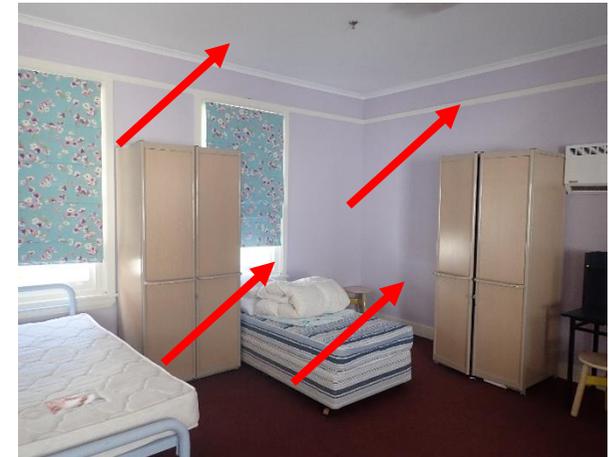
Photo 36: Tivoli Building, assumed lead based internal paint systems
