# Dilapidation Report

## LHAP - Multistorey Carpark

**ADCO** / 10 December 2020

LHAP-ST-TTW-RPT-CP-120001

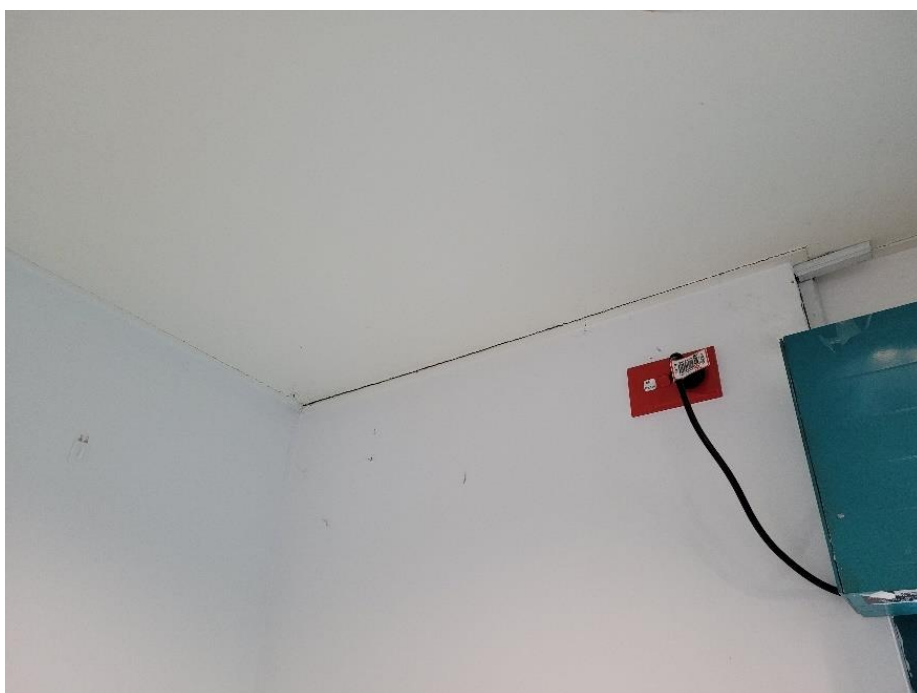
15. Crack in plasterboard  
at wall and ceiling  
junction

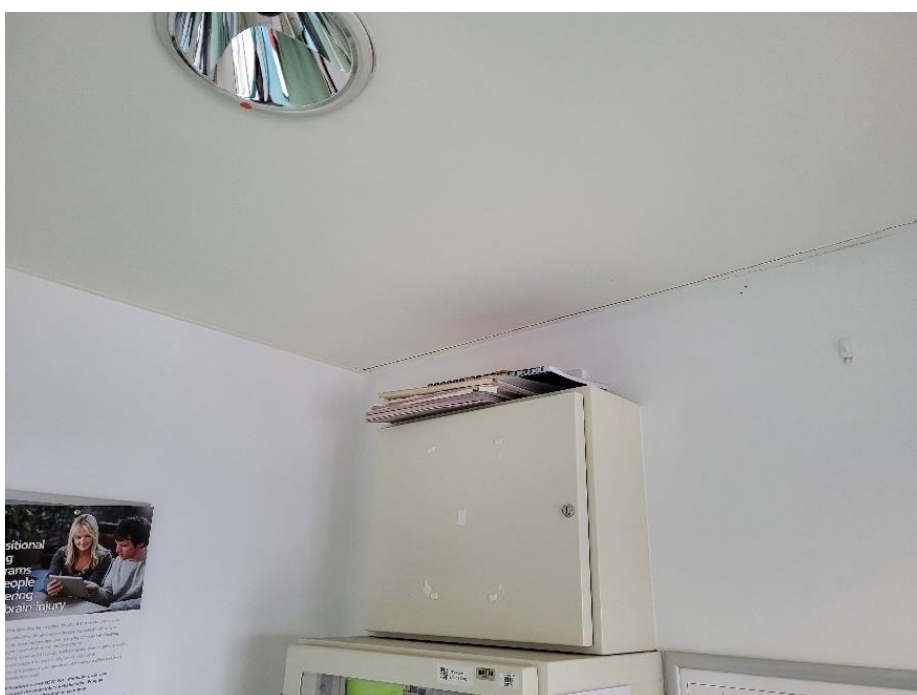
16. Crack in plasterboard  
at wall and ceiling  
junction

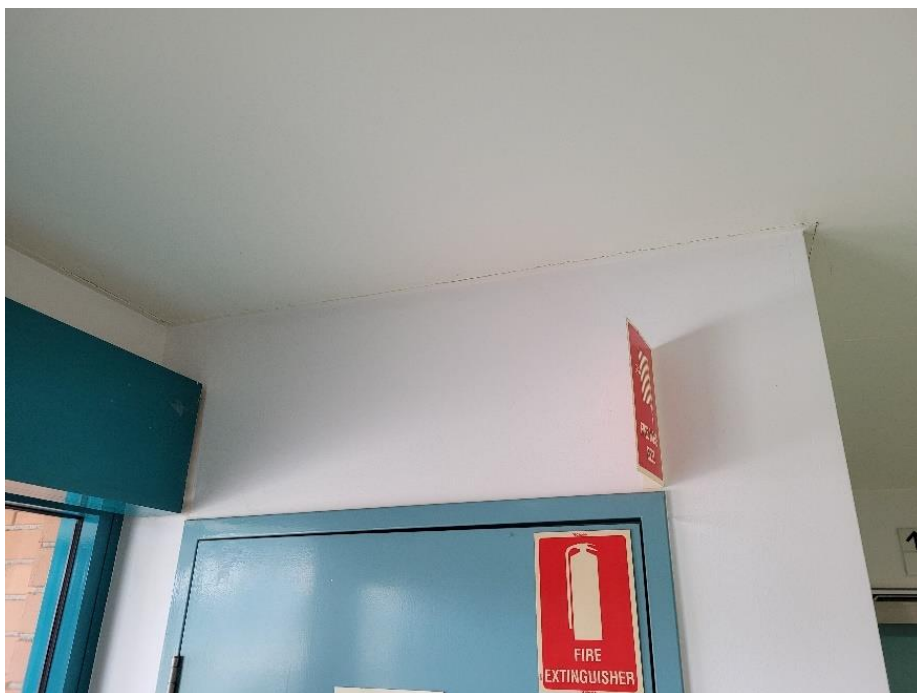
17. Crack in plasterboard  
at wall and ceiling  
junction

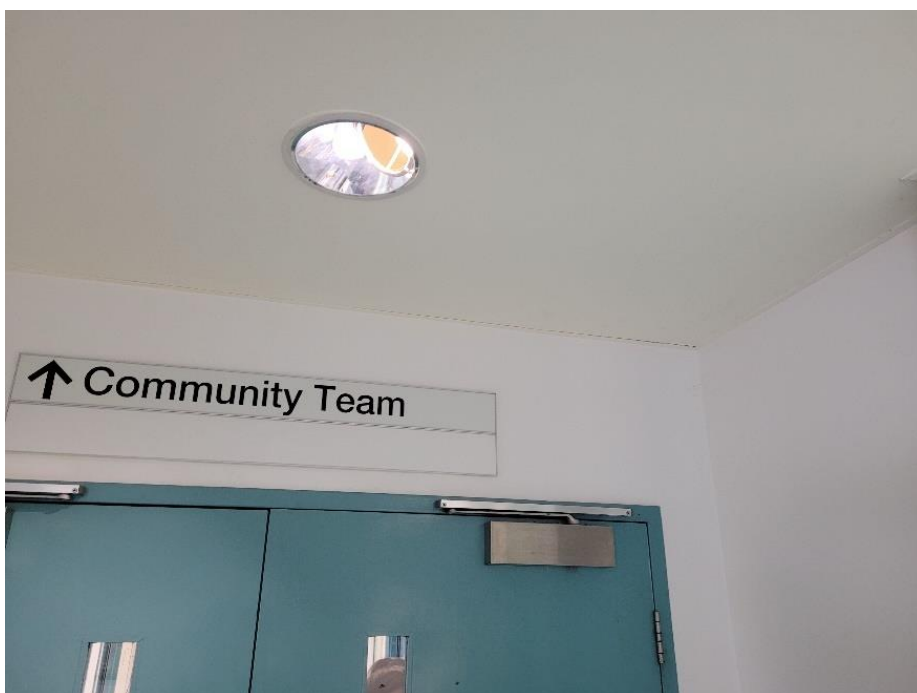
18. Crack in plasterboard  
at wall and ceiling  
junction

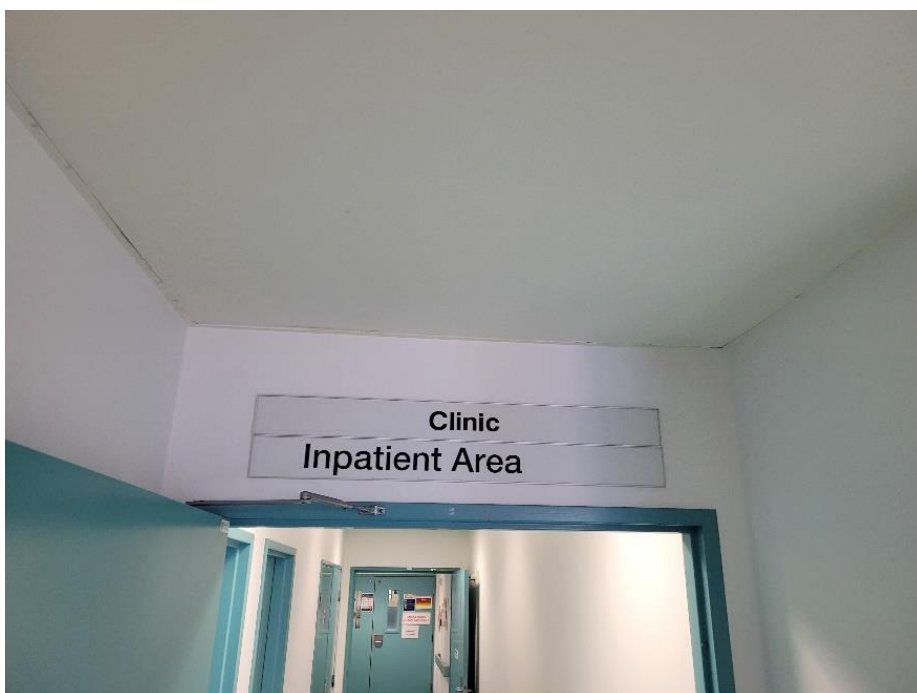
21. Crack in plasterboard  
at wall and ceiling  
junction

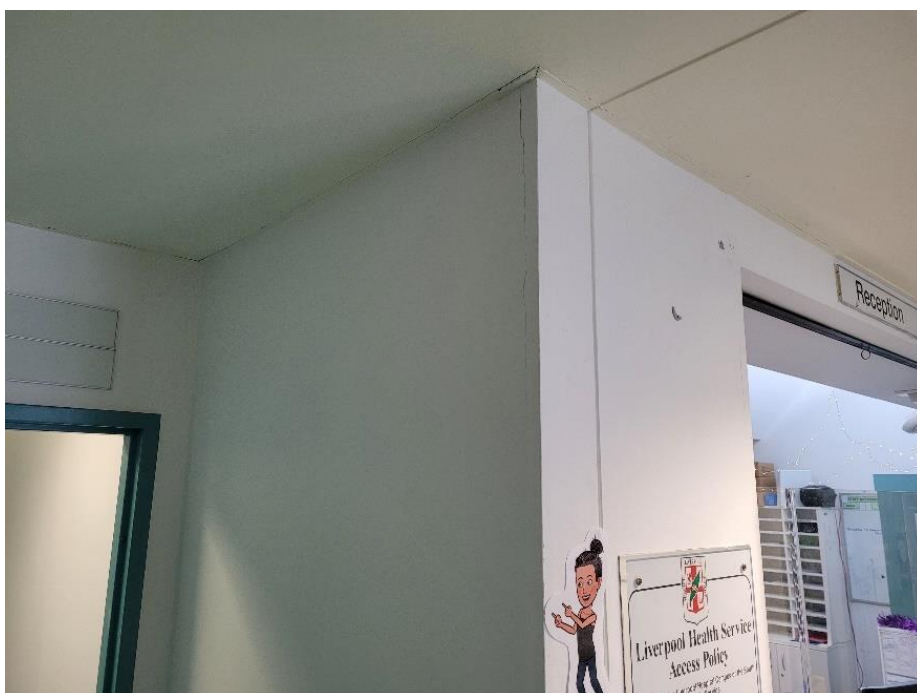
22. Crack in plasterboard  
at wall and ceiling  
junction

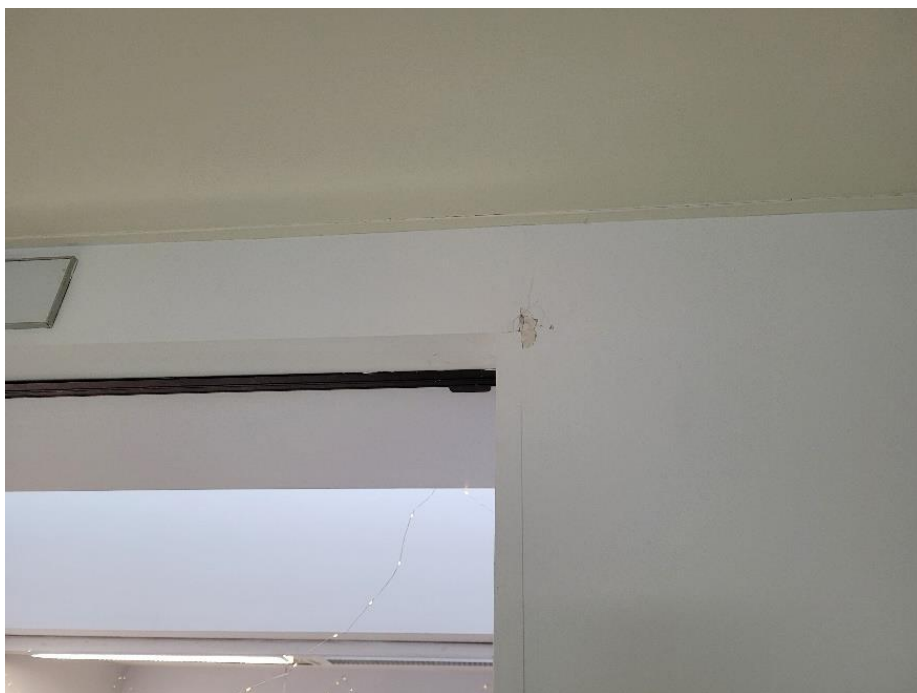
23. Damage to plasterboard in opening corner

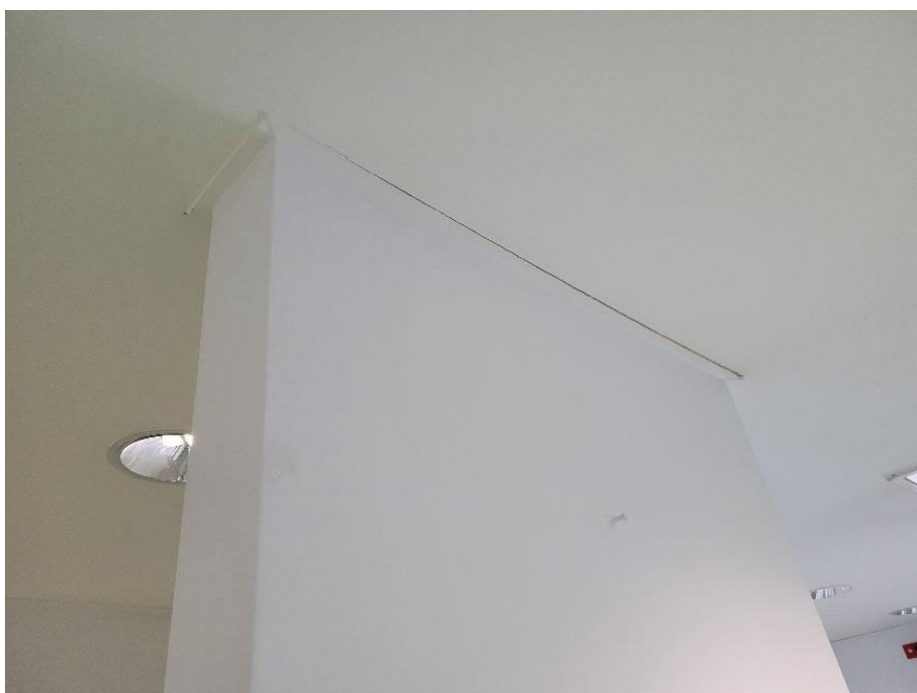
24. Crack in plasterboard at wall and ceiling junction

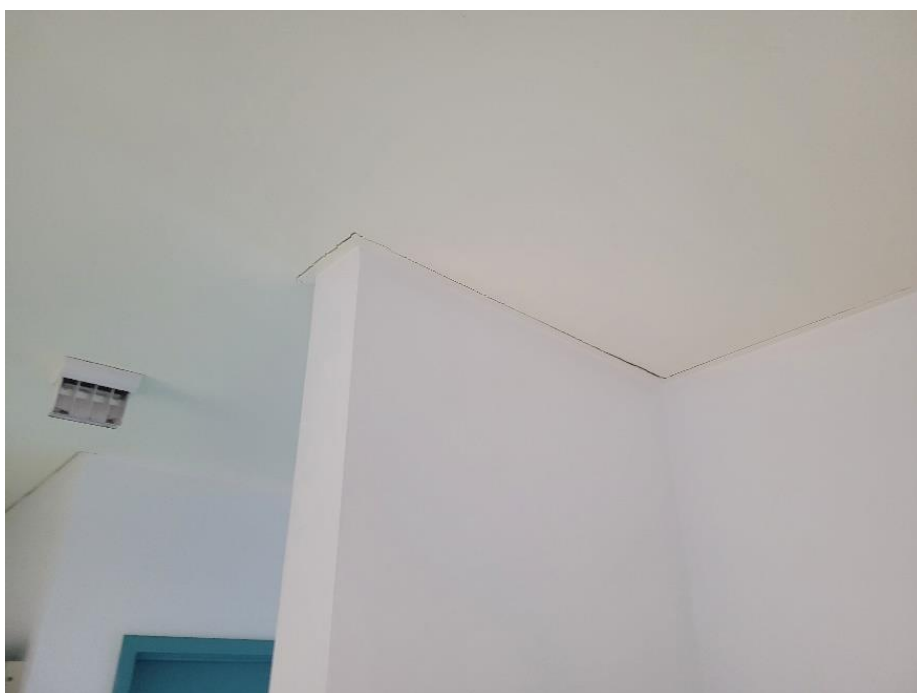
25. Crack in plasterboard  
at wall and ceiling  
junction

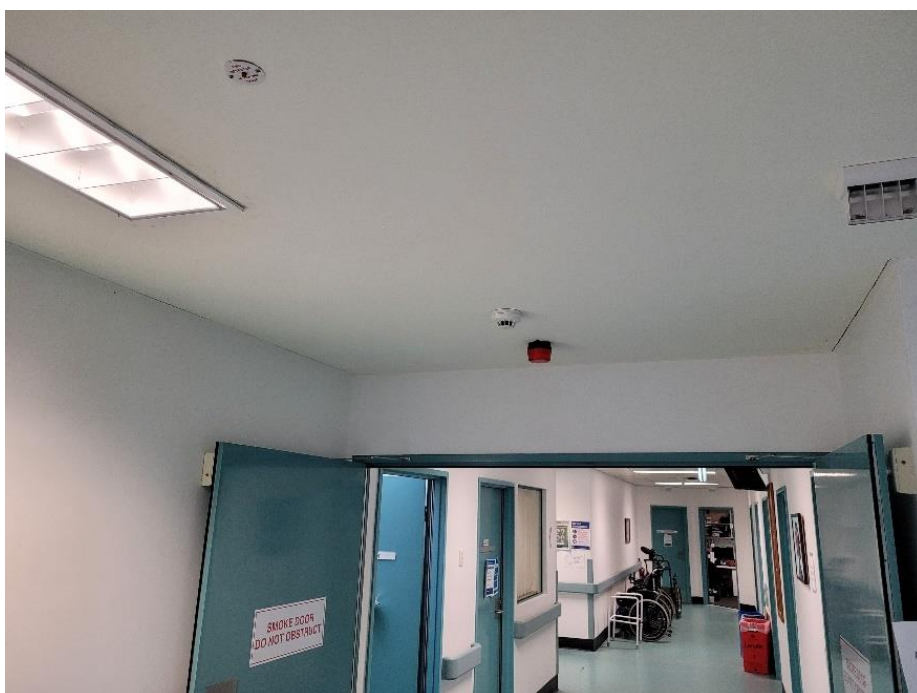
26. Crack in plasterboard  
at wall and ceiling  
junction around perimeter  
of door frame

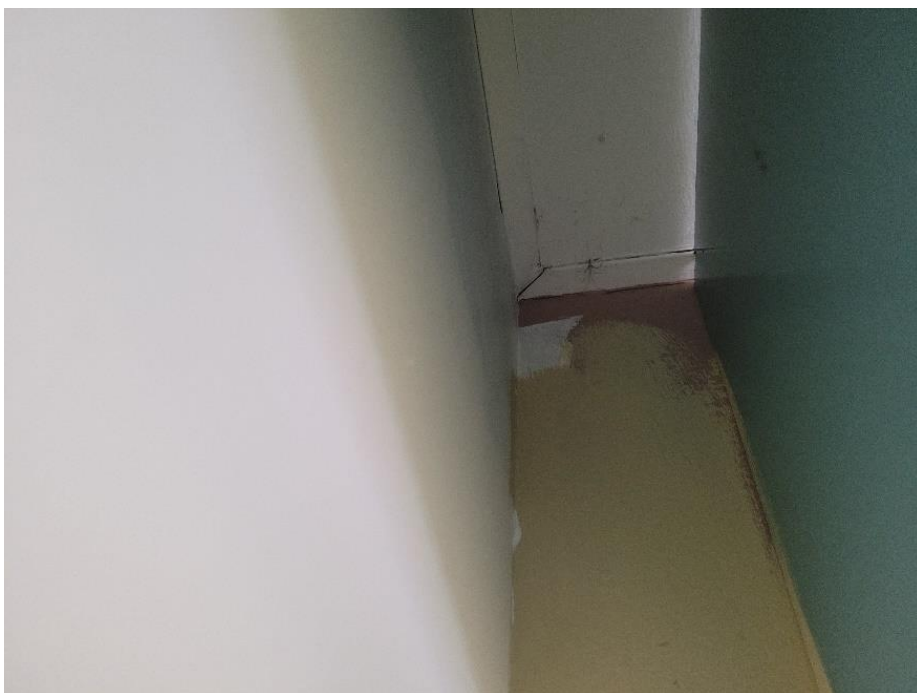
29. Crack in plasterboard at wall and ceiling junction and water damage behind shelf/furniture

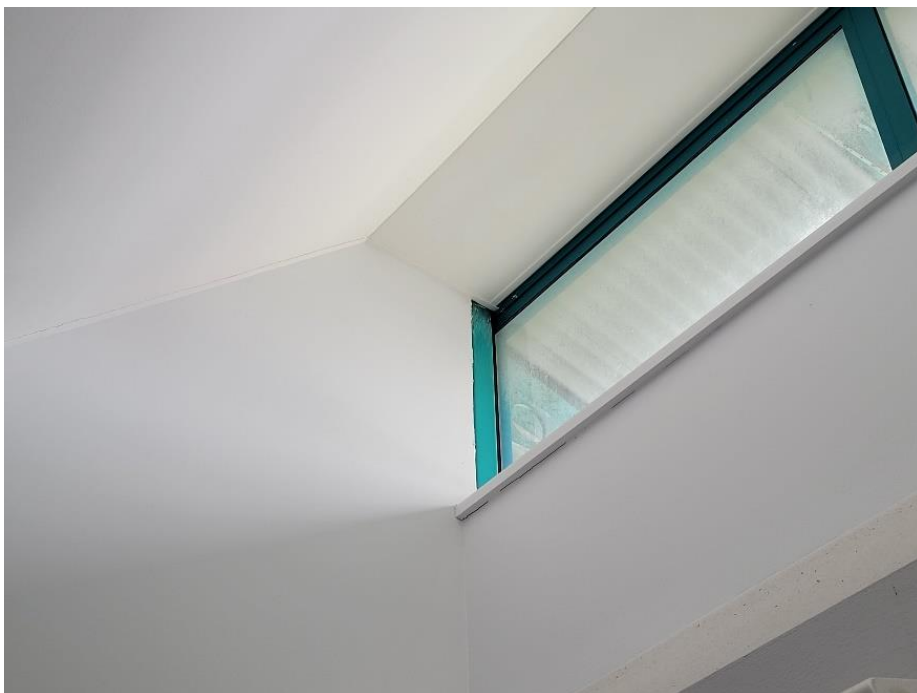
30. Window frame coming away from plasterboard wall

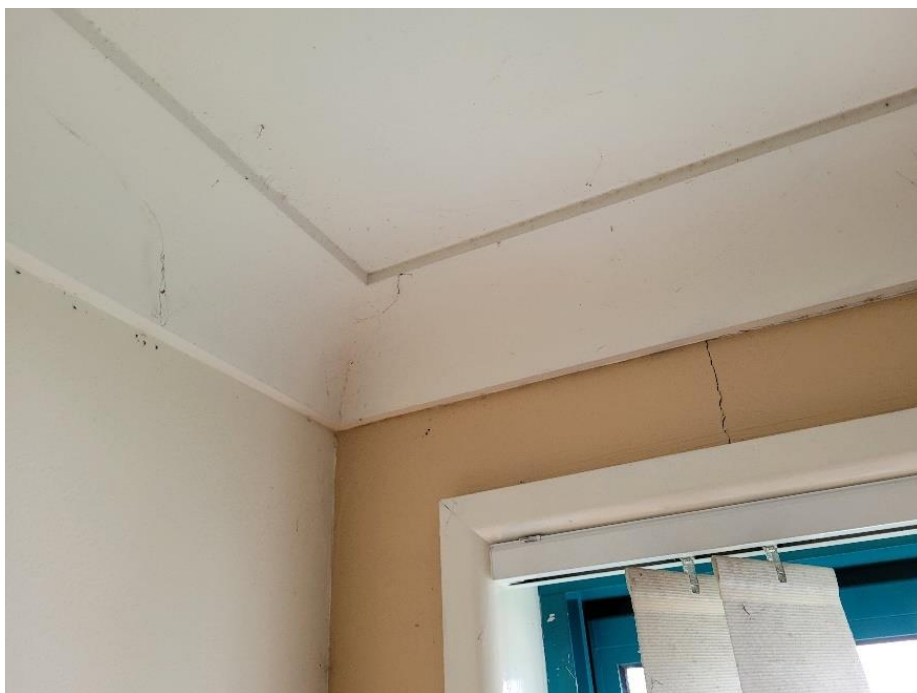
33. Vertical crack in plasterboard on external wall around window

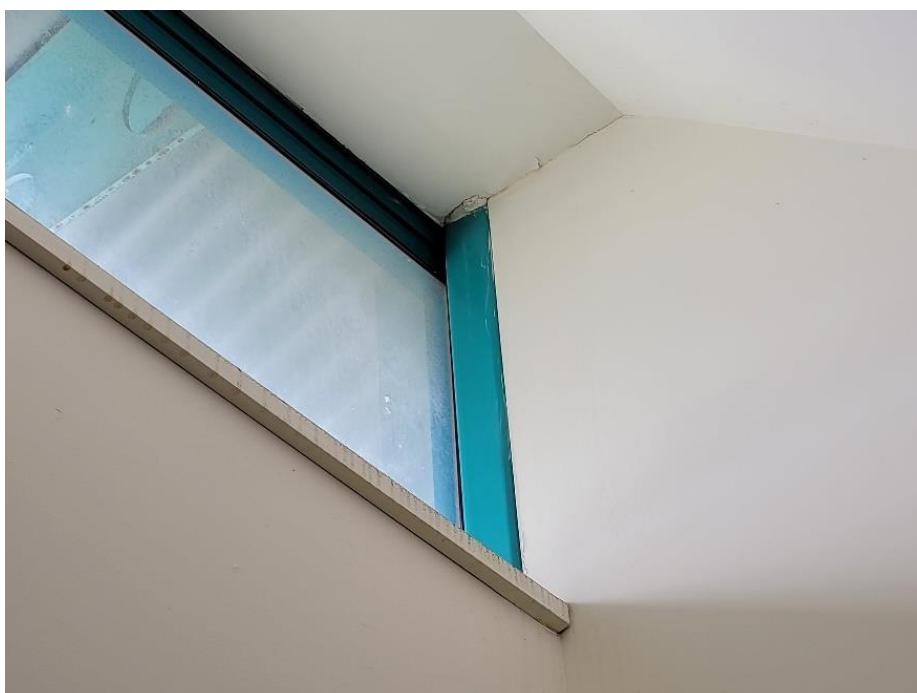
34. Damage to plasterboard around window at junction with steel post.

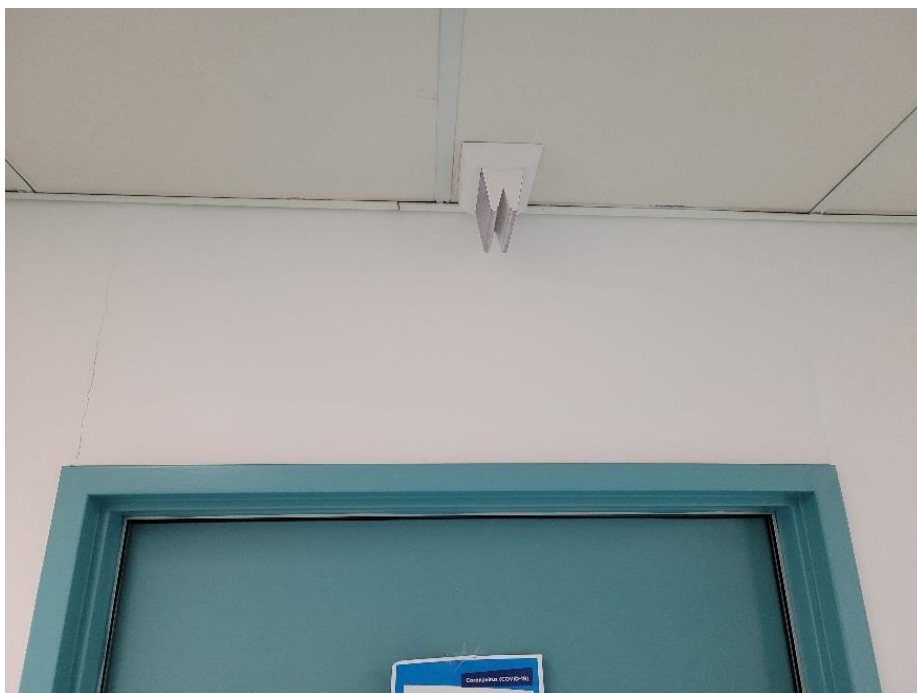
35. Vertical cracks from top of door frame corners to ceiling

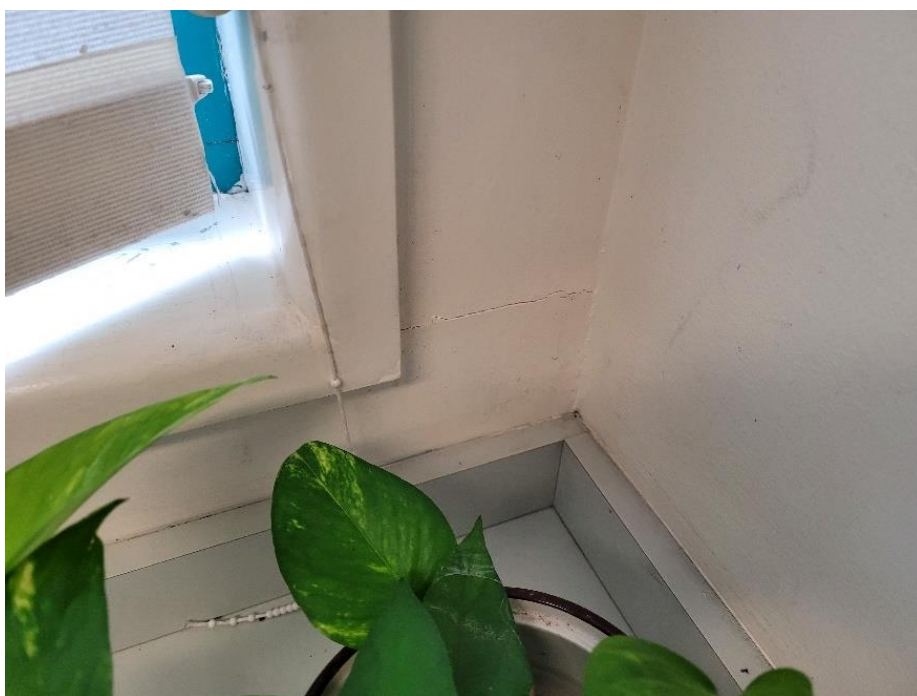
36. Horizontal cracks in plasterboard on external wall around window

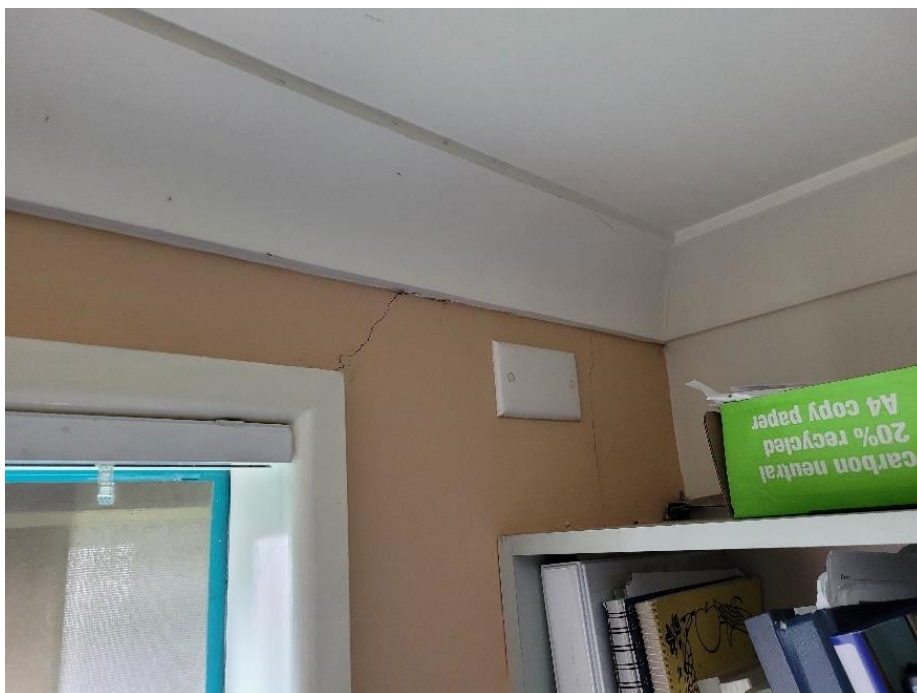
39. Cracking in plasterboard on external wall around window and vertical crack in corner, partially concealed behind furniture

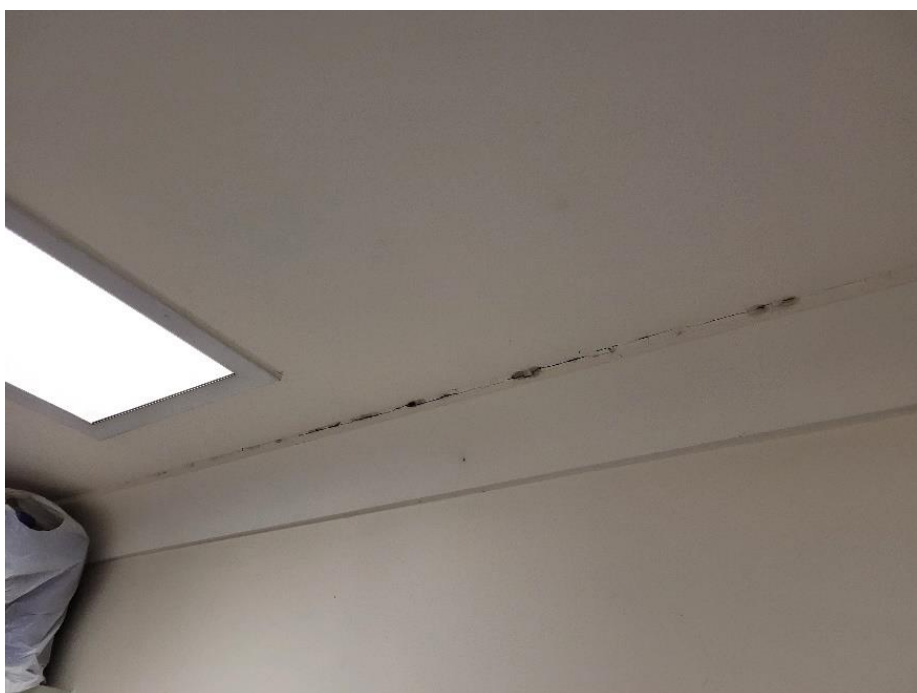
40. Crack in plasterboard ceiling at architrave edge

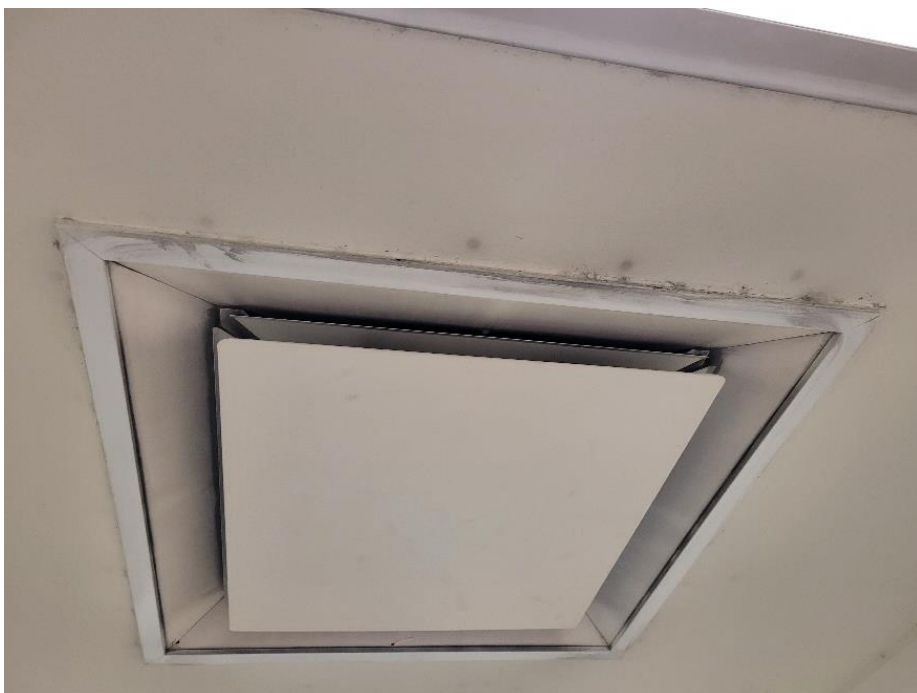
41. Discolouring around vent frame

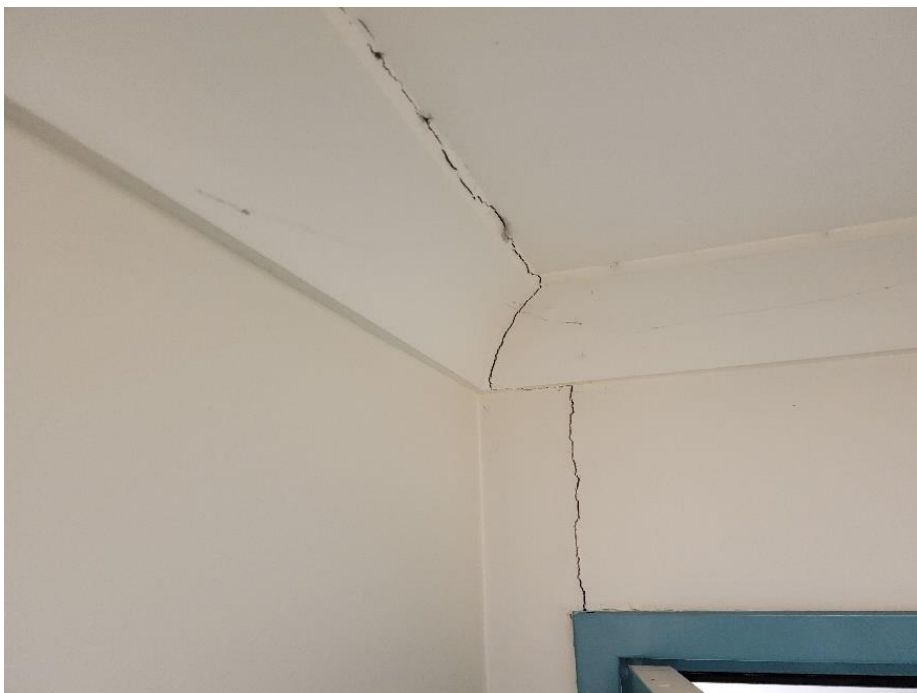
42. Crack in plasterboard at wall and ceiling junction, cracking running from window through into ceiling at joins, partition wall with hallway

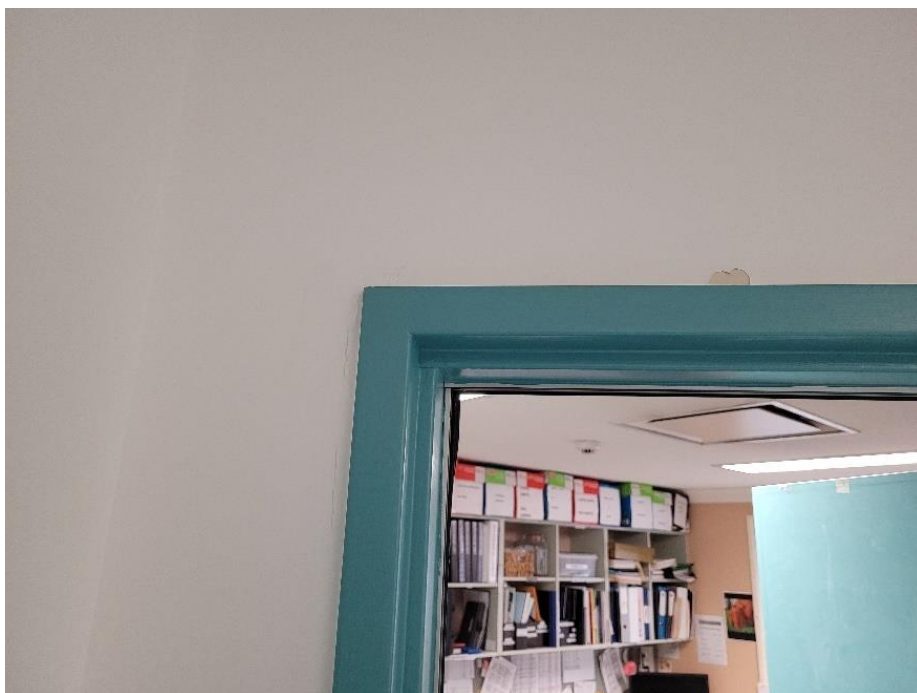
47. Slight cracking around door frame (painted over), chips in paintwork

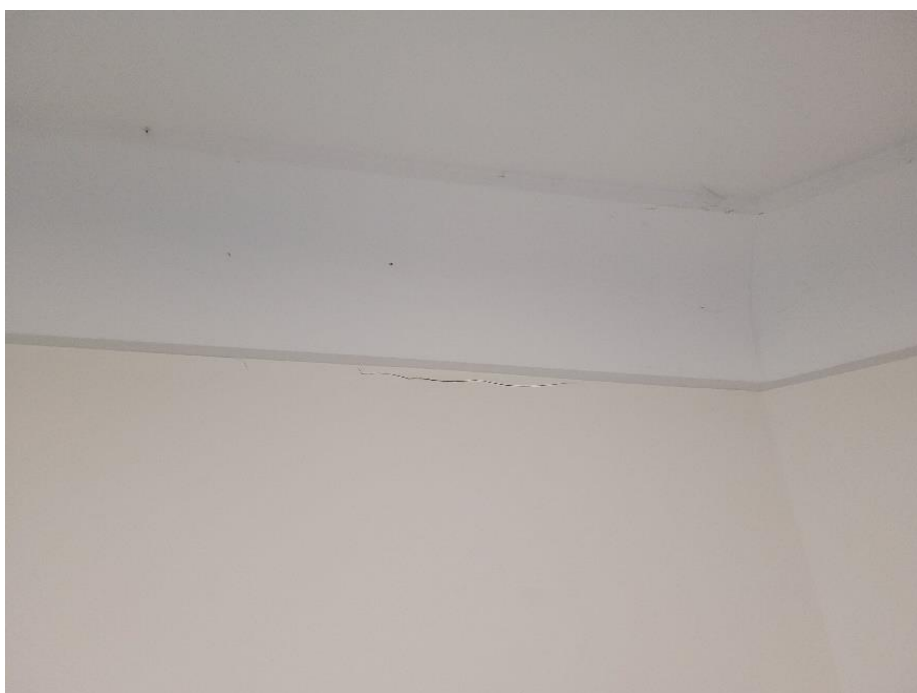
48. Crack in plasterboard at wall and ceiling junction

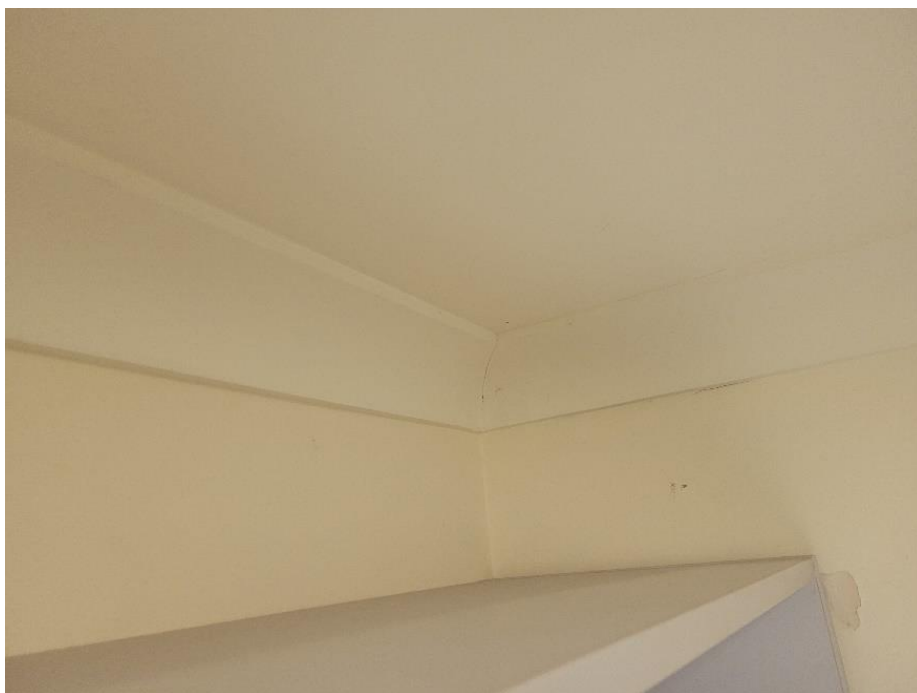
49. Crack in plasterboard  
at wall and ceiling  
junction

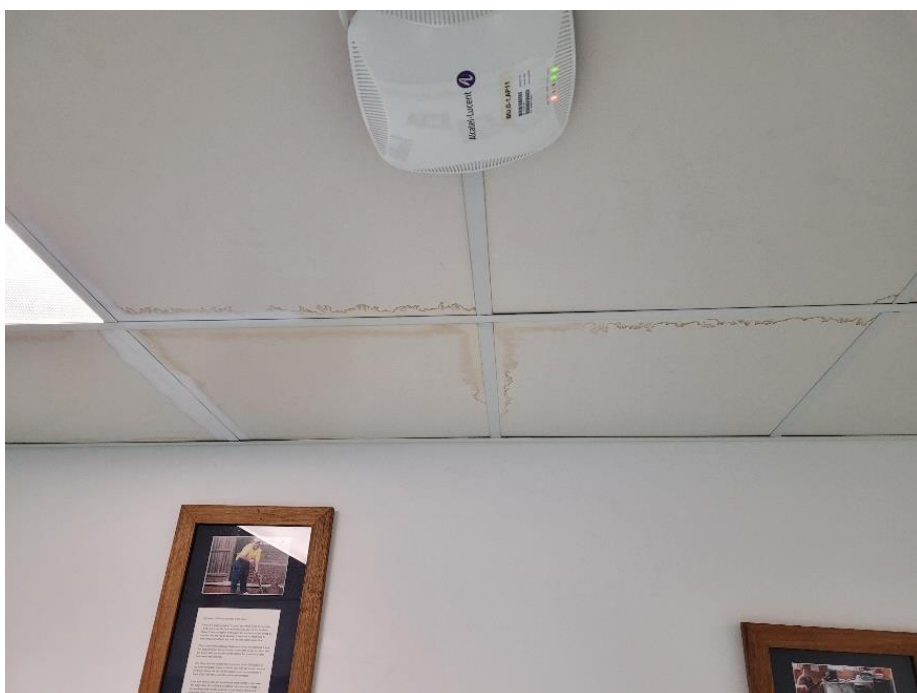
50. Water damage to  
false ceiling

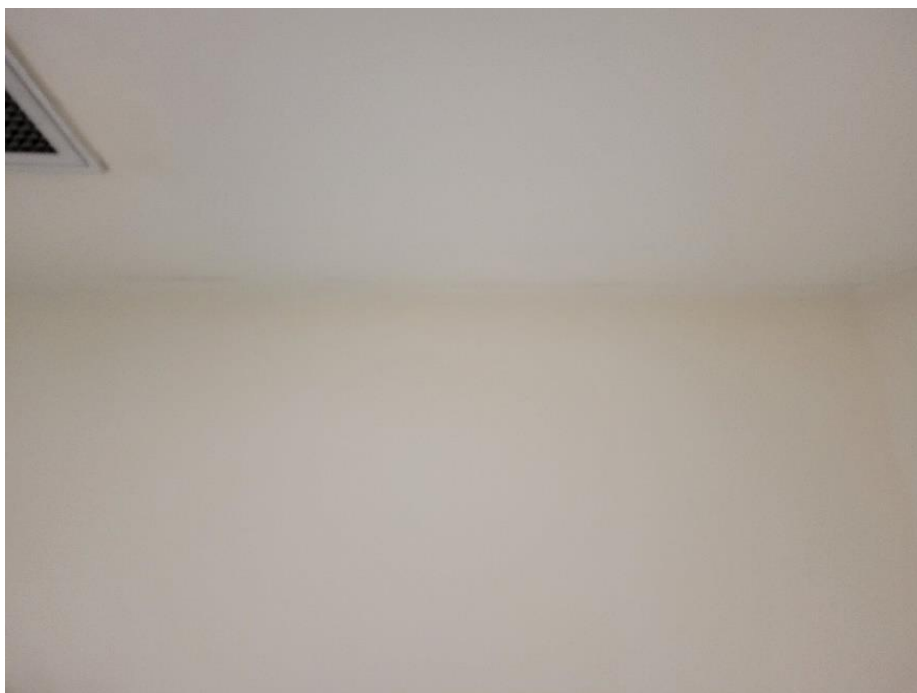
59. Crack in plasterboard  
at wall and ceiling  
junction

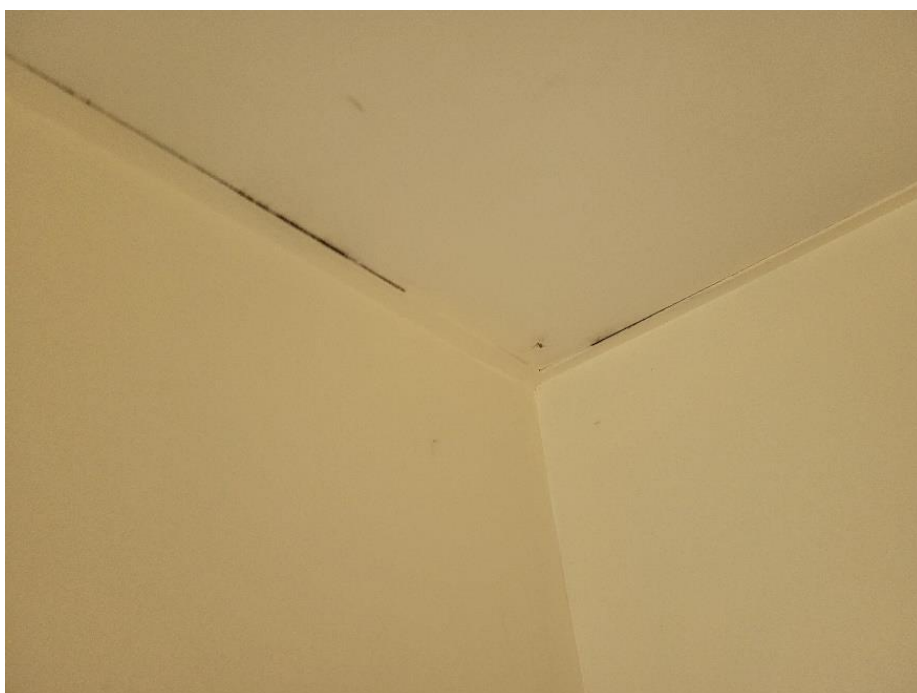
67. Crack in plasterboard at wall and ceiling junction

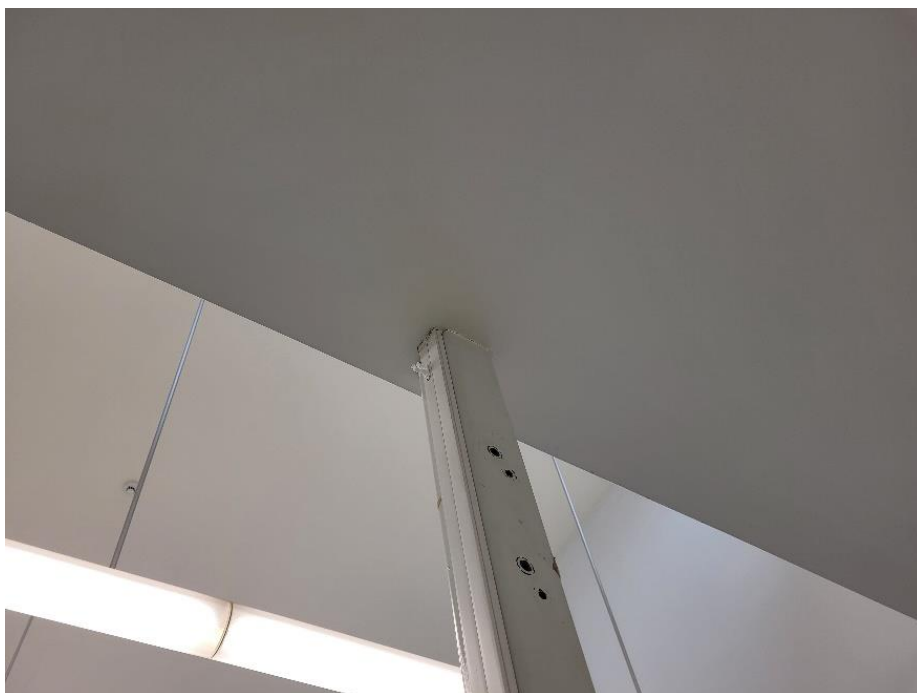
73. Cracking to plasterboard around ceiling junction with steel column

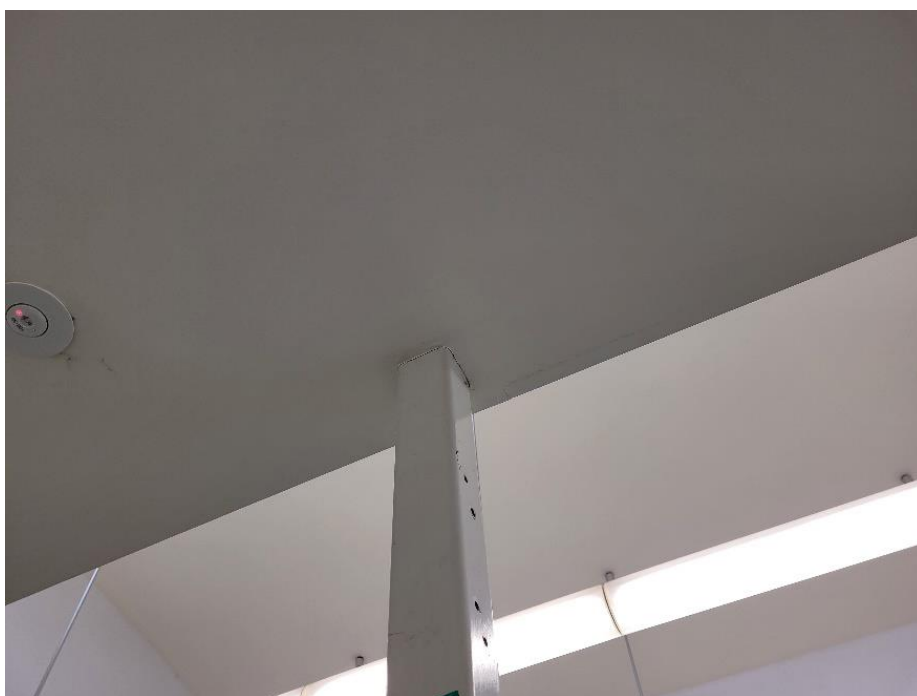
74. Cracking to plasterboard around ceiling junction with steel column

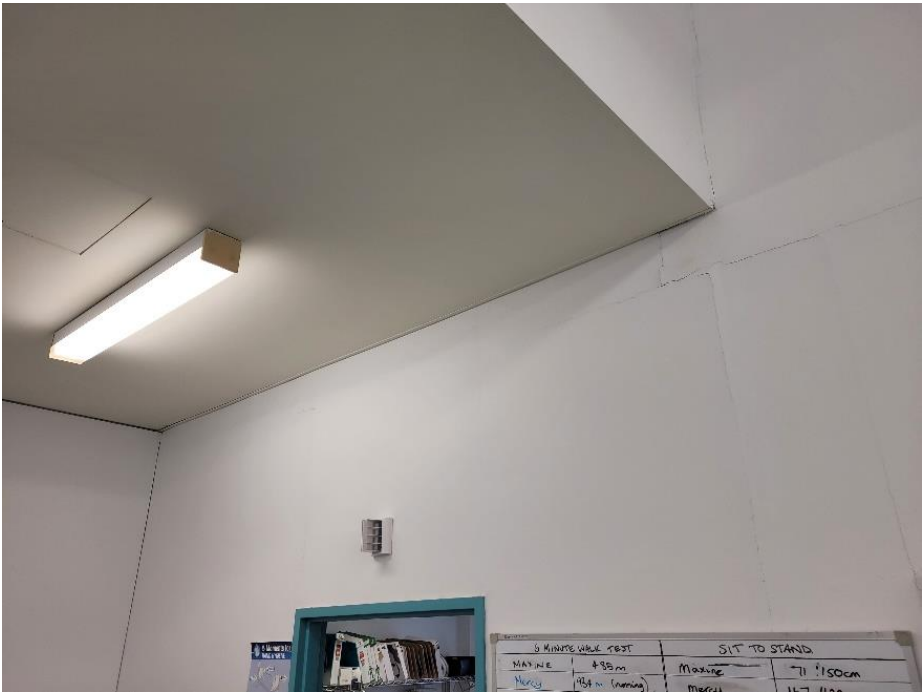
75. Extensive cracking to plasterboard around junction with ceiling, high wall section, lower wall section, light fitting, and external wall to lower ceiling

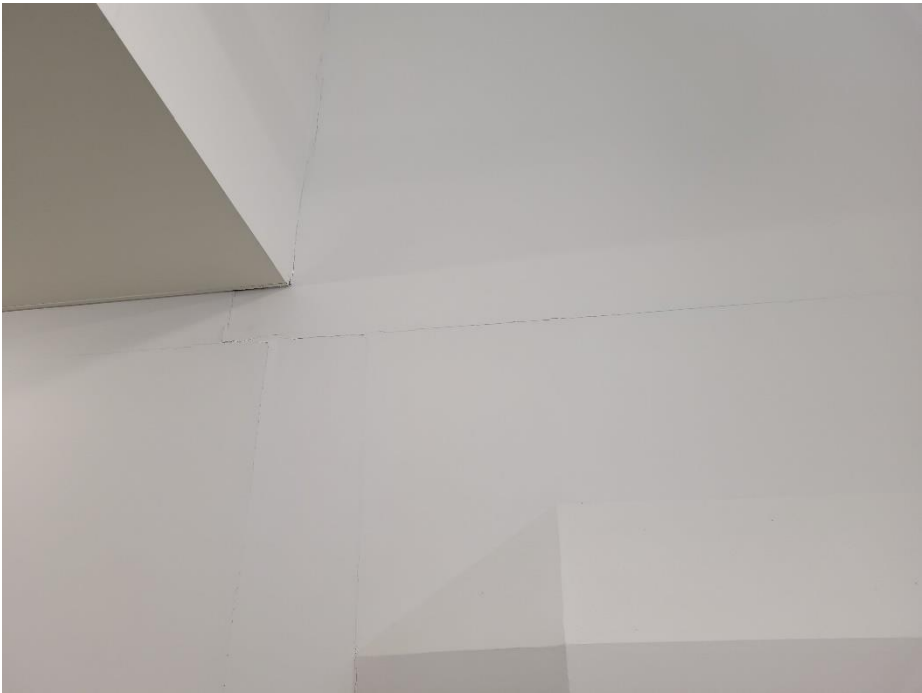
76. Extensive cracking to plasterboard around junction with ceiling, high wall section, lower wall section, light fitting, and external wall to lower ceiling

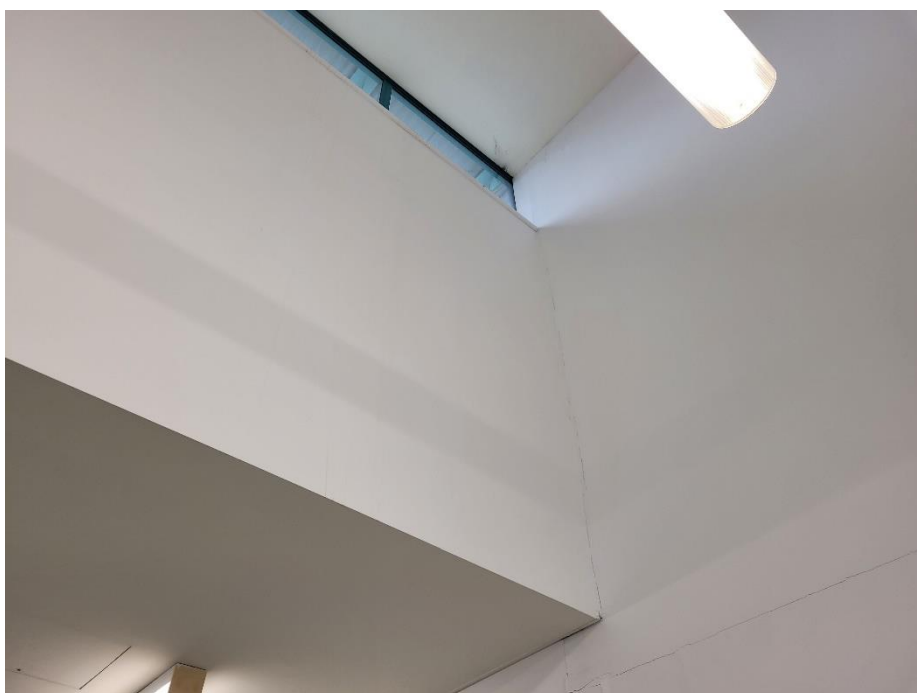
77. Extensive cracking to plasterboard around junction with ceiling, high wall section, cracks also around higher window opening

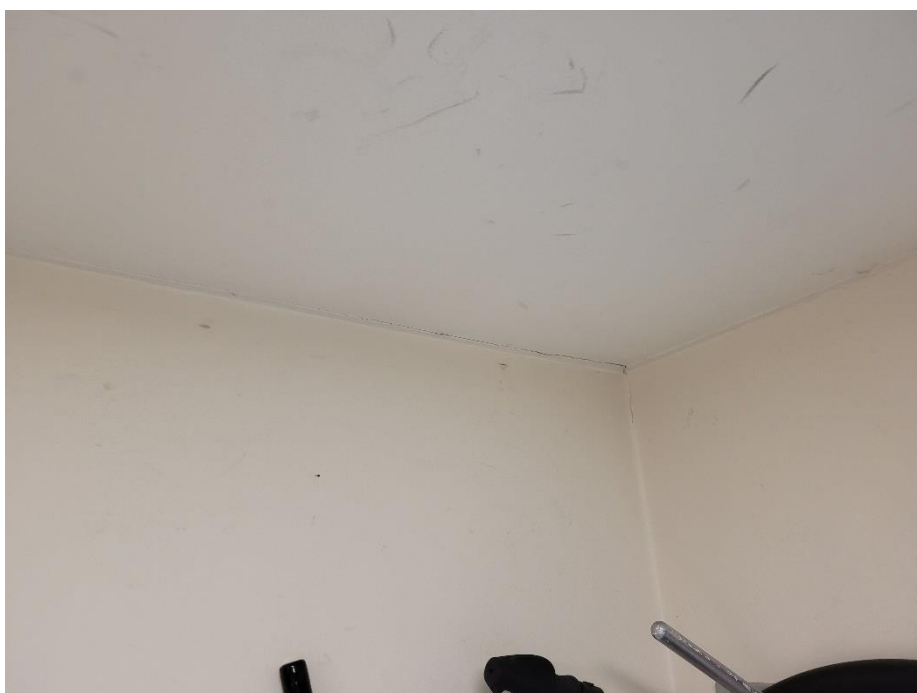
78. Crack in plasterboard at wall and ceiling junction

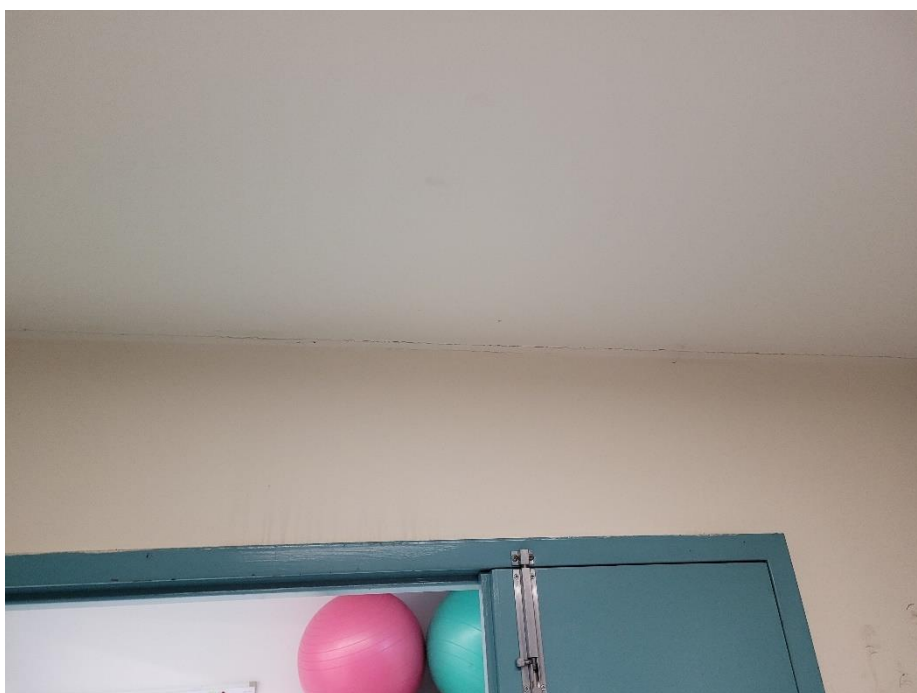
79. Crack in plasterboard  
at wall and ceiling  
junction

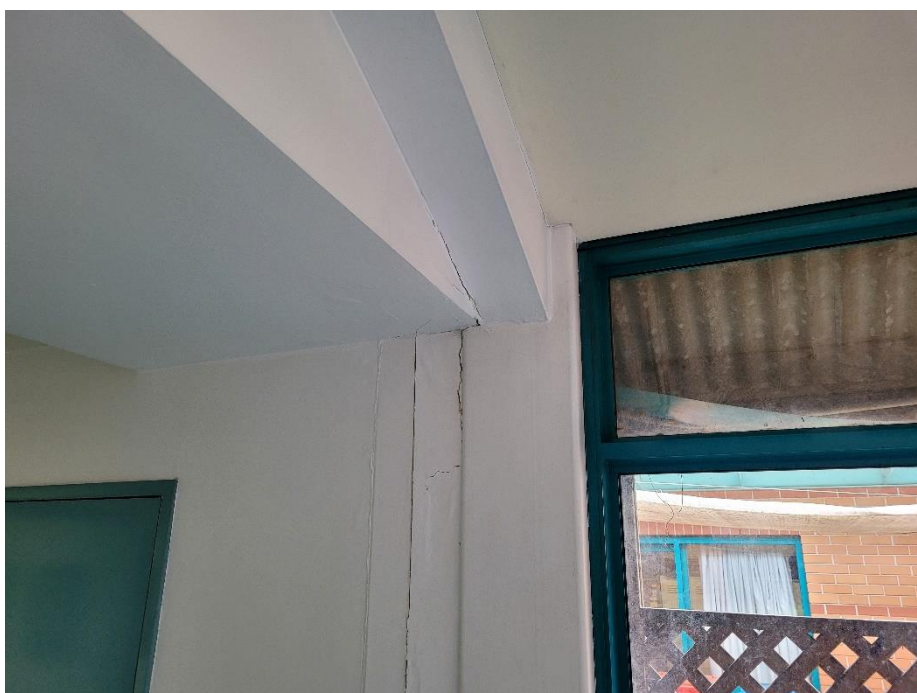
80. Cracking along  
junction with steel post,  
pitched ceiling, wall and  
lower ceiling

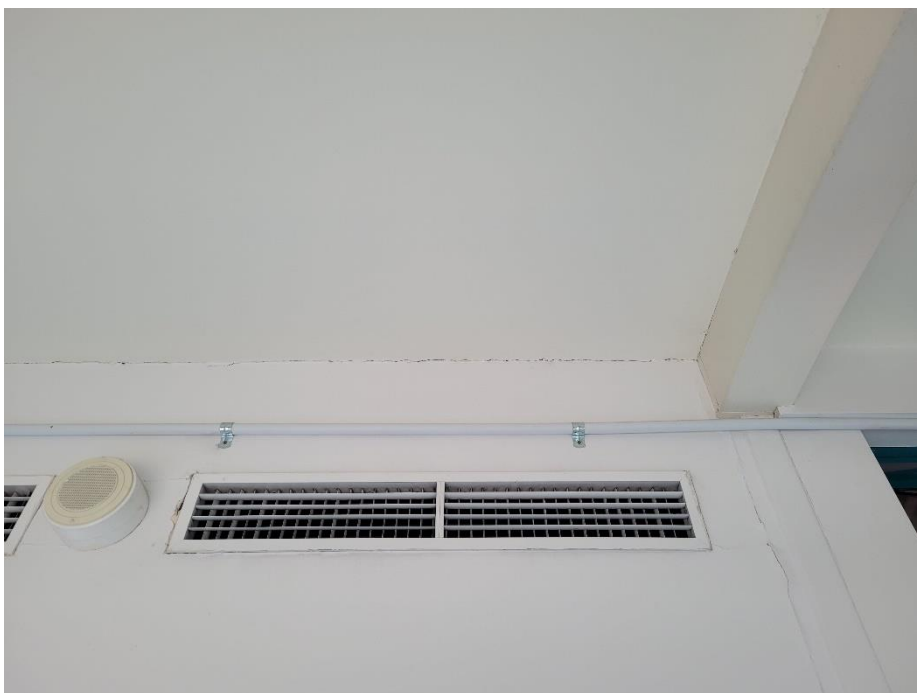
89. Crack in plasterboard at wall and ceiling junction, cracking around vent opening
