# Dilapidation Report

## LHAP - Multistorey Carpark

**ADCO** / 10 December 2020

LHAP-ST-TTW-RPT-CP-120001

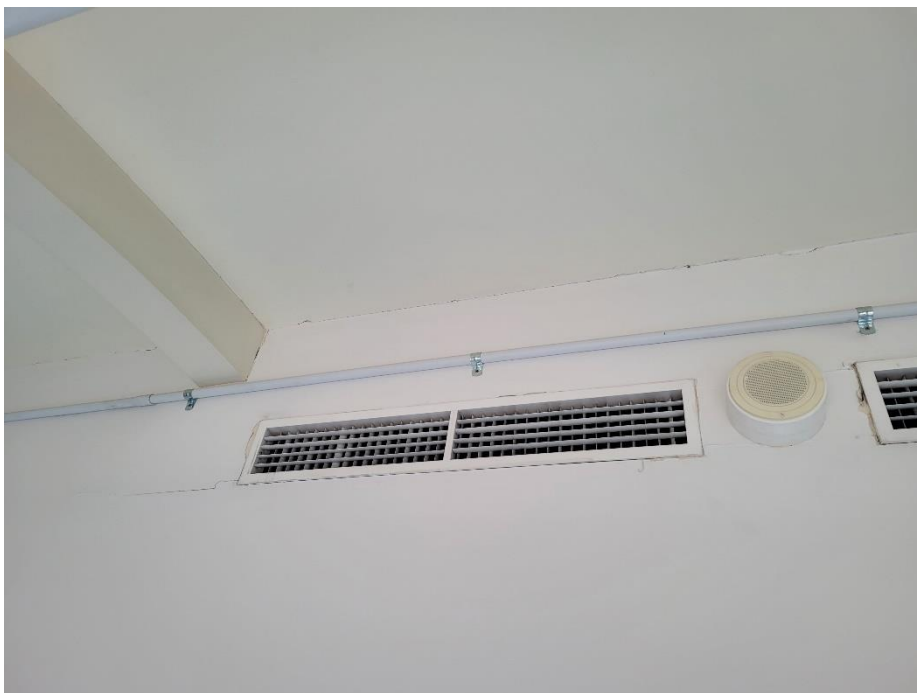
90. Crack in plasterboard at wall and ceiling junction, cracking around vent opening

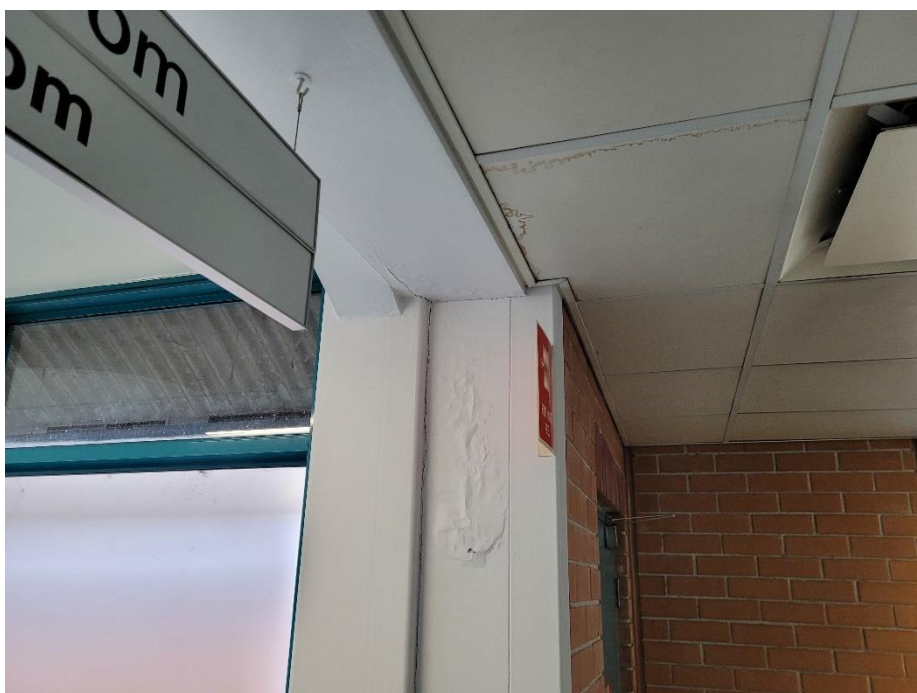
93. Crack in plasterboard at wall and ceiling junction, water damage to wall and false ceiling

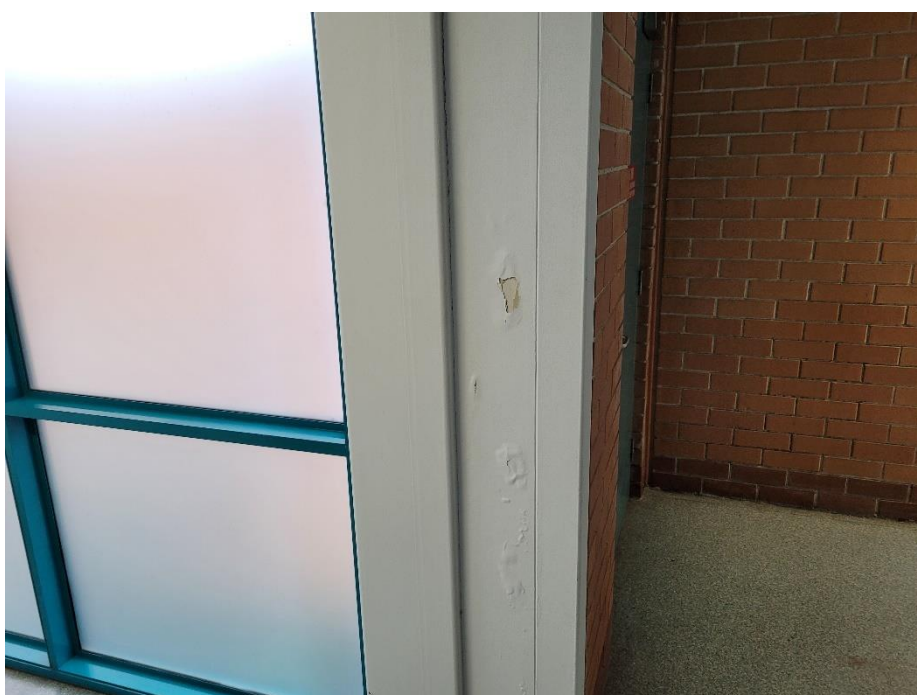
94. Water damage to wall

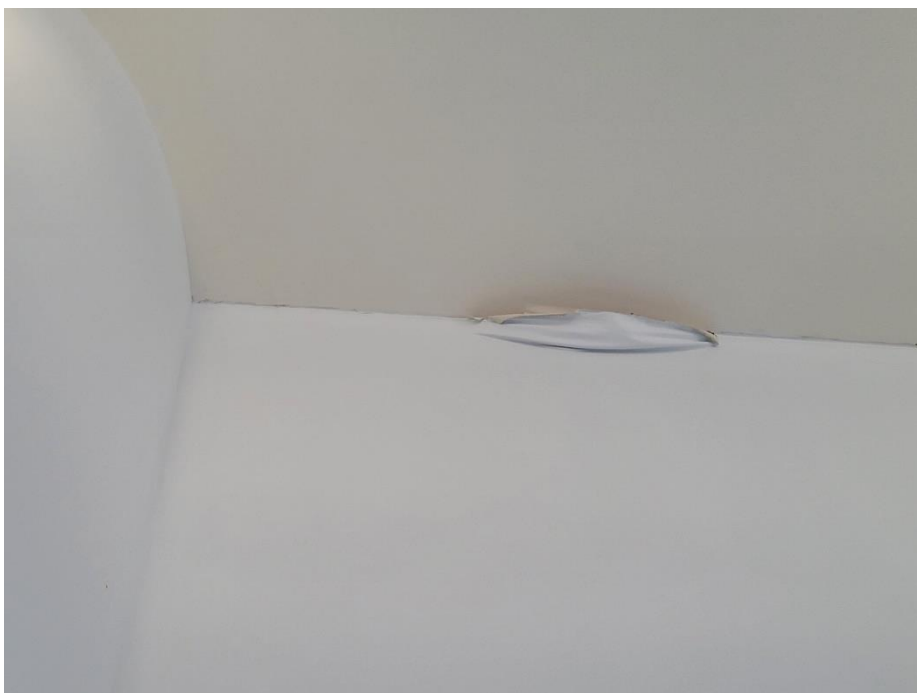
97. Damage to plasterboard at ceiling junction, uncertain whether water-borne or not

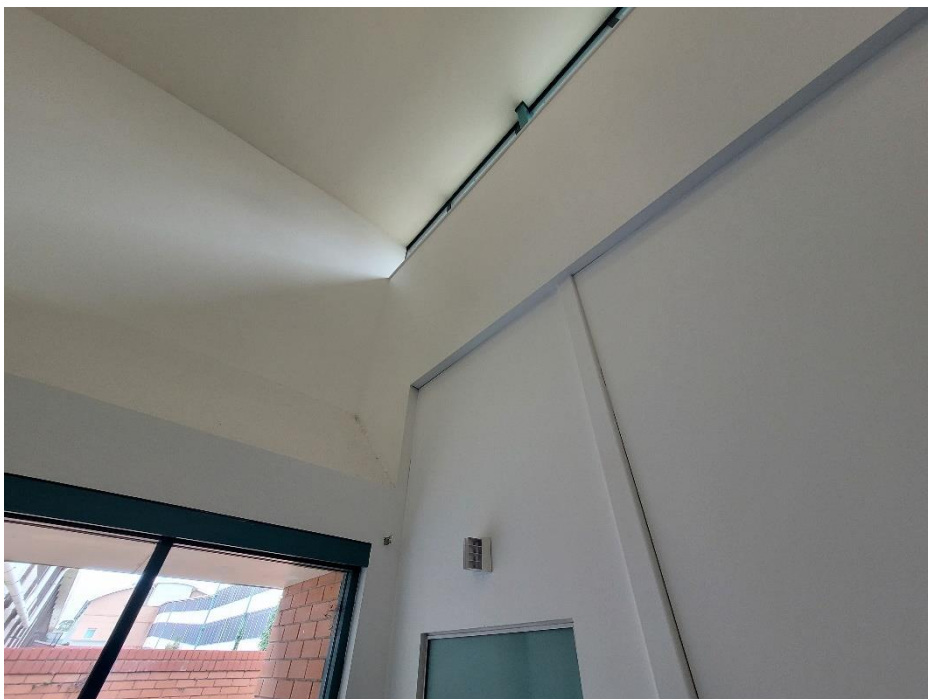
98. Cracking in plasterboard at various locations across wall junction

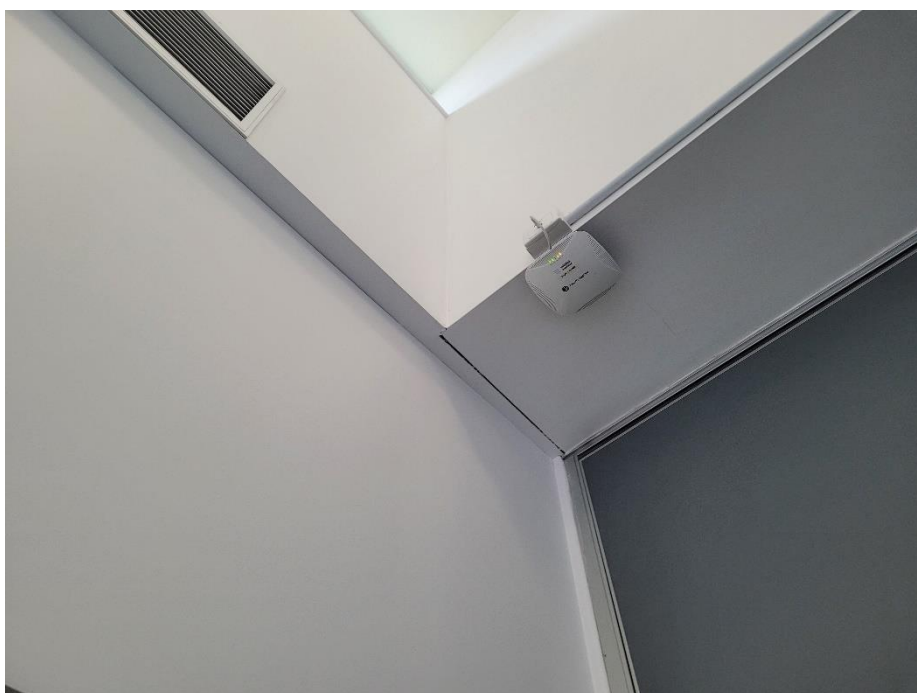
99. Crack in plasterboard  
at wall and ceiling  
junction

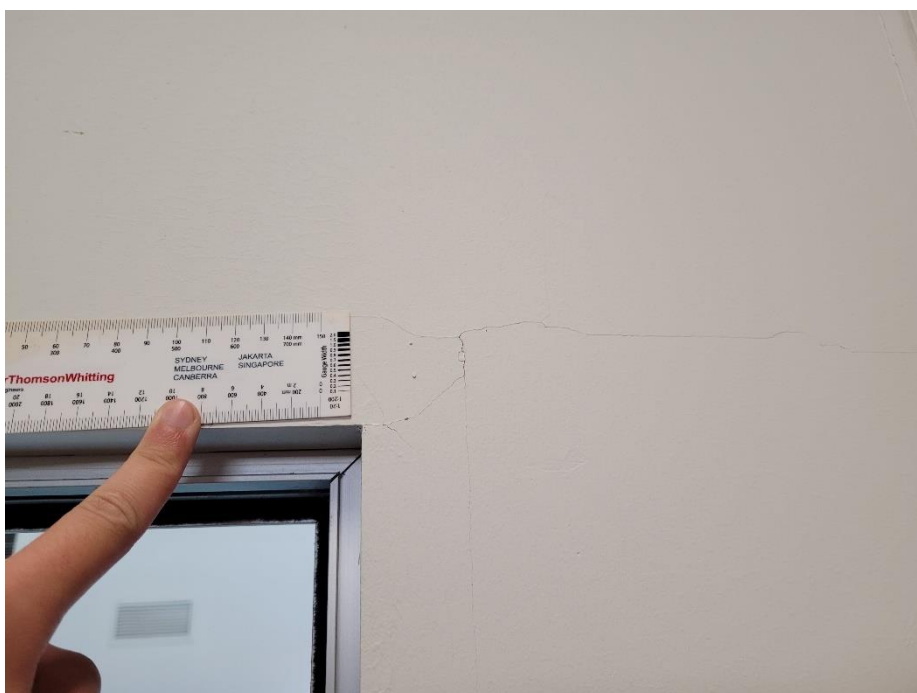
100. Minor cracking next  
to door opening

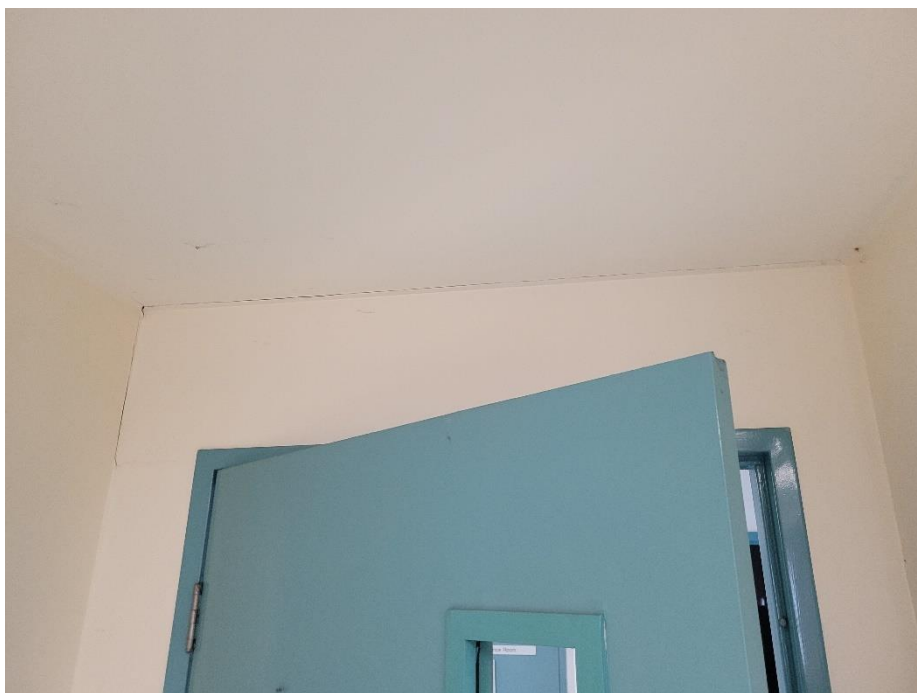
109. Cracks in plasterboard next to door opening

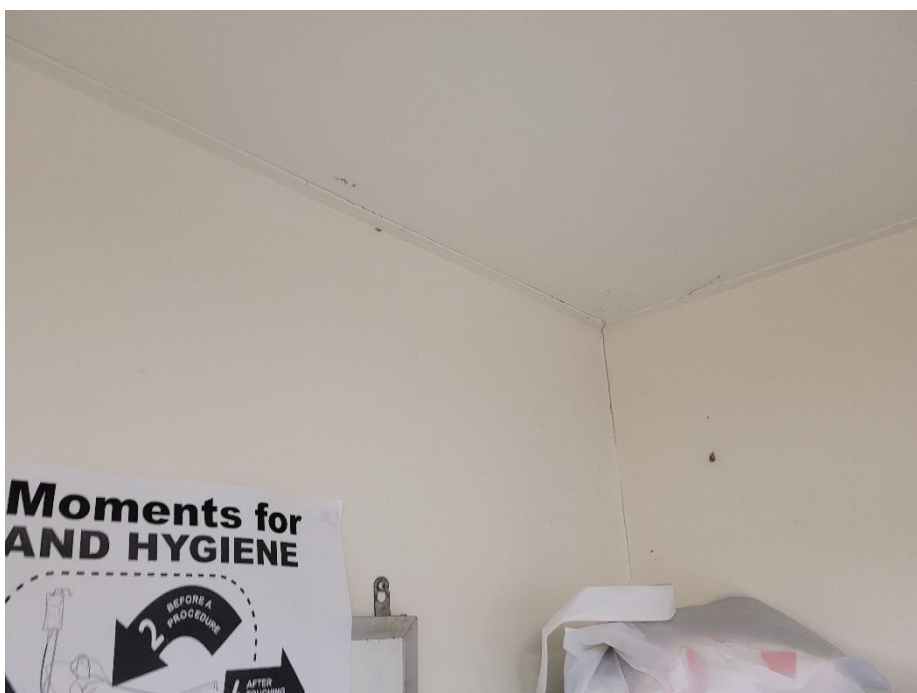
110. Crack in plasterboard at wall and ceiling junction

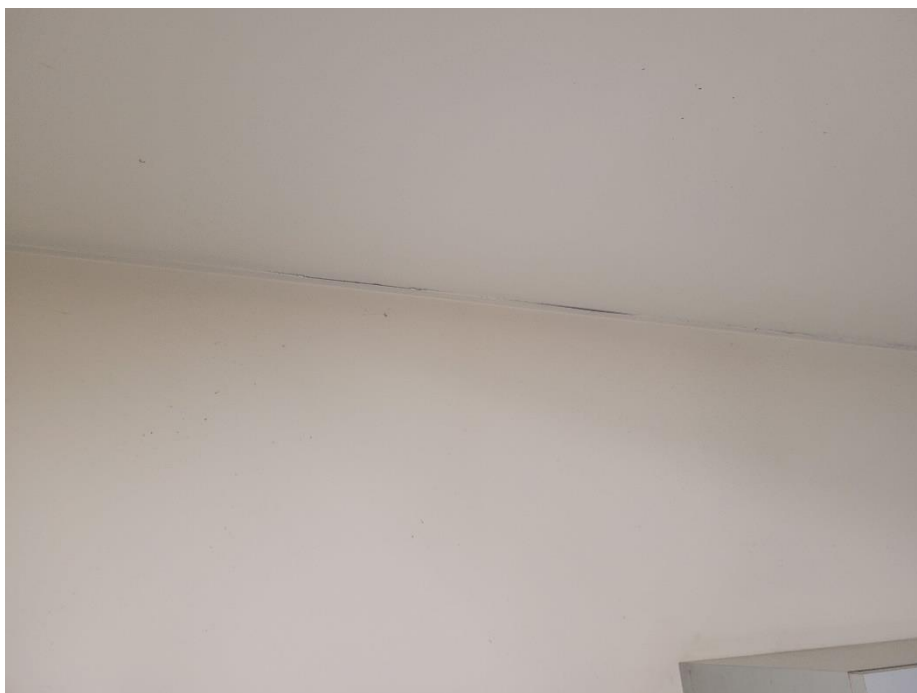
111. Crack in plasterboard at wall and ceiling junction

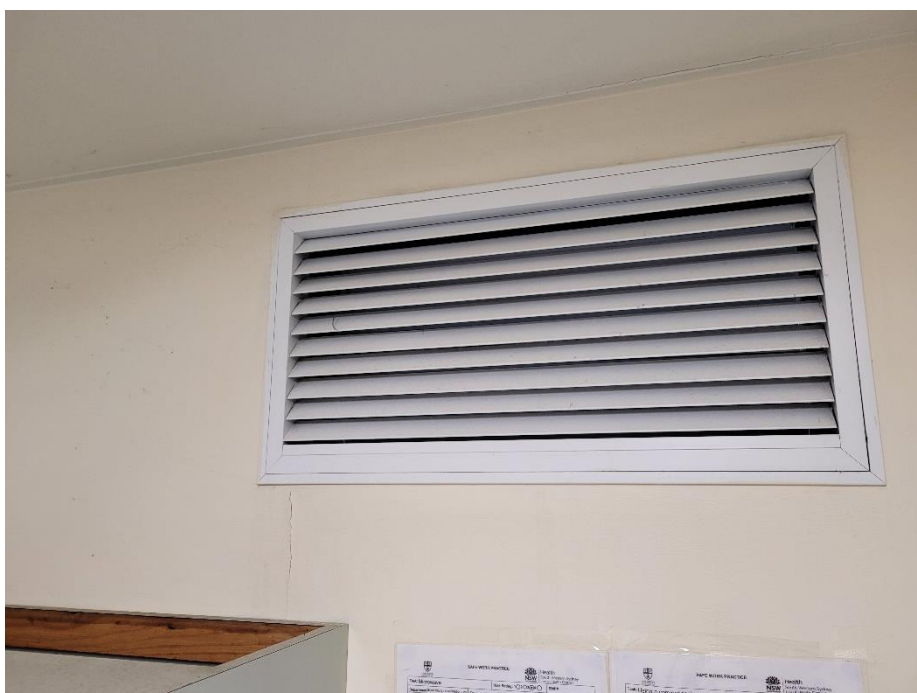
112. Cracking in wall plasterboard around vent opening

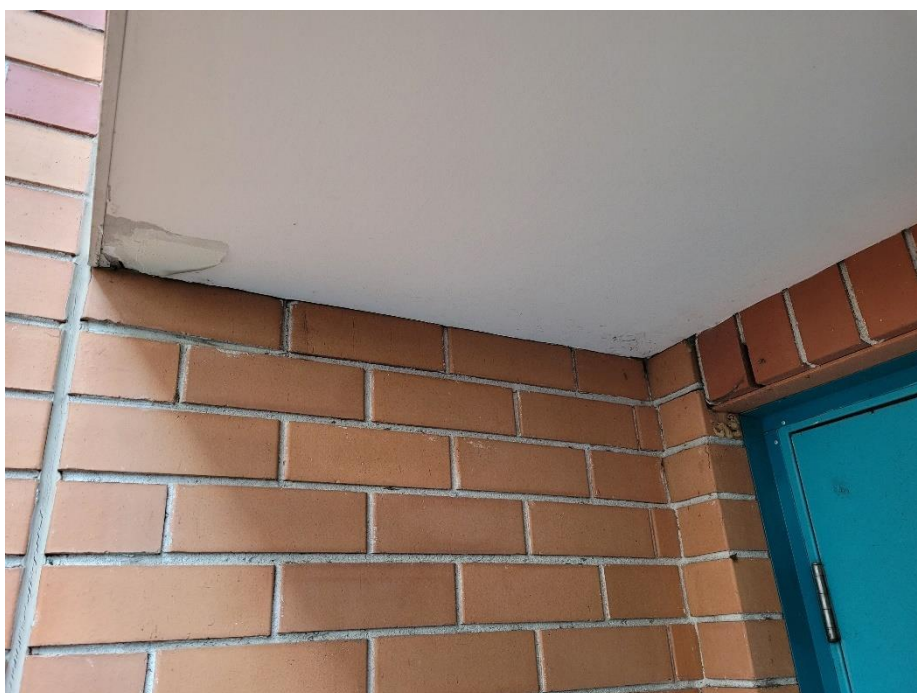
113. Water damage to eave soffit, cracking in external masonry adjacent door opening

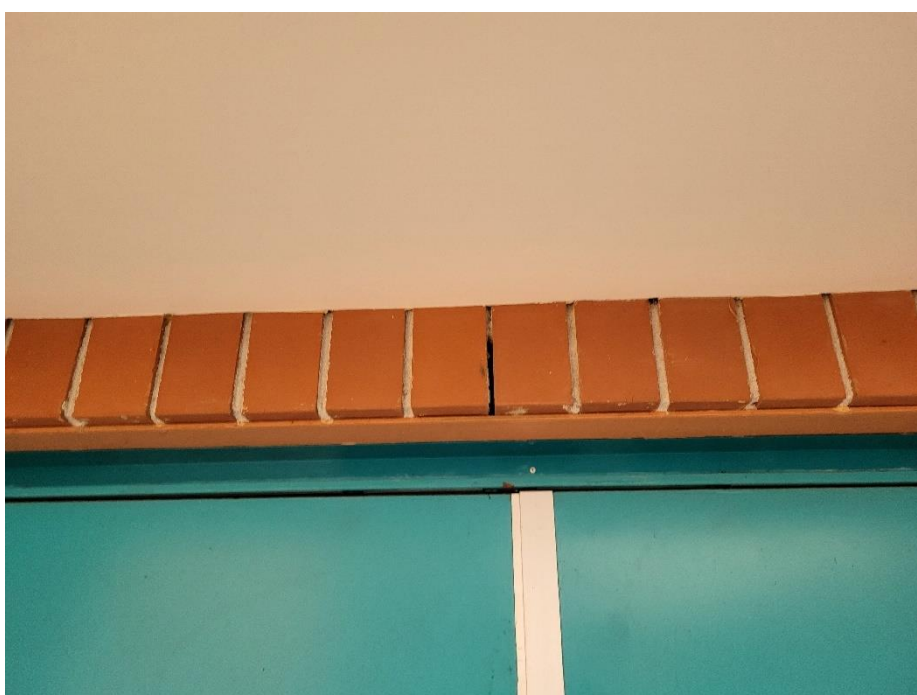
114. Minor cracking to mortar and gaps between soffit and external masonry

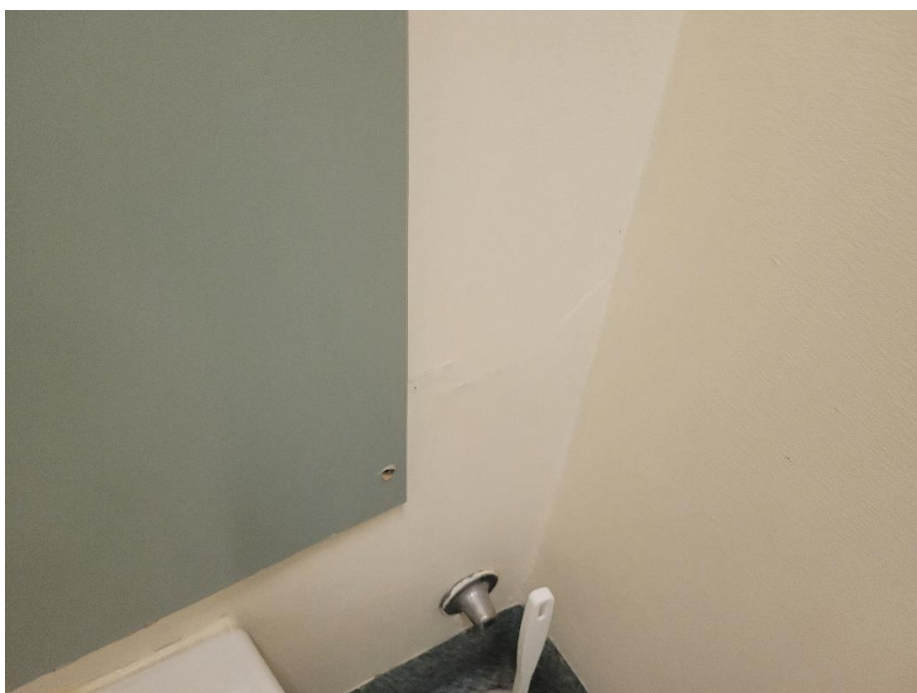
118. Cracking in wall plasterboard in corner and around wall patch

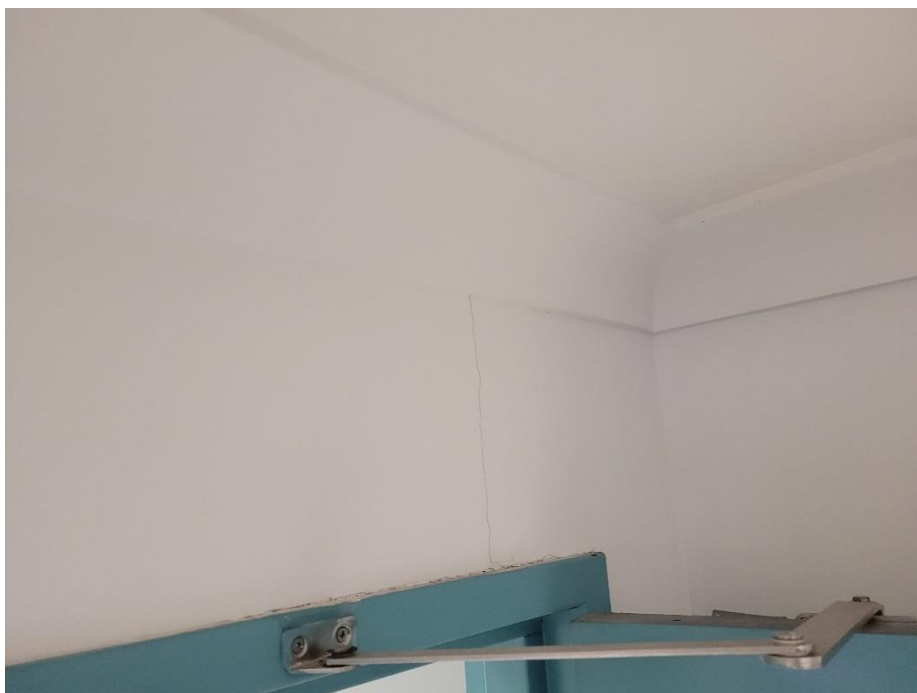
123. Vertical cracking  
from door frame to  
architrave

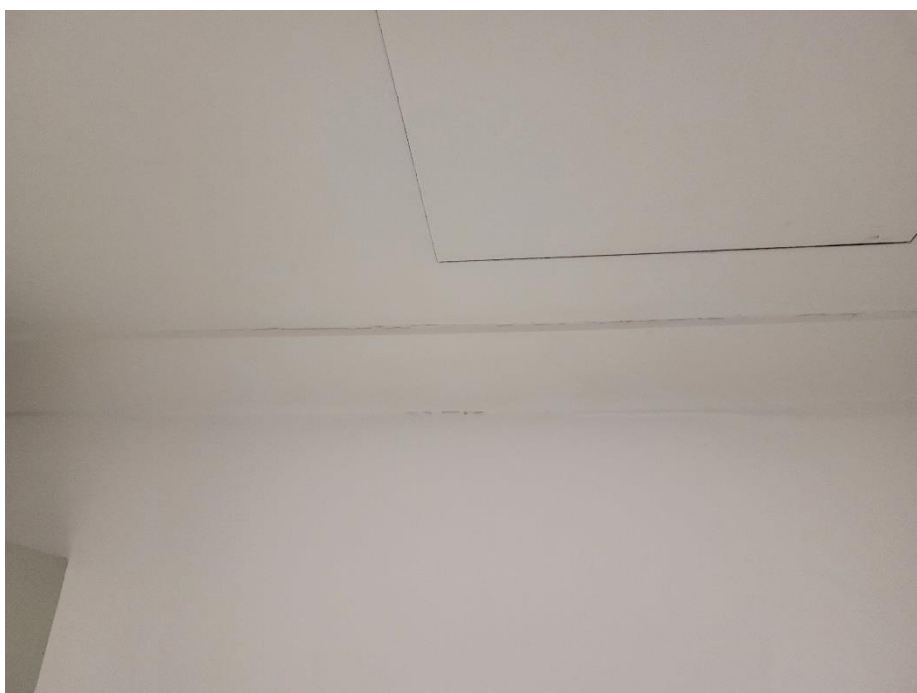
124. Crack in  
plasterboard around  
architrave

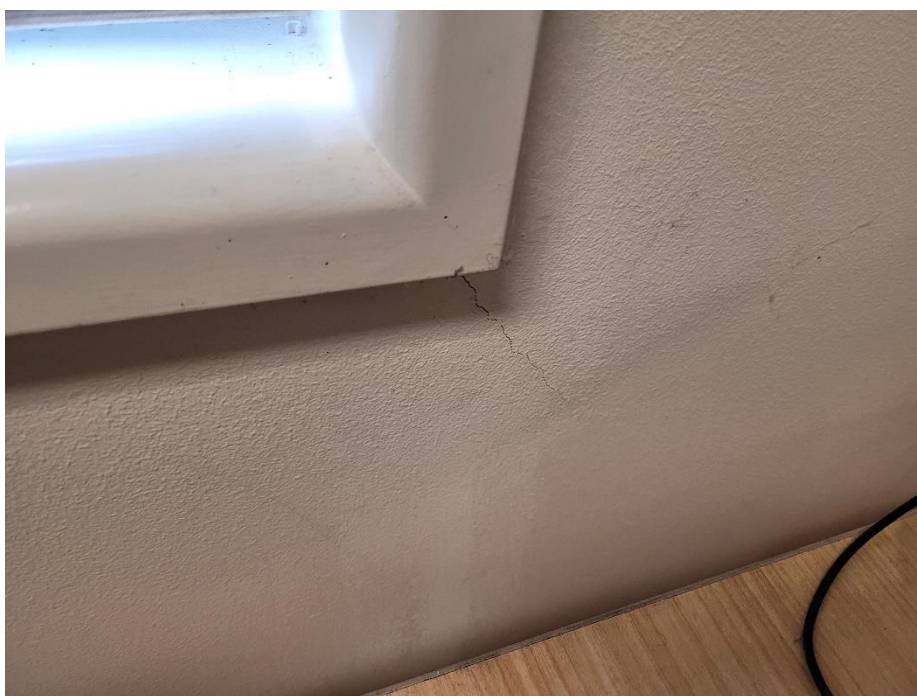
136. Cracking around window in external wall plasterboard

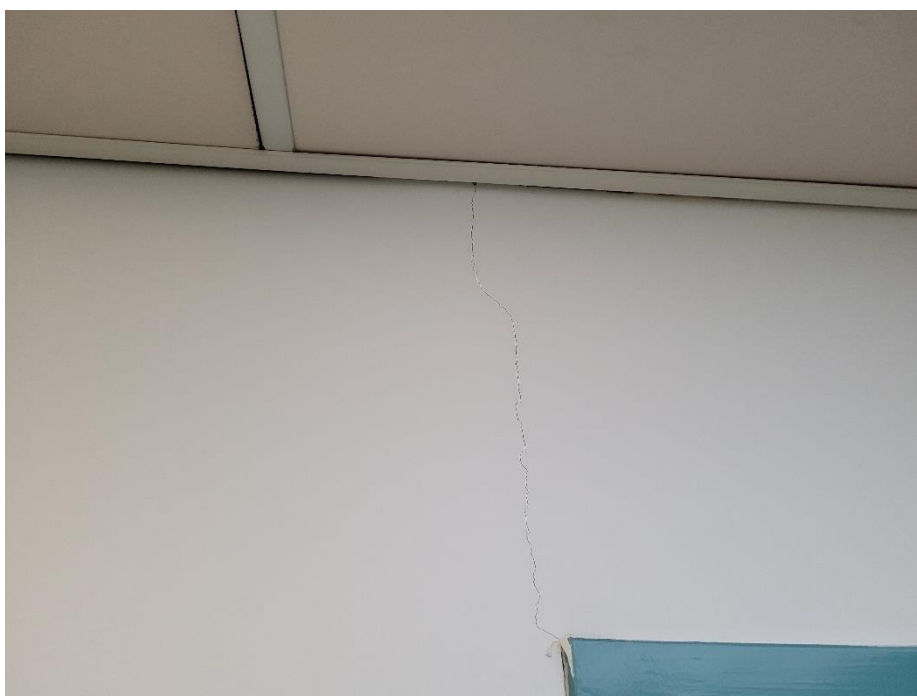
142. Vertical cracking in wall plasterboard from door frame to false ceiling

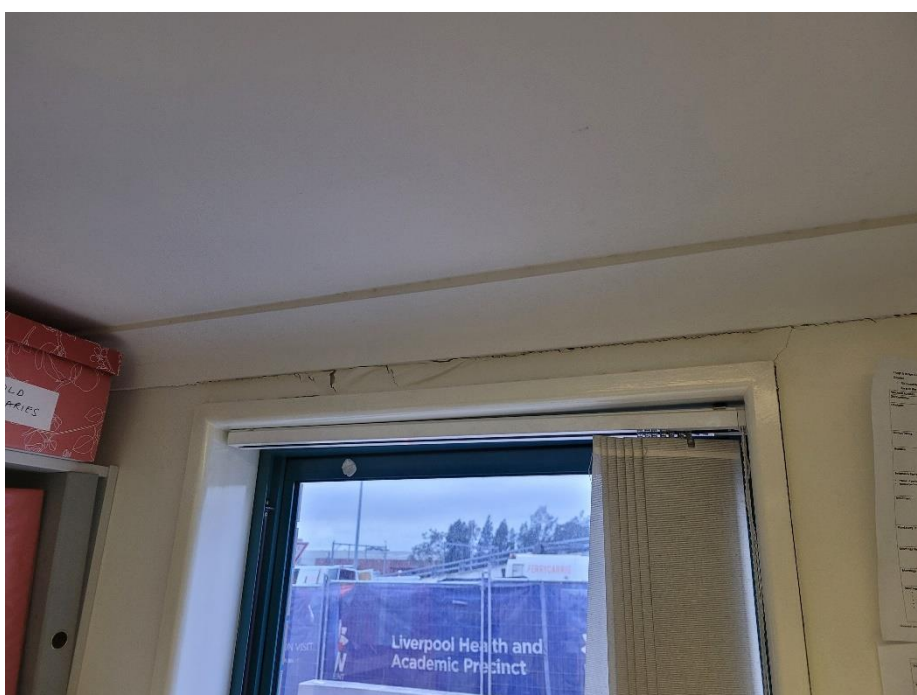
160. Water damage and cracking in plasterboard at wall and architrave around window opening to external wall

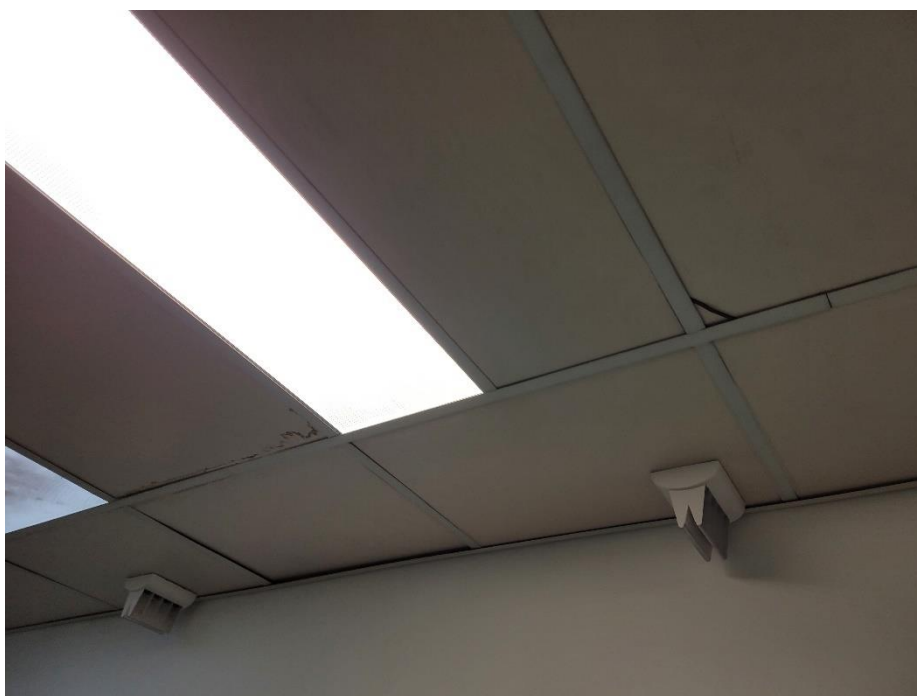
172. Water stains to false ceiling panels, cracking, and poor fit for several panels

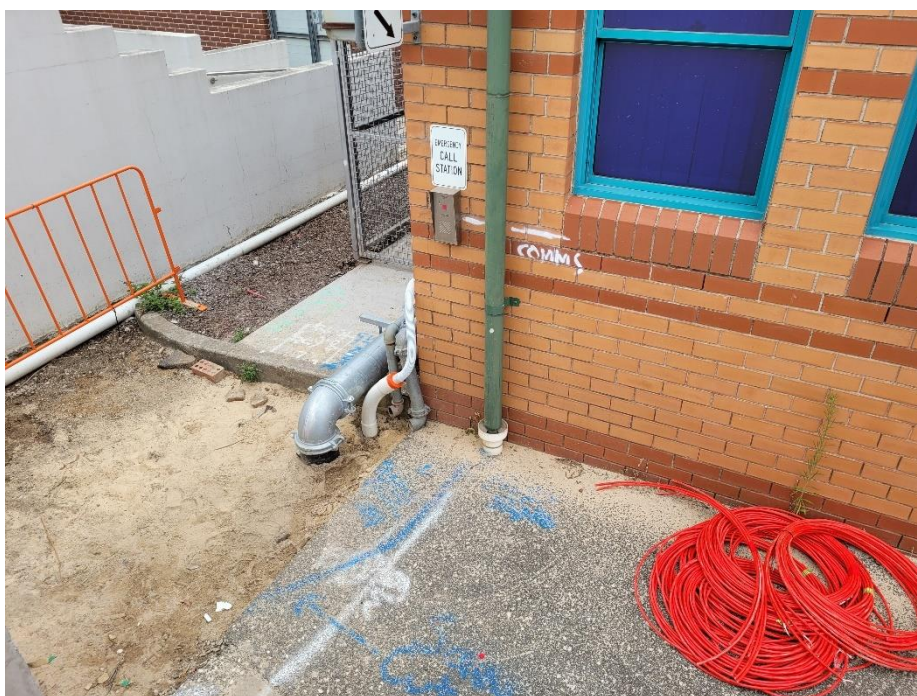
External 2. Cracking to masonry façade at corner and interface with slab on ground

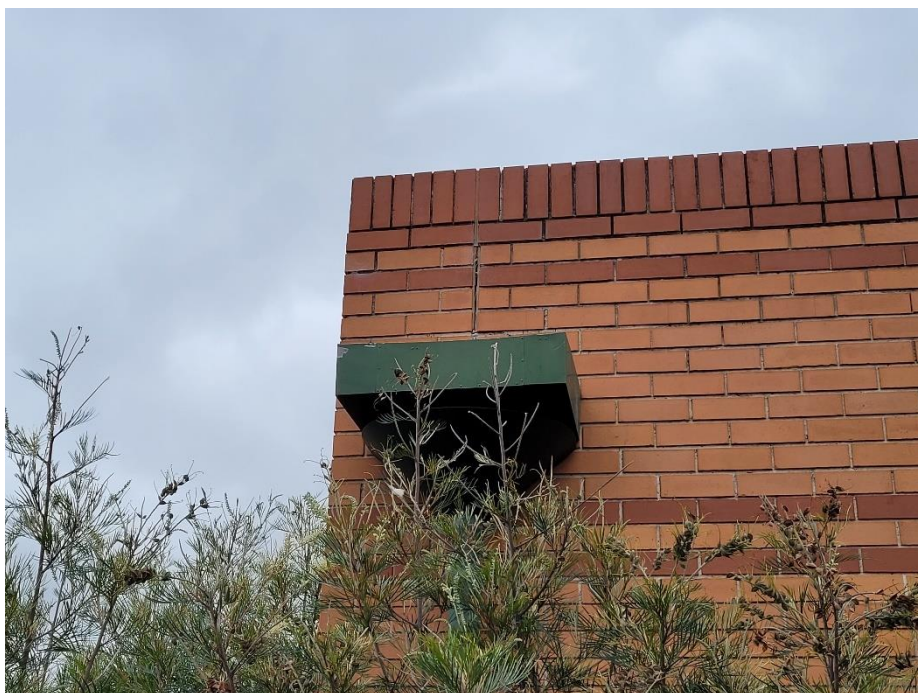
External 11. Cracking to parapet masonry and around water outlet

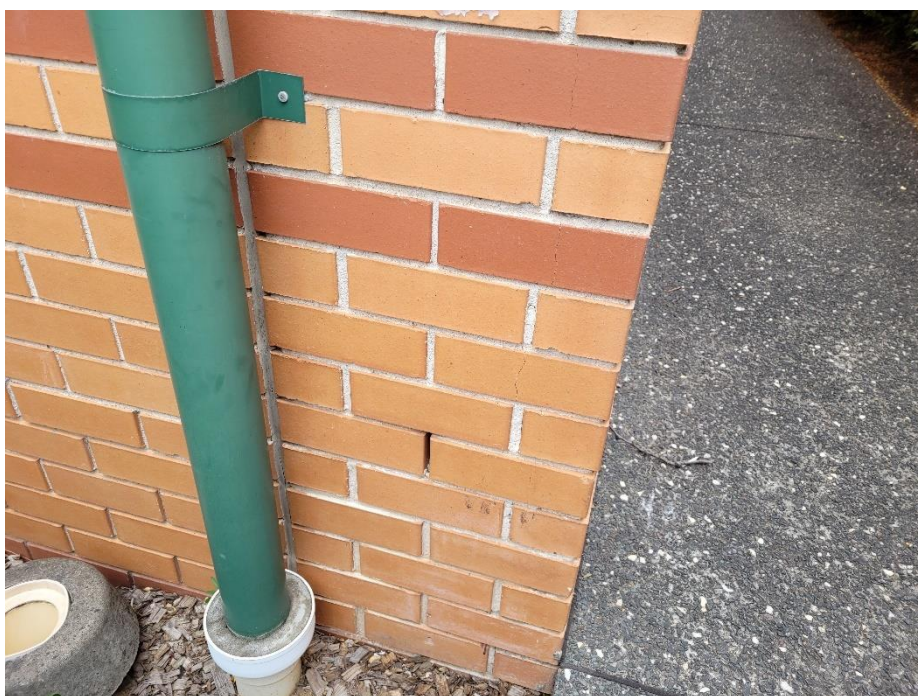
External 12. Vertical cracking in masonry at corner junction in external masonry

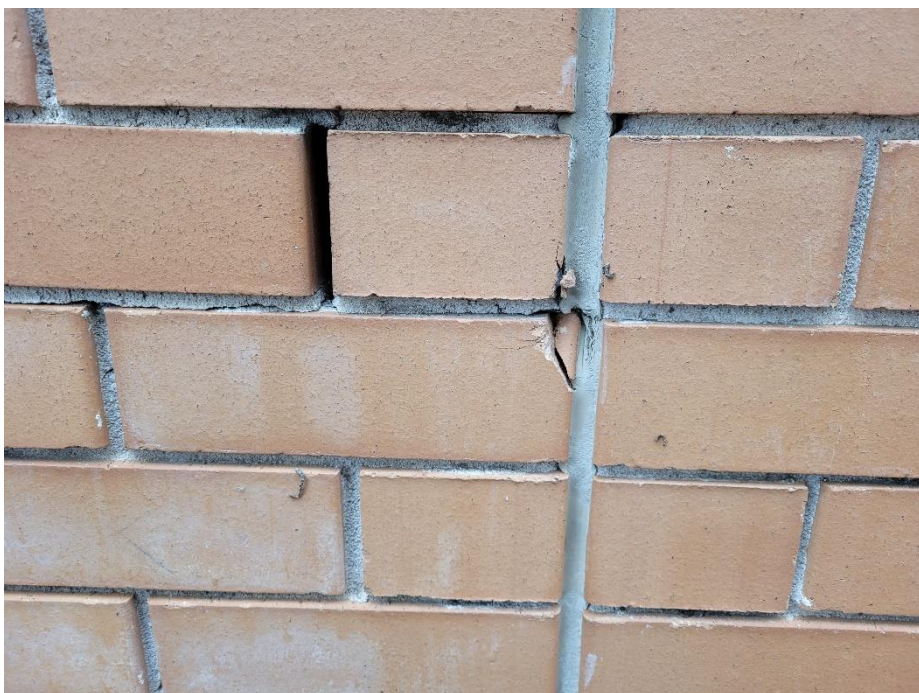
External 17. Cracking to mortar and mortar loss for external wall

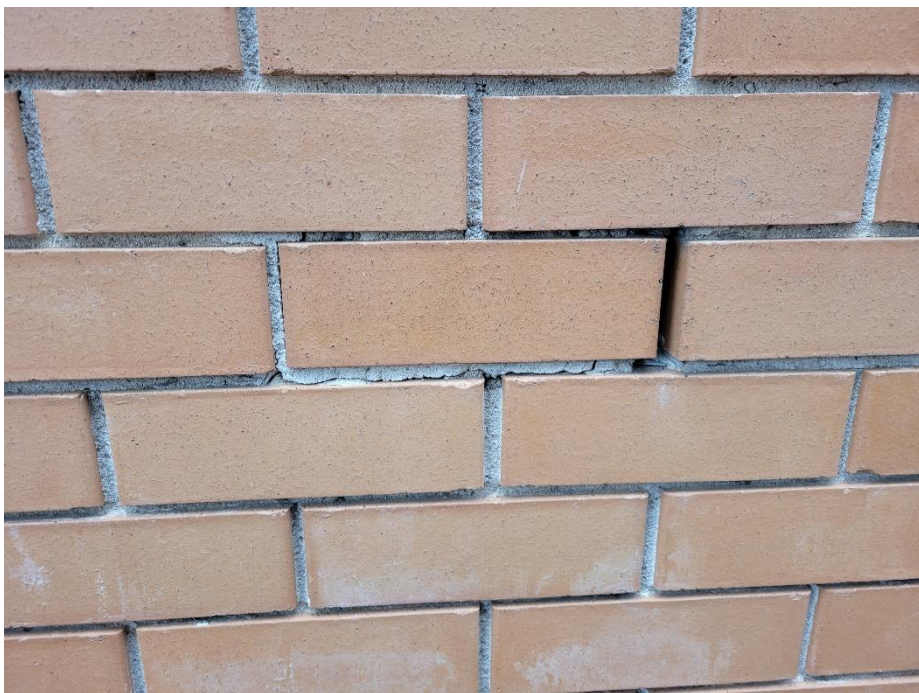
External 18. Cracking to mortar and mortar loss for external wall

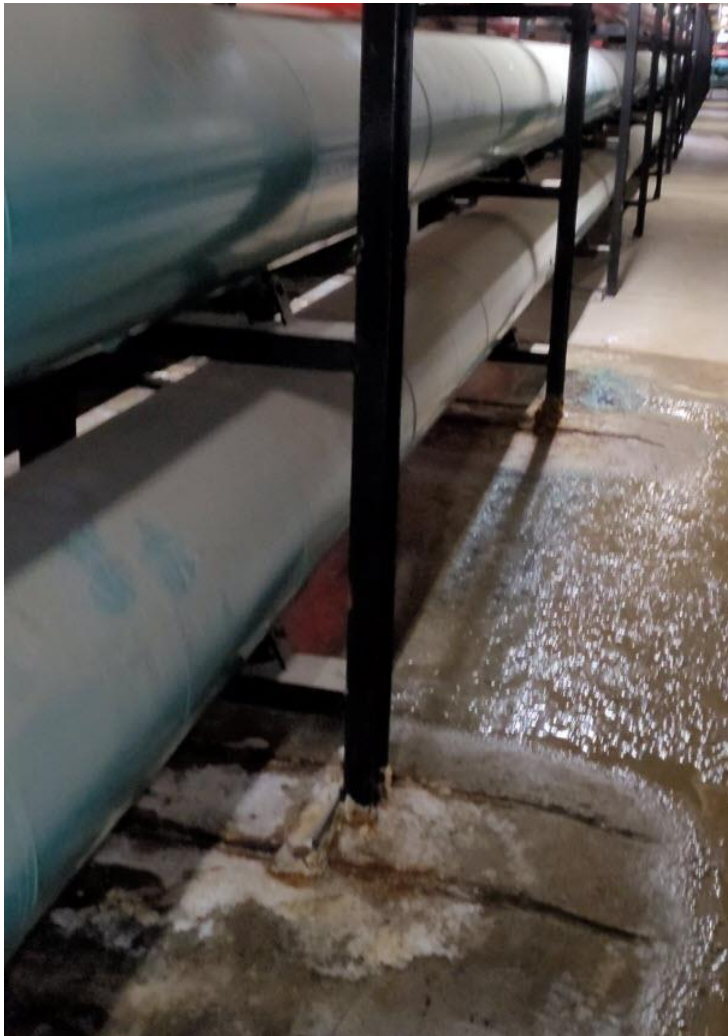
Service Tunnel 5. Leak noted in tunnel to East of BIU access point on southern side of central pipework, unknown origin

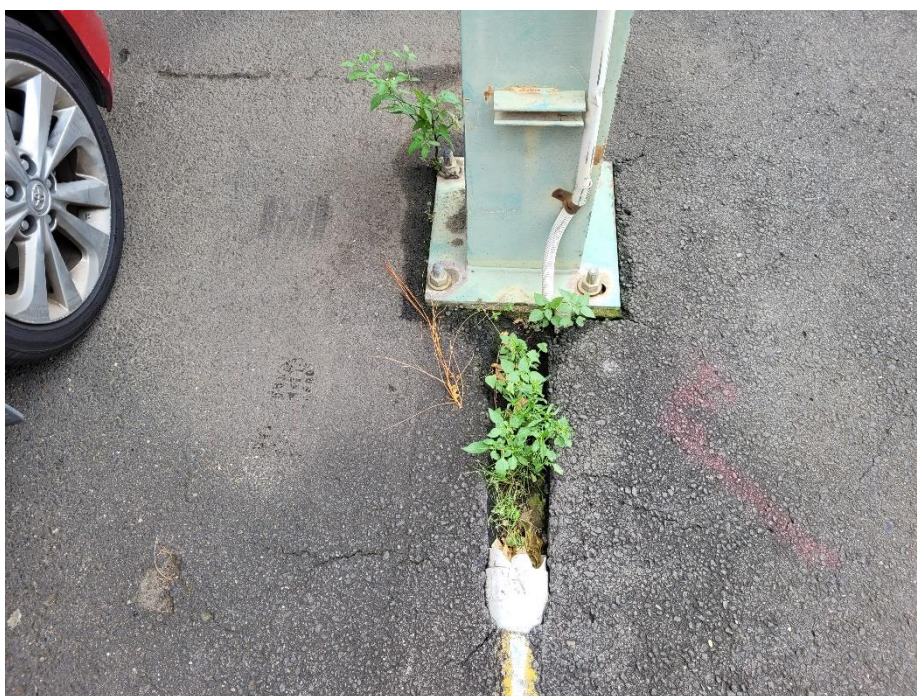
Existing Carpark 2. Signs  
of minimal ongoing  
maintenance

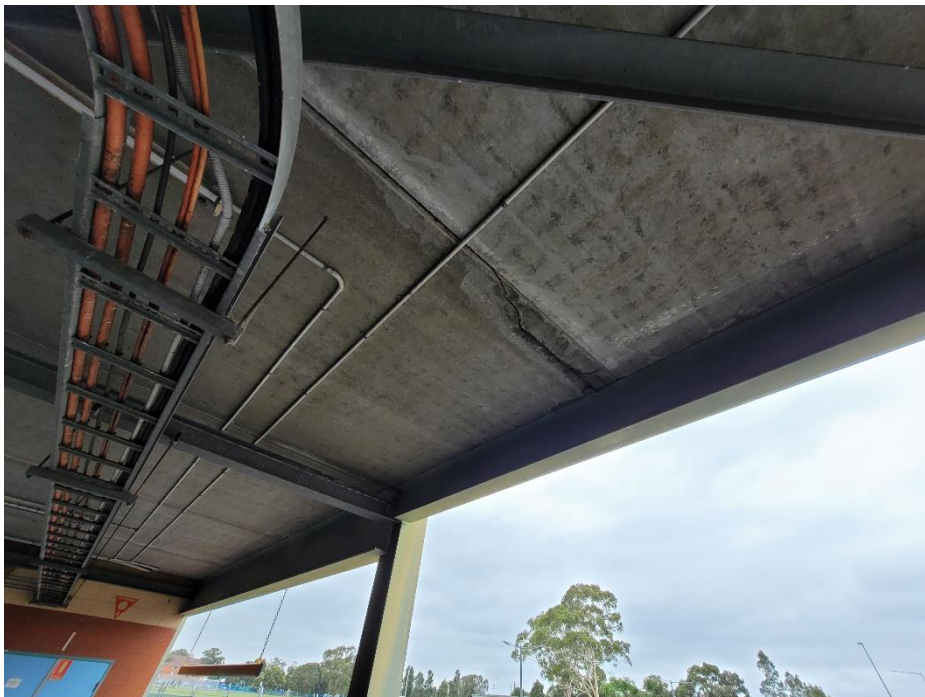
Existing Carpark 4. Cracks to soffit of first floor slab

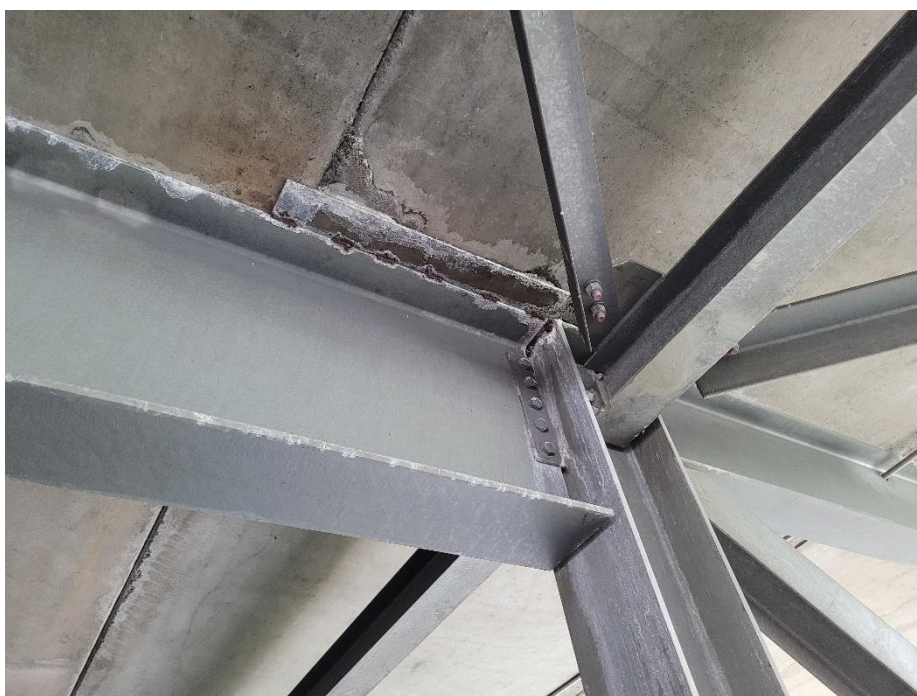
Existing Carpark 8. Water  
stains and potential  
surface corrosion to  
existing steel work

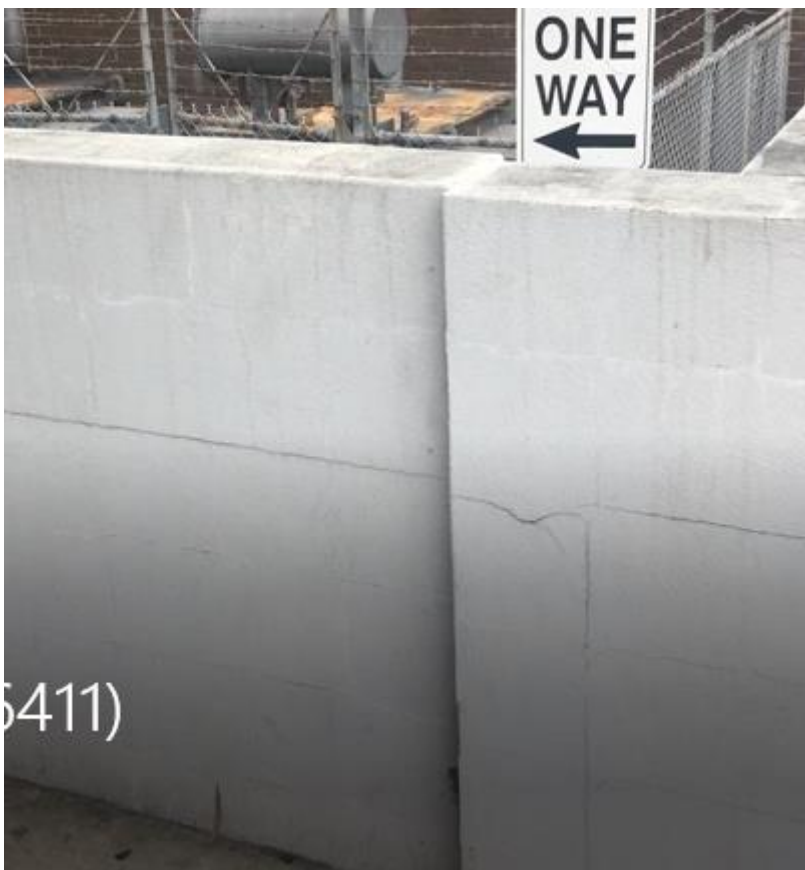
BIU perimeter 2. Cracks  
to existing wall

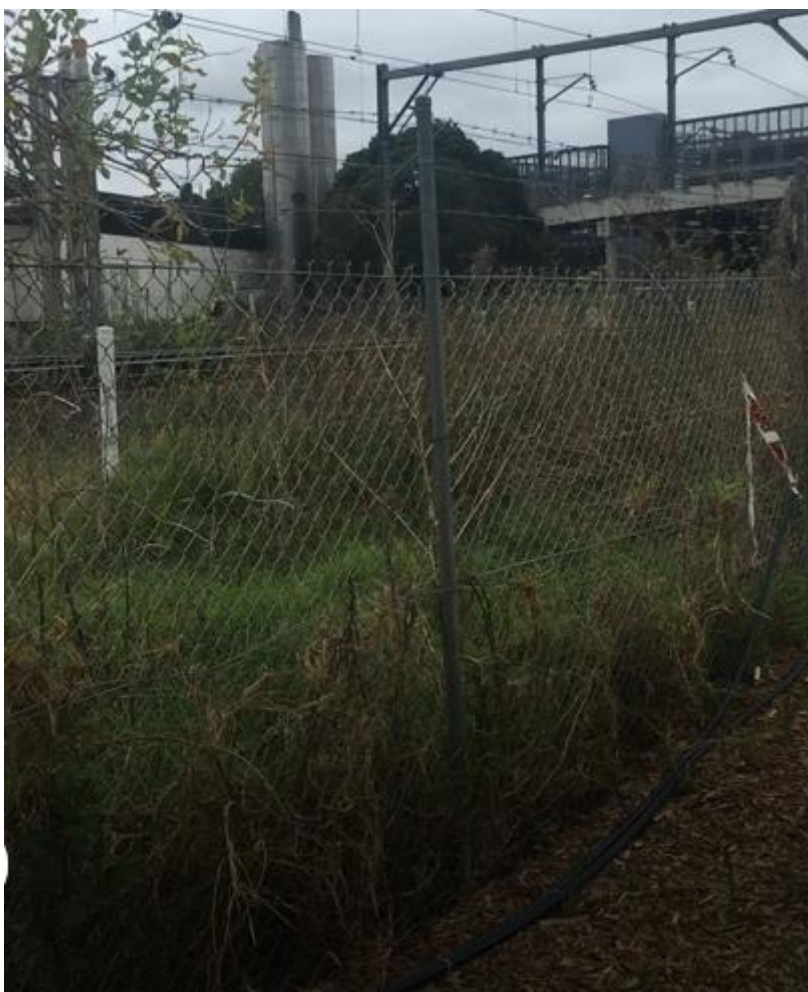
Rail fence 1. Vegetation growth

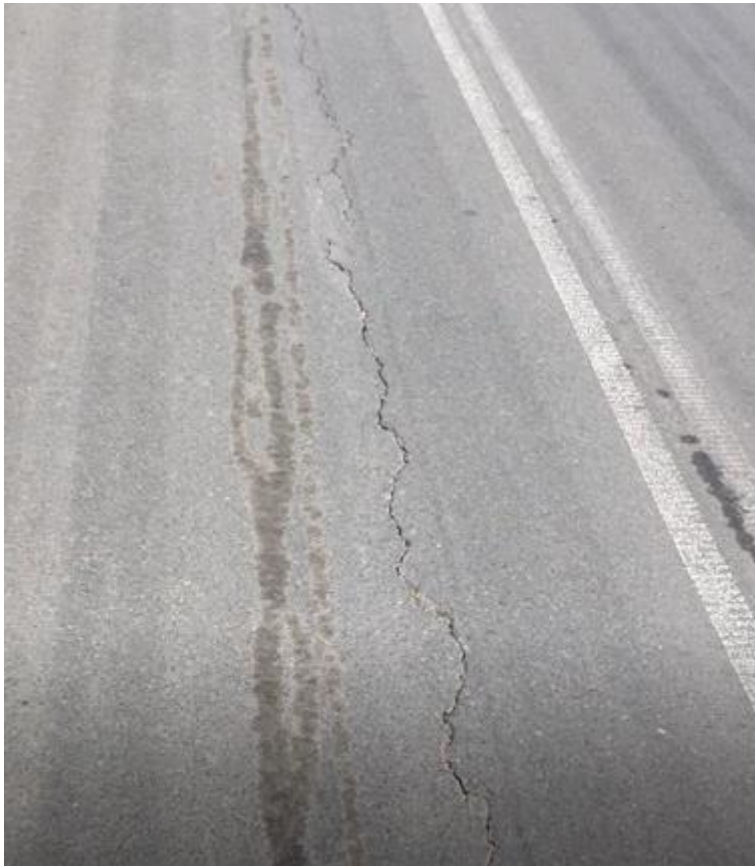
Burnside Drive 5.  
Longitudinal cracking at  
various locations

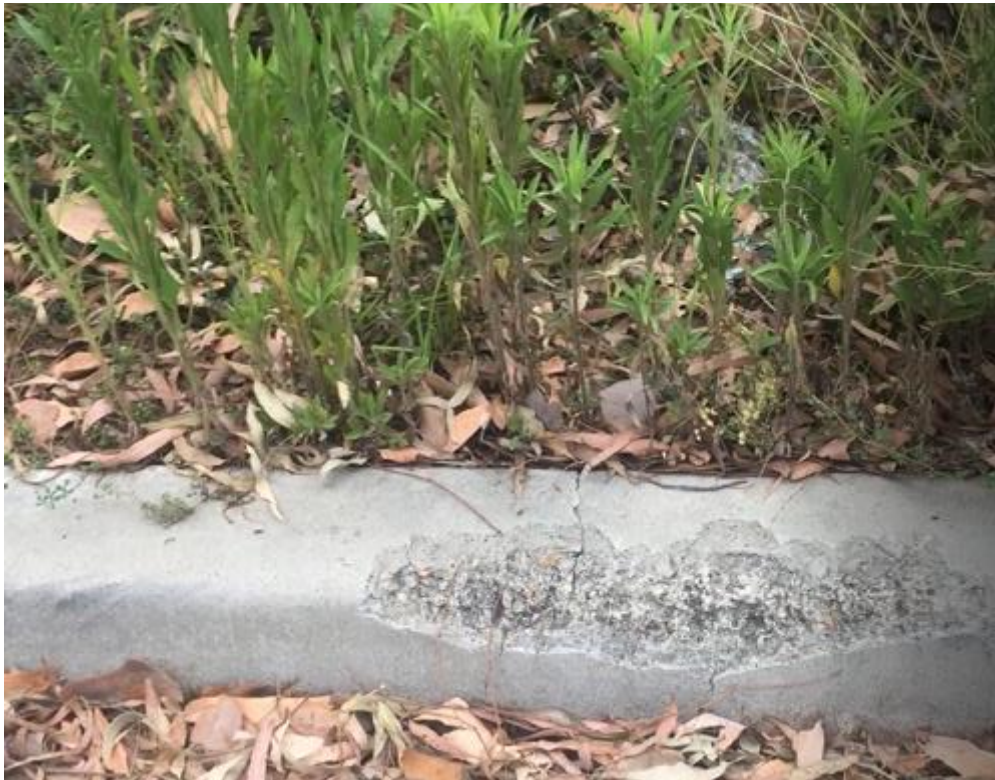
Burnside Drive 9.  
Cracked kerbing
