**Bloompark C/- Monte Sant Angelo
Mercy College**

**Asbestos and Hazardous Materials
Limited Pre-Demolition Survey**

128 Miller Street
North Sydney 2060

14 February 2020

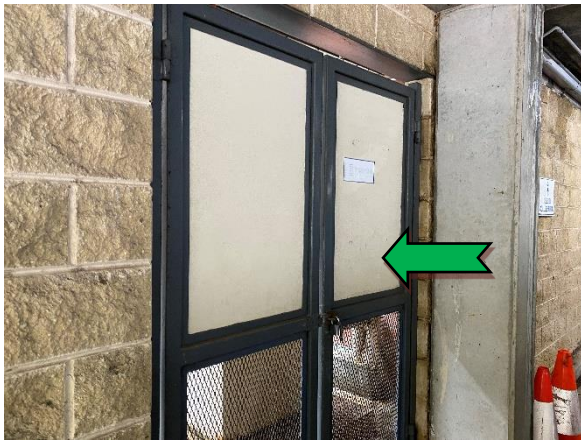
Photo 1 Exterior: carpark, plant room doors, infill panels – non-asbestos containing fibre cement sheeting.

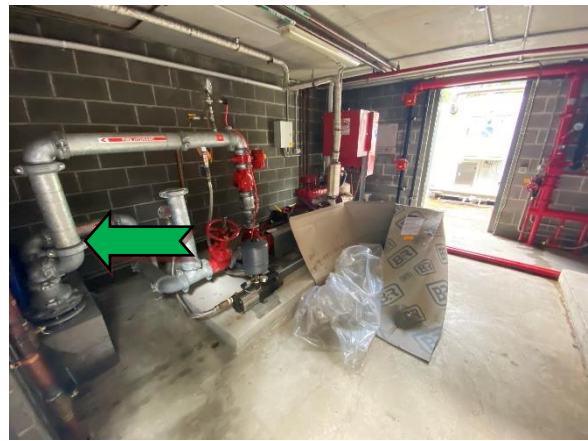
Photo 2 Exterior: pump room, booster pumps, gaskets – suspected non-asbestos containing rubbery gaskets.

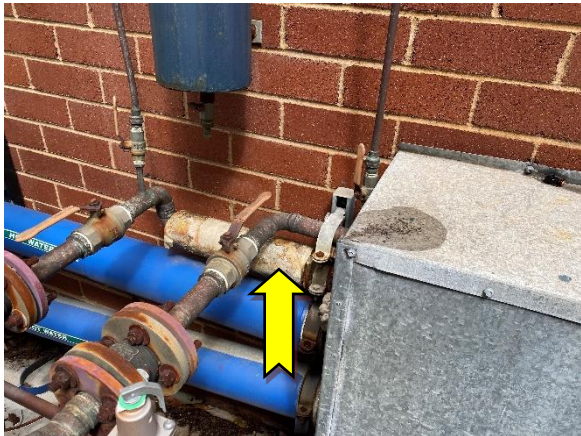
Photo 3 Exterior: AC plant room, pipe work – suspected SMF containing external insulation material.

Exterior	AC Plant room	Pipe work	Insulation material - external	SMF	Visual Observation	Suspected SMF	-	-	-	Good	Sealed	Low	-	-	-	Low	-	Maintain in current condition if to remain in-situ. Remove under controlled SMF conditions as per the Code of Practice for the Safe Use of Synthetic Mineral Fibres [NOHSC: 2006 (1990)].	1 m	-	3
Interior	Pump room, booster pump	Pipe work	Woven material	SMF	Visual Observation	Suspected SMF	-	-	-	Good	Sealed	Low	-	-	-	Low	-	Maintain in current condition if to remain in-situ. Remove under controlled SMF conditions as per the Code of Practice for the Safe Use of Synthetic Mineral Fibres [NOHSC: 2006 (1990)].	15 m	-	4
Interior	Plant room	Air conditioning ductwork	Insulation material - internal	SMF	Visual Observation	Suspected SMF	-	-	-	Good	Sealed	Low	-	-	-	Low	-	Maintain in current condition if to remain in-situ. Remove under controlled SMF conditions as per the Code of Practice for the Safe Use of Synthetic Mineral Fibres [NOHSC: 2006 (1990)].	60 m ²	-	5

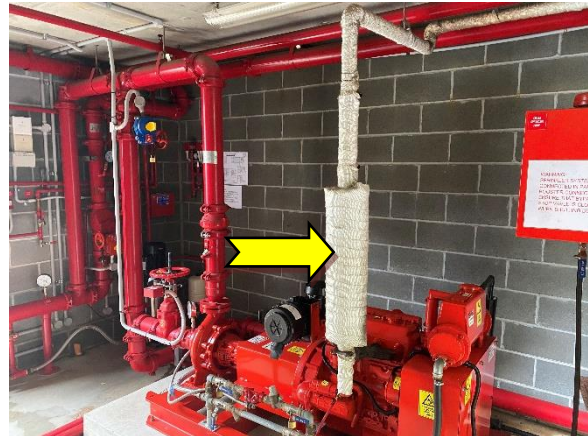
Photo 4 Interior: pump room, booster pump, pipe work – suspected SMF containing woven material.

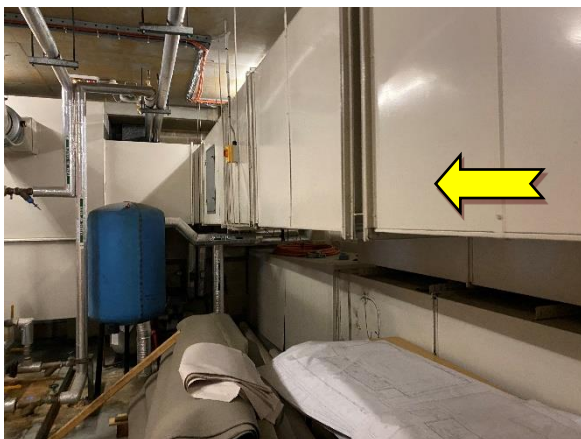
Photo 5 Interior: plant room, air conditioning ductwork – suspected SMF containing internal insulation material.

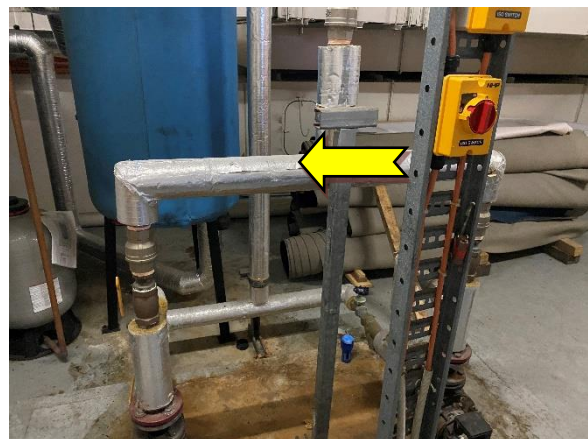
Photo 6 Interior: plant room, pipe work – suspected SMF containing external insulation material.

Interior	Plant room	Pipe work	Insulation material - external	SMF	Visual Observation	Suspected SMF	-	-	-	Good	Sealed	Low	-	-	-	Low	-	Maintain in current condition if to remain in-situ. Remove under controlled SMF conditions as per the Code of Practice for the Safe Use of Synthetic Mineral Fibres [NOHSC: 2006 (1990)].	60 m	-	6
Interior	Store room	Air conditioning ductwork	Insulation material - external	SMF	Visual Observation	Suspected SMF	-	-	-	Good	Sealed	Low	-	-	-	Low	-	Maintain in current condition if to remain in-situ. Remove under controlled SMF conditions as per the Code of Practice for the Safe Use of Synthetic Mineral Fibres [NOHSC: 2006 (1990)].	15 m ²	-	7

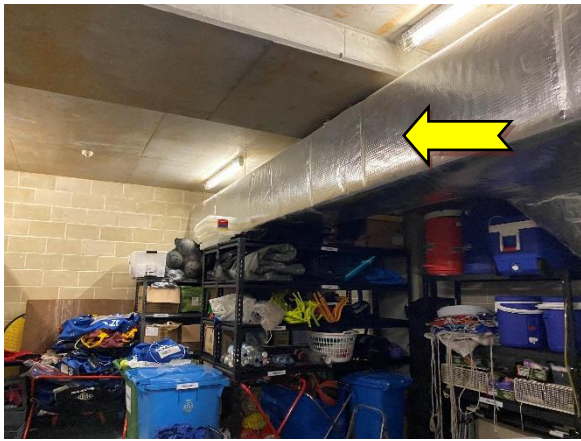
Photo 7 Interior: store room, air conditioning ductwork – suspected SMF containing external insulation material.
