Re – Arborist Inspection – Tree Risk Assessment

St John of God Richmond Hospital

Tree Risk Assessment

23rd October 2019

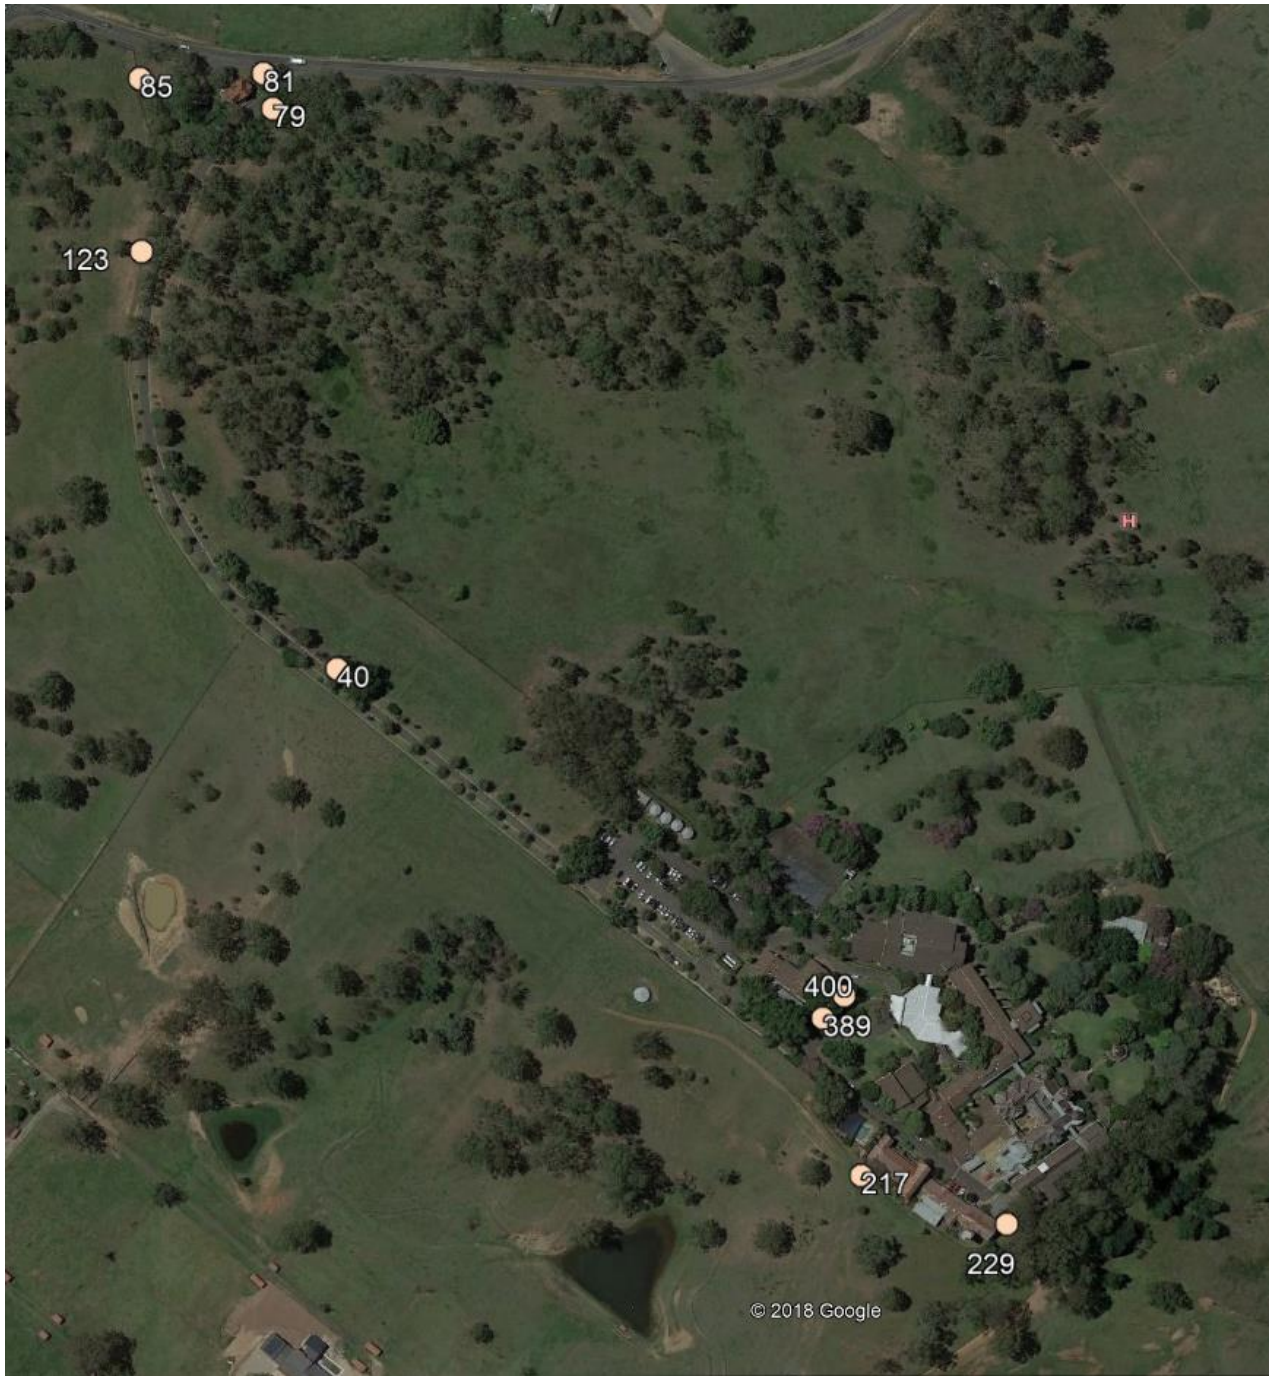
Map 2: High Risk trees

- No (0) trees were assessed as **Critical Risk** or **Urgent Risk**.
- Nine (9) trees were assessed as **High Risk**. These High Risk trees represent approximately 1% of the total tree population and require arboricultural works to reduce the current risk rating as soon as possible.

- 5 the 9 **High Risk** trees require removal. Of these: 3 trees have structural defects that have compromised retention, 1 tree is in advanced decline and will impact a house and 1 tree is dead.
- Removal of trees assessed as **High Risk** needs to be undertaken as soon as possible.

- Note: No (0) trees were assessed as **Critical Risk** or **Urgent Risk** at St John of God Richmond Hospital during the Arboricultural Tree Risk assessment which was conducted in October 2019.
- Undertake tree work actions on the nine (9) trees assessed as **High Risk**. Five (5) of these trees are recommended for removal.

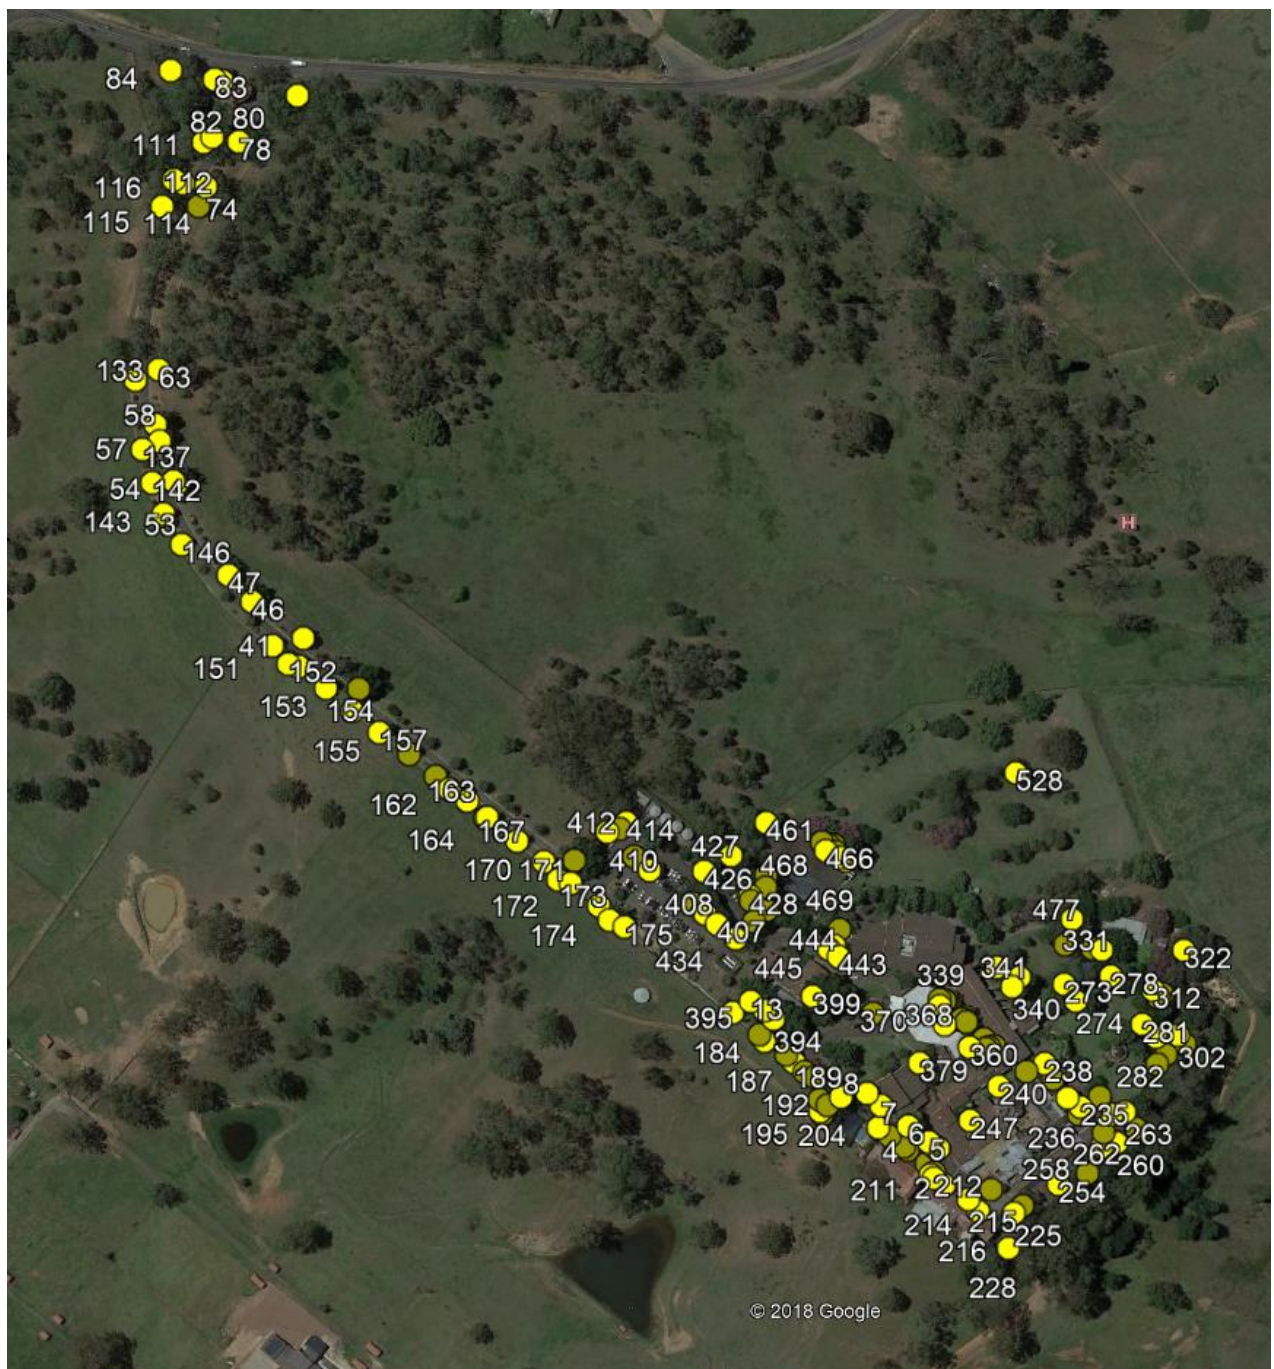
Map 3: Medium Risk trees

- The middle risk category (**Medium Risk**) consists of 174 trees and represents approximately a quarter (27%) of the tree population.
- The lowest risk categories (**Low, Very Low Risk & Negligible Risk**) consist of 451 trees and represent the majority of the tree population (72%).

- Work through the identified work action list in the attached spreadsheets from highest risk to lowest risk ratings.
- Tree work actions for trees assessed as **Medium, Low, & Very Low Risk** can be taken over a longer period of time as determined by St John of God Richmond Hospital.

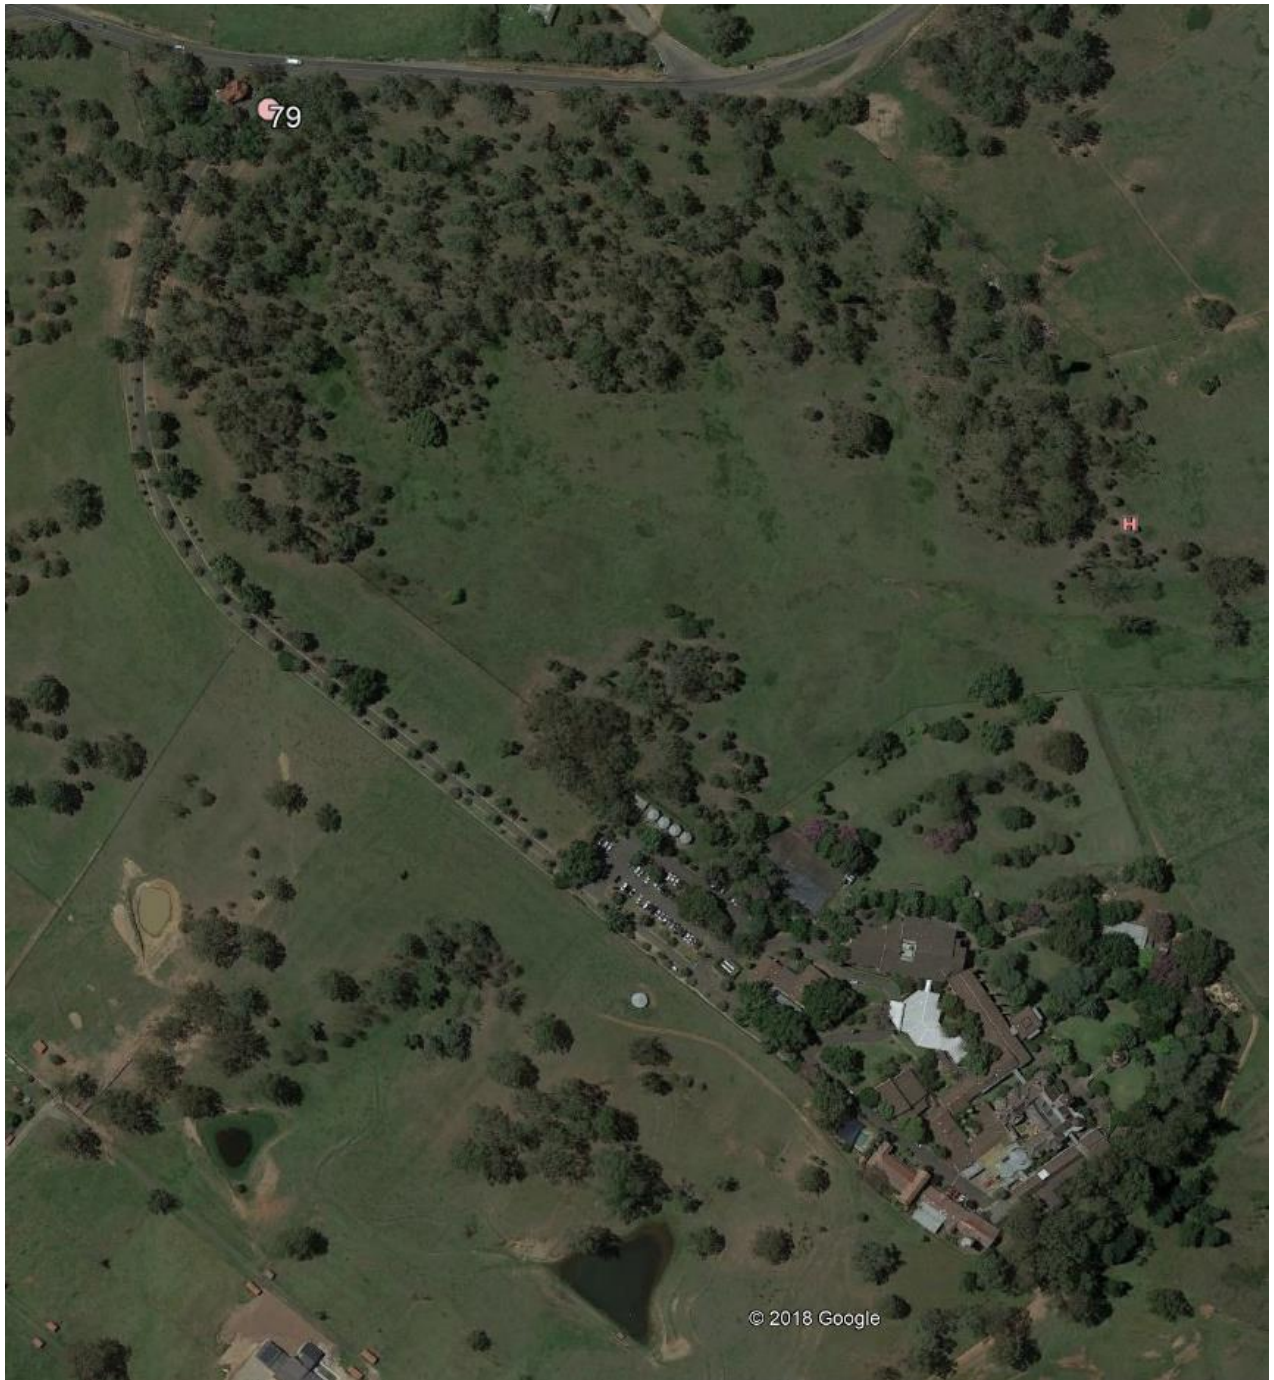
Map 7: Picus Sonic Tomograph Test

- No trees were assessed as requiring aerial inspection with only one (1) tree (tree no. 79) being assessed as requiring further investigation by Picus Sonic Tomograph testing.
- Tree no. 79 is a *Ficus microcarpa* var. *hillii* (Hill's Weeping Fig) which is a large **High Risk** tree. The base of the tree has wounds, cavities and decay and requires a Picus Sonic Tomograph Test before the final decision can be made on the management of this tree.
- A Map of the location of the tree requiring Picus testing is contained in the Appendices – Map 7.

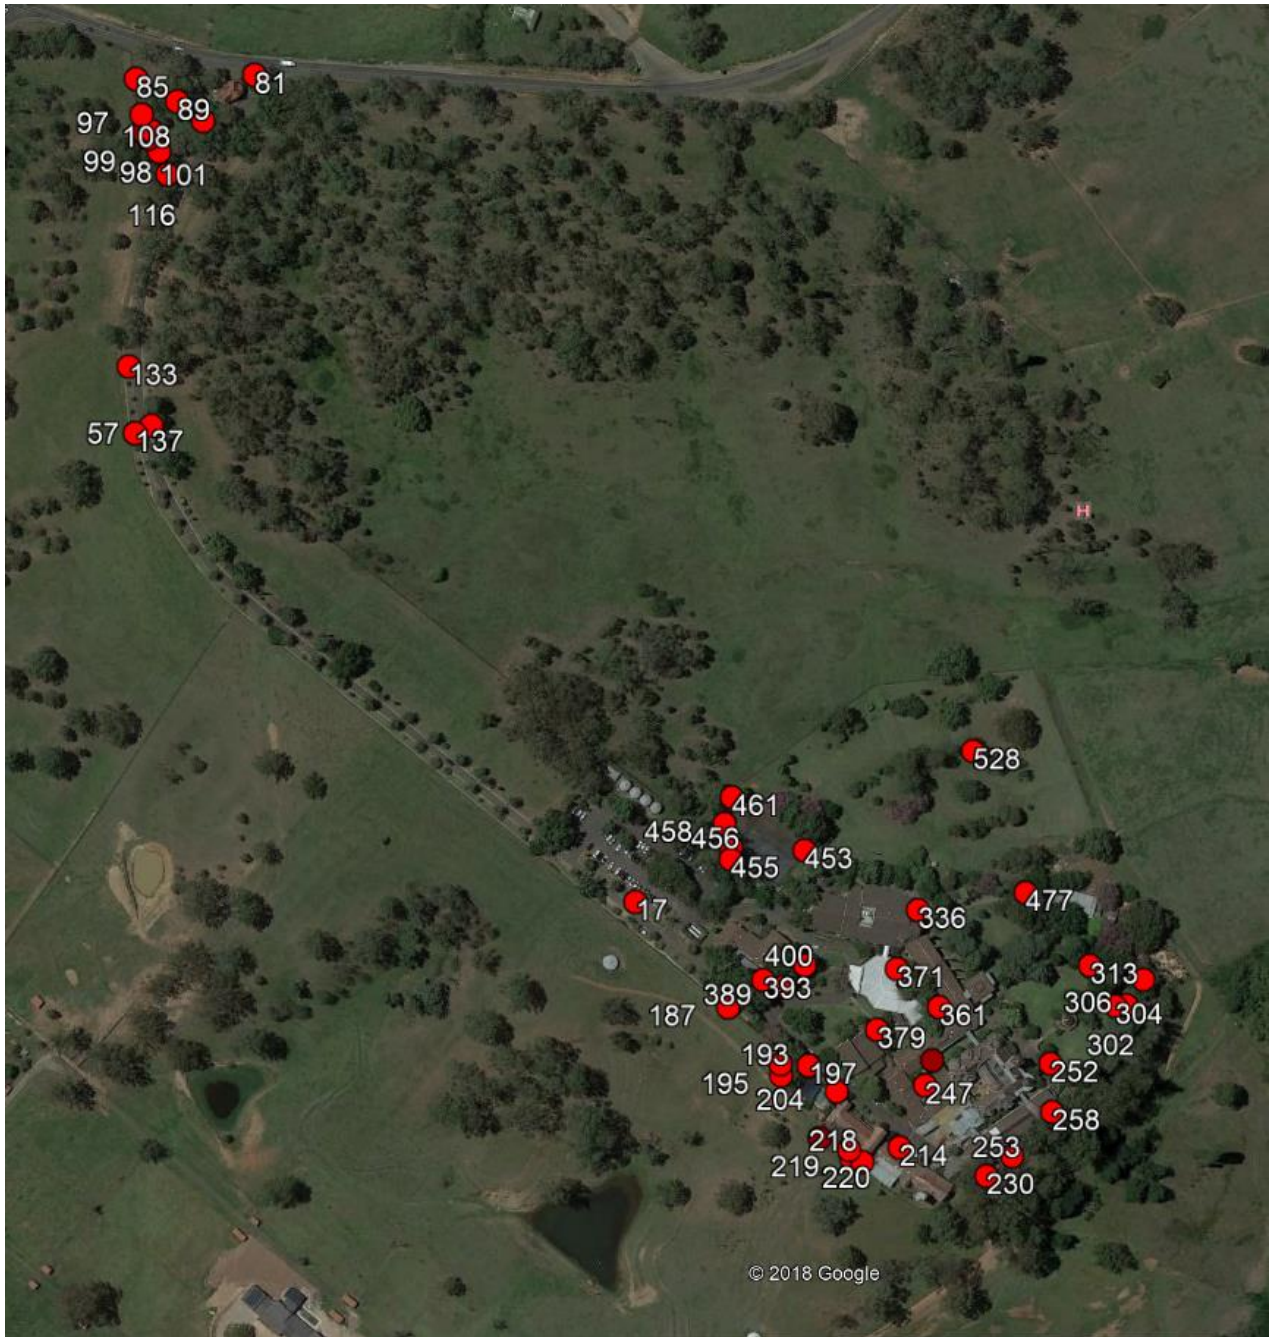
Map 8: Recommended Tree Removals

- Sixty-three (63) trees have been recommended for removal based on hazard, health, structural defects, weed or inappropriate species and inappropriate location.

- 26 of the 174 **Medium Risk** trees are recommended for removal. Of these: 10 are dead, 6 have structural defects, 5 are in advanced decline, 3 are damaging infrastructure and 2 are weed species.
- 14 of the 250 **Low Risk** trees are recommended for removal. Of these: 4 are damaging infrastructure, 3 are dead and several have poor health and structure.
- 18 of the 186 **Very Low Risk** trees are recommended for removal. Of these: 12 are weed species, 5 are dead and 1 tree is in advanced decline.
- No (0) **Negligible Risk** trees are recommended for removal.

- Removal of trees assessed as either **Medium, Low** or **Very Low Risk** can be taken over a longer period of time as determined by St John of God Richmond Hospital.
- Ongoing monitoring of trees whilst they are retained is required to ensure that their risk rating does not increase from lower to higher risk categories.
- A Map of the location of the trees recommended for removal is contained in the Appendices – Map 8.
