**HAZARDOUS
MATERIALS SURVEY**

**St John of God
Richmond Hospital**

**Project No.
47543**

**Date:
18/10/19**

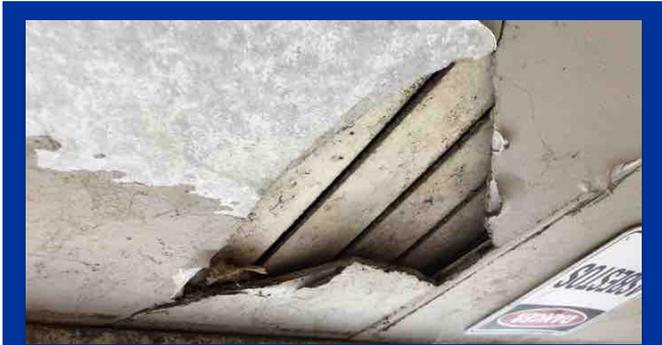
Photo 7

| Location | Material | Sample ID | Sample Status | Photo No. | Asbestos Classification | Condition | Accessibility | Re-Inspect | Current Label | Control Measure | Extent | Action Required | Action Taken |
|---|---|---|---|---|---|---|---|---|---|---|---|--|---|
| External – Rooftop – Eave (bottom layer) | Fibreboard | 47543-52 | Positive | 7 | Non-friable | Moderate | Low | 2024 | No | 4 | ~120m ² | Encapsulate any damaged/broken sections of material with a sealant to prevent fibre release. Remove prior to any refurbishment/demolition works that may disturb the material. Label and maintain in good condition. | |

External - Rooftop - Eave (bottom layer)

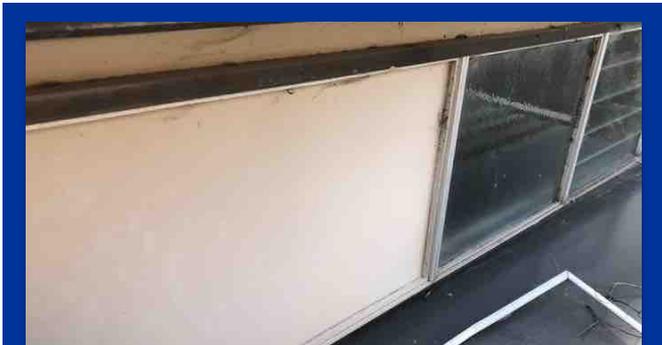
Photo 9

| Location | Material | Sample ID | Sample Status | Photo No. | Asbestos Classification | Condition | Accessibility | Re-Inspect | Current Label | Control Measure | Extent | Action Required | Action Taken |
|---|---|---|---|---|---|---|---|---|---|---|---|--|---|
| External – Rooftop – Infill panels beside windows | Fibreboard | 47543-54 | Positive | 9 | Non-friable | Good | Low | 2024 | No | 4 | ~20m ² | Remove prior to any refurbishment/demolition works that may disturb the material. Label and maintain in good condition. | |

External - Rooftop - Infill panels beside windows.

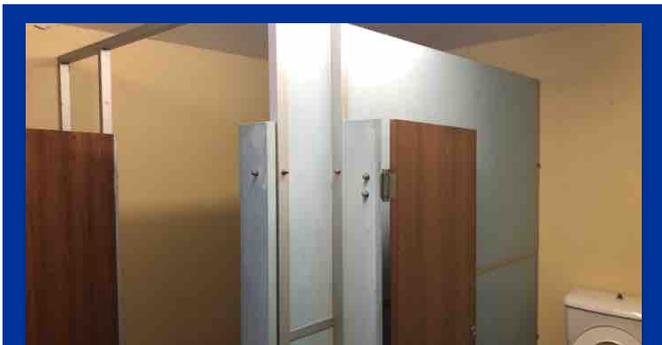
Photo 11

Internal - Lower floor - Existing male toilet (Southeast corner of building) - Cubicle partition and doors.

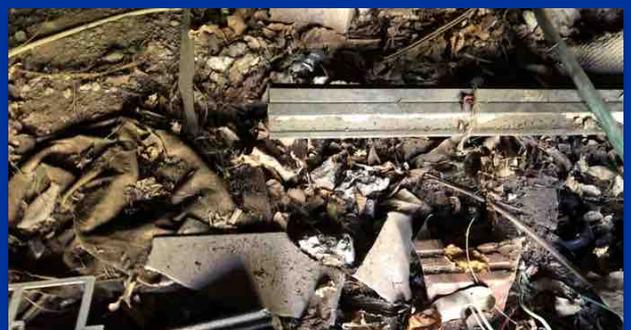
Photo 18

External - Sub-floor – Eastern side – Loose fibrous cement sheet fragments on soil surface .

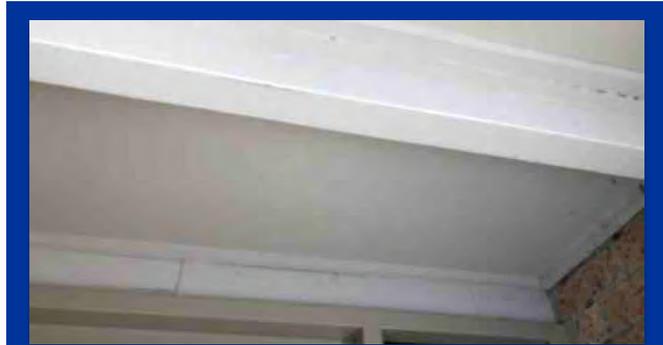
Photo 26

External – Northern building – Southeastern porch – Ceiling panel.

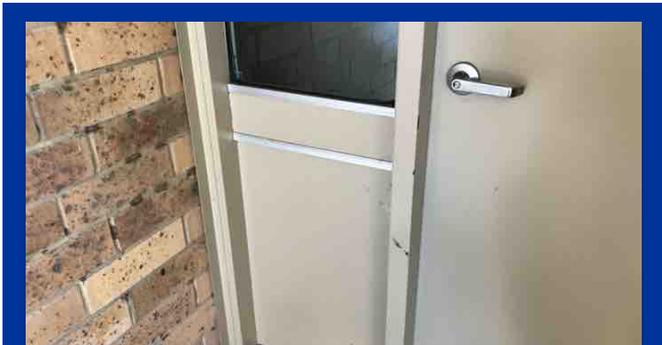
Photo 27

External – Northern building – Southwestern porch – Infill panel below window.

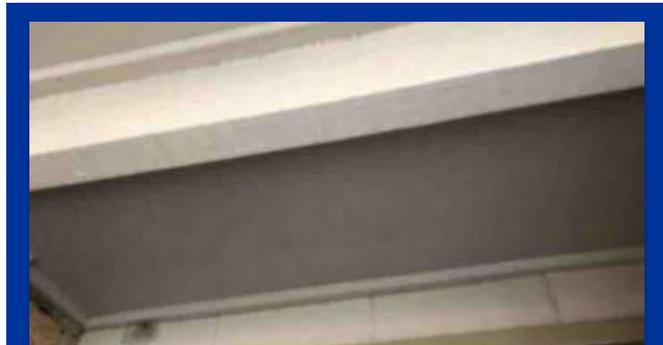
Photo 28

External – Northern building – Southwestern porch – Ceiling panel

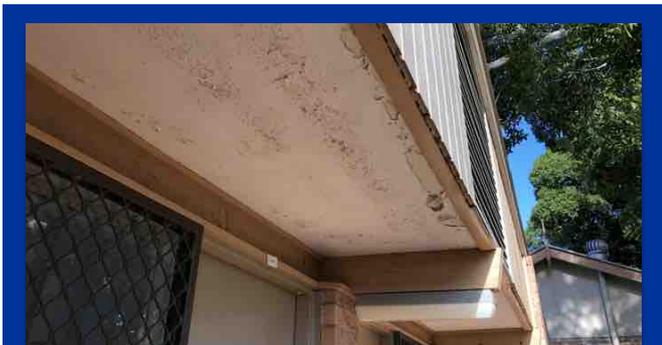
Photo 29

External – Northern building – Southern porch of flat 2 & 3 – Ceiling sheeting

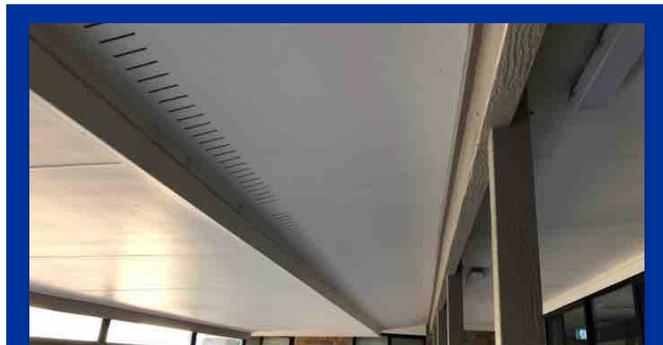
Photo 30

External – Northern building – Northern verandah – Eave lining .

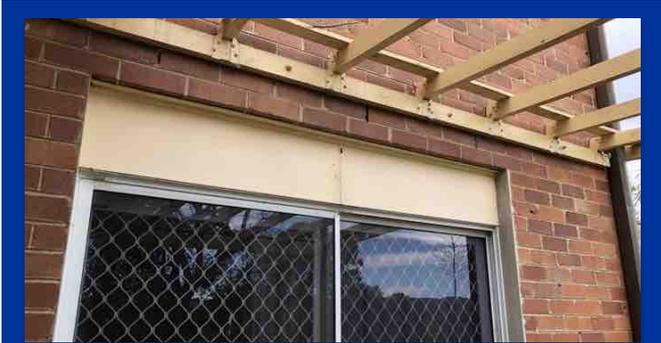
Photo 43

External – Infill panels above sliding doors on southern side

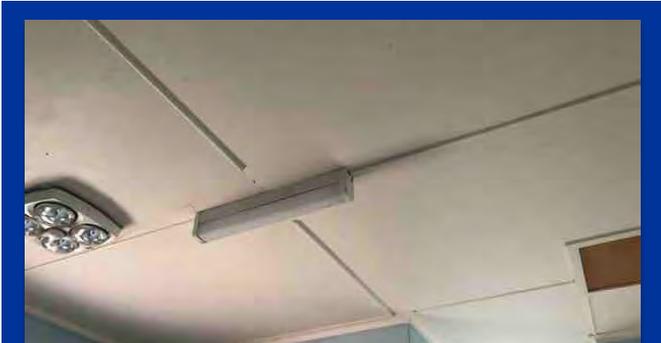
Photo 45

Internal – First floor – Shower area – Ceiling sheeting.

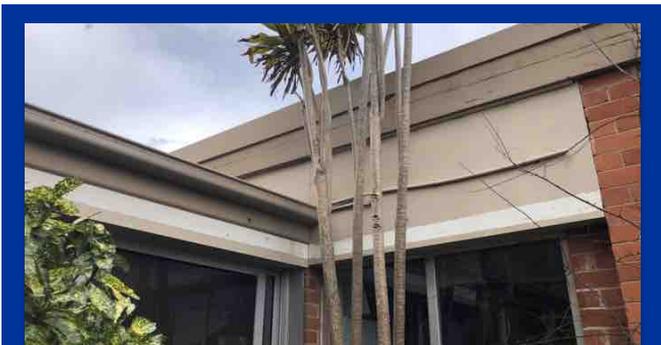
Photo 47

External – Southern side of building – Infill panel above windows and doors.

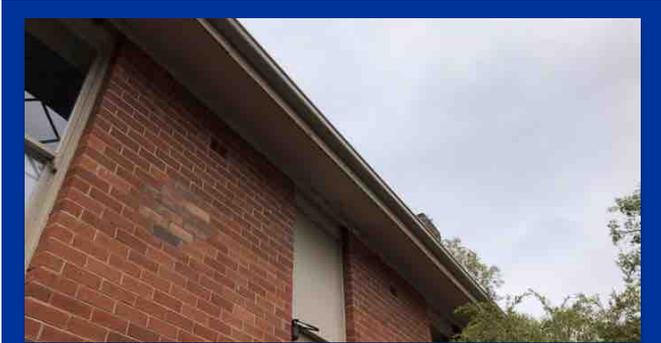
Photo 49

External – Eave sheeting

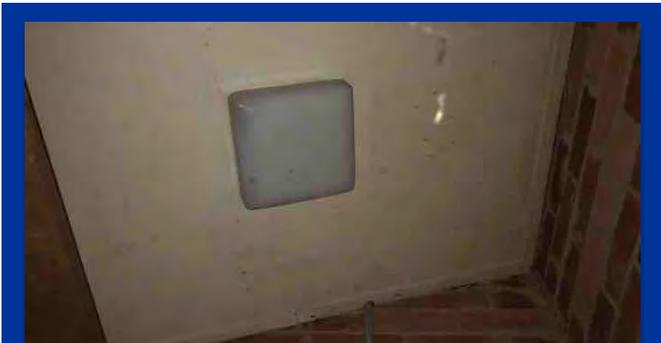
Photo 51

Internal – Ceiling sheeting in storage cupboard near northern entrance .

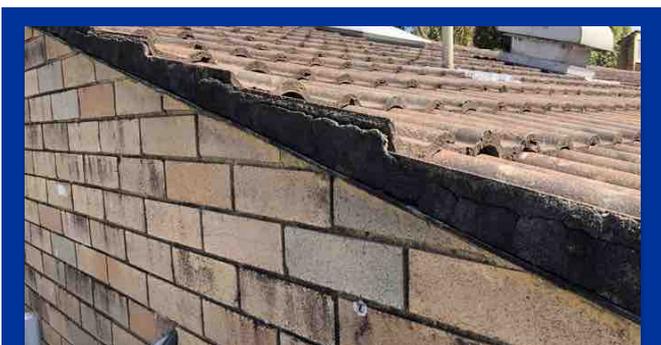
Photo 53

External – Rooftop – Cement sheeting on edges of roof underneath roof tiles

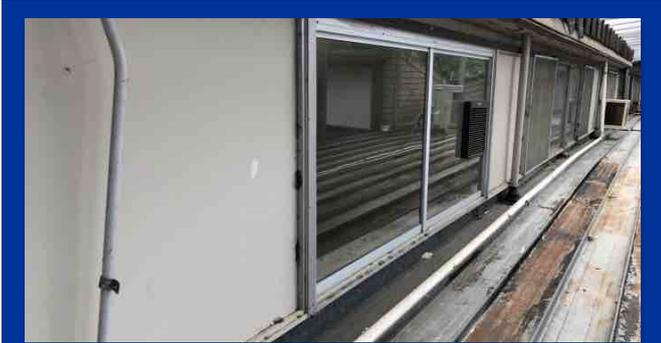
Photo 61

External – Rooftop – Infill panel besides windows in alcove area

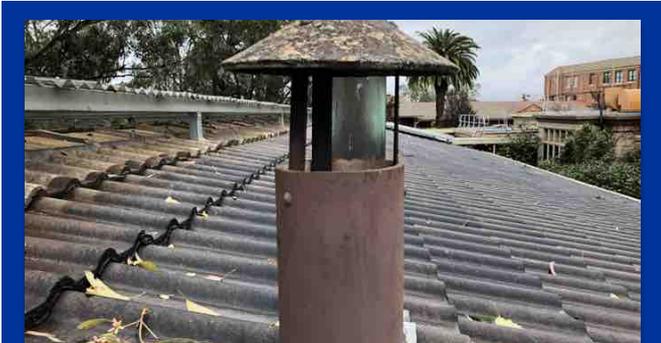
Photo 63

External – Rooftop – Molded fibrous cement flue pipes .

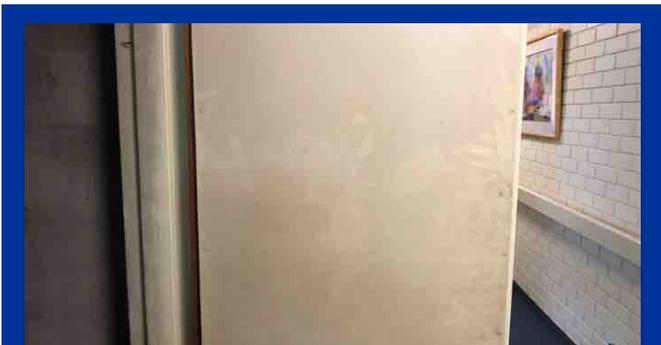
Photo 65

Internal – Hot water heater cupboards – Insulating board on rear of doors

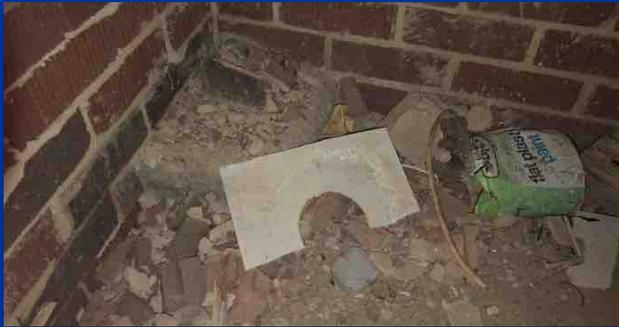
Photo 79

Sub-floor – Loose fiberboard fragments on soil surface and around pipe penetrations

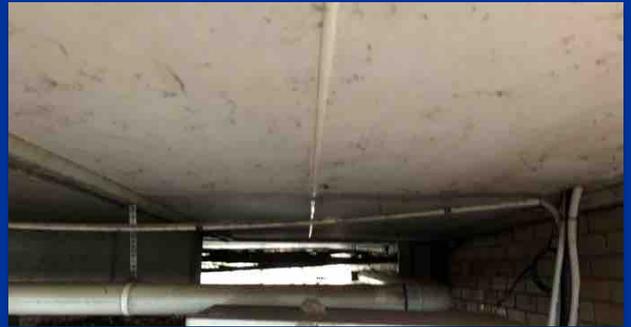
Photo 80

External – Section of fibrous cement sheeting attached to bottom of concrete slab between lower and upper floors of CTC building – Eastern side .

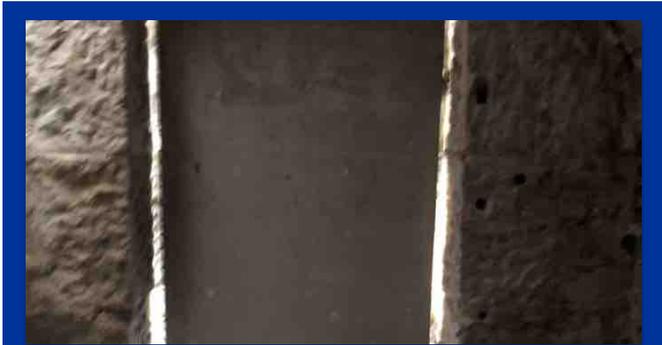
Photo 85

Internal – Basement – Two panels of compressed sheeting over windows in small square room

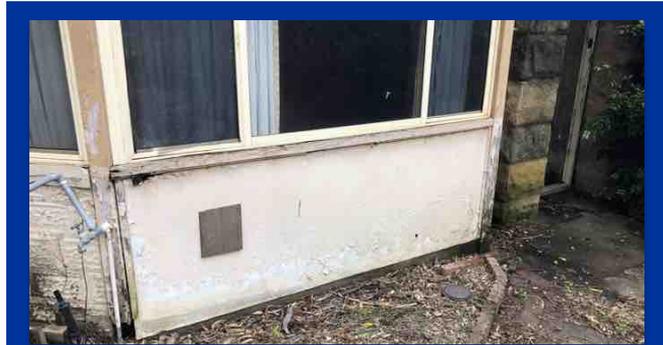
Photo 86

External – Wall sheeting below rear window.

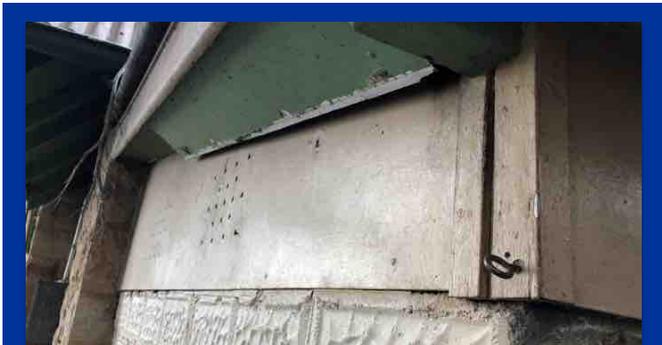
Photo 87

External – Eave sheeting .

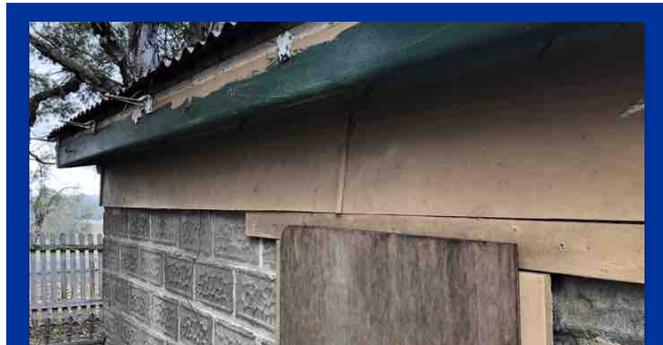
Photo 88

External – Infill panel between top of wall and roof

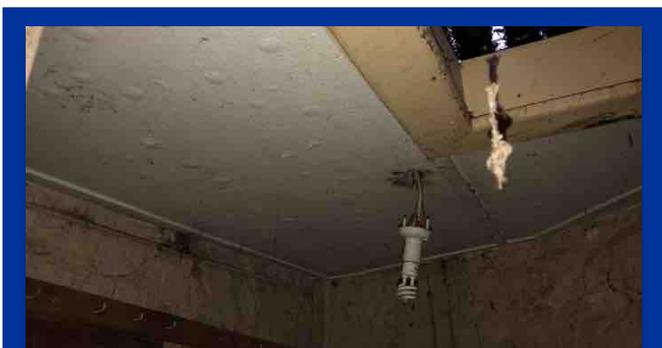
Photo 89

Internal – Toilet – Ceiling sheeting .

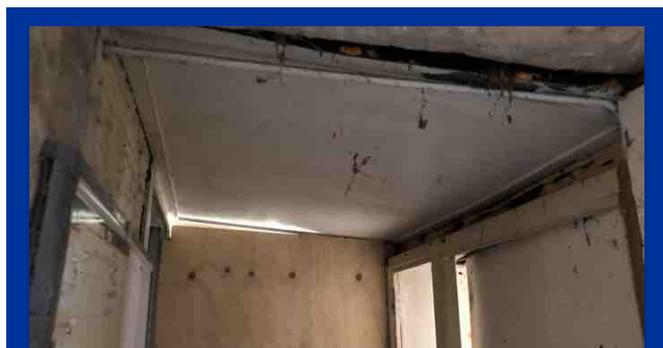
Photo 90

Internal – Small room outside toilet – Ceiling sheeting

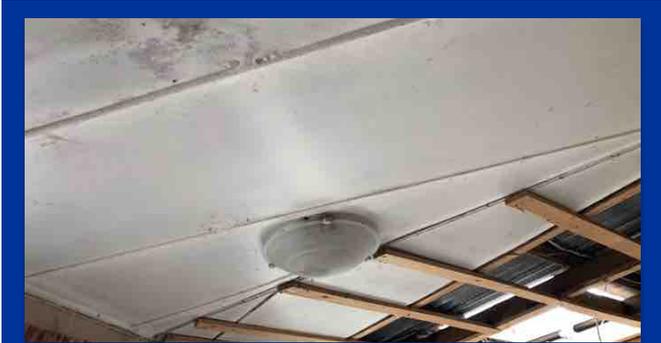
Photo 91

Internal – Rear sunroom area – Ceiling sheeting

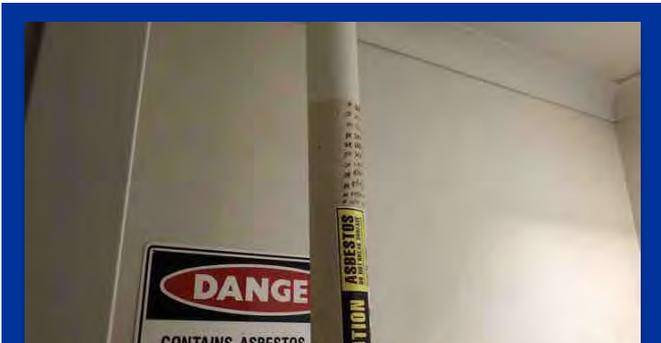
Photo 93

Internal – Northern building – Hot water heater room – Molded fibrous cement flu pipe.

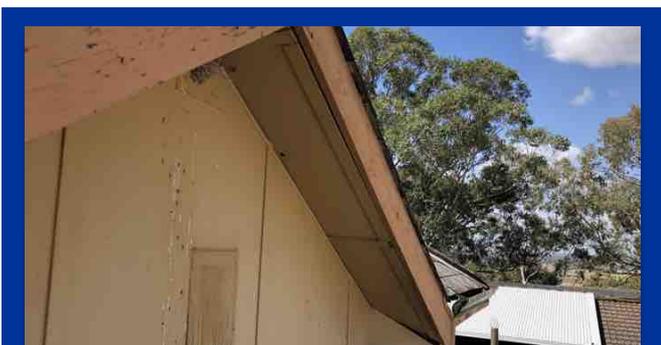
Photo 95

Belmont House – External – Rooftop – Orange/pink paint on rear walls

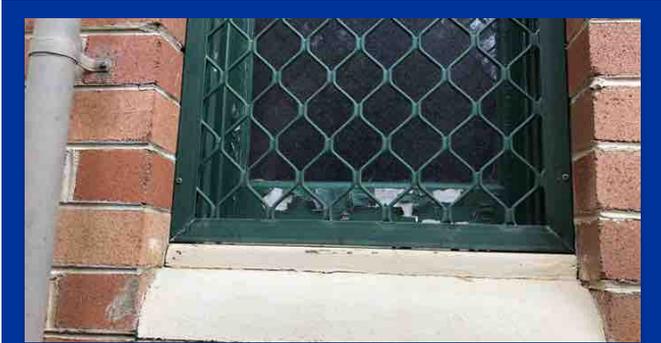
Photo 97

Monastery – External – Dark green paint

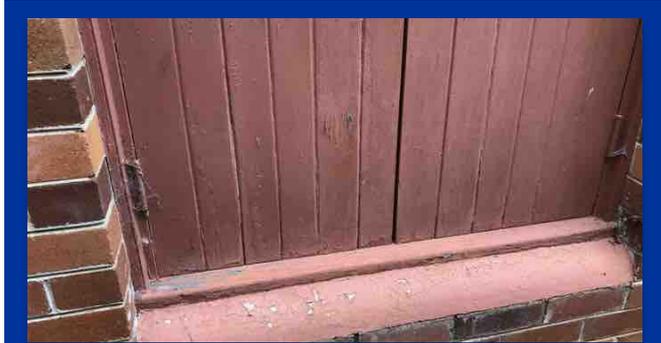
Photo 98

Monastery - External - Red Paint.

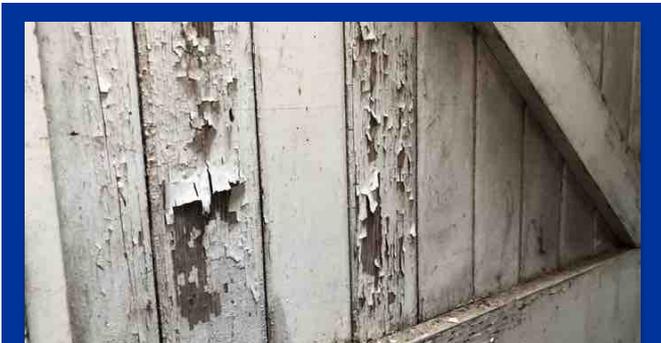
Photo 99

Monastery – External – Hot water boiler shed – White paint on rear of door.

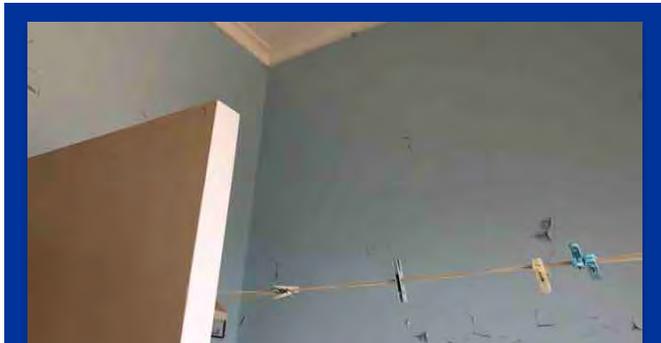
Photo 100

Monastery – Internal – 1st floor – Southwestern room - Light blue wall paint.

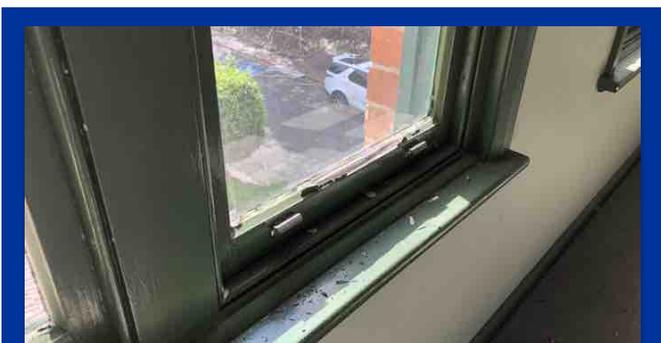
Photo 101

Monastery – Internal – 2nd floor – Olive window frame paint.

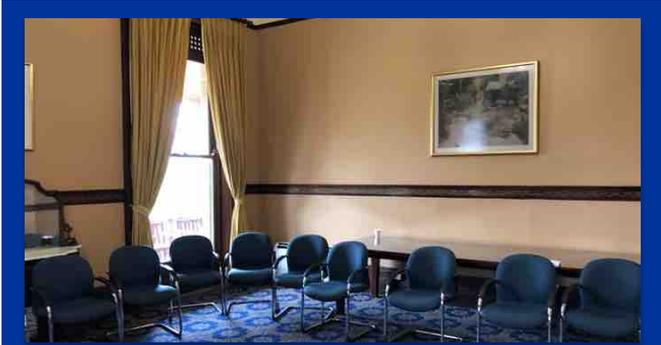
Photo 115

Belmont house – Internal – Pink wall paint in northwestern room

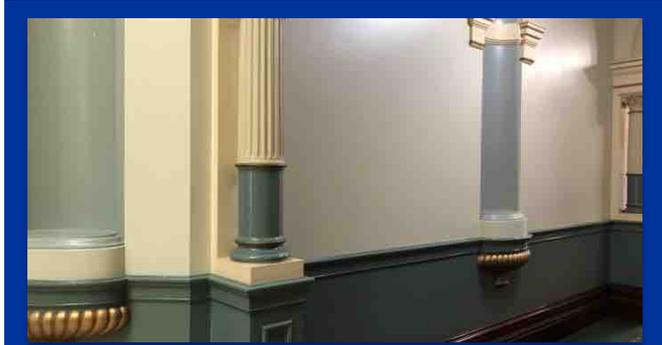
Photo 116

Belmont house – Internal – Aqua lower wall section paint in eastern corridor.

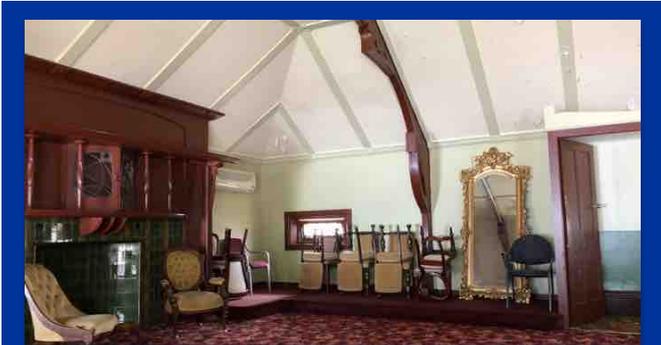
Photo 117

Belmont house – The Granada room – Mint wall paint

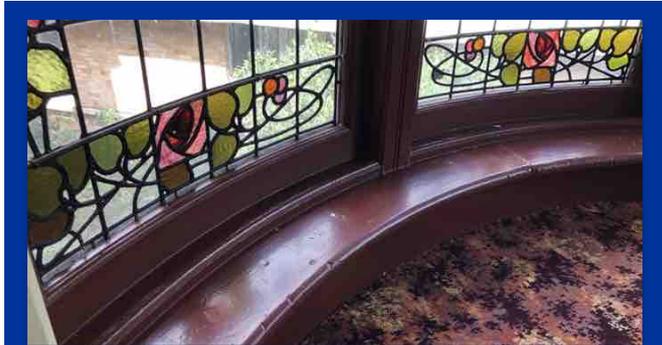
Photo 118

Belmont house – The Granada room – Red paint on window frames and other surfaces.

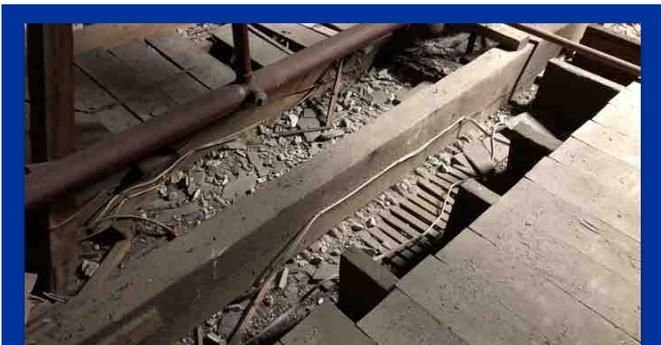
Photo 119

Belmont house – Ceiling space – Northern side - Dust
