FIRE HYDRANT ASSESSMENT REPORT

SELL & PARKER, BLACKTOWN

45 Tattersall Rd, Kings Park NSW 2148

Date: 15 June 2020
Revision: 2
Issue: Issued to Client
Ref. No.: 21000_FHAR

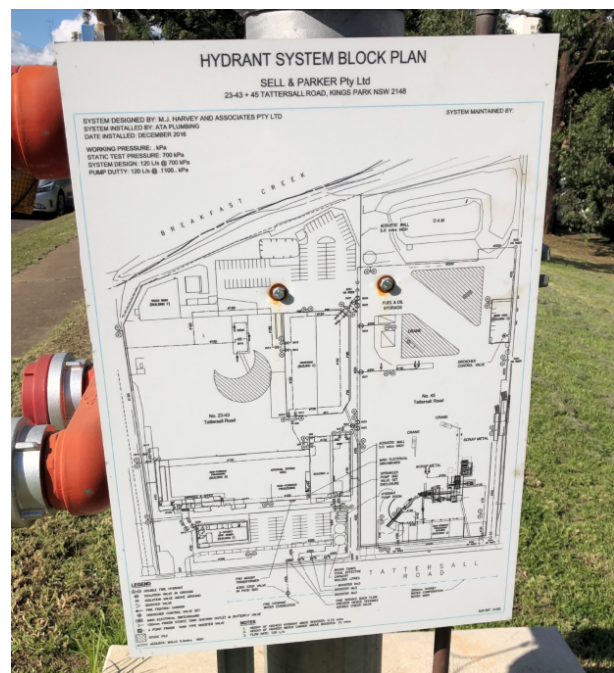
It was observed that the existing booster valves are not secure or locked in the open position.

1. The existing booster assembly is non-compliant due to the booster valves not being secure or locked in the open position.
2. The booster inlet pipes do not have an isolation valves downstream of the booster inlets. Booster inlet pipes are required to have an isolation valve if the head at the inlets can be greater than 50kPa due to the pumps running.
3. No signage to identify the booster assemblies in accordance with Clause 7.10 of AS2419.1 – 2005.
4. FH Block plan has incomplete and incorrect information in accordance with Clause 7.11 of AS2419.1 – 2005
5. The fire brigade hardstand was observed to be non-compliant at the time of inspection due the fire brigade booster assembly being obstructed by parked cars.
6. Boost and Test Pressure signage is not provided for the boosters.

1. The booster valves shall be secured in the open position with a padlock openable by the fire brigade 003 key.
2. Isolation valves shall be provided downstream of the booster inlets.
3. Provide separate stands for signage of

the 'FH Booster' and must be adjacent the suction and inlet points to avoid confusion with the adjacent sprinkler booster.

4. Revise Block plan layout to show the actual configuration of the system including FH30 outside Building B, north arrow, connections for fire monitors, standard of compliance and electrical substation. The location of FH25 adjacent the weighbridge shall be updated on the block plan to reflect the accurate location.
5. The fire brigade hardstand shall not be used as parking. Request council to move no-parking sign beyond booster assembly to keep front of boosters clear at all times.
6. Provide a fade-resistant or engraved sign indicating boost and test pressure in kPa, marked in upper case lettering not less than 25mm in height

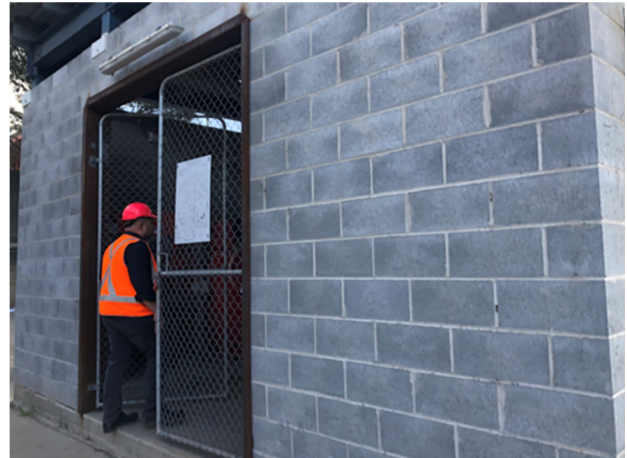
It was observed that the signage for the fire pump room was missing.

The existing fire hydrant pump room is non-compliant because it cannot be identified by appropriate signage.

The pump room shall be provided with signage in accordance with AS2941.1-2013.

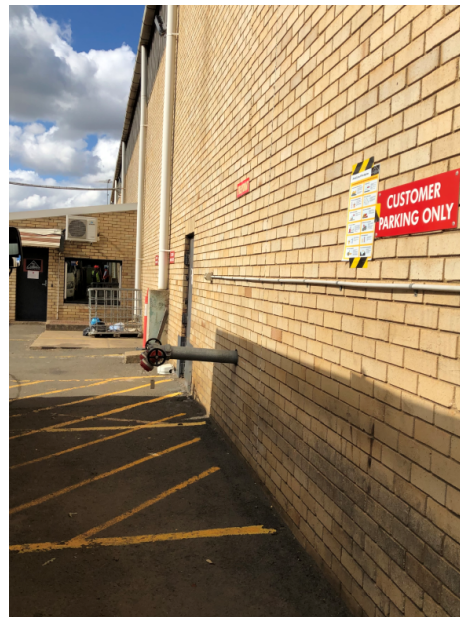
It was observed during the inspection that the fire hydrant (FH3) located outside Building B did not have any adequate support and did not have any bollard protection.

1. The existing fire hydrant is non-compliant because supports are required to be located not further than 1 metre from any change in direction or a junction in the pipework. The distance from the last support to the end of any horizontal pipe shall not exceed 1 m.
2. The existing fire hydrant system is non-compliant because AS2419.1 requires fire hydrants and pipework to be located so that the fire hydrant system is protected from possible mechanical damage by vehicles. The fire hydrants required to, but did not have any protection from physical damage

FH 3 missing adequate support and bollard

1. Provide adequate pipe support for the horizontal pipe feeding the dual external fire hydrant landing valves.
2. Provide bollard protection to fire hydrant.

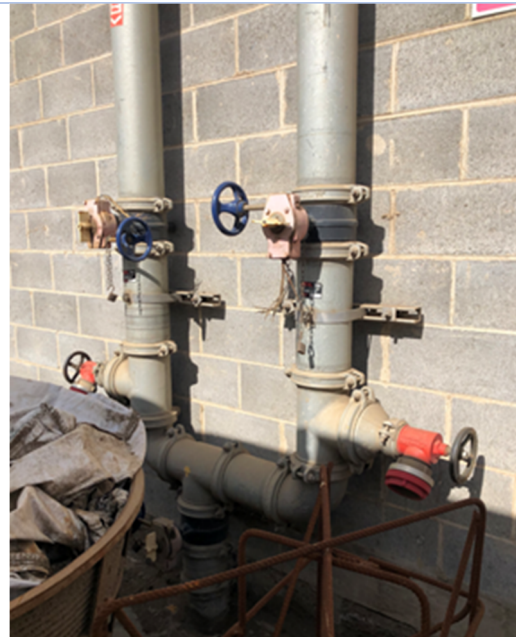
It was observed during the inspection that FH10 and FH11 were obstructed by plant equipment.

The existing fire hydrant system is not compliant due to the fire hydrants being obstructed by plant equipment

FH10 and FH11 obstructed by equipment

The obstructions to accessibility of the fire hydrants shall be removed.

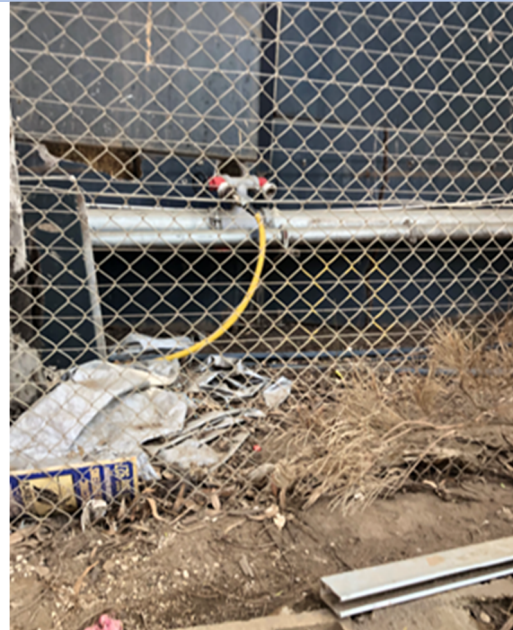
The existing fire hydrant system is not compliant due to the fire hydrant being obstructed by site fencing.

FH7 obstructed by fencing.

The existing fencing shall be modified to provide access to the fire hydrant.

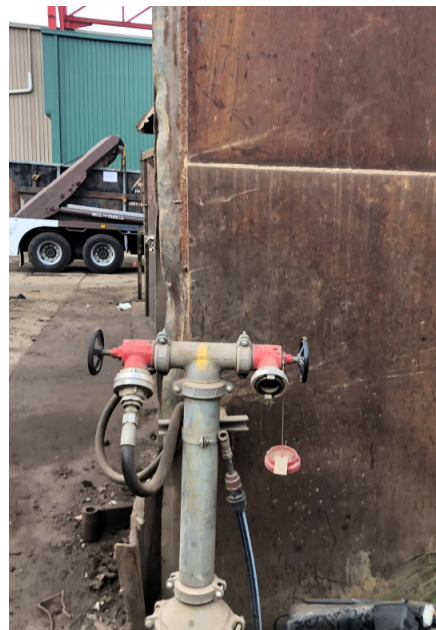
It was observed that the existing fire hydrant outlet was not covered.

The existing fire hydrant system is non-compliant due to the fire hydrant outlet not having protective caps to block debris and other contaminants from entering the pipes.

FH19 without cover

All fire hydrants on site shall be kept covered when not in operation.

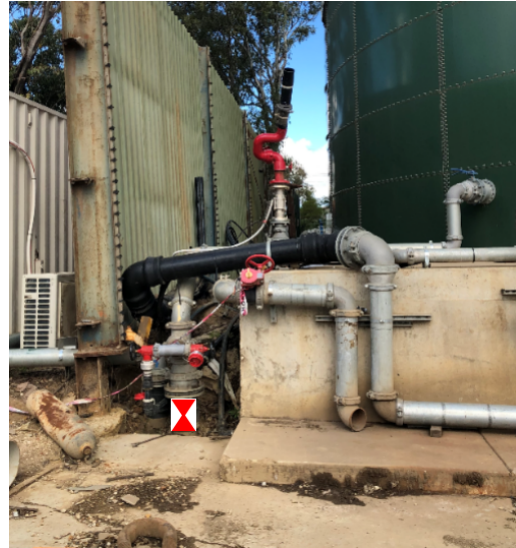
It was observed during the inspection that the fire hydrant located adjacent the sprinkler tank (FH22) had a landing valve at approximately 600mm above finished ground level. The hydrant appears to be fed off a branch from the ring main that serves also serves a water cannon. The water cannon is connected to a pipe that was for backwash purposes as advised during the inspection.

1. The fire hydrant landing valve is non-compliant with AS2419.1-2005 because it is located at a height less than 750mm.
2. The branch pipe from the fire hydrant ring main is required to have an isolation valve if it is serving more than one fire hydrant in accordance with AS2419.1.
3. An isolation valve is required for all connections to the fire hydrant system, shown on the block plan.

Isolation valve required for FH22 shown above

1. Provide the fire hydrant landing valve between 750mm-1200mm above finished ground level.
2. Provide isolation to be able to isolate the pipe branching from the ring main system.
3. Provide isolation valve for connections from fire hydrant pipework, shown on block plan.

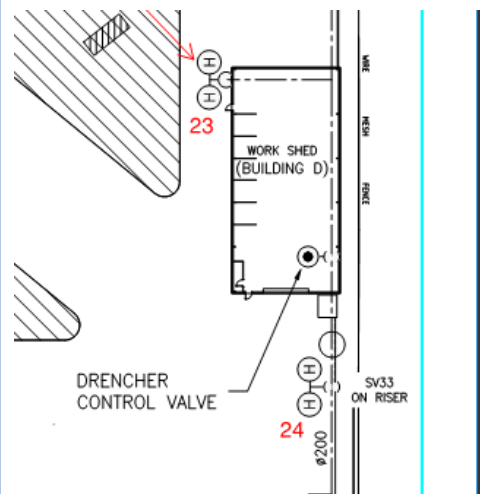
Location of FH24

It was observed during the inspection that FH24 was obstructed by existing sheds and did not have a cover.

1. The existing fire hydrant system is not compliant due to the fire hydrant accessibility being obstructed by the existing sheds.
2. The existing fire hydrant system is non complaint due to the fire hydrant outlet without having a protective cap to block debris and other contaminants from entering the pipes.

1. The fire hydrant shall be relocated to an accessible location in front of the sheds.
2. The fire hydrant shall be kept covered when not in operation. Caps shall be provided to missing fire hydrants.

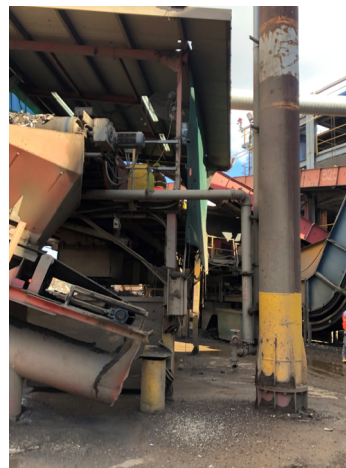
FH27 blocked by debris

3. The fire hydrant shall be kept covered when not in operation. Caps shall be

provided to missing fire hydrants

4. The fire hydrant shall be cleared of the debris and provided with a new maintenance tag in accordance with AS1851-2012.

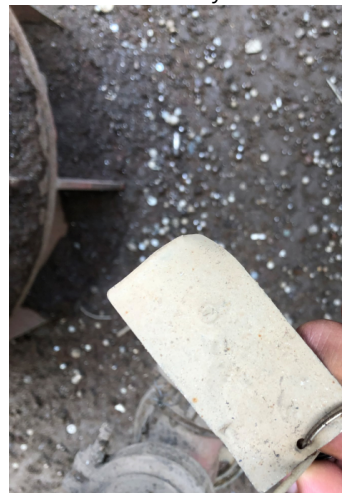
FH27 unreadable maintenance tag

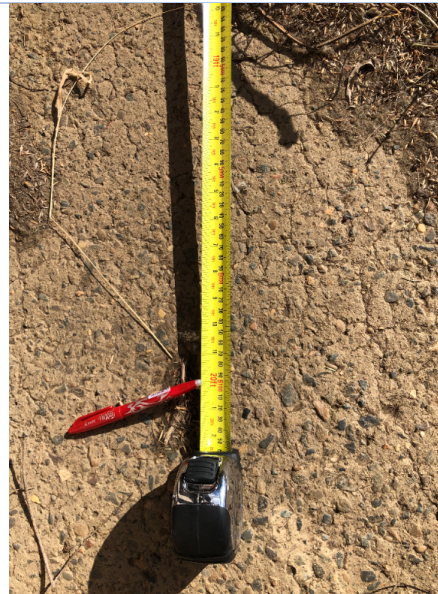
Approximately 6 metres clearance measured

Relocate the fire hydrant to be at least 10 metres away from the existing substation.

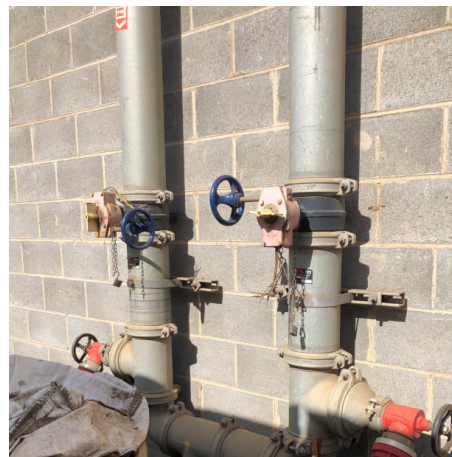
It was observed during the inspection that many above ground isolation valves did not have tags showing the valve numbers. The below ground isolation valves also did not have any tag or mark showing the valve numbers. SV34 shown on the block plan was not observed during the inspection.

1. All above ground isolation valves are required to be clearly identified with a tag showing the valve number on the block plan.
2. Isolating valves installed below ground are required to be suitably tagged or marked by either post reflective marker or reflective paint (to access covers) in 25 mm high text, and shall and be clearly identified with a permanent ground marking showing the valve number on the block plan. Refer to the

Example of SV14 and SV15 not marked

1. Provide isolation valve tags for all above ground isolation valves showing the valve number on the block plan.
2. Provide reflective paint (to access covers) in 25 mm high text to all inground stop valve. These shall and be clearly identified with a permanent ground marking showing the valve number on the block plan.
3. Provide isolation valve SV34 as shown on block plan.

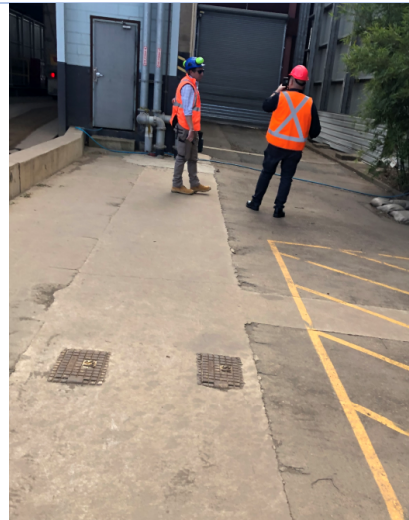
Example of SV17 and SV18 not marked

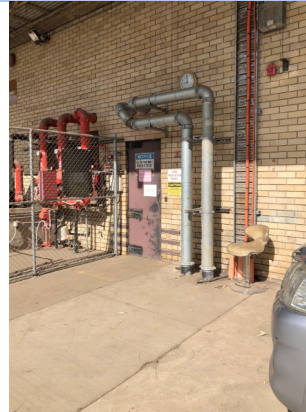
Risers entering Building B from SV1 and SV2 without bollard protection

The risers serving Building B from shall be provided with bollard protection from moving vehicles.

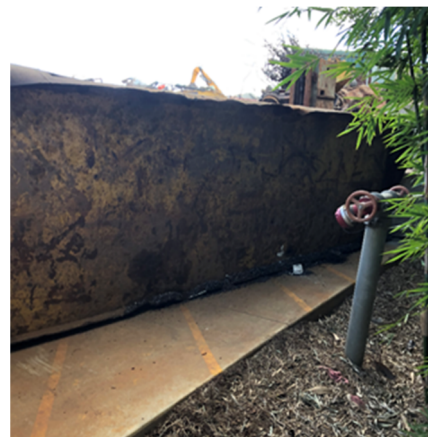
External fire hydrant obstructed by plant equipment

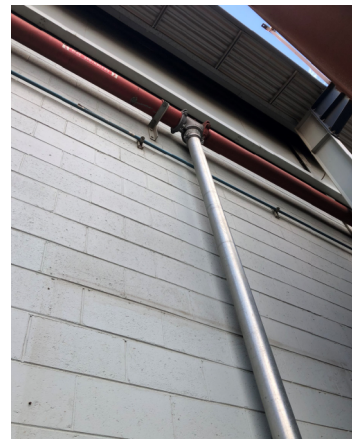
Supply from old sprinkler pipe for fire hydrant (FH30) not shown on block plan.

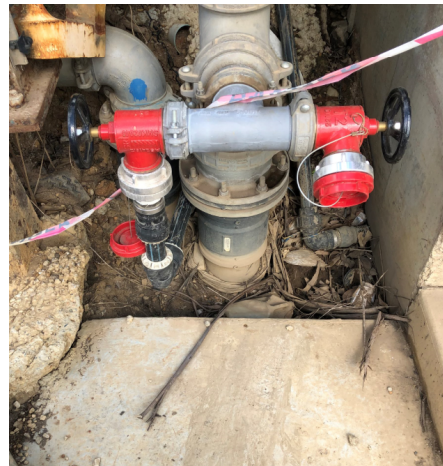
Fire hydrant installed too low (~600mm)

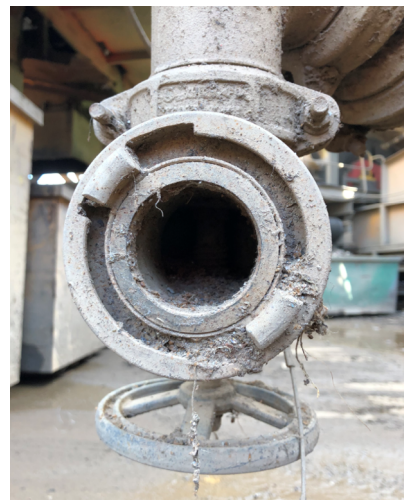
Fire hydrant (FH27) blocked with debris.

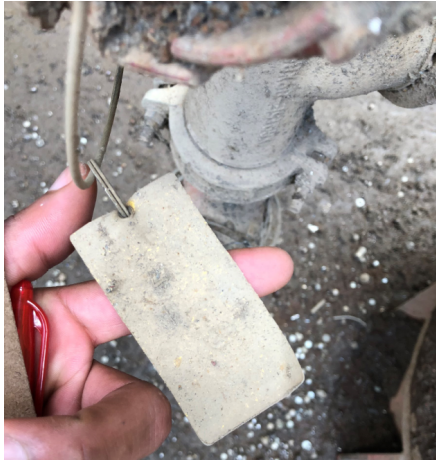
Unreadable maintenance tag (FH27).

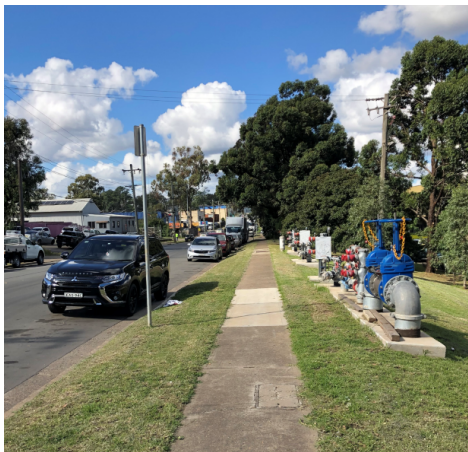
The fire brigade hardstand is currently being used as a carpark.

Vehicles parked on fire brigade hardstand.
