**Re: 23-45 Tattersall Road, Kings Park – Fire Hydrant Assessment Report Close Out**

# FIRE HYDRANT ASSESSMENT REPORT

## **SELL & PARKER, BLACKTOWN**

45 Tattersall Rd, Kings Park NSW 2148

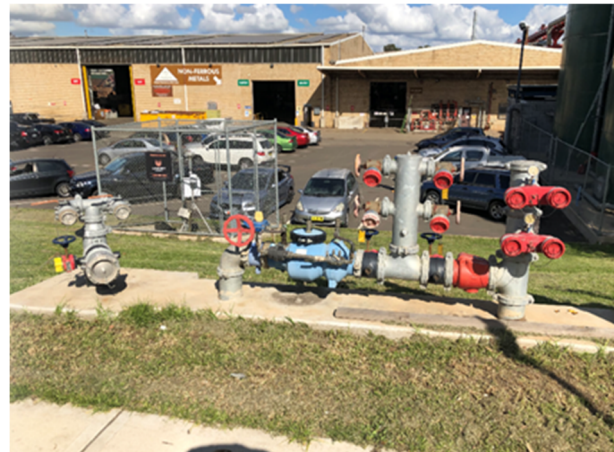
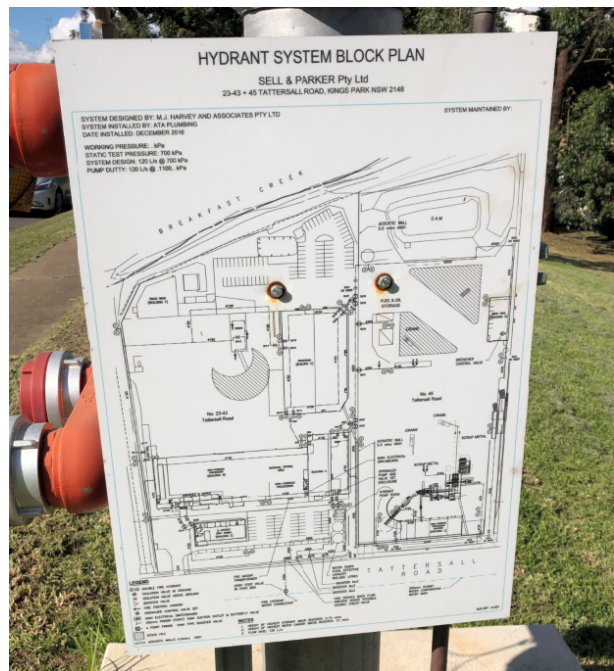
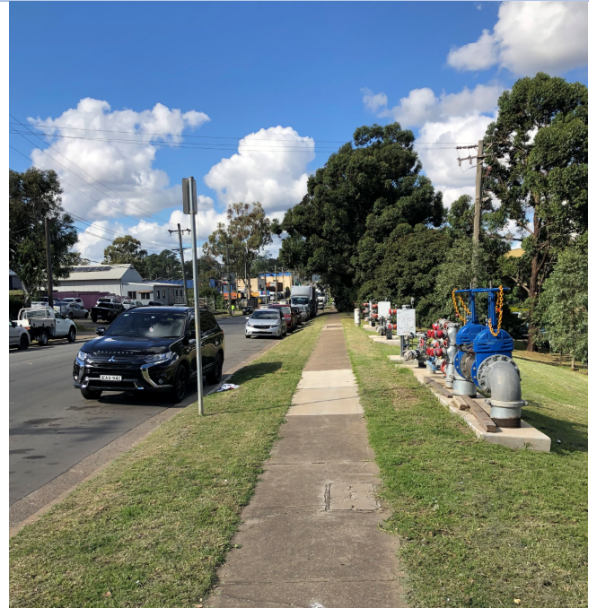
It was observed that the existing booster valves are not secure or locked in the open position.

1. The booster valves shall be secured in the open position with a padlock openable by the fire brigade 003 key.
2. Isolation valves shall be provided downstream of the booster inlets.
3. Provide separate stands for signage of

the 'FH Booster' and must be adjacent the suction and inlet points to avoid confusion with the adjacent sprinkler booster.

4. Revise Block plan layout to show the actual configuration of the system including FH30 outside Building B, north arrow, connections for fire monitors, standard of compliance and electrical substation. The location of FH25 adjacent the weighbridge shall be updated on the block plan to reflect the accurate location.
5. The fire brigade hardstand shall not be used as parking. Request council to move no-parking sign beyond booster assembly to keep front of boosters clear at all times.
6. Provide a fade-resistant or engraved sign indicating boost and test pressure in kPa, marked in upper case lettering not less than 25mm in height

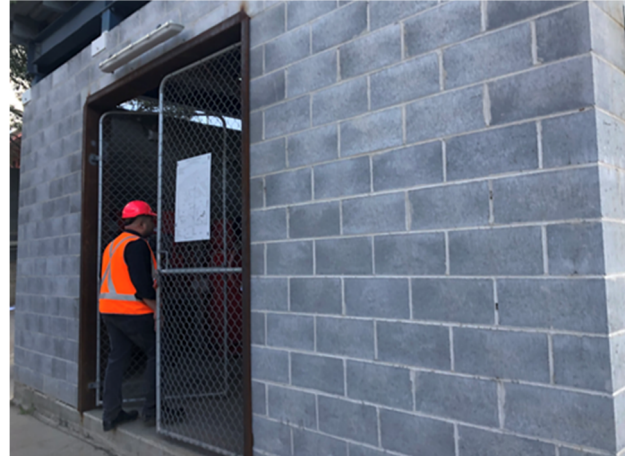
It was observed that the signage for the fire pump room was missing.

The pump room shall be provided with signage in accordance with AS2941.1-2013.

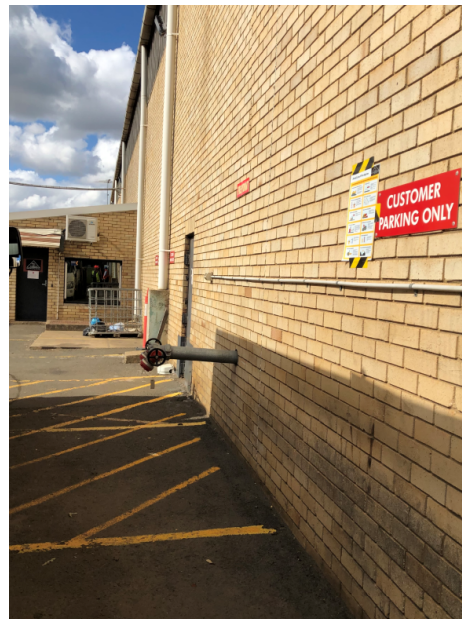
It was observed during the inspection that the fire hydrant (FH3) located outside Building B did not have any adequate support and did not have any bollard protection.

1. The existing fire hydrant is non-compliant because supports are required to be located not further than 1 metre from any change in direction or a junction in the pipework. The distance from the last support to the end of any horizontal pipe shall not exceed 1 m.
2. The existing fire hydrant system is non-compliant because AS2419.1 requires fire hydrants and pipework to be located so that the fire hydrant system is protected from possible mechanical damage by vehicles. The fire hydrants required to, but did not have any protection from physical damage

FH 3 missing adequate support and bollard

1. Provide adequate pipe support for the horizontal pipe feeding the dual external fire hydrant landing valves.
2. Provide bollard protection to fire hydrant.

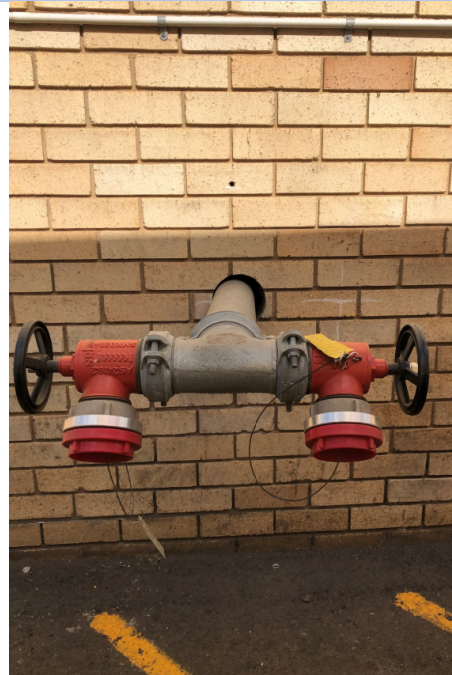
FH 3 missing adequate support

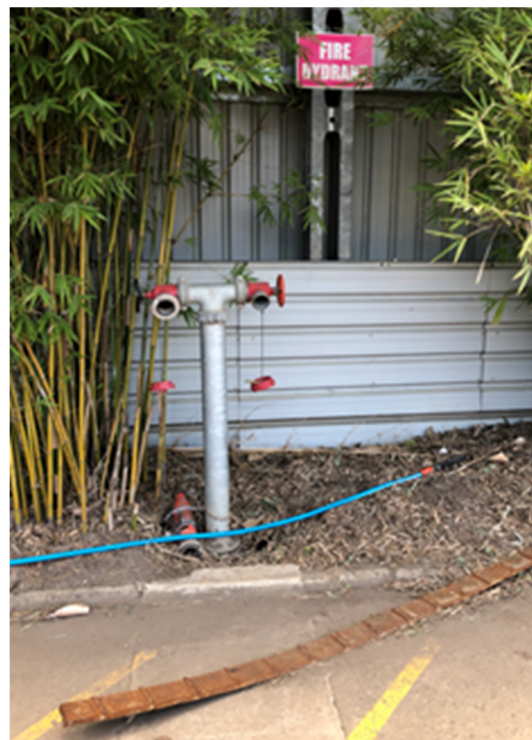
It was observed during the inspection that FH5 did not have any bollard protection and was missing a storz connection and cap.

1. The existing fire hydrant system is non compliant because AS2419.1 requires fire hydrants and pipework to be located so that the fire hydrant system is protected from possible mechanical damage by vehicles. The fire hydrants required to, but did not have any protection from physical damage
2. The existing fire hydrant system is not compliant due to the fire hydrant not having protective caps to block debris and other contaminants from entering the pipes

FH5 without bollard protection and storz

<p>5.4.3 Recommendation for Rectification</p> <ol style="list-style-type: none"> <li>1. Provide bollard protection from moving vehicles.</li> <li>2. Provide storz connection and cap to the fire hydrant</li> </ol>	
<p><b>5.5 Fire Hydrant– FH 6</b></p> <p>5.5.1 Observation It was observed during the inspection that FH6 was obstructed by plant equipment.</p> <p>5.5.2 Non-Compliance The existing fire hydrant system is not compliant due to the fire hydrant being obstructed by plant equipment</p> <p>5.5.3 Recommendation for Rectification The obstructions to accessibility of the fire hydrant shall be removed.</p>	  <p>FH6 obstructed by equipment</p>
<p><b>5.6 Fire Hydrant– FH 7</b></p> <p>5.6.1 Observation It was observed during the inspection that FH7 was obstructed by plant equipment.</p> <p>5.6.2 Non-Compliance The existing fire hydrant system is not compliant due to the fire hydrant being obstructed by plant equipment</p> <p>5.6.3 Recommendation for Rectification The obstructions to accessibility of the fire hydrant shall be removed.</p>	  <p>FH7 obstructed by equipment</p>

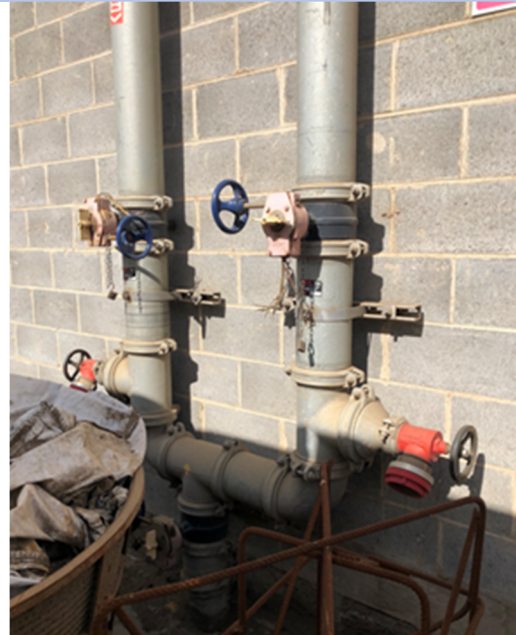
It was observed during the inspection that FH10 and FH11 were obstructed by plant equipment.

FH10 and FH11 obstructed by equipment

The obstructions to accessibility of the fire hydrants shall be removed.

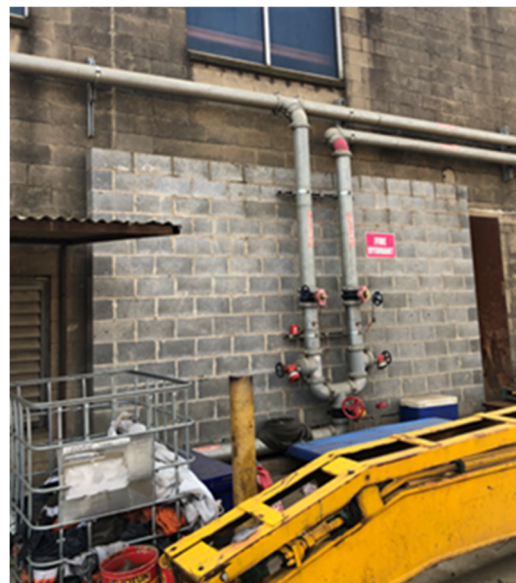
It was observed during the inspection that FH14 and FH15 were obstructed by plant equipment.

FH14 and FH15 obstructed by equipment

The obstructions to accessibility of the fire hydrants shall be removed.

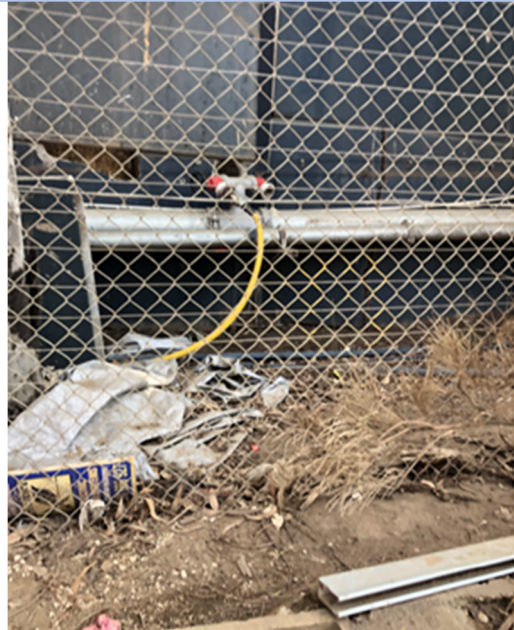
It was observed during the inspection that FH16 was obstructed by plant equipment.

FH7 obstructed by fencing.

The existing fencing shall be modified to provide access to the fire hydrant.

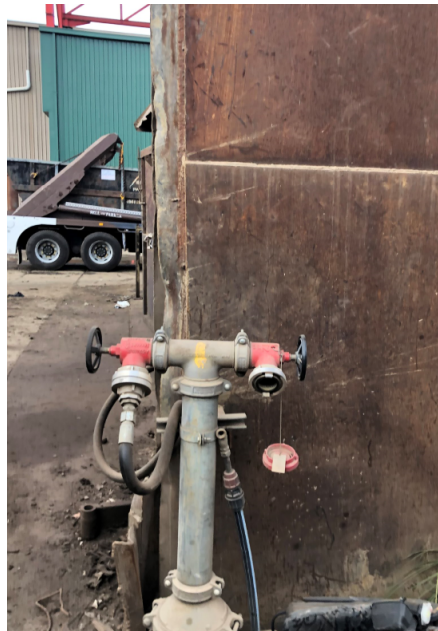
It was observed that the existing fire hydrant outlet was not covered.

FH19 without cover

All fire hydrants on site shall be kept covered when not in operation.

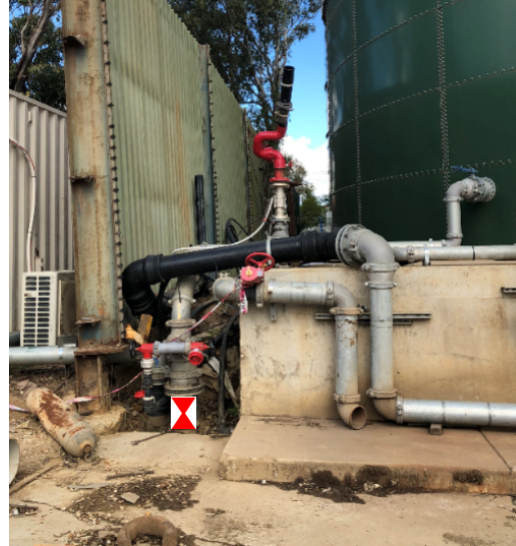
It was observed during the inspection that the fire hydrant located adjacent the sprinkler tank (FH22) had a landing valve at approximately 600mm above finished ground level. The hydrant appears to be fed off a branch from the ring main that serves also serves a water cannon. The water cannon is connected to a pipe that was for backwash purposes as advised during the inspection.

Isolation valve required for FH22 shown above

1. Provide the fire hydrant landing valve between 750mm-1200mm above finished ground level.
2. Provide isolation to be able to isolate the pipe branching from the ring main system.
3. Provide isolation valve for connections from fire hydrant pipework, shown on block plan.

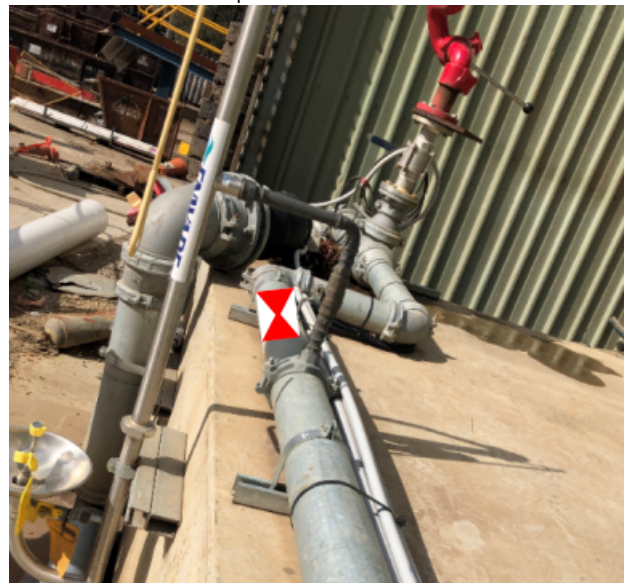
Isolation valve for connections from fire hydrant pipework, shown on block plan.

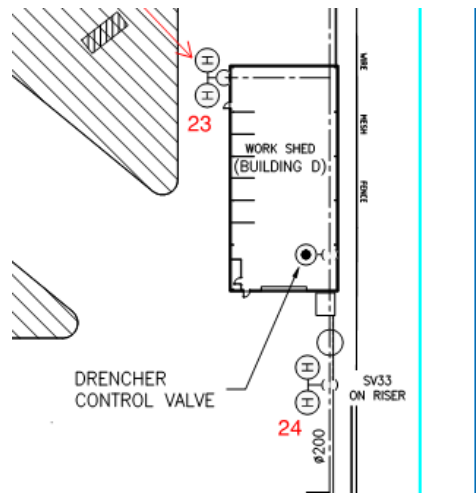
Location of FH24

It was observed during the inspection that FH24 was obstructed by existing sheds and did not have a cover.

1. The fire hydrant shall be relocated to an accessible location in front of the sheds.
2. The fire hydrant shall be kept covered when not in operation. Caps shall be provided to missing fire hydrants.

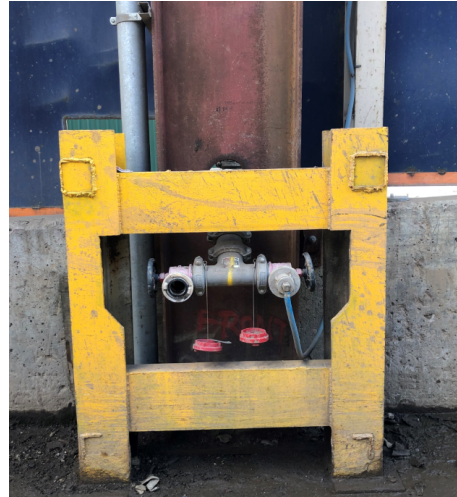
It was observed during the inspection that FH25 has caps not fitted

FH24 without cover

2. The fire hydrant shall be kept covered when not in operation. Caps shall be provided to missing fire hydrants.

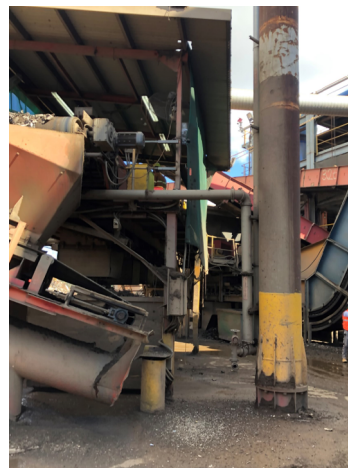
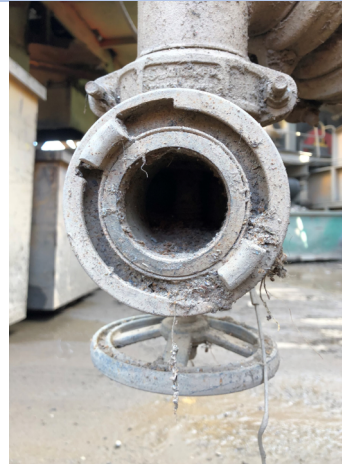
FH27 blocked by debris

3. The fire hydrant shall be kept covered when not in operation. Caps shall be

provided to missing fire hydrants

4. The fire hydrant shall be cleared of the debris and provided with a new maintenance tag in accordance with AS1851-2012.

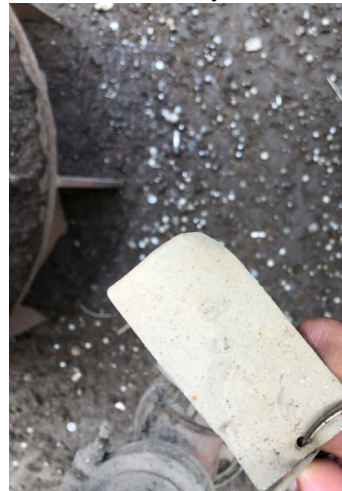
FH27 unreadable maintenance tag

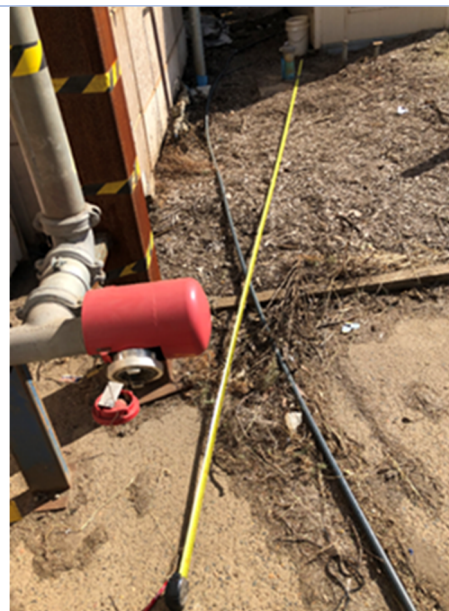
FH29 located too close to substation

Relocate the fire hydrant to be atleast 10 metres away from the existing substation.

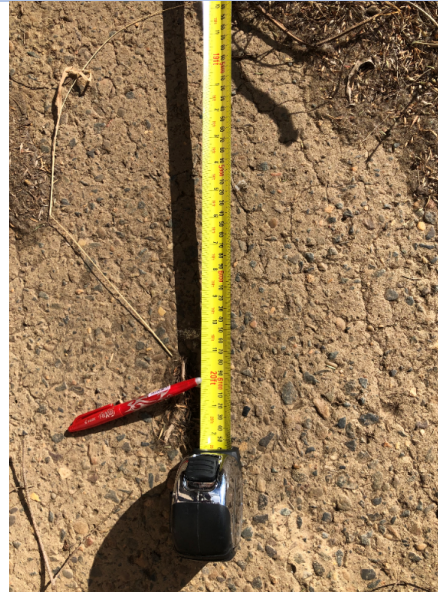
Approximately 6 metres clearance measured

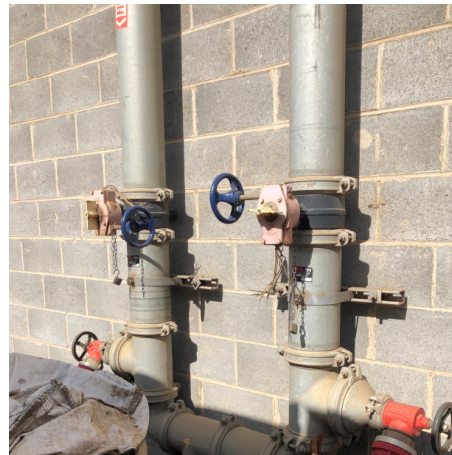
It was observed during the inspection that many above ground isolation valves did not have tags showing the valve numbers. The below ground isolation valves also did not have any tag or mark showing the valve numbers. SV34 shown on the block plan was not observed during the inspection.

1. All above ground isolation valves are required to be clearly identified with a tag showing the valve number on the block plan.
2. Isolating valves installed below ground are required to be suitably tagged or marked by either post reflective marker or reflective paint (to access covers) in 25 mm high text, and shall and be clearly identified with a permanent ground marking showing the valve number on the block plan. Refer to the

Example of SV14 and SV15 not marked

1. Provide isolation valve tags for all above ground isolation valves showing the valve number on the block plan.
2. Provide reflective paint (to access covers) in 25 mm high text to all inground stop valve. These shall and be clearly identified with a permanent ground marking showing the valve number on the block plan.
3. Provide isolation valve SV34 as shown on block plan.

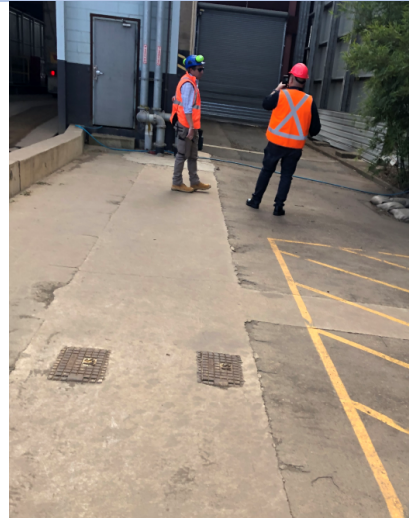
Example of SV17 and SV18 not marked

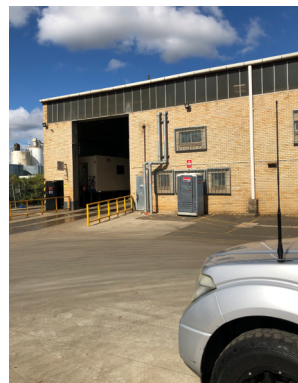
The existing fire hydrant system has pipework and in areas with moving vehicles, without protection of damage from the vehicles.

The existing fire hydrant system is non compliant because AS2419.1 requires fire hydrants and pipework to be located so that the fire hydrant system is protected from possible mechanical damage by vehicles. The following pipes are required to, but did not have any protection from physical damage:

Risers entering Building B from SV19 and SV20 without bollard protection

The risers serving Building B from shall be provided with bollard protection from moving vehicles.

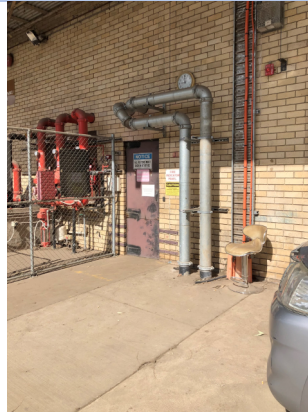
Risers entering Building B from SV1 and SV2 without bollard protection

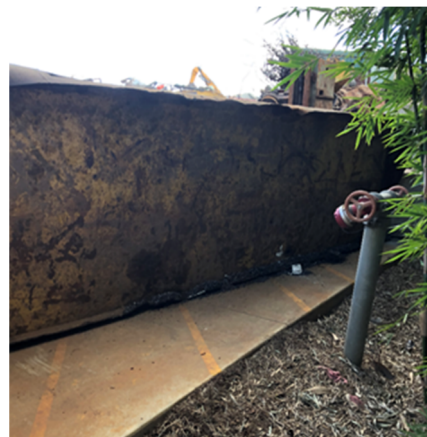
External fire hydrant obstructed by plant equipment

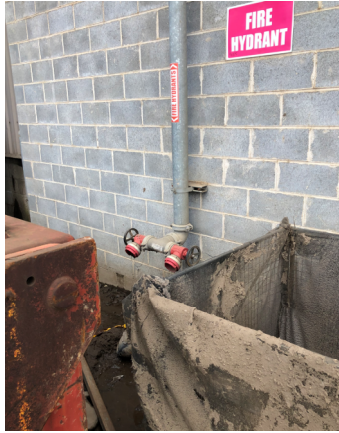
External fire hydrant (FH7) obstructed by plant equipment.

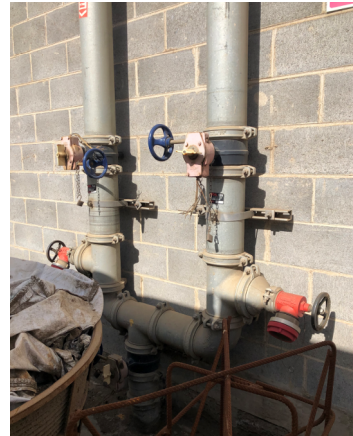
External fire hydrants (FH10 and FH11) and isolation valves (SV9, SV10, SV11) obstructed by plant equipment.

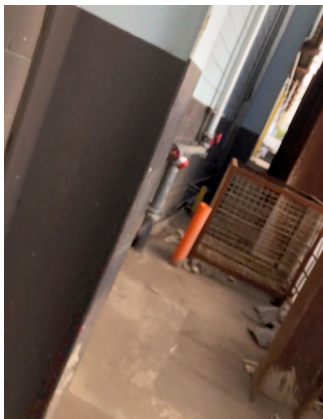
Fire hydrant (FH30) not shown on block plan.

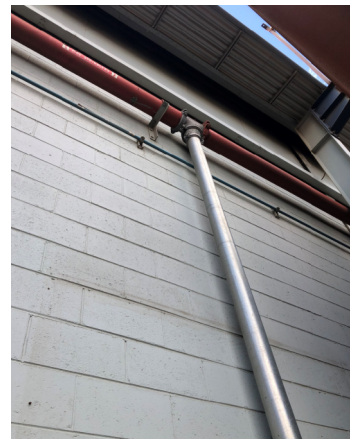
Supply from old sprinkler pipe for fire hydrant (FH30) not shown on block plan.

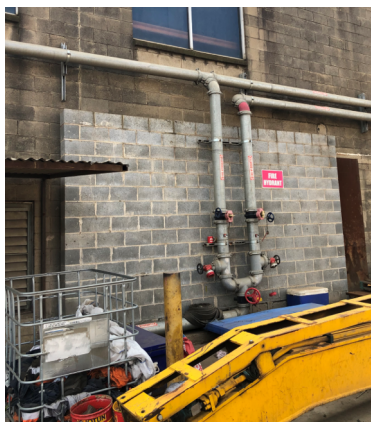
External fire hydrants and isolation valves obstructed by plant equipment

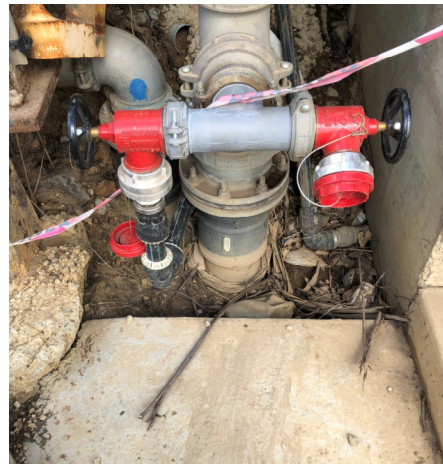
Fire hydrant installed too low (~600mm)

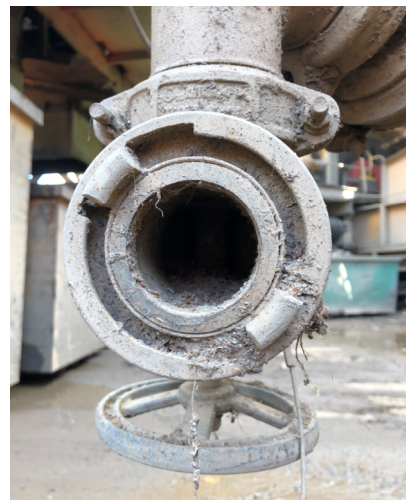
Fire hydrant (FH27) blocked with debris.

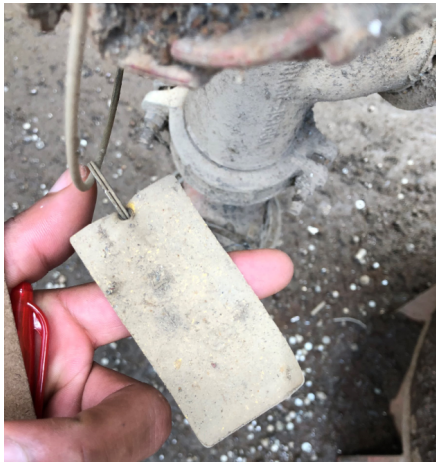
Unreadable maintenance tag (FH27).

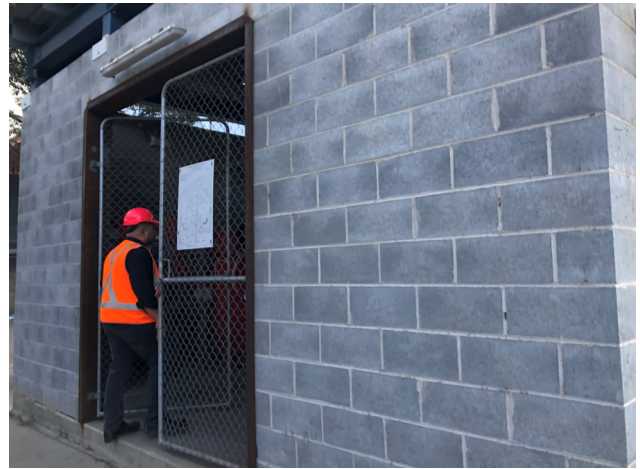
Fire hydrant pumproom missing signage.

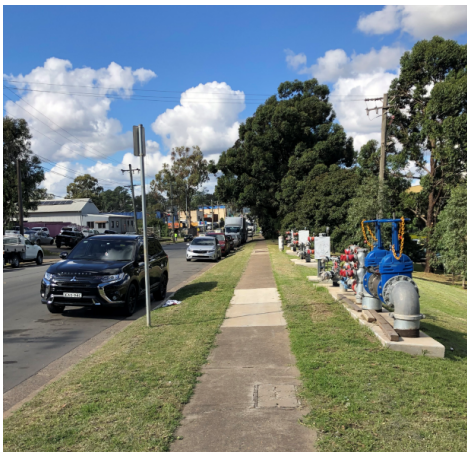
The fire brigade hardstand is currently being used as a carpark.

Vehicles parked on fire brigade hardstand.

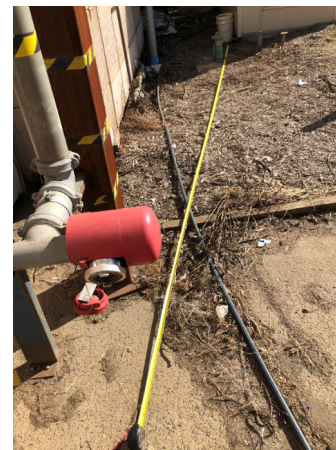
Fire hydrant located within 10m of substation.

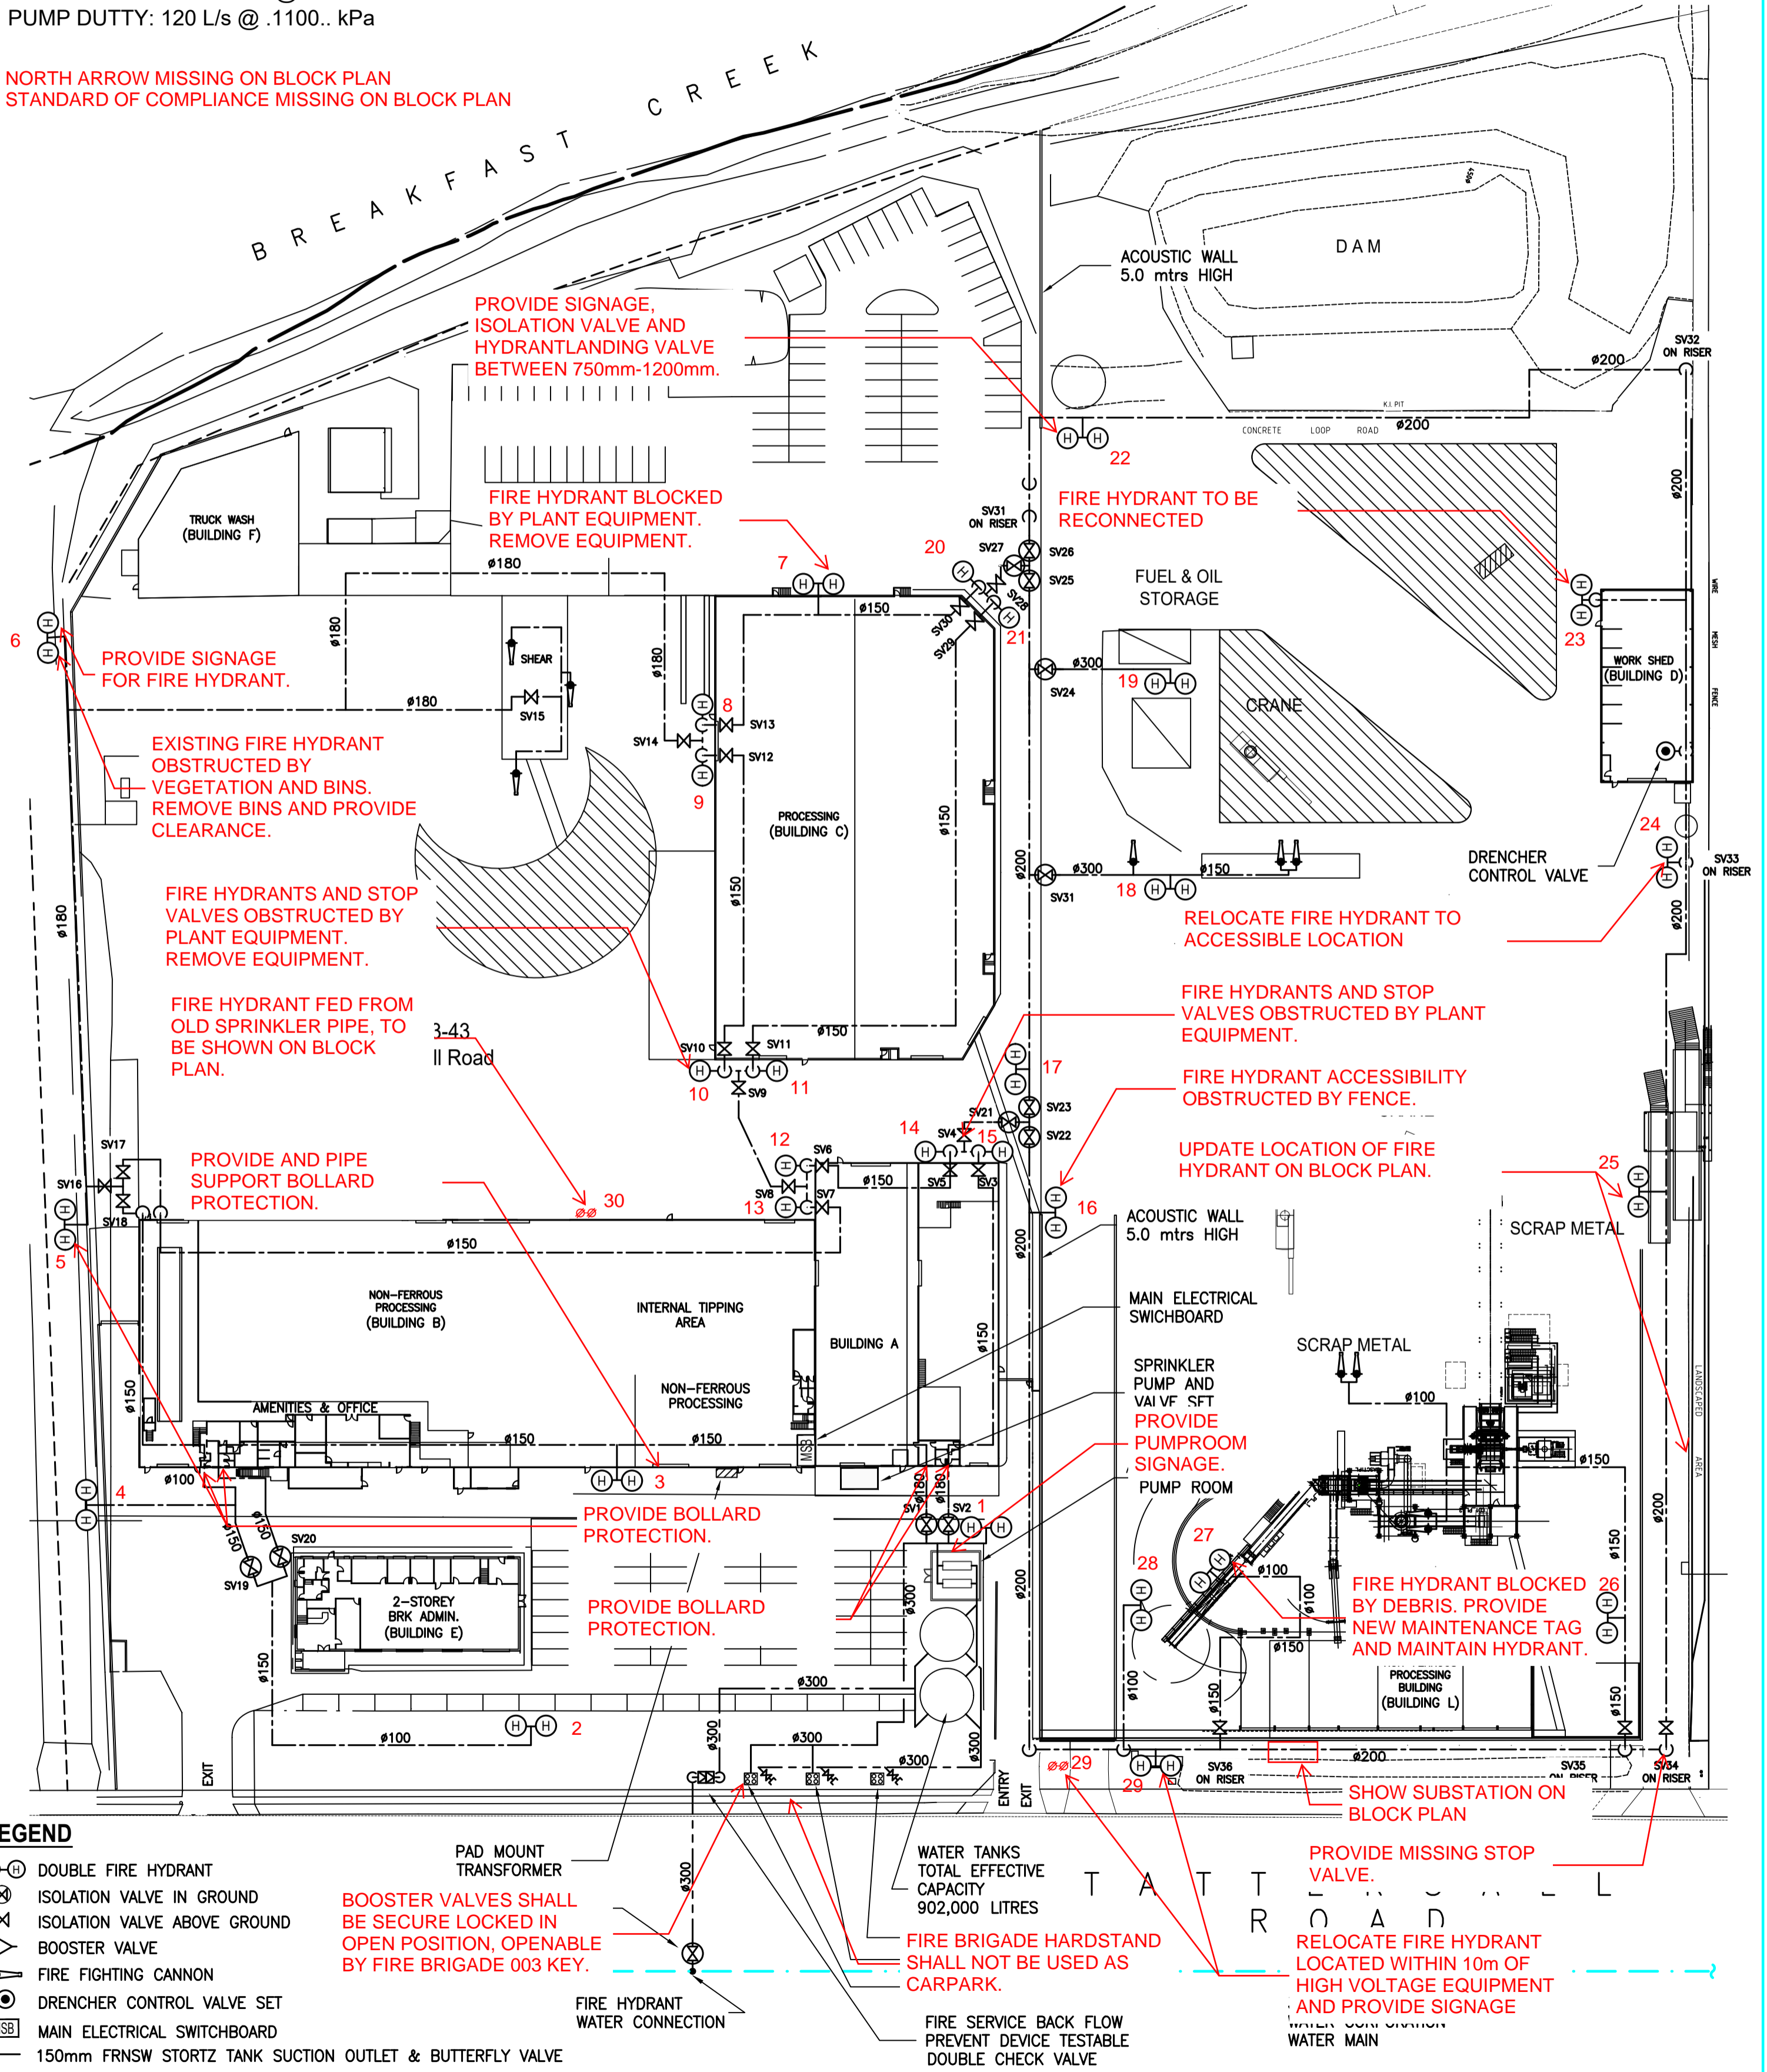
NORTH ARROW MISSING ON BLOCK PLAN  
STANDARD OF COMPLIANCE MISSING ON BLOCK PLAN

PROVIDE MISSING STOP VALVE.
