Deicorp Projects (Tallawong Station) Pty Ltd

Road Safety Audit Report Construction Stage

Tallawong Station Precinct South

May 2020

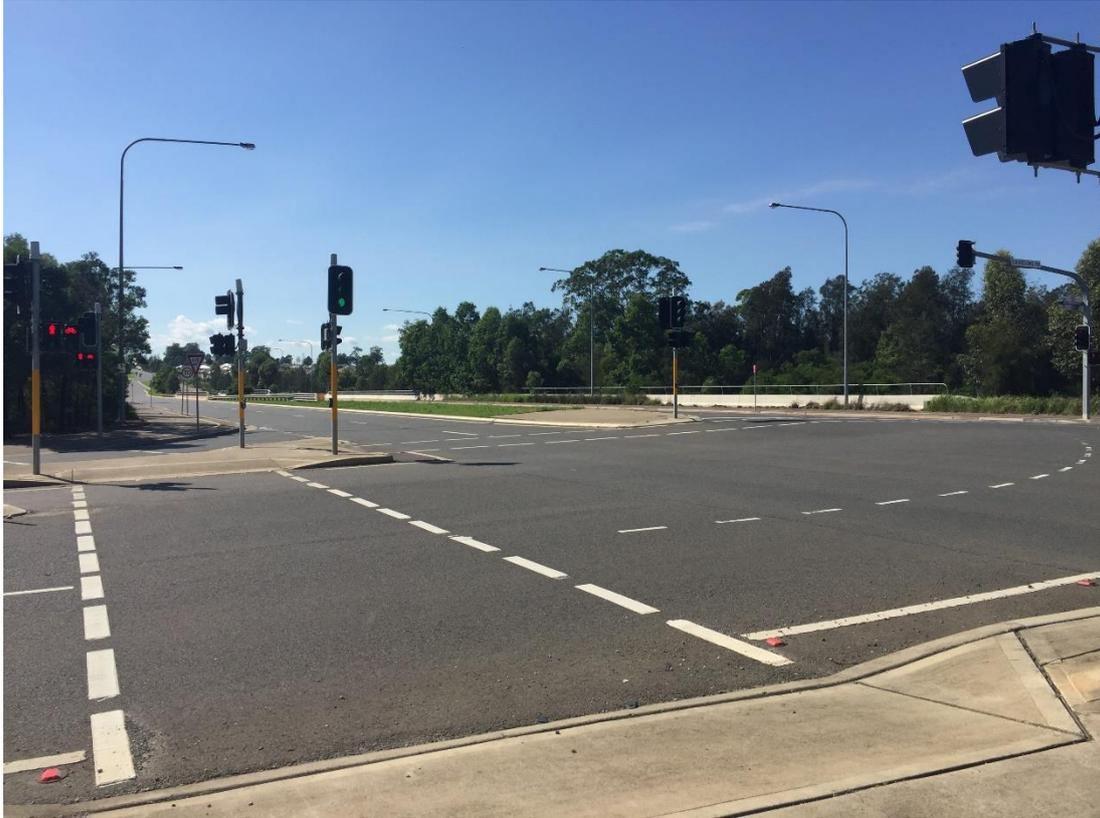
Photo 1 – Schofields Road / Cudgegong Road Intersection

Audit Findings	Suggested Treatments	Risk	Responsible Officer	
			Accept Y/N	Comments
<p>1. The increase in the volume and frequency of heavy vehicle movements increases the risk of crashes with light vehicles, particularly at the Schofields Road / Cudgegong Road intersection where heavy vehicles will turn right across opposing traffic.</p>	<p>Appropriate warning signs should be installed on the northern side of Schofields Road on the eastbound approach to Cudgegong Road to raise driver awareness of heavy vehicle turning movements.</p>	<p>Occasional / Serious = HIGH</p>		
<p>2. Heavy vehicles exiting the site along Conferta Avenue towards Tallawong Road creates a risk of crashes with vehicles accessing the southern portion of the commuter carpark.</p> <p>The likely low travel speed in this area will reduce the severity of potential crashes.</p>	<p>Appropriate warning signs should be installed in Conferta Avenue and Aristada Street to raise driver awareness of heavy vehicle movements.</p>	<p>Occasional / Minor = MEDIUM</p>

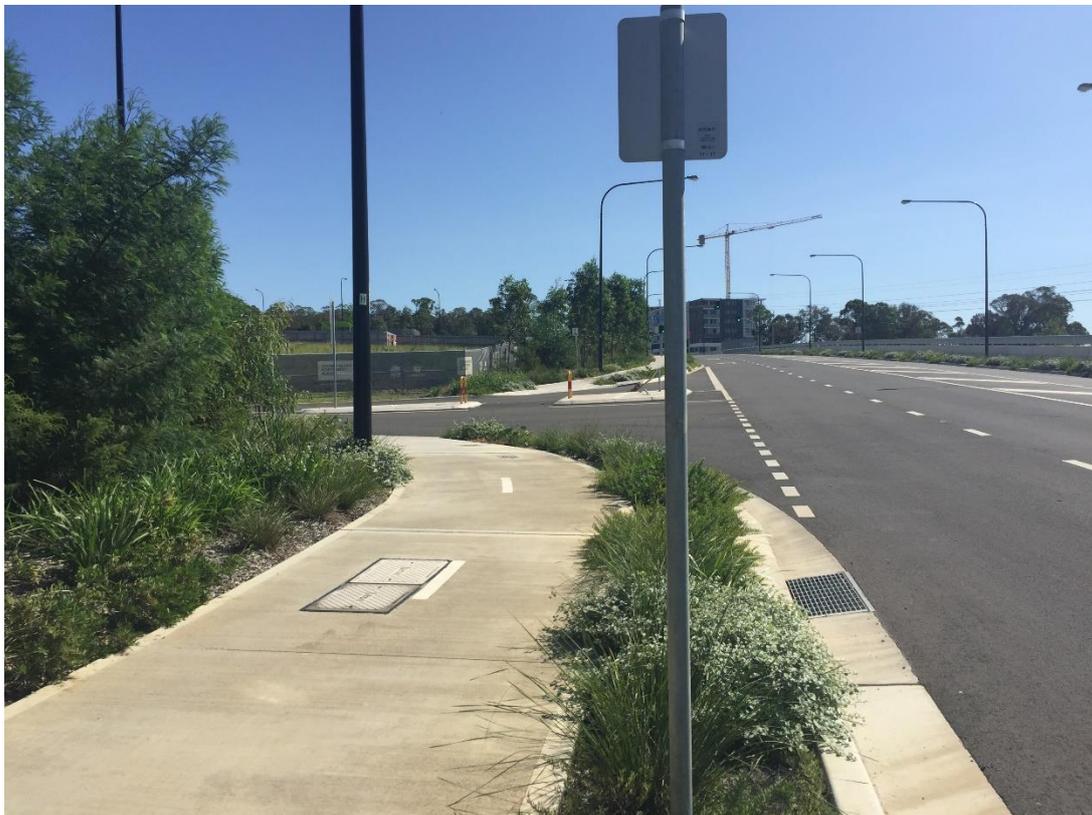
Photo 2 – Cudgegong Road / Conferta Avenue Intersection

<p>3. Heavy vehicle movements at the Cudegong Road / Conferta Avenue intersection, the Tallawong Road / Conferta Avenue intersection and along Conferta Avenue will increase the risk to pedestrians crossing Conferta Avenue at these locations.</p>	<p>Appropriate warning signs should be installed on all roads surrounding the site to raise the awareness of pedestrians about heavy vehicle movements.</p> <p>In addition, it is recommended that traffic controllers stop pedestrian movements across Conferta Avenue between Aristada Street and Tallawong Road while heavy vehicles are exiting the site along Conferta Avenue.</p> <p>Note: All existing shared paths surrounding the site are required to remain accessible</p>	<p>Occasional / Serious = HIGH</p>
