**1-15 AND 2-12 CONFERTA AVENUE,  
ROUSE HILL NSW 2155  
TALLAWONG STATION PRECINCT SOUTH  
PRE-DILAPIDATION REPORT**

**DEICORP PROJECTS  
(TALLAWONG STATION) PTY LTD**

Job No. 191294.0  
05/07/2021

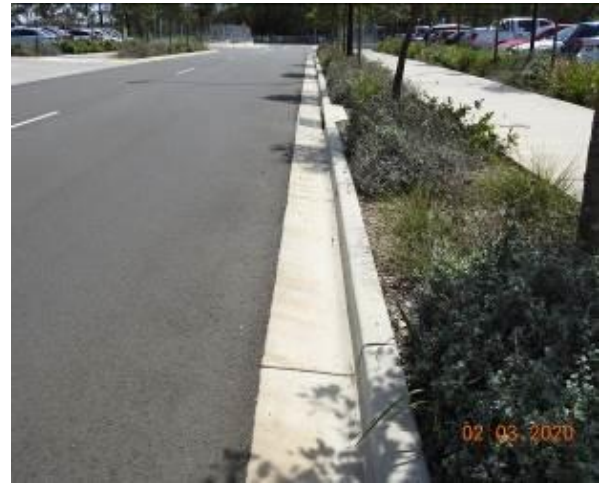
Figure 27 – Crack propagation through kerb and gutter

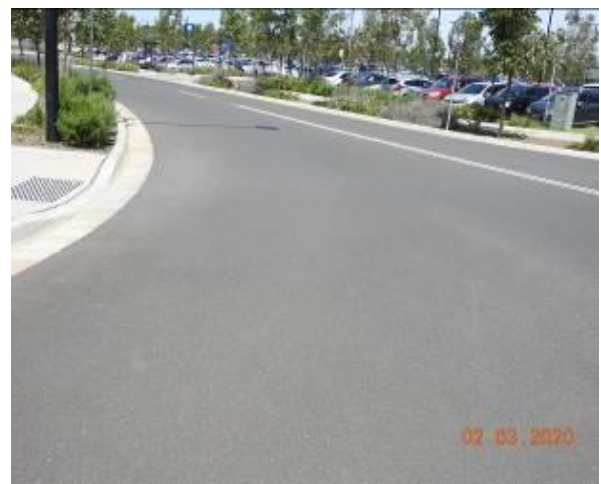
Figure 65 – General Condition of road surface

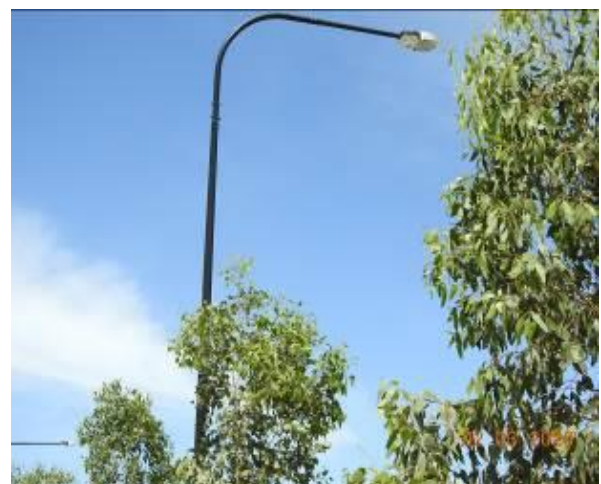
Figure 77 – General Condition of lamp post  
Identification No.922702

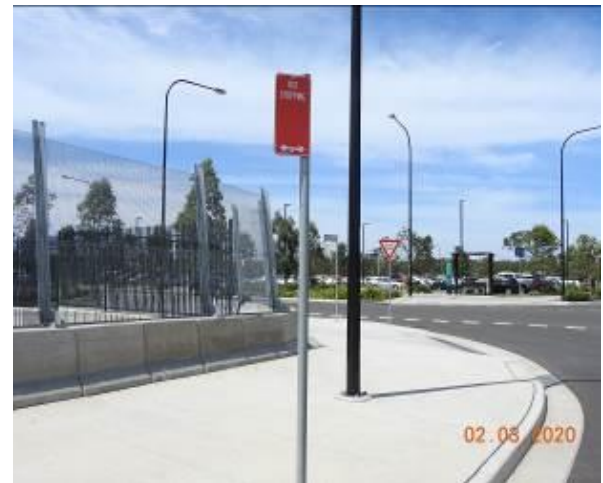
Figure 81 – General Condition of street sign

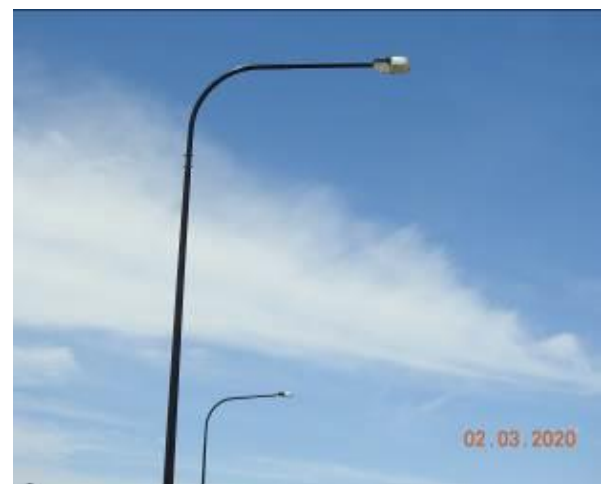
Figure 83 – General Condition of lamp post  
Identification No.922668

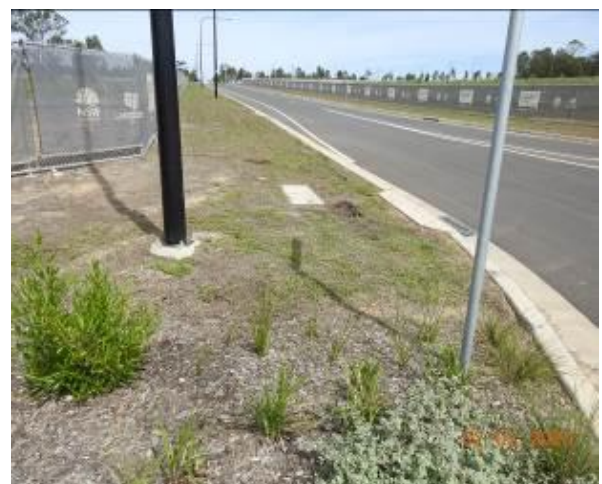
Figure 89 – General Condition of footpath pavement

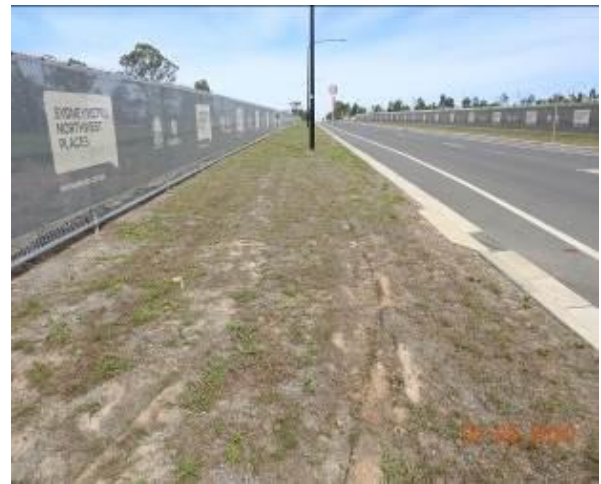
Figure 93 – General Condition of grass area

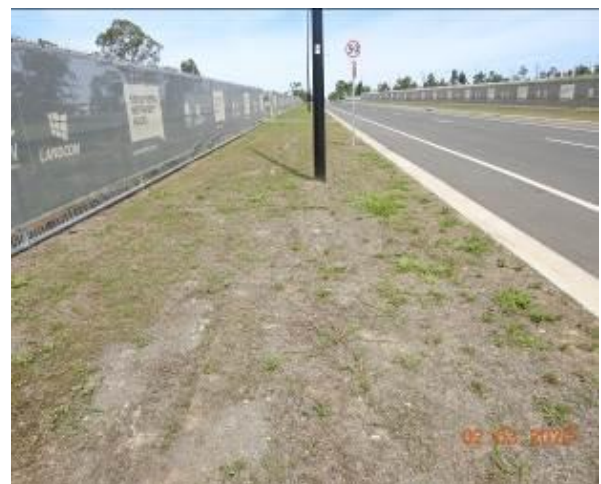
Figure 95 – General Condition of grass area

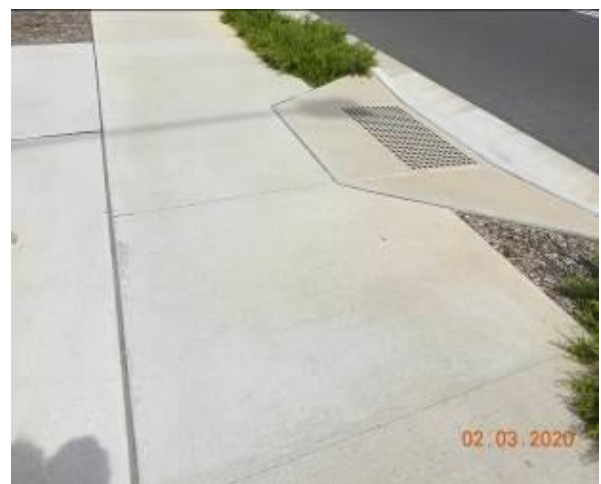
Figure 149 – General Condition of footpath pavement

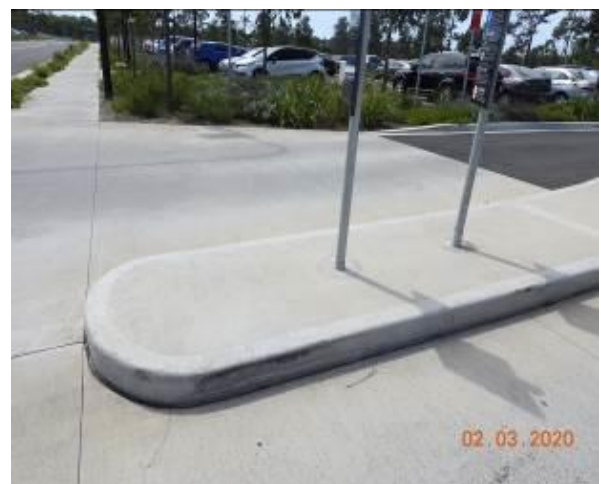
Figure 203 – General Condition of driveway pavement

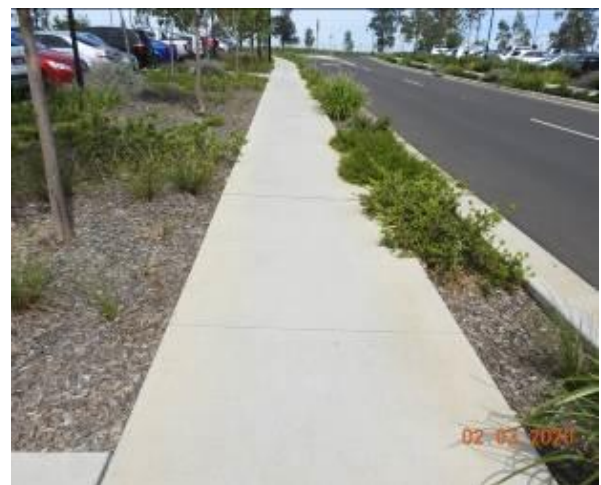
Figure 213 – General Condition of footpath pavement

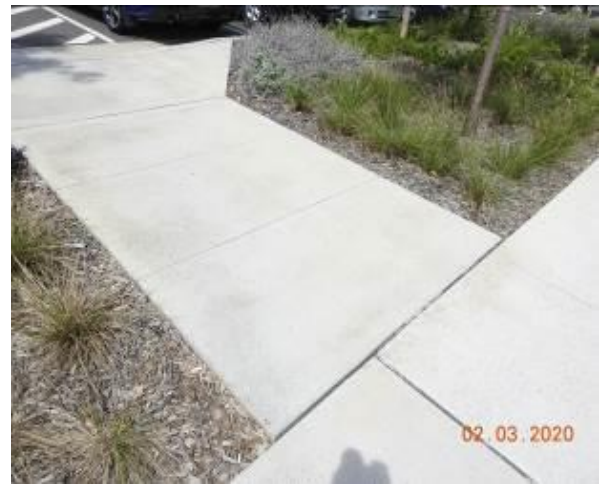
Figure 219 – General Condition of footpath pavement

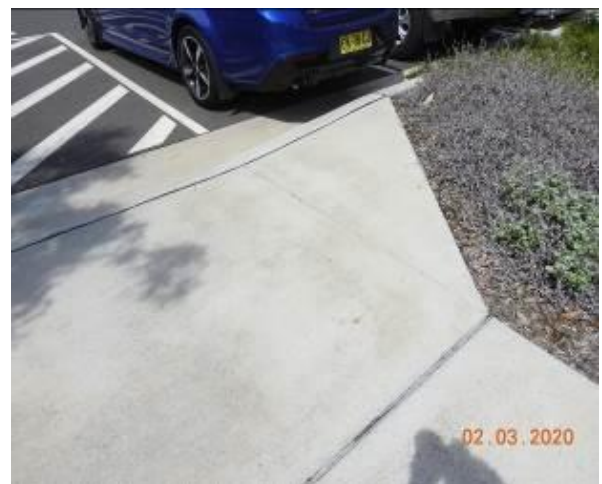
Figure 221 – General Condition of footpath pavement

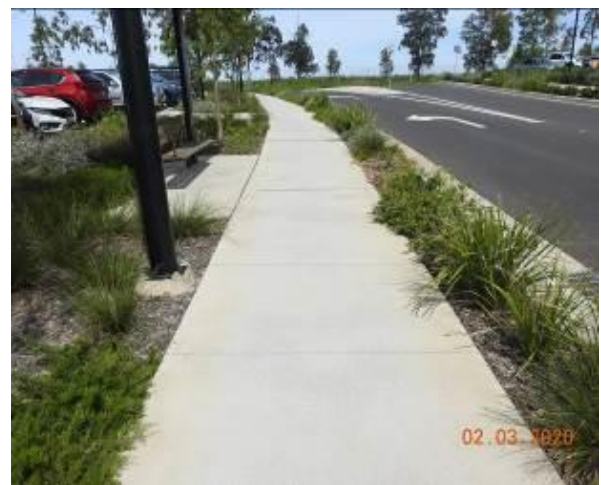
Figure 225 – General Condition of footpath pavement

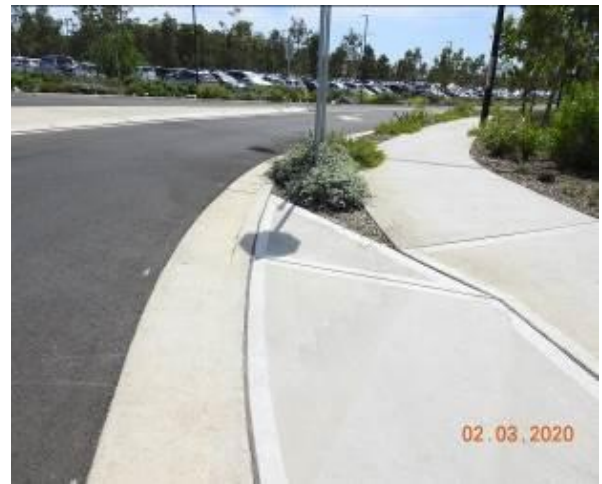
Figure 249 – General Condition of footpath pavement

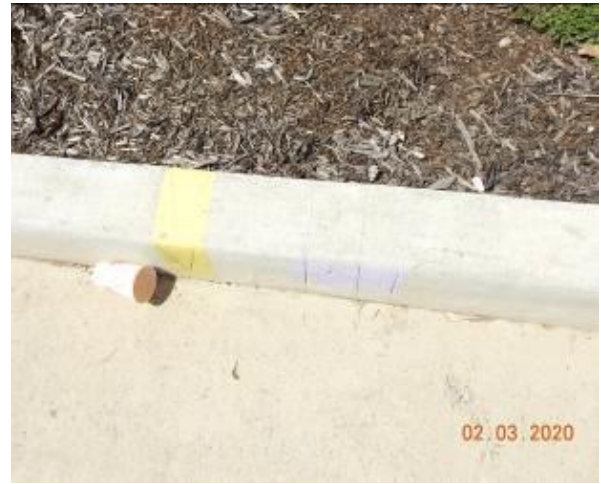
Figure 255 – General Condition of kerb and gutter

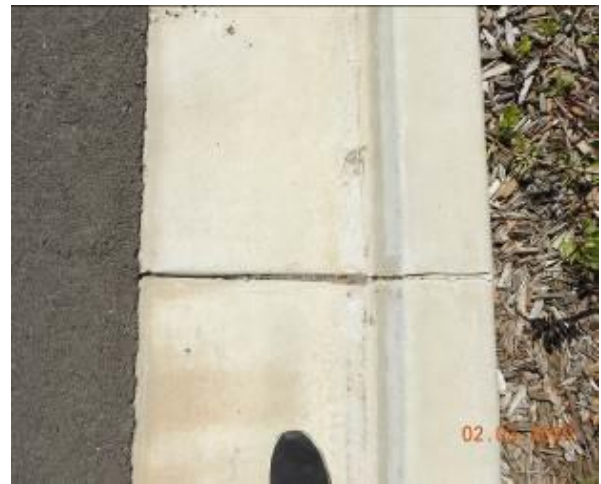
Figure 327 – General Condition of kerb and gutter

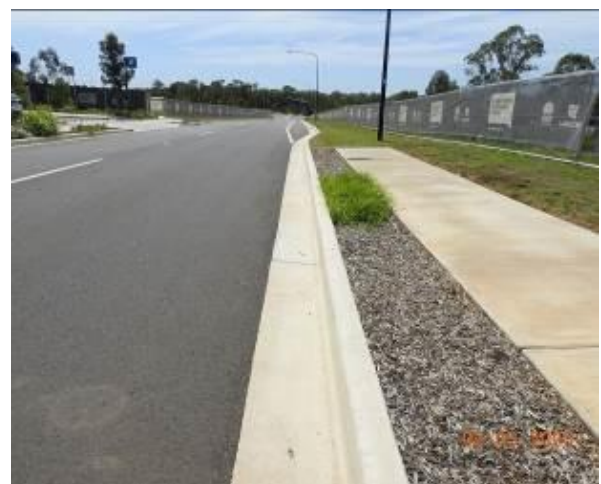
Figure 359 – Crack propagation through kerb and gutter

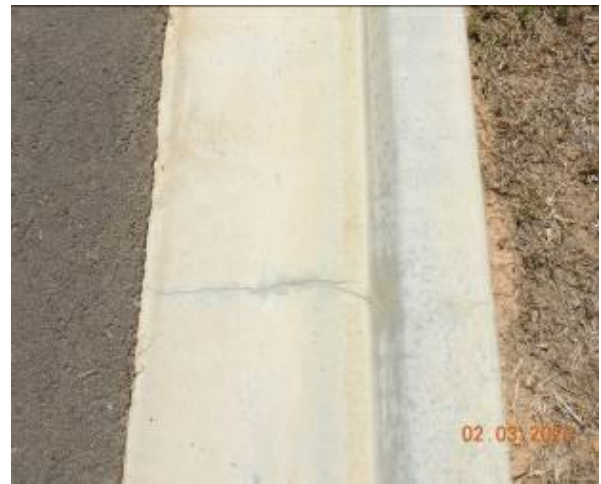
Figure 393 – General Condition of kerb and gutter

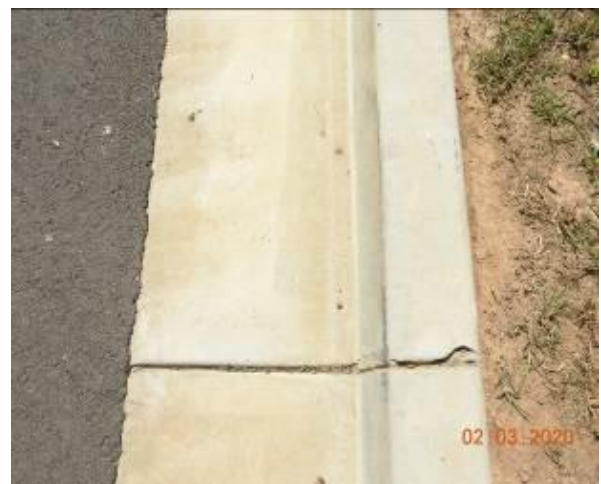
Figure 407 – General Condition of kerb and gutter

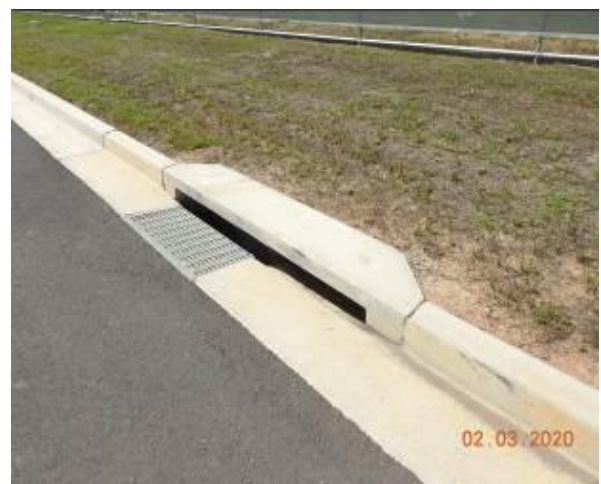
Figure 413 – Crack propagation through kerb and gutter

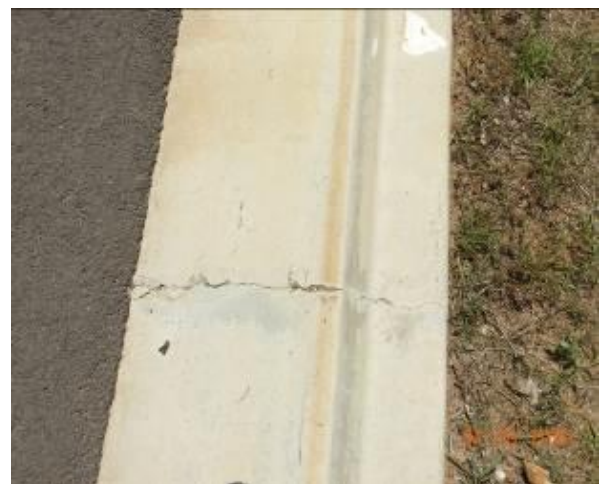
Figure 419 – General Condition of kerb and gutter

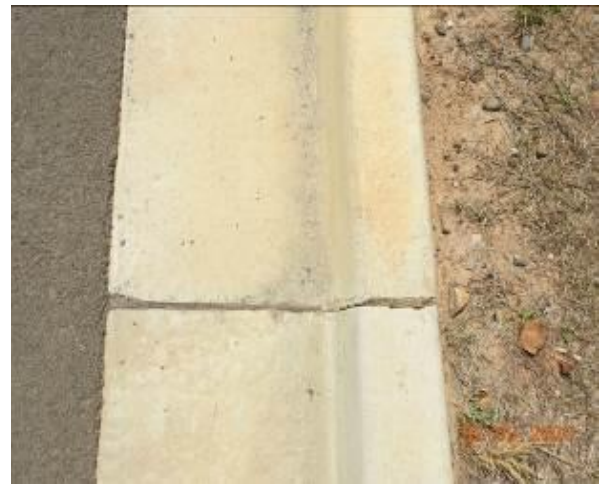
Figure 471 – General Condition of kerb and gutter

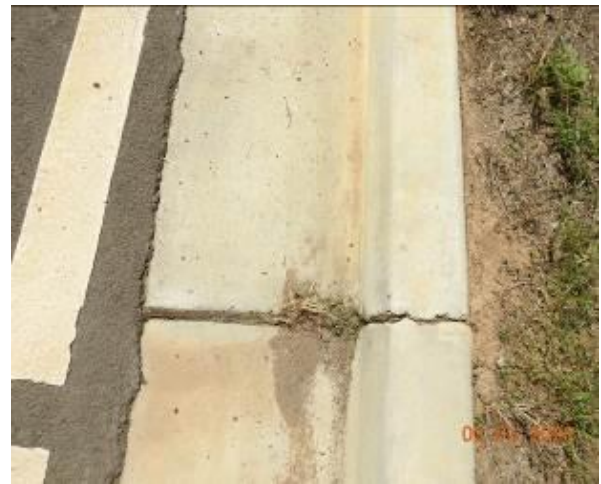
Figure 483 – General Condition of kerb and gutter

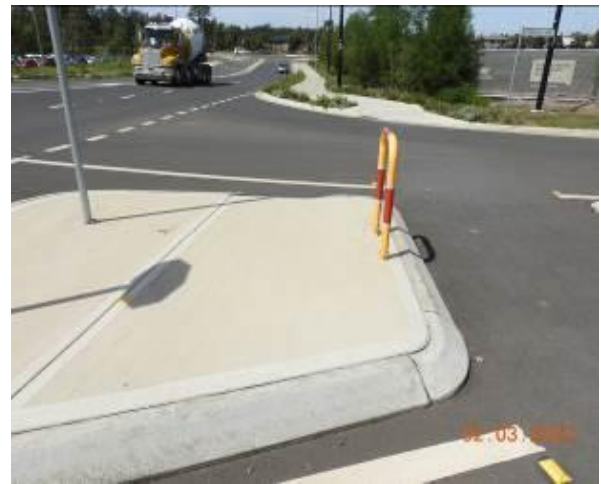
Figure 507 – General Condition of traffic island

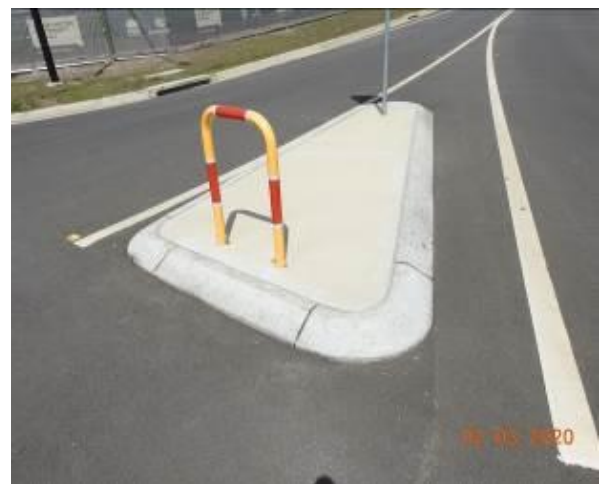
Figure 509 – General Condition of traffic island

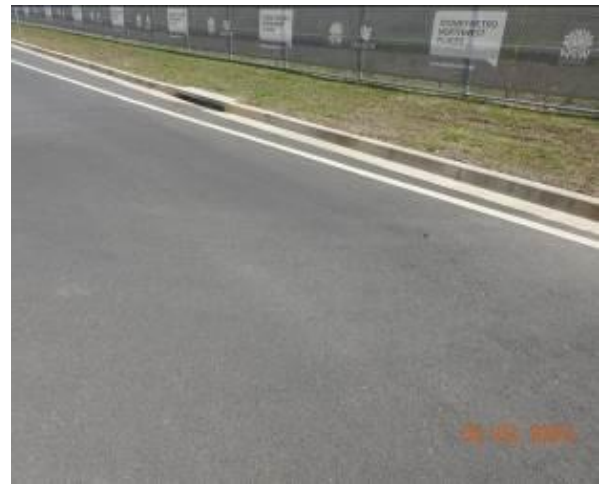
Figure 525 – General Condition of road surface

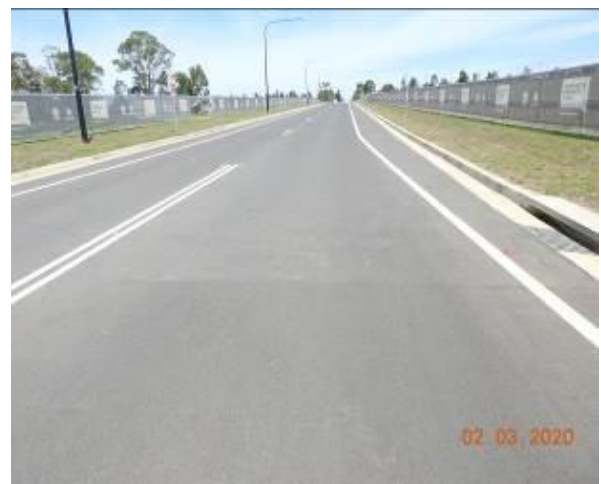
Figure 527 – Loss of material through road surface

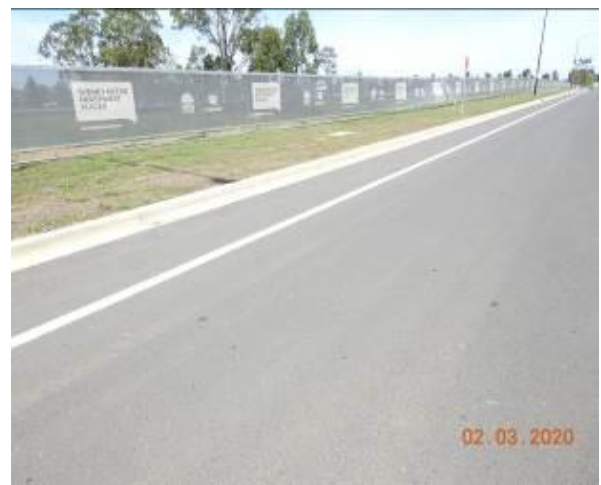
Figure 555 – General Condition of road surface

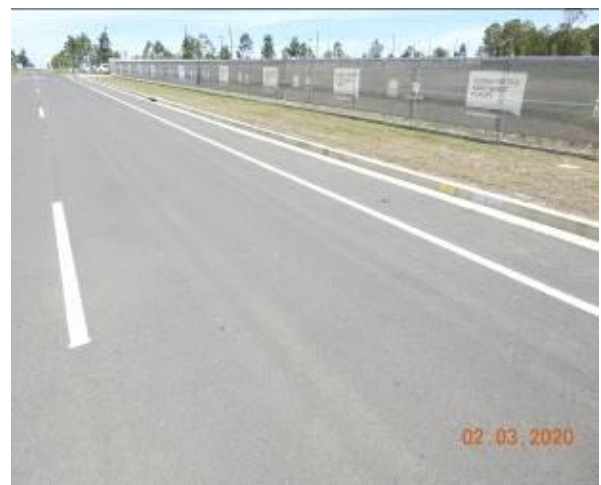
Figure 567 – General Condition of road surface

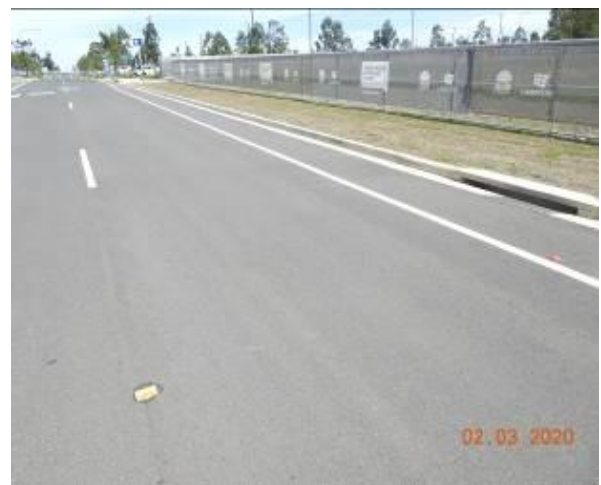
Figure 579 – General Condition of road surface

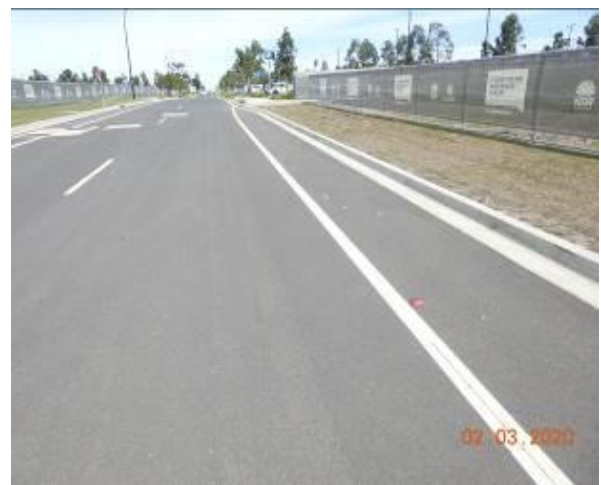
Figure 585 – Loss of material through road surface

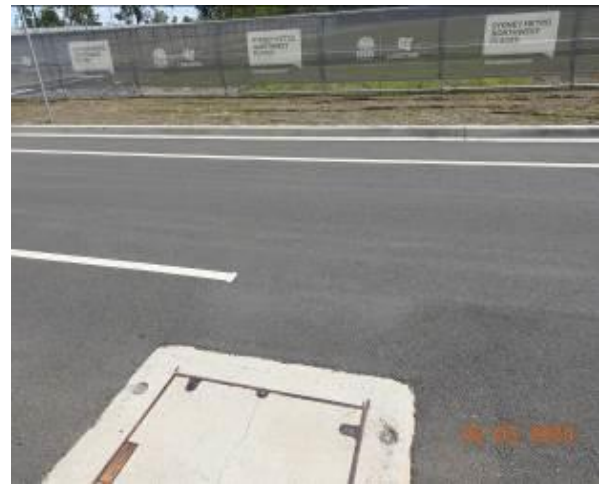
Figure 603 – Loss of material through service pit

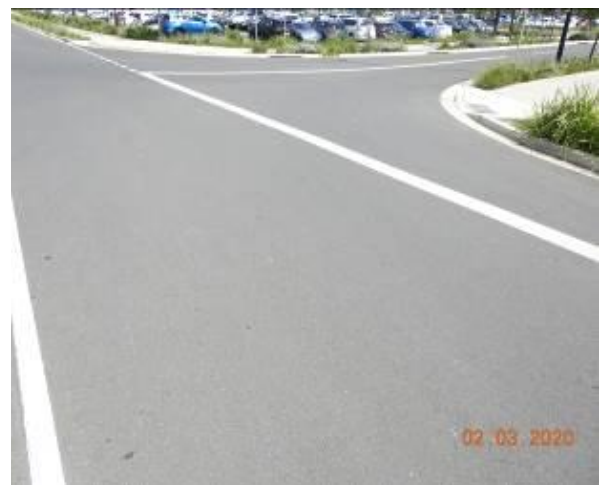
Figure 645 – General Condition of road surface

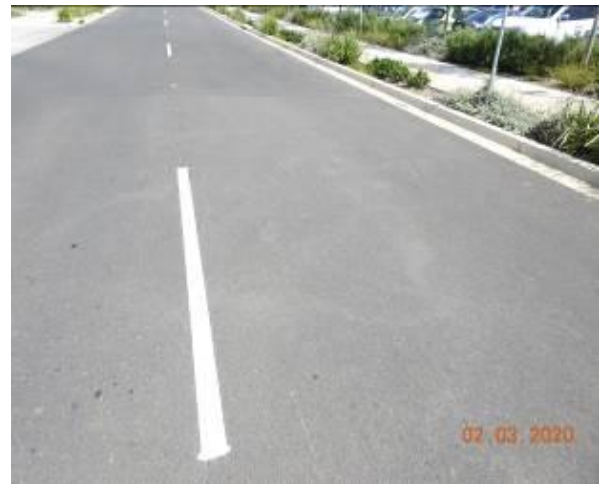
Figure 675 – General Condition of road surface

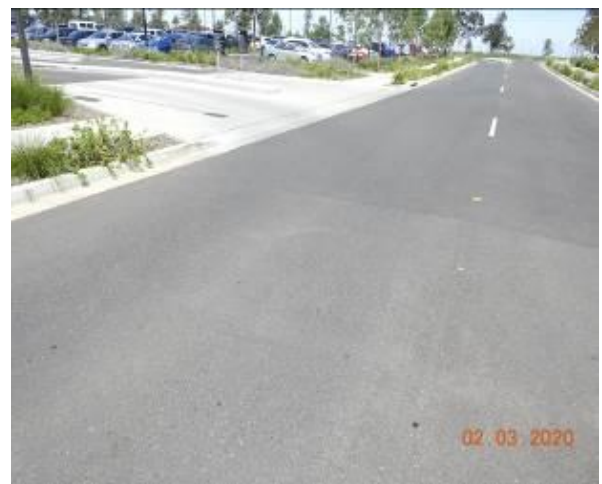
Figure 677 – General Condition of road surface

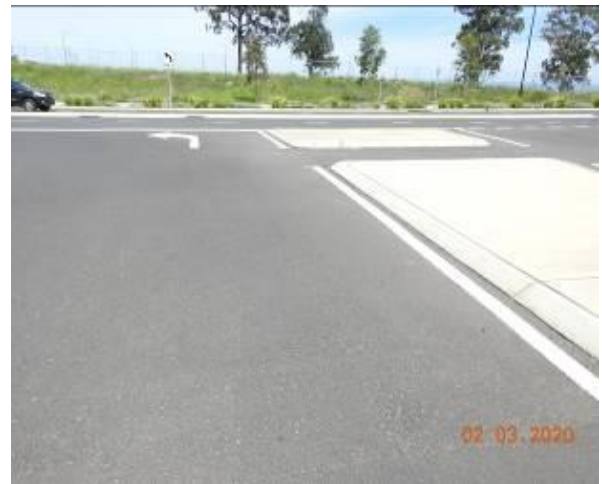
Figure 717 – General Condition of road surface

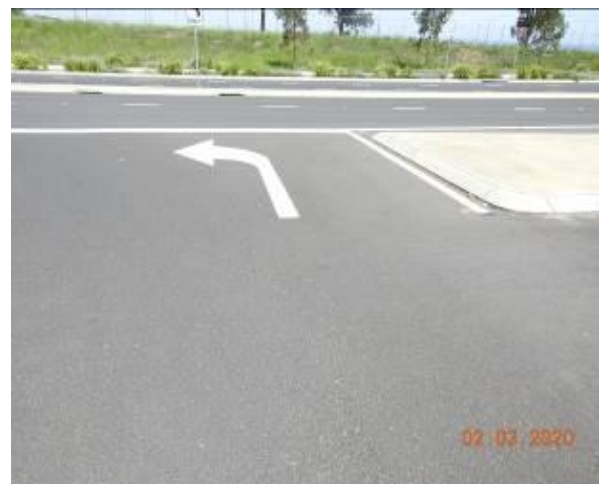
Figure 719 – General Condition of road surface

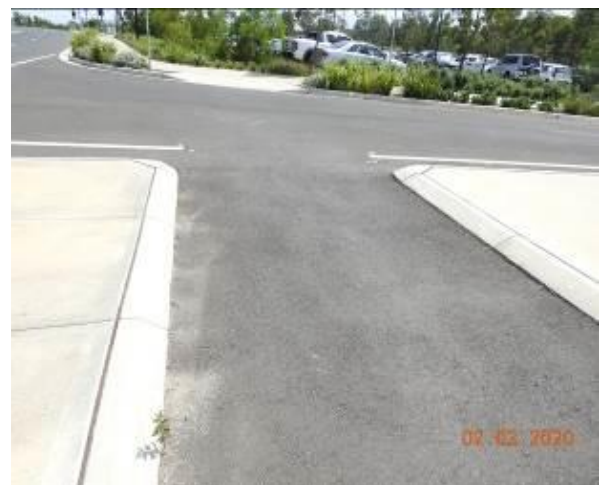
Figure 723 – General Condition of road surface

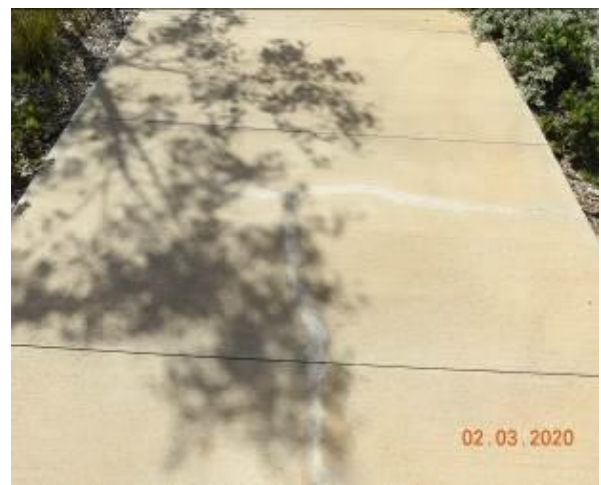
Figure 795 – Crack propagation through footpath pavement

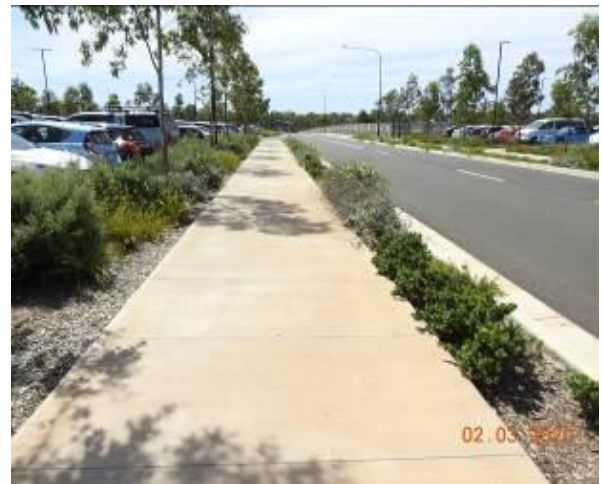
Figure 813 – General Condition of footpath pavement

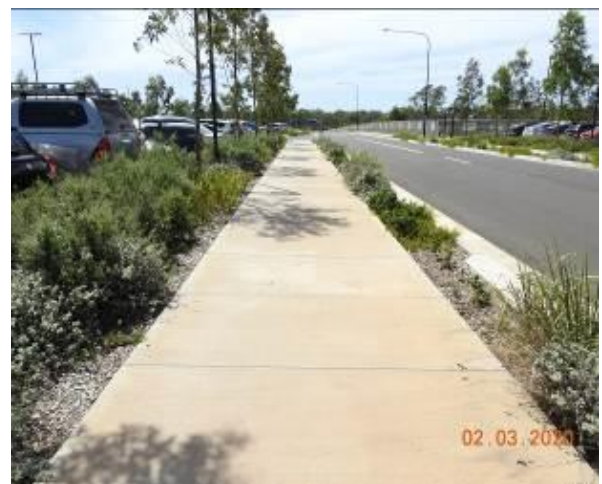
Figure 815 – General Condition of footpath pavement

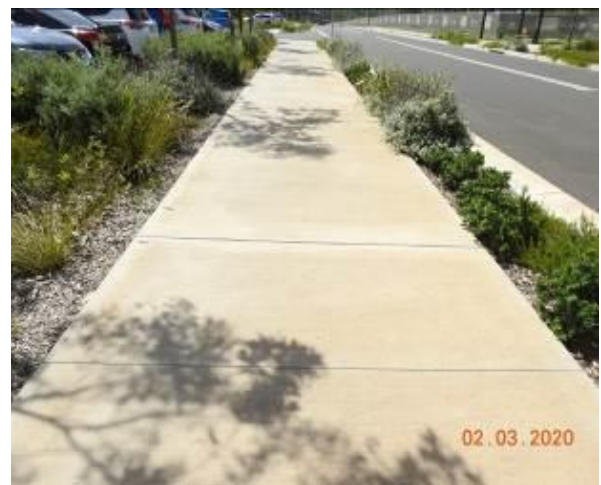
Figure 819 – General Condition of footpath pavement

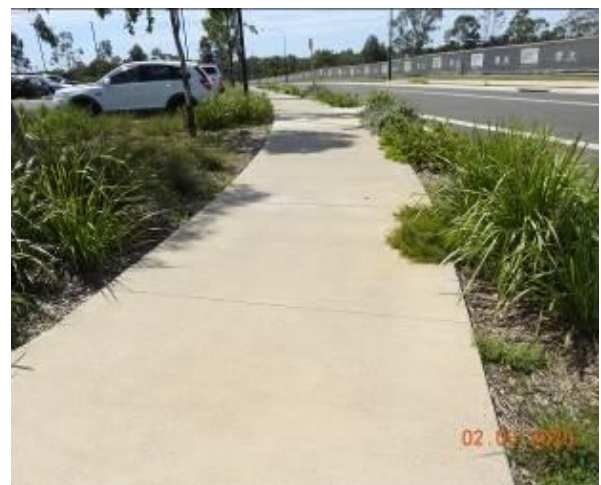
Figure 855 – Crack propagation through footpath pavement

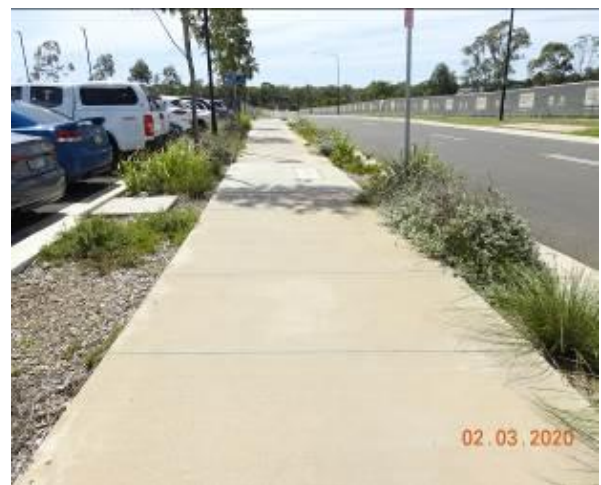
Figure 861 – General Condition of footpath pavement

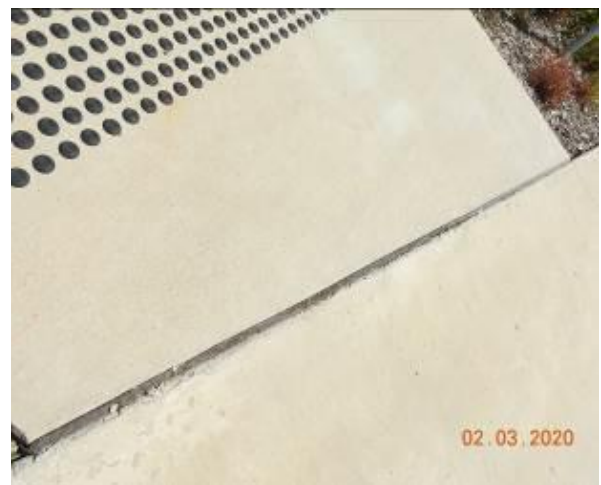
Figure 873 – Crack propagation through driveway ramp

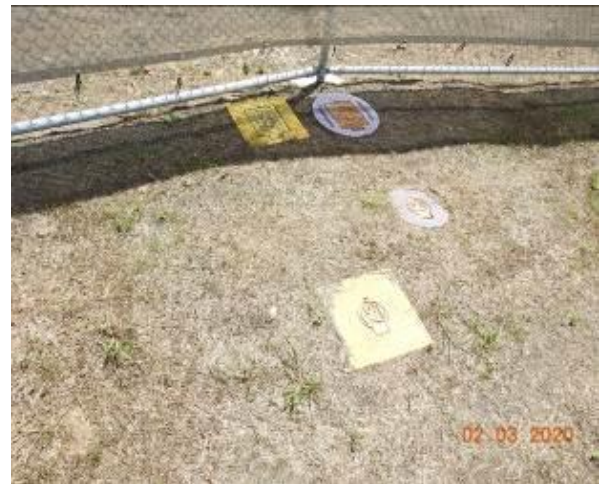
Figure 897 – General Condition of nature strip

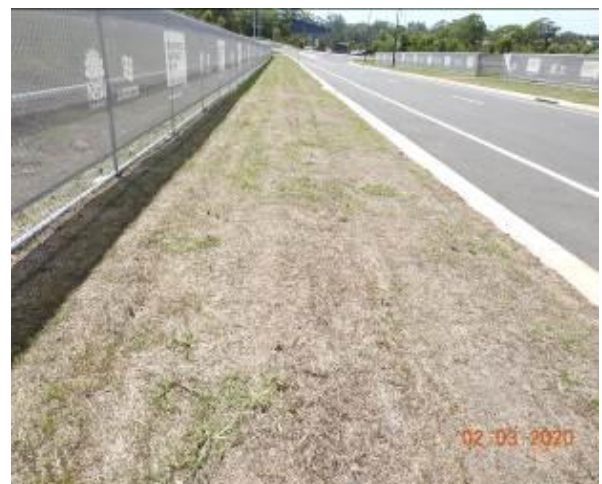
Figure 899 – General Condition of nature strip

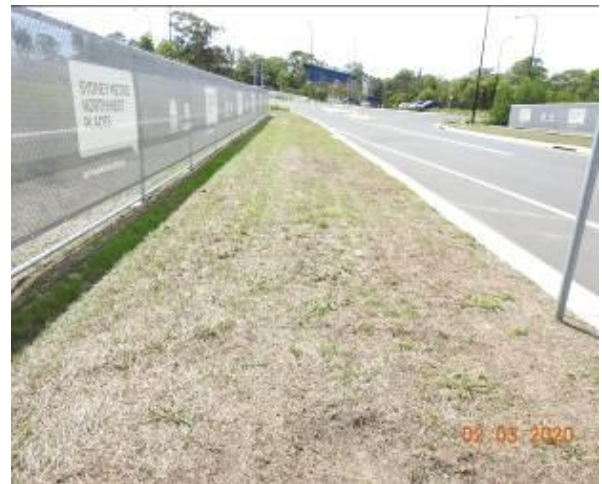
Figure 909 – General Condition of nature strip

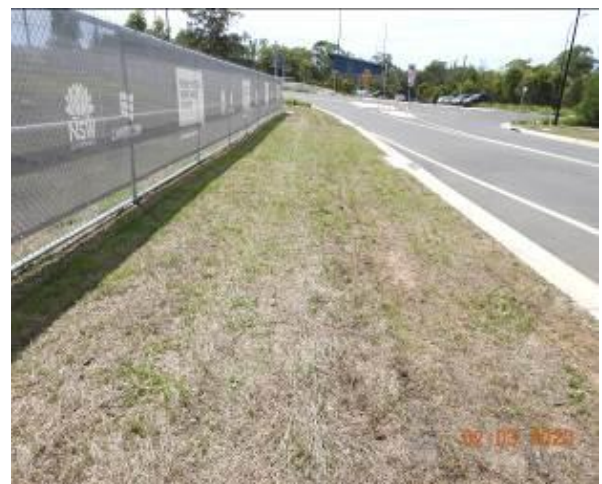
Figure 911 – General Condition of nature strip

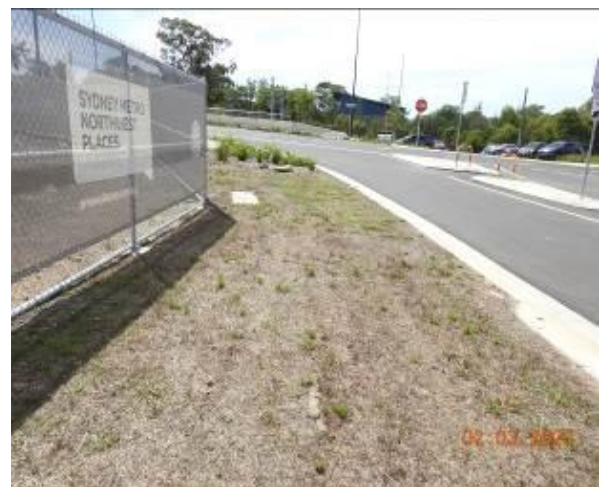
Figure 915 – General Condition of nature strip

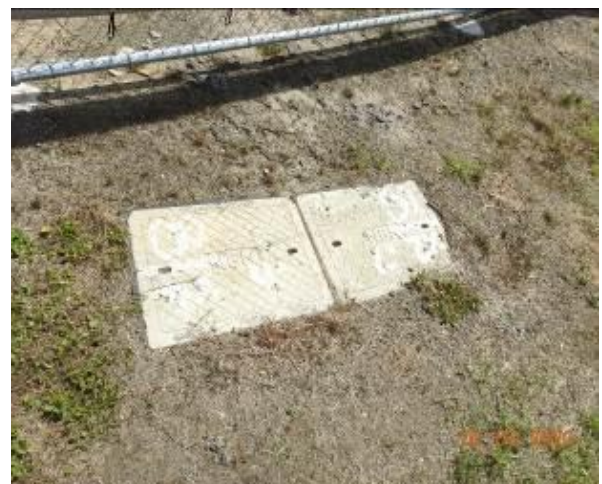
Figure 917 – General Condition of nature strip

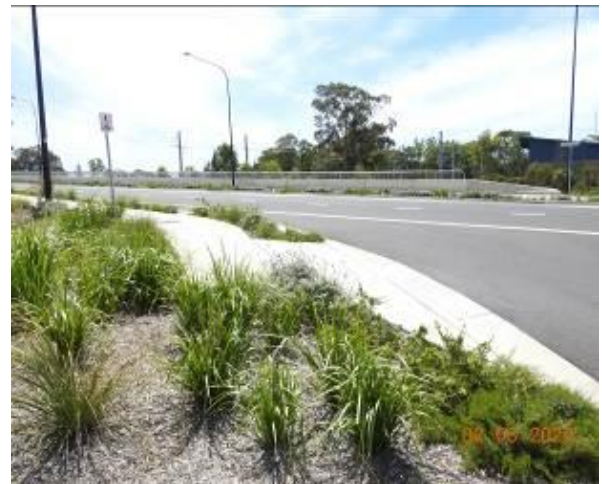
Figure 921 – General Condition of nature strip

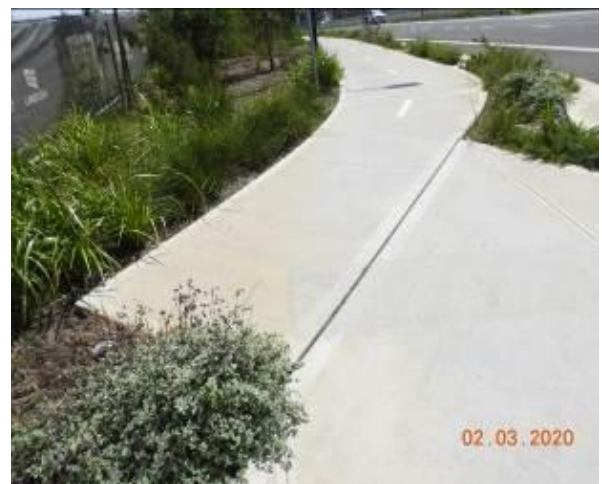
Figure 923 – General Condition of footpath pavement

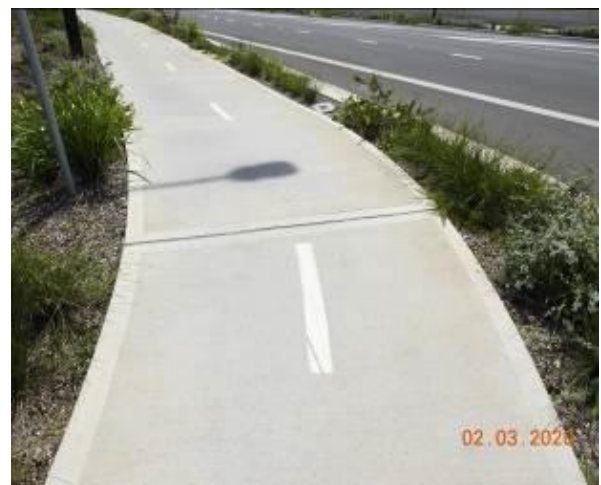
Figure 927 – General Condition of footpath pavement

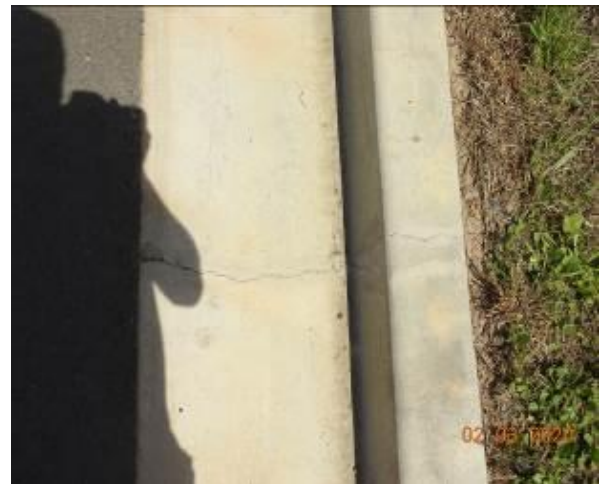
Figure 963 – General Condition of kerb and gutter

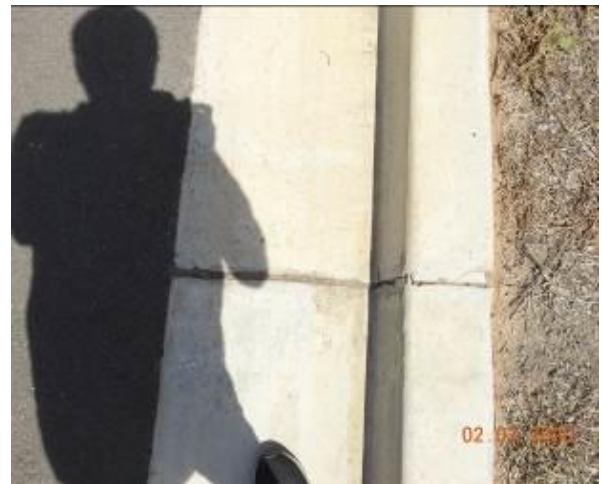
Figure 969 – General Condition of kerb and gutter

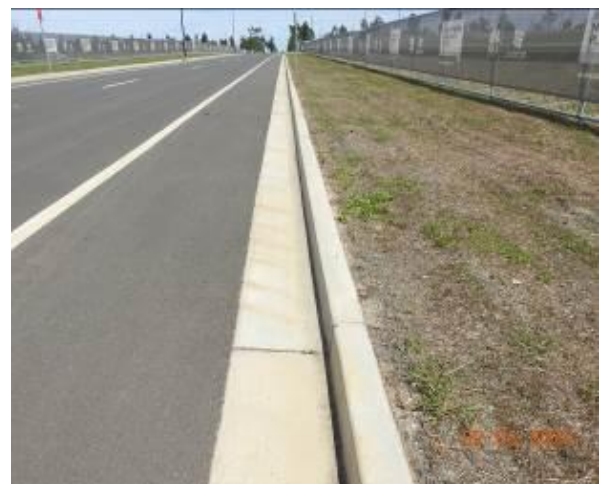
Figure 971 – General Condition of stormwater inlet pit

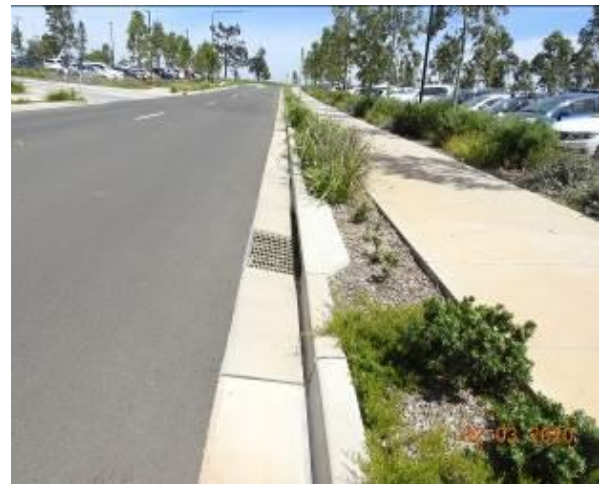
Figure 1077 – General Condition of kerb and gutter

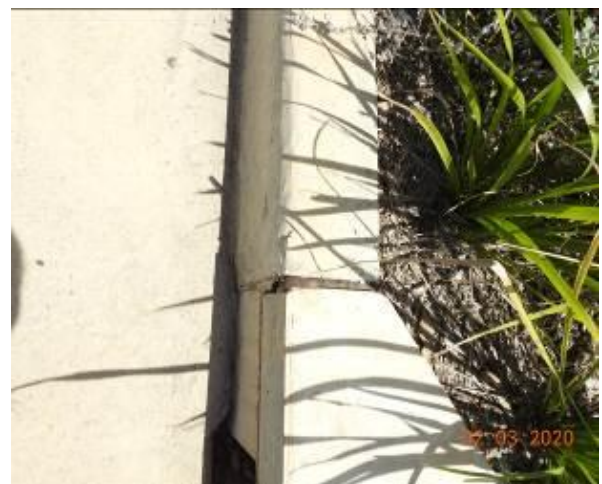
Figure 1079 – General Condition of stormwater inlet pit

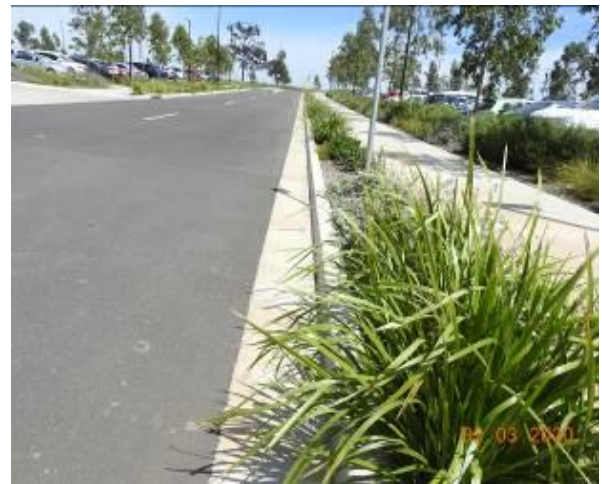
Figure 1083 – General Condition of kerb and gutter

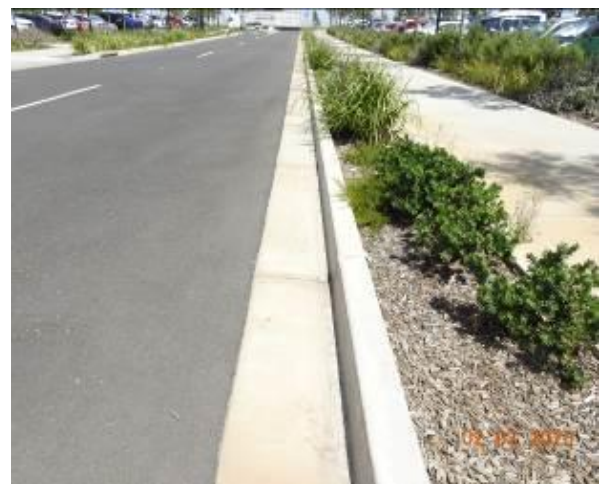
Figure 1085 – General Condition of kerb and gutter

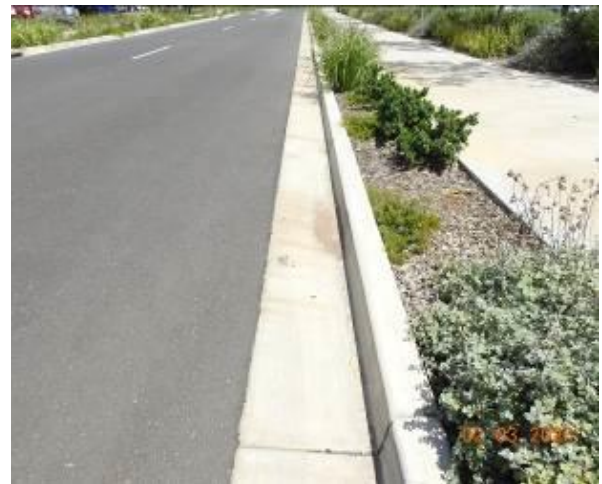
Figure 1089 – General Condition of kerb and gutter

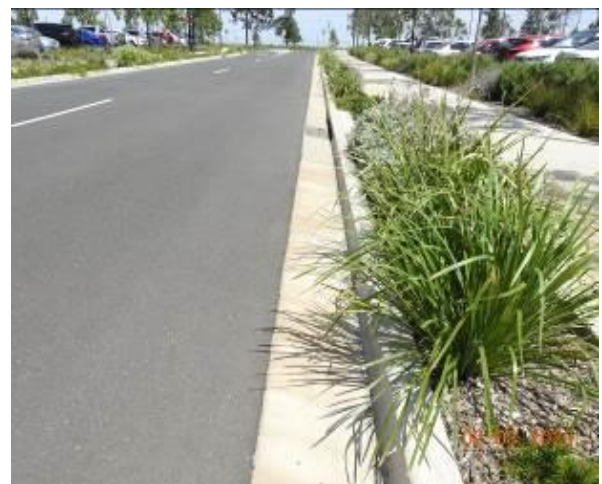
Figure 1091 – General Condition of kerb and gutter

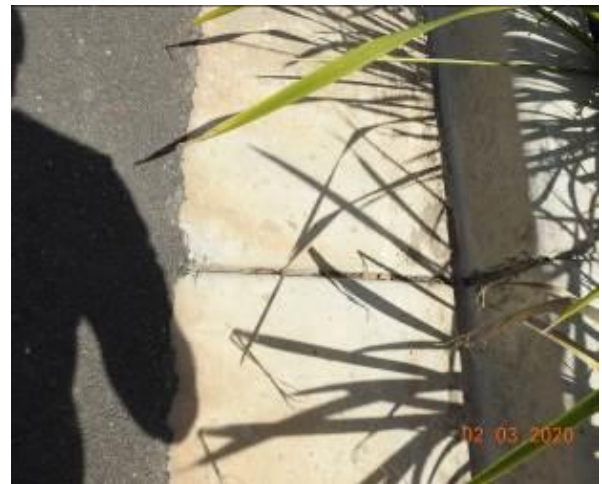
Figure 1107 – General Condition of kerb and gutter

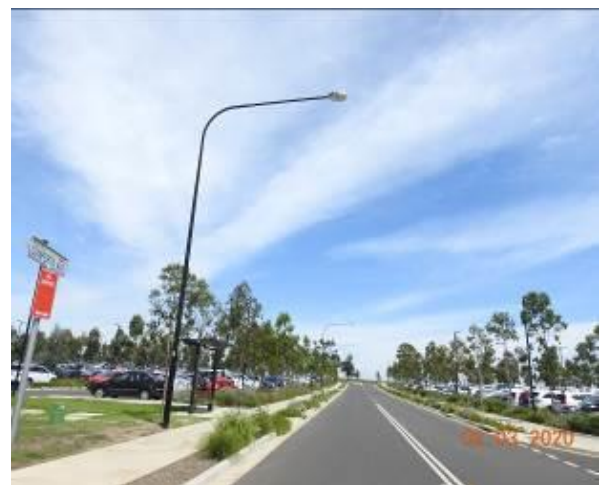
Figure 1155 – General Condition of lamp post  
Identification N.922704

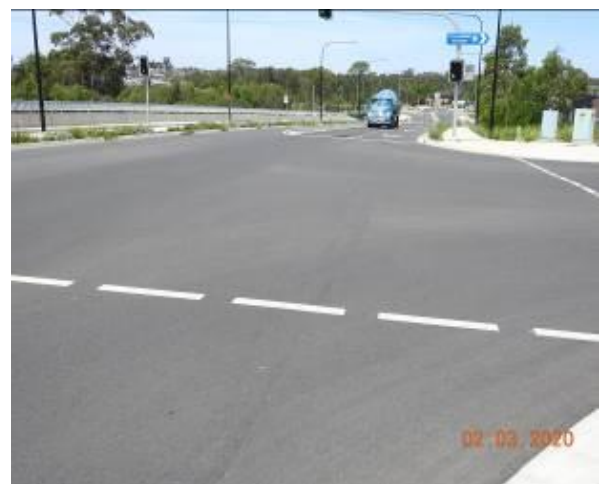
Figure 1282 – General Condition of road surface

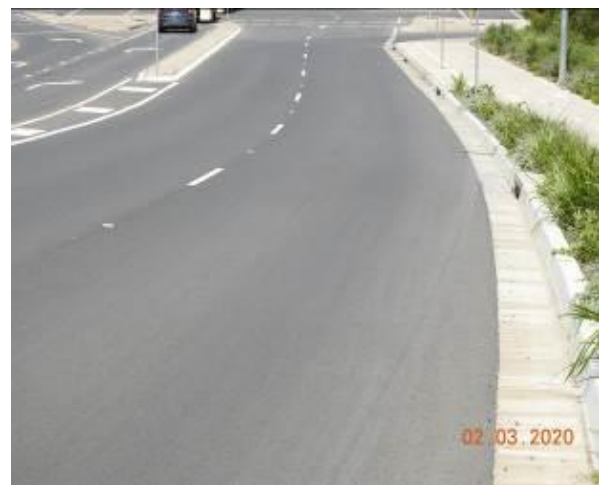
Figure 1292 – General Condition of road surface

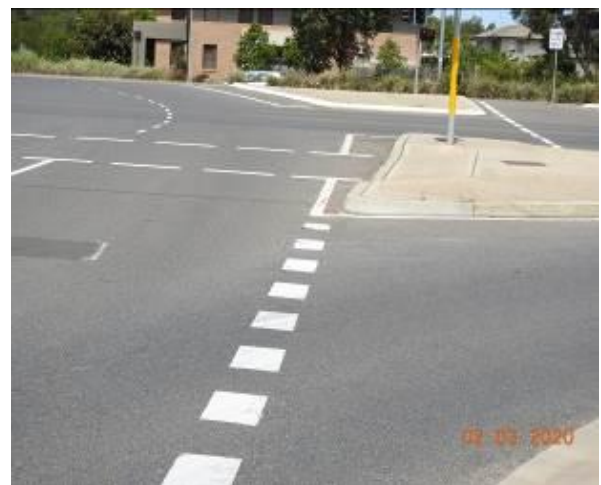
Figure 1298 – General Condition of road surface
