The property Tallawong station – P2 Car Park, is the neighbouring property to our client’s site. It was photographed and inspected prior to any construction works on the subject site and was found to be in a reasonable condition. The property serves as a car park.

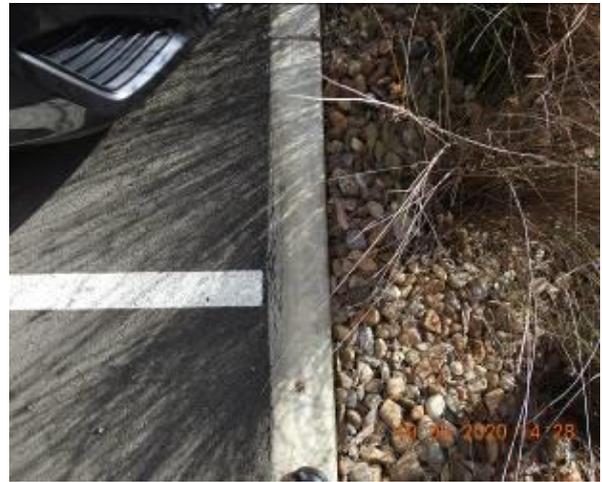
Figure 1205 – Crack propagation and loss of material through car park kerb

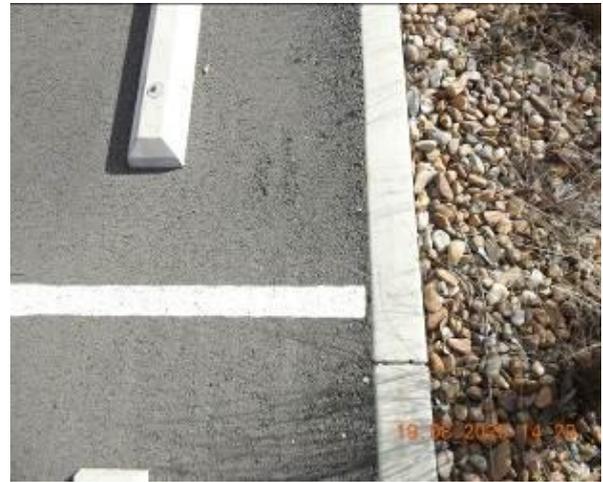
Figure 1229 – Crack propagation through car park kerb

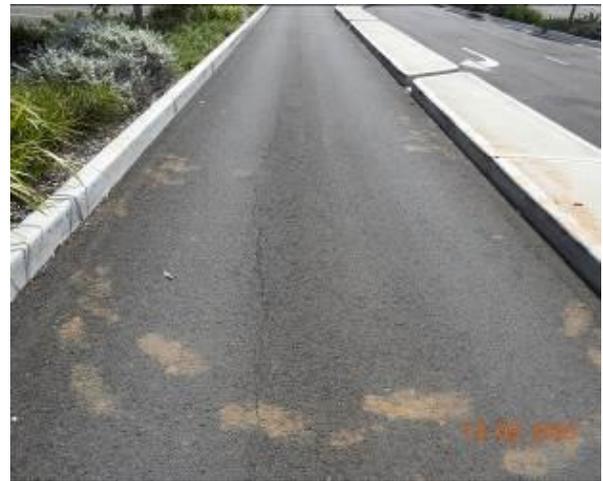
Figure 1415 – Crack propagation through car park pavement

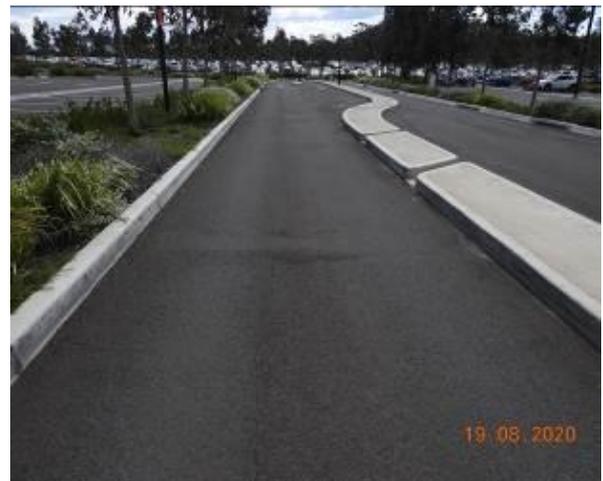
Figure 1417 – Crack propagation through car park pavement

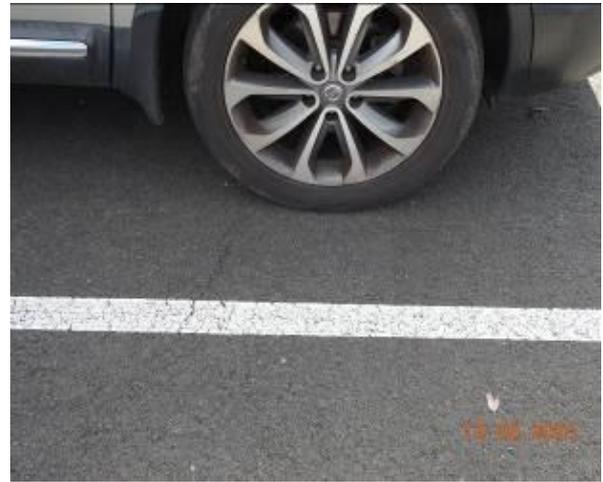
Figure 1523 – Evidence of patchwork through car park pavement

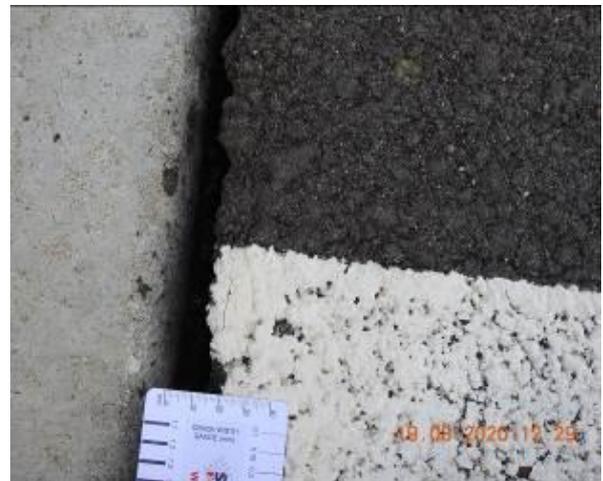
Figure 1865 – Crack propagation through car park kerb

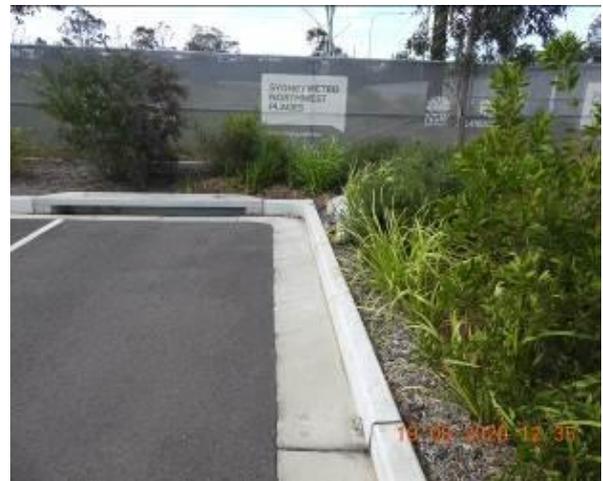
Figure 1913 – General condition of service pit and crack propagation through car park gutter

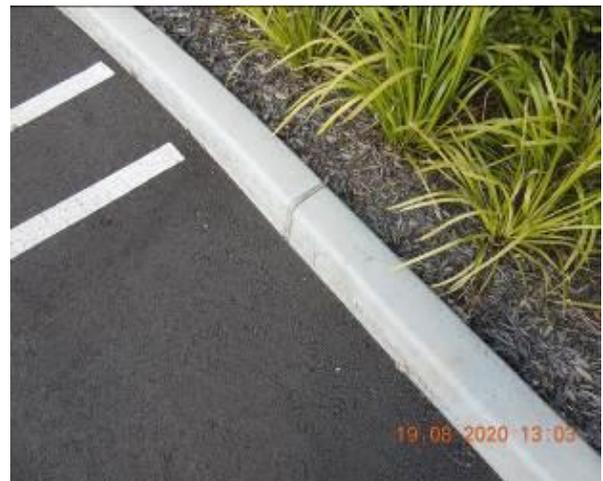
Figure 2227 – Crack propagation through car park kerb

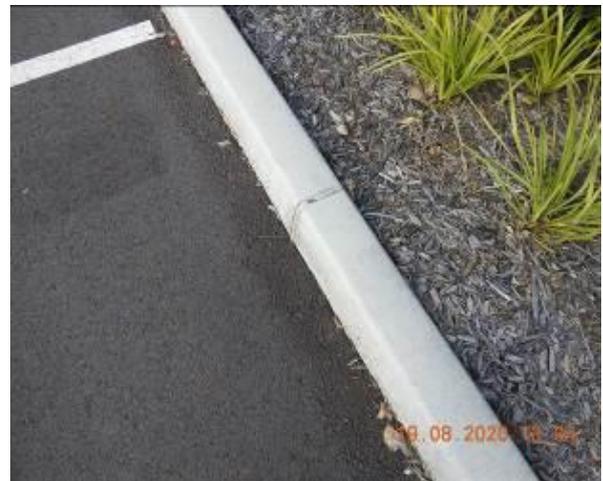
Figure 2243 – Crack propagation through car park kerb

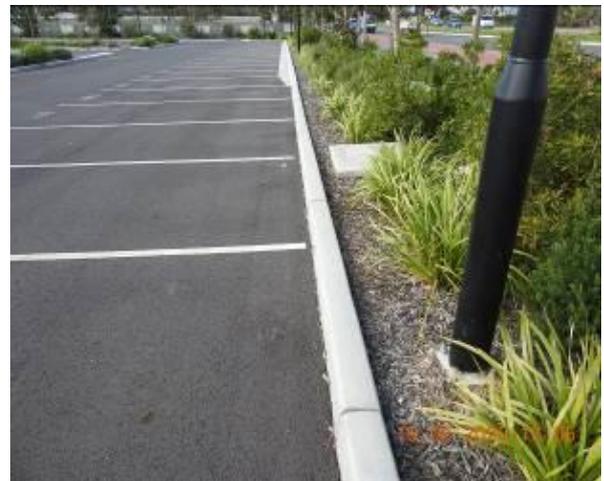
Figure 2255 – Crack propagation through car park kerb

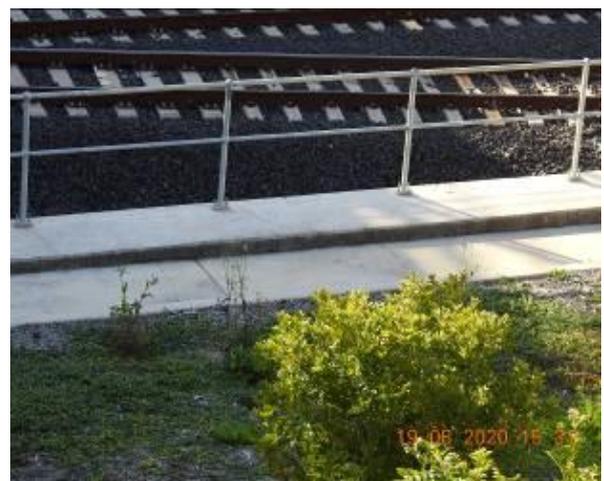
Figure 2380 – Crack propagation through RailCorp retaining wall
