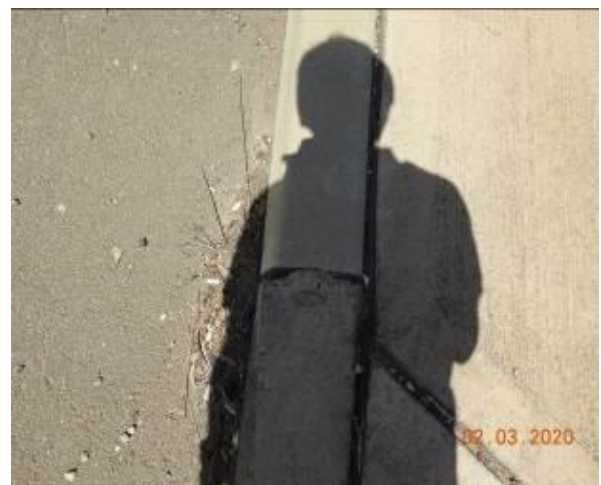
Figure 1536 – General Condition of kerb

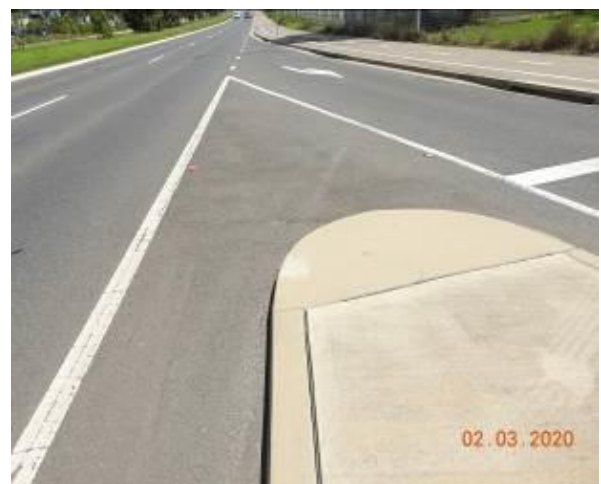
Figure 1544 – General Condition of kerb

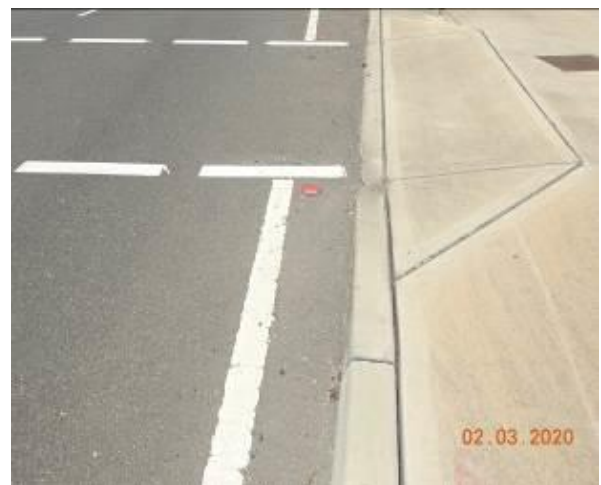
Figure 1554 – General Condition of kerb

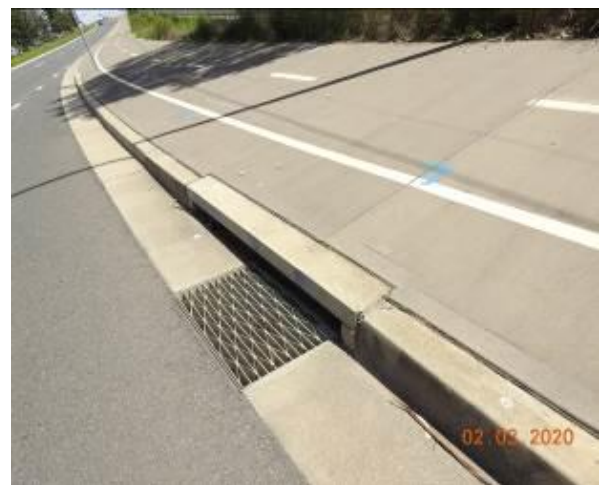
Figure 1572 – General Condition of kerb and gutter

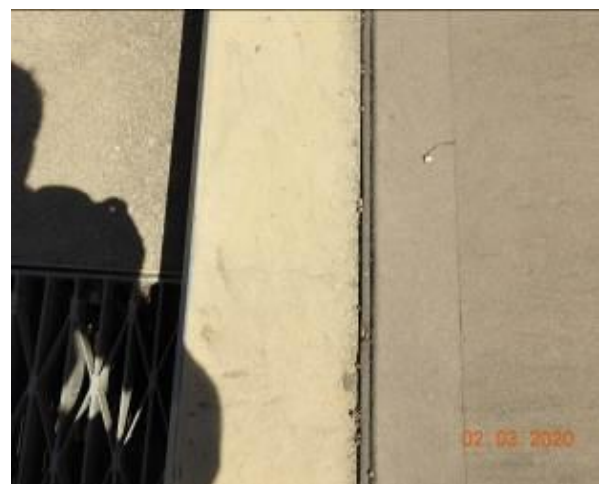
Figure 1574 – Loss of material through stormwater inlet pit

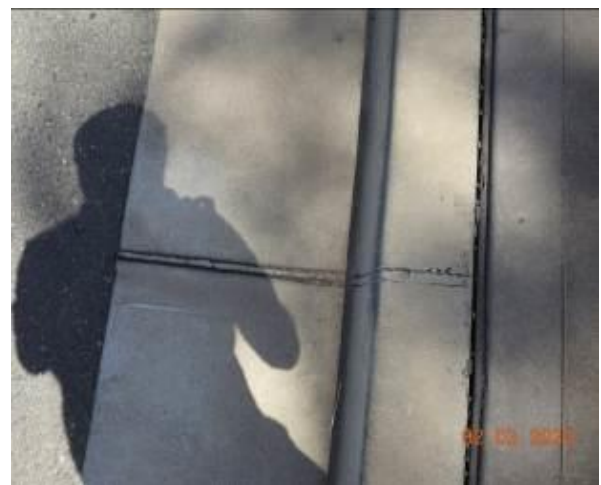
Figure 1578 – General Condition of kerb and gutter

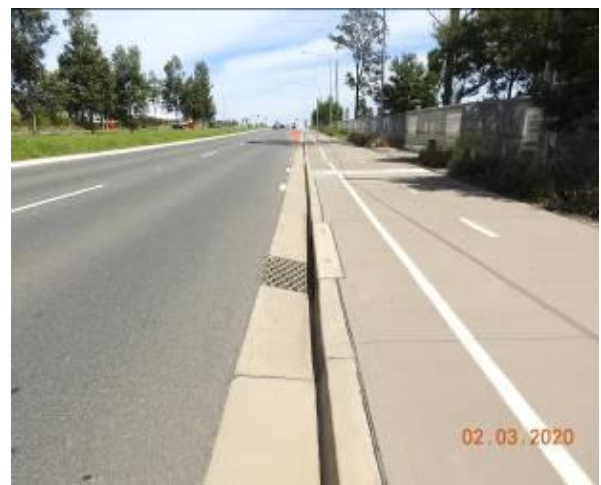
Figure 1626 – Crack propagation through kerb

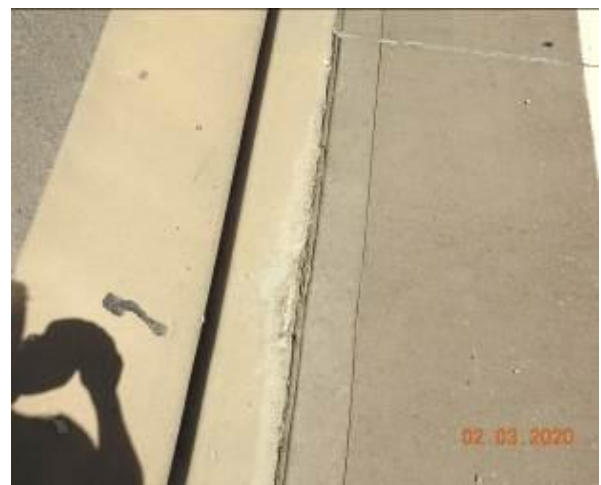
Figure 1638 – Crack propagation through kerb

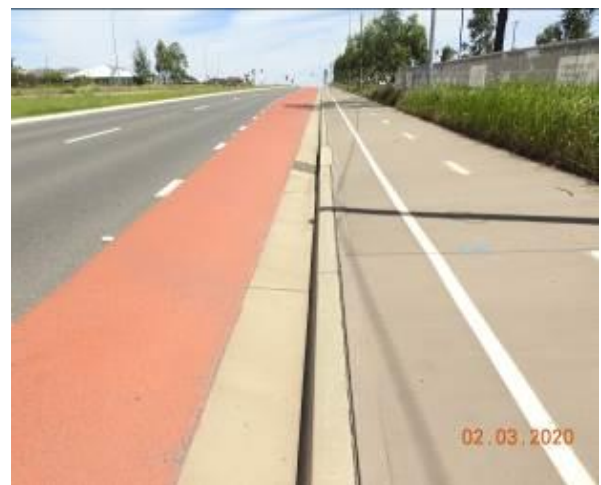
Figure 1650 – Crack propagation through kerb and gutter

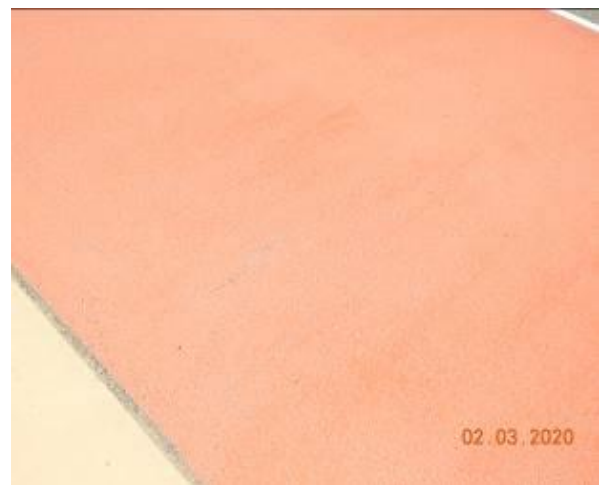
Figure 1710 – General Condition of road surface

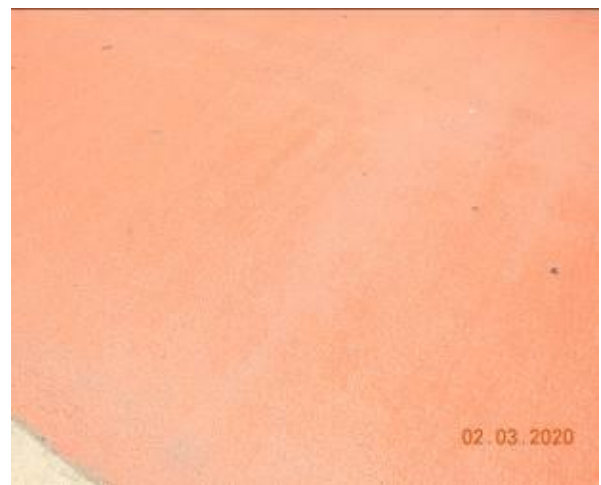
Figure 1716 – General Condition of road surface

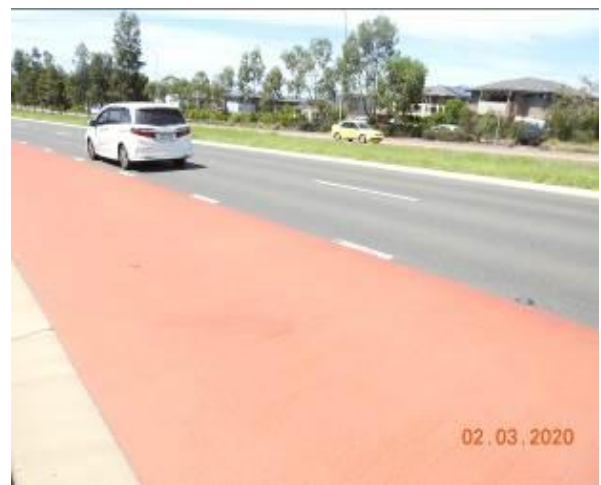
Figure 1722 – General Condition of road surface

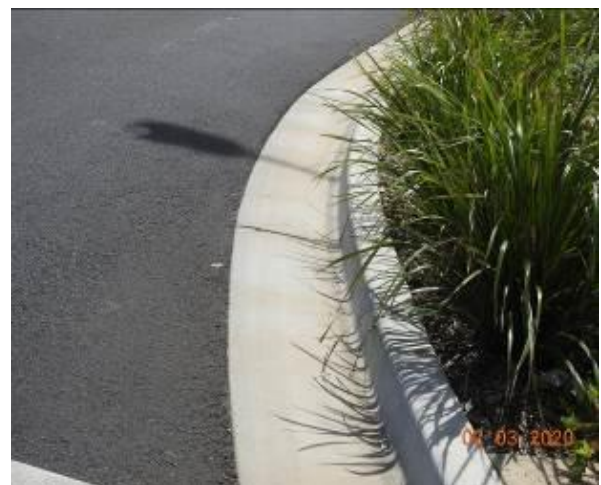
Figure 1951 – Crack propagation through kerb and gutter

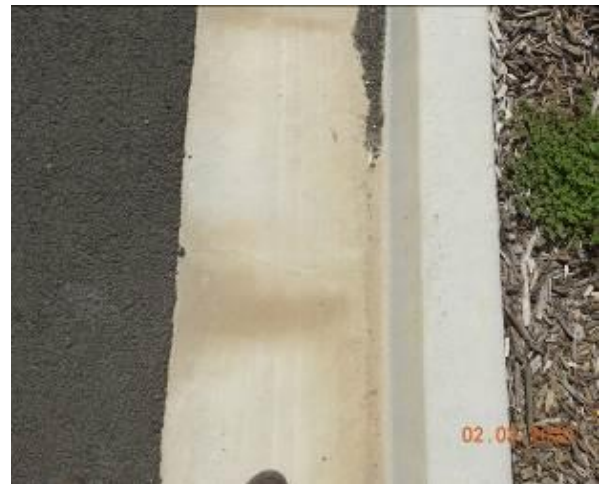
Figure 1987 – Crack propagation and loss of material through kerb

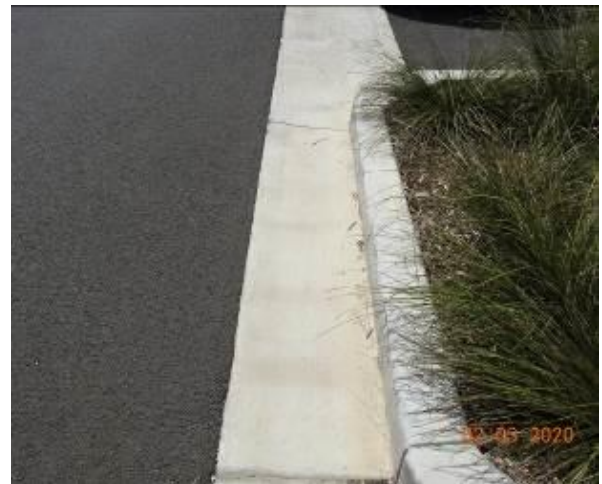
Figure 2077 – Crack propagation through kerb

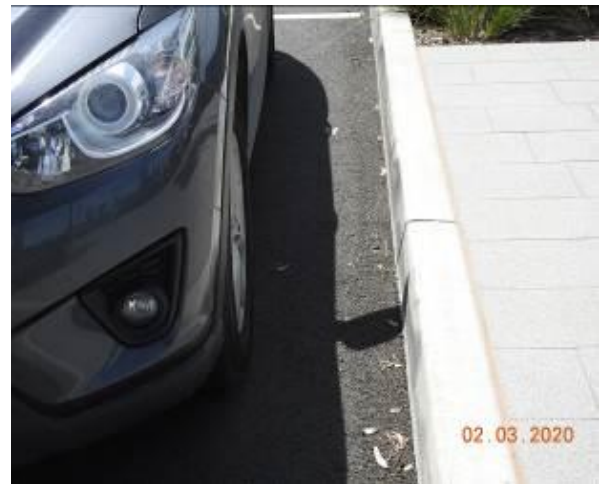
Figure 2083 – Separation through kerb

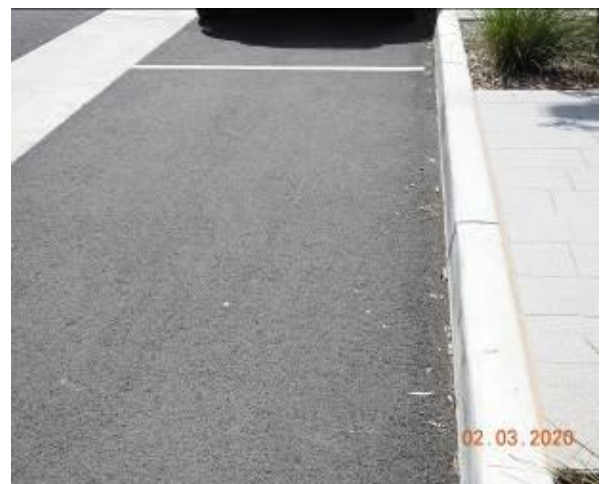
Figure 2085 – Crack propagation through kerb

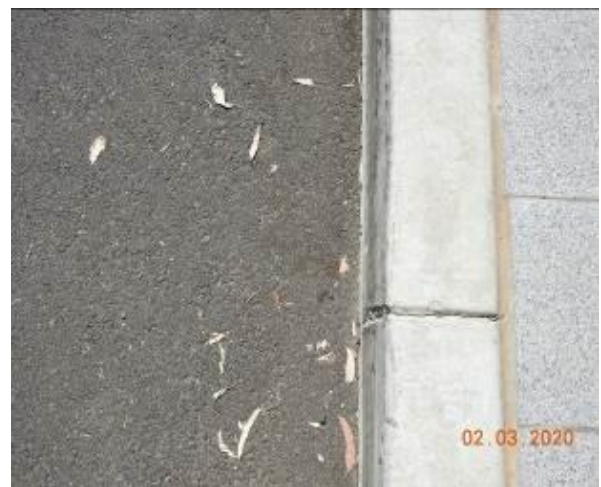
Figure 2137 – Crack propagation through kerb

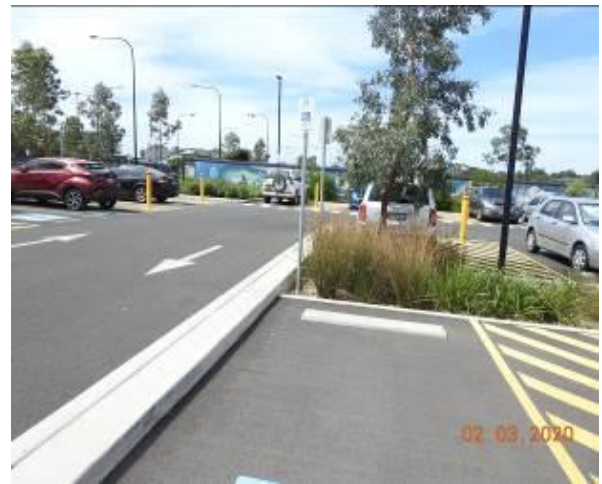
Figure 2442 – Physical damage traffic bollard

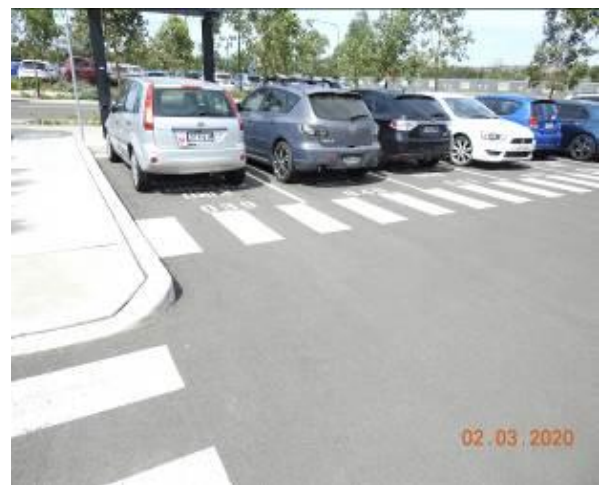
Figure 2566 – Crack propagation through carpark pavement

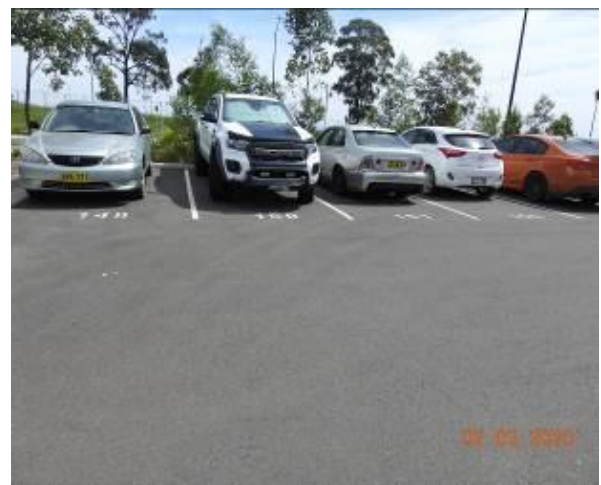
Figure 2620 – Crack propagation through carpark pavement

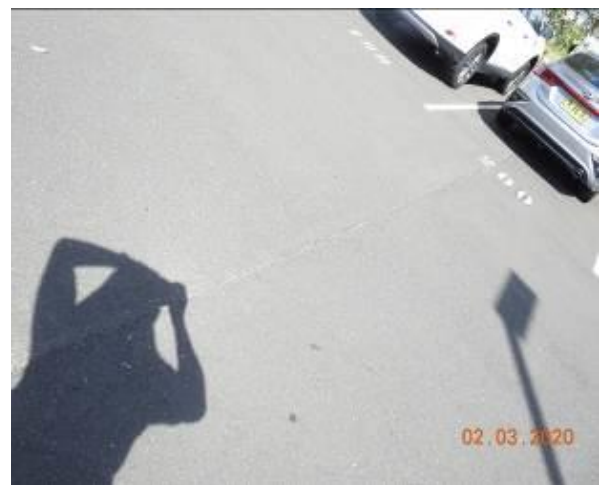
Figure 2912 – Crack propagation through carpark pavement
