Hunter Water Infrastructure – Blasting

**REVIEW OF RISKS AND ASSESSMENT OF POTENTIAL
BLAST IMPACTS FROM THE PROPOSED STONE RIDGE
QUARRY ON HUNTER WATER INFRASTRUCTURE**

Report prepared for Umwelt (Australia) Pty Ltd on behalf of Australian Resource
Development Group Pty Ltd

Report No. SR-2205-150523

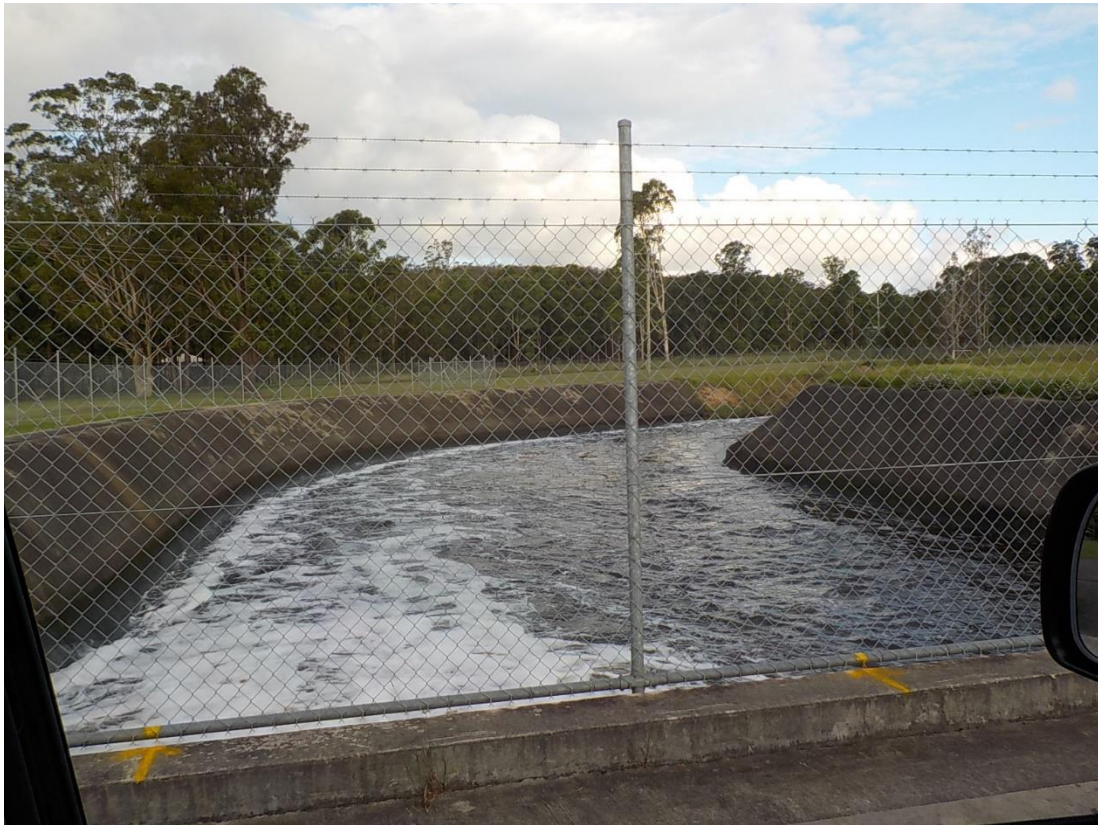
Appendix 2A – View of Balickera Channel Leading to Balickera Tunnel

However, for the upper section of the Balickera Channel (from the pumping station onwards), the channel edges have been reinforced with a concrete lining (approximately 150 millimetres (mm) in thickness). This is to prevent ongoing water erosion in view of the high-water flow (see **Appendix 2A**).

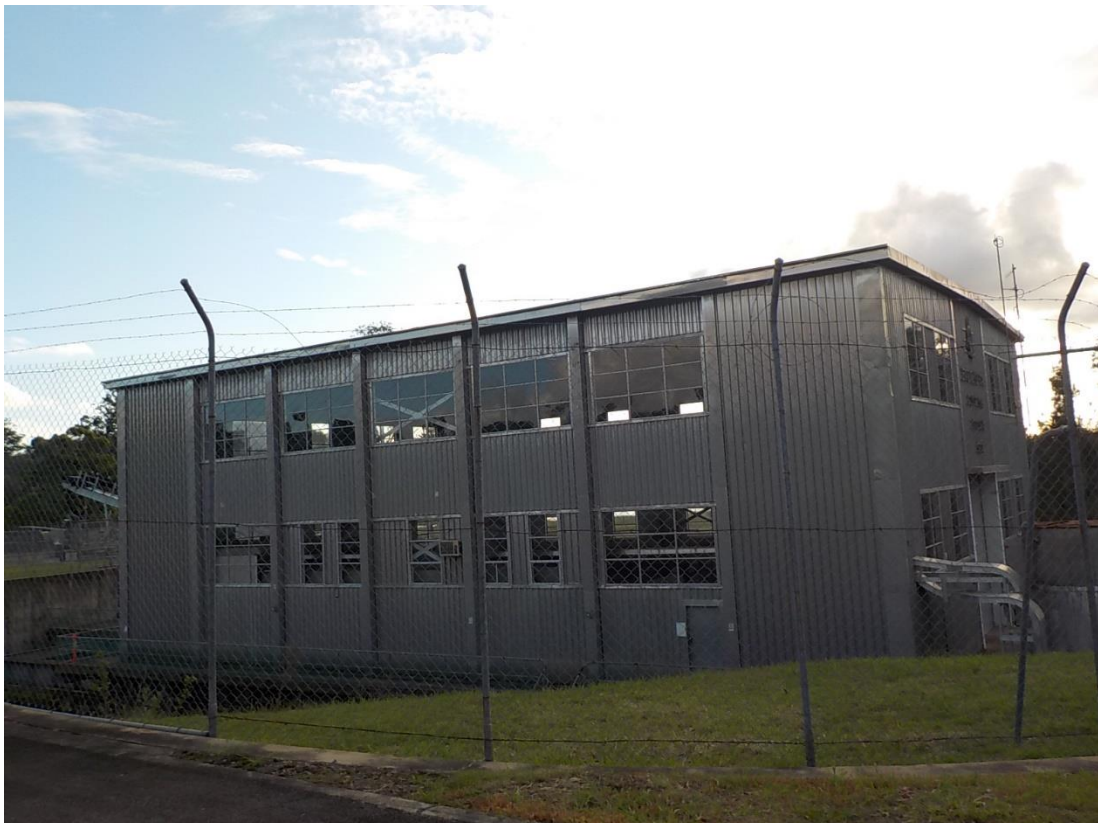
Appendix 2B – View of Water Pumping Station

The water pumping station building is constructed of materials that include concrete, steel, and corrugated iron (see **Appendix 2B**). The pumping station itself is erected on a concrete slab.

Because of the nature of its operations, some level of vibration is continuously generated and experienced by the pumping station. Therefore, construction of the pumping station is designed to sustain ongoing vibrational exposure.

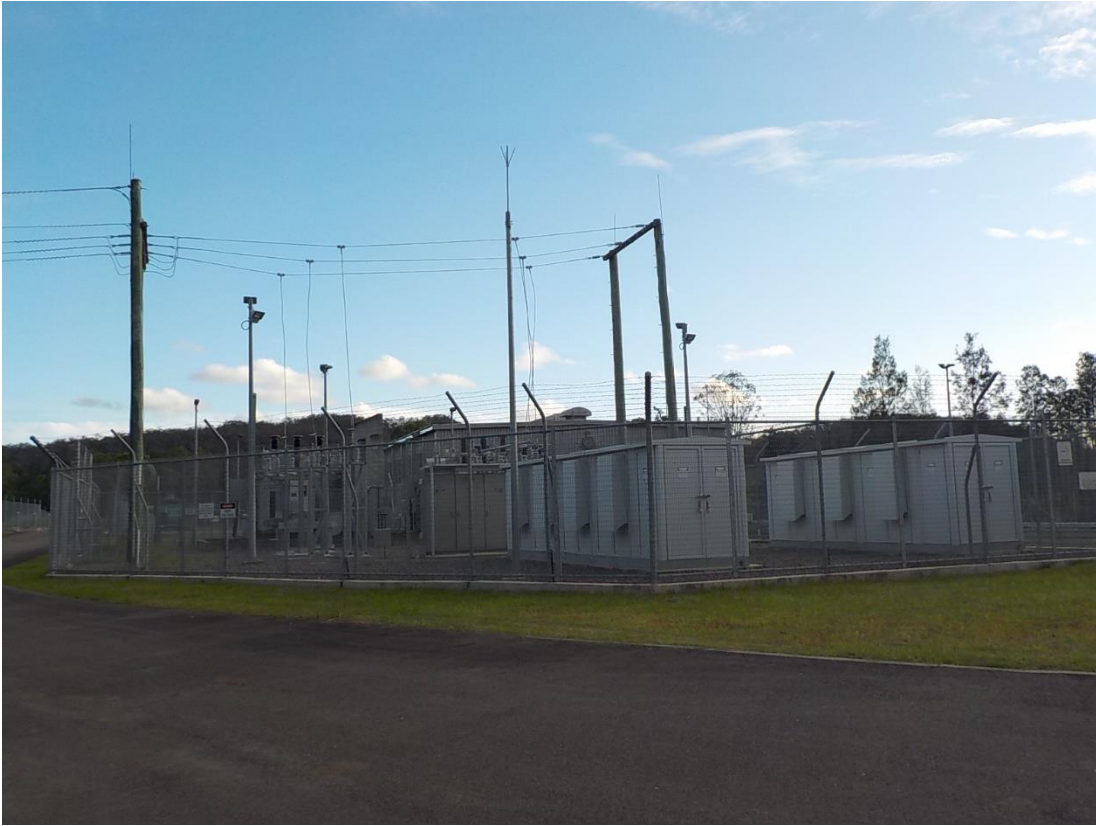
Appendix 2C – View of Electrical Substation

The electrical substation is located adjacent to the water pumping station. The electrical substation consists of power lines, power poles, transformers, and switches which are located on a concrete slab. The substation supplies electricity directly to the water pumping station (see **Appendix 2C**).

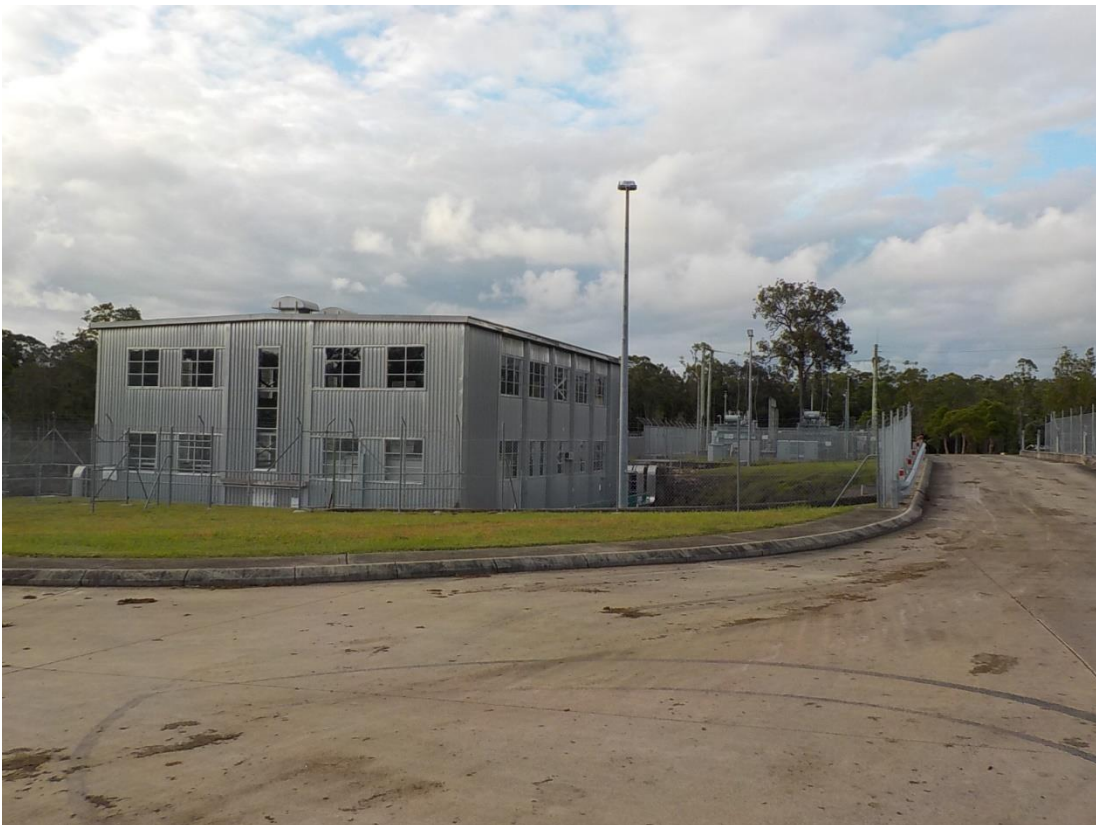
Appendix 2D – View of Concrete Bridge over Balickera Channel

There is a small concrete bridge located in close proximity to the water pumping station spanning over the Balickera Channel, the bridge provides access across the channel (see **Appendix 2D**).

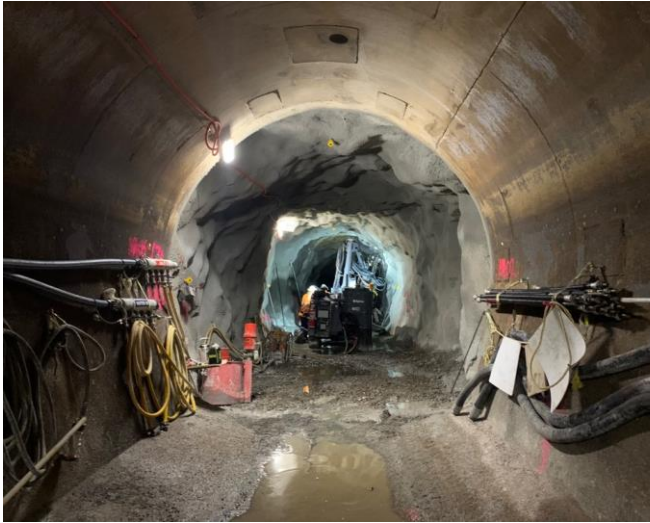
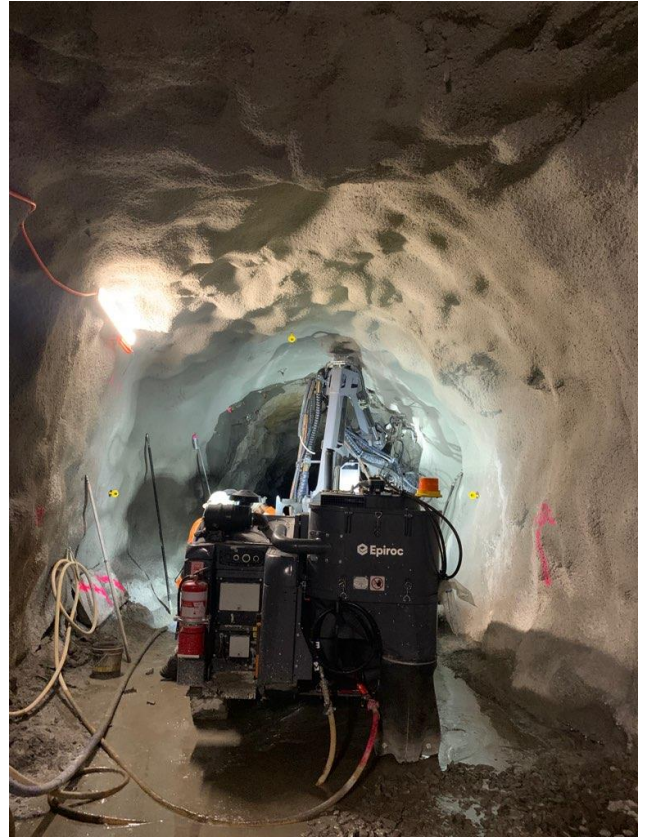
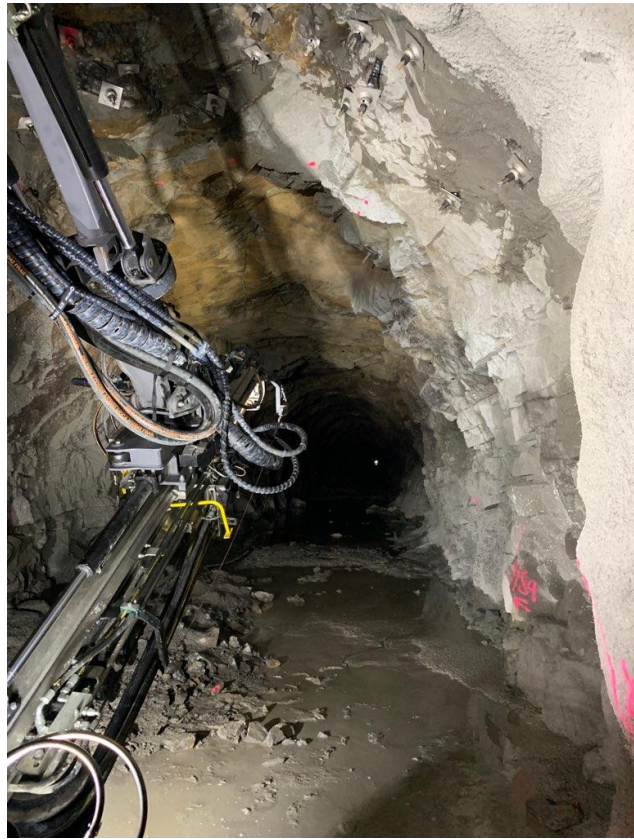
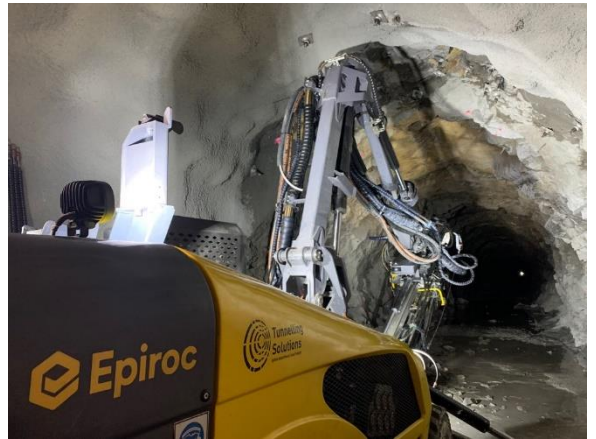
APPENDIX 3A – Balickera Tunnel Remediation Work

A downside of such method is the potential for degradation and/or corrosion over time of the installed rock bolts. Corrosion is mainly driven by the presence of water and/or high humidity while it is noted that some of the geotechnical reports indicated corrosion of bolts and plates detected in the tunnel on some previously installed bolts.

Nevertheless, the described defects of potential roof bolt corrosion were identified and rectified with the remediation tunnel works. This included installation of roof bolts replacing corroded bolts with new bolts and installing additional bolts in highly affected areas. In addition, any suspected and/or potential unstable rock strata areas identified were scaled and bolted up (see **Appendices 3A-B** showing the process of rock strata bolting).
